# BGS Karst Report Series: C7. Karst in the Chalk of the South Downs

Environmental Change, Adaptation & Resilience Programme

Open Report OR/21/057

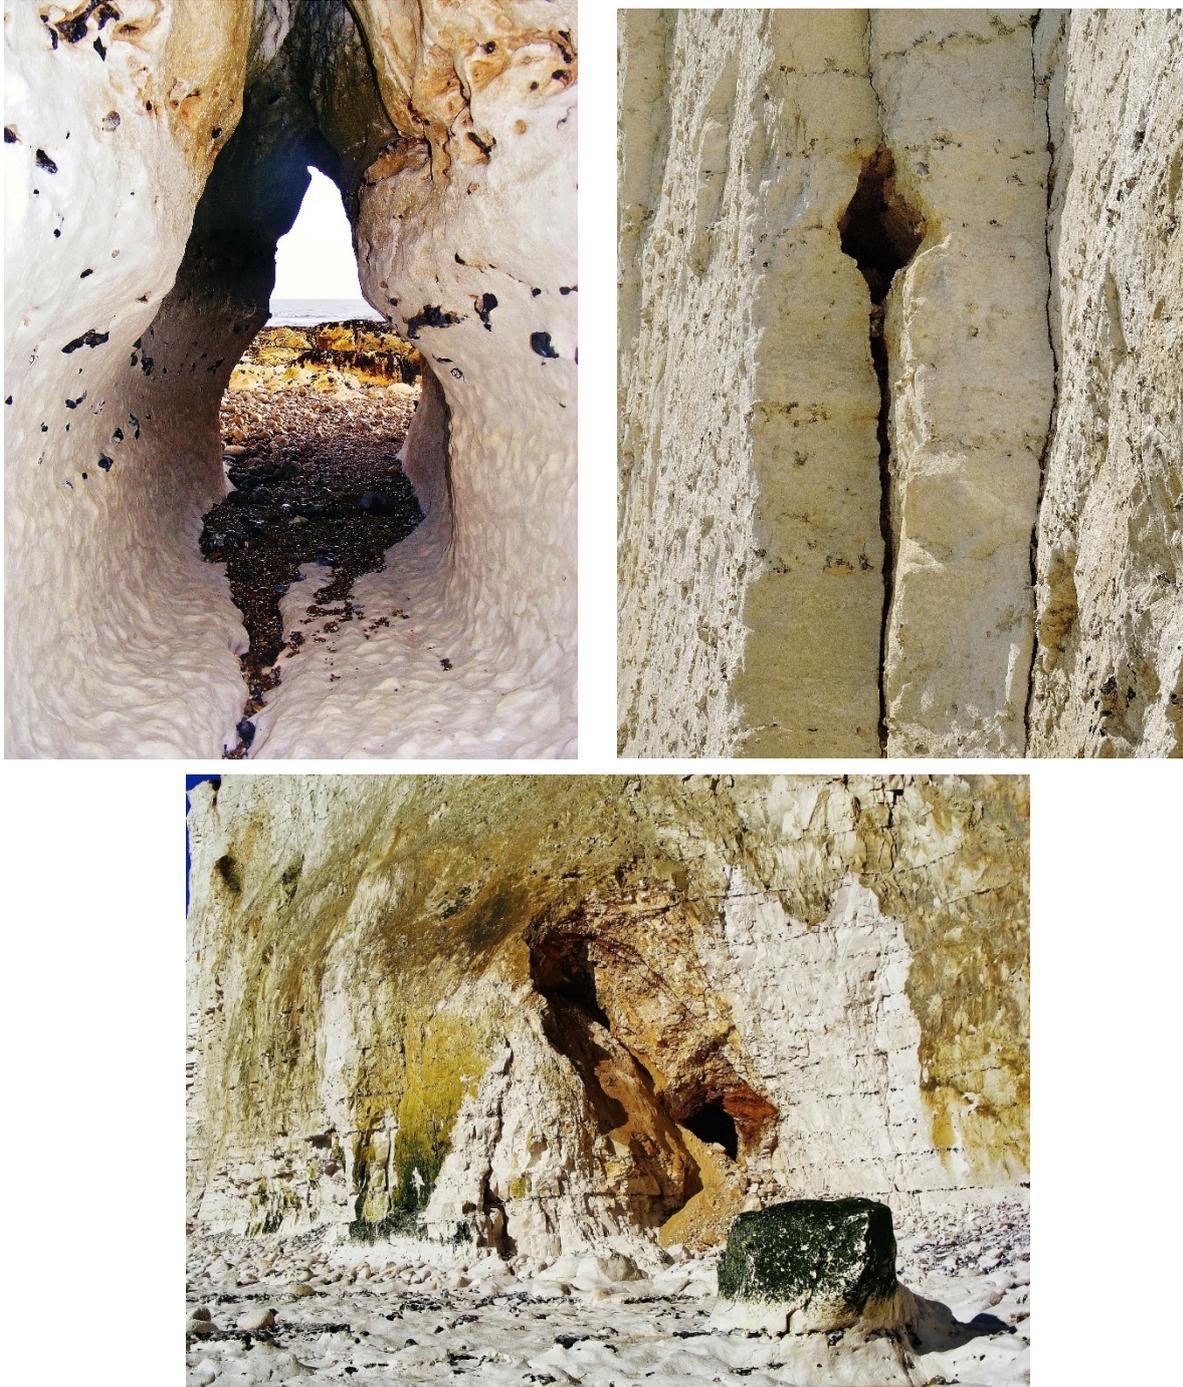
Figure 7. Examples of coastal caves with evidence of karst. Photos courtesy of Terry Reeve.

*Solutional scallops indicating past water flow in a cave at Seaford Head (top left), cave high up in the cliff at Seaford Head (top right), and a cave suddenly exposed by cliff retreat at Seven Sisters (bottom).*

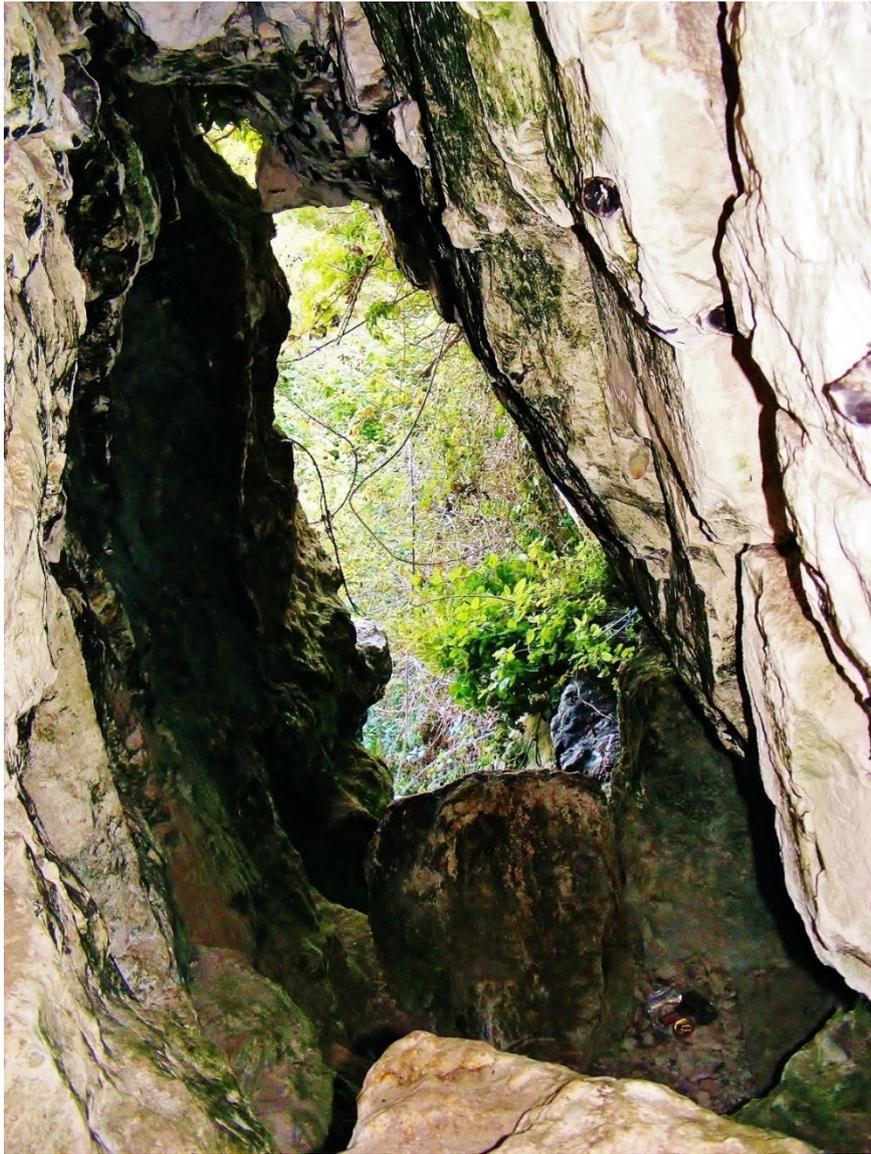
Figure 8. Cave intersected by quarrying near Amberley with dissolution on the walls and roof indicating water flow (photo courtesy of Terry Reeve).

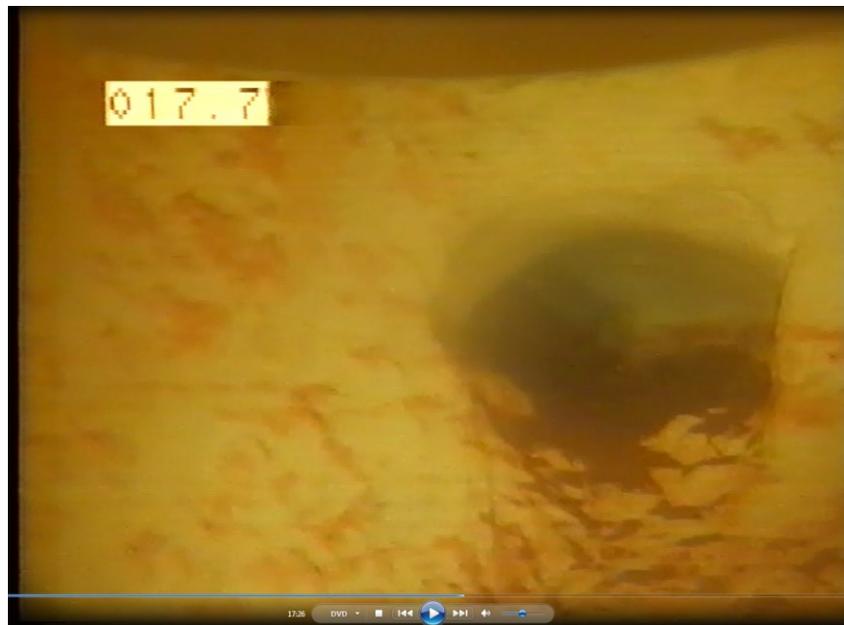
Figure 10. Conduit observed in an abstraction borehole (Photo courtesy of Portsmouth Water)

There is also evidence for saturated zone conduits and fissures. Such features are commonly observed in image logs of abstraction boreholes (discussed in karst knowledge exchange meetings with water companies; also reported in Farrant et al., 2021b,c). Most successful abstraction boreholes where image logs have been undertaken have images revealing solutionally enlarged fissures, or more circular shaped karst conduits (e.g. Figure 10). Further work to develop a borehole image dataset to characterise the size and stratigraphical position of flowing karstic fissures and conduits observed in boreholes would be useful to improve understanding of where the karstic flowpaths occur within the aquifer. Hydrogeological evidence for solutional fissures/conduits in the saturated zone is reviewed in Section 4.

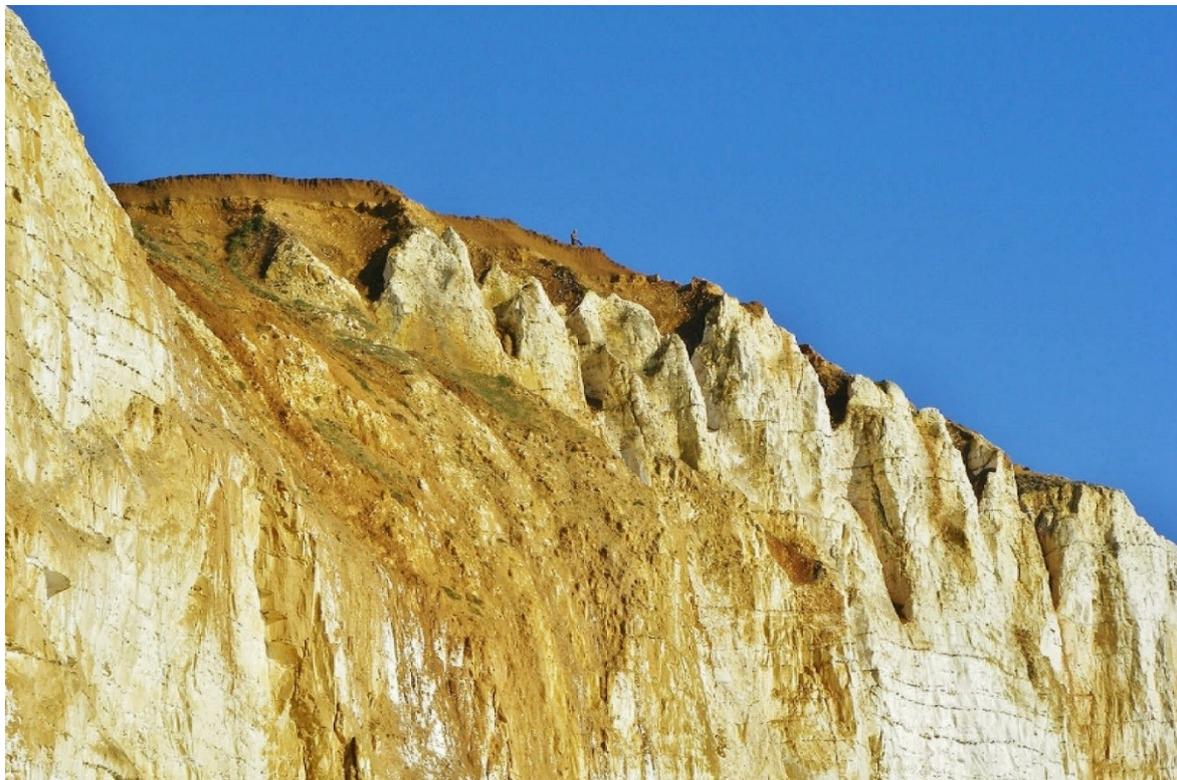
Figure 13. Closely spaced dissolution pipes at Seaford Head (photo courtesy of Terry Reeve)

Dissolution pipes are also observed in coastal cliffs (Reeve, 2021a; Farrant et al., 2021a). Reeve (2021a) reports that there are dissolution pipes exposed at Seaford and Beachy Head. He notes that at Seaford Head, the closely spaced pipes occur in dense clusters creating pinnacles of chalk resembling the egg box type karst that is seen in classical karst areas (Figure 13). Farrant et al. (2021c) note that there are dissolution pipes exposed in the coastal cliffs beneath the Clay-with-Flints capping Seaford Head which are up to 10 m deep. Additional pictures of dissolution pipes at Seaford Head are provided in Appendix 6.

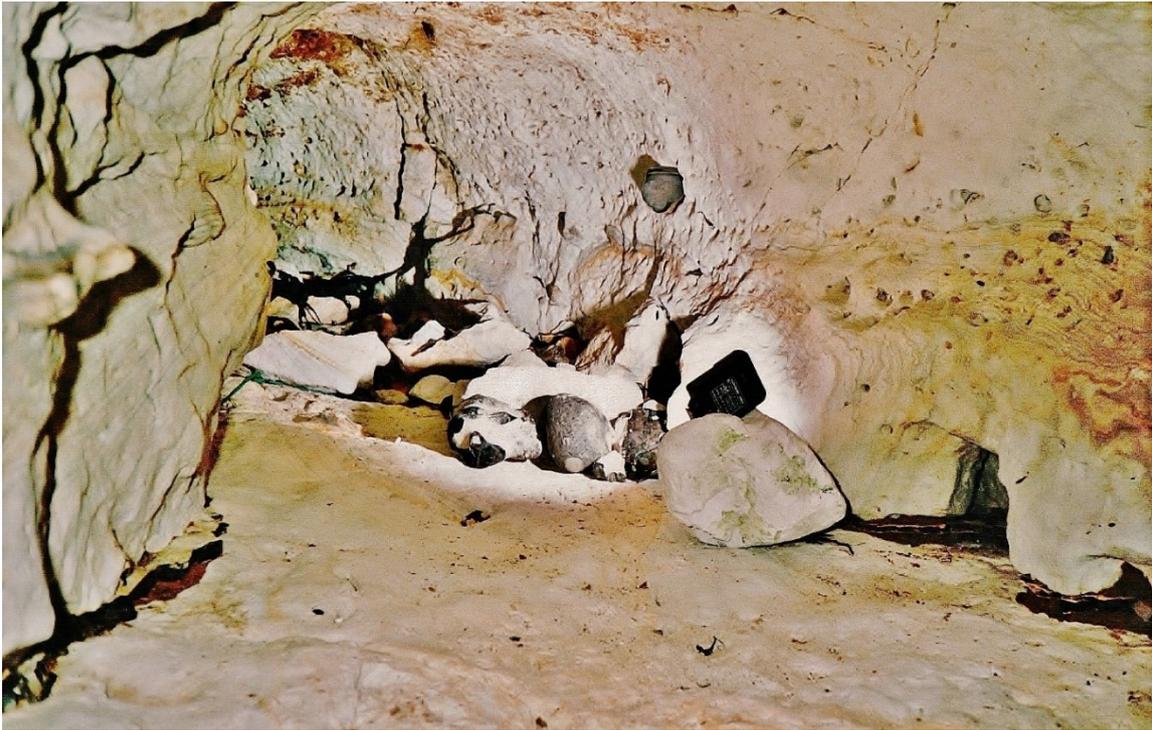
Small conduits in the side of the passage above the tabular flint in Seaford Head Cave (photo courtesy of Terry Reeve)

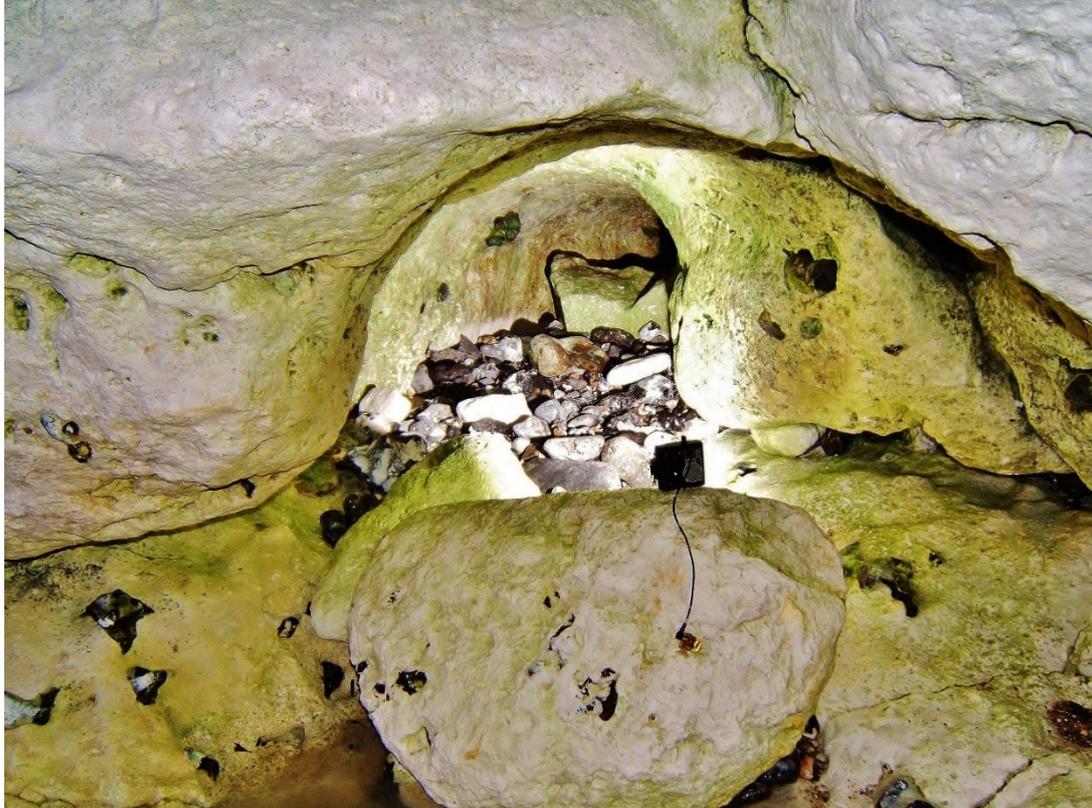
Blocked end of Seaford Head Cave, with clay infill beyond the beach pebbles (photo courtesy of Terry Reeve)

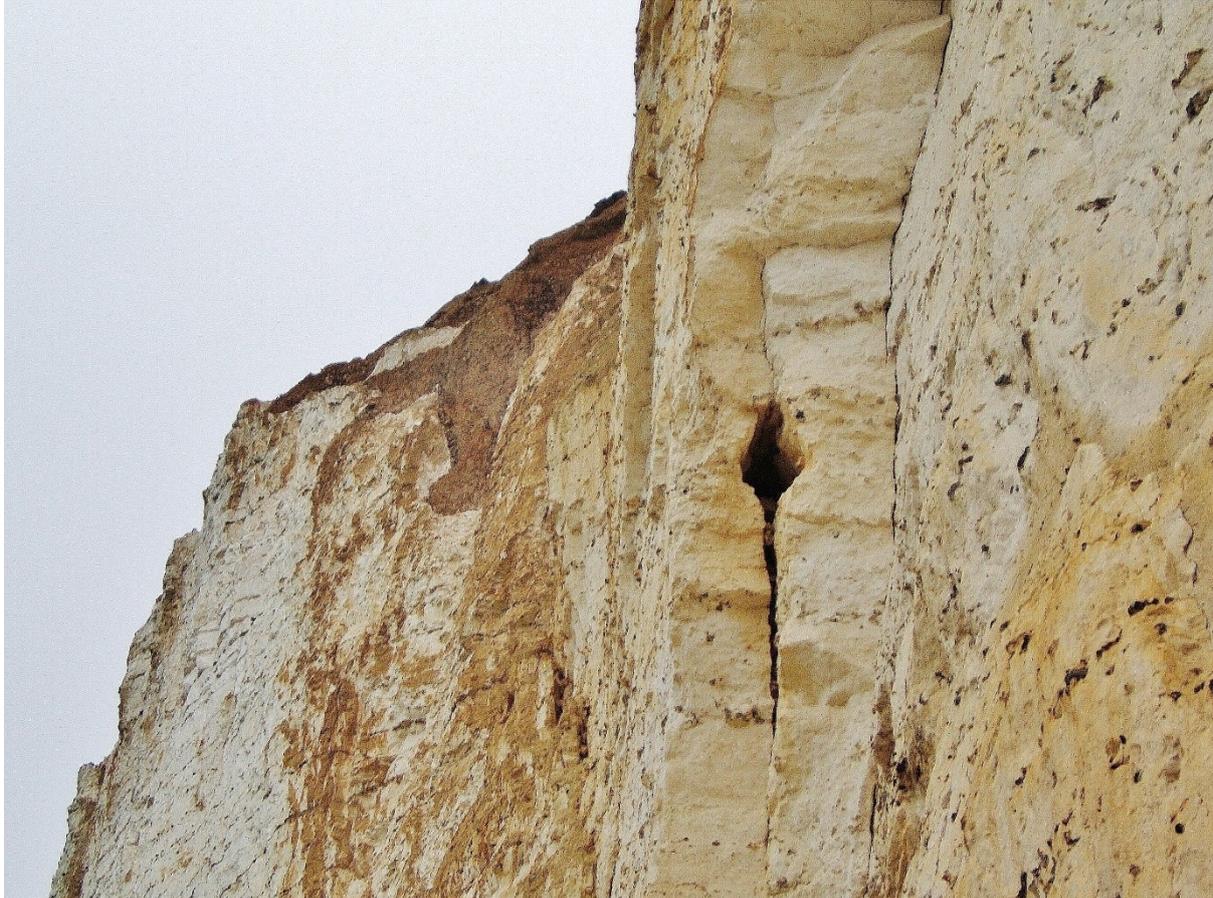
Cave entrance about 8 m above the beach at Seaford Head (photo courtesy of Terry Reeve)

A 0.8 m wide cave entrance was observed about 8 m above the beach in the Seaford Head cliffs. It is likely to be developed within the upper part of the Lewes Nodular Chalk Formation that dominates this section of the coastline, and may have been lost to cliff retreat.

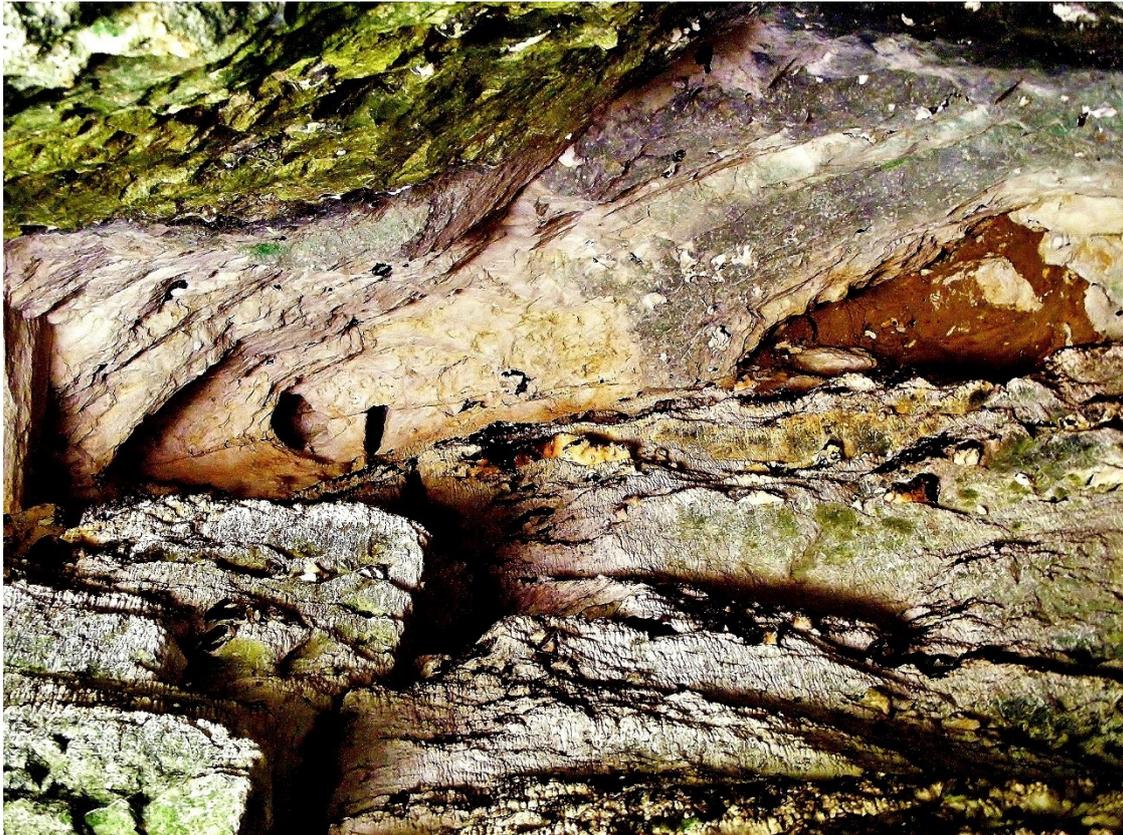
Looking up at rounded solutional features and a sediment filled cavity in the cave roof (photo courtesy of Terry Reeve).

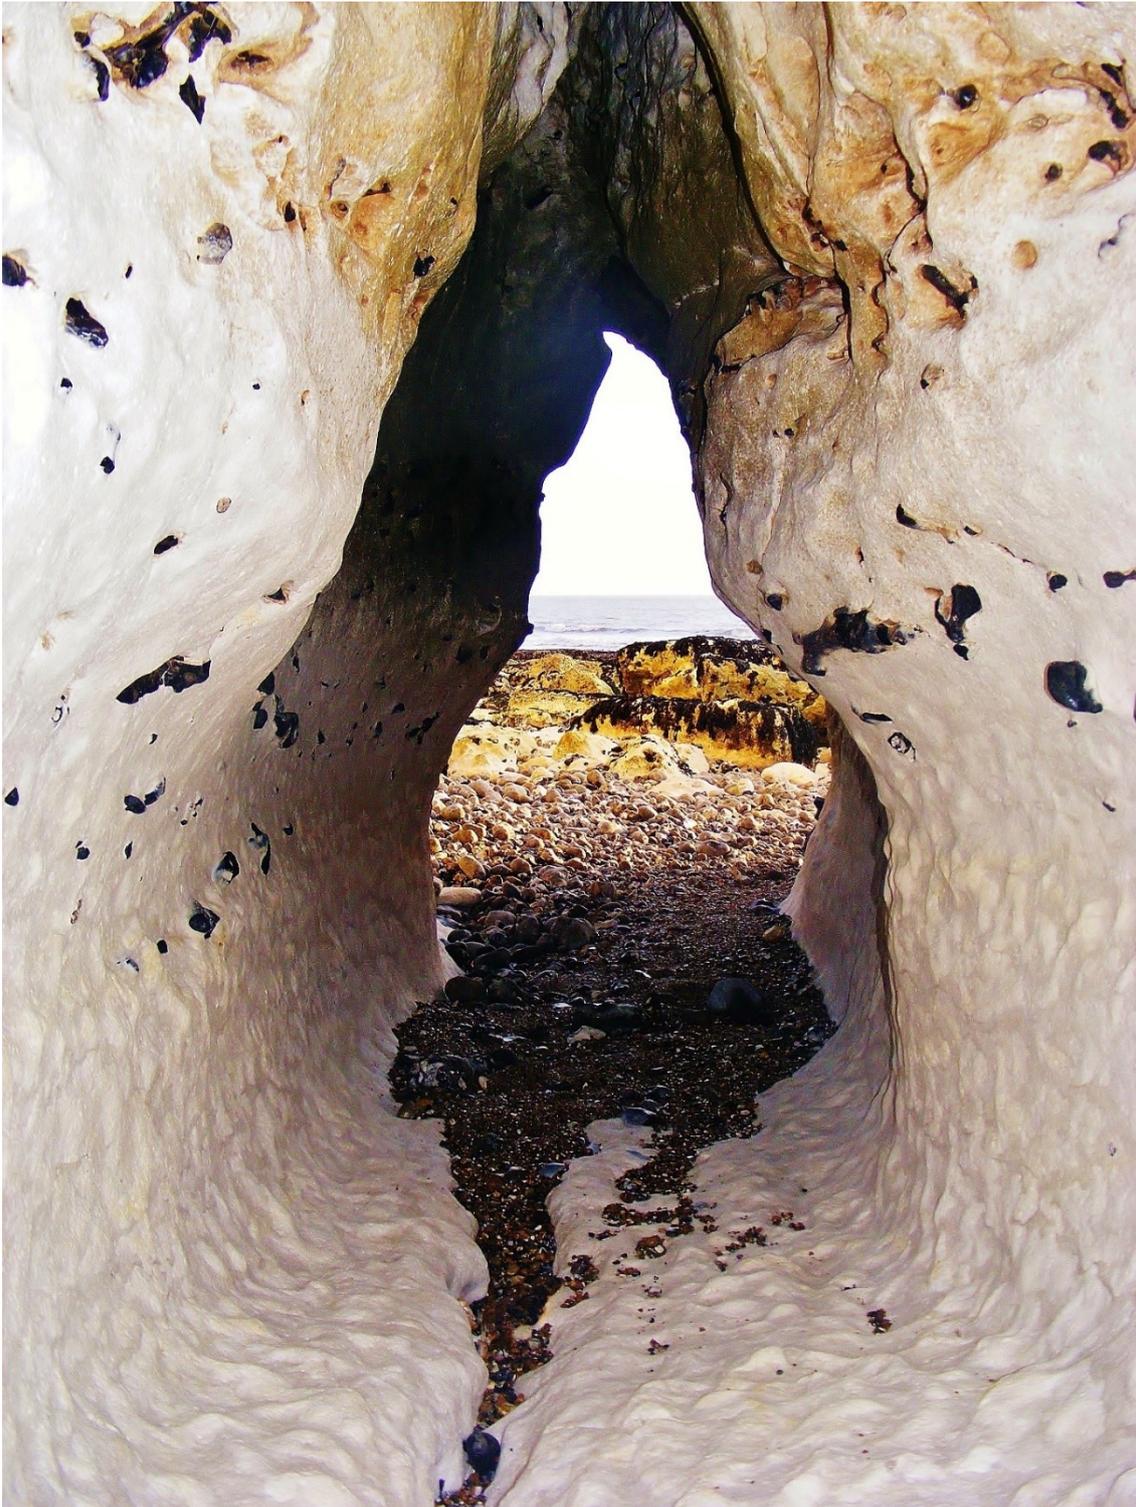
Solutional scallops on the passage walls of Seaford Head cave 3b (photo courtesy of Terry Reeve)

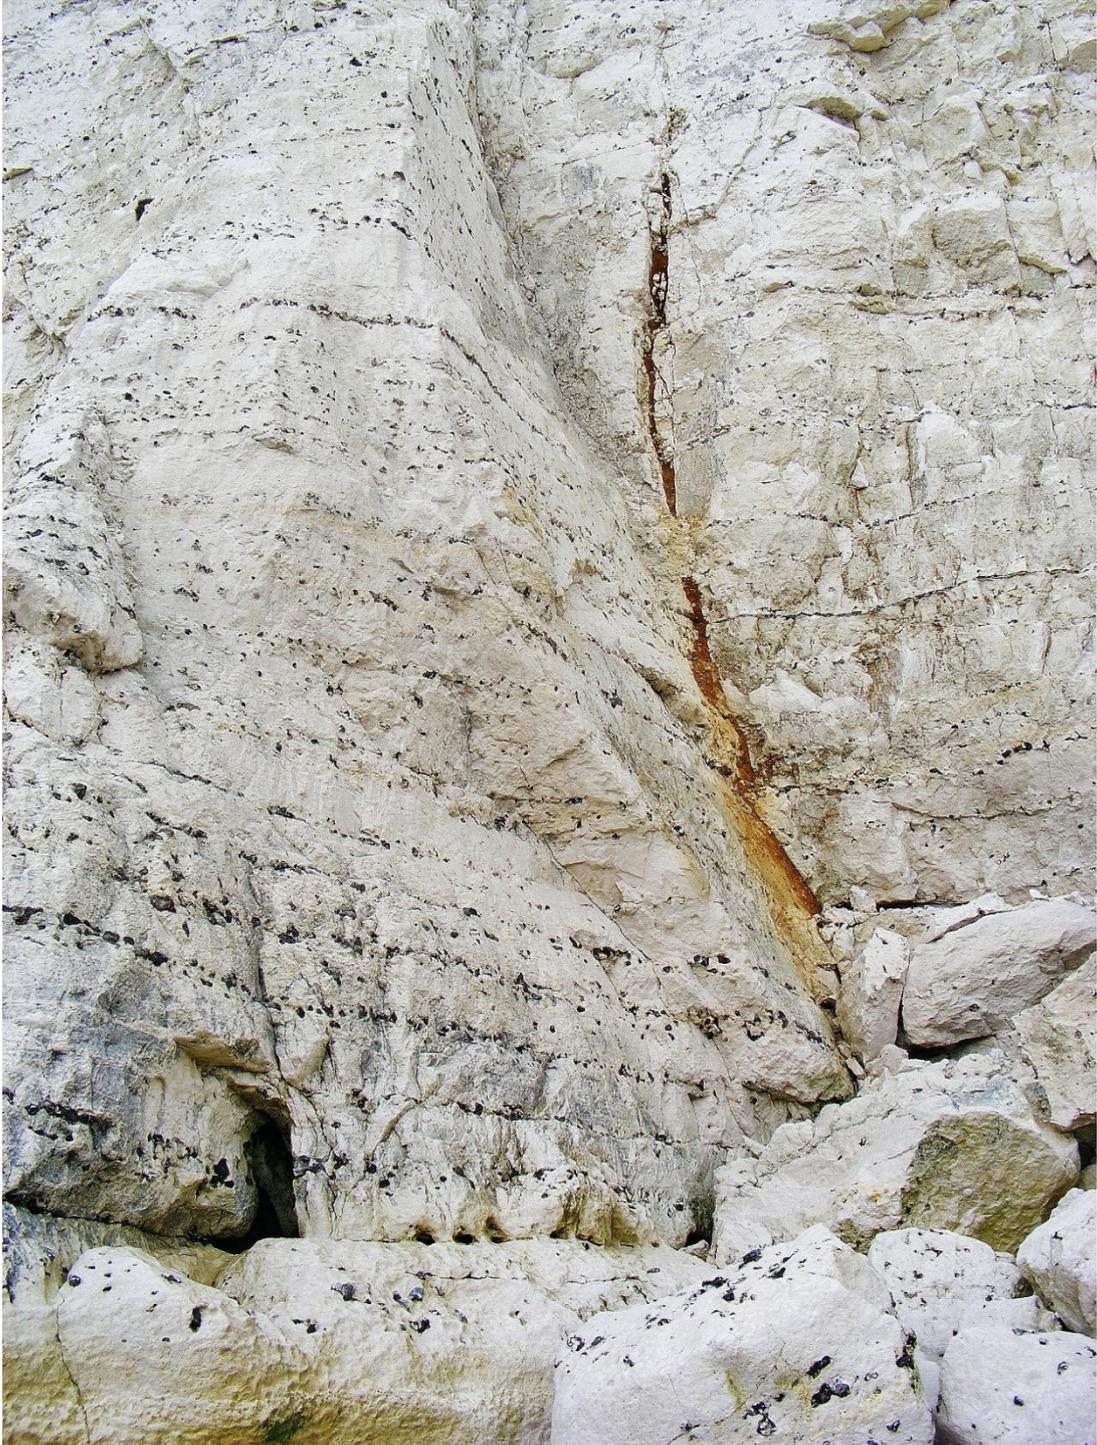
Fissure with sediment fill outside entrance to Cave No. 6a (photo courtesy of Terry Reeve)

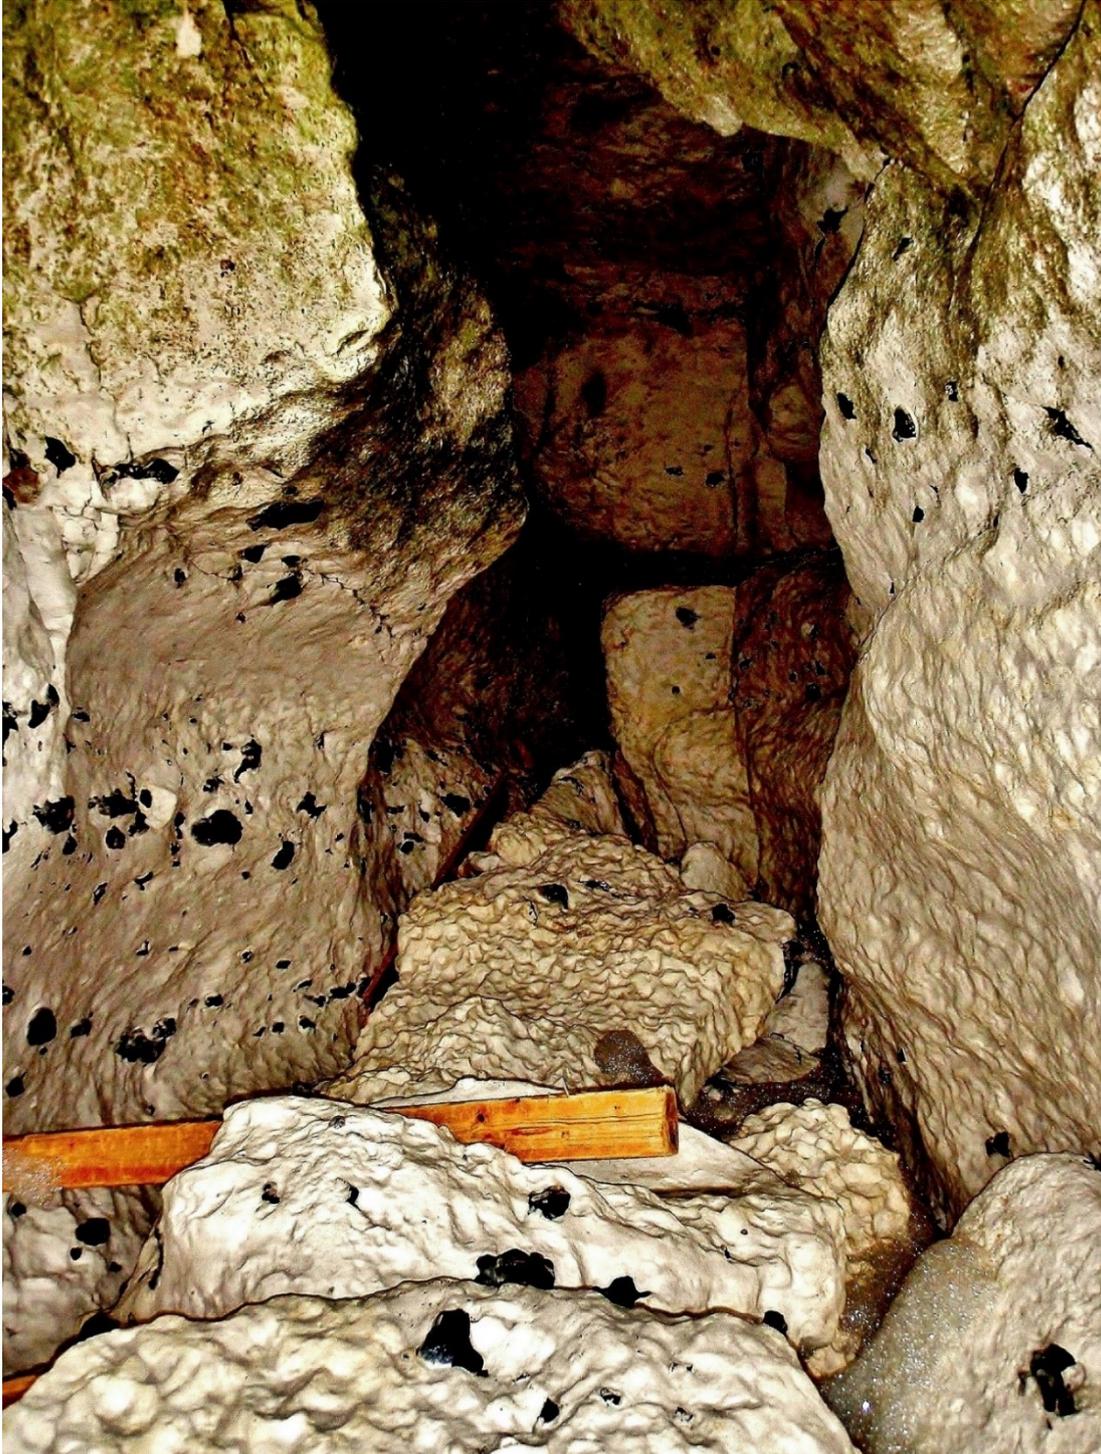
View inside Cave No. 7 at Seaford Head, showing clear signs of dissolution (photo courtesy of Terry Reeve)

Originally 24 m in length, the cave has been shortened by 8 m after a cliff fall. The roof, walls and boulders on the floor all show signs of dissolution and past water flow. The cave is likely to be developed in the Lewes Nodular Chalk Formation.

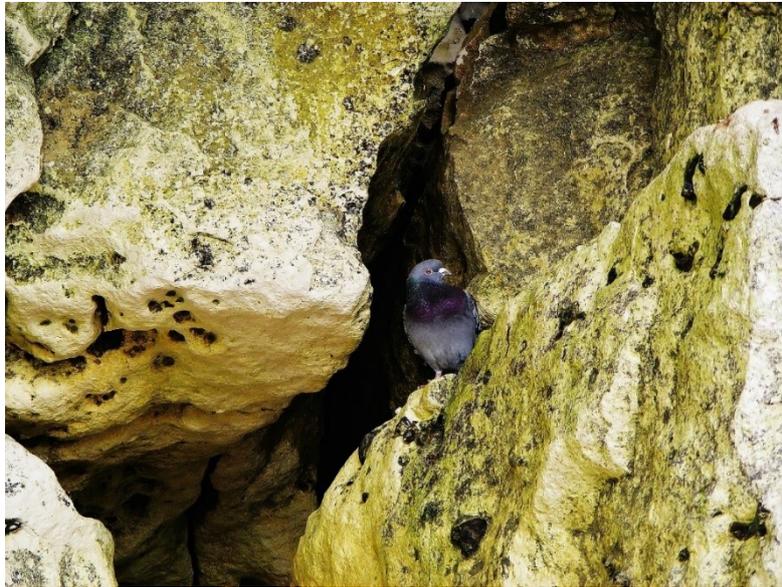
Solutional erosion of roof and walls, cave 8 at Seaford Head (photo courtesy of Terry Reeve)

This cave is developed on a thin flint seam about 2 m above the beach and cliff erosion revealed this cave is connected to part of cave No. 6. There are also several small tubes, between 10 cm and 60 cm wide on this flint layer. To the right of these conduits, a predominantly sediment filled fissure was also observed extending halfway up the cliff. The cave is likely to be developed in the Seaford Chalk Formation.

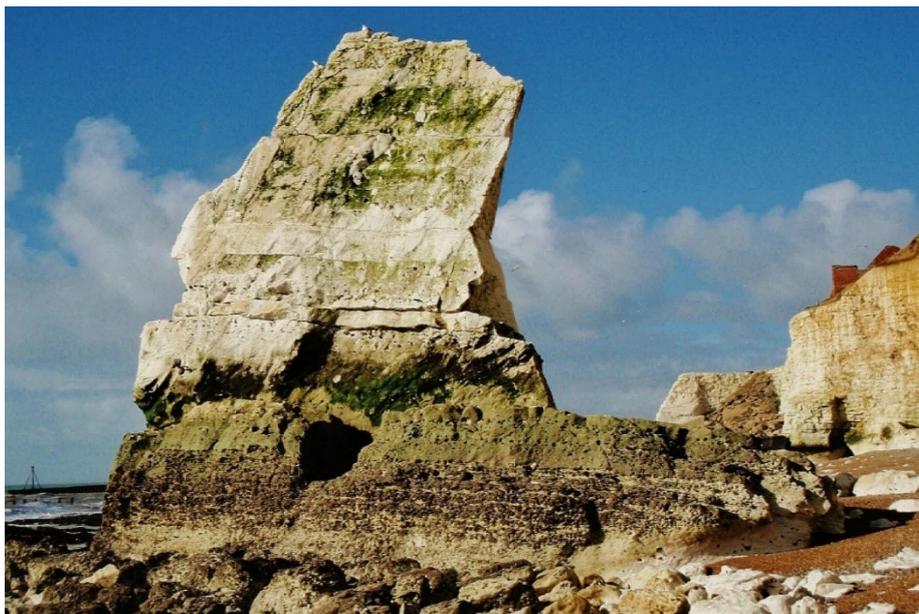
A hole can be observed in the side of a large sea stack at Splash Point, Sussex. The feature potentially forms the base of a deep solution pipe. The hole is thought to pre-date the formation of the stack as the spur that was breached to form the stack formed part of the wall of a cave with a complex network of tubes and cavities. The cave is developed in the lower part of the Newhaven Chalk Formation.

Sea stack at Splash point (photo courtesy of Terry Reeve)

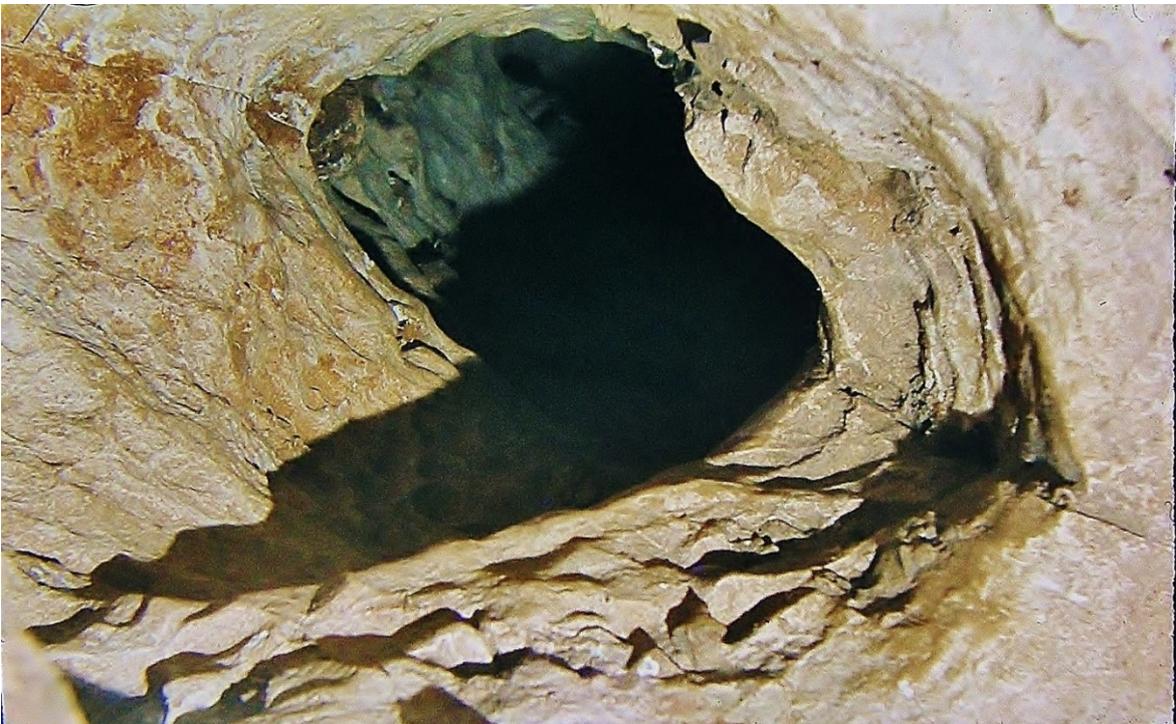
Tube in the roof of Beachy Head Cave (photo courtesy of Terry Reeve)

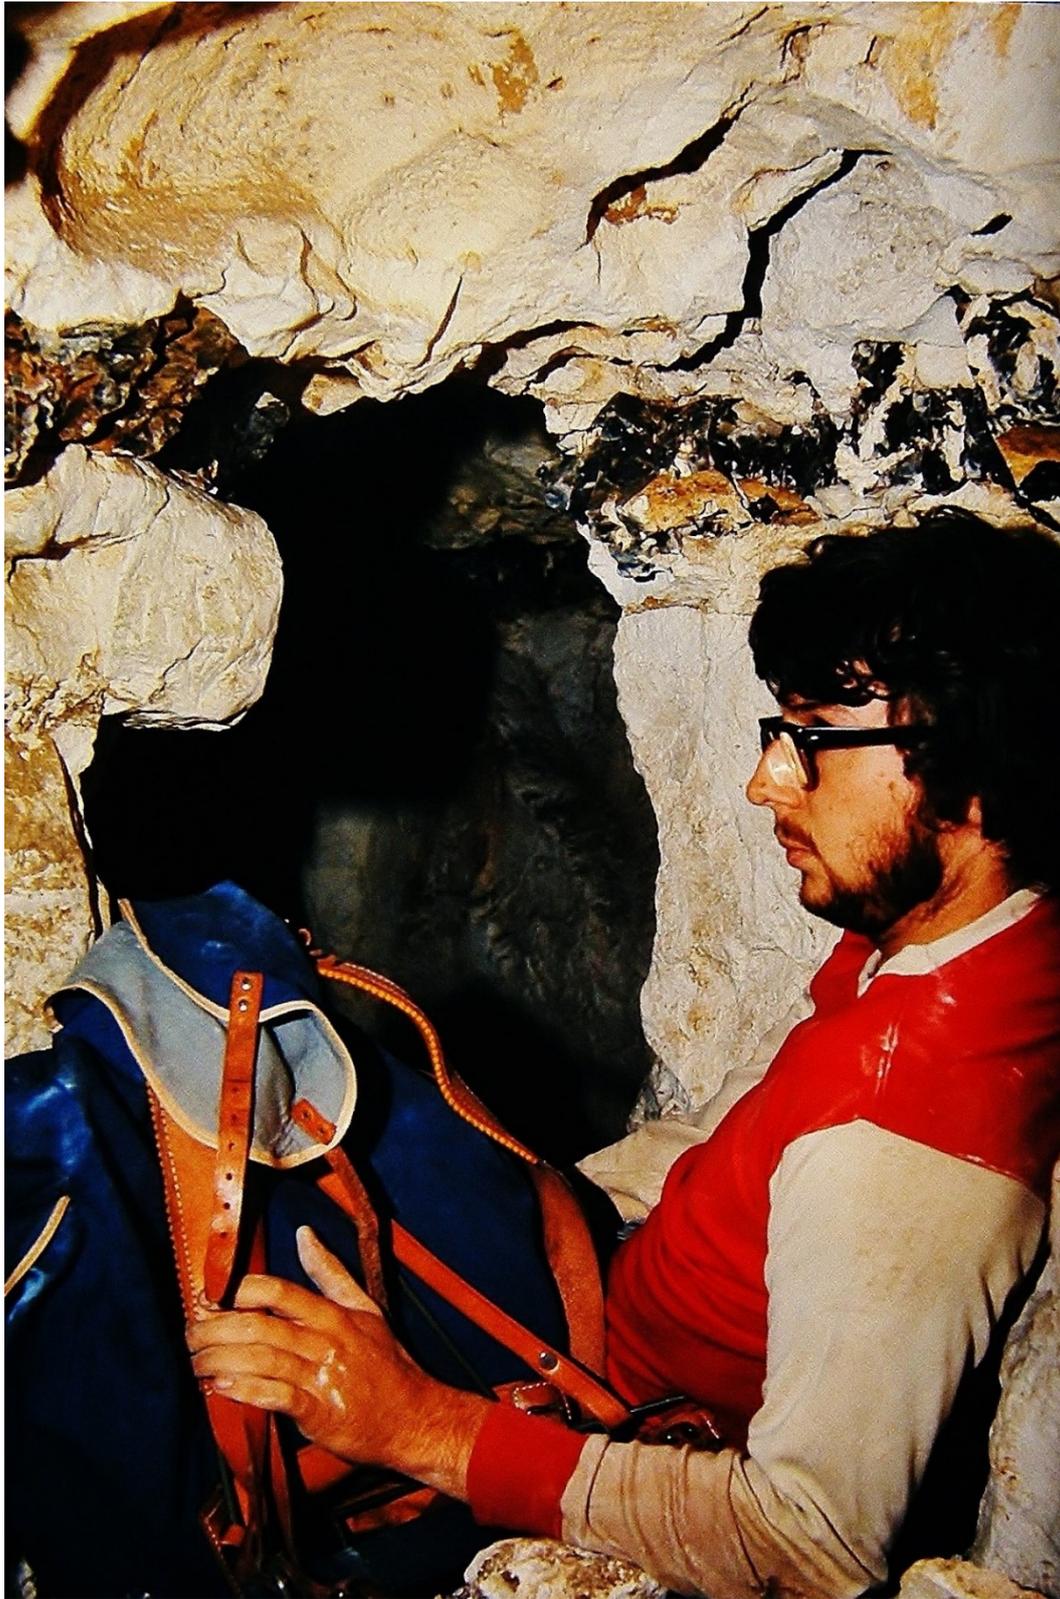
Seven Sisters flint seam in Patricks Rift (photo courtesy of Terry Reeve)

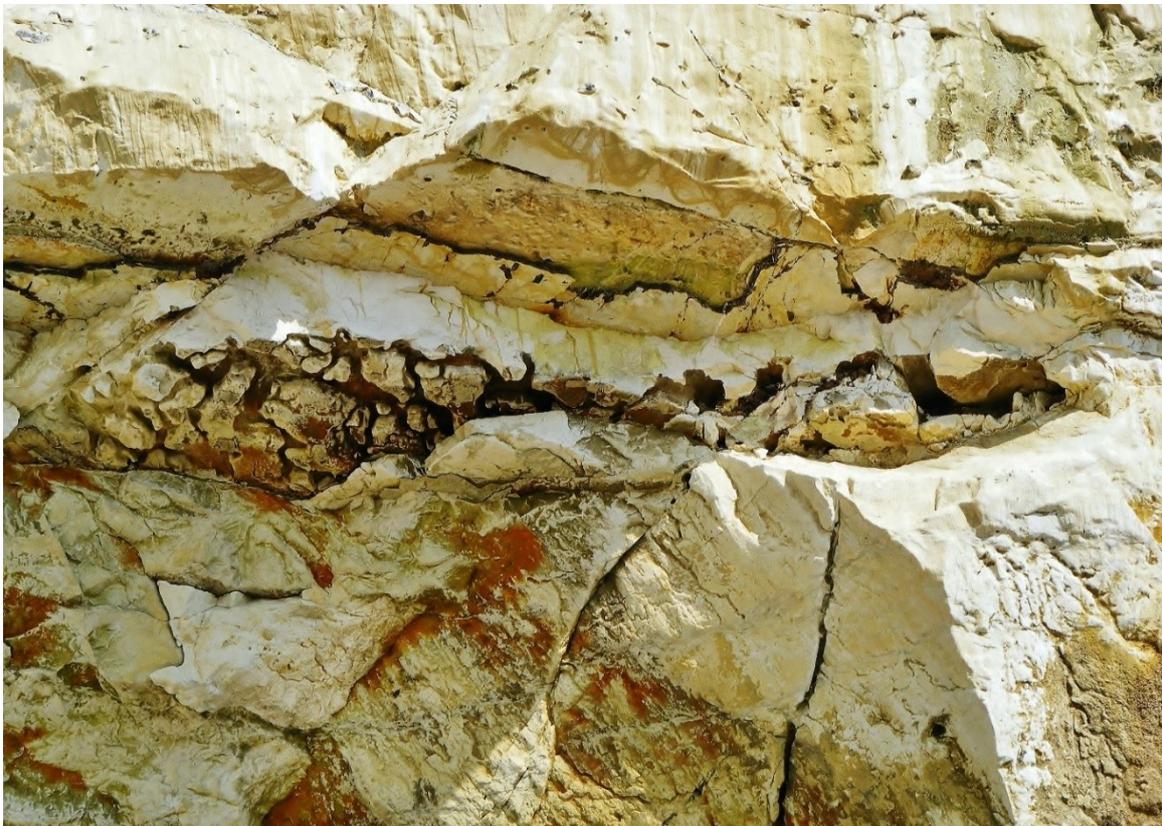
Anastomoses filled with Paleogene sediment at Newhaven (photo courtesy of Terry Reeve)

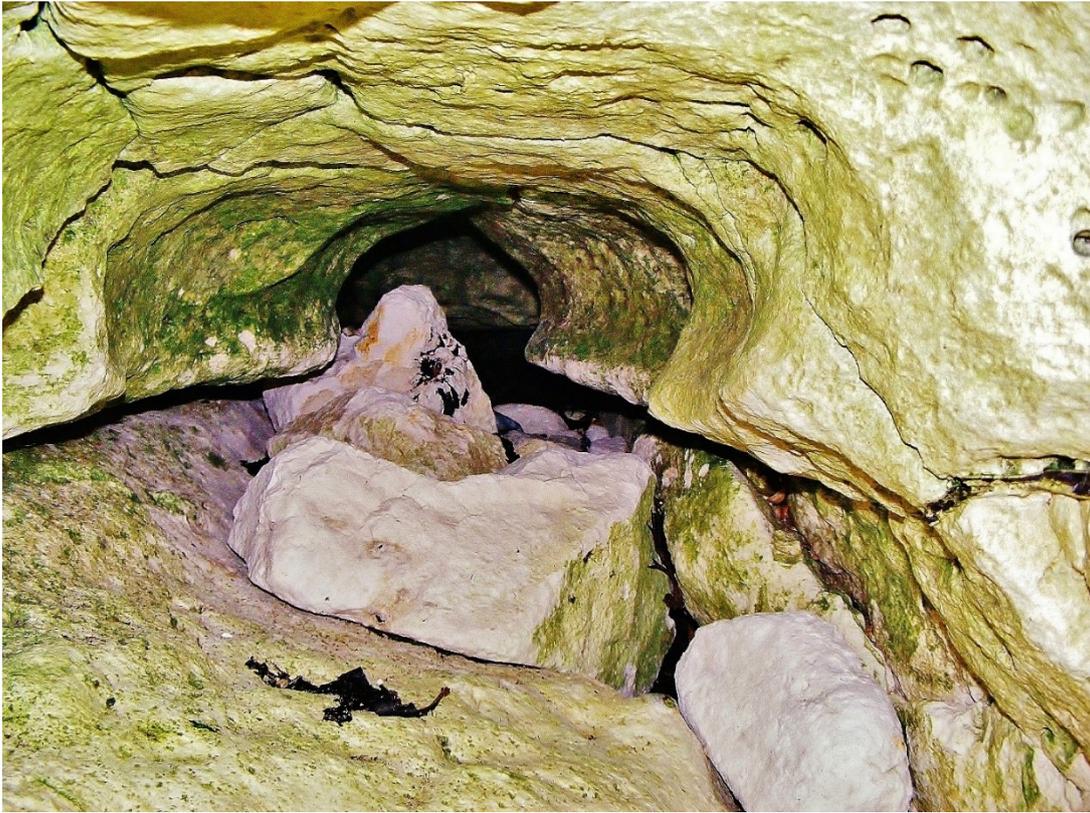
Small karstic conduit about 60 to 80 cm wide and 30 to 40 cm high (photo courtesy of Terry Reeve)

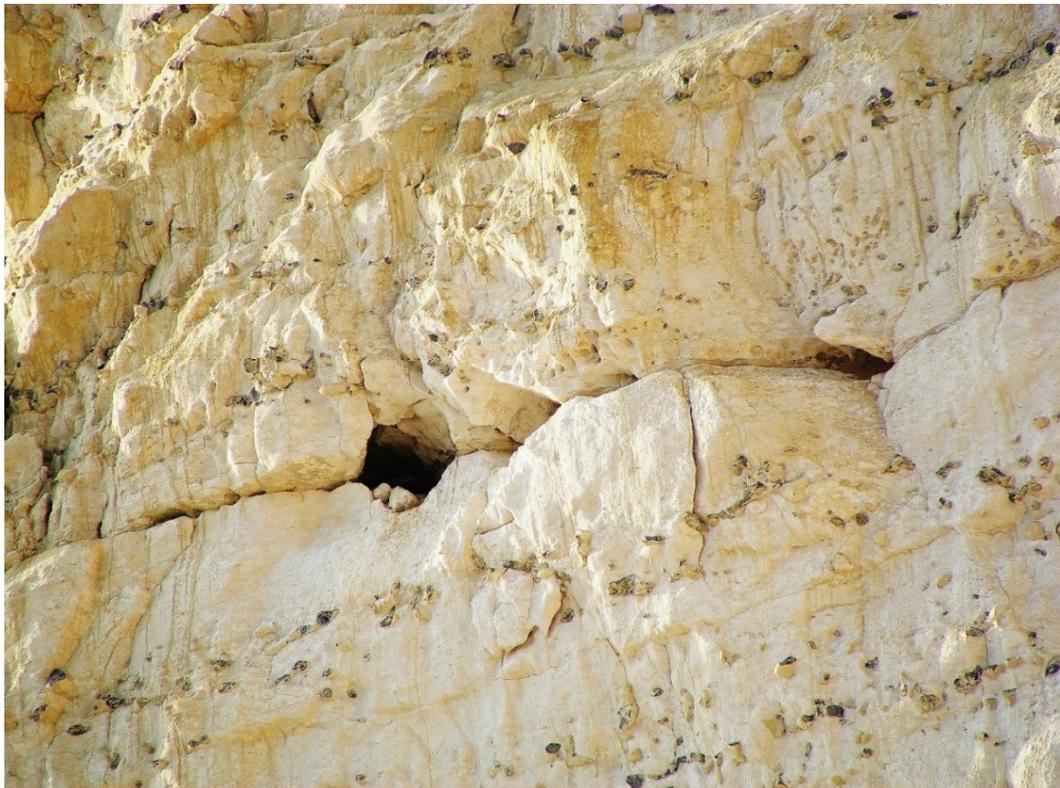
Small karst conduits high up in cliff, (photo courtesy of Terry Reeve):

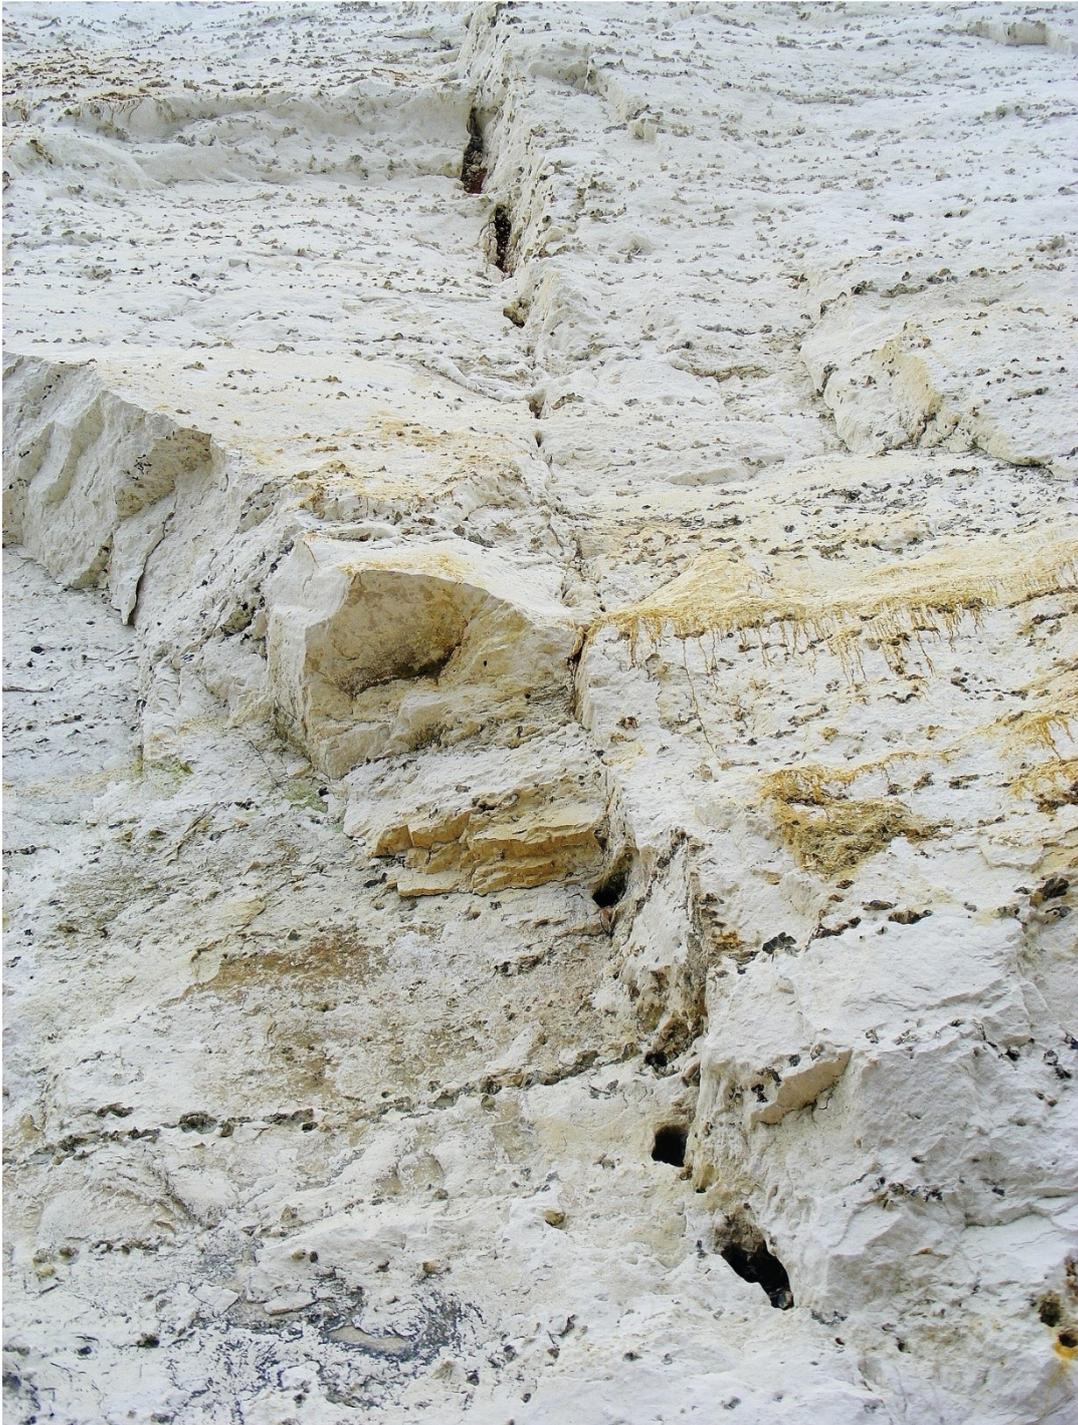
Small dissolution cavities on a vertical fissure, (photo courtesy of Terry Reeve)

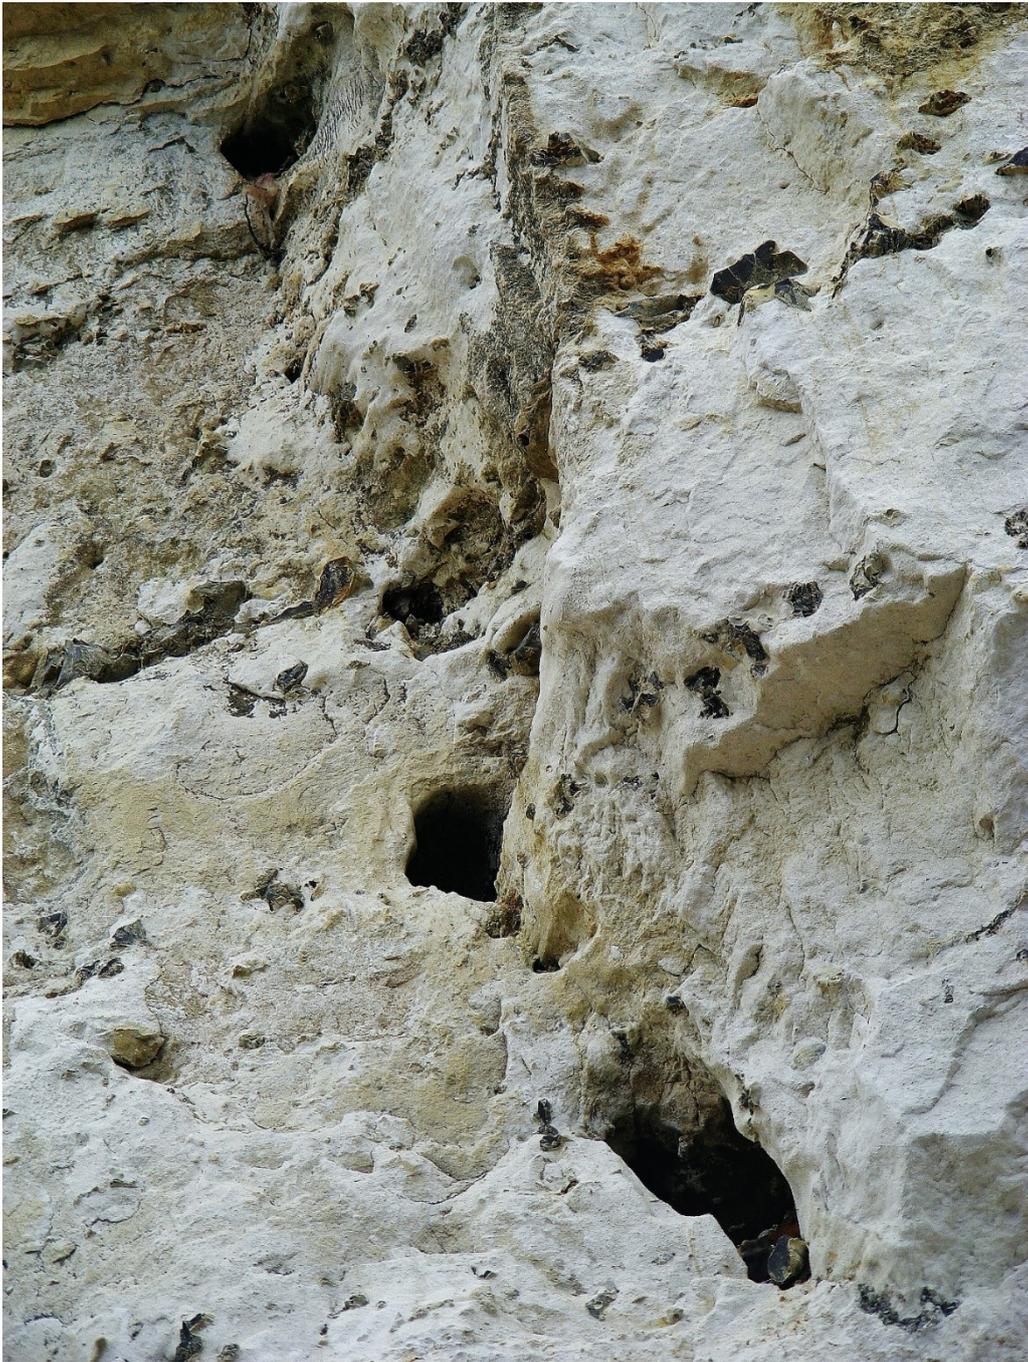
Closer view of solutional cavities (photo courtesy of Terry Reeve):
