# BGS Karst Report Series: C7. Karst in the Chalk of the South Downs

Environmental Change, Adaptation & Resilience Programme

Open Report OR/21/057

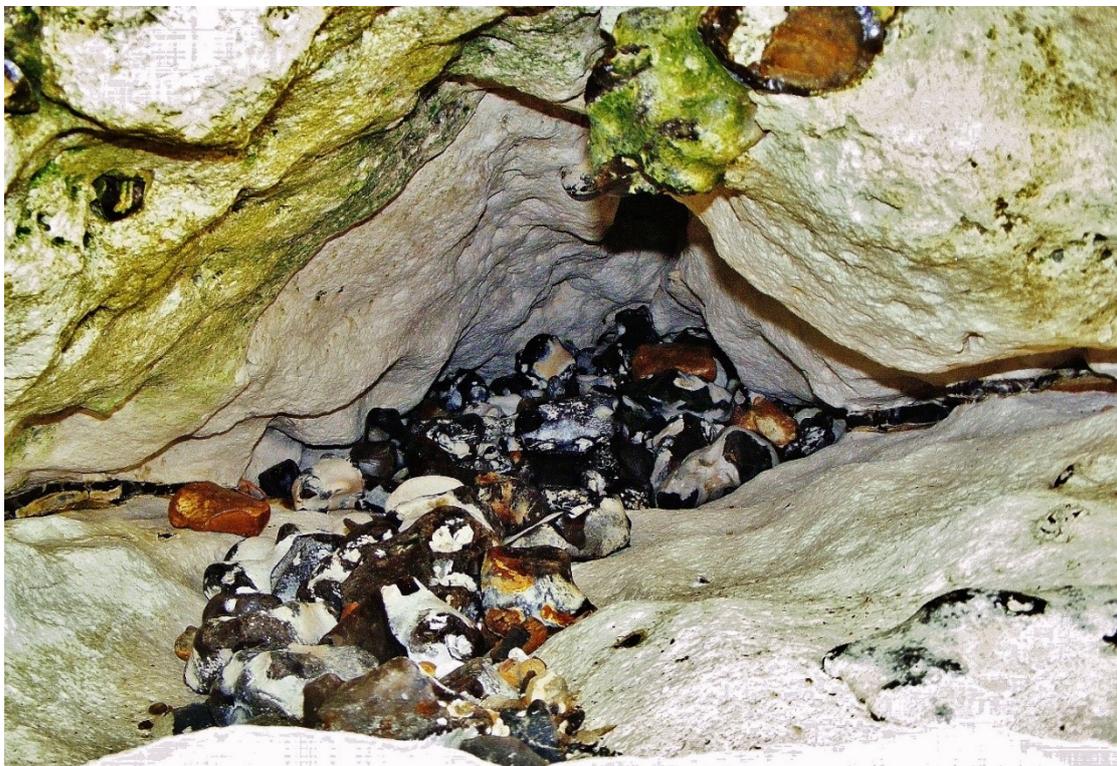
Conduit on a sheet flint 1.5 m above beach (photo courtesy of Terry Reeve)

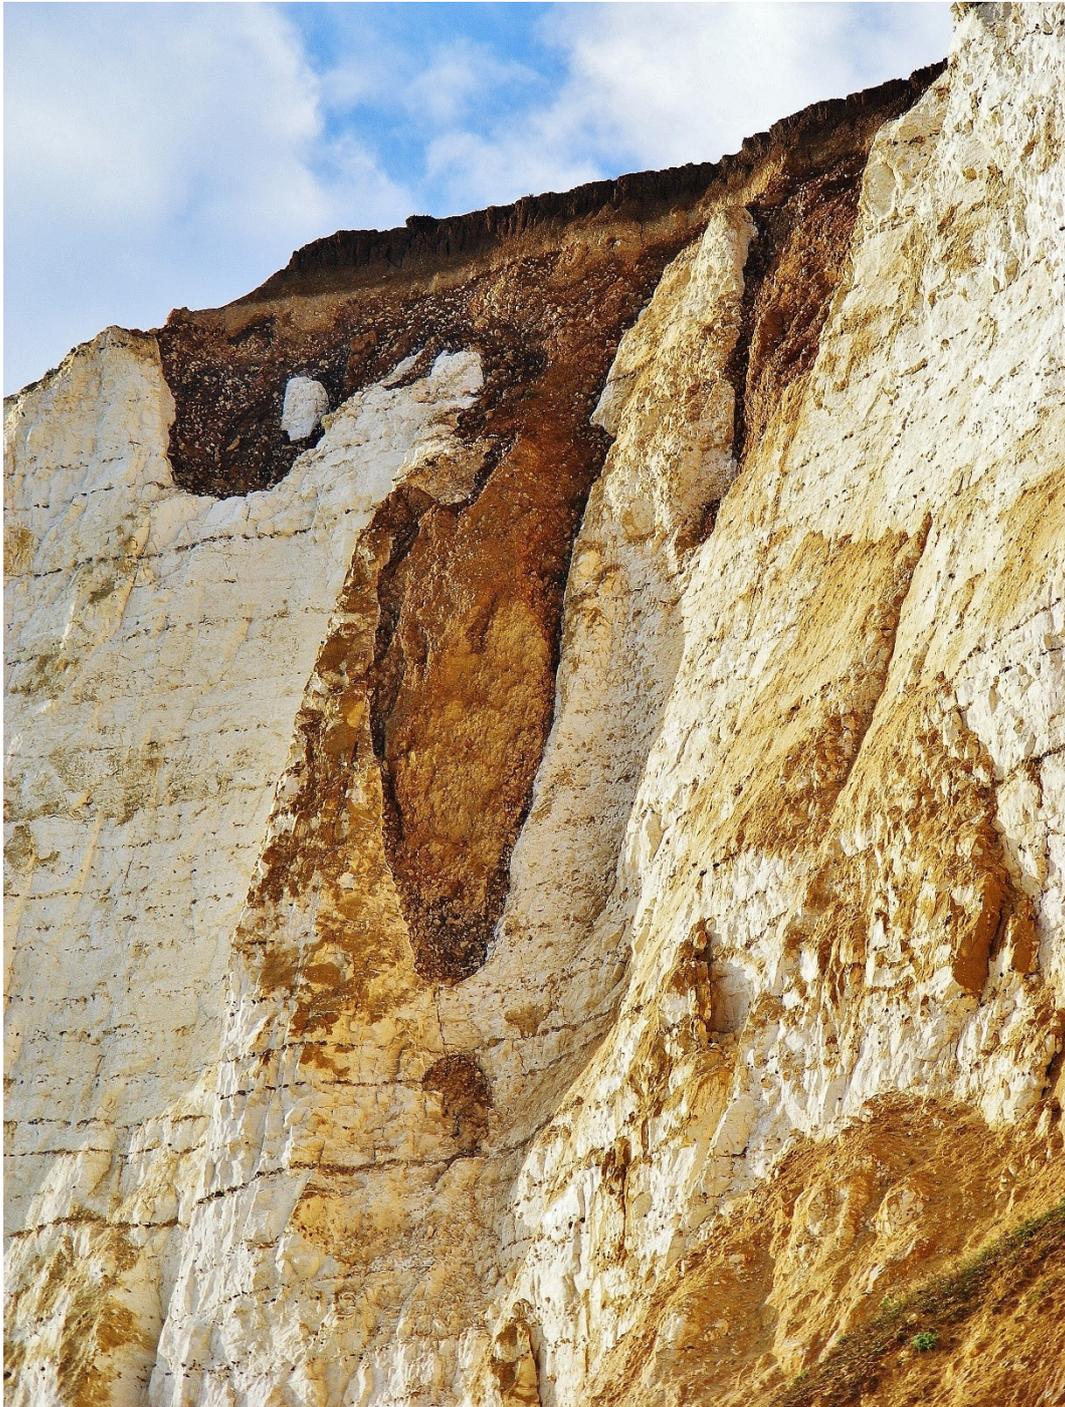
Large dissolution pipe in the cliff (photo courtesy of Terry Reeve)

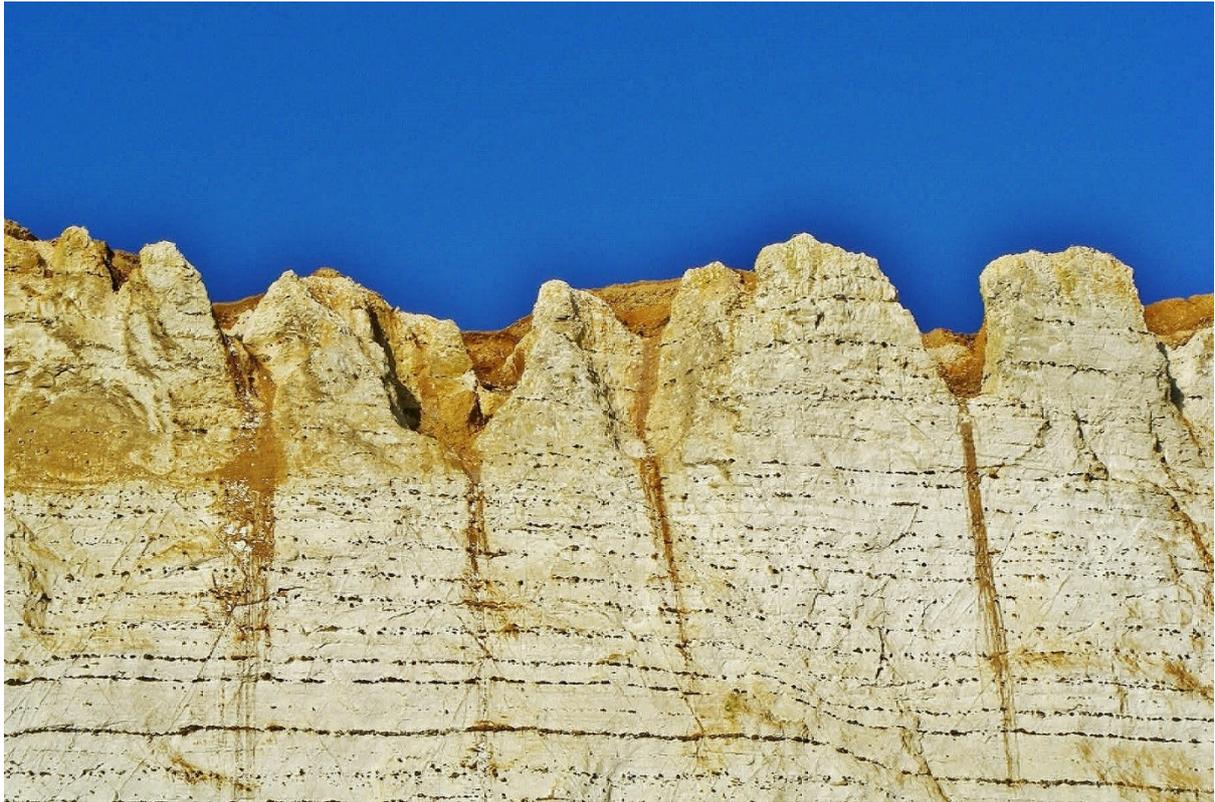
Dissolution pipes with sediment filled solutional fissures below (photo courtesy of Terry Reeve)

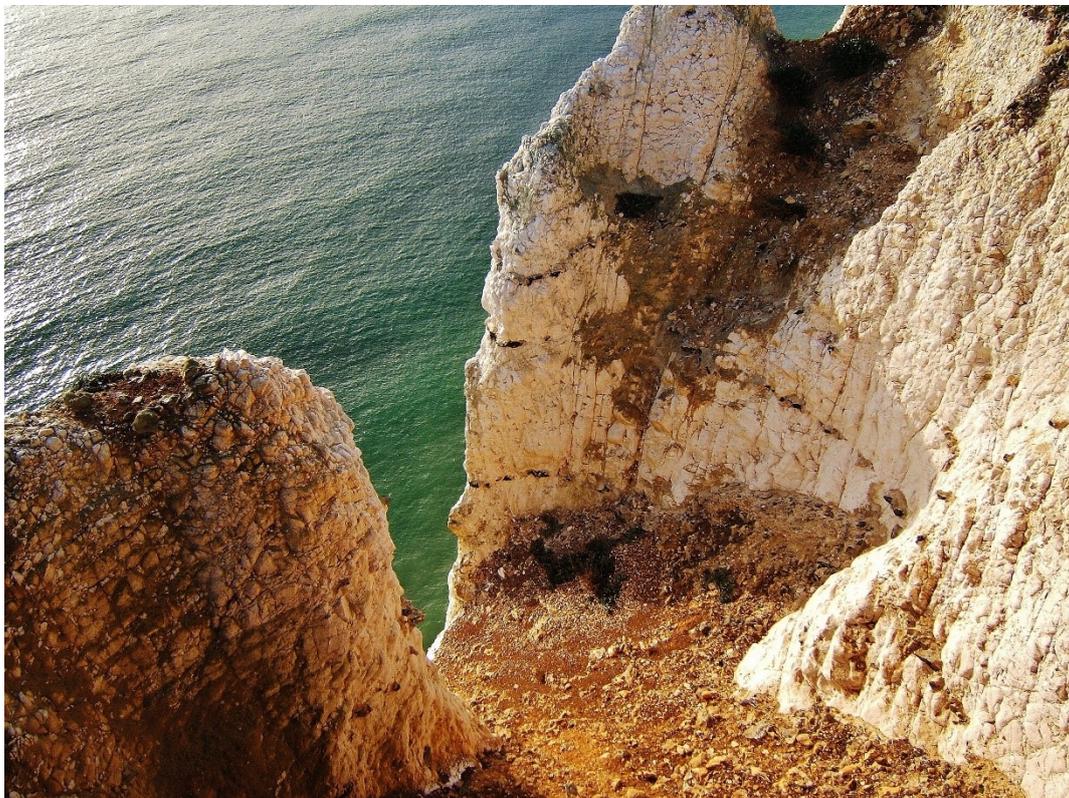
Looking down at a dissolution pipe from the cliff top (photo courtesy of Terry Reeve)
