# Increasing road network resilience to the impacts of ground movement due to climate change: a case study from Lincolnshire, UK

**Abstract:** The UK road network is deteriorating due to ageing infrastructure, climate change and increasing traffic. Due to community and economic reliance on a functioning road system, there is an urgent requirement to build resilience. The roads of south Lincolnshire have high susceptibility to ground movement due to the underlying geology. Deposits such as peat, tidal flat deposits and alluvium have a high susceptibility to compress, particularly when loaded or through loss of water content driven by climate change or lowering of water in drainage channels. The shallow foundations of Lincolnshire's rural evolved roads, originating from old mud tracks, are poorly constructed, increasing their vulnerability to movement. Types of damage include longitudinal cracking, edge failure and uneven long-section profiles. Through knowledge exchange, data sharing and collaboration between the British Geological Survey and Lincolnshire County Council, a direct relationship between road condition and geohazard susceptibility has been demonstrated; showing compres

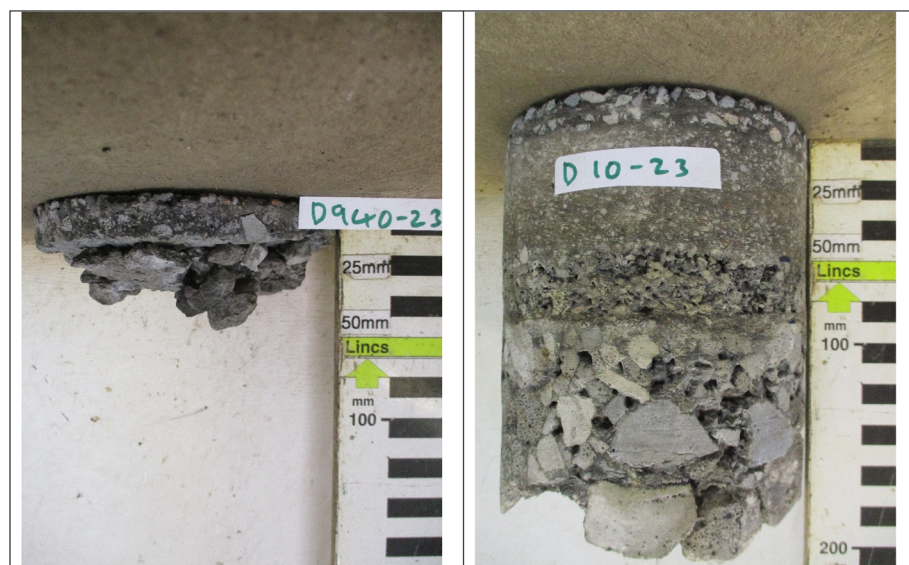
**Fig. 4.** Typical depths of 'evolved' road foundations in the county. (Left) Chalk Lane, Withern has a depth of 2.5–5 cm and (right) Church Lane in Friskney has a depth of 20 cm. At least four surface courses can be seen to have been added at Friskney.

vulnerability due the shallow foundations of the evolved road network, which originates from old mud tracks. [Figure 4](#) demonstrates common road structure and thickness in the county. At Chalk Lane, Withern (543327, 382202), the thin surface course of 25 mm has no underlying foundations; as seen in Church Road, Friskney (546188, 355195), if repair work is required these courses have been overlaid and the thickness gradually built up, reaching a depth of 200 mm.

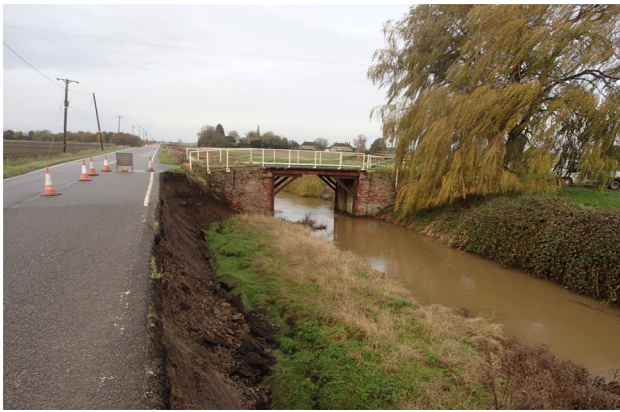
**Fig. 5.** Landslide in a large ditch adjacent to road, causing road subsidence and closure for repairs in autumn 2019. Fodderdyke Bank, Midville. © Mark Heaton, Lincolnshire County Council.

Flooding resulting in embankment and ditch slope failures has increased in occurrence recently due to more frequent high-intensity rainfall events. For example, a bank failure occurred in November 2019 at Fodderdyke Bank, following a high-intensity rainfall event, causing the bank to become quickly saturated. This caused the adjacent highway to become unstable as the minimal subgrade to the carriageway slipped away as part of the bank failure ([Fig. 5](#)).

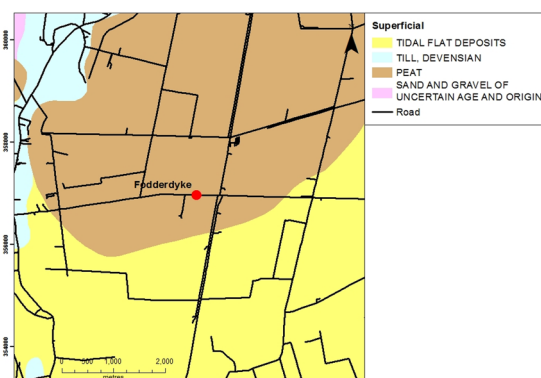
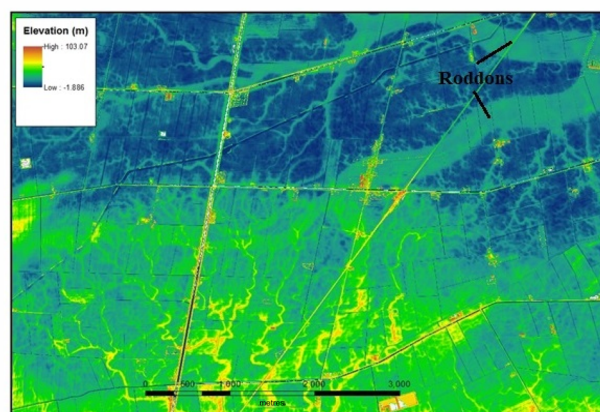
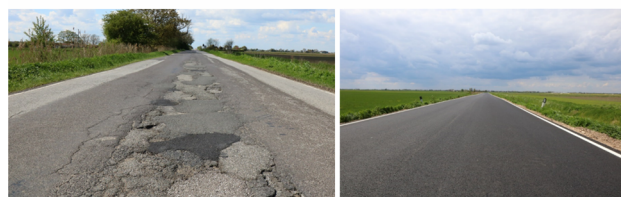
**Fig. 7.** (Top) Superficial geological map. (Middle) LiDAR image. © Environment Agency copyright and/or database right 2022. All rights reserved. (Bottom left) Previous road damage and patching work at Fodderdyke western stretch (May 2018). BGS © UKRI 2018. (Bottom right) Present-day post road repair Fodderdyke eastern stretch (May 2018). BGS © UKRI 2018.

During the last decade, splitting along the longitudinal section (Fig. 7), undulations, deformation including localized shears, slope movement and other subsequent highway failures have developed. Due to the worsening state of the road, it became relatively unsafe for travelling on at speed. In 2015 a road traffic incident took place; tragically, this resulted in a fatality, and a lower speed limit was enforced until repair work could be completed. Mitigation work was successfully completed by the local authority during 2018. Although overlays had been the typical repair method, a different approach was used to increase the life of the road and reduce future maintenance requirements. This entailed recycling of the existing road surface; therefore, not introducing additional load. Due to the length of this road this is a rolling programme with works being undertaken each year. It is still ongoing, giving the highway authority the opportunity to review, monitor and make fine adjustments to the design, whilst continuing its research.

The Environment Agency (EA) LiDAR scan data (Fig. 7) show the lower ground to the north of Fodderdyke, which coincides with the highly compressible peat deposits. These are topographically similar to the tidal flat deposits to the south, which are also susceptible to consolidation due to loading and shrinkage due to a reduction in water, although this movement is less than found in the peat as they have a lower natural water content and show less ground movement. The roddons cross the area from north and south, raising the ground surface, appearing as 'inverted channels'. North of the road, compression of the peat deposits has led to the land surface lowering, and therefore a lowering of the overlying roddons. Due to less movement in the tidal flat deposits to the south of the road, the roddons have a comparably slightly higher elevation to the south compared to the north. However, in all locations, roddons provide a positive topographical feature. The presence of deposits with different lithology and characteristics along the road leads to large variation in the amount of movement seen.

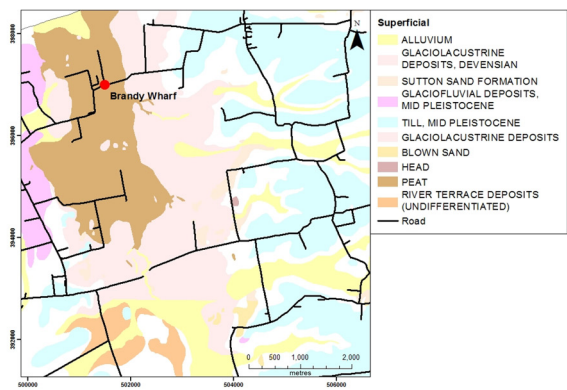
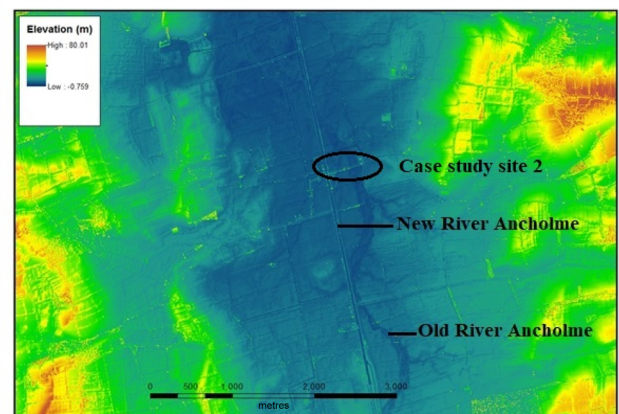
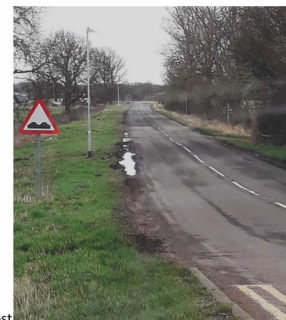
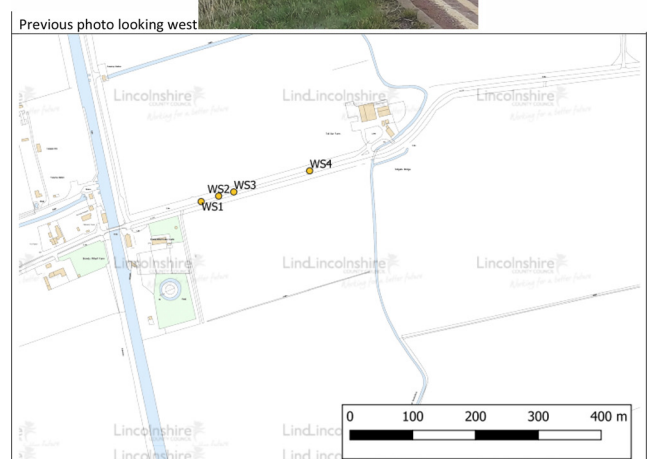
**Fig. 8.** Brandy Wharf. (Top) Superficial geological map. (Middle) LiDAR data. © Environment Agency copyright and/or database right (2022). All rights reserved. (Second to bottom) Photograph of case study site, looking west, showing the undulating road surface (September 2020) © Mark Heaton, Lincolnshire County Council. (Bottom) Sample hole locations. ©Lincolnshire County Council.

In September 2020, Lincolnshire County Council undertook windowless sample holes, drilling to a maximum depth of 4.5 m, at four points along the stretch of road (Fig. 8). The road surface had a consistent 40 cm of asphalt, underlain by *c.* 60 cm of fill and sub-base. The depth of peat in the boreholes beneath the road ranges from 1 to 3 m, showing large variability between each of the sites; with WS4 recording much shallower peat than WS1–WS3 (Figs 9–12). The deposits underlying the peat at all four sample holes are clayey peats and clays with rare organics, considered to be glaciolacustrine deposits. These are much thicker in WS4 than at the other three locations. Sand with flint gravel is at depth in all four holes, located at around 2 m depth at WS1–WS3 and at almost 4 m at WS4. The LiDAR image (Fig. 8) indicates the presence of a roddon at WS1 and the old River Ancholme passing through WS4.

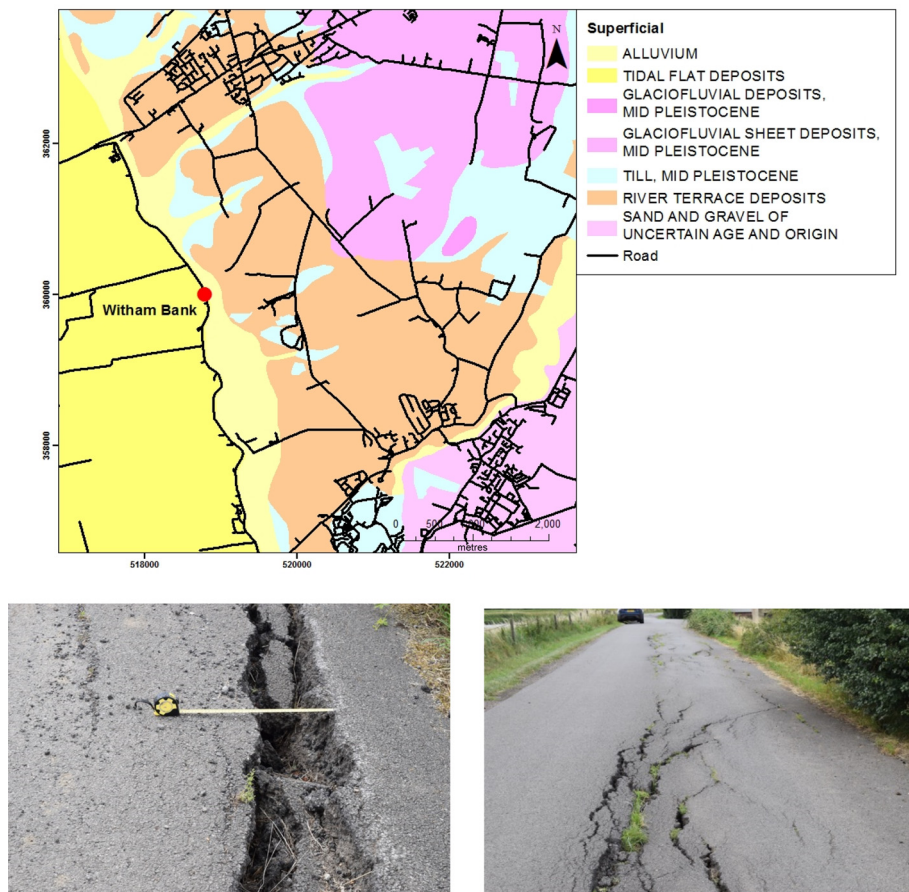
**Fig. 13.** Longitudinal cracking at Witham Bank. (Top) Superficial geological map. (Bottom left) Present-day photograph (June 2020). © Mark Heaton, Lincolnshire County Council. (Bottom right) Road surface damage, looking south (May 2018). BGS © UKRI 2018.

Lateral variation in water content across the carriageway has led to subsidence and the generation of a longitudinal crack in the road surface (Fig. 13), commonly up to 20 cm wide. A likely cause of this variation is the increase in vegetation along the western edge during the last decade, as seen in Figure 13 (May 2018), which

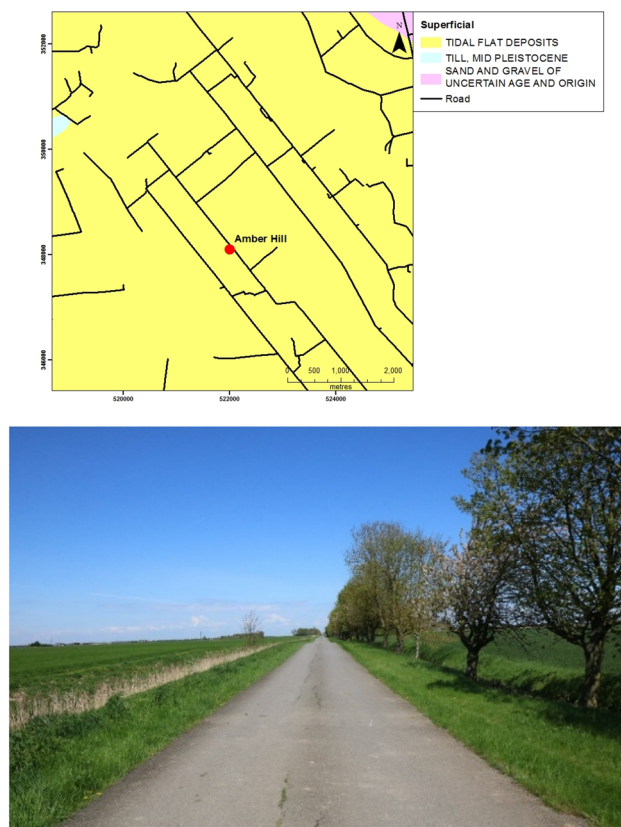
**Fig. 14.** Amber Hill. (Top) Superficial geological map. (Bottom) Photograph taken in May 2018 showing longitudinal cracking along the centre of the road. BGS © UKRI 2018.

Longitudinal cracking has occurred down the centre of the carriage way, as can be seen in Figure 14.

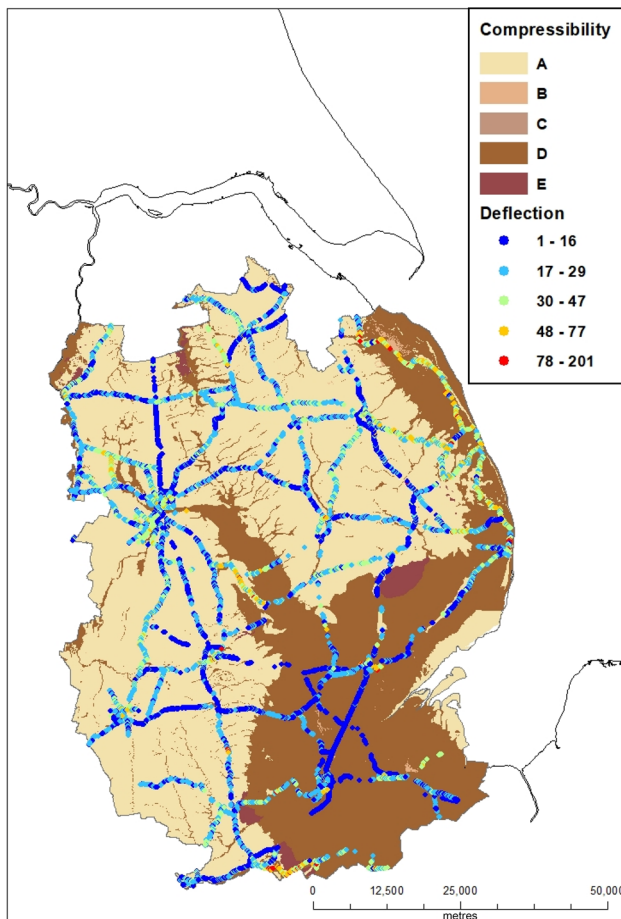
**Fig. 15.** Lincolnshire County Council deflectogram survey residual life (RL) data for 2010–2013 and the BGS GeoSure compressibility susceptibility map. © Lincolnshire County Council. Contains Ordnance Survey data © Crown copyright and database right [2022].

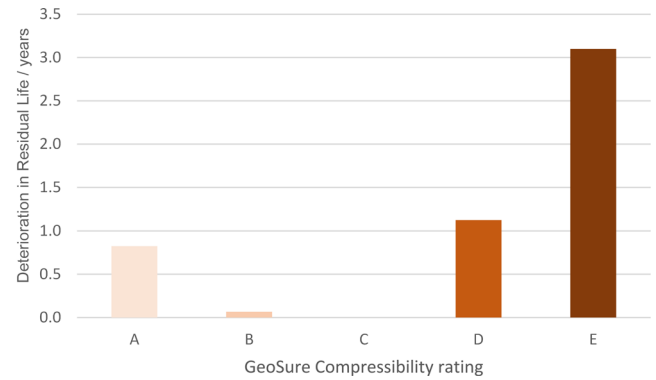
**Fig. 16.** GeoSure compression values against the residual life (RL) deterioration rates (all roads).

When analysing these datasets further and removing all A roads, a much faster road deterioration, and therefore decrease in RL, is shown on roads underlain by geology with a very significant compressibility GeoSure rating (E), increasing from a deterioration

rate of just 3 years to 17 years annually. Areas with compressibility GeoSure rating D, also see a large increase in deterioration; from 1.1 years per year including A roads to 3.2 years per years without. Similarly, removing the A roads in the analysis of areas with higher clay shrink–swell susceptibility also leads to an increase in deterioration of the roads. This demonstrates that when A roads are removed, the rate of road deterioration increases in areas of high susceptibility to ground movement, indicating that engineered A roads, with deeper foundations, are more robust and less influenced by natural ground conditions.

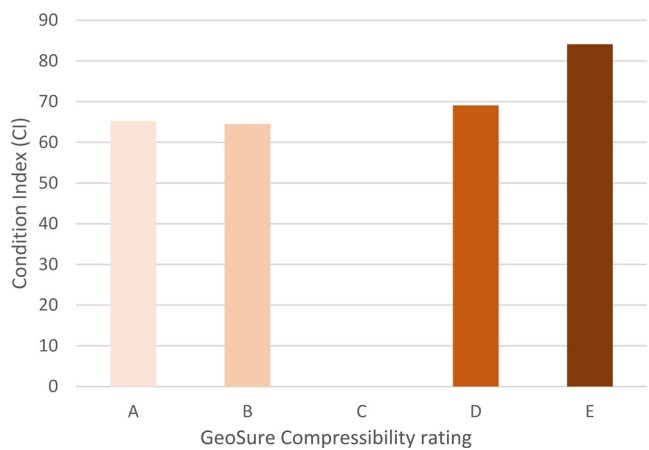
**Fig. 17.** Average Condition Index (CI) between 2010 and 2013 of all surveyed Lincolnshire roads in areas with a GeoSure compressibility rating of A–E.

value of C, the higher CI values with worse structural condition are in areas with very high susceptibility to ground movement due to compression.

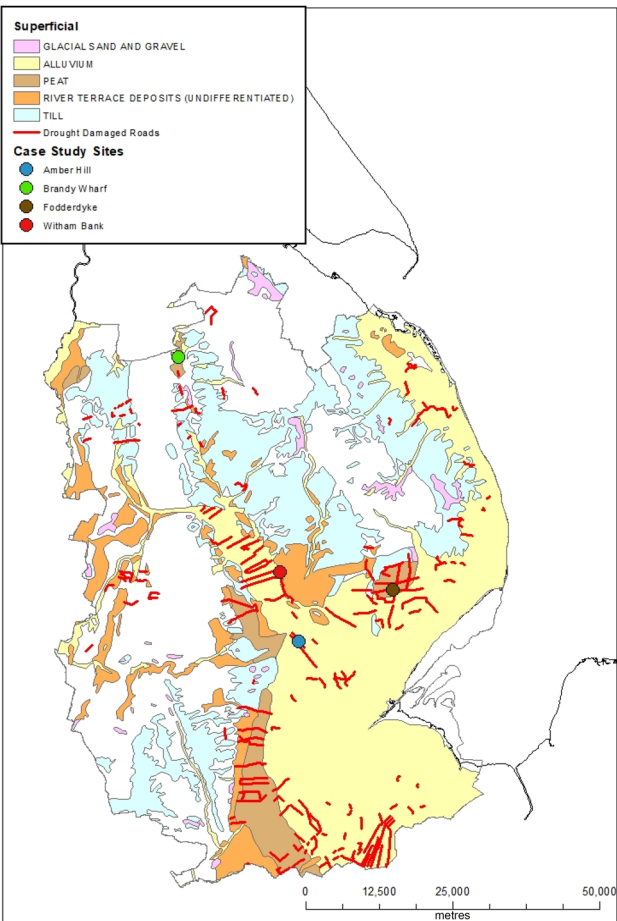
**Fig. 18.** Drought-related subsidence claims in Lincolnshire 2011 and the BGS 625 k scale superficial geological map. © Lincolnshire County Council. The four case study sites are highlighted by the coloured dots. NB The 625 k scale generalized superficial geological map compiles alluvium and tidal flat deposits as alluvium. Contains Ordnance Survey data © Crown copyright and database right [2022].

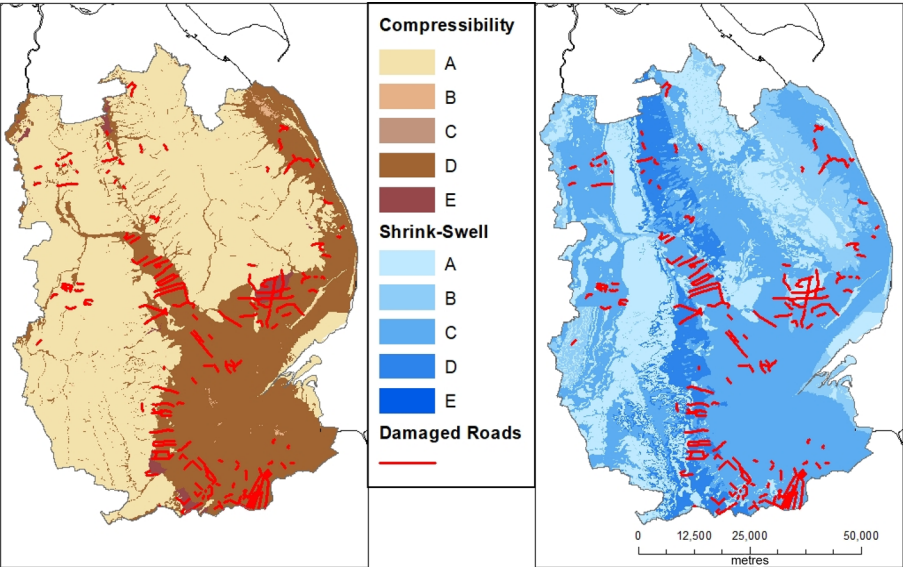
**Fig. 19.** GeoSure compression and clay shrink-swell with sites recorded (red lines) by Lincolnshire County Council as requiring remedial work due to drought damage during 2011–2012. © Lincolnshire County Council. Contains Ordnance Survey data © Crown copyright and database right [2022].

A comparison of Lincolnshire County Council drought-damage data and BGS GeoSure clay shrink–swell compression datasets (Fig. 19) showed that clay shrink–swell was not the county’s only likely cause of road damage, and that compressible ground had a greater correlation with road damage than was originally considered (Pritchard *et al.* 2015).

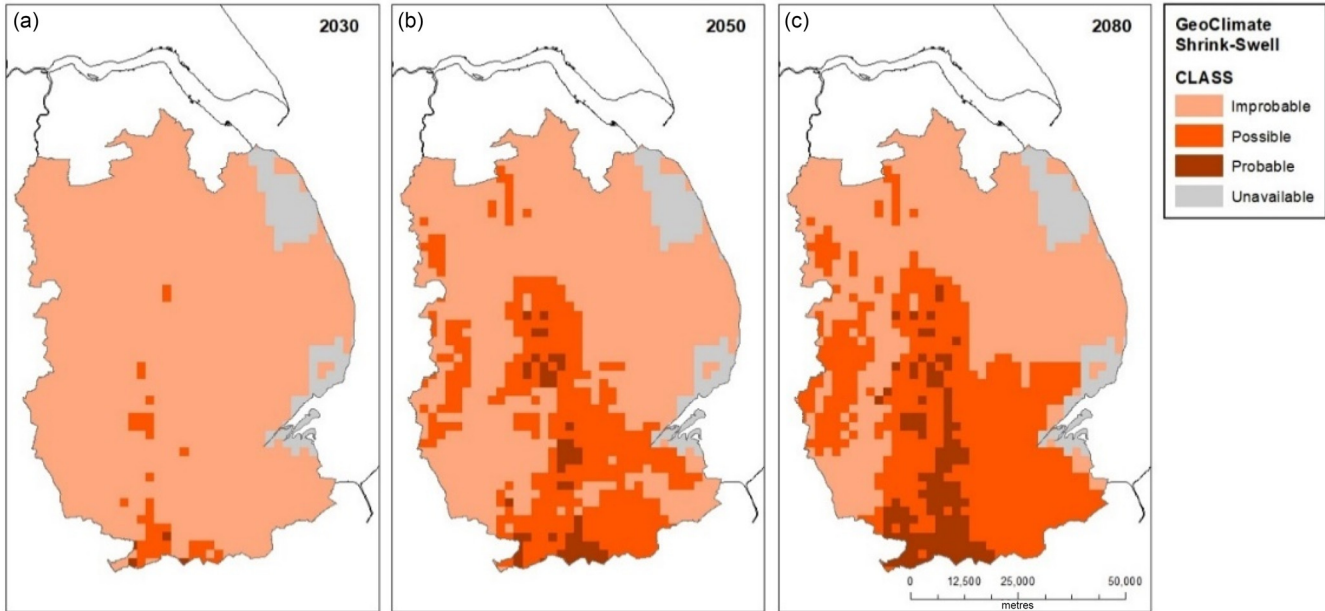
**Fig. 20.** GeoClimate09 Open for Lincolnshire: (a) 2030s (b) 2050s and (c) 3080s. Contains Ordnance Survey data © Crown copyright and database right [2022].

geotechnical properties of the ground (Tables 6 and 7) to provide long-term, modelled analysis for resilience assessments. They provide information on the potential for clay shrink–swell to occur at a given location during a given future time period. GeoClimate projections for clay shrink–swell susceptibility for Lincolnshire for the coming century are shown in Figure 20.

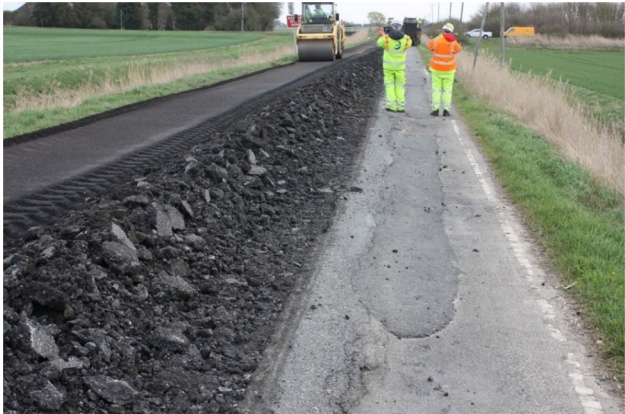
Fig. 21. Shaping and compaction of the pulverized existing road surface at Fodderdyke Bank (March 2018). © Mark Heaton, Lincolnshire County Council.

- (a) to pulverize the existing road to a depth of *c.* 250 mm;
- (b) shape and compact the pulverized material to make a new and increased thickness sub-base;
- (c) lay 60 mm of AC20 binder course material (asphaltic concrete with a maximum aggregate size of 20 mm),
- (d) lay and pin a steel reinforcing grid over the whole width, including overlaps at the joints;
- (e) lay 60 mm of AC20 binder course material; and
- (f) lay 40 mm of 40 mm surface course.

Remedial work at Fodderdyke was carried out during 2018 (Figs 21–23), reflecting the knowledge of the underlying road conditions, their geotechnical properties and the impact of projected climate scenarios on susceptibility to movement in the future. Recognizing the addition of added weight would cause more compression, the existing road surface was recycled. A mesh was included, covering the width of the road, enabling it to move as a single entity and thus experience less differential movement, resulting in less surface cracking. Although this initial repair work was costlier and took longer than the traditional patching, this informed decision-making was targeted and defensible. It alleviates the requirement of abundant future repair work and associated road closures with their resultant economic costs, demonstrating improvements both financially for the authority

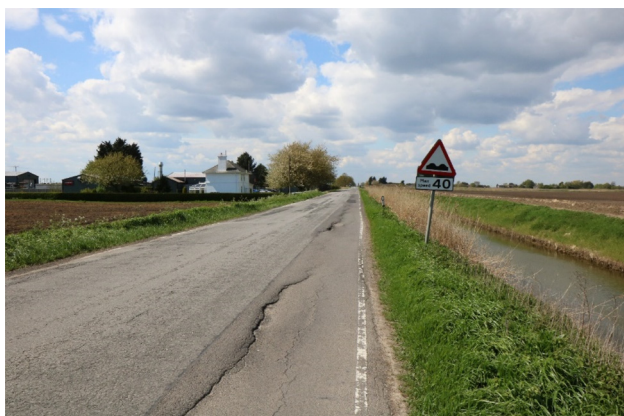
**Fig. 22.** Station Road (western end of Fodderdyke), Eastville, underlain by tidal flat deposits (May 2018). BGS © UKRI 2018.

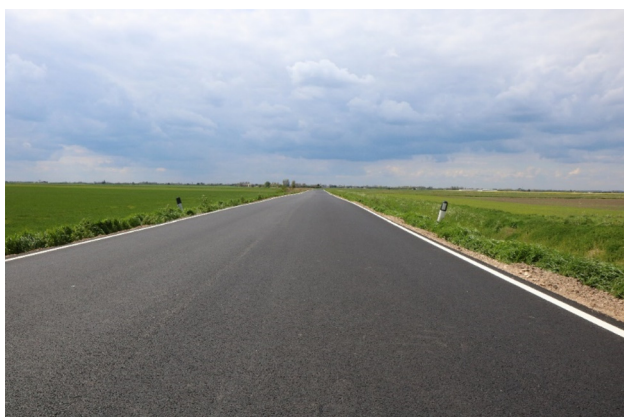
**Fig. 23.** Fodderdyke (eastern end of Fodderdyke) following resurfacing using the new recycling method (May 2018). BGS © UKRI 2018.
