UK Geoenery Observatories Cheshire: Hydraulic Testing of TH0424 Technical Summary

Open Report OR/23/037

OPEN REPORT OR/23/037

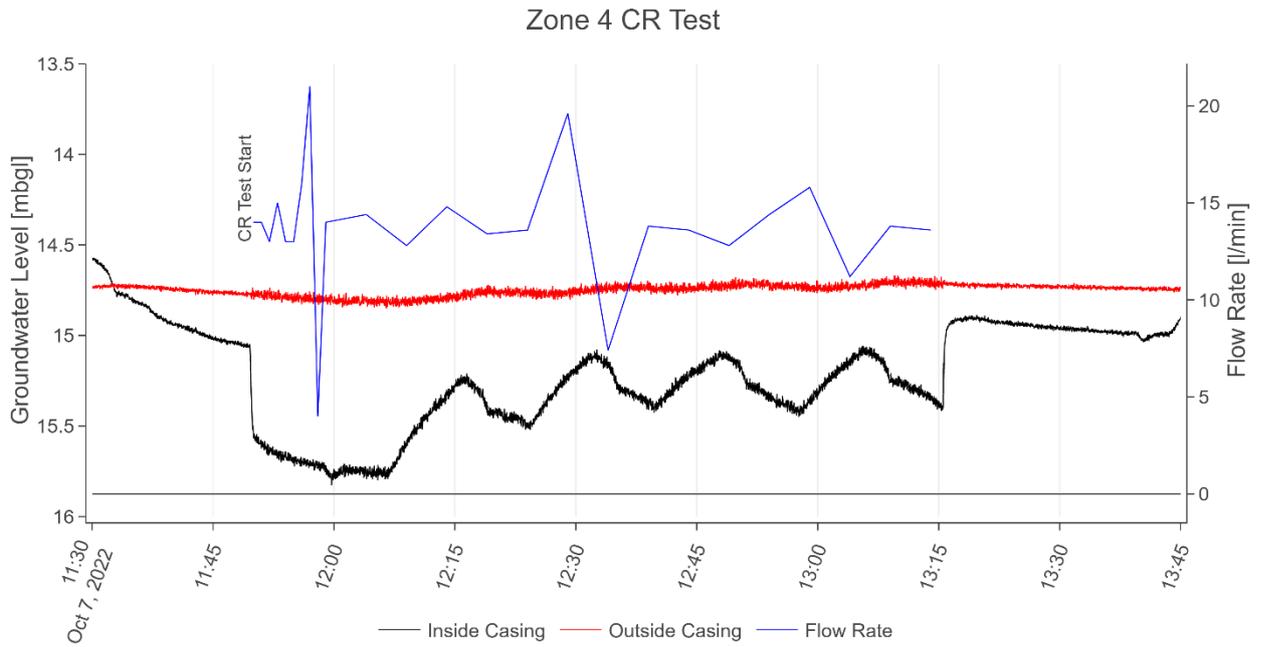
Test 8 shows significant interference from local drilling events in the isolated zone and to a lesser extent in the outside casing above the isolated zone. Even though the groundwater level was falling prior to the start of the test, the test was started at 15.0 mbgl as this was the starting point for the previous step test where levels were relatively static. The initial drawdown phase was relatively unimpacted by external influences until ~17 mins into the test where a cyclical increase in inside (and to a lesser extent outside casing) groundwater level was observed. Subsequent data are not useable for further hydraulic analysis but may again be used in conjunction with the drilling record to reveal connectivity. Data prior to drilling perturbations may be used for further analysis, although a static pumped groundwater level was not achieved. A drawdown of 0.75 m was recorded at a median flow rate of 13.8 l/min. An abstraction event was in progress at the start of the test ending at 11:59; recovery from this event would have been ongoing through the majority of the test. The end of this abstraction event may have caused the small deviation at 11:59 prior to obvious drilling related perturbations.

Figure 6.9 - Test 8: Zone 4 constant rate test time series

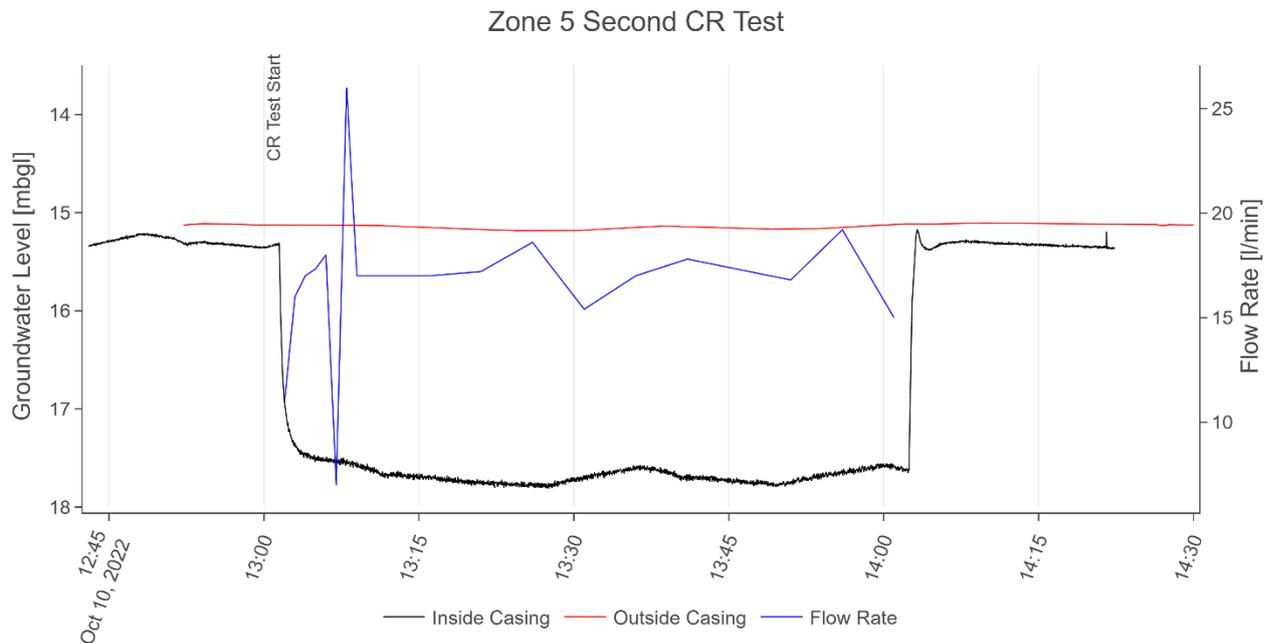
Test 11 carried out the same constant rate test as test 10 in zone 5 but using different level loggers. Isolated zone groundwater level drawdown was 2.46 m from the static inside level at a median flow rate of 17.2 l/min. Some cyclical influence was detected creating ~0.18 m increases in level in the inside casing and ~0.05 m increases in the outside logger level. The recovery curve shows a potential failure of the check valve with the resemblance of a critically damped response consistent with a slug of water being reinjected back into the well. No abstraction event was recorded during the test, however an event finished at 12:14 with possible continuing recovery of local levels during the pump test.

Figure 6.11 - Test 11: Zone 5 constant rate test time series
