# Laboratory tests to understand tephra sliding behaviour on roofs

## Abstract

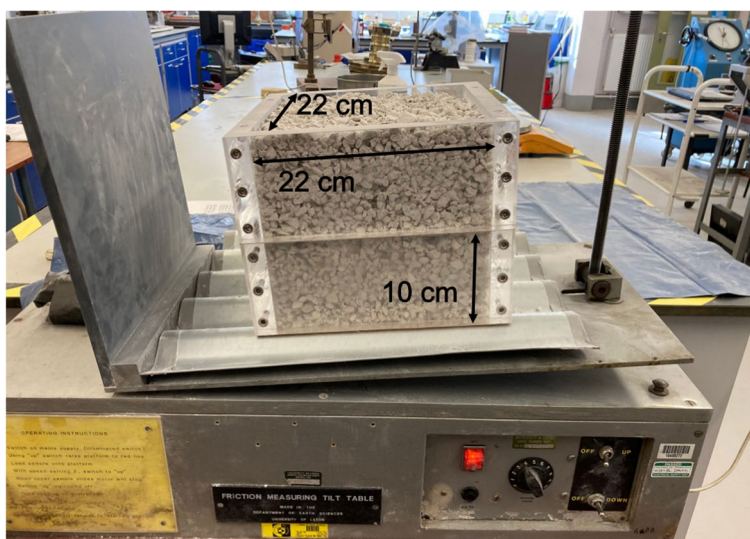
**Fig. 2** Tilt table set-up. The roof material was placed on the horizontal tilt table, the cell was placed on it and filled with tephra. The inclination of the table was then increased in half degree increments until tephra sliding occurred

With the tilt table set horizontally, the roof material and then the load cell were added (Fig. 2). The tephra sample was weighed, and tephra was carefully poured into the cell and distributed to ensure that the deposit was evenly dispersed into the corners of the cell. After the cell was filled, the remaining tephra was weighed and the

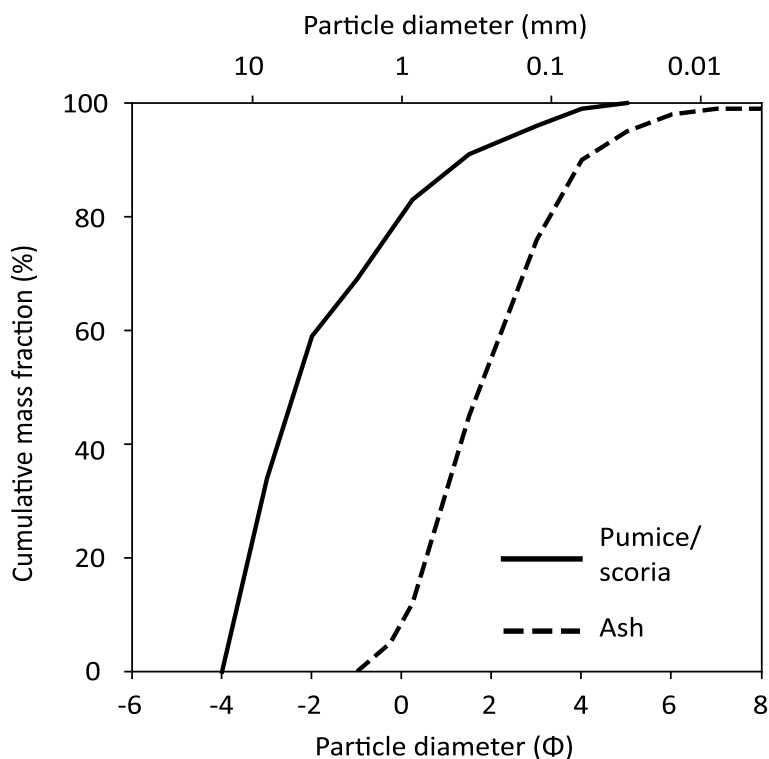
**Fig. 3** Grain size distribution for pumice, scoria and ash used in sliding tests

2022). To investigate the influence of grain size distribution and bulk density on sliding behaviour, we used three tephra samples (detailed in Fig. 3; Table 1): low density, coarse-to-fine grain size distribution (GSD) (pumice); high density, coarse-to-fine GSD (scoria) and high density, fine GSD (ash). We wanted to consider sliding from uniformly applied loads and hence minimise any affect from individual large clasts and we therefore selected a maximum grain size of  $-4 \phi$  (16 mm). This maximum grain size is also consistent with samples used to assess the geomechanical properties of tephra (Osman et al. 2022), where the size of the apparatus used to conduct the geomechanical tests limits the maximum size of individual particles relative to the total sample size.

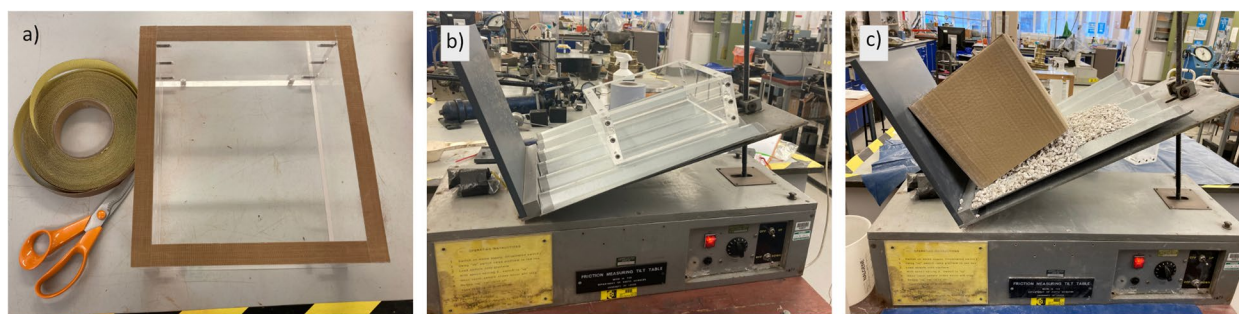
**Fig. 4** Initial test set-up, **a** Perspex cell with edges coated in PTFE tape, **b** testing the sliding angle for one empty Perspex cell on metal sheet, **c** testing the sliding angle using a cardboard cell

We conducted sliding tests with an empty cell to identify the minimum angle at which sliding would be controlled by the tephra. The edges of the empty cell were coated in PTFE tape (“TEFSIL 3’ from Techbelt Ltd, with coefficient of friction ≤0.10) to reduce friction (Fig. 4a). The cell was placed on each roof material and the roof angle increased until sliding occurred (Fig. 4b). Sliding angles are shown in Table 2. For the tiles, the sliding angle was >30° which is similar to the expected internal angle of friction for tephra deposits (Osman et al. 2022), and so the PTFE tape was also applied to the tile directly beneath the cell.

For the corrugated metal and fibre cement sheets, tests with 10 cm thickness of pumice were carried out with the cell edges over the troughs and the ridges of the roofing sheet to check whether the direct contact of the ridges along the entire down-slope length of the cell impacted the sliding angle. When the cell edges were over the ridges, little tephra leakage occurred. When

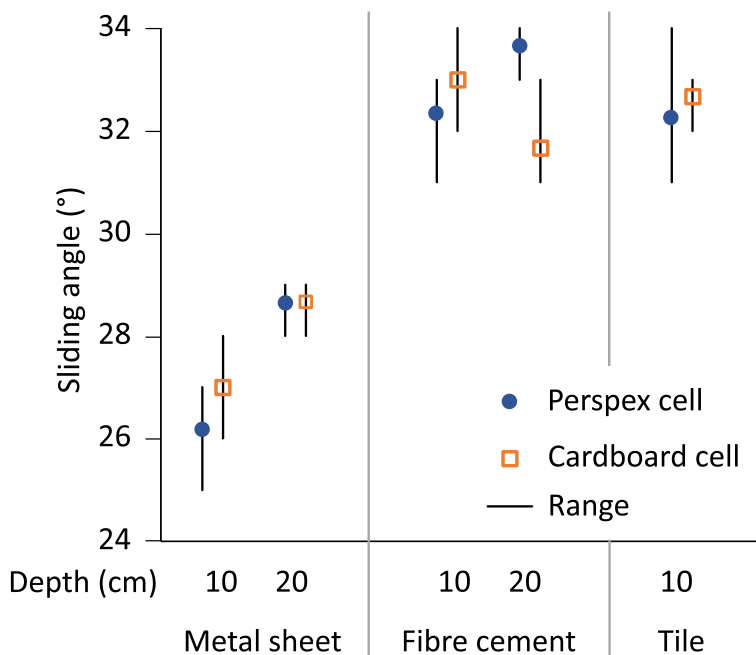
**Fig. 5** Comparison of sliding angles for cardboard and Perspex cells with 10 and 20 cm thickness of pumice on metal sheet, fibre cement and tiles

To investigate whether the presence of the Perspex cell or the area of the cell in contact with the roofing material affected the sliding angle, we carried out tests using a cardboard cell weighing < 50 g, with the cell walls being ~ 0.3 cm thick (Fig. 4c). We tested 10 and 20 cm of pumice on all roof materials using the cardboard cell. The only notable observed difference between the Perspex cell (of weight 2.35 kg for each 10 cm depth) and the cardboard cell was that on tiles with 20 cm thickness of pumice, the tephra “leaked” from beneath the sides of the cell before sliding occurred. No measurable difference was seen between the sliding angles for tests using the cardboard and Perspex cells (Fig. 5).

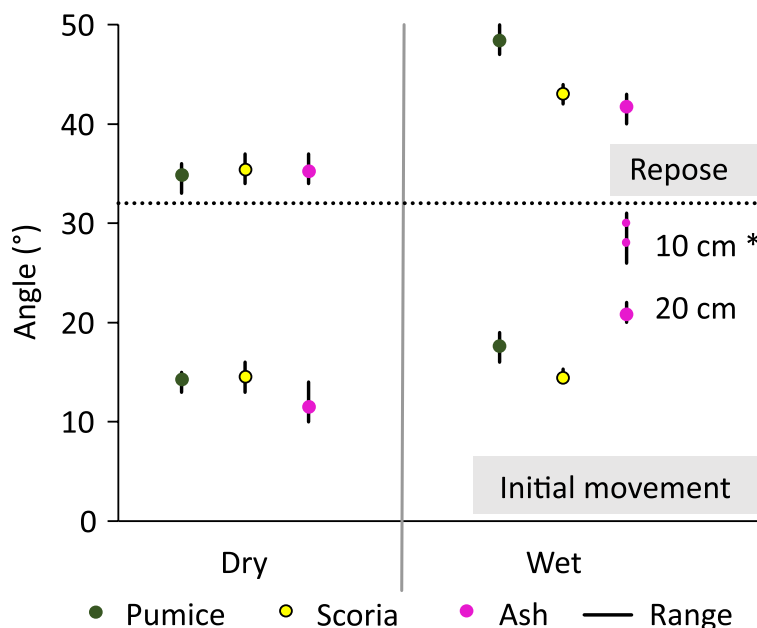
**Fig. 6** Repose angle and angle at which tephra grains started to move on the surface of the deposit for dry and wet pumice, scoria and ash. \* Initial movement of wet ash varied with deposit thickness. 10 cm: sliding at the base (between tephra and roof) at 28° on metal sheet and slumping of deposit at 30° on fibre cement and tile; 20 cm: slumping at 21°

In dry samples, grains initially started rolling and sliding over each other at tilt angles of 10–14° for ash (mean: 12°) and 13–16° for the coarser-grained samples (mean: 14° for pumice and 15° for scoria). No change was seen when scoria was wetted, but wet pumice grains required a higher tilt before movement started (mean value 18°), as shown in Fig. 6. Wet ash behaved very differently to the dry sample, with apparent cohesion between the grains resulting in more stable deposits. The 10 cm deposit failed by sliding at the base at a tilt angle of 28° on metal sheet, and slumping at a tilt of 30° on fibre cement and tile, and slumping at a tilt of 21°.

- The angle at which grains initially move (Fig. 6) represents the lowest roof pitch at which any tephra load is likely to be removed by sliding.
- The deposit sliding angle (Fig. 7) represents the steepest pitch on which any ash will remain.
- Load reduces linearly for roofs with pitches between these values.
- Initial sliding occurs at the same angle in 20 and 30 cm deposits (as we were unable to measure this for 30 cm thickness with our equipment).
- Where tephra deposits slide internally rather than at the interface with the roofing material, this action results in the erosion of the underlying deposit so that there is little difference between deposits that fail at the base or internally.

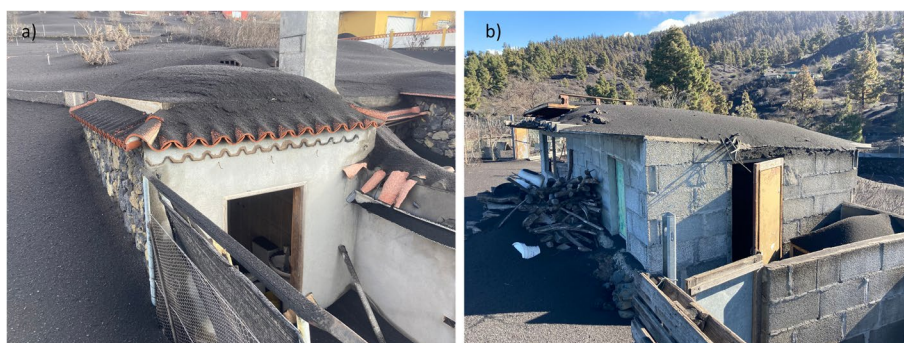
**Fig. 9** Low pitched roofs in (a) Las Manchas and (b) Tacande, La Palma following the Cumbre Vieja 2021 eruption, showing no evidence of the deposit sliding except at the deposit edges where the angle of repose has been formed

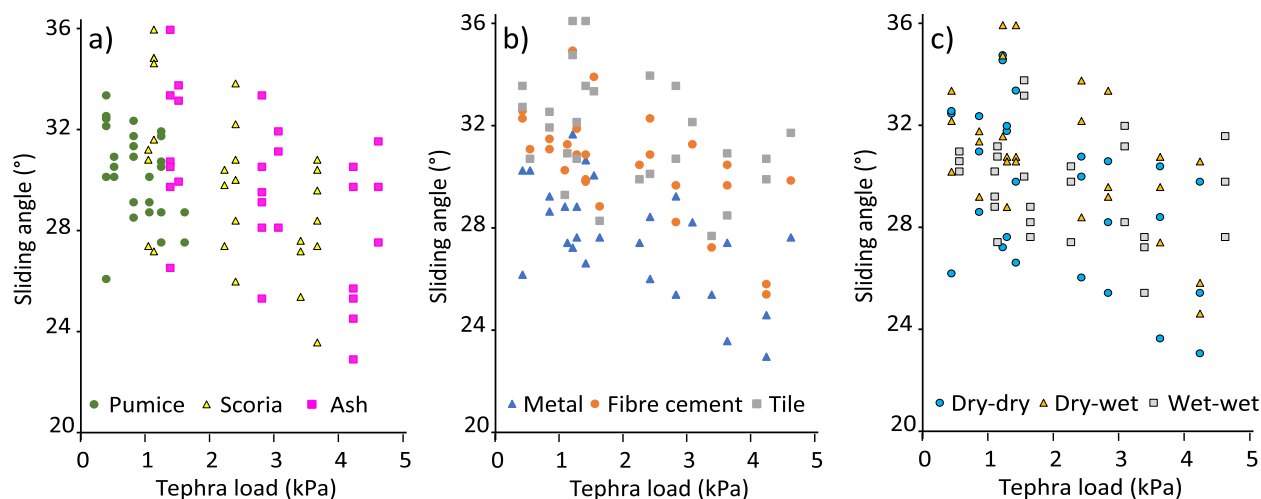
**Fig. 10** Summary plot showing variation of mean sliding angle with tephra load for all tests, highlighted by a tephra type, b roof material and c presence of water

maximum tested pumice test loads of  $<2$  kPa (Fig. 10a) are unlikely to lead to collapse unless roofs are of poor quality or badly maintained (Jenkins et al. 2014). However, test loads of 1–4 kPa and 1–5 kPa for scoria and ash respectively could lead to collapse in good quality buildings, hence sliding is an important factor to consider. As expected, our results show that sliding occurs at a shallower angle on the lower friction metal sheet compared to the rougher surfaces of fibre cement and tiles (Fig. 10b). When considering the other factors we investigated (shown in Fig. 1), namely deposit thickness, tephra type, grain size distribution and presence of water, there is a clear trend on each roof type for the sliding angle to be lower for higher loads (i.e. thicker deposits) (Fig. 10), but no clear trends related to the other factors (Fig. 10a, c). This suggests the increased weight of tephra is key in overcoming the frictional forces that resist sliding when compared to other factors.

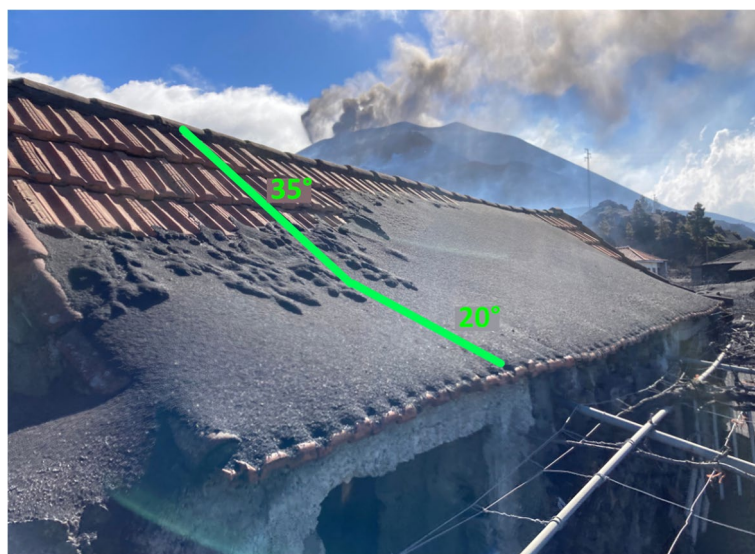
**Fig. 11** Tephra deposit on a roof in Tacande, La Palma, December 2021 during the Cumbre Vieja eruption. Tephra has slid on the steeper part of the roof ( $\sim 35^\circ$  pitch) but accumulated on the lower, shallower part ( $\sim 20^\circ$ )

We found that metal roofs require a pitch  $\geq 32^\circ$  to ensure the deposit is substantially shed, consistent with larger scale tests using dry basaltic ash, where  $\sim 45\%$  of the deposit remained on a  $30^\circ$  metal sheet roof, reducing to  $<10\%$  at  $35^\circ$  (Hampton et al. 2015). For fibre cement and tiles, a pitch of  $\geq 35^\circ$  is needed to significantly shed tephra, which is consistent with our observations of tile roofs in La Palma, where sliding had occurred on a pitch  $\sim 35^\circ$  but tephra built up on a  $\sim 20^\circ$  section (Fig. 11).

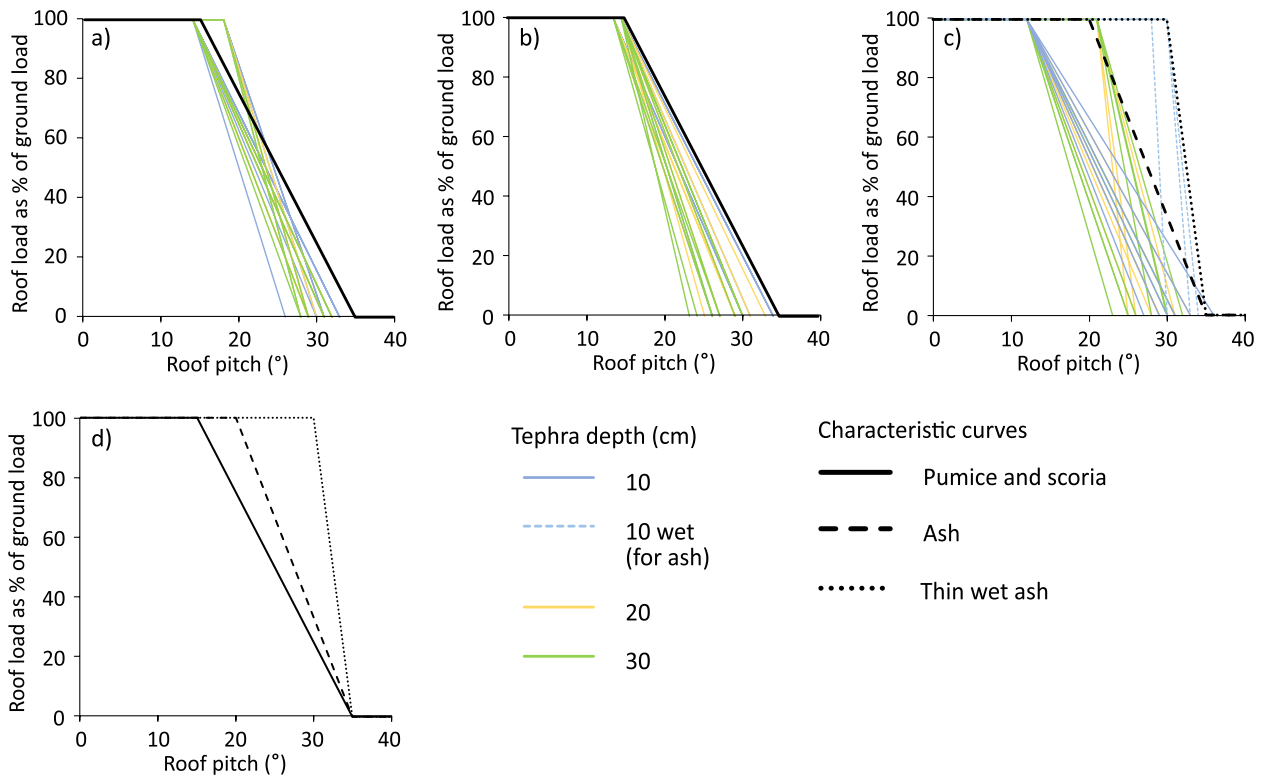
**Fig. 12** Summary of all tests showing percentage of ground tephra load expected to remain on a roof for deposits of (a) pumice, (b) scoria, (c) ash. Characteristic values for each tephra type are shown in (d). Load is assumed to reduce linearly for roof pitches between lab values for initial movement and total sliding

For tephra loading, the characteristic value of the ground load could routinely be obtained from numerical modelling of different eruption scenarios (e.g. Barker et al. 2019; Vázquez et al. 2019; Wild et al. 2019). To build up a comprehensive set of sliding coefficients tephra sliding behaviour must be quantified on a wide range of roof shapes and materials. As a first step towards this, our results can inform values for simply pitched roofs. By making the following assumptions, we can summarise all our results to show how the fraction of ground load remaining on a roof varies with roof pitch for the different tephra types we considered (Fig. 12a-c):

We can then select characteristic curves for each tephra type (Fig. 12d). In building design, it is usual to present results with a 95% confidence interval, but the number of tests needed for that is beyond the scope of this study due to the limited size of the test equipment and roofing materials available to test. We have however
