A short report on a landslide survey in the Sheffield Area

OPEN REPORT OR/08/020

This report is the published product of an investigation into the distribution and nature of landslides on the Sheffield Sheet, undertaken as part of the East Midland regional remapping project.

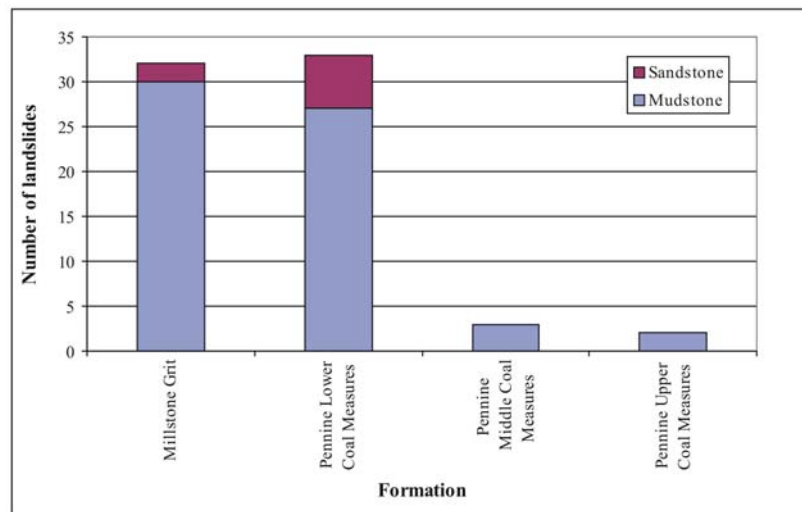
Figure 2: Frequency of landslides in sandstone and mudstone for formations on the Sheffield Sheet.

Many of the landslides are shallow in nature and therefore the materials involved are likely to be a mixture of Head (if present), soil and weathered bedrock. A large proportion of landslides in this study (88%) have developed on slopes over mudstone (Figure 2) which is likely to relate to the weakening effect of weathering on mudstones and other similar lithologies (Waters *et al.*, 1996). Failures in slopes of sandstone occur within the Millstone Grit and Pennine Lower Coal Measures present across the sheet.

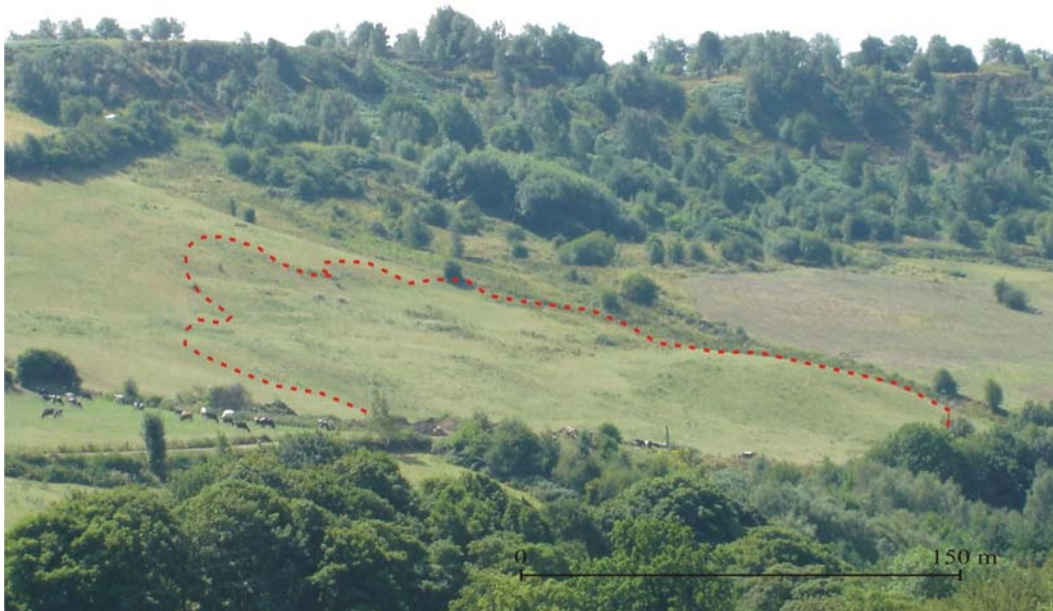
Figure 5: Shallow earth slide failure at SK290867. This failure occurs next to a more degraded, larger slide that is obscured by the trees. (Photograph taken from 429600 387831).

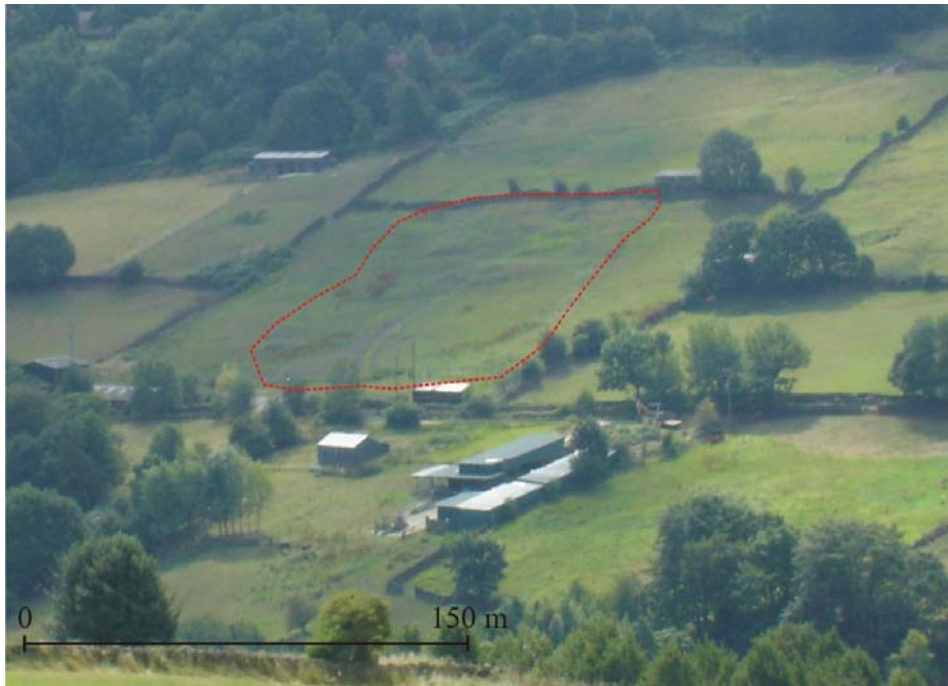
Figure 6: Shallow earth slide at SK306872, one of several on this section of slope.
 (Photograph taken from 429600 387831).

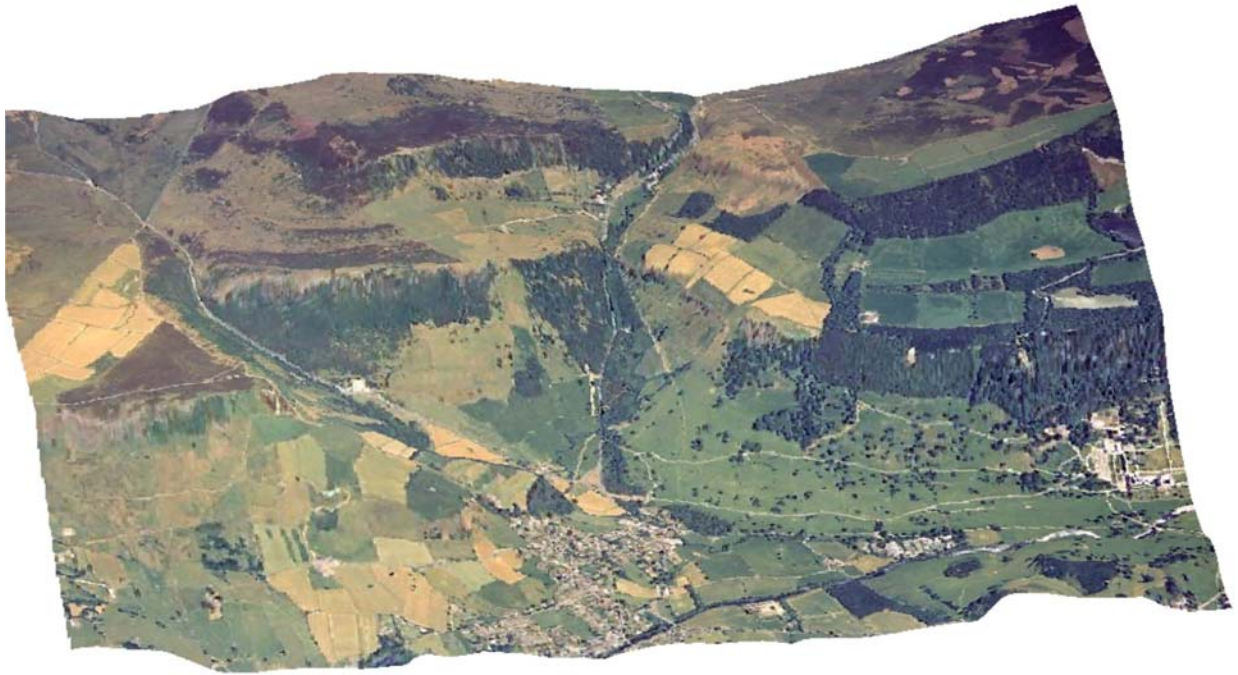
Figure 9: 3D image of the northern section of Chatsworth Deer Park showing the topography of the area.

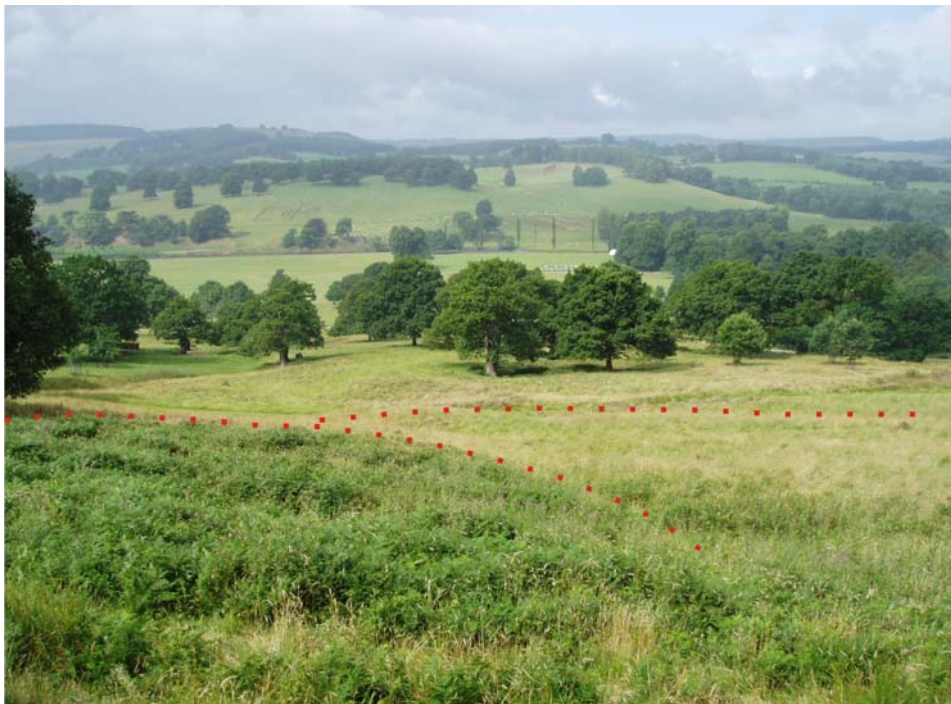
There was one instance recorded during this study of a large scale landslide involving the sandstone units of the Millstone Grit. This was at Chatsworth House where a large scale backscar was visible in the woods behind the Deer Park. The polygon is around 2.5 km long but only 100 m wide; with an area of 0.3 km² (Figure 8). The width of the landslide may be thinner than expected due to landscaping in the grounds which may have removed the surface expression of the landslide toe. The landslide itself involves both the mudstone and sandstone parts of the Millstone Grit with the backscar being within the harder sandstone section. In the area around Chatsworth the Millstone Grit sandstones form benches with the weaker mudstones in-between; this benched topography is visible in Figure 9. The base of the landslide was mapped along a line of hummocky ground which could clearly be distinguished from the landscaped grounds of the park (Figure 10).

Figure 10: Hummocky ground in Chatsworth Deer Park

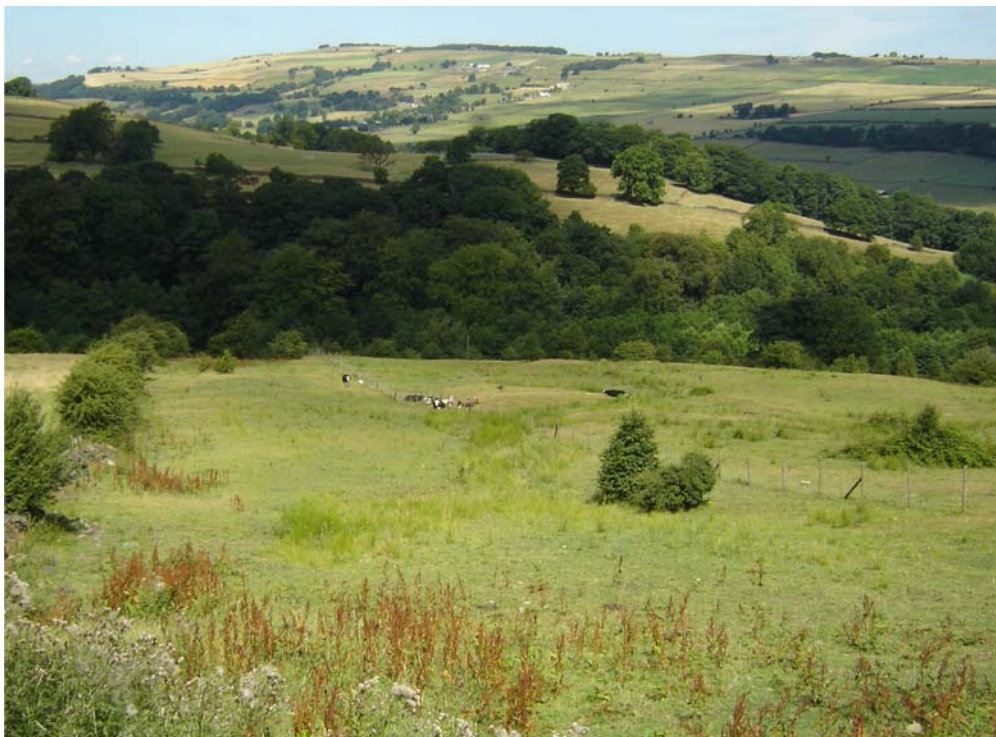
Of the 38 landslides that occur on the Pennine Coal Measures Group the majority of these are within the Pennine Lower Coal Measures (84%). Many of the landslides occur in association with a boundary between the sandstone and mudstone units. Most of the landslides on the Pennine Coal Measures occur over the mudstone sections and are predominantly slides of both rotational and translational nature with a few flows. Figure 12 shows the distribution of four landslides that were mapped around Crowhole Reservoir in the south of the Sheet. There were a total of five landslides in this area, with all but one slide occurring in the mudstone bands of the Pennine Lower Coal Measures. All of the landslides were shallow translational slides. Landslides in the Pennine Lower Coal Measures tend to be shallow in nature and this can lead to a subdued hummocky topography which is difficult to identify without stereo aerial photographs (Figure 13).

Figure 13: Subdued landslide topography of the Pennine Lower Coal Measures Mudstone lithologies (SK298890).
