# A socio-material analysis of rural water supply performance in Africa

IAH Congress, Davos  
10<sup>th</sup> September 2024

# Hidden Crisis: unravelling failures for future success

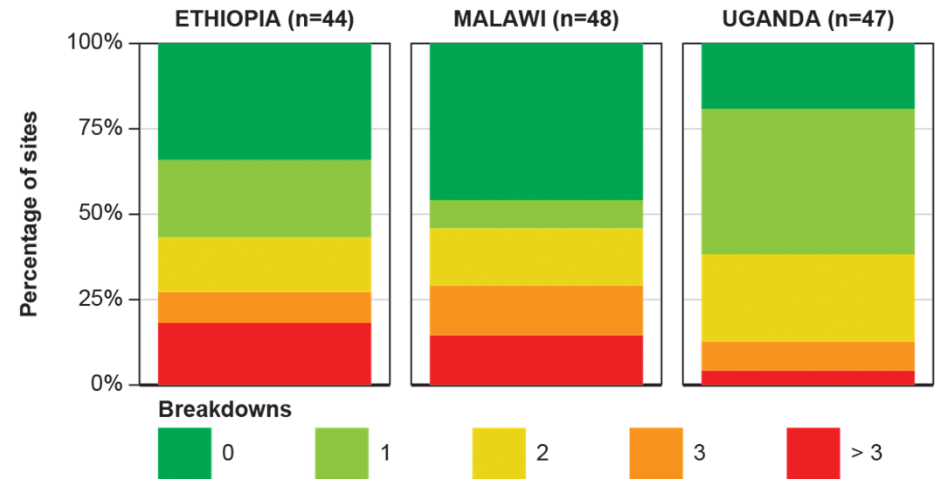
Cumulative number of breakdowns in last year

- Up to two breakdowns per year is most common, more is rare.
- Highest proportion of HPs with > 3 breakdowns and > 3 weeks previous and cumulative downtime in Ethiopia.
- Highest proportion of HPs with previous and cumulative downtimes < 1 week in Malawi.

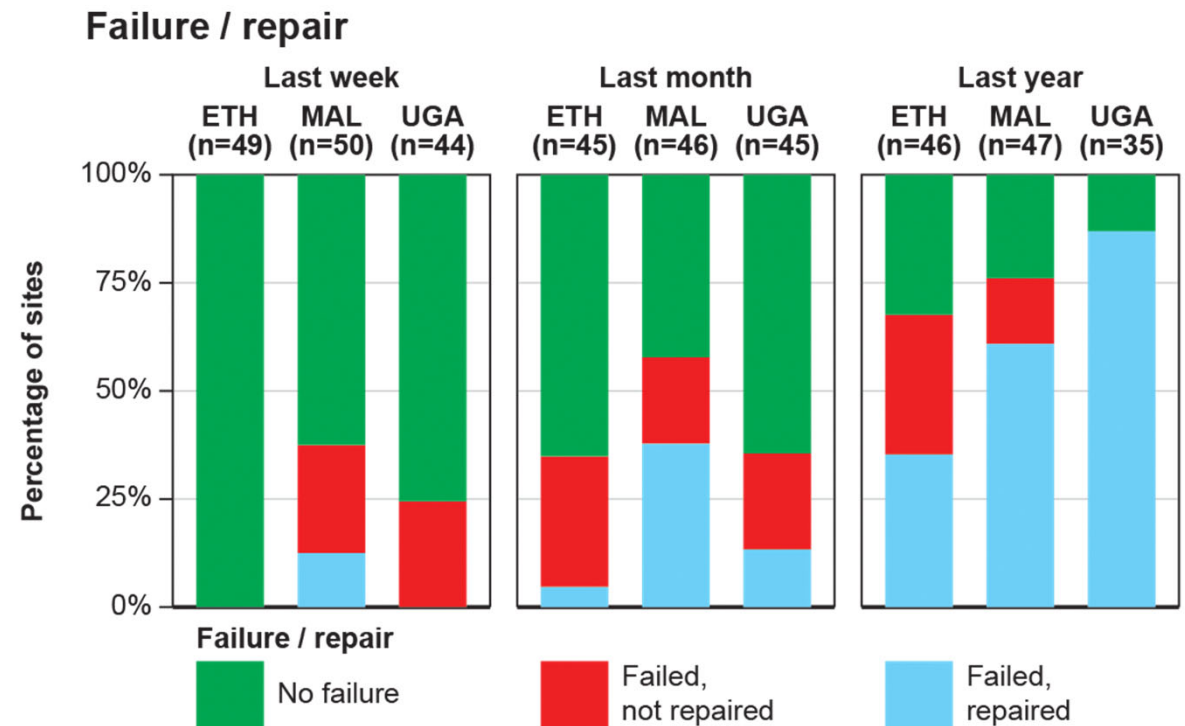
# Repair of handpump boreholes

- Malawi experienced quickest repair times (12% in one week, 38% within a month).
- Repairs least likely within a year in Ethiopia (35% needed repair only 51% repaired).
- In Uganda 87% of HPs that needed repair were repaired within a year.

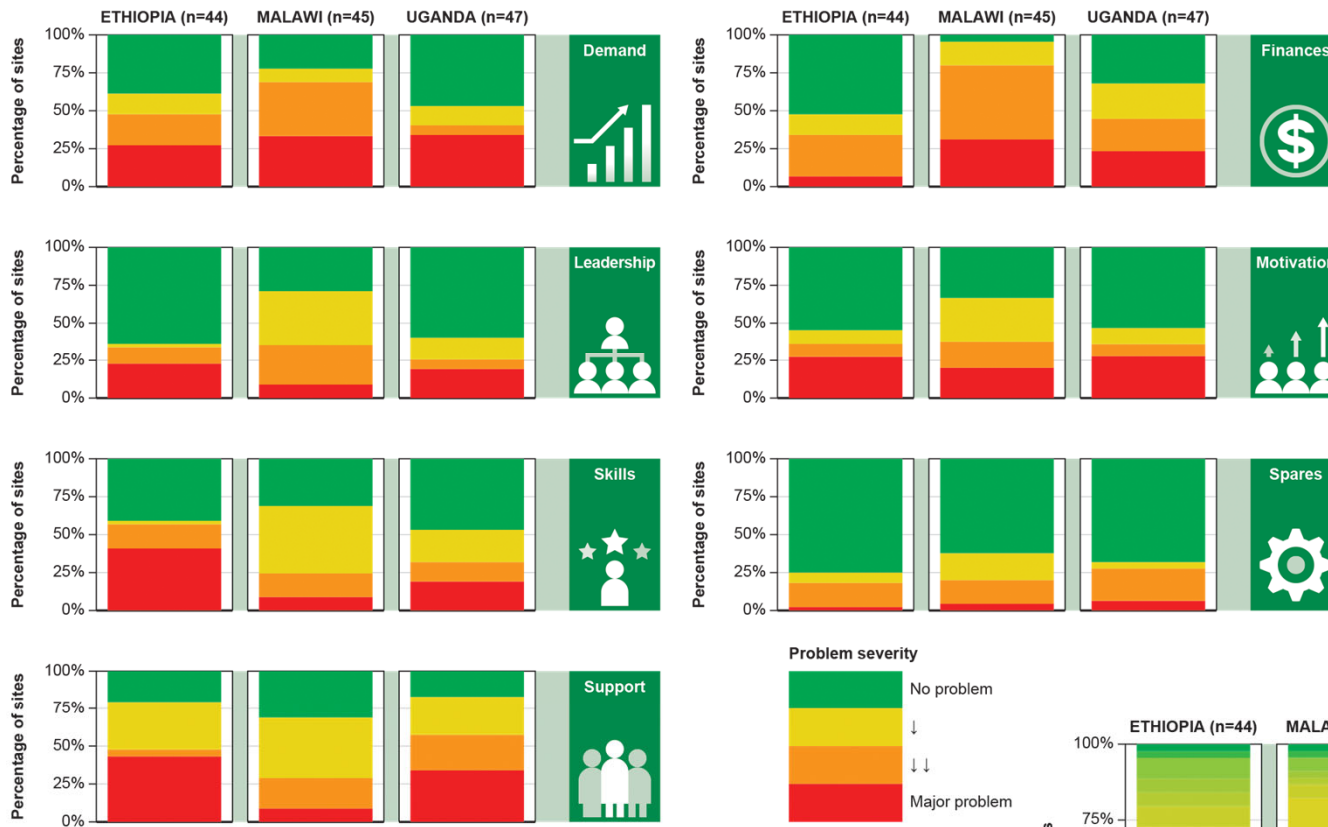
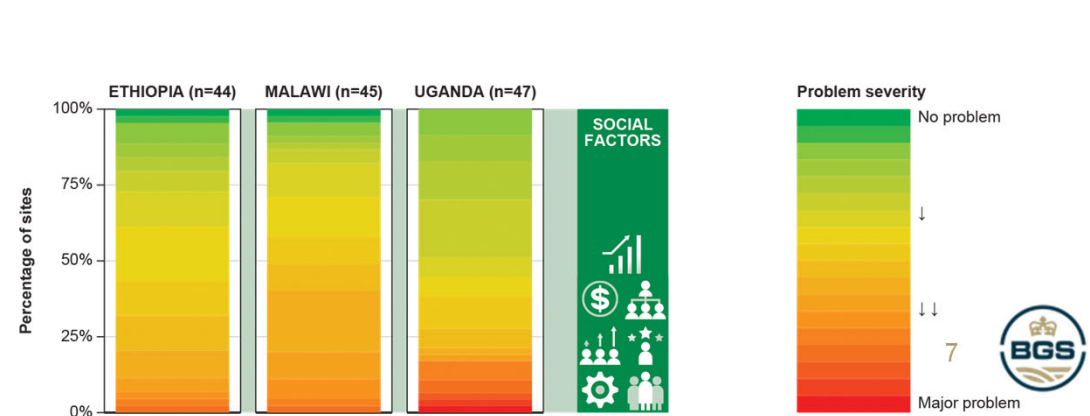
# Social factor state

- Malawi has weakest social context.
- Least problems across factors in Ethiopia.
- Access to spares is the least problematic issue.
- Access to external support, finance are the most problematic issues.

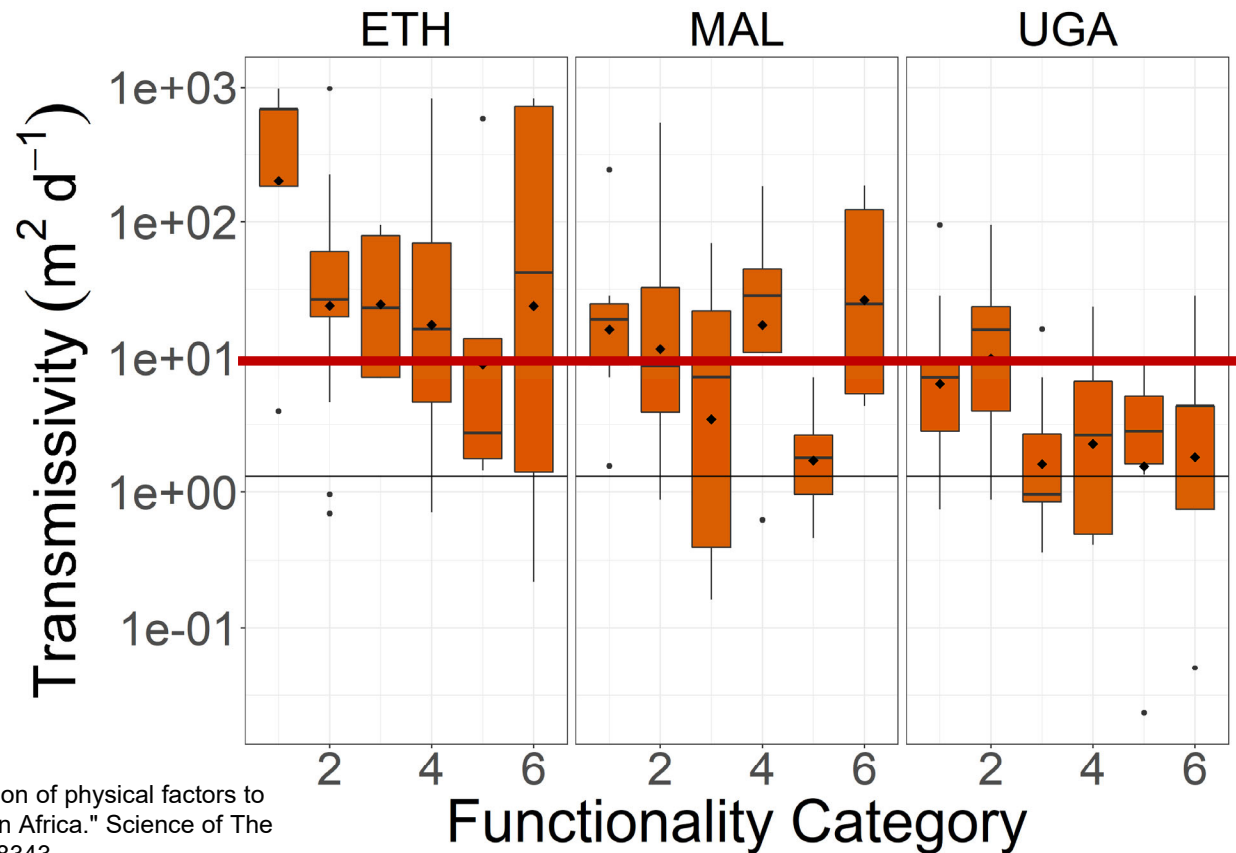
# Hydrogeology – aquifer pumping test

- Transmissivity particularly problematic in Uganda.
- Transmissivity results have implications for larger reticulated systems (e.g. solar pumps).

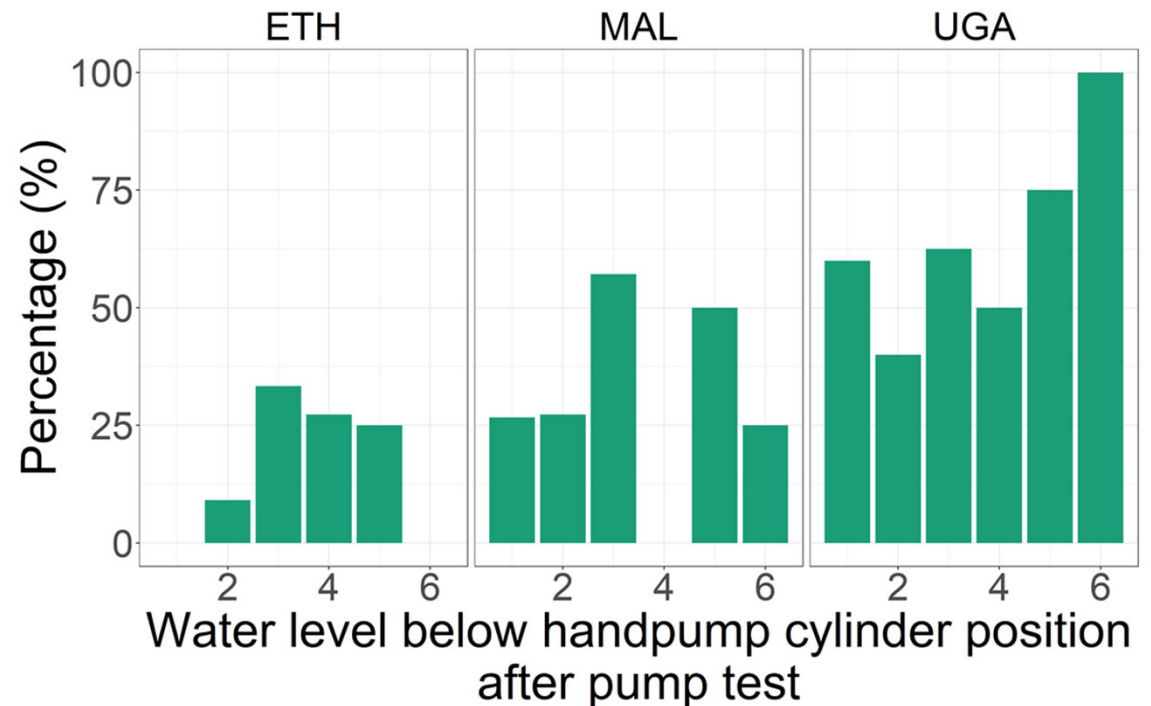
# Borehole construction and configuration – CCTV survey

- Due to design or maintenance flaws, risk of water dropping below cylinder at many sites.
- In dry season this means handpump cannot extract water.

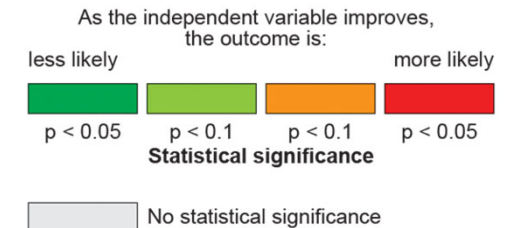
# Socio-material factors influence on performance

- **Finances:** important across all performance and response outcomes.
- **Skills:** increases probability of repair occurring and shorter downtimes.
- **Support:** increases probability of repairs occurring but results in longer cumulative downtime.
- **Borehole layout and construction** (cylinder position): increases probability of less failures and timely repairs *not* occurring.
- **Hydrogeology** (transmissivity): increases probability of shorter downtime and timely repairs *not* occurring.

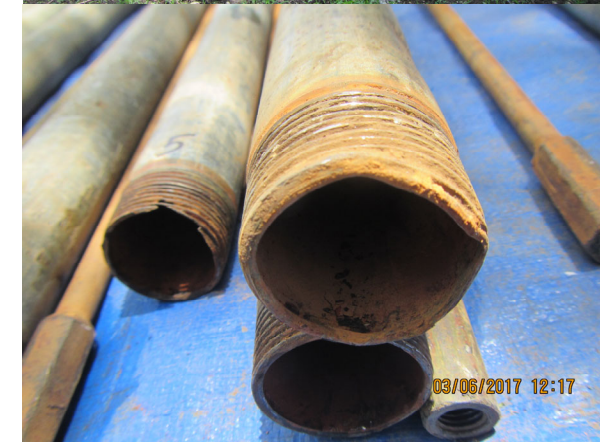
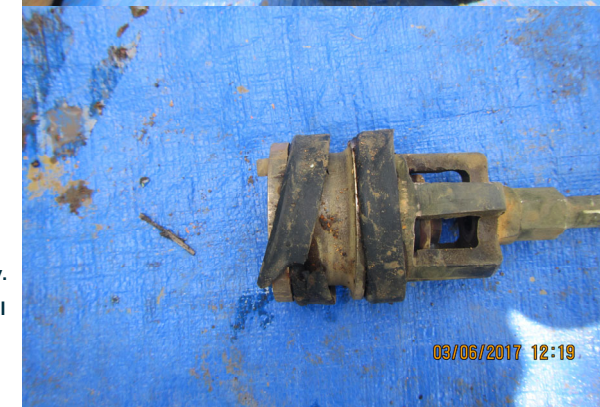
# Abeshge, Ethiopia (EAE01)

- Until recently technical **support** for the HP was provided by an NGO with equipment to remove pipes during repair. The community were happy.
- The NGO left and handed technical support over to the Woreda water office. They don't have the right equipment and must remove pipes by hand.
- As a result, Woreda staff are reluctant or unable to perform some repairs.
- Often repairs are followed quickly by breakdowns. In the previous instance, only two jerry cans were filled before the HP stopped working.
- This has created tension between the community and the Woreda, the community feel that their support is not being carried out in good faith.

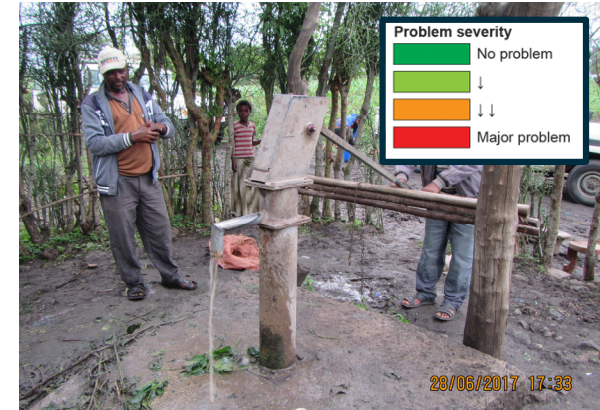
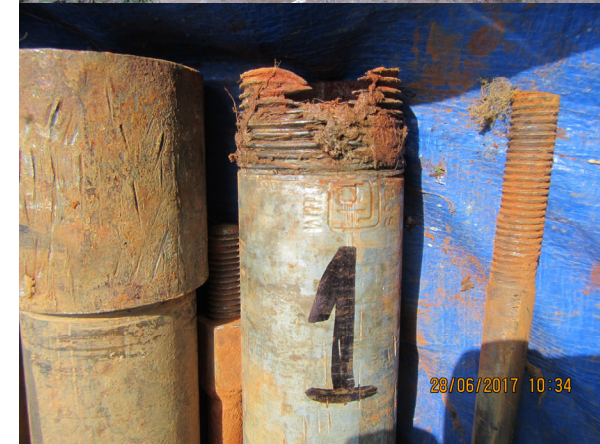
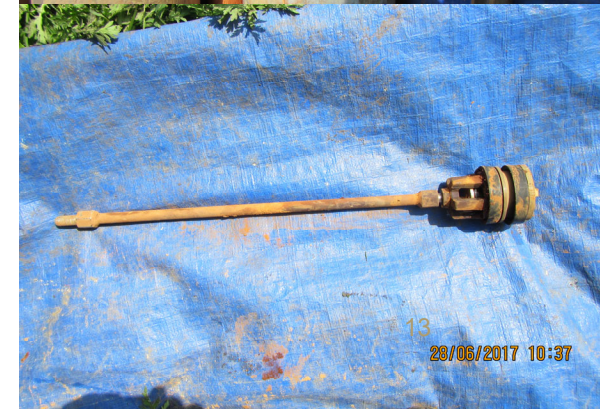
# Abeshge, Ethiopia (EAE07)

- Strong governance within the community (HP committee, village council, and 'idir' – a traditional burial society) and good hydrogeological conditions, has resulted in good HP performance.
- This has allowed the governance structure to evolve beyond the waterpoint.
- The community increased HP fees (finance) from 10 to 25 cents to fund other projects, including piped water with tap stands.
- However, the HP can also be used as an instrument of control. The HP is locked to ensure community members attend meetings or contribute time and labour to projects.

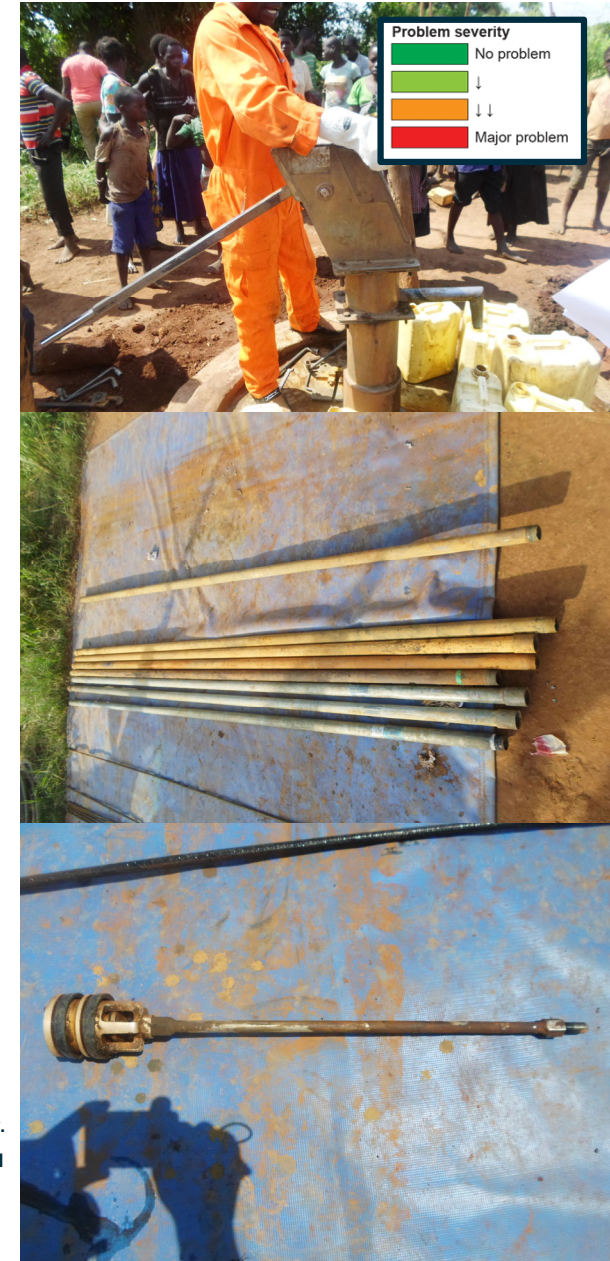
# Oyam, Uganda (UOY08)

- Reasonable **hydrogeology** and an effective management arrangement, evidenced by minimal downtime, have resulted in the HP **finance** system evolving into an interest-accruing loan scheme.
- The need to finance this scheme, and the potential to accrue interest, has increased the impetus to collect user fees.
- The scheme has been accompanied by a harsher system of fines and rules relating to the use of the HP are strictly enforced.
- Good performance of this HP is implicated in the evolution of an institutional innovation that, despite enabling that good performance, has the potential to promote perverse incentives and is liable to abuse.

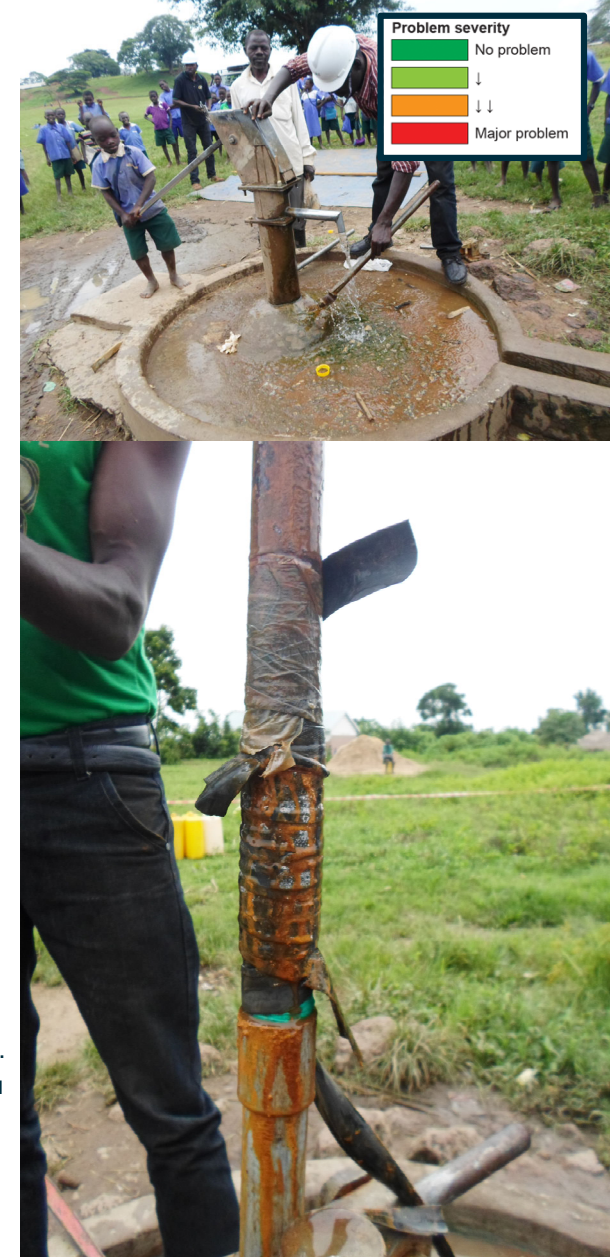
# Oyam, Uganda (UOY19)

- The only person to have received maintenance and repair training is the committee chair.
- **Borehole** siting influenced this because the HP is located near a school. The school headmaster drew upon its proximity to exert control by volunteering only his son for training.
- The dependency on the son's **skills**, and the link to his father as an authority figure, influenced decisions about the committee chair.
- Only having one trained mechanic makes the HP vulnerable to poor performance, evidenced by its classification as unreliable and low yielding.
- The community report that pipes commonly need repaired or replaced due to corrosion.
