# A Review of Lake Shoreline Restoration Techniques

Mackay, E. B., Gunn, I .D. M and Carvalho, L.

Date 11/07/2022

**Client** Natural England

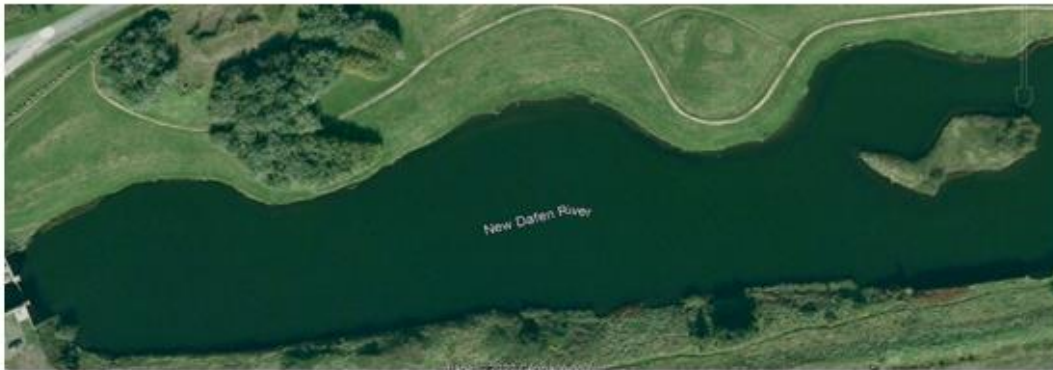
Before: 2009

The project has succeeded in providing shoreline habitat along the north shore of the lake which has benefitted the water voles, wildfowl and other wildlife as well as improving the aesthetics of the site. The vegetation in some areas took longer to establish, however within two or three growing seasons all sections were growing well. The vegetated margin is now up to approximately 3m wide on most sections, providing habitat and protection from wave wash.
