Volcanic eruptions and the global subsea telecommunications network

Abstract

Keywords Volcanic eruption · Submarine cables · Telecommunications infrastructure · Volcanic hazards · Marine geohazards

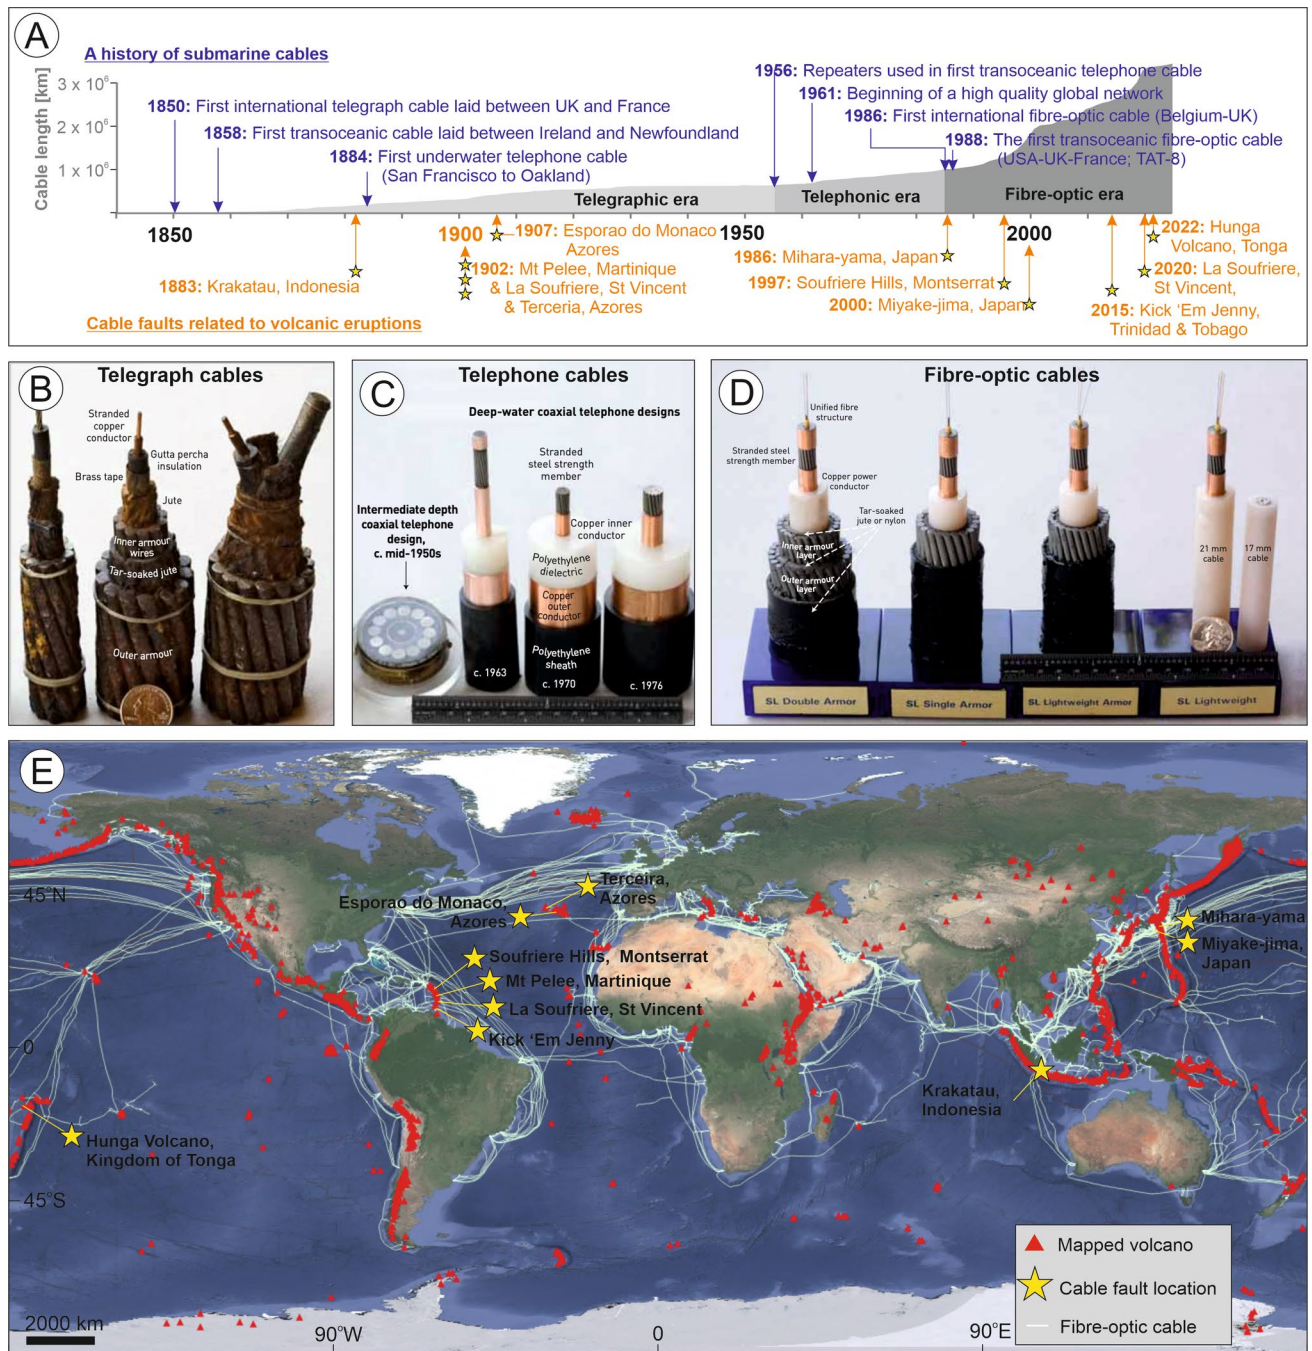
Fig. 1 Overview of case studies in this review and their timing and location relative to the expansion of the subsea cable network. **A** Timeline illustrating the history of subsea cables (blue) and cable damage associated with volcanic eruptions (orange). Instances of cable damage are annotated by yellow stars. Photographs show exam-

ples of cables from the telegraph (**B**), telephonic (**C**), and fibre-optic (**D**) era. **E** Geographic distribution of in-service fibre-optic subsea cables, cable faults (stars), and volcanoes (red triangles) based on GVP (2024). Background relief is from Google Earth

Our analysis shows that there have been at least 11 eruptions since the installation of subsea cables in the 1850s that have led to damage to one or more subsea cables worldwide (Fig. 1A, E; Table 2). These events relate to eruptions at volcanic islands ($N = 7$) or underwater volcanic edifices ($N = 4$), and are particularly significant compared to typical cable damage for a number of reasons. The first is that eight out of 11 volcanic events damaged the primary and only cable, disconnecting an island or region. Second, some volcanic events damaged multiple cables; in some cases, up to six cables were damaged by a single event. Third, the extent of the damage is greater than that experienced during typical instances of cable breaks due to bottom contact fishing or anchor drops, which tend to be very localised. While the full

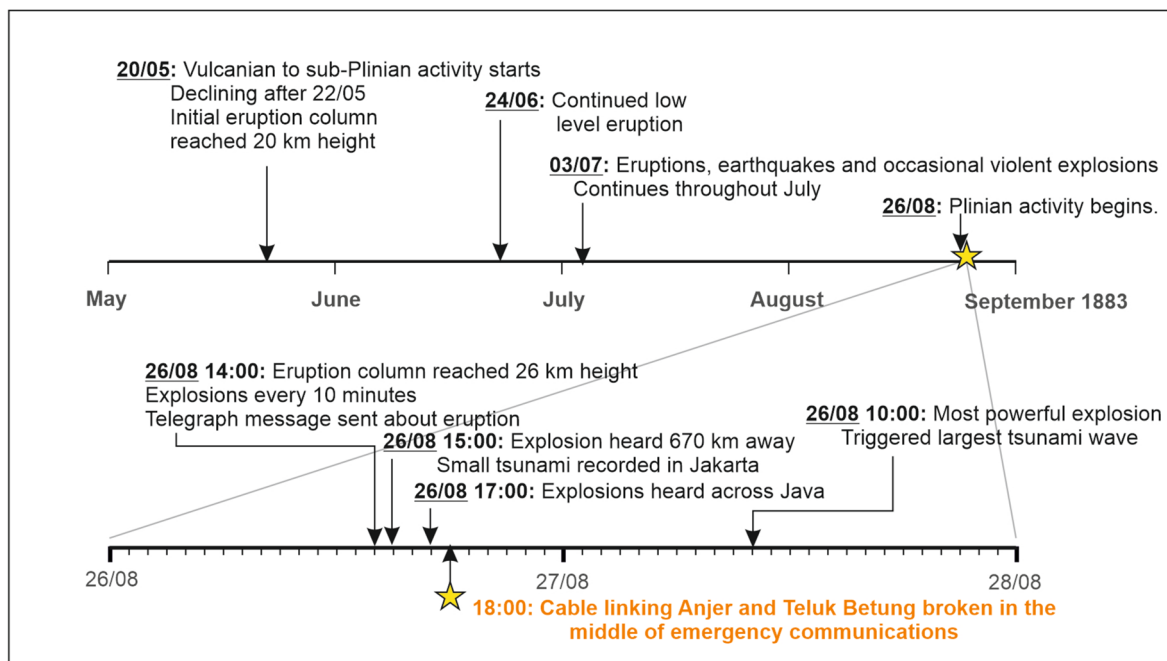
Fig. 2 Timeline for the 1883 eruption of Krakatau volcano, Indonesia, highlighting key events in the build-up to the climactic eruption and the timing of damage to the subsea telegraph cable connecting

Anjer and Teluk Betung (yellow star) that related to a tsunami, based on accounts and events documented in Verbeek (1885), Latter (1981), Dörries (2003), Madden-Nadeau et al. (2021), and Toivanen (2021)

The 1883 eruption of Krakatau commenced in late May, with Vulcanian to sub-Plinian activity that created a 20-km-high eruption column on 20 May (Fig. 2; Table S-2; Self 1992). The eruption escalated on 26 August, as reported by a telegraph message that was sent along the subsea cable network from Batavia that reached Europe within a day (Dörries 2003). This was followed by more intense explosions, culminating in tsunamis, during which a cable that linked Anjer and Teluk Betung to the north was cut at 18:00 on 26 August (Fig. 2). Damage was attributed to seafloor entanglement of vessel masts and debris that were sunk during a tsunami. Arrangements were made for repair of the broken cable, which commenced at 01:00 (Toivanen 2021) but were ultimately unsuccessful due to the impacts from the tsunami. As a result of the extreme destruction in Anjer and a lack of capacity to repair the cable station, the cable route crossing the Sunda Strait was abandoned, and a different route selected. Aside from this damaged cable, the wider regional telegraphic network continued to be important through the culminating stages of the eruption. Soon after the paroxysmal 10:00 explosion on 27 August, an overland telegram from Serang (west Java) to Batavia reported the fall of pumice and mud rain, with a message afterwards reporting that Merak, and all telegraph lines west of Serang, had been destroyed. The line from Serang was then interrupted for around 24 h (Simkin and Fiske 1983). The subsea network from Batavia remained active, however, and was important in distributing news globally of the event. Several messages on the late morning of 28 August reported the extreme destruction on the coastlines of the Sunda Strait, including the message at 12:00 that said “where once Mount Krakatau stood, the sea now plays” (Simkin and Fiske 1983).

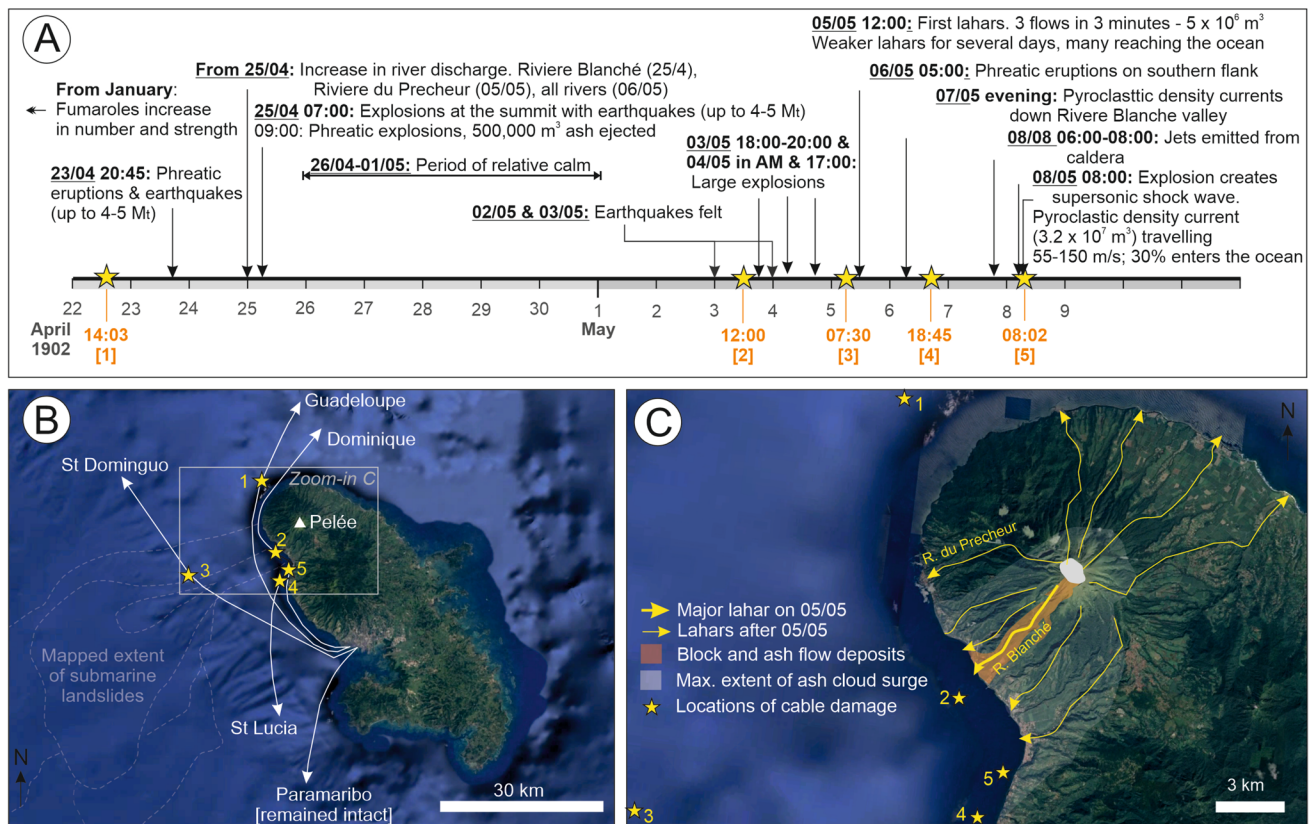
Fig. 3 Timeline for the 1902 eruption of Mount Pelée, Martinique, highlighting **A** the timing of five discrete instances of cable damage (yellow stars) and key events in the build-up to the climactic eruption on the 8 May; **B** the approximate locations of cables (and the locations to which they connected) and extent of older submarine landslides as mapped by Brunet et al. (2016); and **C** detailed view

showing the known pathways of lahars and the extent of ‘block and ash flow’ and ‘ash cloud’ deposits that indicate the pathway of the large PDC on 8 May. Timeline based on observations in Westercamp (1987), Chrétien and Brousse (1989), and Tanguy (1994). Background relief based on Google Earth

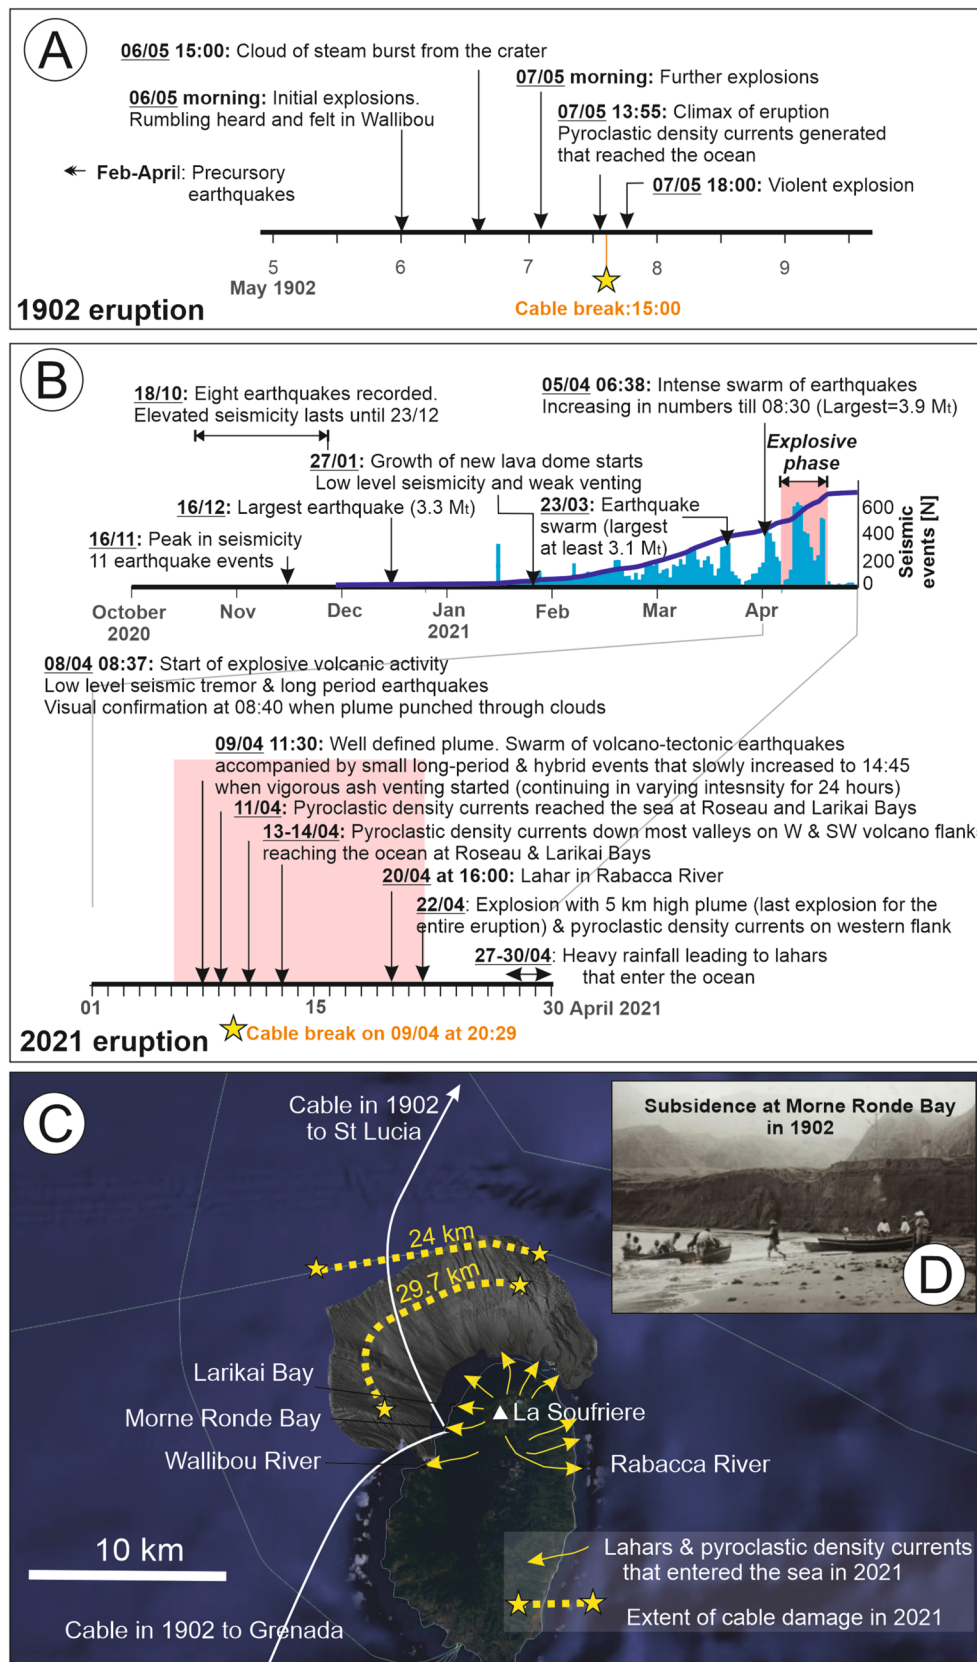
Fig. 4 Timeline for eruptions of La Soufrière, St Vincent, and known locations of cable damage, including **A** 1902 eruption during which six telegraph cables were damaged (although the precise timing is only known for one, and the locations of cables remains unclear based on existing information); **B** 2020/2021 eruption during which two cables were damaged (the timing is only known for the cable closest to shore), which includes information on seismicity derived from land-based seismic monitoring; **C** location of cables and extent/site of damage (where known), and pathways of lahars and PDCs that reached the sea during the 2021 eruption phase; and **D** photograph illustrating collapse of shoreline along a 200-m stretch of coastline at Morne Ronde Bay (from Nottingham Evening, 1902). Timeline and locations of events based on accounts and Ronde observations in Foster Huggins (1902), Anderson and Flett (1903), Roobot and Smith (1975), Pyle et al. (2018), Phillips et al. (2024) and Robertson et al. (2024). Multibeam backscatter data to the north of St Vincent that illustrate seafloor relief is from Irvine and Lipsham (2019)

More recently, two fibre-optic cables were damaged following the 2020/21 eruption of La Soufrière, which was also a VEI 4 event (Fig. 4B, C; Robertson et al. 2024). As St Vincent now has five international cables that connect to the south (i.e. far away from the volcano), data traffic could be

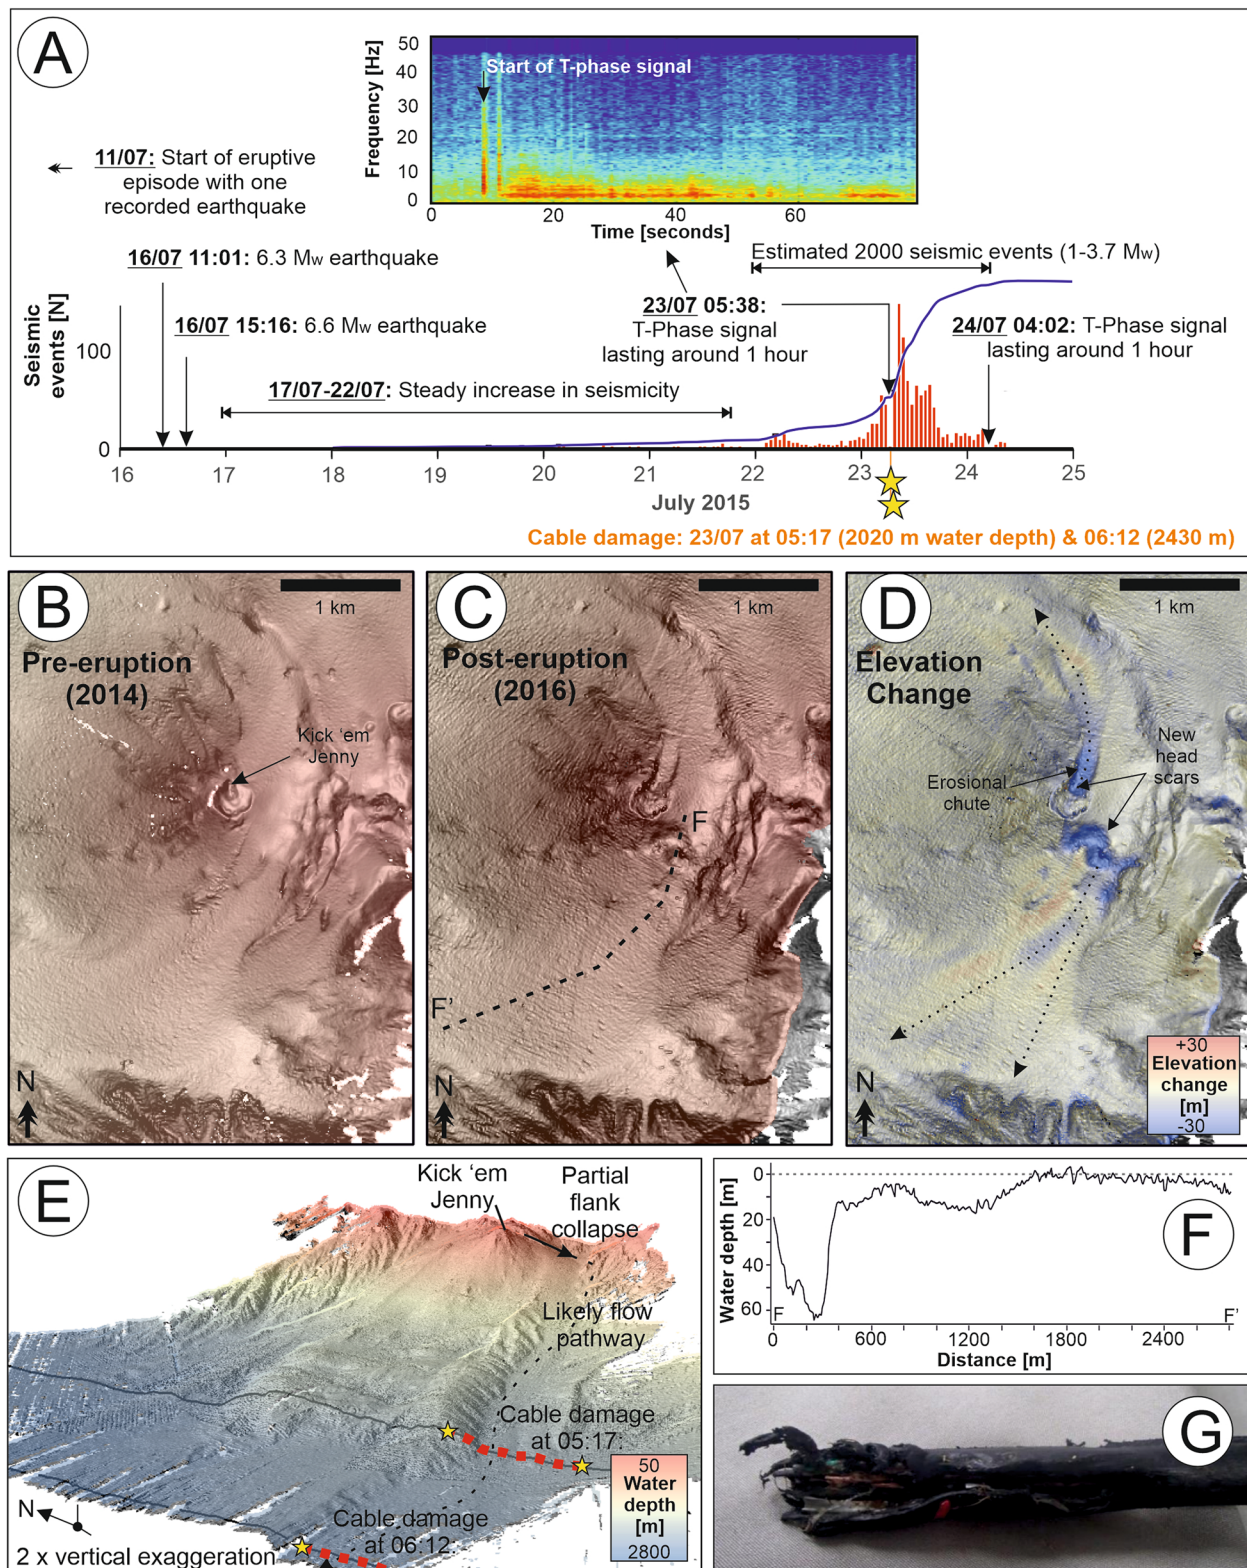
Fig. 5 Timeline and context for 2015 eruption of Kick ‘em Jenny and associated damage to two subsea cables. Observational time series data (A) are based primarily on information derived from land-based seismic monitoring network, which includes an hour-long T-phase signal (inset shows focus on the first minute of that signal from Latchman et al. 2023) that coincides with when the cable damage occurred. Maps of seafloor relief illustrate the seafloor morphology before (B), in 2014, and after (C), in 2016. D Change in elevation from 2014 to 2016. Two collapse scars on the volcano flank are evident: one on the south-east flank that produced a mass flow that flowed to the south-west where it reached a submarine channel as shown in the 3D seafloor rendering in E where the inferred pathway of the flow that damaged the two seafloor cables is annotated. A profile of seafloor elevation change between 2014 and 2016 along the collapse on the south-east flank is shown in F. A photograph of the northern-most recovered end of the cable closest to Kick ‘em Jenny is shown in G. Seafloor surveys are from Allen et al. (2018)

connections between Grenada, St. Vincent, Barbados, and Trinidad (Fig. 5A, E). Trinidad had one unaffected subsea cable, which provided critical back-up, demonstrating the importance of geographic diversity in cable routing. The

cable damage was recorded first with a cut at 2020-m (at 05:17) and then 2430-m water depth (at 06:12), at straight-line distances of 12 km and 18 km respectively to the west of Kick 'em Jenny (Fig. 5E, G). Damage affected a 3–4-km

length of each cable, as noted during the repair operations. Repairs were initially delayed until it was deemed safe to enter an exclusion zone around the volcano and completed on 4 August (TSTT 2015; TechNews, 2015). The timing of both instances of cable damage precedes the peak in seismicity that represents the climax of volcanic unrest (Fig. 5A; Latchman et al. 2023).

An hour-long T-phase signal was recorded at land-based seismometer stations starting at around 05:38–05:44 (Fig. 5A; Allen et al. 2018; Latchman et al. 2023). While T-phase signals have been linked to submerged volcanic explosions, the unusually long duration and the fact that this T-phase signal progressively increased in intensity over the first 10 min indicate that this signal may instead have been caused by a submarine mass movement (Allen et al. 2018; Latchman et al. 2023). Seafloor surveys performed in 2014 and 2016 reveal debris flows occurred on the southern flank of the volcano, as a result of partial flank collapse. These events emplaced remobilised material over an area of $9.6 \times 10^3 \text{ m}^2$ with an average thickness of 10 m towards the south-east (as determined by Allen et al. 2018; Fig. 5B–F). This collapse was likely primed by oversteepening of the flank of Kick ‘em Jenny during an earlier eruption in 1988, and ultimately triggered by intense seismic activity in 2015 (Latchman et al. 2023).

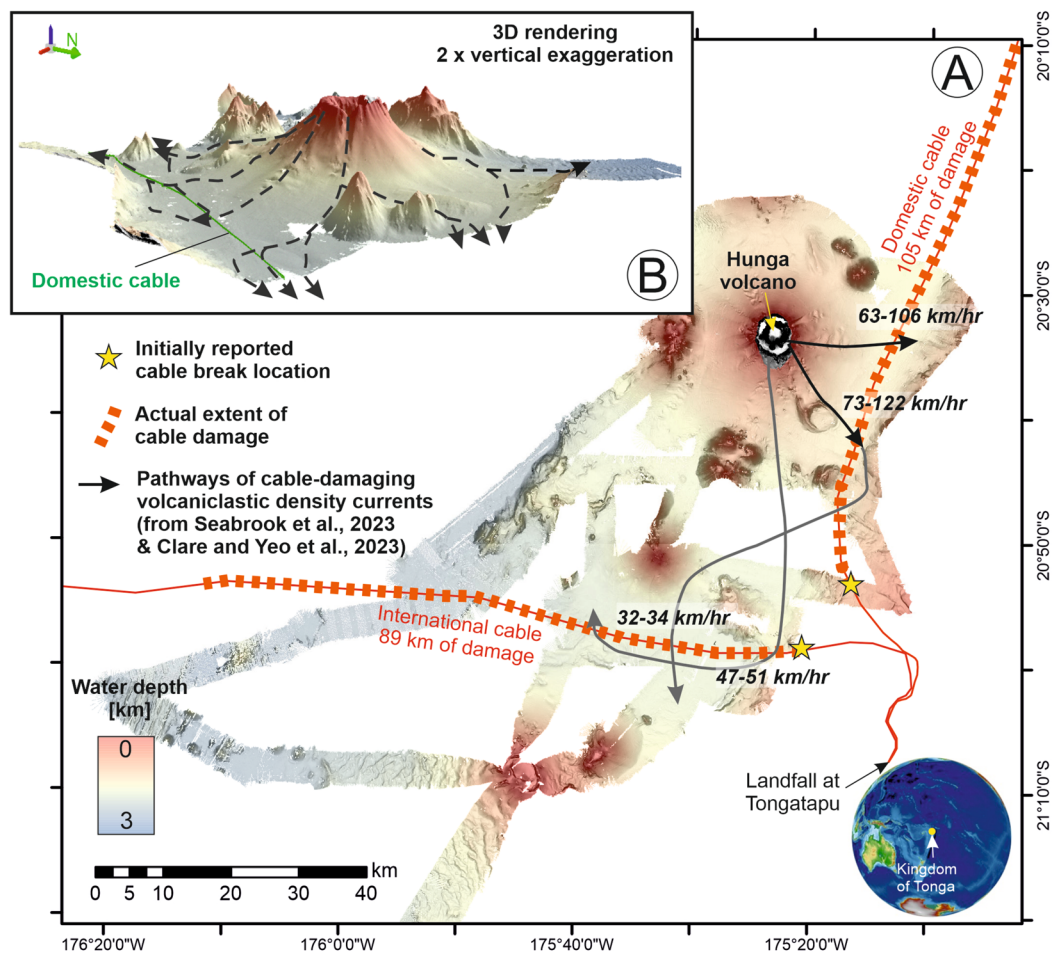
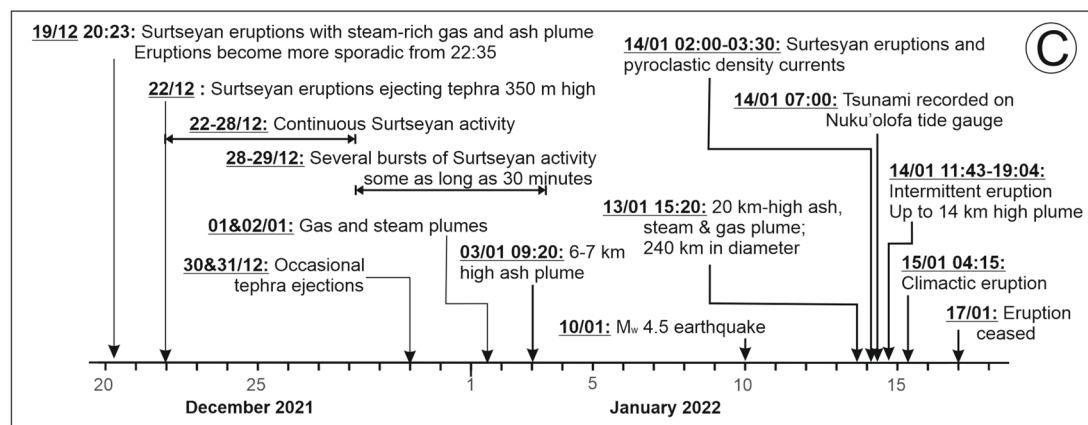
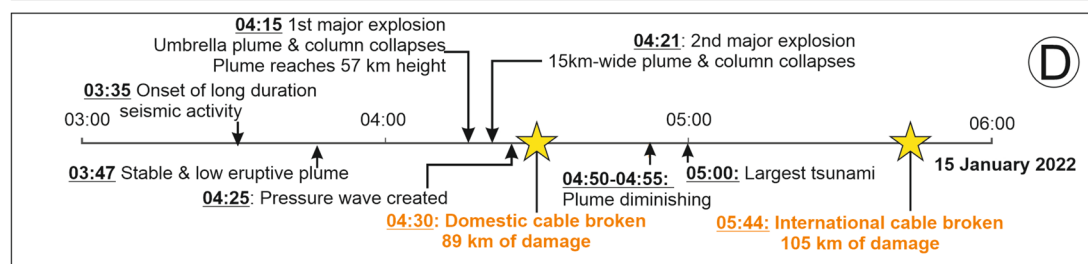
Fig. 6 Timeline and context for 2021–2022 eruption of Hunga volcano, Kingdom of Tonga. **A** Location and extent of subsea telecommunications damage and/or burial and indicative pathways of volcanoclastic density currents that intersected with cables overlain on bathymetric data acquired 3 months after the eruption. **B** Three-dimensional rendering of Hunga volcano illustrating the many pathways likely taken by volcanoclastic density currents that radiated from Hunga volcano during the eruption on 15 January 2022, which were steered by pre-existing relief (based on Seabrook et al. 2023 and Clare et al. 2023a). **C** Timeline of the eruption of Hunga volcano from inception in December 2021, to completion on 17 January 2022, and detail **D** on the climactic phase of the eruption when the two sub-sea cables were damaged

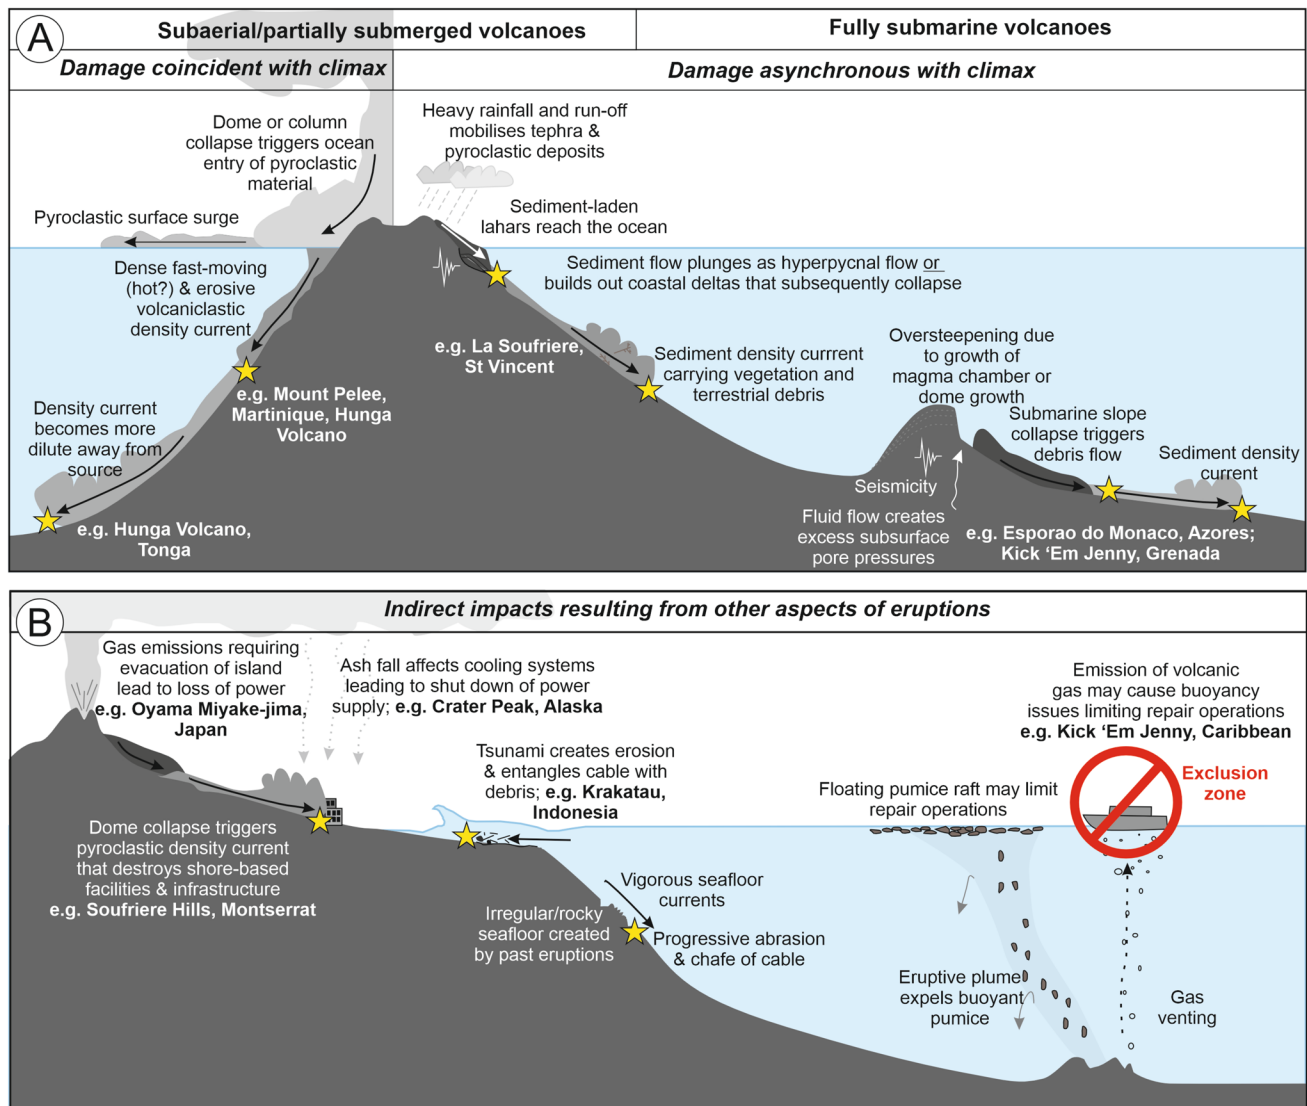
Fig. 7 Schematic diagram showing different aspects of volcanic eruptions and associated hazards that can damage subsea cables. **A** Direct impacts associated with volcanic eruptions, including those that coin-

cide with an eruption climax and those that occur asynchronously. **B** Indirect effects of volcanic eruptions that can impact subsea telecommunications connections

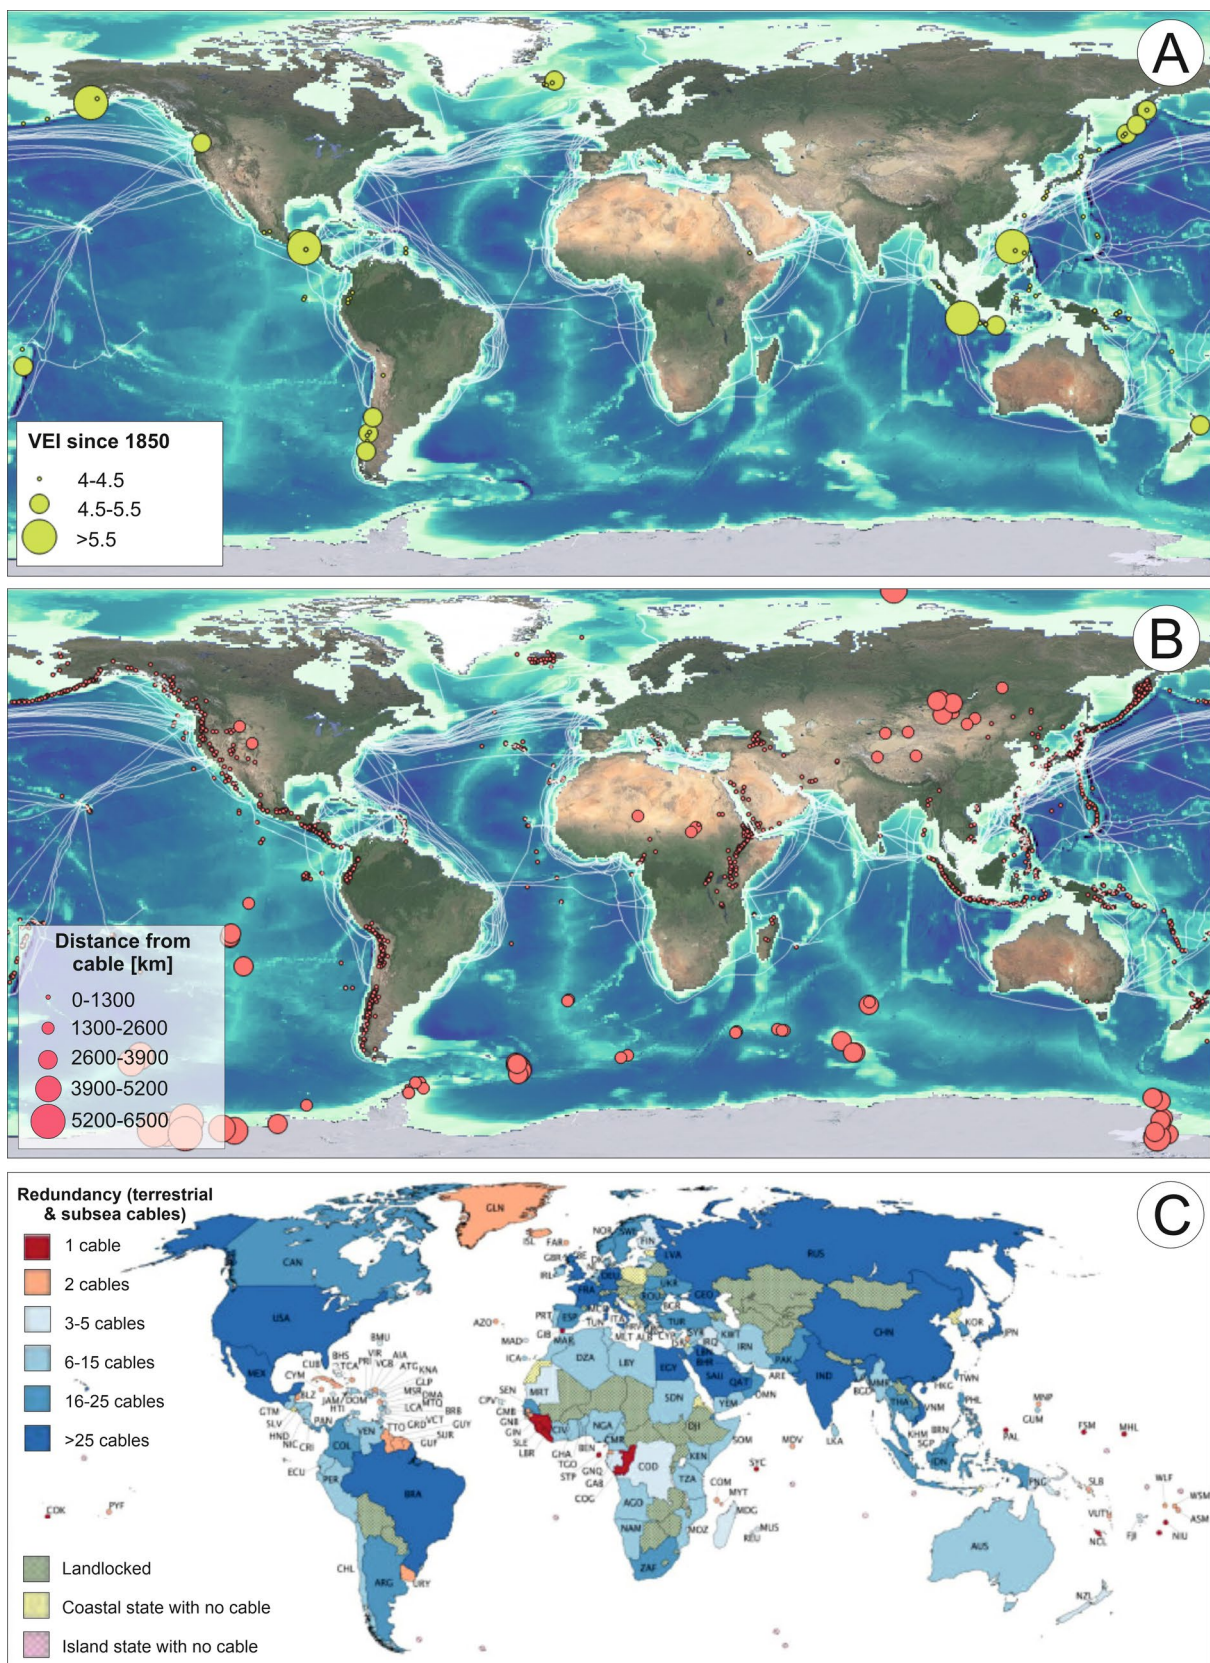
Fig. 8 Global context for risks posed by volcanic eruptions to sub-sea cables, including: reported Volcanic Explosivity Index (VEI) for eruptions recorded worldwide based on GVP (2024) since 1850 (i.e. when subsea telegraph cables were first installed) for eruptions greater than VEI 4 (A); distance of mapped volcanoes relative to in-service subsea telecommunications cables based on known volcanoes (B); and overview of national redundancy of telecommunications based on number of terrestrial and subsea cable systems (modified from Franken et al. 2022) (C). Note that many of the least resilient locations are in volcanically active regions (e.g. South Pacific, Caribbean). Global topography and bathymetry in (A) and (B) from Smith and Sandwell (1997)

Locations that have few cable connections are generally more vulnerable (Fig. 8C), such as Tonga that has only one international connection; hence, it is important to ensure routes are carefully designed and that appropriate back-up measures (e.g. satellite communications) are in place in case of any outages. However, a greater number of cables does not always guarantee resilience if systems are all laid in a location that could be exposed to the same hazardous event, as was the case for the 1902 eruptions of Mount Pelée (Martinique) and La Soufrière (St Vincent). Several so-called pinchpoints exist globally, where multiple cable systems have to be routed close to
