A building stone assessment of the buff sandstone masonry of the Hawick Flood Protection Scheme, Scottish Borders

Commissioned report CR/25/069

DECARBONISATION AND RESOURCE MANAGEMENT PROGRAMME
COMMISSIONED REPORT CR/25/069

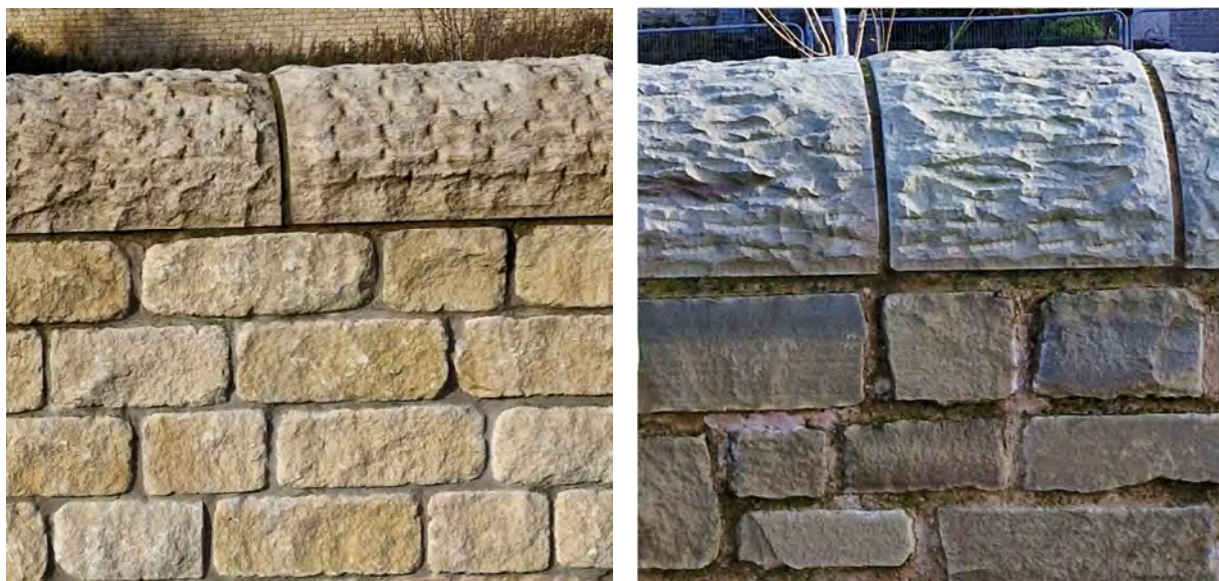
Figure 1 (left). Image showing the buff sandstone walling and copes featuring in part of HFPS work section 25 (Teviot Road). Ordnance Survey grid reference [NT 5020 1460].

Figure 2 (right). Image showing the grey sandstone walling and copes featuring in part of HFPS work section 26 (Wee Haugh). Ordnance Survey grid reference [NT 5030 1490].

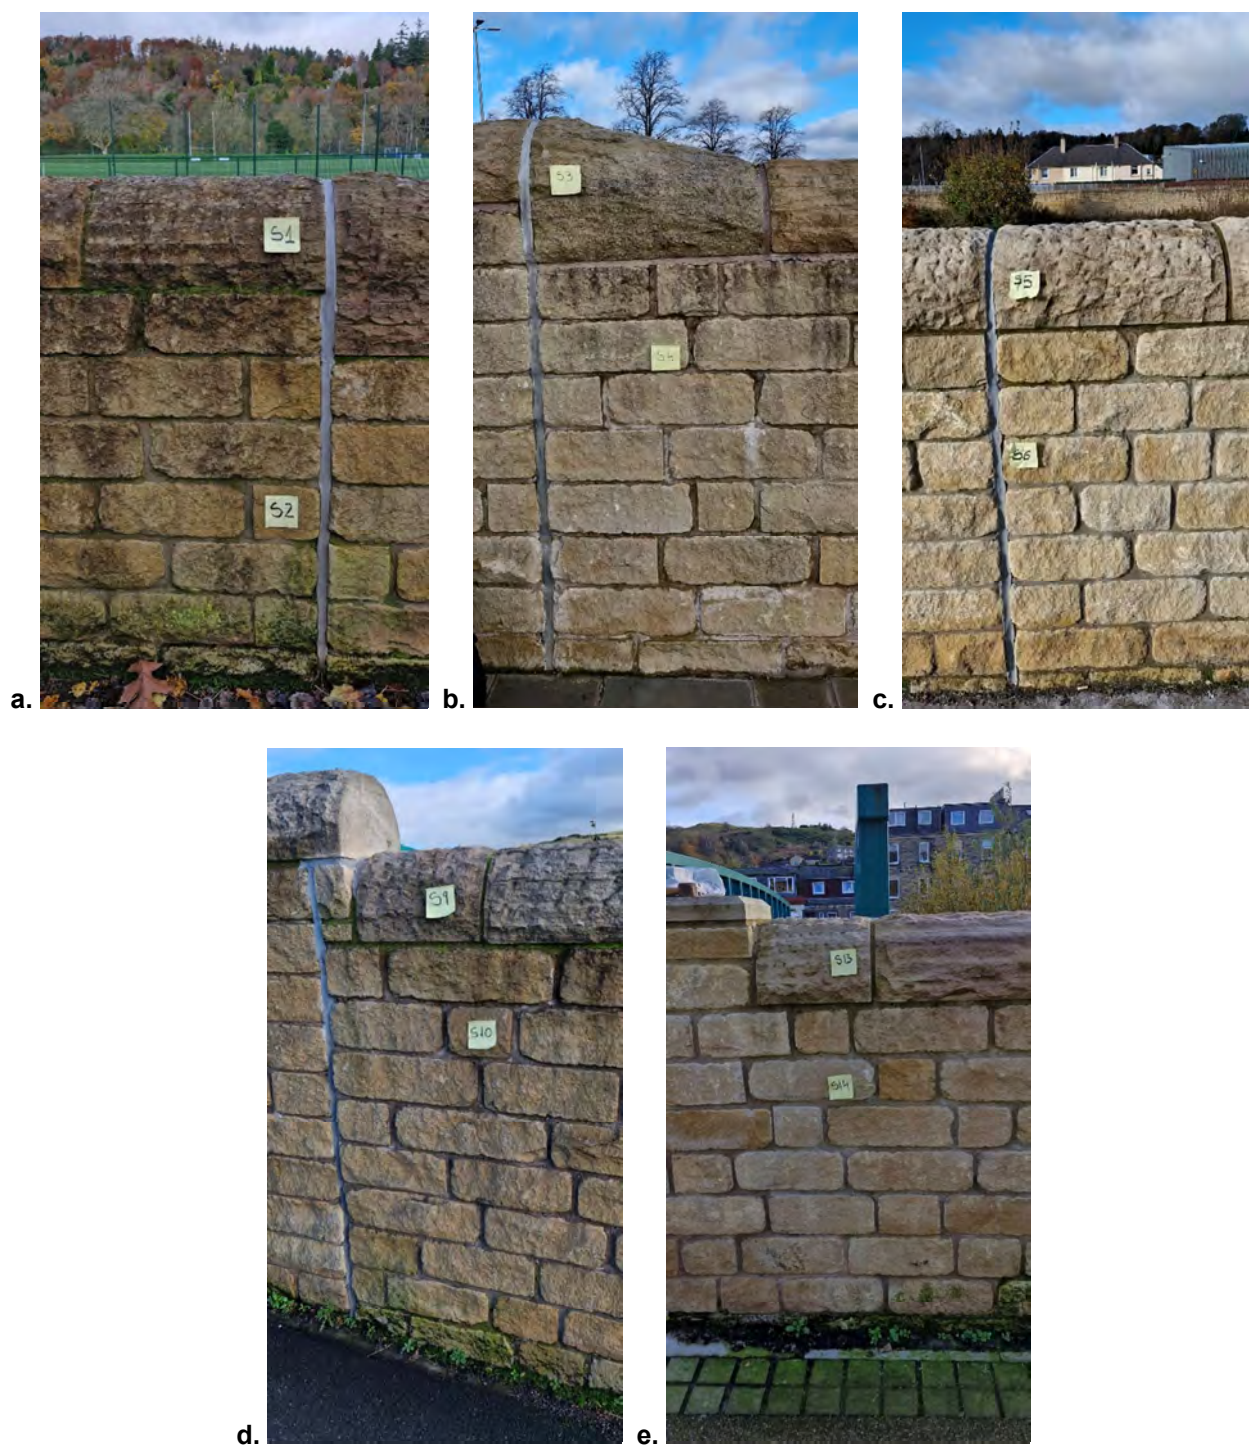
Figure 4. Photographs of the buff sandstone masonry at the five sampling locations ('numbered' stickers identify the sampled masonry units):

- a.** Volunteer Park (work section 16); samples S1 (copestone) and S2 (walling)
- b.** Common Haugh (work section 2), samples S3 (copestone) and S4 (walling)
- c.** Teviot Road (work section 25); samples S5 (copestone) and S6 (walling)
- d.** Bath Street (work section 7); samples S9 (copestone) and S10 (walling)
- e.** Mansfield Road (work section 9); samples S13 (copestone) and S14 (walling)

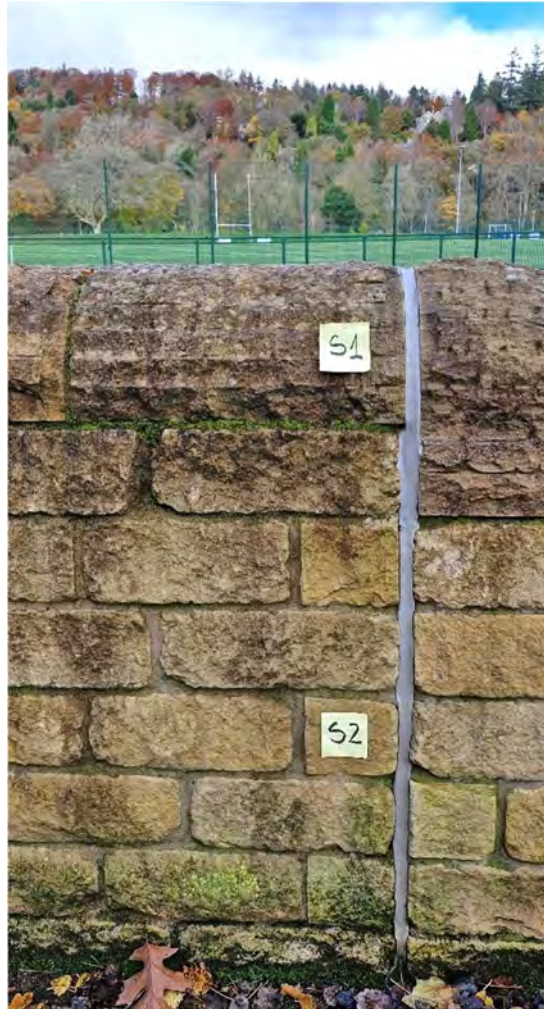
Figure 7. Wall at sampling location, Volunteer Park (work section 16). Numbered stickers on the wall indicate the blocks each sample was collected from.

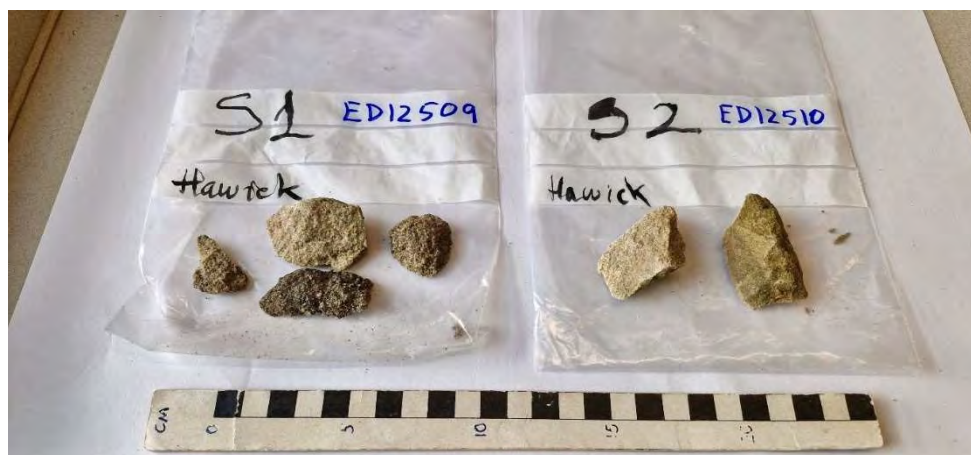
Figure 8. Samples S1 and S2, which were obtained from the copestones and walling, respectively, at the Volunteer Park sampling location (work section 16).

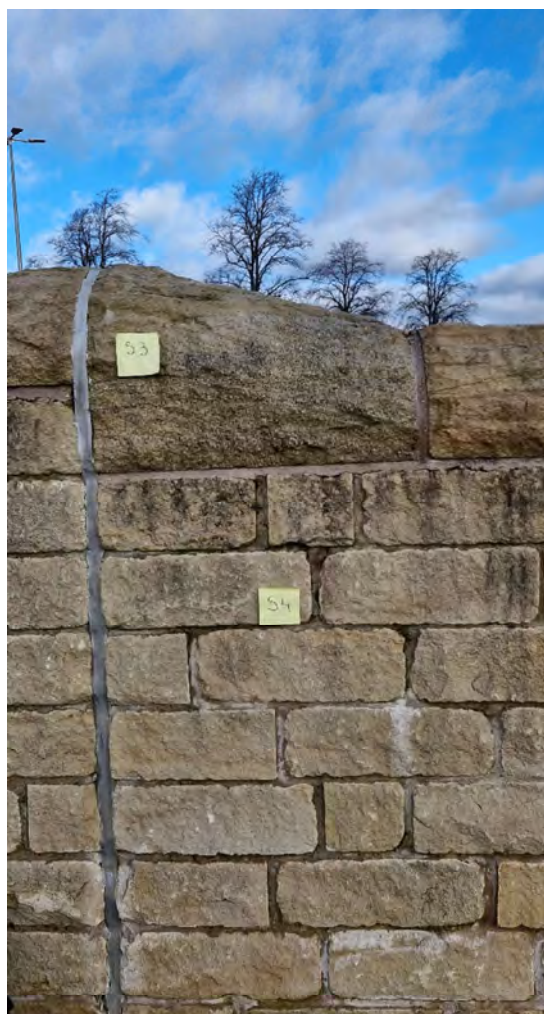
Figure 11. Wall at sampling location, Common Haugh (work section 2). Numbered stickers on the wall indicate the blocks each sample was collected from.

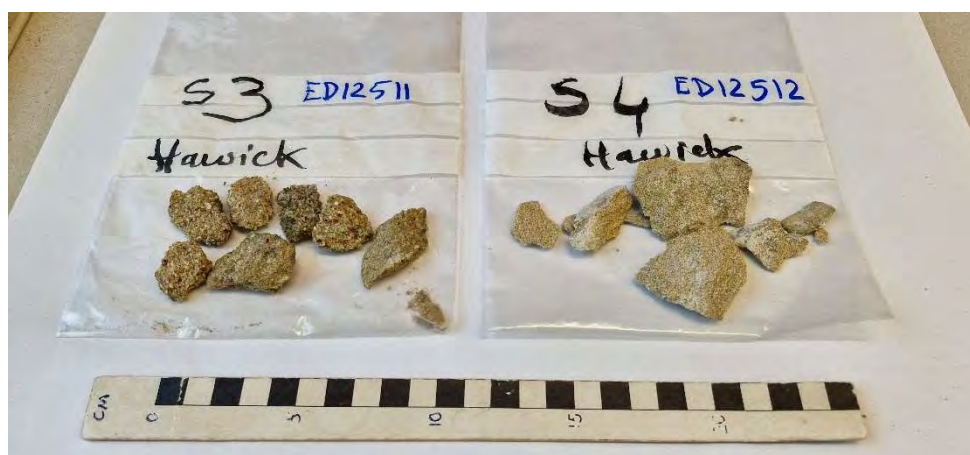
Figure 12. Samples S3 and S4, which were obtained from the copestones and walling, respectively, at the Common Haugh sampling location (work section 2).

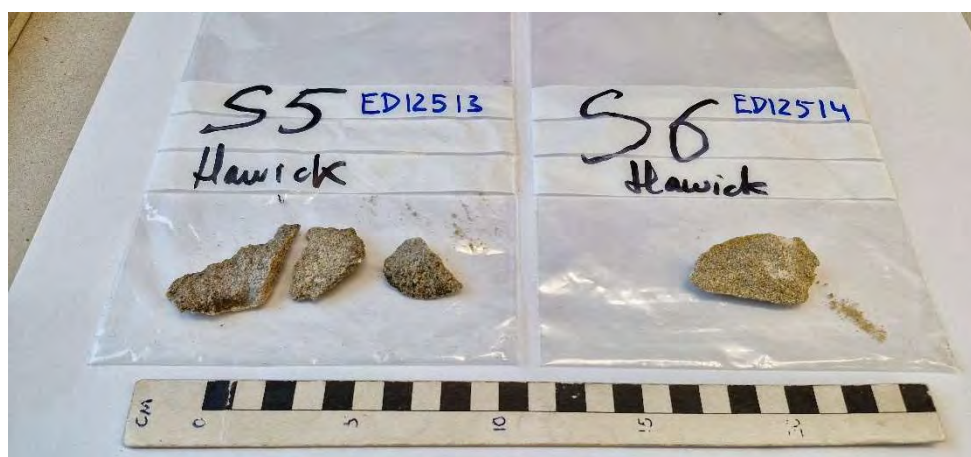
Figure 16. Samples S5 and S6, which were obtained from the copestones and walling respectively, at the Teviot Road sampling location (work section 25).

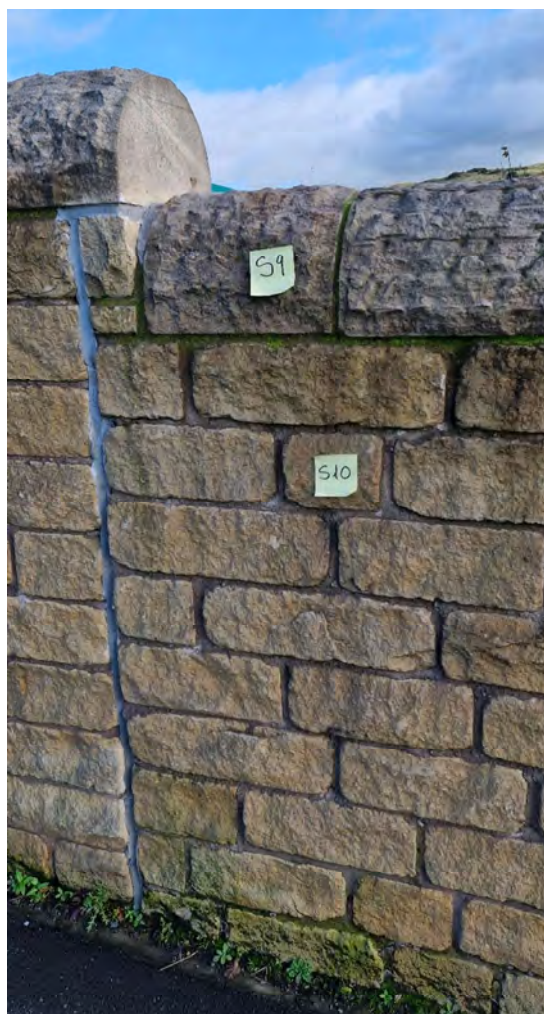
Figure 19. Wall at sampling location, Bath Street (work section 7). Numbered stickers on the wall indicate the blocks each sample was collected from.

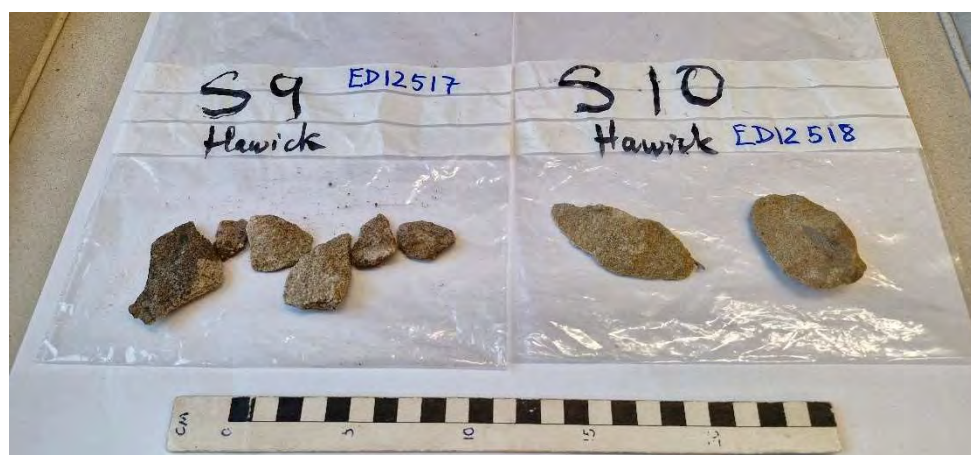
Figure 20. Samples S9 and S10, which were obtained from the copestones and walling, respectively, at the Bath Street sampling location (work section 7).

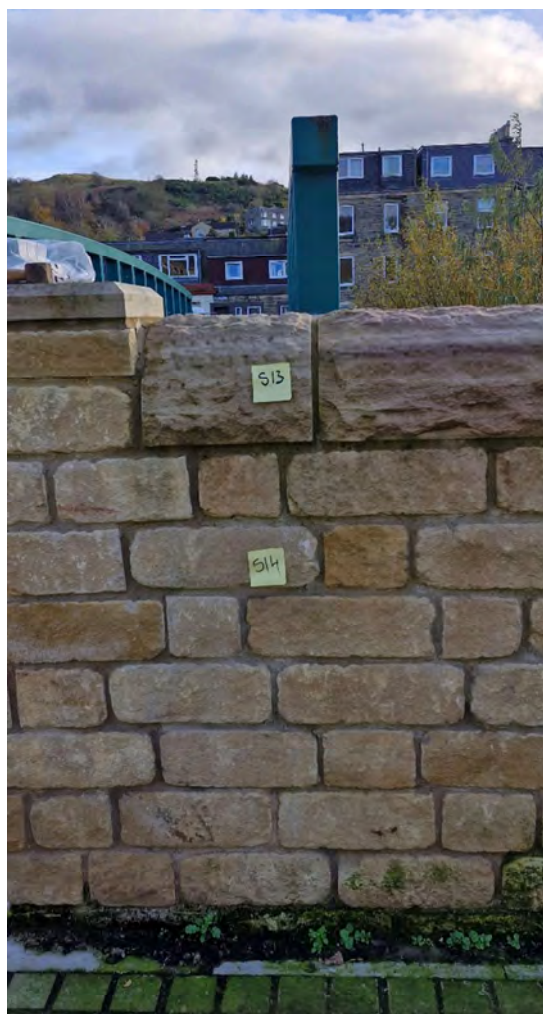
Figure 23. Wall at sampling location, Mansfield Road (work section 9). Numbered stickers on the wall indicate the blocks each sample was collected from.

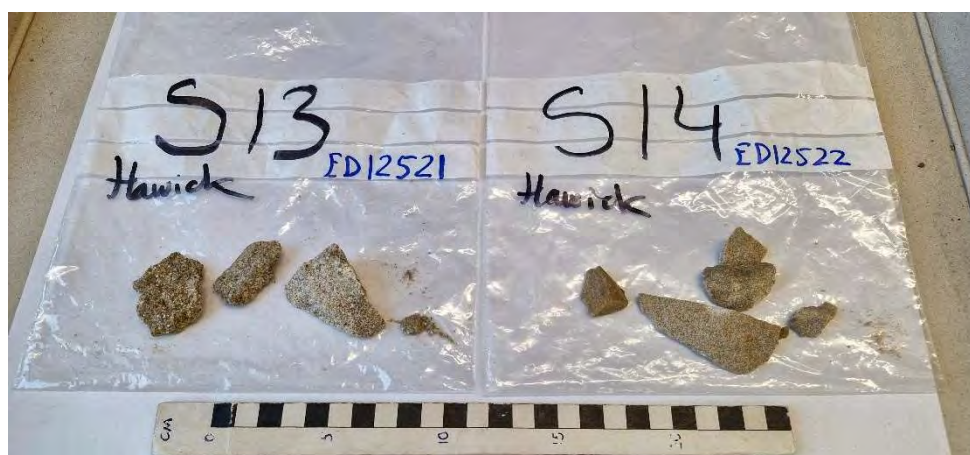
Figure 24. Samples S13 and S14, which were obtained from the copestones and walling, respectively, at the Mansfield Road sampling location (work section 9).

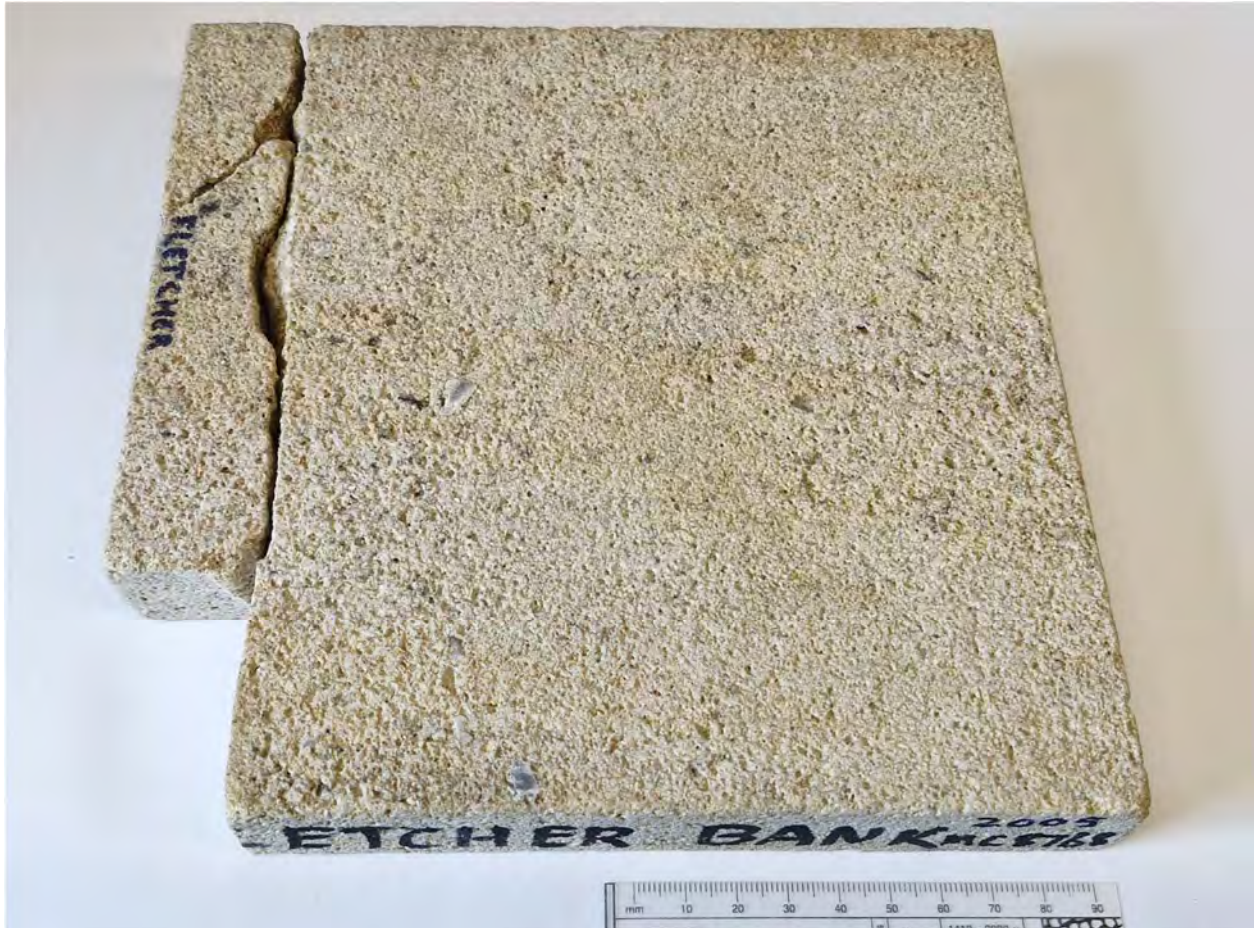
Figure 27. Sample of Fletcher Bank sandstone held within the BGS Collection of Building Stones. The scale shown is in millimetres.
