A report for Edinburgh World Heritage and The City of Edinburgh Council by British Geological Survey

COMMISSIONED REPORT CR/07/148

Historic sandstone pavement in the New Town of Edinburgh: A study of materials and paving patterns

Ewan K. Hyslop & Sarah L. Hamilton

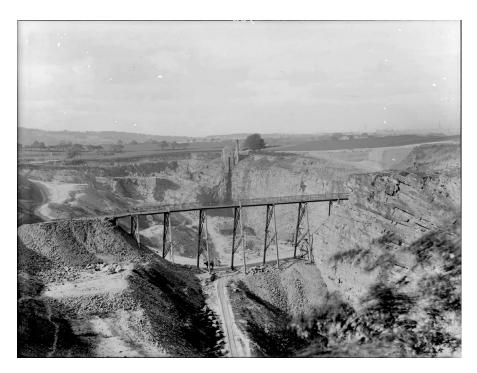
Photos 1 & 2. Hailes quarry in 1913. Photo 1 (Top image; BGS photo P000183) shows general view of the quarry looking north showing a steam pump engine house with Corstorphine Hill and Donaldson's Hospital in the background. Photo 2 (Bottom image; BGS photo P000184) is detail of part of the quarry face showing the thinly bedded nature of the sandstone at the south end of the quarry. Hailes quarry is now infilled and used as a public park.

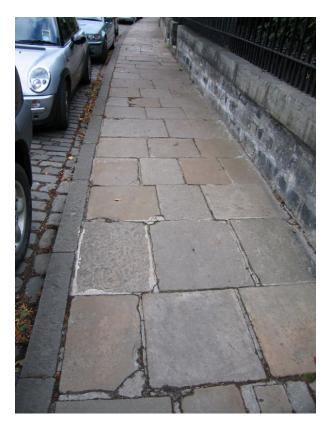
Photo 3. Typical section of sandstone paving in Ann Street showing relatively small slab size and range of colours from grey to reddishbrown. Note the variable surface texture including ripple textured surface to some blocks.

The paving is a dullish grey-brown sandstone, worn to give a smooth surface, some blocks showing ripple bedding with variable stronger reddish-brown colour. The slabs are aligned perpendicular to the kerb with an irregular course width, and multiple blocks of mixed width are present within a course (Photo 3). The slab size is variable with relatively small sizes in some parts of the street and larger slabs dominating in other areas. The kerbs are whinstone, with a setted gutter comprising three rows of whinstone setts aligned parallel to the kerb. The road surface comprises whinstone setts.

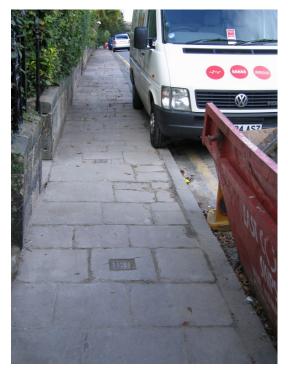
mortar. Many flagstones immediately adjacent to the kerb are commonly broken due to vehicles parking on the pavement edge (Photo 4).

Photo 4. Illustration of the modern pressures on traditional paving. The parking of vehicles on the pavement edge causes flagstones to break. (Ann Street).

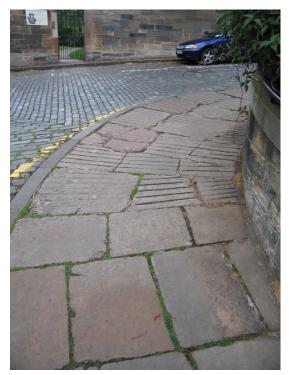
Photo 5. Corner of Ann Street and Upper Dean Terrace with slabs showing tooling with parallel grooves cut as an anti-slip measure on the slope. Note the course width fan-out around the corner.

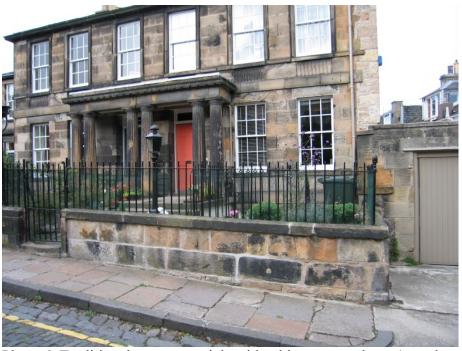
Photo 6. Traditional stone materials with whinstone roadway (setted street, gutter and kerbs) and sandstone flags to pavement, with sandstone boundary walls and buildings. The preservation of natural stone materials provides a continuity between the streetscape and buildings. (Ann Street).

The sandstone paving in Ann Street is a good illustration of the importance of stone materials in both the streetscape and the buildings. There is a continuity in the use of stone from the roadway, pavement, low boundary walls and the buildings themselves (Photo 6).

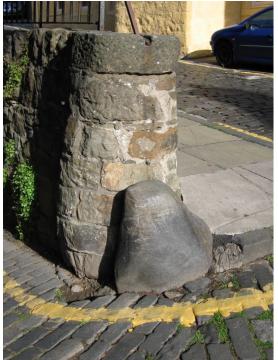
Photo 7. Spur stone (whinstone) protecting a corner, Bell's Brae.

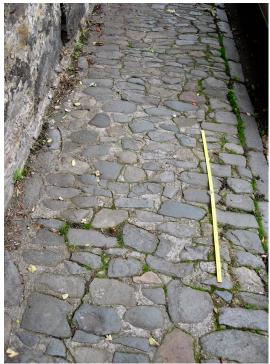
Photo 8. Pavement on Dean Path constructed using a mixture of cobbles of different stone types and reclaimed whinstone setts.

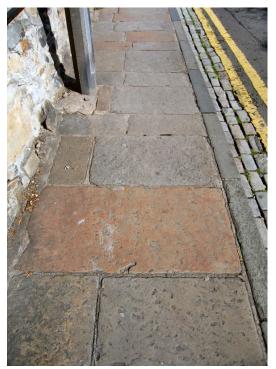
Photo 9. Traditional sandstone paving showing the typical range of colours and natural surface textures caused by presence of ripple bedding within the sandstone. This provides a natural antislip surface (Bell's Brae).

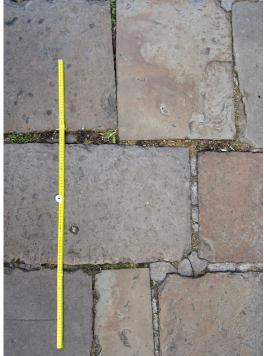
On the north side of the main part of Bells Brae there is a near-continuous section of sandstone paving (Photo 9). Unfortunately most of it appears to have been re-dressed and re-laid with little care to avoid irregular joint widths (Photo 10). Many blocks display sawn edges and in places there are repairs of asphalt. The sandstone has an overall grey-brown colour with some more reddish blocks. The surfaces are typically smooth, with some distinctive ripple textured surfaces. The bock size is generally small, similar to Ann Street, and ribbed tooling is occasionally preserved on the surfaces of less worn slabs. The kerbs are whinstone and granite.

Photo 10. Poor quality re-laid pavement using original sandstone slabs cut with a mechanical saw. Slab edges and joint widths are irregular and the hard cement mortar is broken. Scale is 1 metre (Bells Brae).

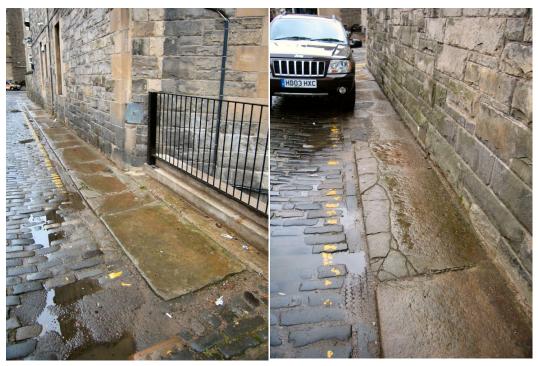
A single row of sandstone paving slabs are present on the south side at the east end of **Lynedoch Place Lane**, near the entrance to **Drumsheugh Gardens** (Photo 11). The slabs are large in size and aligned parallel to the lane. No kerb is present, and a thin whinstone gutter borders the whinstone setted roadway. The sandstone is fine to medium grained, with a pale buff-brown colour varying to a reddish-brown patina where worn. The surfaces commonly displays a ripple bedded 'contour-textured' surface. The measured drawing of Lynedoch Place Lane is shown in Figure 4. The slab size is a fixed width (c.840 mm) with variable length ranging from 725 to c.1500 mm. Many blocks are cracked at the pavement edge where mounted by vehicles (Photo 12). Some slabs are missing and have been replaced by asphalt and cement.

Photo 11. Typical single width sandstone paving in a lane, with large slabs aligned parallel to the lane, and no kerbstone. Note the poor maintenance of the whinstone setted lane. (Lynedoch Place Lane).

Photo 12. Typical damage to natural sandstone paving caused by parked vehicles mounting the footway. (Lynedoch Place Lane).

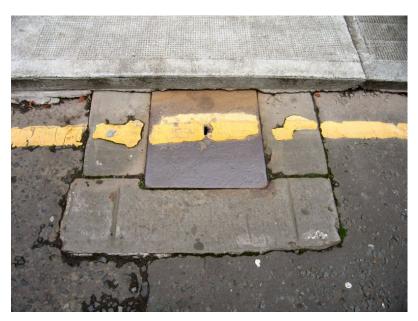
Photo 13. Example of one of the few remaining sandstone surrounds to cellar entrances on Atholl Crescent, on the road adjacent to the pavement. The entrance itself is infilled by a metal plate.

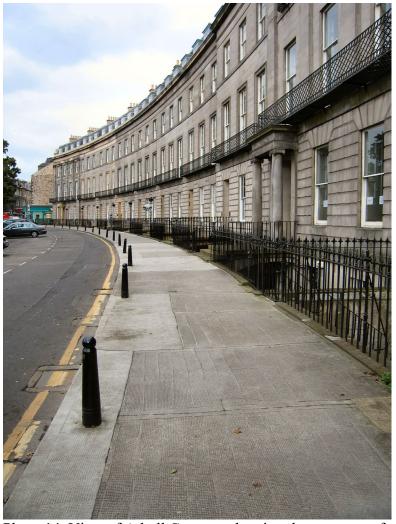
Photo 14. View of Atholl Crescent showing the presence of unsightly concrete pavement. A number of entrances to coal cellars are present at the road edge, marked with sandstone surrounds.

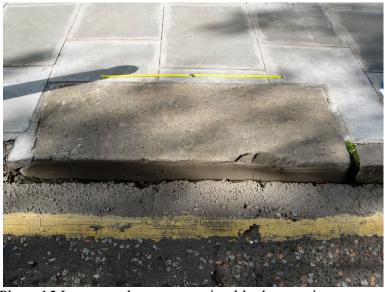
Photo 15.Large sandstone mounting block opposite a property entrance in Coates Crescent (No. 16). A number of these original mounting blocks are still present, although all the pavement surfaces have been replaced by concrete.

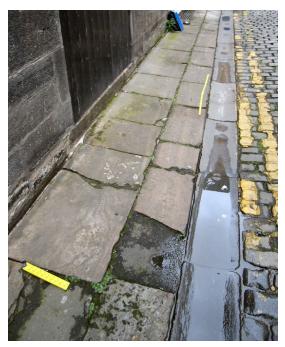
The measured section of sandstone paving in Thistle Street NE Lane (Figure 6) consists of a single course of slabs aligned parallel to the kerb, with an unusually thick sandstone kerb, and dished whinstone gutter and setted roadway (Photo 16). The slabs have a relatively dark purple to grey-brown colour with smooth surfaces. Less worn slabs show remnants of coarse broaching aligned perpendicular to the slab direction. The sandstone kerb blocks are c.345 mm wide with a variable block length ranging from c.600 to c.1340mm, with a ripple bedded texture on surfaces. Several blocks are cracked, other show asphalt repairs (Photo 17). Caithness flagstone (now badly broken) has been used in the lane further to the west.

Photo 16. Thistle Street NE Lane. Single row of sandstone flags aligned parallel to the broad sandstone kerb, with dished whinstone gutter and whin setted roadway. Note tarmac repairs to broken and missing kerbstone.

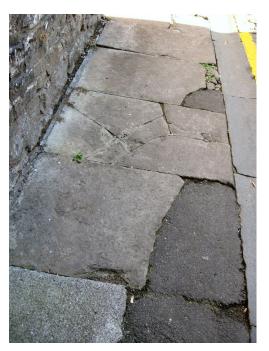
Photo 17. Original sandstone paving in Thistle Street NW Lane, showing damage due to vehicle parking with tarmac and concrete repairs.

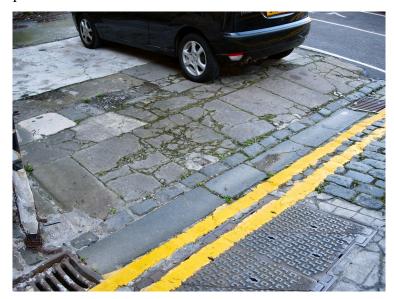
Photo 18. Damaged area of sandstone paving with whinstone kerb and gutters in Hill Street North Lane.

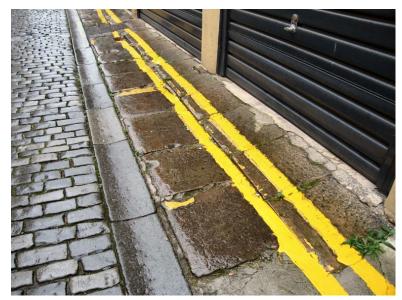
Photo 19. Well-preserved section of sandstone paving in Young Street N Lane, showing a double row of sandstone flags aligned parallel to the kerb, with dished whinstone gutter and whinstone setted roadway.

- 3. Only one lane (Young Street North Lane) has two courses, each of relatively square slabs, laid in an off-set pattern with no kerb and a dished whinstone gutter (e.g. Fig. 7, Photo 19).

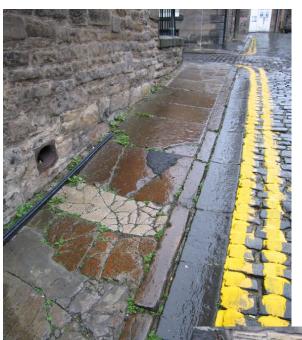
Photo 20. Poorly preserved area of sandstone paving, severely damaged by vehicle parking, with a single row of large sandstone flags with sandstone kerb, dished whinstone gutter and setted roadway (Young Street N Lane, west return to Young Street).

Photo 21. Poorly preserved area of original sandstone paving with carved drainage channel in sandstone below the downpipe outfall. Note the light coloured cement patch repairs (Young Street S Lane, west return to Young Street).

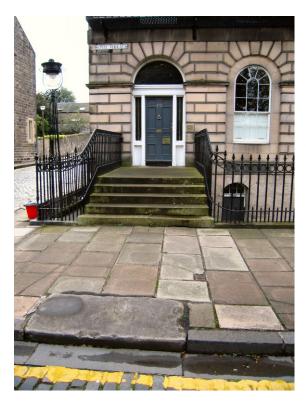
Areas of sandstone kerbstones, kerb steps and isolated sandstone mounting blocks are present on the south side of Royal Terrace, westwards from No. 5 to Greenside Church (Photo 22). The top/upper kerbstone is whinstone along the entire length of the street. A number of individual wide kerbstones (kerb block) are present opposite the entrances to Nos. 18, 21, 22, 24, 27, 37 and 40 at the east end of Royal Terrace. On the pavement itself, the original paving slabs have all been replaced with coloured concrete slab.

Photo 22. Original sandstone kerb block at the pavement edge (large grey block), directly opposite a property entrance, with whinstone kerbs, dished whinstone gutters and setted roadway. The pavement itself has been re-laid with coloured concrete slabs.

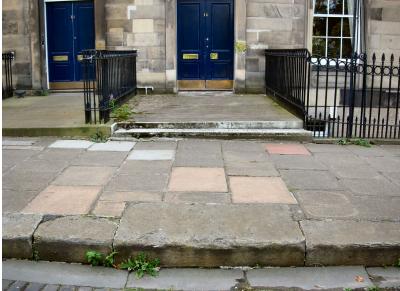
Photo 23. Original sandstone kerb and mounting block, Carlton Terrace. The paving slabs have been replaced by concrete slab. Mounting blocks are present adjacent to a number of the property entrances.

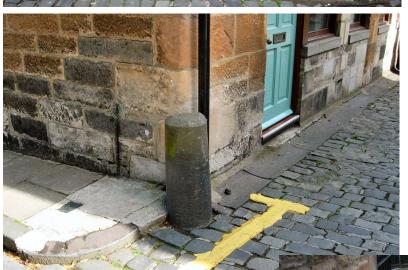
Photo 24. Whinstone spur stone Carlton Terrace Mews, with whinstone setted roadway and dished gutter stones.

Photo 25. Typical sandstone paving with a single row of large slabs aligned perpendicular to the kerb. The flagstones have a naturally rough surface due to the presence of ripple bedding laminae. The original kerb has been removed and replaced by concrete, and a dished whinstone gutter and setted roadway are present. (Carlton Terrace Lane).

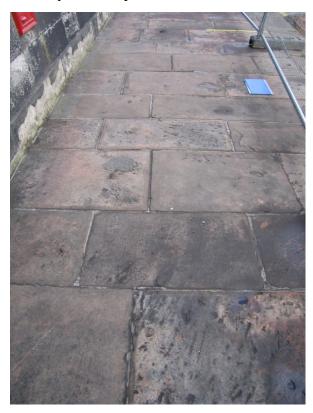
The sandstone paving at the west end of Regent Terrace has a relatively uniform size and composition (Figure 12; Photo 26). It is a medium grained sandstone, weathering to a reddish-brown buff colour. Some blocks have more variable patchy strong redbrown colours in areas of more wear. Most blocks have a smooth surface with a 'contour effect' due to wear through the bedding laminae. Approximately 25% of the blocks show a rippled surface. Slabs are present in courses aligned perpendicular to the kerb, each course of irregular width and containing multiple blocks per course. Rare broached tooling is preserved in less-worn areas on the inside of the pavement. The orientation of the tooling varies between different blocks. The roadway is whinstone setts with sandstone gutter stones preserved along a part of the paved area. The sandstone flags are of relatively large size, dominantly c.470 to 660 mm wide and 900 to 1100 mm length. Sandstone gutter stones are more uniform, typically 345 mm wide and 960 to 1300 mm long. The pavement is in good condition with little damage and only minor repairs.

Photo 26. Sandstone pavement in Regent Terrace, showing relatively regular-sized and uniform large blocks with typical dark grey-buff colour with a reddish brown patina on worn surfaces. The variable, naturally rough surface is caused by the ripple bedded nature of the sandstone.

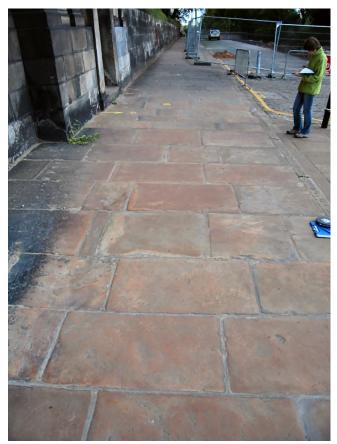
A section of original sandstone paving is present at the junction of Regent Road and Regent Terrace (Photos 27 & 28). The pattern and sandstone type are slightly different from that on the adjacent Regent Road. The sandstone is fine to medium grained with a pale grey-brown colour, ranging to stronger reddish-brown orange in many blocks. Surfaces are generally smooth but commonly have a rippled surface texture and less common linear bedding features. The pavement consists of courses of variable width, aligned perpendicular to the kerb. Surface tooling is preserved on less worn areas on the inside of the pavement with coarse broaching along the length of blocks with finer droved tooling at right angles. The pavement blocks are of widely variable size, with widths ranging from 435 to c.750mm and widely varying lengths up to c.1300mm. The pavement is in good condition with little damage and rare minor repairs, although some damage has been caused by recent service repairs.

Photo 27. Sandstone paving in Regent Road showing attractive strong reddish brown patina on worn surfaces with a variable surface texture caused by the presence of bedding and ripple laminations in the stone.

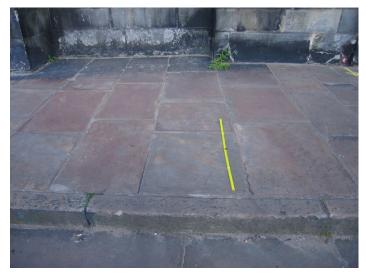
Photo 28. Detail of sandstone paving in Regent Road showing the courses aligned perpendicular to the kerb, with long kerbstones and gutter stones both made from similar sandstone. Note the dark discoloured surface where the slabs are less worn along the inside of the pavement -here the original broached tooled surface of the sandstone is preserved. Scale is 1 metre long.

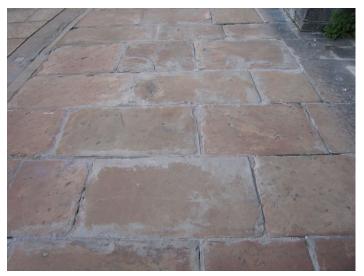
Shortly before the survey (Autumn 2006) part of this pavement was lifted and re-laid, apparently as part of utility maintenance works (Photos 29 & 30). The slabs have been crudely replaced using a grey cement mortar, and some have been damaged. In addition, several of the sandstone flags have not been replaced in the correct position within courses, resulting in less worn blocks from the inside edge of the pavement which preserve broached surface tooling being re-laid in other positions, disturbing the historical pattern.

Photo 29. Part of the sandstone pavement on Regent Road recently re-laid following utility maintenance works. The slabs have been crudely replaced using a grey cement mortar, and some have been damaged.

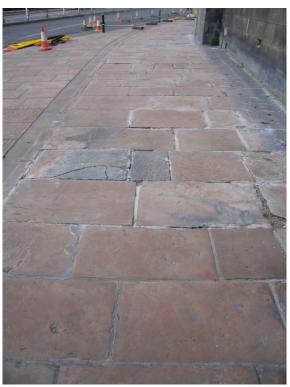
Photo 30. Part of the sandstone pavement on Regent Road recently relaid following utility maintenance works. The slabs have been crudely replaced using a grey cement mortar, several have been damaged, and the two (now broken) darker slabs in the centre of the image were originally located against the wall on the inside of the pavement, having been re-laid in the wrong position.

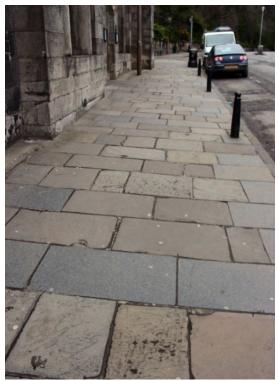
A substantial area of sandstone pavement is present at the eastern end of the north side of Waterloo Place, continuing round the corner along the south side of Calton Hill (Photos 31 & 32). Both areas appear to be have been re-laid and many original blocks have sawn edges, with areas of replacement Caithness and modern 'York sandstone' paving particularly adjacent to the kerb where it has presumably been damaged by parked cars. The slabs appear to have been re-laid to a poor standard and many are loose and broken. A short section of narrow sandstone kerb is present on Calton Hill, alongside a broad cast iron drainage channel.

Photo 31. Re-laid sandstone paving in Waterloo Place, showing a mixture of original sandstone blocks which have been redressed to smaller uniform sizes, interspersed with Caithness flagstone (dark blue-grey slabs) and modern York sandstone paving (uniform buff-grey colour). The original sandstone flags have a more variable colour and variable surface texture.

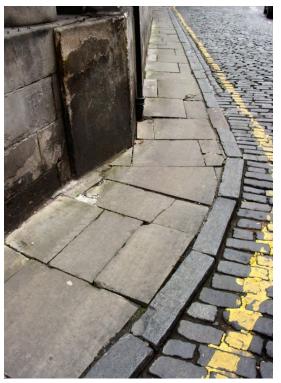
Photo 32. Corner of Waterloo Place and Calton Hill, showing 'modern' York sandstone paving with poorly detailed and badly laid sawn slabs, many of which are now loose. The buff-grey colour is more uniform and bland than nearby areas of original sandstone paving with more variable colours and surface texture.

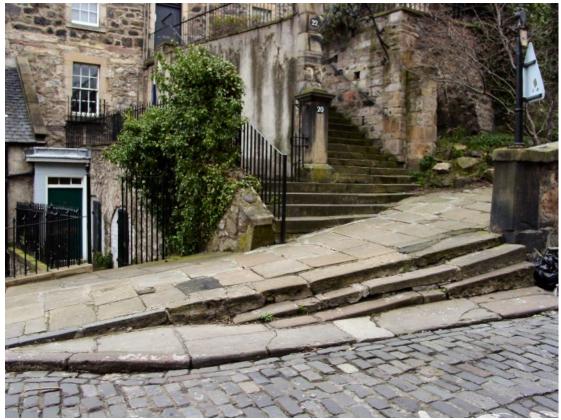
Photo 33. Original sandstone pavement and steps on the north side of Calton Place, with whinstone kerbs and setted roadway. Although the paving slabs are now in poor condition, the continuity of stone materials from roadway, footpath, entrance steps and buildings adds to the character of the historic built environment.

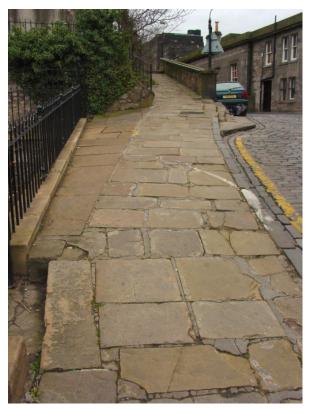
Photo 34. North side of Calton Hill showing original sandstone paving, now in poor condition, but showing typical varied character with variable block size and colour. The paving on the left-hand side adjacent to the railings appears original, whilst that to the right may have been re-laid (note latter has irregular layout, variable slab sizes and wide and irregular joint spaces).

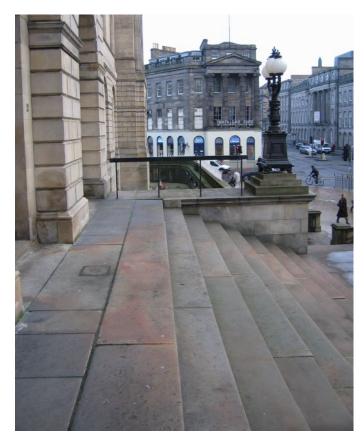
Photo 35. Main entrance steps, General Register House, showing characteristic greyishbrown colour with reddishbrown patina on worn surfaces.

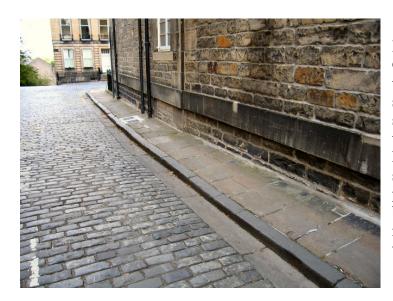
Photo 40. Entrance to Gloucester Lane showing typical arrangement of a single row of sandstone slabs aligned perpendicular to the kerb, with whinstone kerb, dished gutter and setted road surface. The pavement surface is a greybrown sandstone with a reddish-brown patina on worn surfaces.

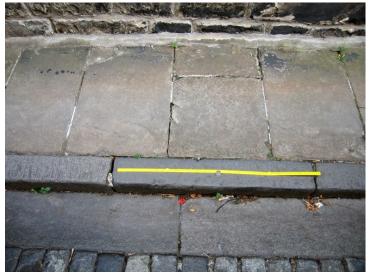
Photo 41. Gloucester Lane pavement showing sandstone slabs, whinstone kerb, dished whinstone gutter stone and setted road surface. Scale is 1 metre long.

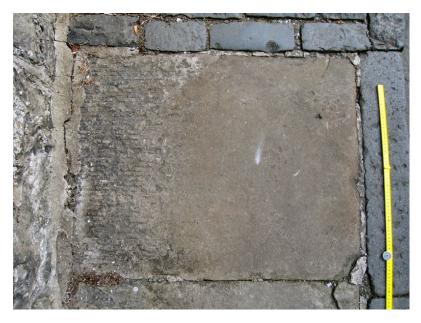
Photo 42. Detail of sandstone paving slab in Gloucester Lane showing typical brownish-grey colour and fine to medium grained texture, with remains of original broached tooled surface preserved where less worn close to the wall (left-hand side). Ruler scale is c.750 mm long.

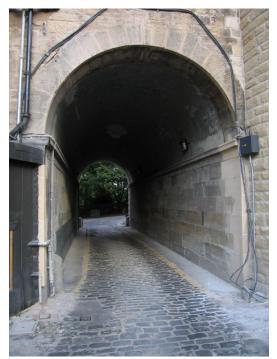
Photo 43. Recently refurbished covered lane entrance to Wemyss Place Mews, with original sandstone pavement and setted roadway. Spur stones are present on three of the four corners.

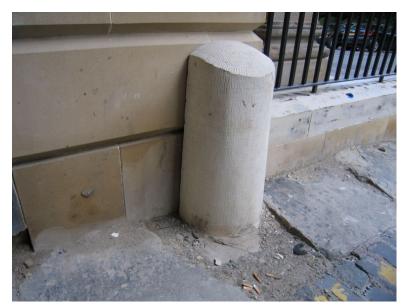
Photo 44. Recently reinstated replacement sandstone spur stone at entrance to Wemyss Place Mews.

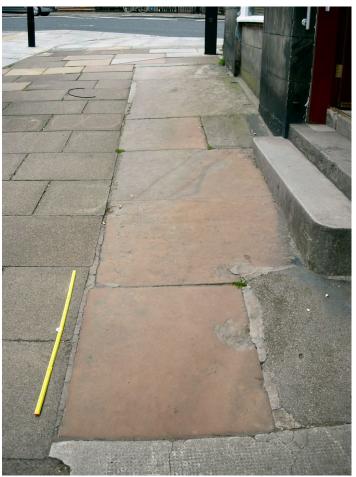
Photo 45. Remains of original stone paving in Wemyss Place with large slabs of characteristic orange-brown weathering sandstone, with replacement concrete slab over most of the pavement. The steps to the adjacent property entrance are also sandstone.

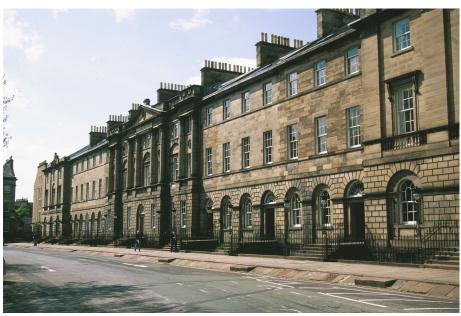
Photo 46. General view of the north side of Charlotte Square showing large area of original sandstone pavement with sloping kerb slabs and large mounting blocks opposite the principal entrances.

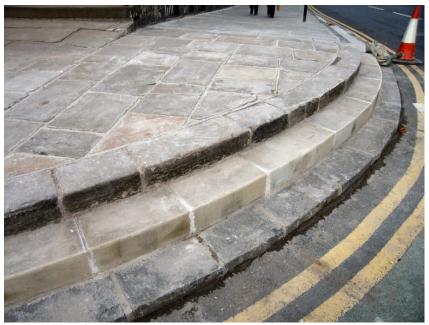
Photo 47. Recently repaired and re-laid original sandstone paving and kerb at the northeast corner of Charlotte Square, reinstating the previous paving arrangement following disruption from repeated service works over many years. Because of damage to some original kerb stones, the middle row of kerb steps has been replaced using a sandstone from the north of England. The standard of workmanship and the care taken to reuse original materials where possible should be seen as a model of good practice. The photo was taken immediately after completion of the work before the area had been cleaned to remove excess sand and mortar.

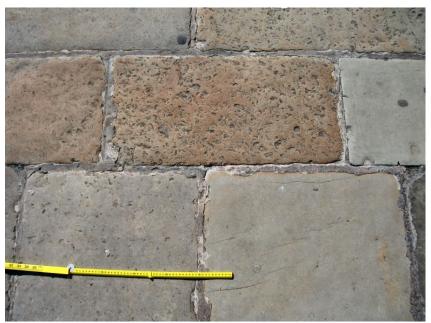
Photo 48. Sandstone paving on the north side of Charlotte Square, showing typical variable appearance ranging from dominantly greyish to reddish-brown colour with variable surface texture from smooth to rippled surface. These variations are typical of the original sandstone paving found throughout in the Edinburgh New Town. The pale grey slab (centre right-hand side) is a later replacement sandstone (note the straight sawn edges). Scale ruler is c.750 mm long.

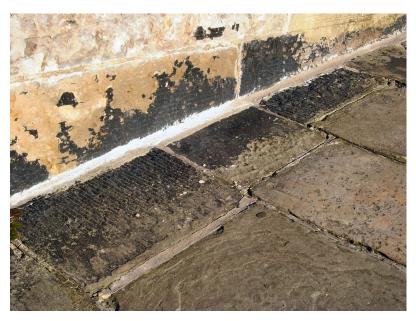
Photo 49. Sandstone paving in Glenfinlas Street, showing original broad broached tooling preserved in the lessworn areas adjacent to the inner boundary wall. The paving shows the typical variation in colour and texture characteristic of original sandstone paving in Edinburgh.

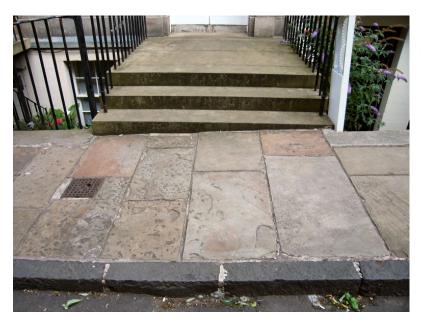
Photo 50. Sandstone paving in St Stephen Place showing typical variable appearance and surface textures, with colour ranging from grey to reddish-brown. The steps and entrance plat are replacement 'York sandstone' rebuilt in 1985.

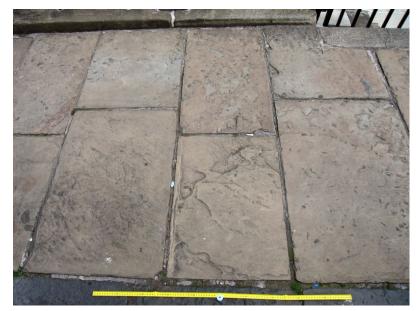
Photo 51. Detail of original paving in St Stephen Place showing typical variation in colour and surface texture and uniform offset laying arrangement.

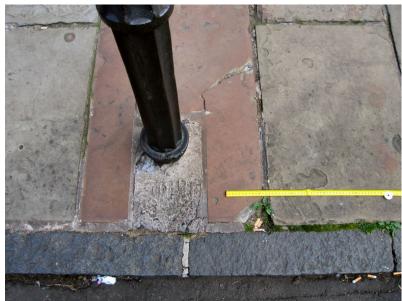
Photo 52. 'Recent' installation of bollard into sandstone paving, St Stephen Place, with over-large sawn area patched using cement and cracks to the sandstone slab.

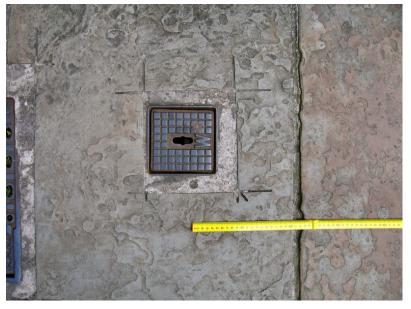
Photo 53. Detail of sandstone paving, St Stephen Street showing installation of utility service point, showing unsightly sawing of slab and cement patching.

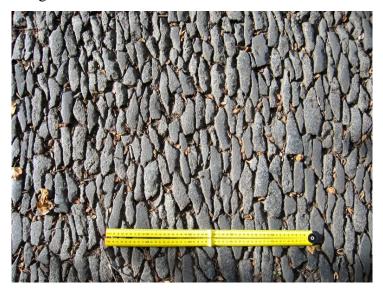
Photo 54. Horonizing in Glenfinlas Street, showing typical well packed dolerite (whinstone) fragments. Scale ruler 50cm long.

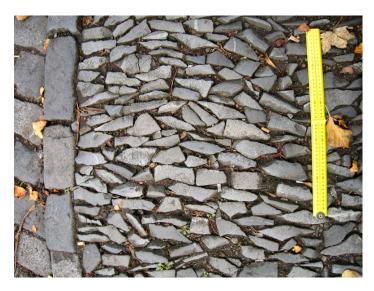
Photo 55. Horonizing on St Colme Street showing irregular sized whinstone fragments, noticeably less well packed than that on Glenfinlas Street. The kerb is formed from a single line of whinstone setts. Scale rule is 50cm long

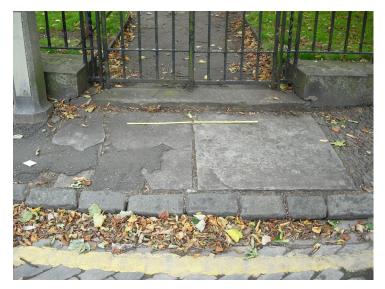
Photo 56. Northern garden entrance, Ainslie Place, with two large sandstone slabs partly covered in asphalt.

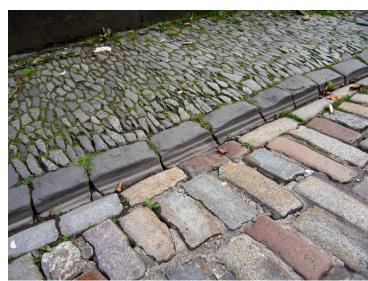
Photo 57. Whinstone horonized pavement in Ainslie Place, with whinstone kerb and granite gutter and setted road surface. Note the wear to the kerb stones.

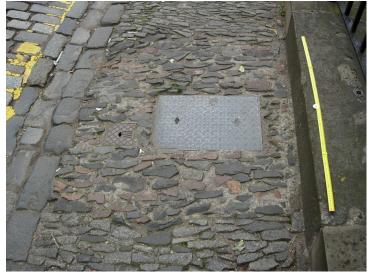
Photo 58. Poor attempt to mimic horonizing following installation of service duct, using a mixture of original material and red whinstone fragments, loosely packed in a cement matrix. Southeastern side of Ainslie Place.

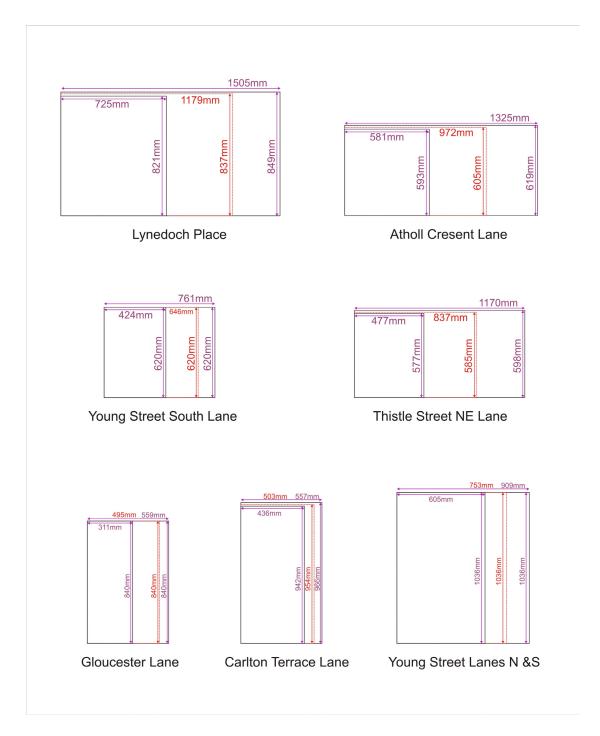
Figure 20. Diagrammatic figures showing maximum, minimum and average slab lengths and widths for the seven measured survey sites of historic sandstone pavement in lanes in the Edinburgh New Town. Average dimensions for each site are shown in red. At four of the sites the long axis of the slab (i.e. slab length) is parallel to the road direction, whilst three sites have the long axis of the slab (i.e. slab length) perpendicular to the road direction.

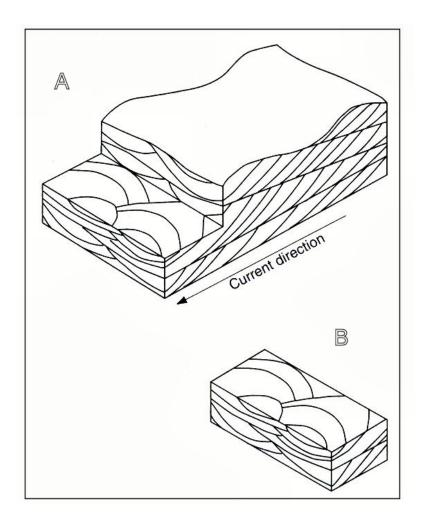
Photo 61. Cartoon block diagram showing the internal bedding structure of ripple bedded sandstone (A), and its origin from the deposition of sand layers in a flowing water current. The thin beds contain a series of multiple, thin oblique ripple (or trough) bedding laminae. On the upper surface of the stone block this gives a 'contour effect' (B), enhanced as the stone becomes worn with use. This is the familiar surface texture seen on many original sandstone paving slabs in Edinburgh.

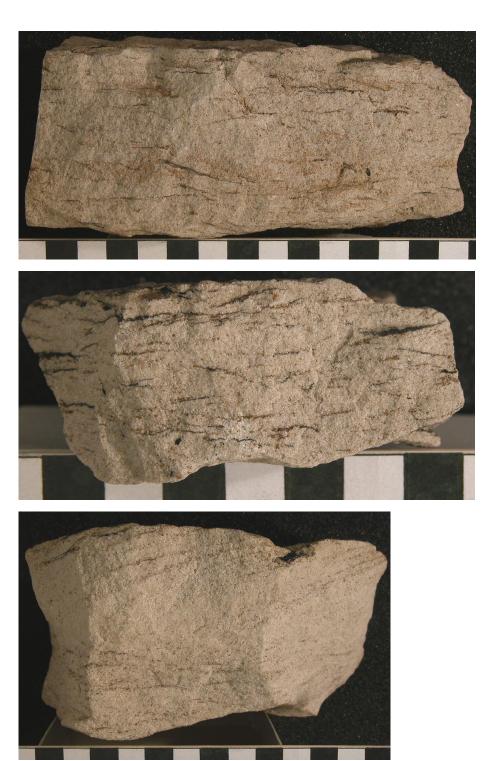
Photo 62. Top image: Sample of typical Hailes type sandstone from paving at Charlotte Square, showing the characteristic irregular dark ripple bedding laminae. Centre image: Sample of sandstone pavement from Calton Hill, showing the typical characteristics of Hailes type sandstone, in particular the presence of irregular dark coloured bedding planes. Bottom image: Typical 'Hailes type' sandstone from Craigiemill quarry in Edinburgh, one of the quarries formerly producing Hailes sandstone used for paving in Edinburgh. The sample has the same characteristics as many samples of historic pavement collected during this study. The Craigiemill quarry in now closed and infilled and there are no quarries operating in this area or producing this type of sandstone. Scale divisions are centimetres.

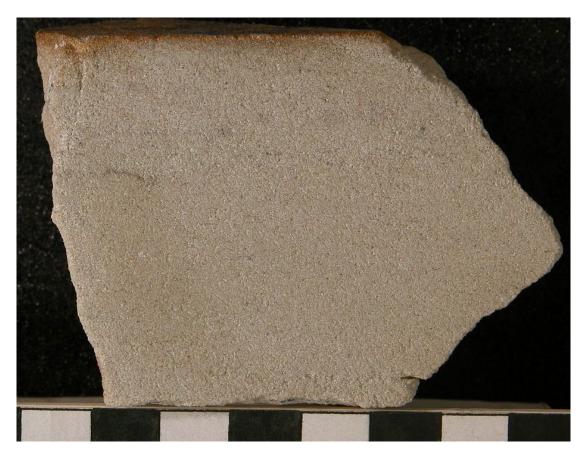
Photo 64. Cut section through sample of paving from General Register House showing typical 'Craigleith type' characteristics with very pale quartz-rich sandstone with medium grainsize and uniform texture. Note the top weathered surface with an orange-brown patina, distinctive of this type of stone, formed by weathering of microscopic iron oxide grains throughout the stone. BGS sample ED10186. Scale divisions are cm.

Craigleith sandstone is typically a medium grained, highly quartz-rich sandstone with a pale colour, uniform texture and relatively open porosity (Photo 64). The compositional characteristics and well developed silica mineral cement make this a highly durable sandstone. It was one of the most favoured sandstone building stones used in Edinburgh, popular as freestone for ashlar frontages. Some varieties of Craigleith stone which had a more bedded texture may have not been considered suitable for ashlar work, and it is likely that these were utilised for other functions including paving. Towards the end of its life, the Craigleith quarry became an increasingly important producer of paving stone (Craig 1893).

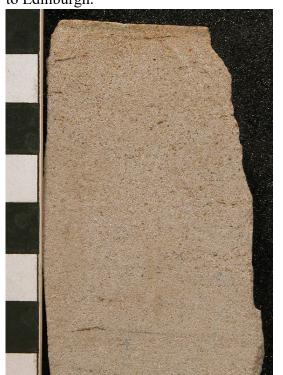
Photo 66. Top: Cut section through paving slab from Regent Road showing typical characteristics of Carboniferous sandstone

Sandstones in this category are medium grained, quartz-rich, pale coloured sandstones with a relatively high and open porosity, although typically compact and well cemented. They differ from the Craigleith sandstone type in having a less quartz-rich composition, containing characteristic dark iron oxide grains scattered throughout, and fine grained clay minerals which locally infill the porosity. The iron oxide grains produce a distinctive orange-brown speckled appearance to the stone (Photo 66). Bedding laminae are commonly present, but variable and not prominent. Compared to Hailes sandstone they are coarser grained and more uniform with less bedding laminae. Samples from the large areas of pavement at Regent Road and Regent Terrace show these characteristics.

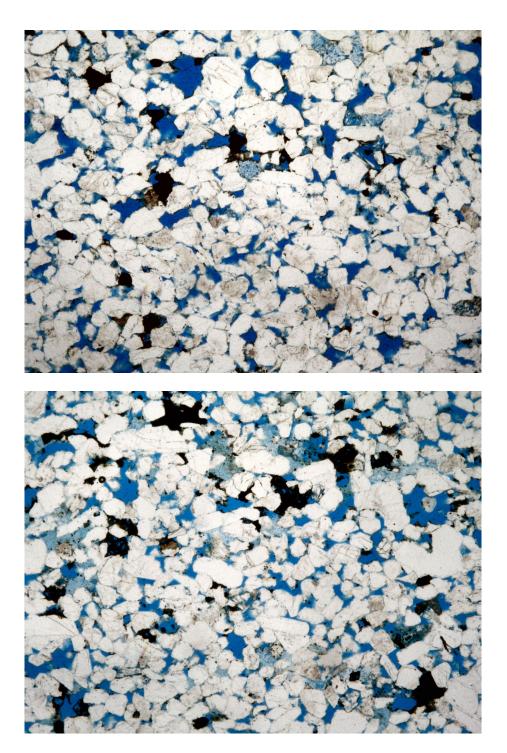
Photo 67. Microscopic thin section image of sample of pavement from Regent Terrace (Top image) and sandstone from Drumhead (Doghillock) quarry, near Denny (Bottom image), both showing almost identical medium to coarse grainsize, quartz-rich composition with high porosity and presence of dark iron oxide grains (black). Image c.3 mm across, plane polarised light; porosity highlighted by blue dye resin.

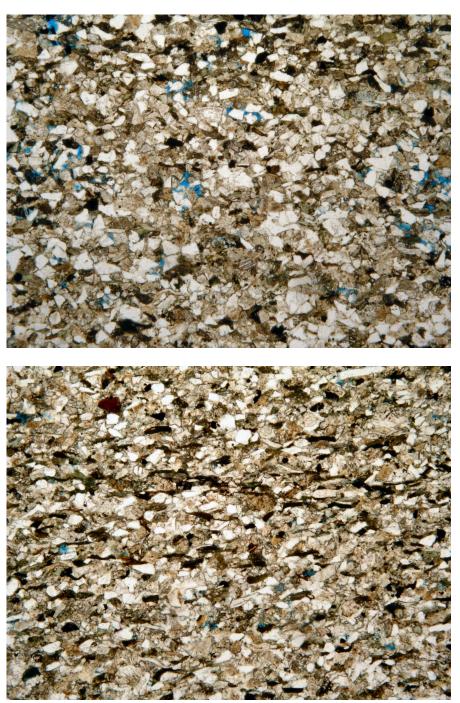
Photo 69. Microscopic thin section image of sample of pavement from Register House (Top image) and sandstone from Carmyllie quarry in Angus (Bottom image), both showing fine grained compact texture with little porosity, with a complex mineral composition seen by the abundance of dark and brown iron-bearing grains. Image c.3 mm across, plane polarised light; porosity highlighted by blue dye resin.

Angus sandstone is typically fine to very fine grained, with a pale greenish-grey colour (Photo 68). It typically has a planar bedded texture consisting of parallel bedding laminae showing grainsize variation, with white mica concentrated along bedding surfaces. Ripple laminae are rarely present. Colour can vary, with red-brown varieties present depending on the iron oxide content. The stone is generally highly compact and microscopically is seen to consist of poorly sorted angular grains (contrasting with more rounded grains in Carboniferous sandstones) (Photo 69). These factors give it a very low porosity.

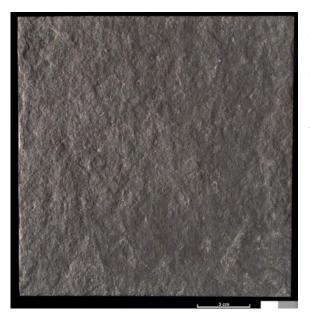
Photo 70. Sample of Caithness flagstone from Spittal quarry near Halkirk, showing typical dark colour and fine grained texture, giving characteristic distinctive appearance. Natural riven surface.

Scotland sandstones traditionally used for paving in Edinburgh, giving it a quite different appearance (Photos 70 & 71). There is some evidence for the historical use of Caithness flagstone in the Edinburgh New Town e.g. small areas around New Register House and in North St David's Street, but its extent appears limited.

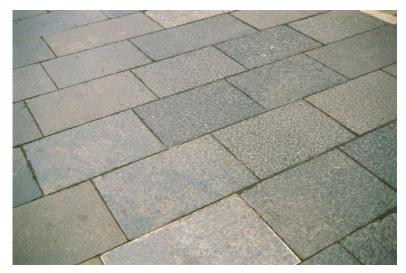
Photo 72. 'Modern' Caithness flagstone pavement, showing characteristic dark grey appearance, contrasting with the pale and orange-buff coloured historic Edinburgh sandstone pavement. Elder Street, Edinburgh.

In recent decades, Caithness flagstone has been used for external pavement extensively in the Old Town of Edinburgh and in various pedestrian schemes in the New Town such as Castle Street and Elder Street (Photo 72). It is currently used ubiquitously for streetscape improvement schemes in towns and cities throughout the UK. Whilst Caithness flagstone is without doubt a very high quality paving material, it has geological characteristics that are markedly different from the historic paving stone types used in the Edinburgh New Town, resulting in a very different appearance and weathering characteristics.

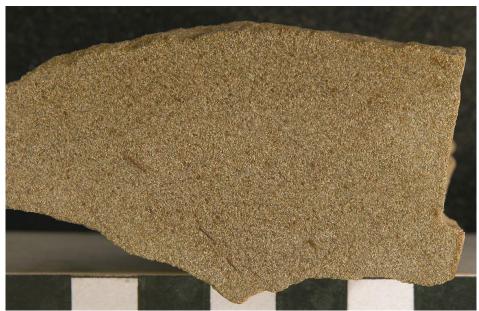
Photo 73. Cut section through 'modern' replacement Yorkshire Sandstone paving slab from Register House, showing typical medium grainsize and uniform texture, containing variable mineral composition with relatively common iron oxide grains giving a strongly speckled ('grainy') appearance and overall buff colour. BGS sample ED10188. Scale divisions are cm.

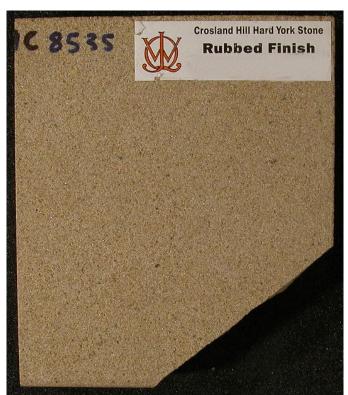
Photo 74. Sample of Crossland Hill York Stone, typical of many Yorkshire sandstones currently used for paving, showing typical buff colour and uniform appearance.

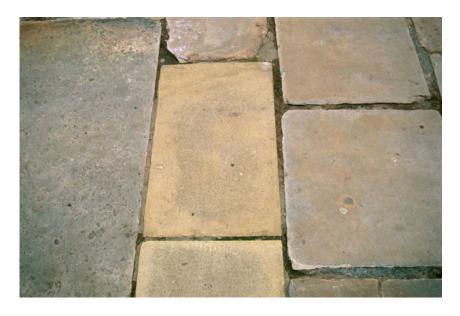
Photo 76. Small area of modern replacement paving in Charlotte Square, with two slabs of Yorkshire sandstone (centre of image) showing typical uniform strong yellow-buff appearance, contrasting with the original 'Hailes type' sandstone showing a more variable appearance ranging from grey to orange-brown colour.

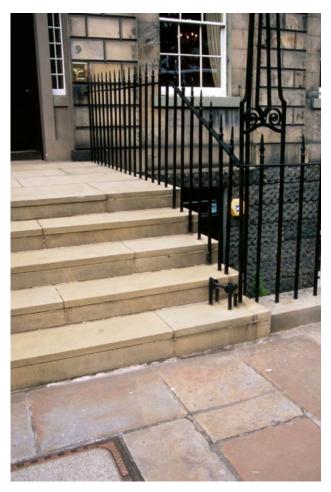
Photo 77. Use of replacement Yorkshire sandstone as replacement steps adjacent to original 'Hailes type' sandstone paving. The typical uniform yellow-buff colour of the York stone contrast with the more variable and stronger coloured original paving slabs.

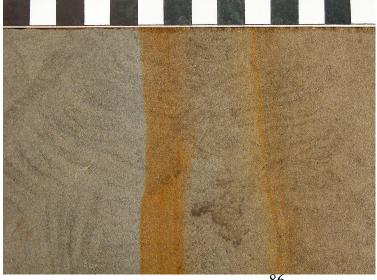
Photo 78. Sample of Scout Moor sandstone showing sawn top surface with variable colour from grey to orange-brown, and 'contour-effect' texture caused by the presence of fine ripple bedding laminae. These characteristics are similar to those of Hailes type sandstone. Scale divisions are centimetres.

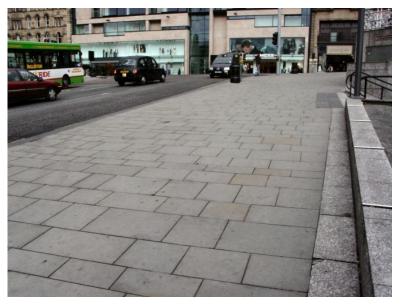
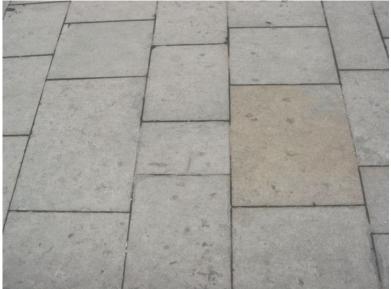
Photo 79. Modern natural stone pavement on Waverly Bridge, Edinburgh, typical of sandstone from Scout Moor quarry. This stone type has some similar characteristics to historic sandstone paving used in Edinburgh, in particular a variable colour from pale grey to orange-brown and the presence of bedding planes on the surface. The variability of slab sizes and course widths also helps to give this pavement a similar character to historic footpaths.

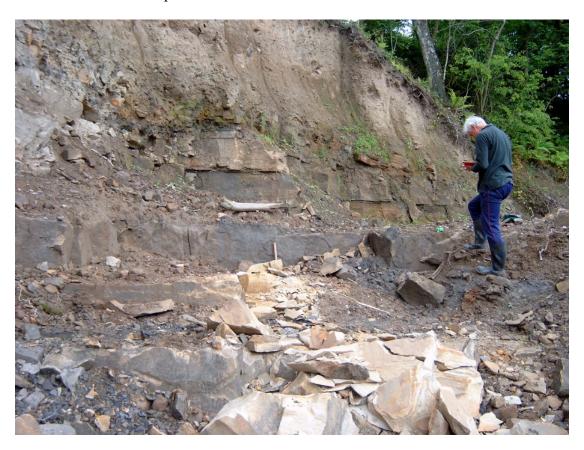
Photo 80. The former working face of Drumhead (Doghillock) quarry near Denny, typical of many of the now disused sandstone quarries which produced sandstone in Central Scotland. This quarry reputedly supplied paving stone to Stirling, and it is documented that paving sandstone from the Denny area was imported into Edinburgh by canal from the 1820s.

This sandstone is typical of Carboniferous sandstone from quarries to the west of Edinburgh and from the Central Belt of Scotland, in particular from the Stirling and Falkirk areas. The samples from Regent Road and Regent Terrace are similar to quarry specimens from Drumhead quarry (also known as Doghillock quarry) at Denny, near Falkirk. It is recorded that this quarry supplied paving stone to Stirling, and there is documentary evidence stating that paving stone from the Denny area was brought by canal into Edinburgh in the 1820s. It is likely that sandstone of this type was obtained from a number of quarries in the Central Belt and transported by canal to Edinburgh.
