RESEARCH EXPEDITION REPORT

RRS *Discovery* Expedition DY200

**AtlantiS, PISCES, REDRESS, RISC, MARS and JNCC survey
at Greater Haig Fras and The Canyons MCZs**

23 September – 12 October 2025

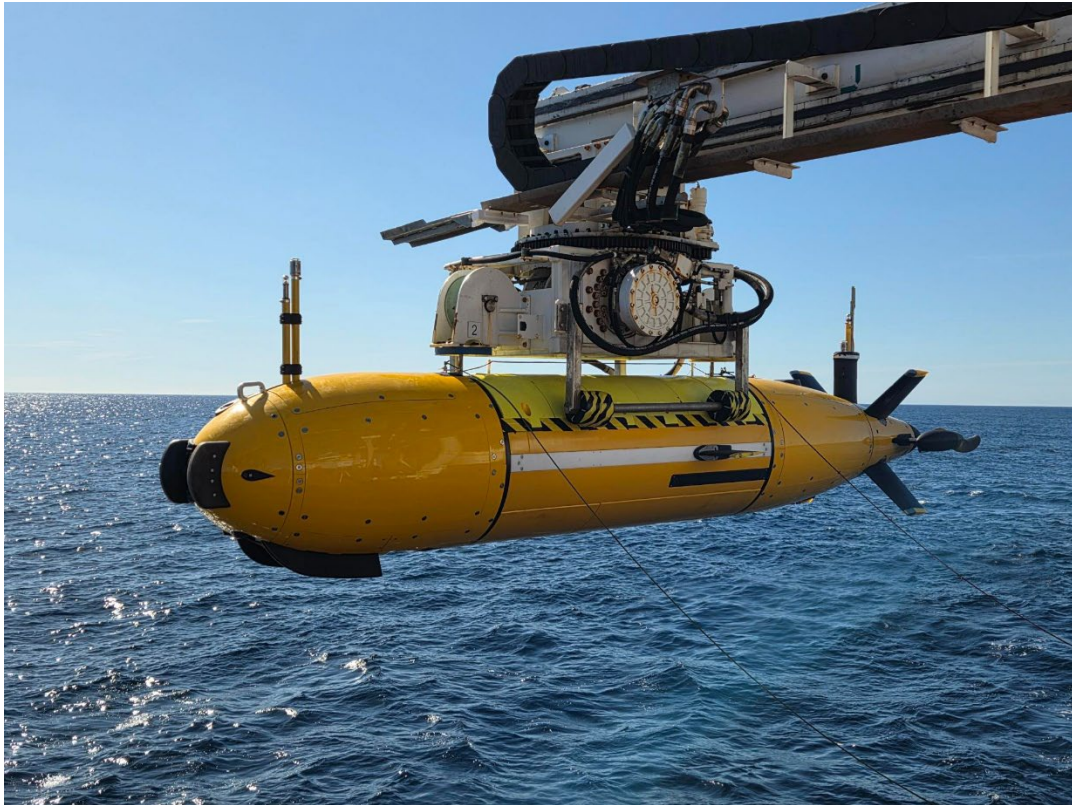
Fig. 6.1. Autosub 5 vehicle on the gantry before launch.

Autosub 5 was running an initial configuration of 6000m rated foam and five 5 kWhr Batteries which at present allow for ~100 km and ~24 hour operations with all sensors running.

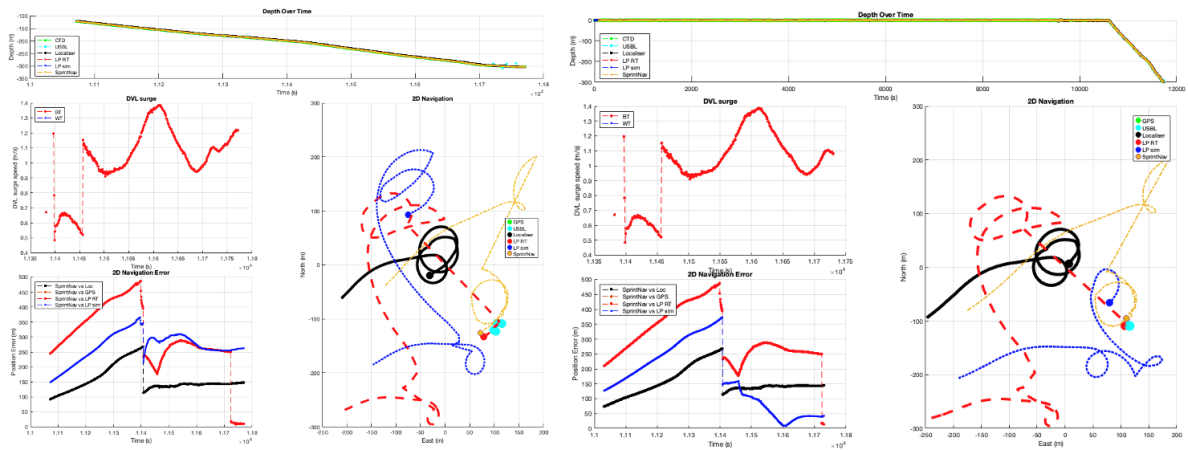
Fig. 6.3. (Left) Initial DVL bottom-track velocities introducing position corrections that degrade performance (M128). (Right) The same mission is replayed with the initial DVL data excluded from fusion by LP sim. The LP sim is now able to correct for past velocity errors and achieve good agreement with USBL.

- b) Implement a higher level of DVL pre-filtering. High-quality DVL data is essential not only for accurate filtering but also for smoothing and correcting past errors. Fig. 6.3 illustrates the importance of removing potentially invalid DVL measurements. The same issue is highlighted in Fig. 6.4.

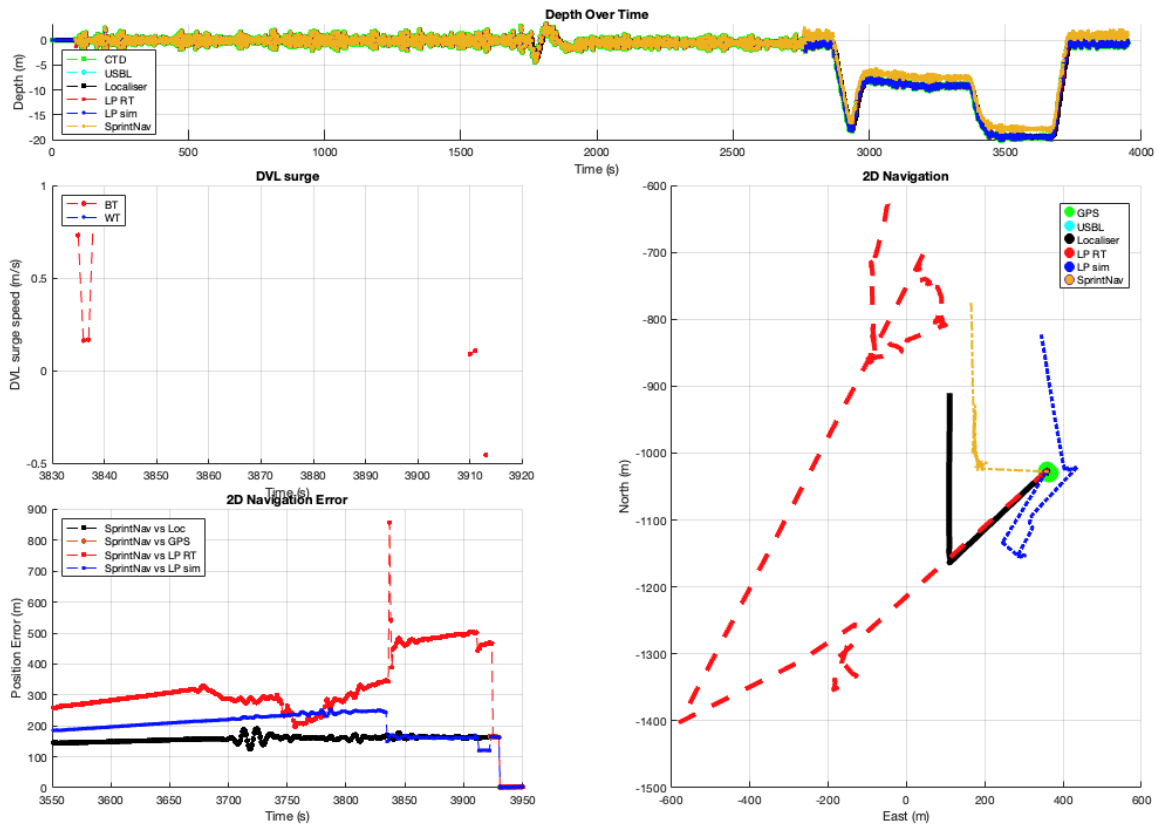
Fig. 6.4. Spurious DVL data cause the LP to make large horizontal position jumps, leading to degraded performance (M125).

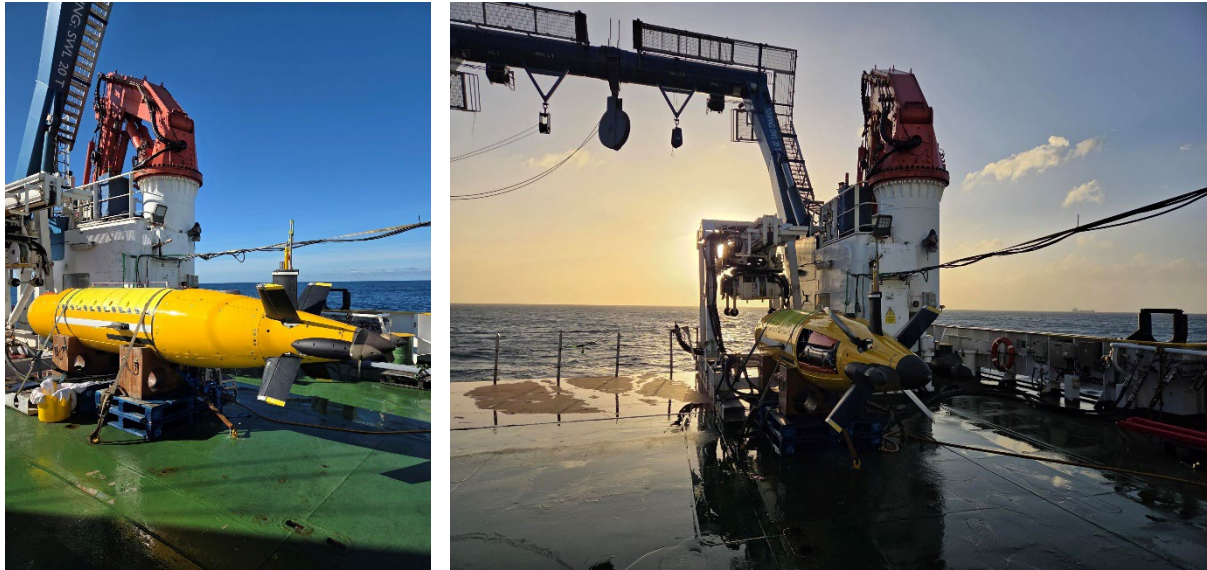
Fig. 6.5. Autosub 5 on the aft deck during non-operational times. The LARS is stowed away so that the top of AUV can be accessed with ease.

During the cruise, upon request from the ship's captain, AS5's forward mast was taken down after each recovery and the LARS stowed away from the AUV. This provides free access to the top of the AUV in case the lithium-ion fire blanket has to be applied, as well as providing better access for AUV Ops to do maintenance tasks.

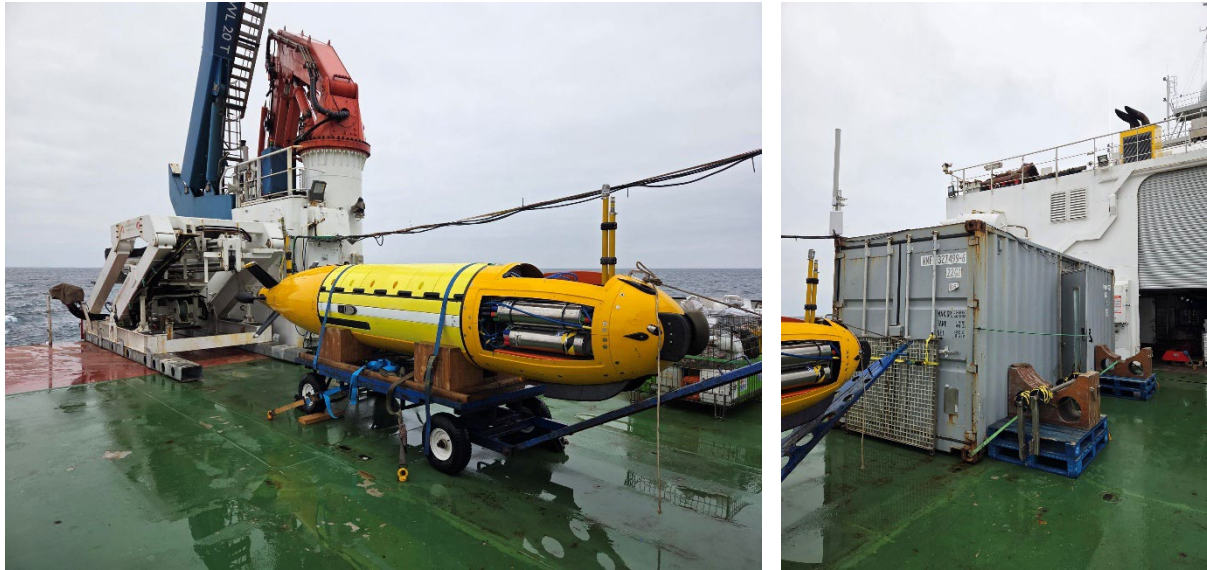
Fig. 6.7. Autosub 5 on its trolley after the last recovery, with the LARS already taken down to its storage configuration, on the afternoon of the second last day of the cruise.

After the last recovery, Autosub 5 was deposited immediately onto its trolley from the LARS and then towed as far forward as possible, next to the aft end of the workshop container. This solution enabled the team to start taking down the LARS and preparing it for transfer (in safe conditions with mild waves), thus speeding up de-mobilisation significantly once in port.

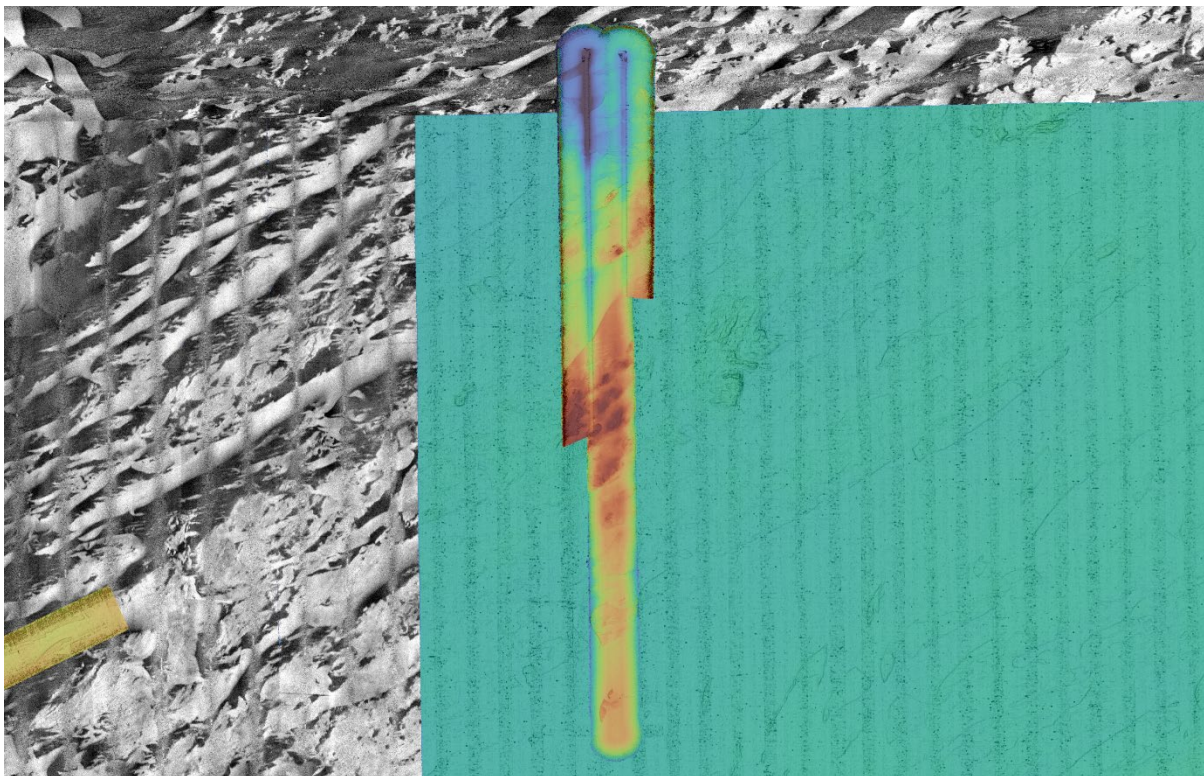
Fig. 6.9. Preliminary MBES data from the first part of AS5M124, against background of shipboard EM710 MBES data and backscatter data in the area

The MBES plot shows an AUV angle of list/heel/roll of 1.8° and a crabbing of the vehicle towards port so that the starboard side of the MBES line is less defined and thus present a small gap between neighbouring track legs. The SSS and SBP data were as expected (the SBP data are not particularly useful due to the rocky terrain). No photos could be taken due to a malfunction with the camera.

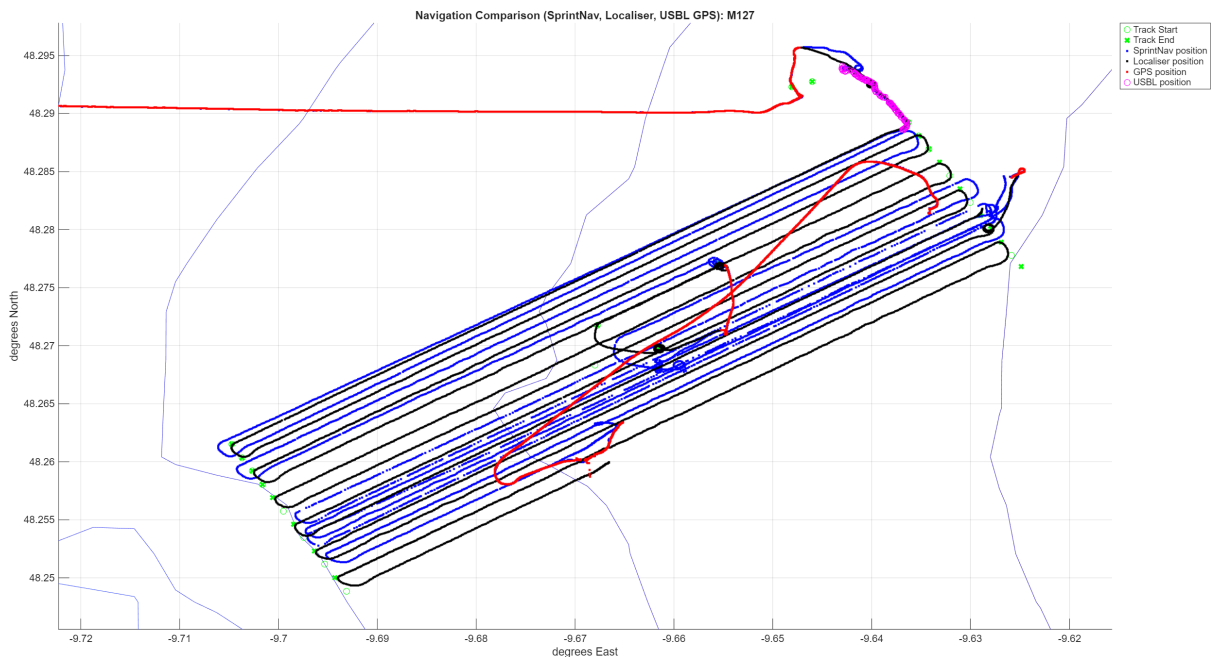
Fig. 6.10. Track plot of the different navigation solutions for AS5M127

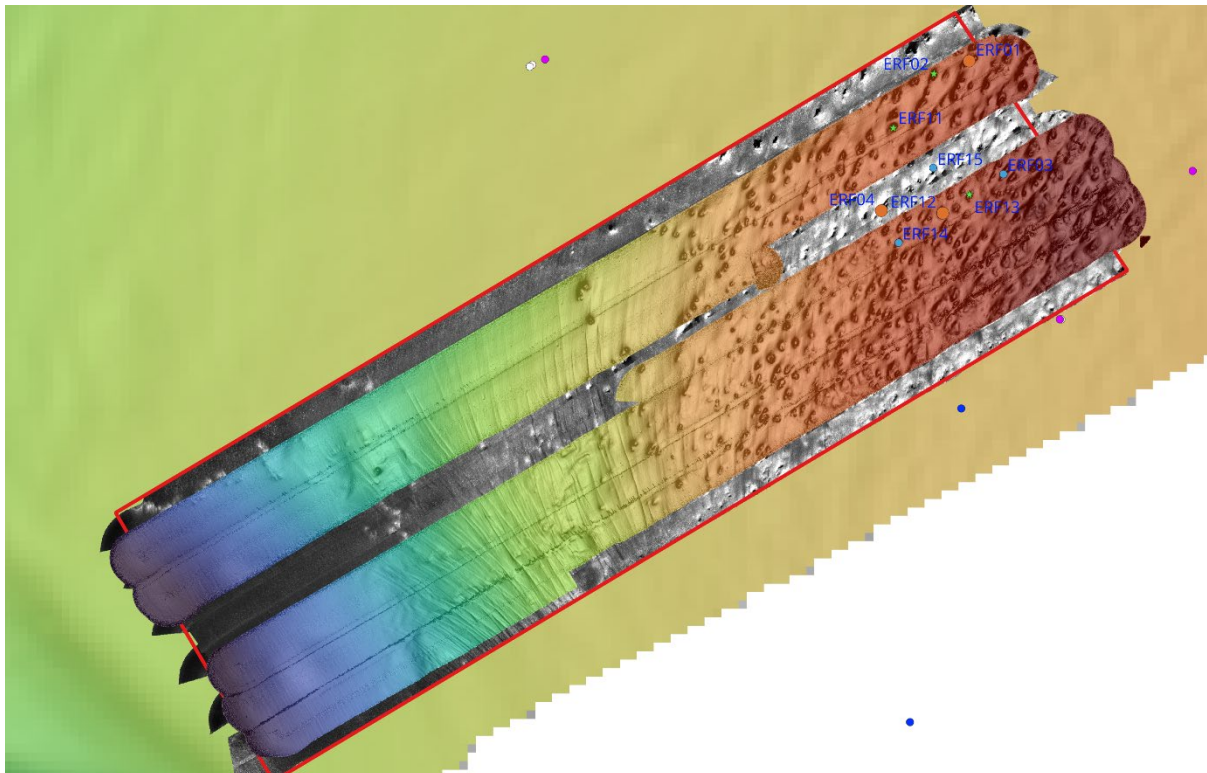
Fig. 6.11. Initial MBES bathymetry map based on the data collected during AS5M127. Note the gap in the data caused by the different parts of the mission and the drift of the vehicle during ascent and descent.

Due to the two surfacing events, the AUV ended up having a large error when diving which resulted in a gap in the MBES survey. However, the quality of the MBES bathymetric map is extremely high, showing interesting lines potentially caused by the current at the site.

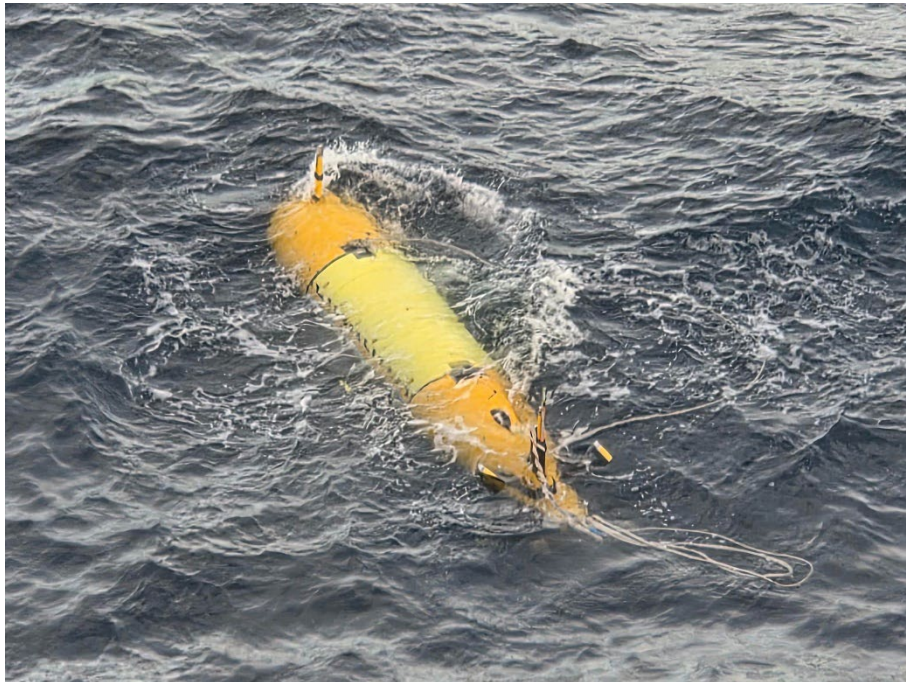
Fig. 6.13. Autosub 5 with its forward recovery line wrapped around the aft antenna mast.

After dawn and an emergency recovery toolbox talk, RRS Discovery approached AS5 slowly in a swell with a significant wave height < 2.5 m. From the bridge, it was clear that the forward rope box had become loose, and the line was out and entangled on the AUV's starboard side, with a loop around the aft antenna mast. The aft rope box looked intact.

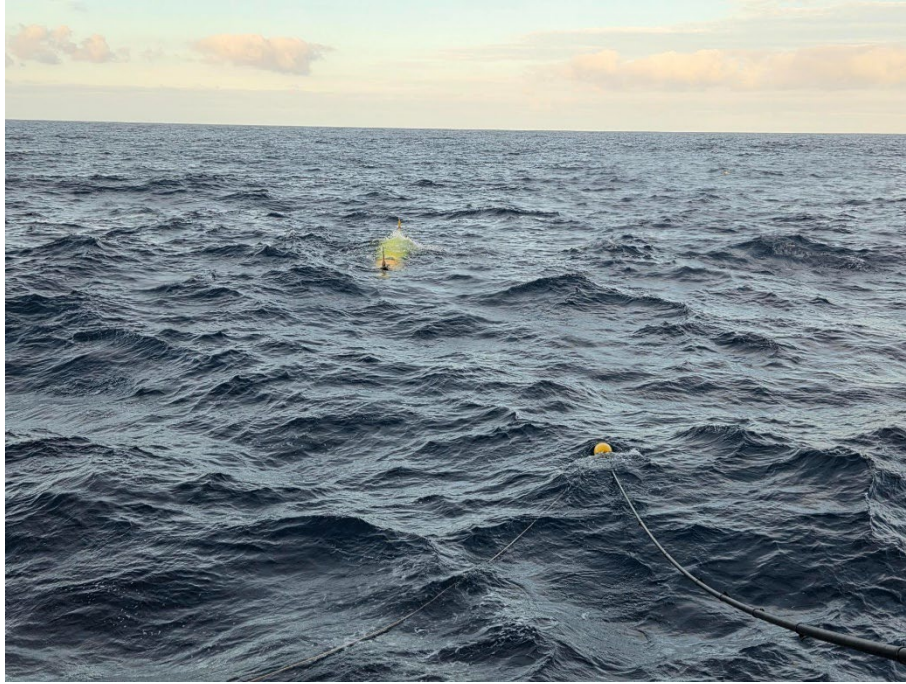
Fig. 6.14. Autosub 5 near RRS Discovery being grappled with the Templeton pole.

By using ALR's long Templeton pole, the line was grappled and the two recovery lines brought aboard for a standard recovery with the LARS. During the recovery, the aft Xeos beacon became dislodged from its position, but was still hanging from the cable and the antenna mast was undamaged. The forward line was damaged, presenting bumps and stretched parts, but the recovery was smooth and successful, although extra time was needed in removing the forward line from the LARS.

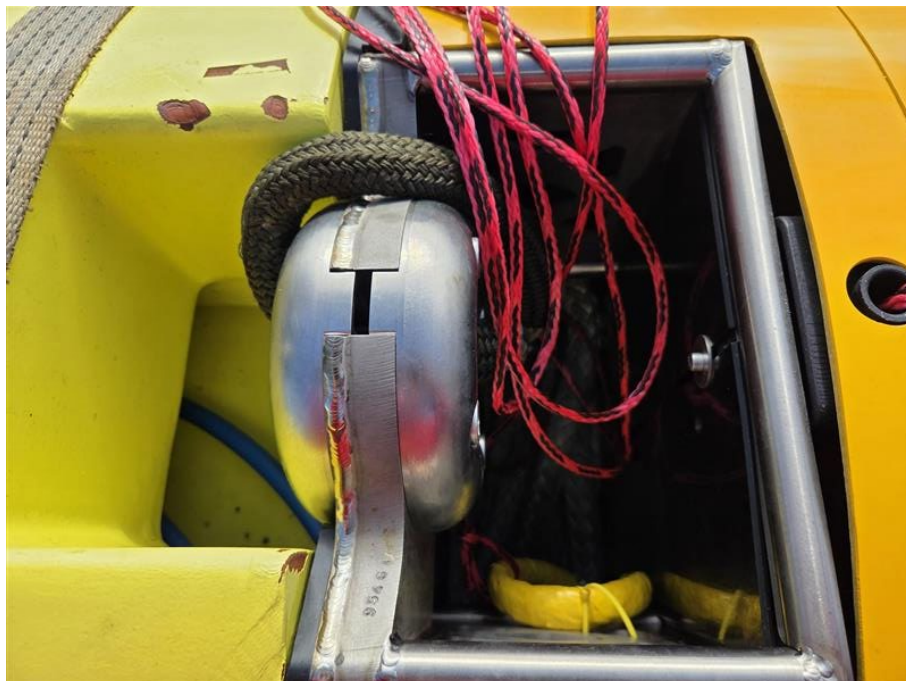
Fig. 6.15. Preliminary new design for the rope boxes with small yellow snap ties.

For future missions, a revised design was implemented for the recovery line rope boxes, which uses small snap ties, and which was improved throughout the cruise.

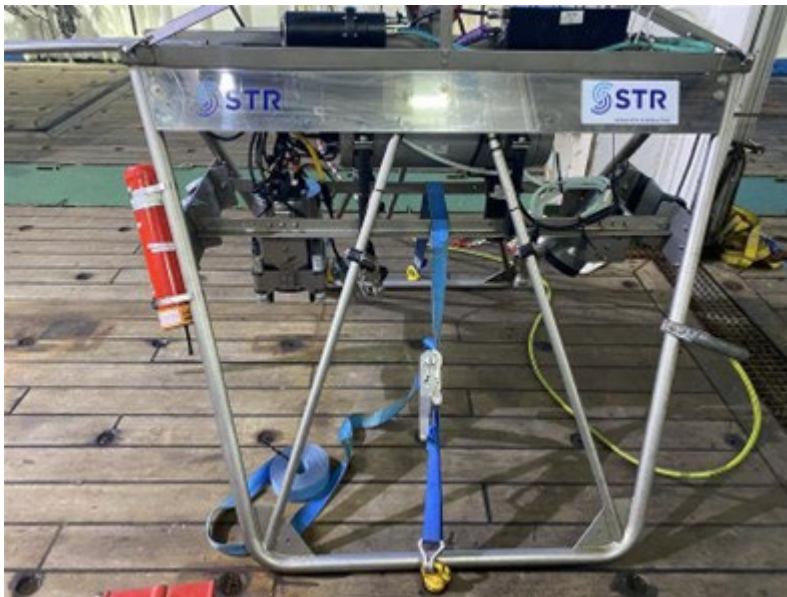
A STR SeaSpyder HDFO 3000 m system was mobilised to the RRS Discovery on the 20th of September 2025. The SeaSpyder was set up to obtain still images and video footage on separate cameras to increase quality of imagery obtained. This system contained a SeaSpectrum Mini IP Video Camera (Model: SP-MIP-4000T) as a robust 720 – 1080p video camera angled obliquely at 30°. The camera utilises Internet Protocol Interface for high performance vs bandwidth ratio. A SeaSpyder telemetry 24-megapixel (MP) Cannon EOS 250D Digital Stills Camera mounted vertically (downward facing) was mobilised to collect still images and also interfaced with four downward facing 2000lm light emitting diode (LED) lights (model: STR Sealight LED-2-DC), four downward facing category 3 lasers (model: STR SeaDot Green Laser Pointer, MP-GLP2-6000A-0°/5mW), an STR high powered flash (model: 50705-MP-FT) mounted at 34°, altimeter, combined depth compass and multiplexer. The lasers were mounted to the housing of the stills camera and calibrated to achieve a 17 cm x 17cm square box.

Fig. 6.22. STR SeaSpyder HDFO 3000m DDC system mobilised to the RRS Discovery

Whilst the SeaSpyder was on deck, the metal frame was earthed to the deck earthing point via an earthing lanyard as visible in Fig. 6.22.

Interfaced with the mobilised camera system was a subsea positioning system linked to the vessels ultra short baseline (USBL) transponder by the attachment of a USBL beacon to the camera frame as shown in Fig. 6.22. The beacon positioning software was interfaced with the video software to provide an overlay of positioning and second by second logging file containing camera position along with other sensor information.

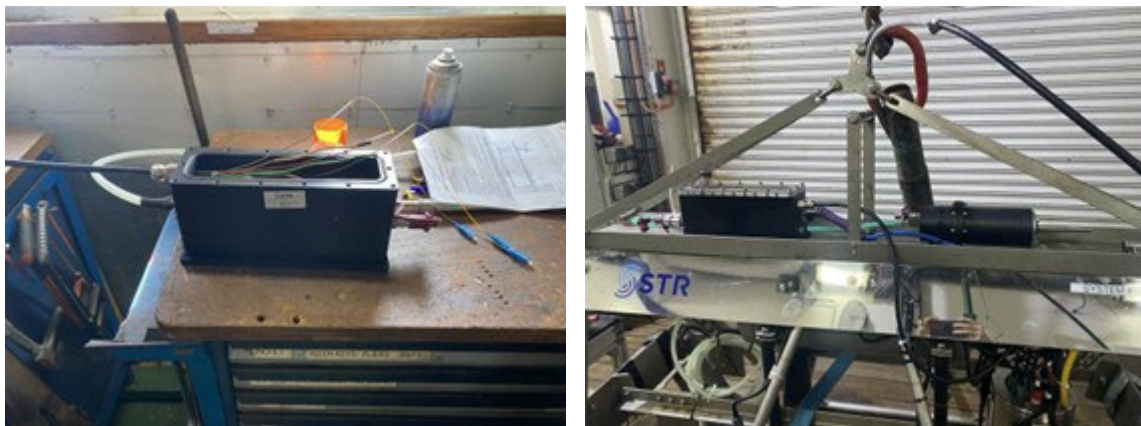
The electrical and fibre optic tails were then connected to the SeaSpyder with the black fibre used for telemetry and the red fibre used for the Mini IP Video camera. The connection was undertaken within a subsea silicon oil filled junction box fitted with an oil filled compensator mounted on the top of the SeaSpyder frame.

Fig. 6.23. Connection of the SeaSpyder to the ship's winch system: Deep tow winch termination showing fusion spliced fibre optic tails and STR SeaSpyder junction box (left). Mounted silicon oil filled junction box with oil filled pressure compensator on the SeaSpyder (right).

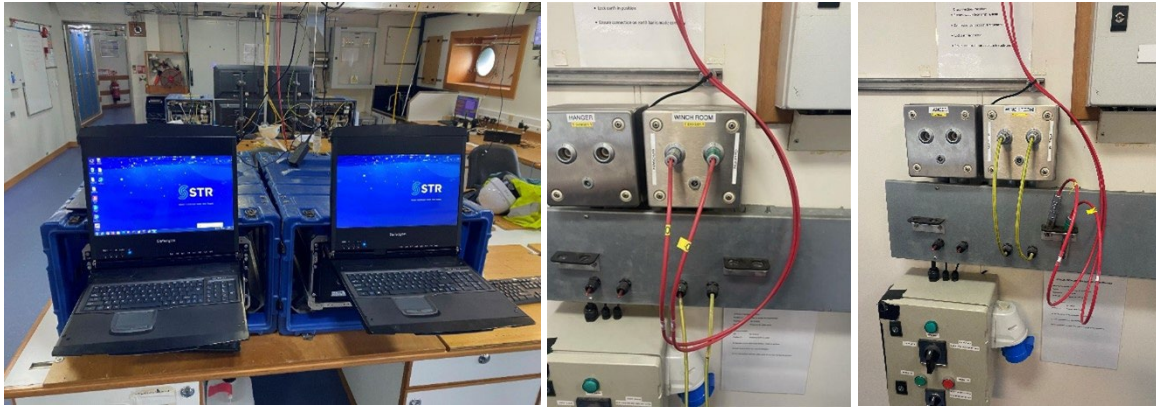
On 21 and 22 September 2025, the STR SeaSpyder topside multiplexer and topside computer station were set up on the second bay of the main laboratory allowing space for the winch operator to set up a station with clear view of the CLAM and CCTV monitors mounted at the winch control station as shown in Fig. 6.24.

Fig. 6.24. Lab set-up: SeaSpyder topside station in the main lab (left). LEMO connectors (middle). LEMO connectors with earthing procedure (right)

A 10m SeaSpyder HDFO Power Cable was purpose manufactured to carry power from the SeaSpyder topside mux processor located in the main laboratory to LEMO connectors also located in the main laboratory. These LEMO connectors were routed via the ships internal wiring to the deep tow winch as shown in Fig. 6.24.

During deployment, the SeaSpyder vehicle was powered off and any voltage remaining within the winch line was removed using the earthing system shown in Fig. 6.24. At an approximate depth of 10m, the vehicle was then powered on for the remainder of the operations.

During recovery, the SeaSpyder was brought to a depth of 10m where the system was then powered off and any voltage remaining within the winch line was removed using the earthing system shown in Fig. 6.24.

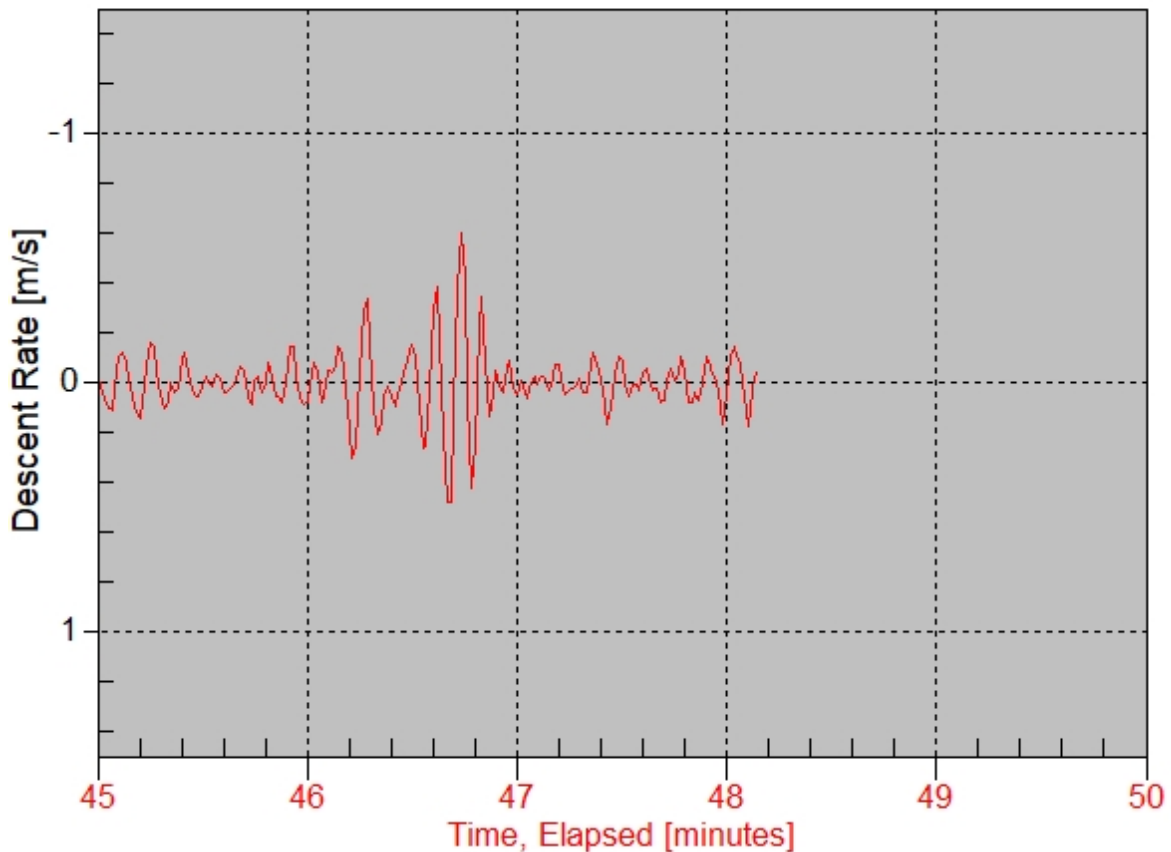
Fig. 6.28 Illustration of the effect of the Active Heave Compensation on the CTD descent rate (AHC taken off at 46 mins and put back on at 47 min).

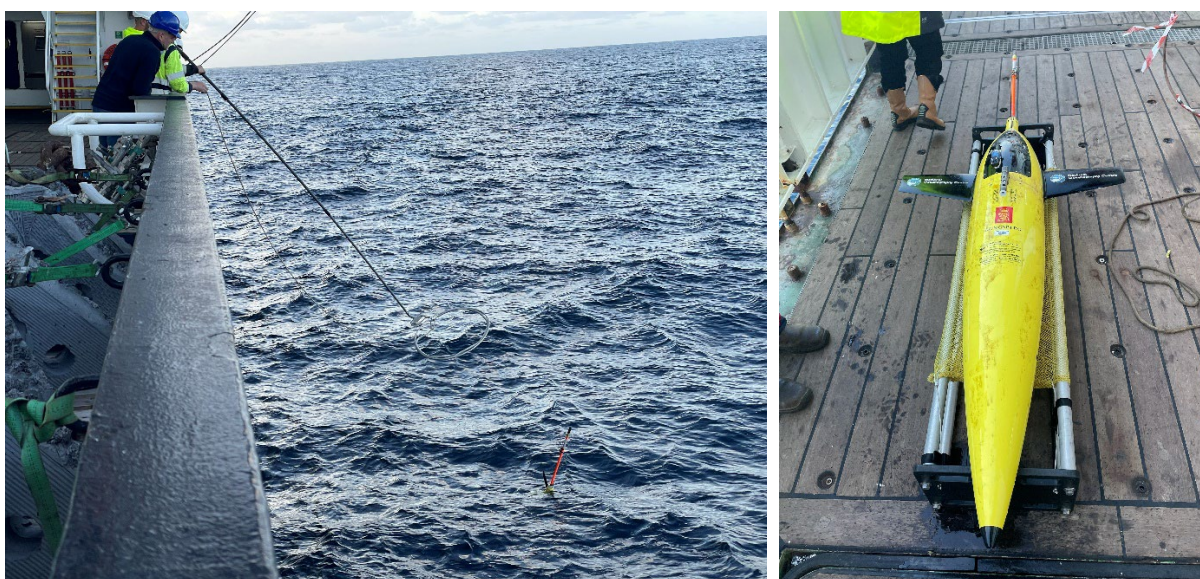
Seaglider SG605, deployed on DY196 (PISCES cruise) was recovered successfully on 28 September 2025 using the standard operating procedures for the recovery of Kongsberg Seaglider (lasso-loop; Fig. 6.29). Upon recovery, the system was washed with fresh water and transferred into its storage box ready for demob and transport onshore.

Fig. 6.29 Seaglider recovery using pole with lasso loop (left); Seaglider on board (right)

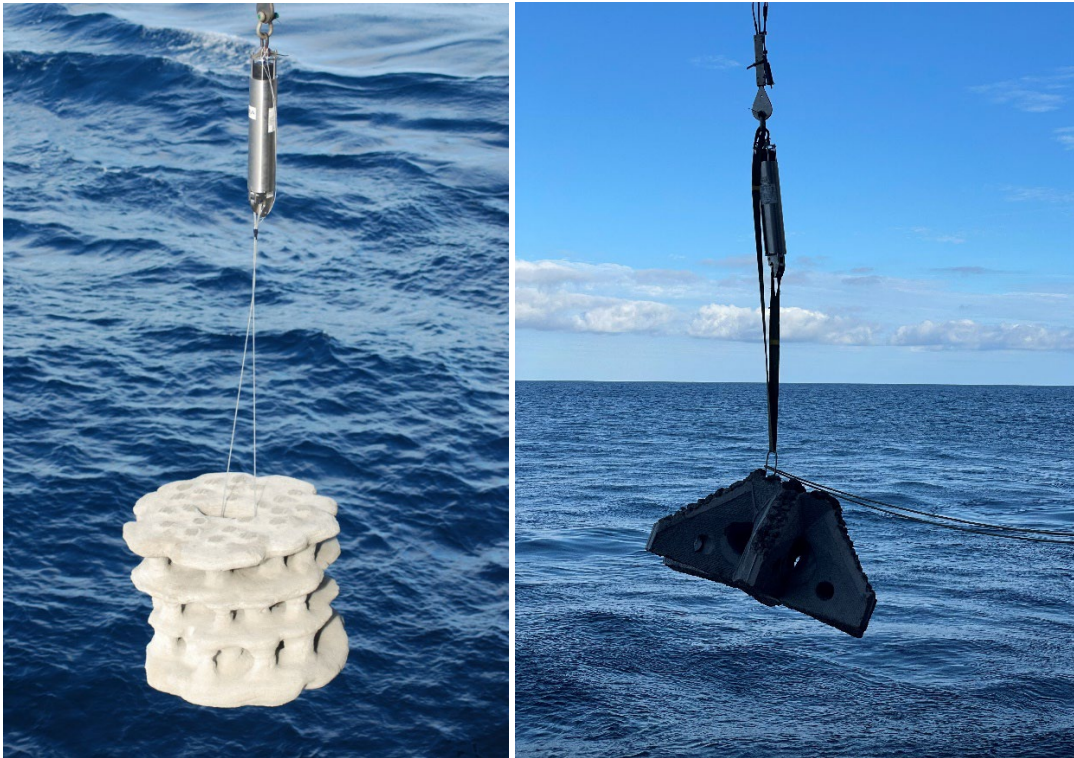
Fig. 6.31 Deployment setup for the ecoreefs: Large wedding cake (left) and star shape (right)

The setup for the “star” type reefs was similar except that a webbing strop was used instead of the steel wires as the risk of snagging was much less. The strop was routed through the lifting point, one end was attached to the acoustic release hook and the other end attached to the shackle connecting the acoustic release to the ships wire.

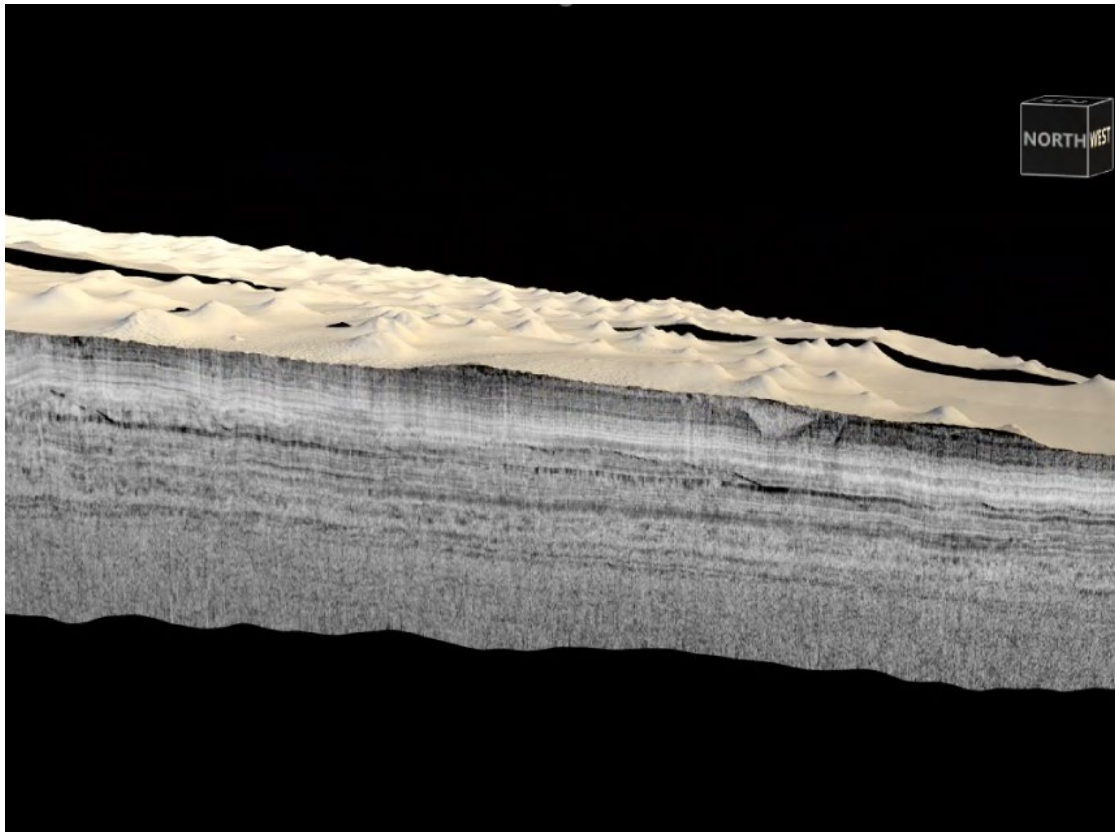
Fig. 7.11 Example of 3D visualisation of AUV bathymetry and sub-bottom profiler data.

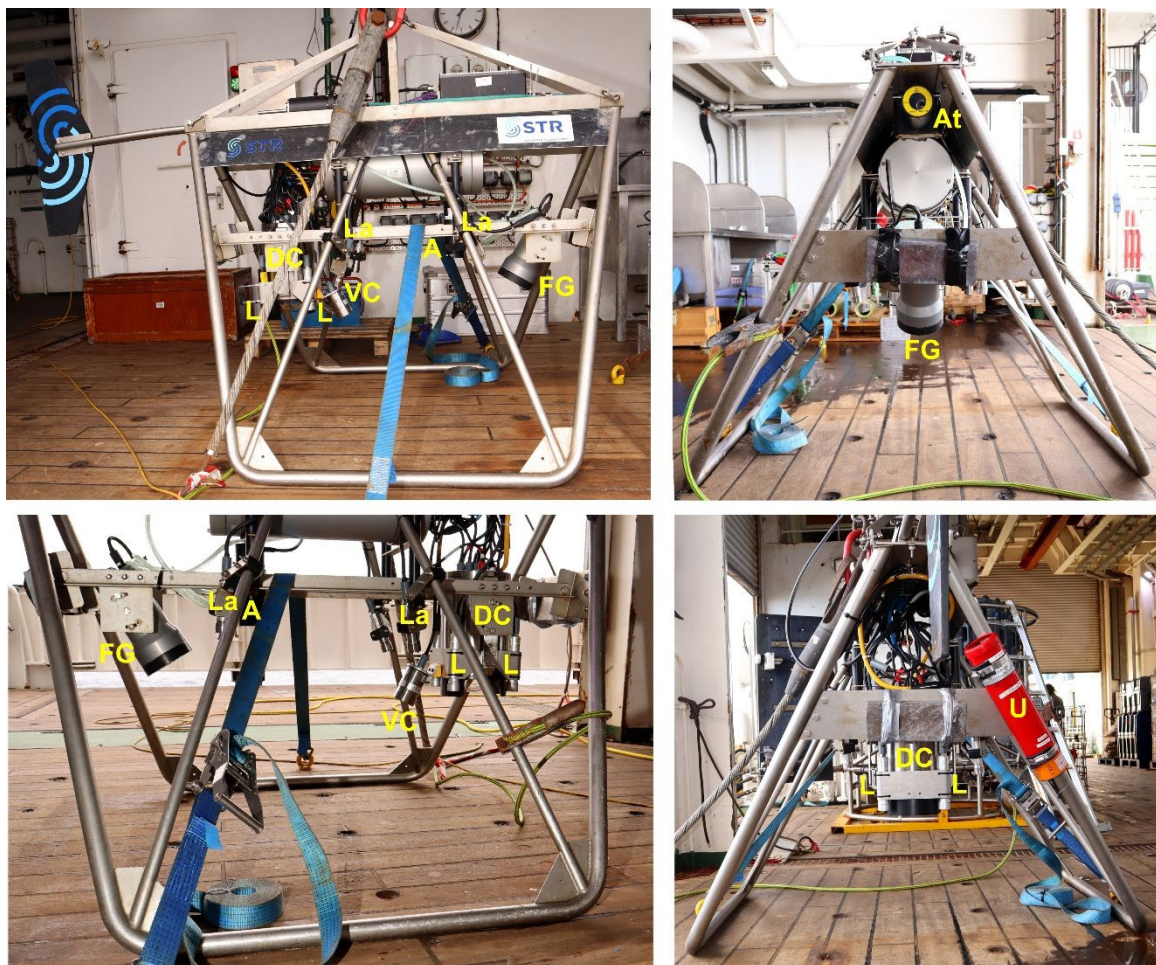
Fig. 7.12 SeaSpyder camera platform illustrating general layout of instrument payload (DC, digital [stills] camera; VC, video camera; L, laser; LA, [video] lamp; A, altimeter; FG, flashgun; At, attitude and pressure sensor (?no data); U, NMF-supplied USBL beacon.

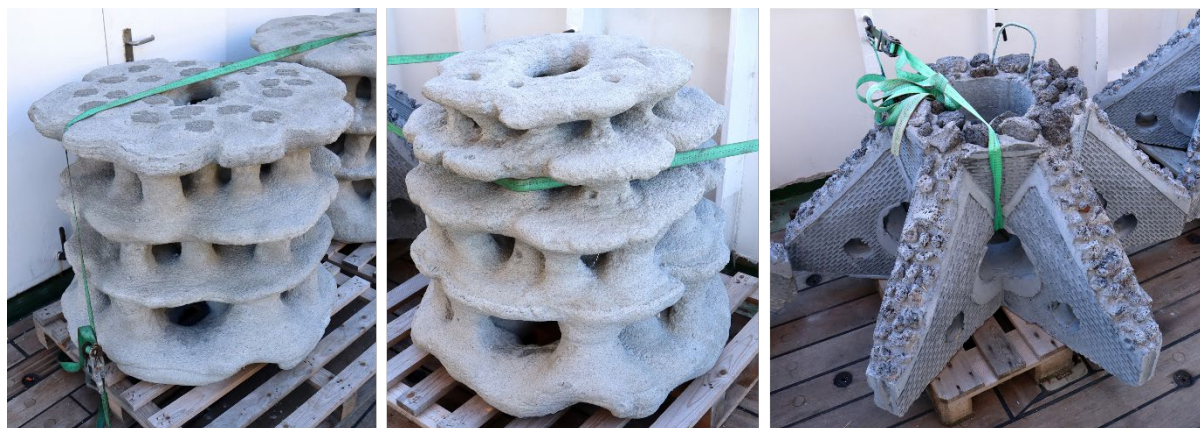
Fig. 7.28 Ecoreef models. Left and middle are the D-shape “wedding cake” type, AG900-3-REDRESS and AG800-5 , respectively, and right shows “star” type of the Life Lophelia project.

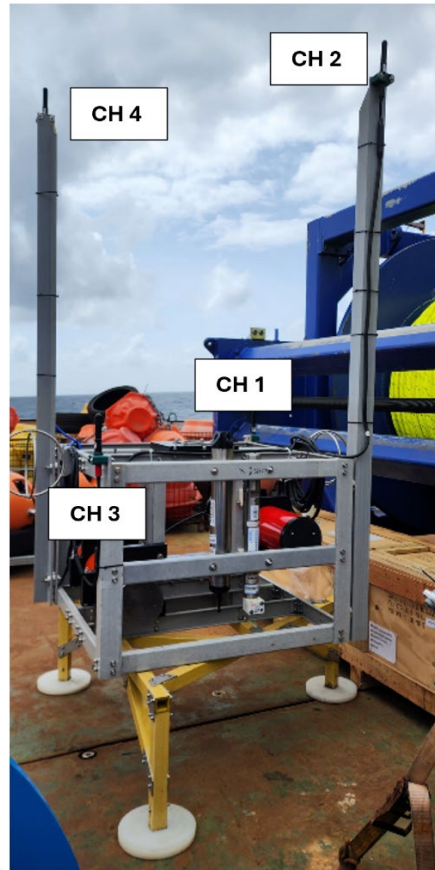
The lander was sited on the Explorer Interfluve and hosted four hydrophones connected to two acoustic recorders (RS Aqua PORPOISE-84D And RS Aqua ORCA 72D). Two hydrophones (recording to channels 2 and 4 on the ORCA) were mounted diagonally at an approximately 1.5 m vertical offset from the two hydrophones (recording to channels 1 and 3 on the ORCA) that were mounted diagonally at the corners of the main frame. The channel 1 hydrophone mounted on the main frame was connected to both the PORPOISE and the ORCA recorders to enable synchronisation across instruments since the ORCA was configured for a 30 min on/30 min off duty cycle (see Fig. 7.32). Its configuration was designed to enable exploration of localisation of signals.

In addition to the hydrophones and their accompanying recorders, the lander was outfitted with a current meter (Nortek) and a CTD (SBE 37-SM MicroCat, Sea-Bird Scientific), as shown in Fig. 7.32.

Fig. 7.32 Whittard lander: schematic of the planned lander (top left), channel mapping (top right), and layout of instruments on the acoustic lander (bottom). The vertically mounted hydrophones were approximately 1.5 m above the hydrophones on the main frame (diagonal distance ~1.5 m).

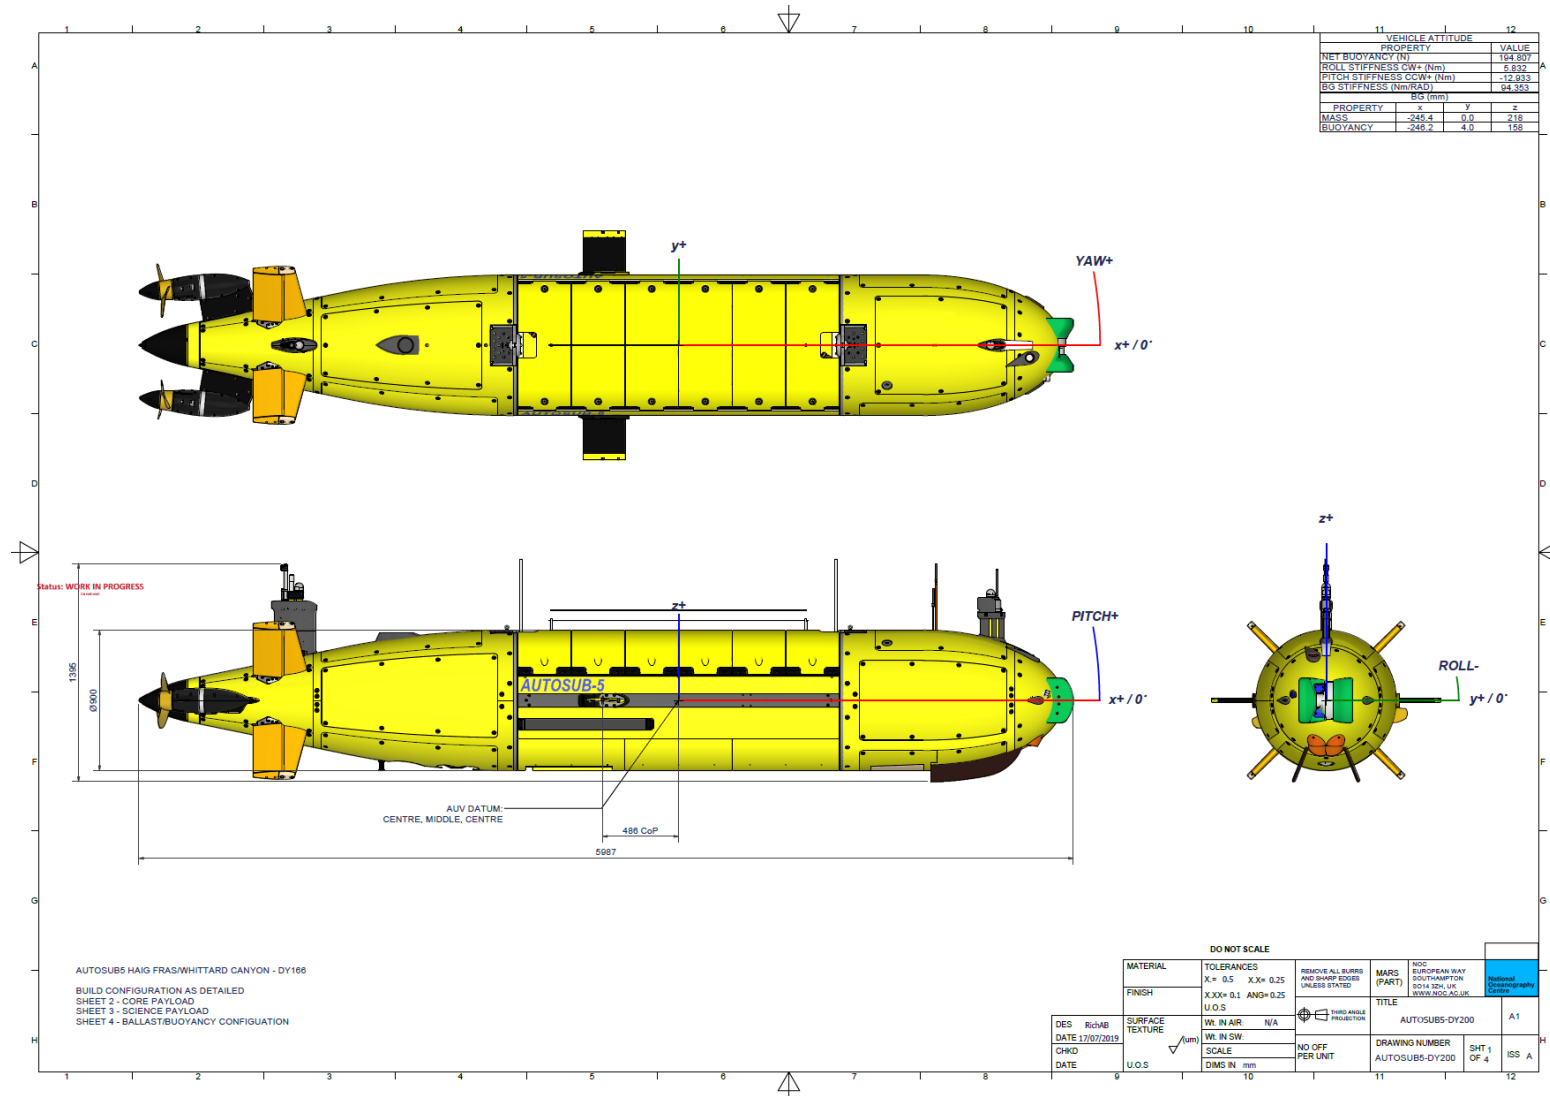
VEHICLE ATTITUDE			
PROPERTY	VALUE		
NET BUOYANCY (N)	164.807		
ROLL STIFFNESS C_{RW} (Nm)	5.832		
PITCH STIFFNESS C_{PW} (Nm)	-12.833		
YAW STIFFNESS (Nm/deg)	64.383		
BIC (mm)			
PROPERTY	x	y	z
MASS	-245.4	0.0	215
BUOYANCY	-245.2	4.0	155
