Drilling and as-built borehole design report for the UK Geoenergy Observatory in Cheshire

UK Geoenergy Observatories programme

Internal report OR/26/008

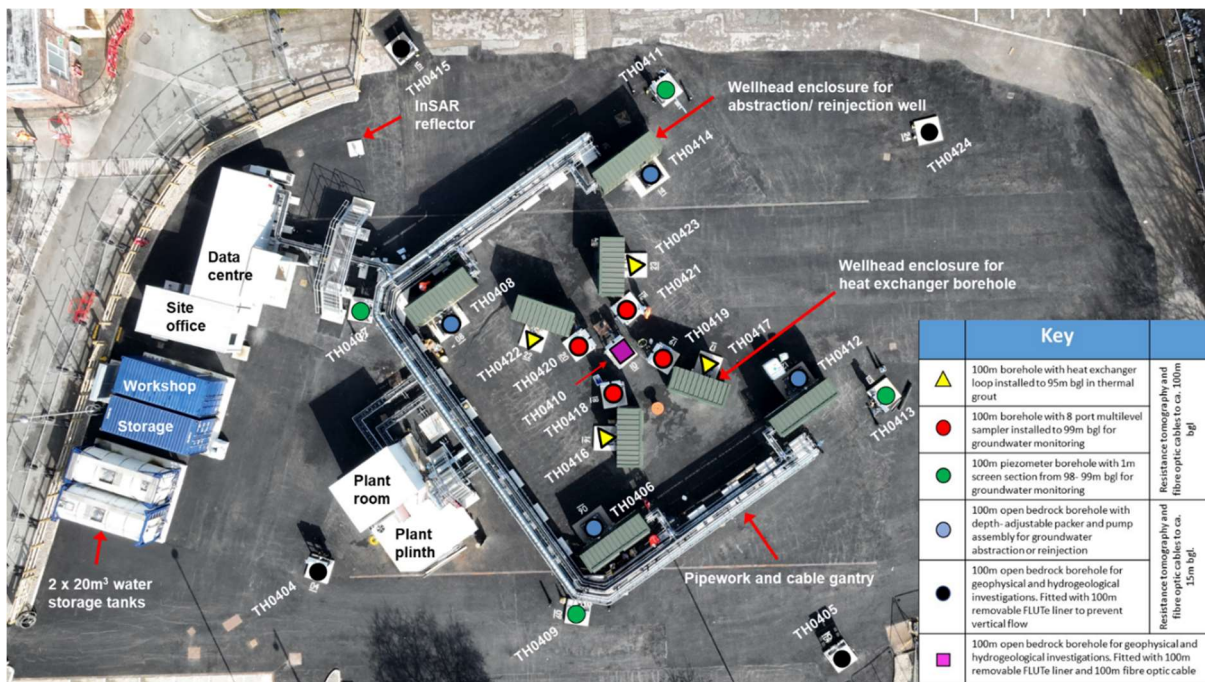
Figure 3 Aerial photo of the Cheshire site with the borehole array identifiers overlaid

The Cheshire Observatory comprises a symmetrical array of 21 boreholes drilled to ~100.0 m below ground level (bgl) and instrumented to either ~15.0 m or ~100.0 m with fibre optic cable, resistance tomography electrodes and thermistor strings (**Figure 3**). It has five borehole types arranged on approximately north- south and east- west axes, see **Figure 3**. Working outwards from the centre these are as follows:

- Central borehole with PVC casing to 20.0 m and then open in the bedrock to 100.0 m (TH0410).
- Four Waterloo 401 type multilevel groundwater monitoring wells (TH0418, TH0419, TH0420, TH0421).
- Four boreholes with single loop HakaGerodur GEROtherm®-RT borehole heat exchangers (TH0416, TH0417, TH0422, TH0423).
- Four abstraction- reinjection wells with depth adjustable packers for control of groundwater flow velocity (TH0406, TH0408, TH0412, TH0414).
- Four deep piezometer wells (TH0407, TH0409, TH0411, TH0413).
- Four boreholes with PVC casing to 15.0 m and then open in the bedrock to 100.0 m (TH0404, TH0405, TH0415, TH0424).

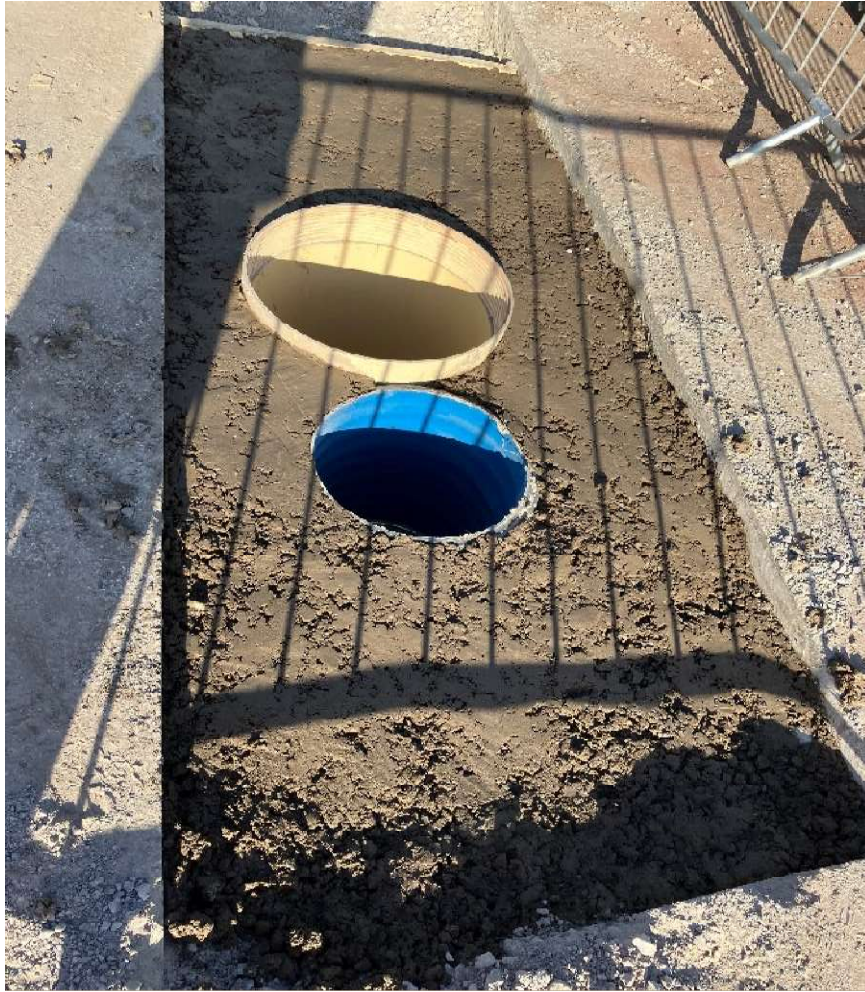
Figure 6 Installed 24” surface casing and smaller sump used during drilling phase only

It should be noted that the top of the 24” surface casing was used as the primary depth reference for all drilling, coring and wireline logging throughout the entire operation. The depths have subsequently been worked back to AOD where needed (**Table 3**).

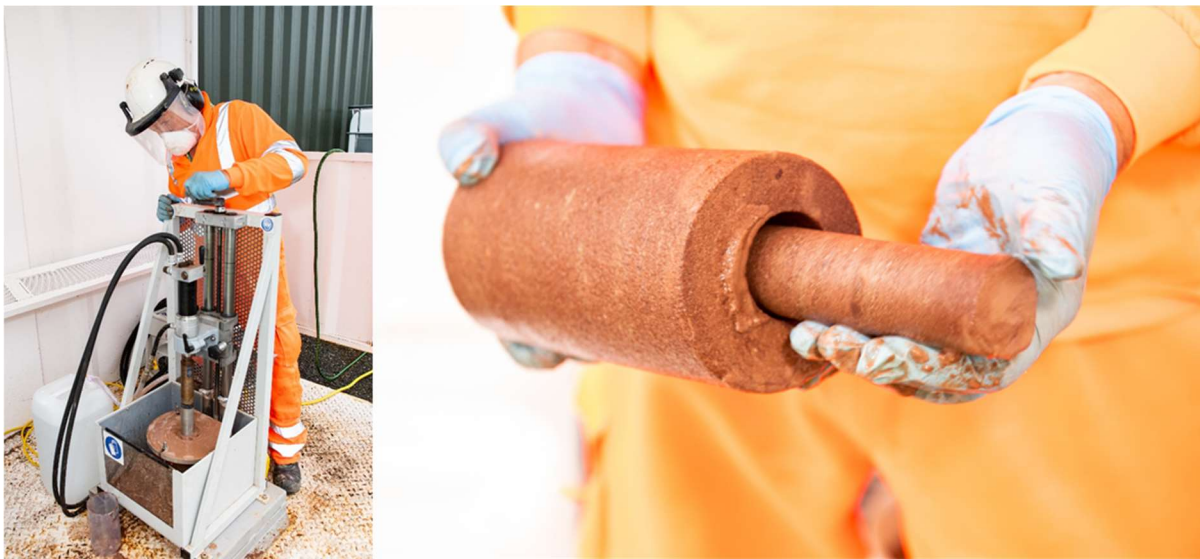
Figure 7 Sub- coring drill press and example sub-core

Core was processed using a sub-coring drill press and a diamond wheel cutoff saw (Figures 7 and 8 respectively). A gravity feed of deionised water from an IBC was used to cool and flush away cuttings from the sub coring drill and cut-off saw to minimise sample contamination. Core samples were collected every ca. 3.0 m at TH0410 and every ca. 6 m in the other boreholes. Additional samples were collected adjacent to a fracture zone at ~80 m bgl in TH0419 to check for gradients in the porewater chemistry and microbiology (Figure 21).

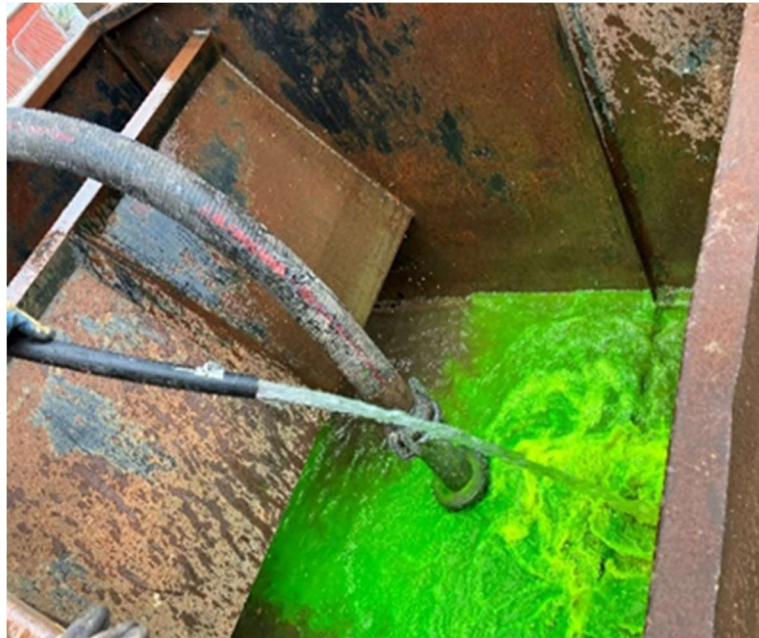
Figure 10 Sodium Fluorescein being added to the active tank system.

Operations on TH0410 commenced on the 22nd September 2022. The rig and associated equipment were rigged up, and 2 x 500 ml bottles of sodium fluorescein solution were added to the active mud tank (**Figure 10**). Fluorescein was added as a tracer to assess the degree of drilling fluid contamination in TH0410 drill core subsamples collected for pore water and microbiological analysis.

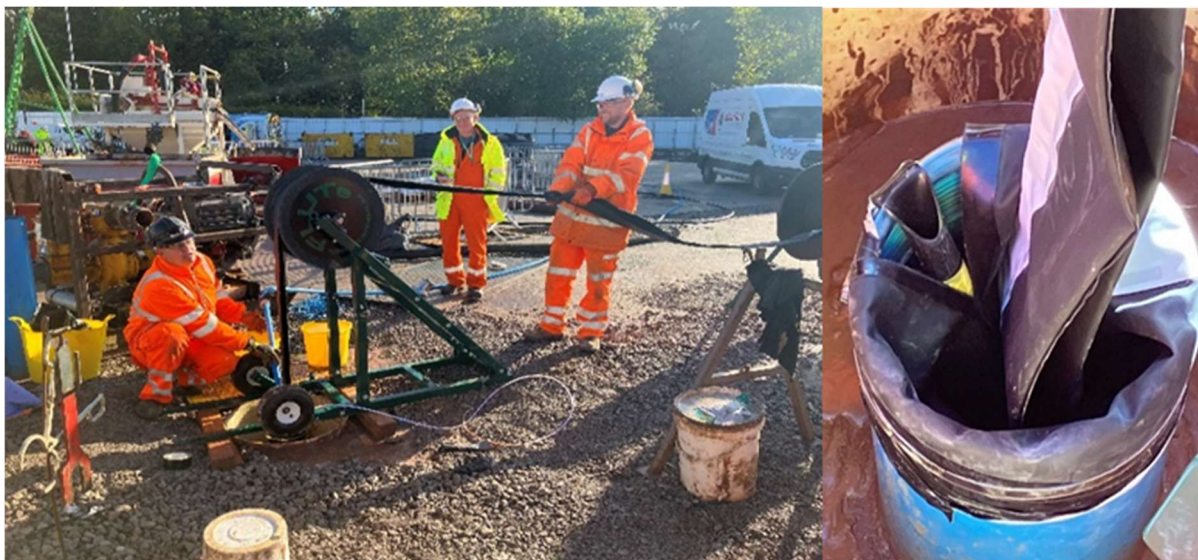
Figure 12 FLUTe liner deployment into TH0410 using “Green Machine”

Bentonite was introduced to bring the total depth of the well up to 100.0 m for the FLUTE liner install. The well was dipped at 100.5 m and accepted by BGS. A spooling apparatus supplied by FLUTE called a “Green Machine” and other equipment needed for liner deployment were rigged up before installing the liner as per the manufacturer’s instructions (**Figure 12**). The liner and tether were secured at surface before making the well safe and rigging down.

The drillers rigged up a weight indicator to the top drive, attached the FLUTe liner and commenced pulling the liner out of hole (indicator showed 330 kg pull). It was pulled using a 2-strop technique using the main top drive and the rig winch. The liner was successfully recovered on the 22nd June 2023 but with damage in several locations.

The Green Machine was rigged up and Bentonite pellets introduced to the base to bring the total depth up to 100.0 m. A replacement liner was successfully deployed to depth on the 13th July 2023.

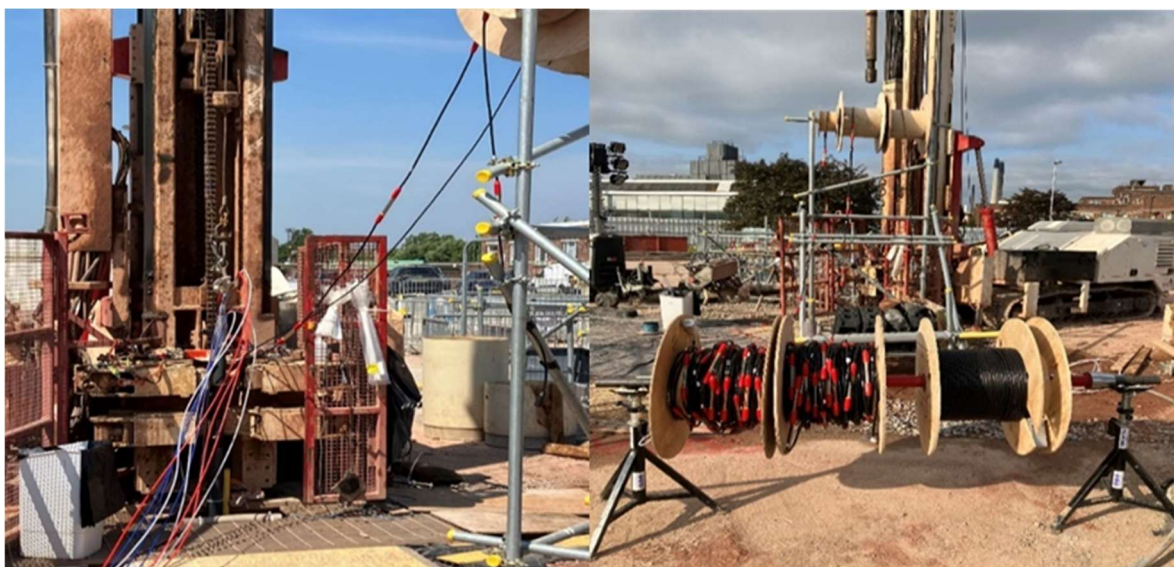
Figure 17 Images of the installation being run into TH0418 showing the MLS lines, the ERT and FO cables

The installation bottom hole assembly (BHA) was prepared, and cable reel stands and other equipment deployed in preparation for running. MLS cables and tubing were laid out on a 100.0 m run around the site perimeter on a heavy-duty polyethylene sheet. The installation was then RIH to the final setting depth at 99.96 m with the casing assembly as per the install tally (Solinst Waterloo MLS tubing 60.3 mm OD / 50 mm ID), attaching all line and the ERT and FO cables to the MLS tubing. The ERT and FO cables were tested together with the groundwater sampling pumps before commencing the backfilling operation. See **Section 4.2.7** for the backfill materials, intervals and the 8 x MLS port depth. Once the final layer of filter pack had been emplaced the upper section of the well from 11.06 m was grouted back to surface with Geotherm X grout.

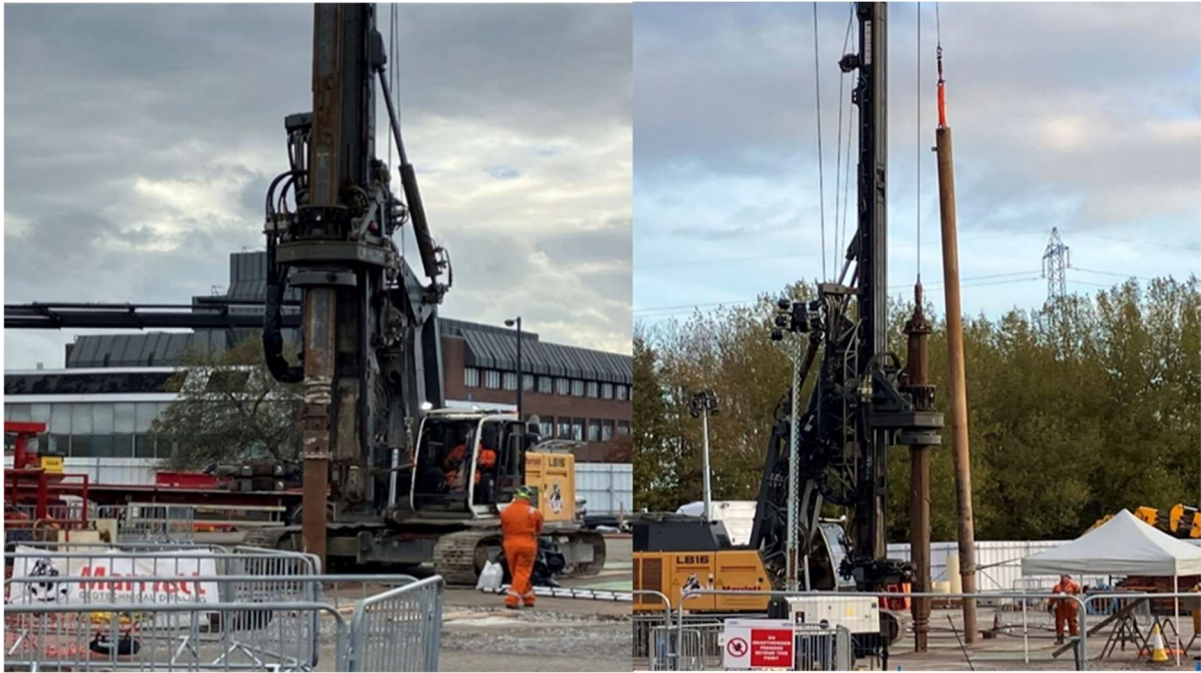
Figure 26 Marriotts Liebherr rig casing recovery operation

Decision taken to over drill the stuck 10 ¾" casing with a 12" wash pipe string. The string was worked down over the next 4 days (full details can be found in **Section 4.4.10**) to 16.5 m where high torque was seen. Gravel was introduced to add additional friction between the 10 ¾" casing and 12" wash pipe. The string was worked and confirmed the string had been freed. POOH both strings before rigging down the Liebherr rig.

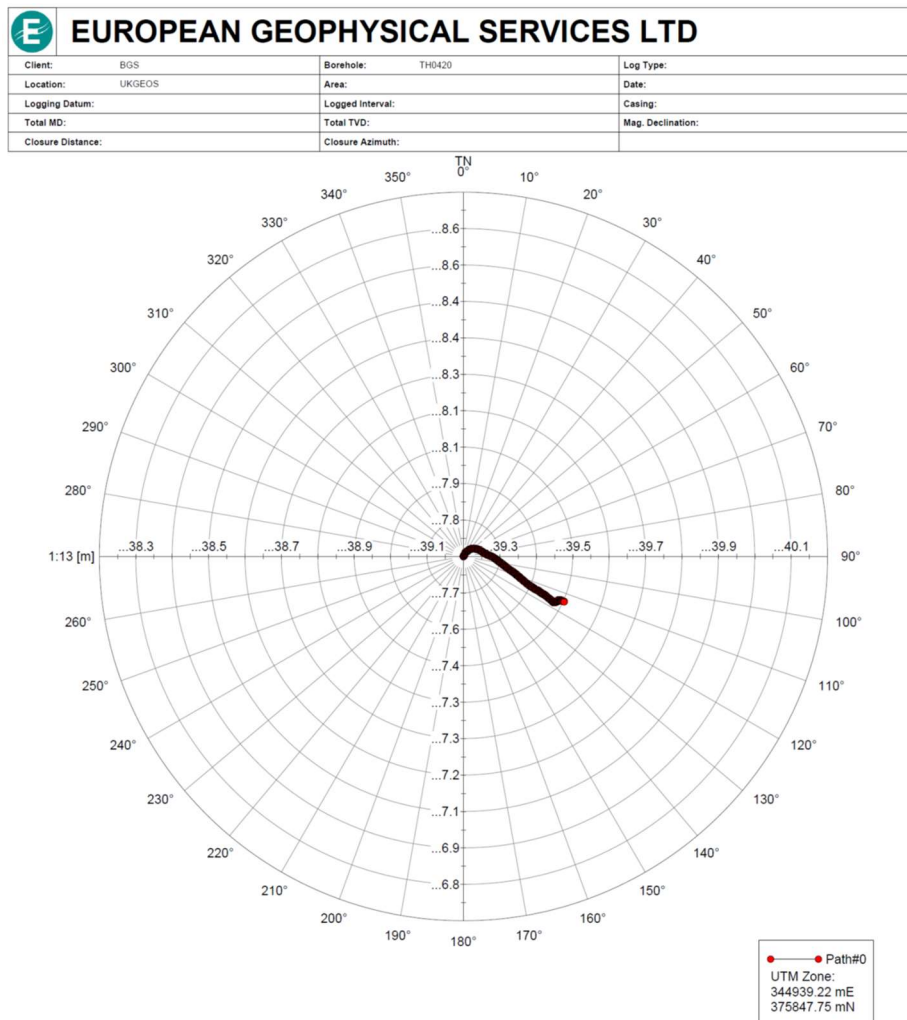
Figure 27 Verticality bullseye plot for TH0420, © European Geophysical Services Ltd

The inclination of the well was checked once total depth had been achieved, as shown in the bullseye plot below. The maximum step out recorded was 0.31 m and within the 1/100 tolerance.

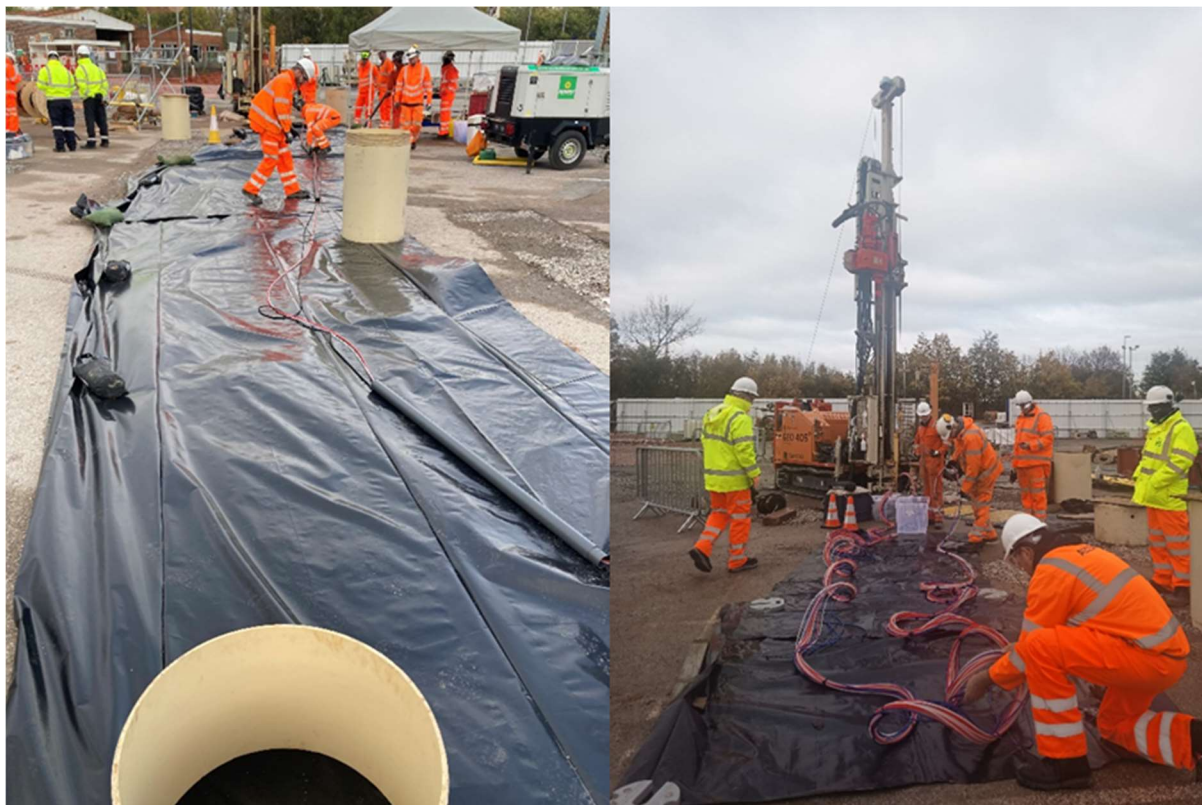
Figure 28 left hand image showing preparation works for running, right hand image shows the end of the install, and all MLS ports run.

The 8 MLS pneumatic double- valve groundwater sampling pumps were tested prior to installation to confirm that they functioned correctly. The 8 MLS pressure sensors (4,500 SOL vibrating wire transducers) were also checked to confirm that pressure readings were within 0.1% of the factory calibration values. The well was dipped at 99.75 m and the depth accepted by BGS as the installation tally and final setting depth was 98.99 m.

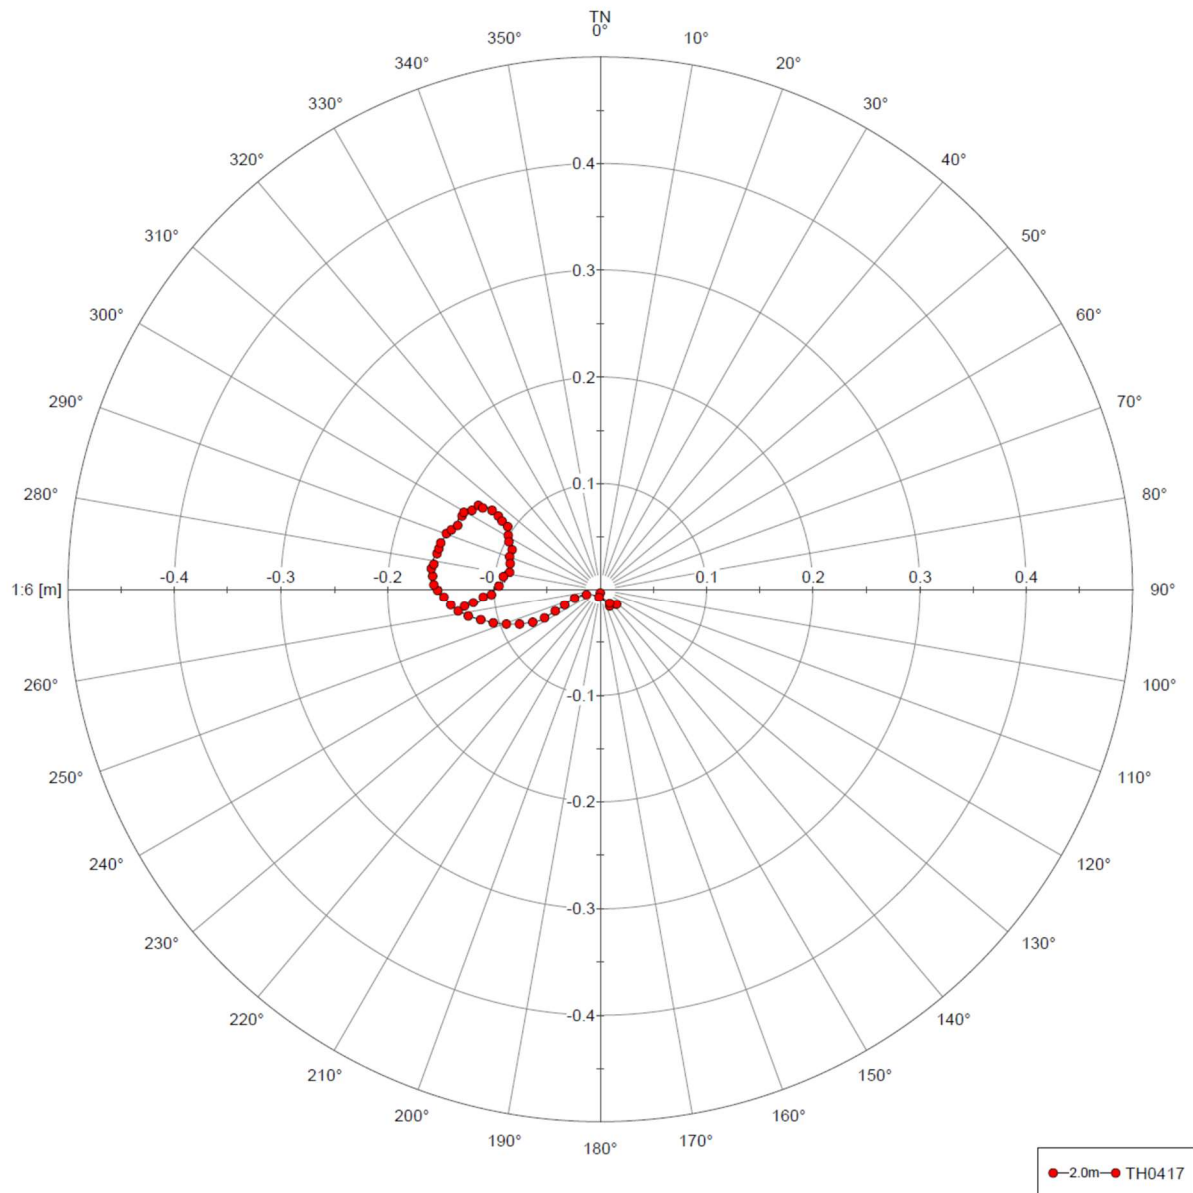
Figure 43 Verticality bullseye plot for TH0417, © European Geophysical Services Ltd

The inclination of the well was checked once total depth had been achieved and this is shown in the bullseye plot below. The maximum step out recorded was 0.14 m and within the 1/100 tolerance.

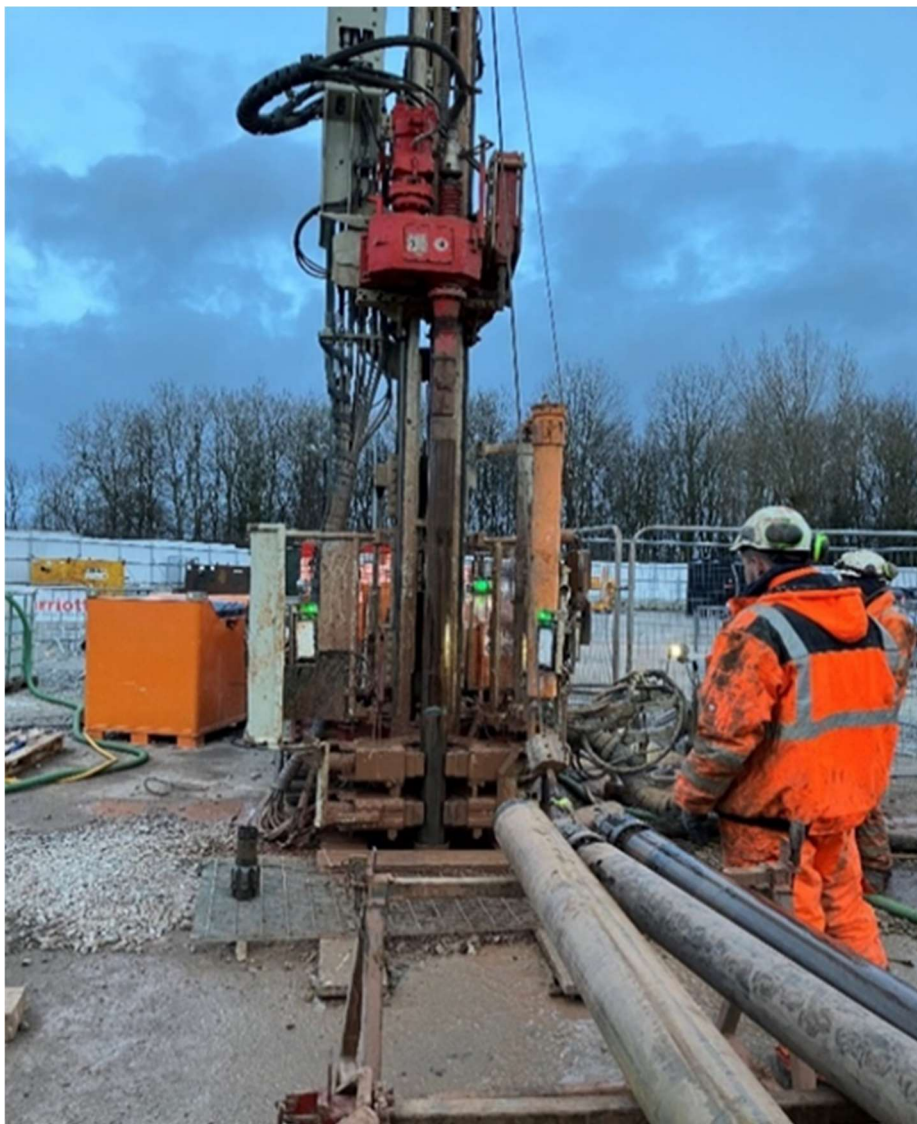
Figure 50 Coring ahead in TH0422

Continued to core to 82.4 m where it became increasing difficult to treat and seal the fractures and remain within the loss rates stated within the Site Instruction issued to the Principal Contractor as a requirement of the NEC 4 contract. The decision was taken to add Bentonite to the active system to provide a filter cake to reduce seepage losses. As the well advanced deeper and more open hole was exposed the seepage losses were contributing to the fluid loss threshold stated within the introduction for an LCM pill to be pumped to treat a fracture zone. This approach did not allow the drillers flexibility and to make judgement calls based on the depth of hole and how the well was reacting.

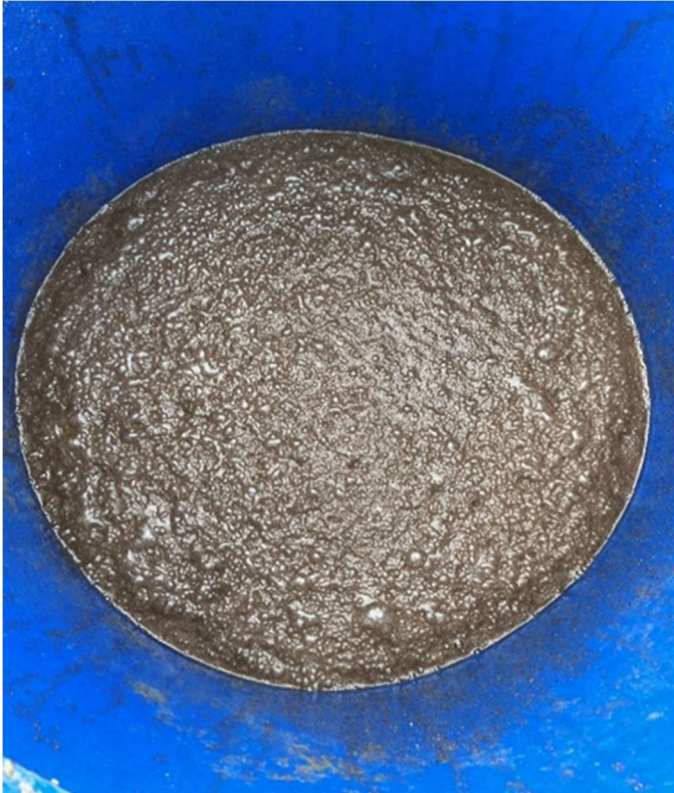
Figure 51 A 100 L 40 ppb LCM pill prepared ready to be pumped.

Bentonite was introduced into the mud system toward the base of the well to reduce the seepage losses and produce a filter cake. As the well advanced deeper and more open hole was exposed the seepage losses were contributing to the fluid loss threshold stated within the introduction for an LCM pill to be pumped to treat a fracture zone. This had limited success as the concentration introduced couldn't be maintained at the optimum level as mud checks weren't being undertaken.

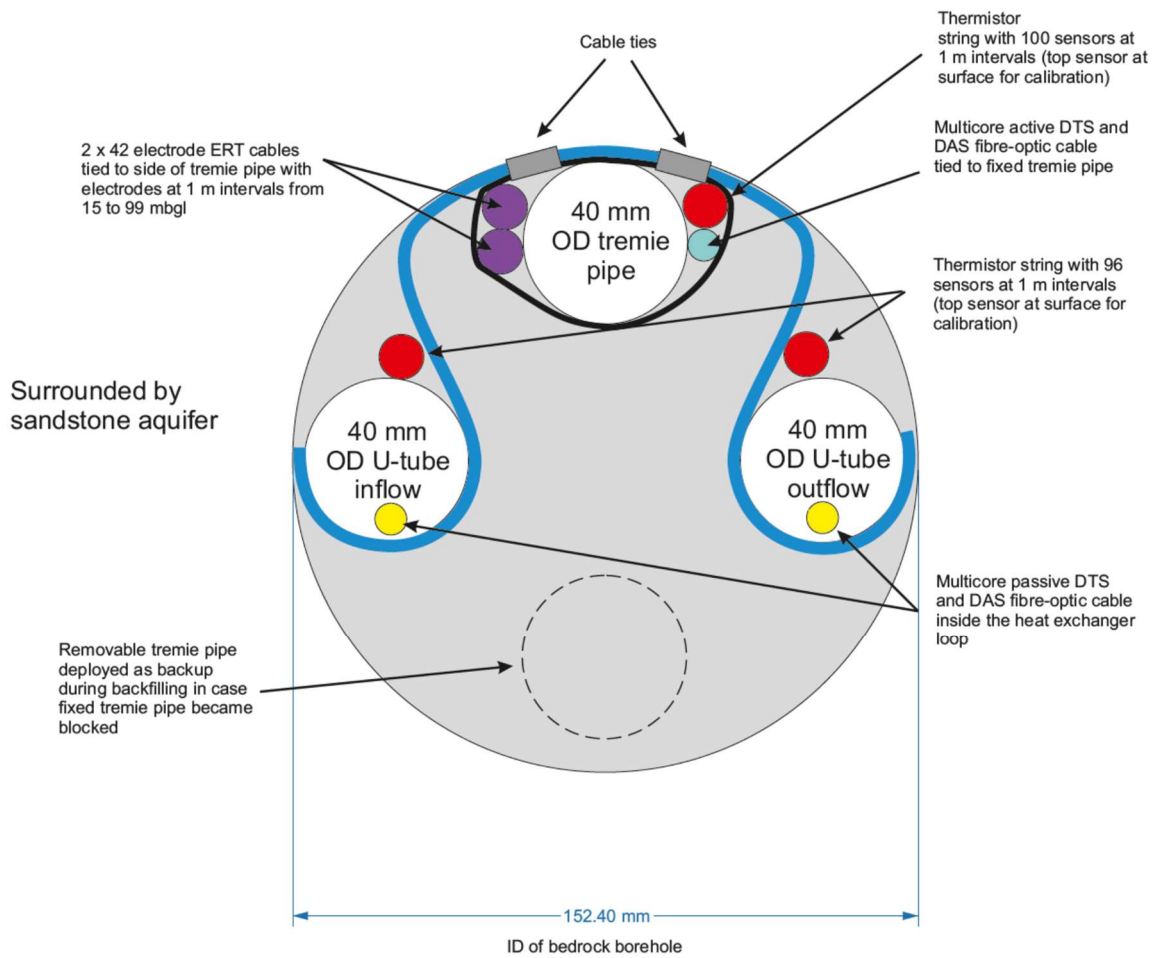
Figure 53 Schematic showing the placement of the various sensor cables on and within the installation for TH0422

The Loop Master was lowered to the ground, and all cable strings were tested (FO, ERT and thermistor strings) before rigging up and pressure testing the heat exchanger loop for a second time to 7.5 bars, following the GSHPA guidelines and in accordance with the SN EN80. Good test observed.

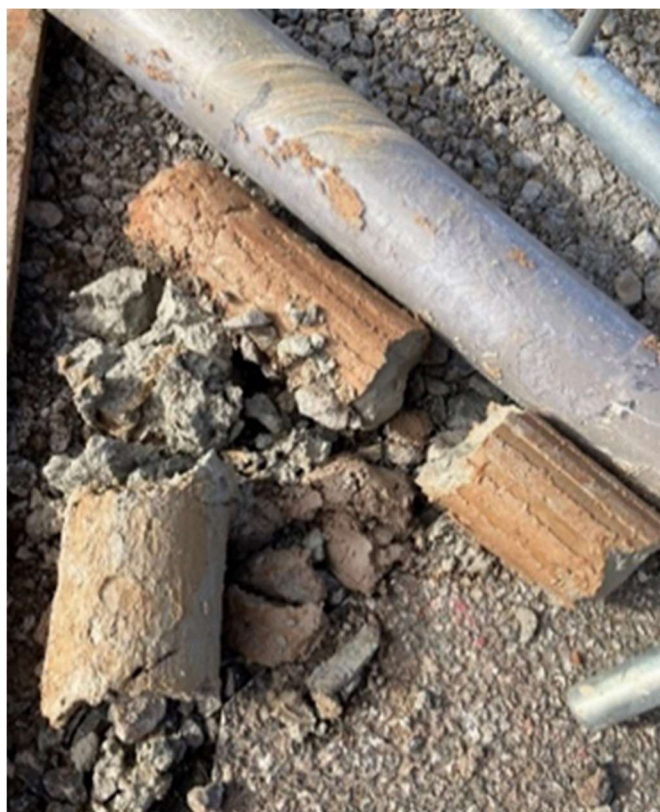
Figure 58 Cored out Geotherm X cement plug from 44.9 m to 47.9 m

Borehole dipped at 35.6 m. Ran back in hole the coring assembly and washed through the grout with no resistance until 44.9 m (3 m off bottom). Cored through the cement and recovered in the core barrel.

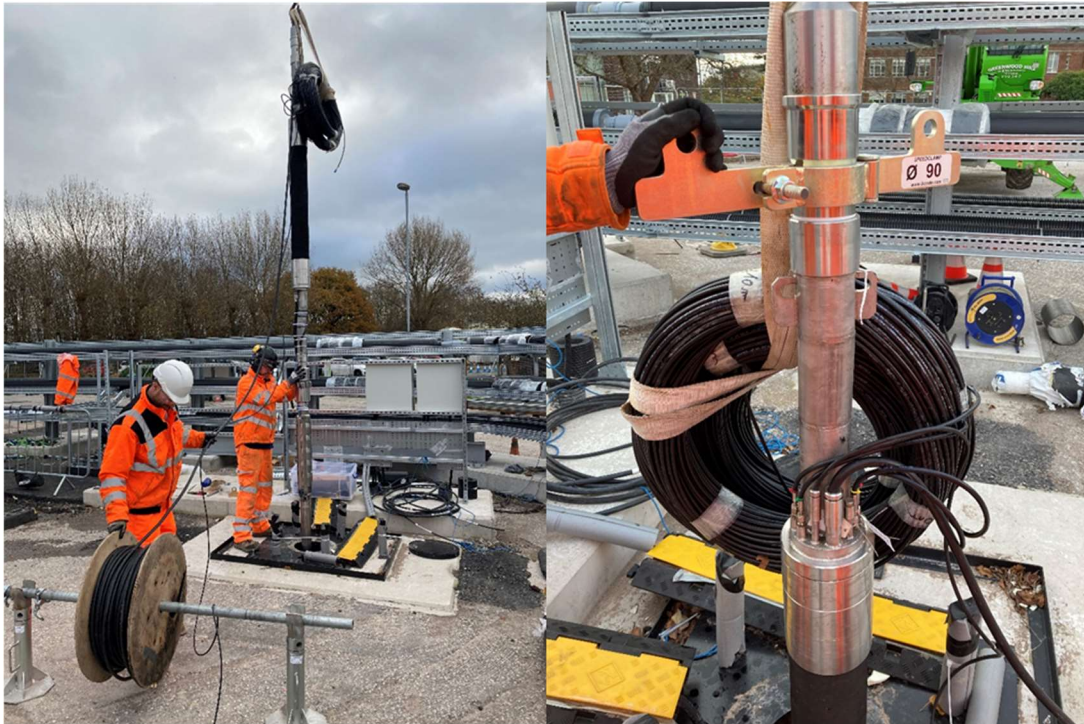
Figure 69 TH0406 pump and packer assembly being RIH

The packer, downhole valve and pump assembly was made up in a single assembly on the ground. The pump power cable was terminated in a resin filled connector and all hydraulic lines were made up to the packer mandrel. The completed assembly was picked up and RIH utilising a telehandler with a hydraulic winch attachment.

The assembly was RIH on sections of 3 ½" Ecoline Heavy Duty PN26 rising main as per the installation sheet placing the mid element of the packer at 35.04 m. The rising main was secured at surface on a C plate with the Speedclamp still attached. The packer was inflated with 15 bars before rigging down. The pump wasn't run at this stage as the inverter drives in the well enclosures hadn't been wired in to the surface connection and infrastructure.

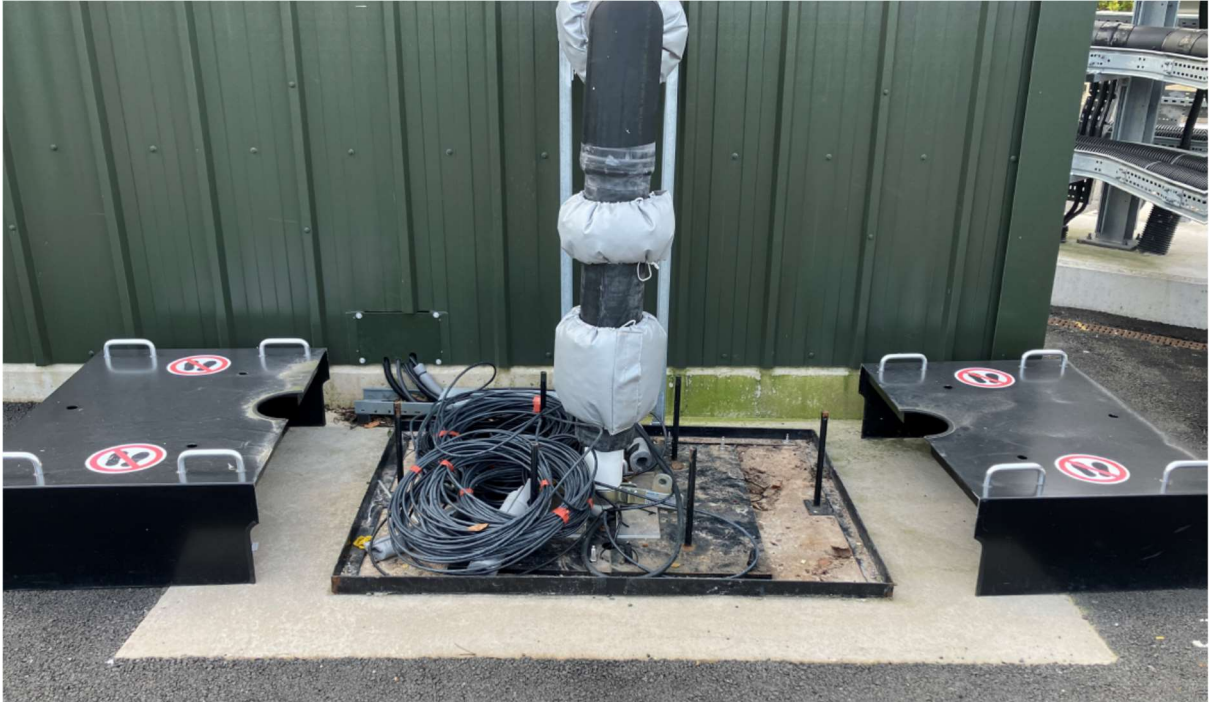
Figure 71 Wellhead status TH0406

Note: lines shown are for the hydraulically operated valve above the pump

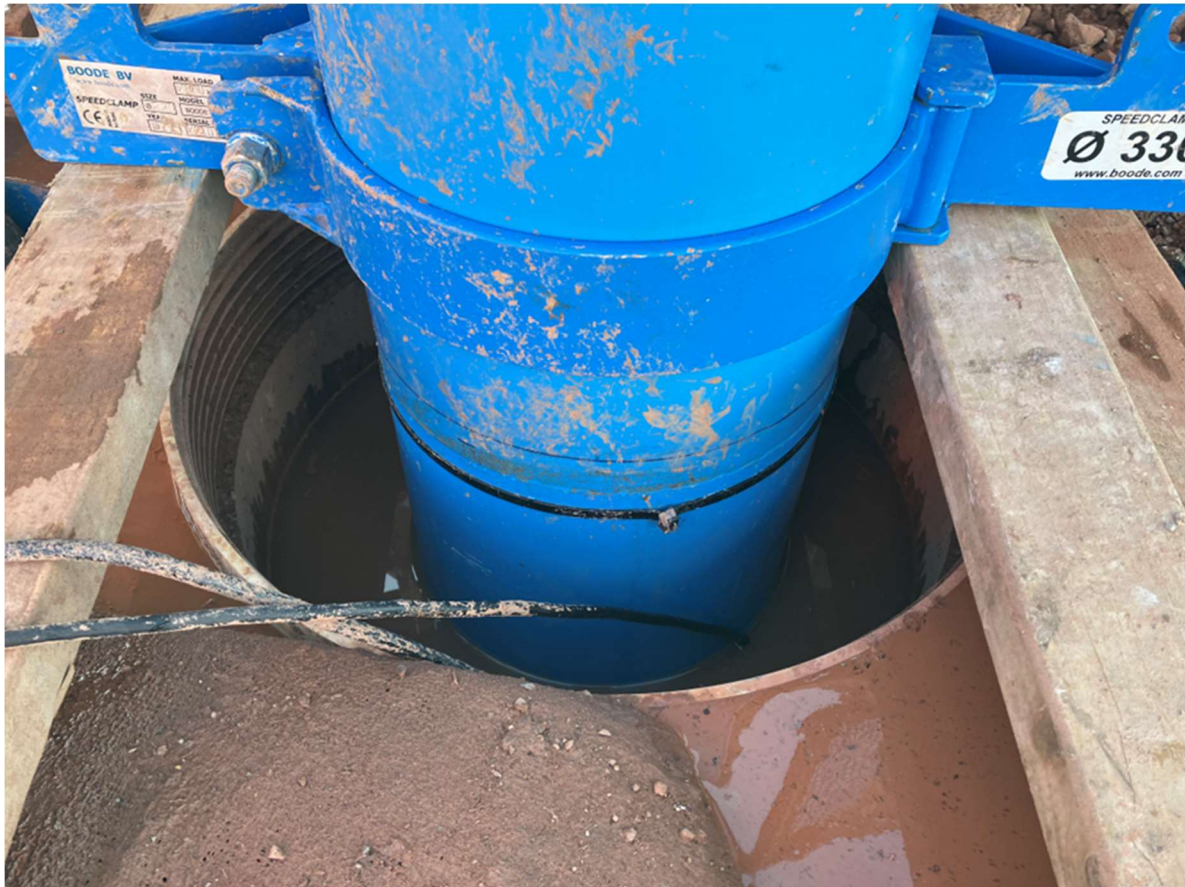
Figure 73 Intermediate 330 mm OD casing installed with ERT and FO, grout level below GL

The 444 mm reamer and pilot bit opened out the hole down to 15.5 m and the well circulated with full returns before displacing to clean mud. The assembly was POOH and laid out before setting up to run the intermediate casing. A temporary shoe was made up to the first joint of 330 mm OD casing with ERT and fibre optic cables secured to the outside and RIH. The shoe joint comprised of a short section of casing that had a precast concrete plug in the base. This had been predrilled and raw plugs inserted through the side to help grip the cement plug and avoid it falling out when run (this occurred on TH0424 with no additional securing method). The remaining joints of casing were run, securing the ERT and fibre optic cable to the outside with cable ties with the shoe at 15.0 m (0.5 m above reamed shoulder). The grout unit was rigged up before grouting the 330 mm annulus with 6 x 100 L batches of grout with a weight between 1.70 and 1.72 sg.

A thermally conductive grout was used which satisfied the Specification for the intermediate casing string. The grout product used was “Geotherm-X GR,” which was mixed with water to a ratio of 7.5 bags (24 kg) to 100L of water.

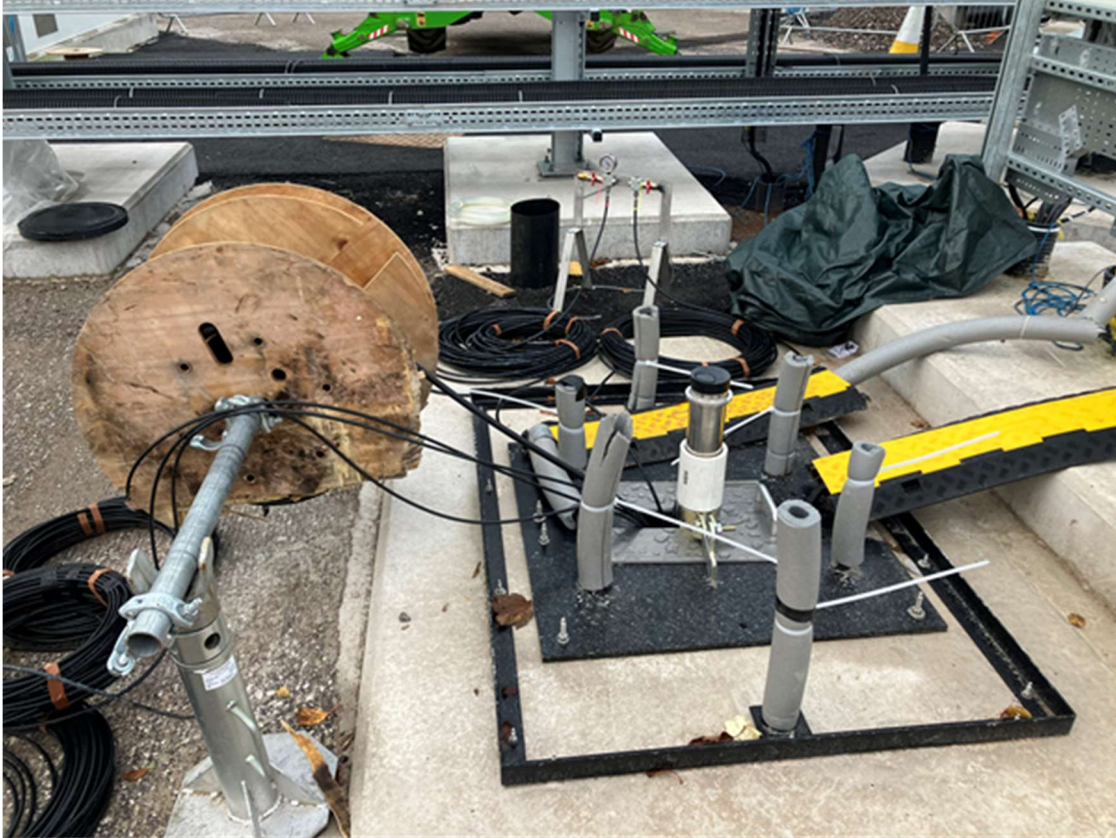
Figure 76 TH0408 pump and packer successfully RIH.

The packer, downhole valve and pump assembly was made up in a single assembly on the ground. The pump power cable was terminated in a resin filled connector and all hydraulic lines were made up to the packer mandrel. The completed assembly was picked up and RIH utilising a telehandler with a hydraulic winch attachment. The packer was inflated when just below ground level and checked for leaks before bleeding off, deflating and continuing in hole.

The assembly was RIH on a 3 ½" Ecoline Heavy Duty PN26 rising main as per the installation sheet placing the mid element of the packer at 33.11 m. The rising main was secured at surface on a C plate and with the Speedclamp still attached. The packer was inflated with water to 15 bars before rigging down. The downhole pump wasn't tested at this stage as the inverter drives in the well enclosures hadn't yet been wired in to the surface connections.

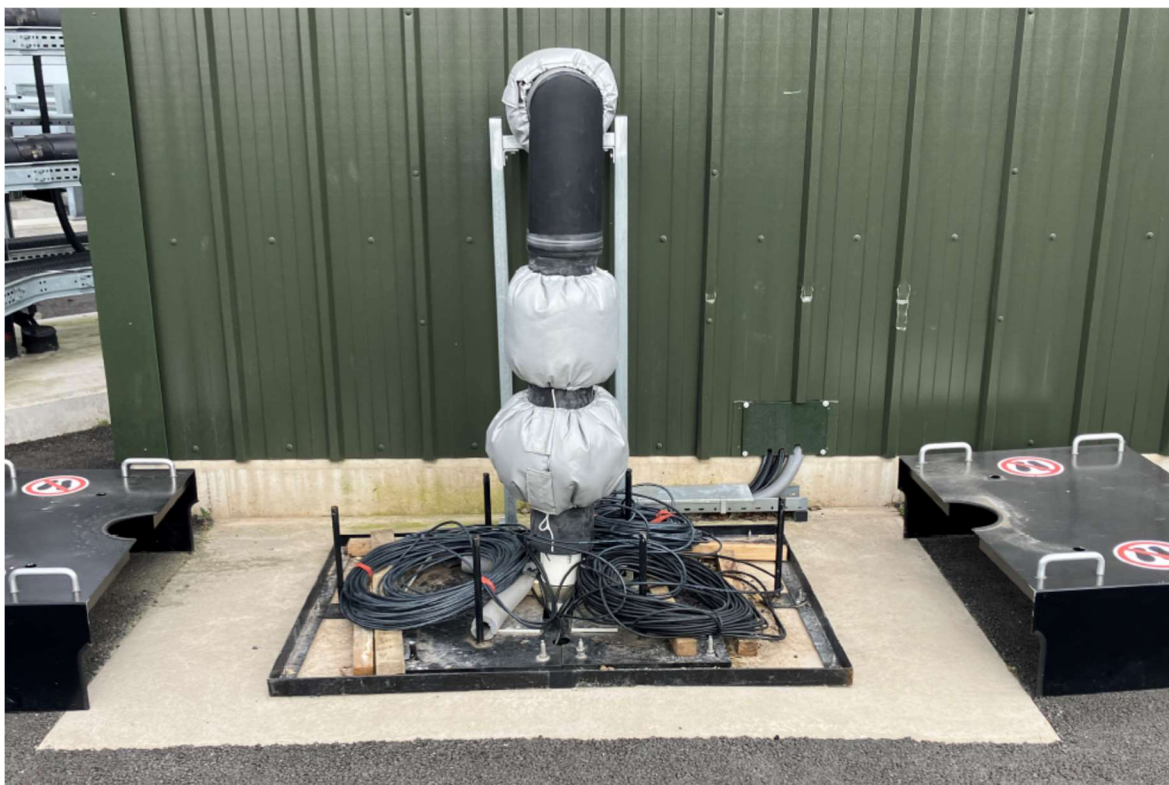
Figure 78 Wellhead status TH0408

Note: lines shown are for the hydraulically operated valve above the pump

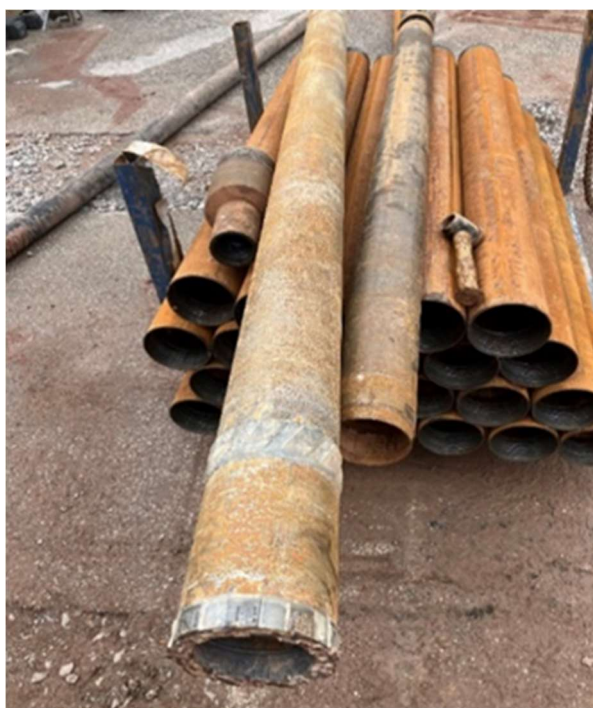
Figure 80 Image of the 146 mm Geobore coring assembly and rods

Made up and RIH the 146 mm Geobore S coring assembly and cored from 2.0 m to 16.2 m with full returns throughout utilising a polymer mud system. The hole was circulated clean before POOH the assembly.

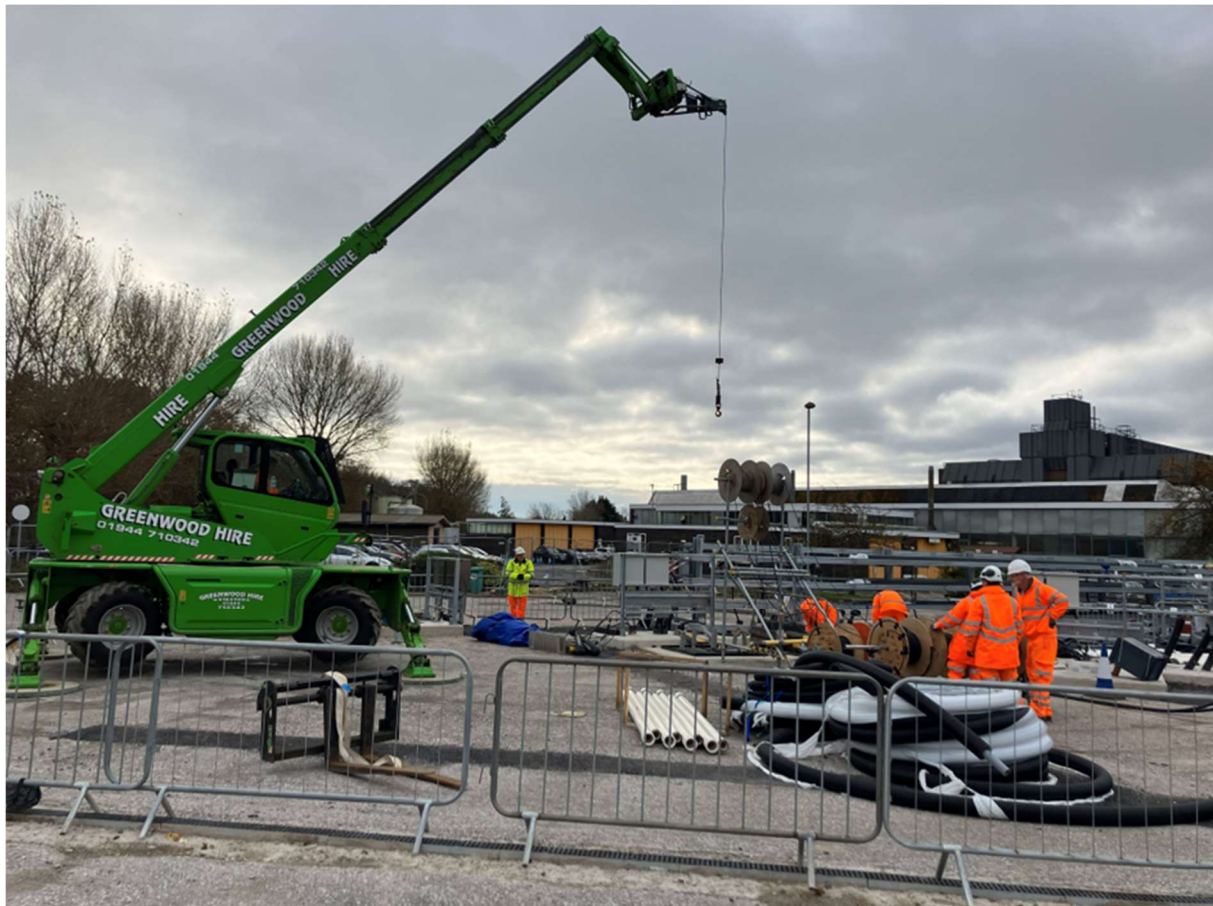
Figure 82 Setting up in readiness for running the packer and pump assembly into TH0412

The packer, downhole valve and pump assembly was made up in a single assembly on the ground. The pump power cable was terminated in a resin filled connector and all hydraulic lines were made up to the packer mandrel. The completed assembly was picked up and RIH utilising a telehandler with a hydraulic winch attachment. The Packer was inflated when just below ground level and checked for leaks before bleeding off, deflating and continuing in hole.

The assembly was RIH on a 3 ½” Ecoline Heavy Duty PN26 rising main as per the installation sheet placing the mid element of the packer at 34.12 m. The rising main was secured at surface on a C plate and with the Speedclamp still attached. The packer was inflated with 13.5 bar before rigging down. The downhole pump wasn’t tested at this stage as the inverter drives in the well enclosures hadn’t yet been wired in to the surface connections.

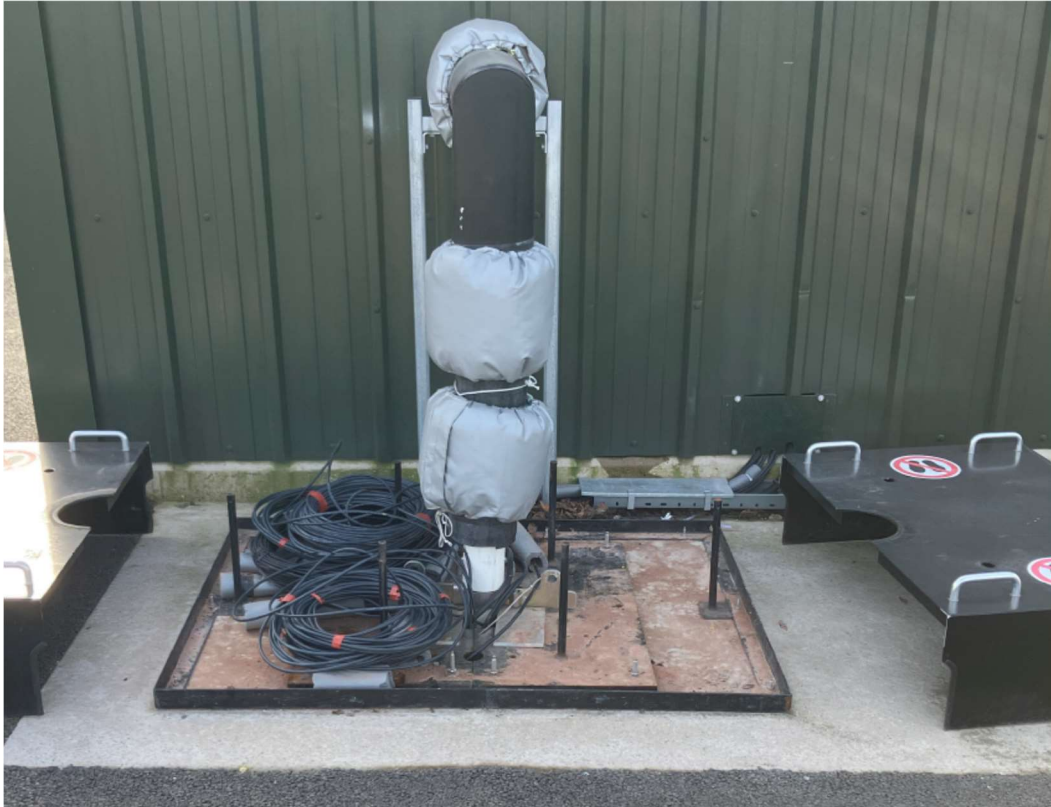
Figure 84 Wellhead status TH0412

Note: lines shown are for the hydraulically operated valve above the pump

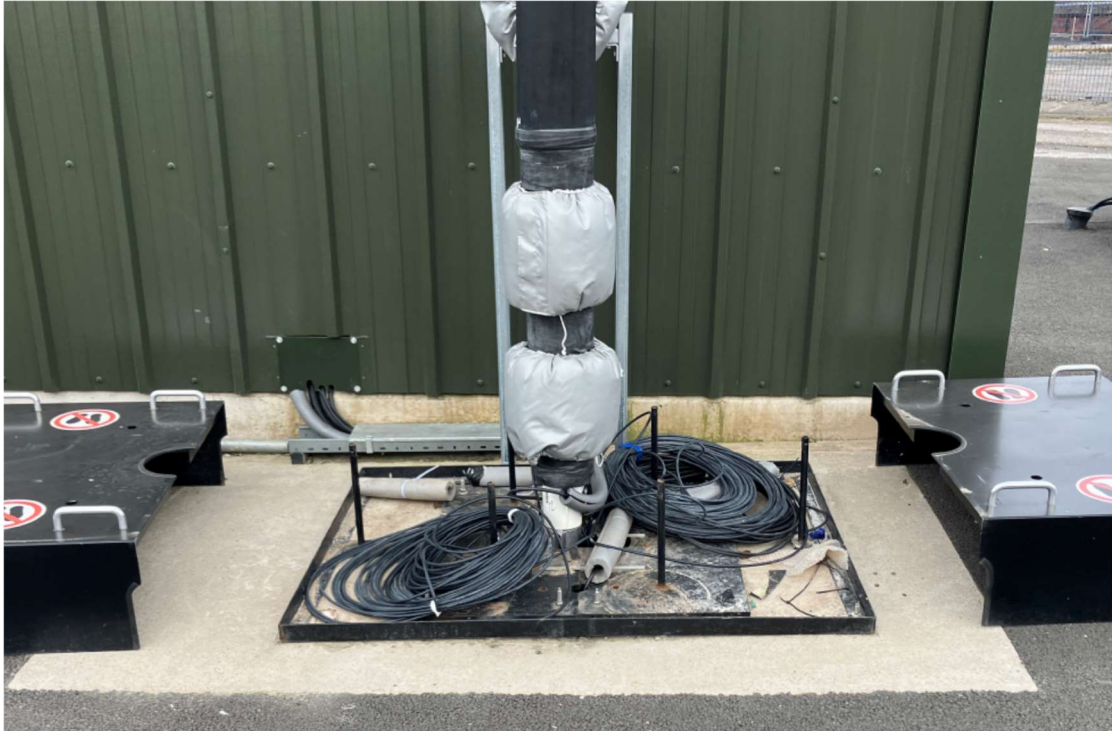
Figure 89 Wellhead status TH0414

Note: lines shown are for the hydraulically operated valve above the pump
