Drilling and as-built borehole design report for the UK Geoenergy Observatory in Cheshire

UK Geoenergy Observatories programme

Internal report OR/26/008

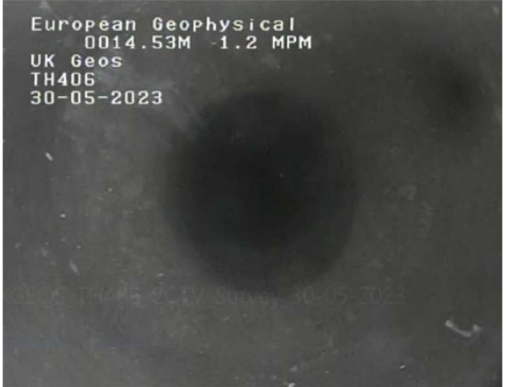
<p data-bbox="387 734 895 801">Poor cement job beneath original casing, shoe however still attached.</p>

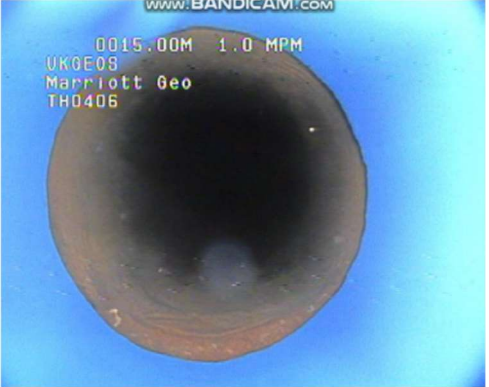
<p data-bbox="922 734 1493 936">Step and drag bit used to create rebate. Casing seated but camera run showed approximately 13 mm overhang to the open hole below (snagging risk). Sleeve removed. Rebate worked and string rerun and worked by hand into socket.</p> <p data-bbox="922 1003 1493 1070">Sleeve casing - 280 mm OD x 255 mm ID and set at 15.58 m.</p>
TH0408

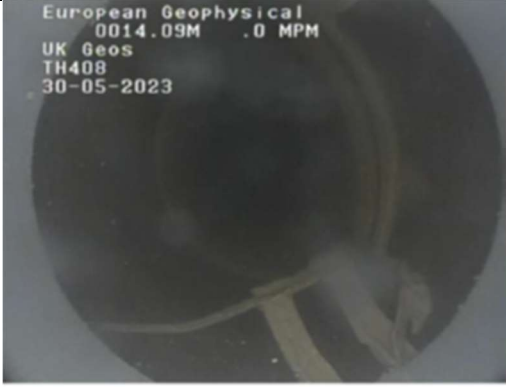
<p data-bbox="387 1473 895 1541">Failed casing shoe: shoe fully turned off and detached.</p>

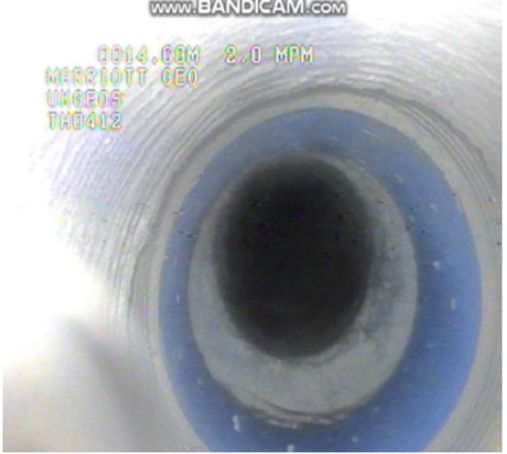
<p data-bbox="387 640 896 835">Casing shoe fully detached and dropped, no grout present and centraliser across well creating a snagging risk. Damage to the bottom 3 x ERT electrodes, shoe fully turned off and detached.</p>

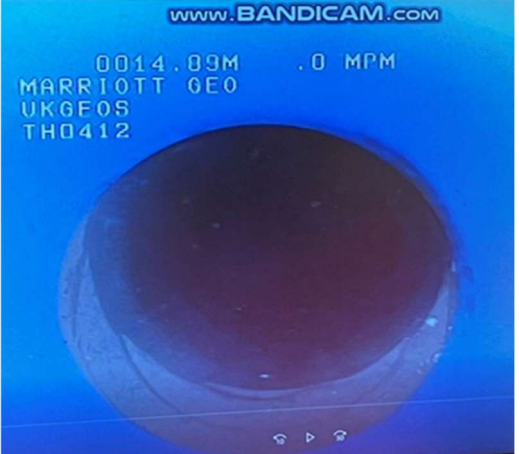
<p data-bbox="927 640 1490 983">Not sleeved, attempted but misalignment between permanent casing and lower hole reduced the access to the lower section. Well not drilled in centre of previous casing. Solution was to perform a secondary cement job around the shoe and drill out. A temporary plug was used as a base for cement. This was subsequently drilled out and the debris pushed to bottom - well dipped at 96.0 m.</p>
TH0414

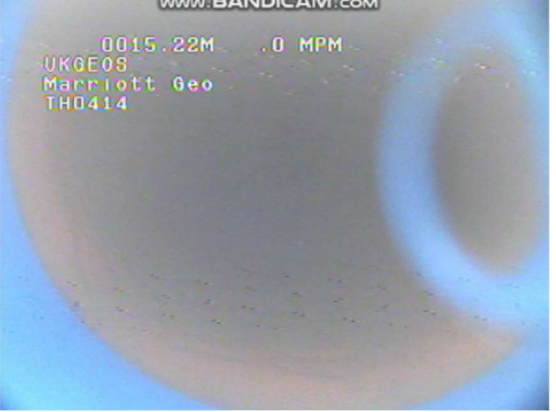
<p data-bbox="927 1438 1490 1565">Grout knocked out of shoe and sleeve casing run and landed on original shoulder. Sleeve casing - 280 mm OD x 255 mm ID and set at 15.44 m.</p>

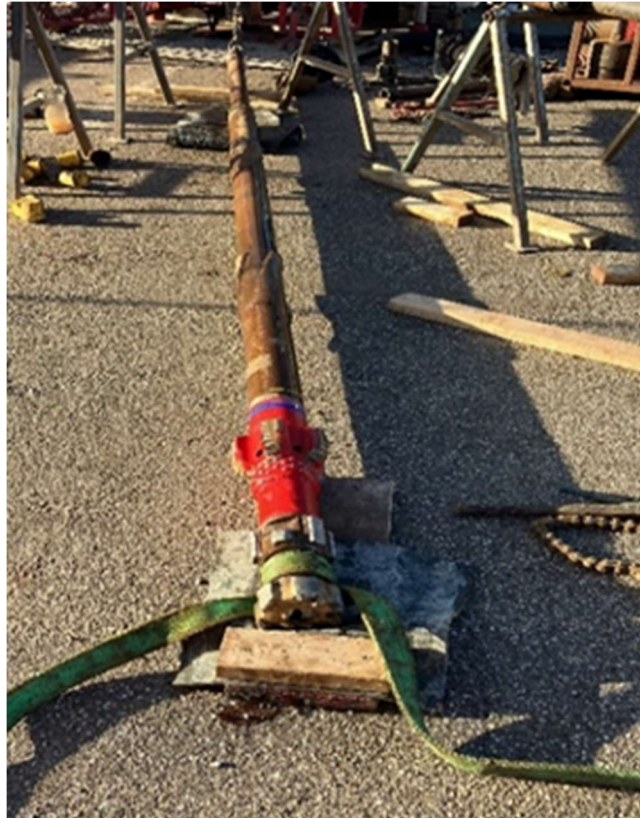
Figure 97 200 mm reamer assembly

A 200 mm reamer assembly was made up and RIH and opened out the hole from 146 mm down to 60.0 m where the hole was circulated clean and the assembly recovered. A crosswire check was completed in two-way direction at 14 stations (same depths at E-Totco readings) as it was advanced deeper to ensure verticality and to cross check the survey tool results. Assembly recovered and the 200 mm reamer was run back in hole.

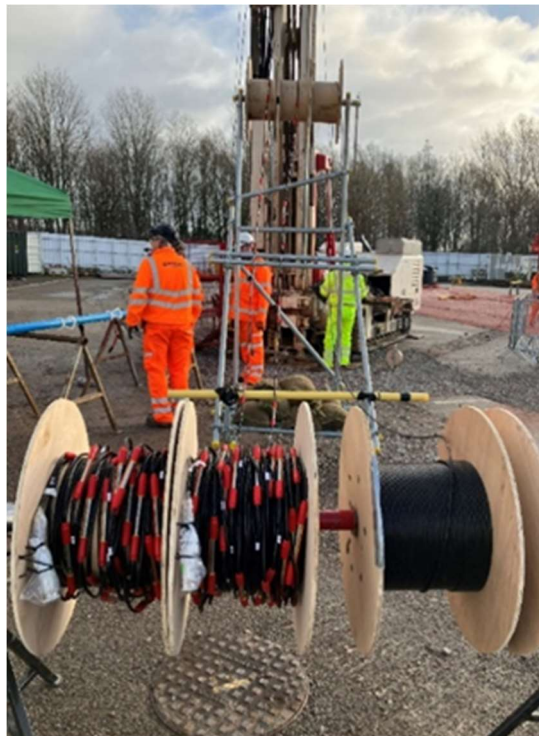
Figure 104 TH0411 installation setup

Prepared the installation BHA and setup the cable reel stands and equipment in preparation for running. A 60 mm retrievable tremie pipe was RIH 97.18 m.

Held a pre-installation meeting with all parties before commencing. Made up the ERT BHA with the base plug, screen section and first full joint of 75 mm OD pipe and lowered

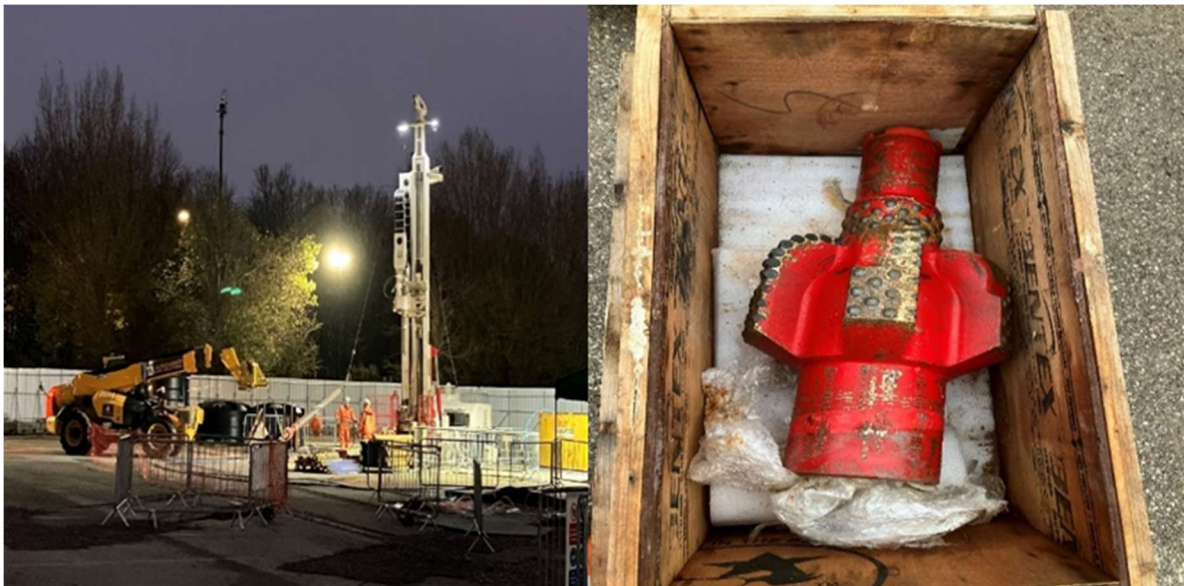
The Soilmec rig was mobilised back to TH0413 on the 30th November 2022 and the 311 mm reamer assembly was made up and RIH. The hole was opened out down to 6.4 m before circulating the hole clean and POOH.

Figure 109 Lefthand image is of the 311 mm reamer assembly being picked up. The righthand image is the 311 mm reamer before make up

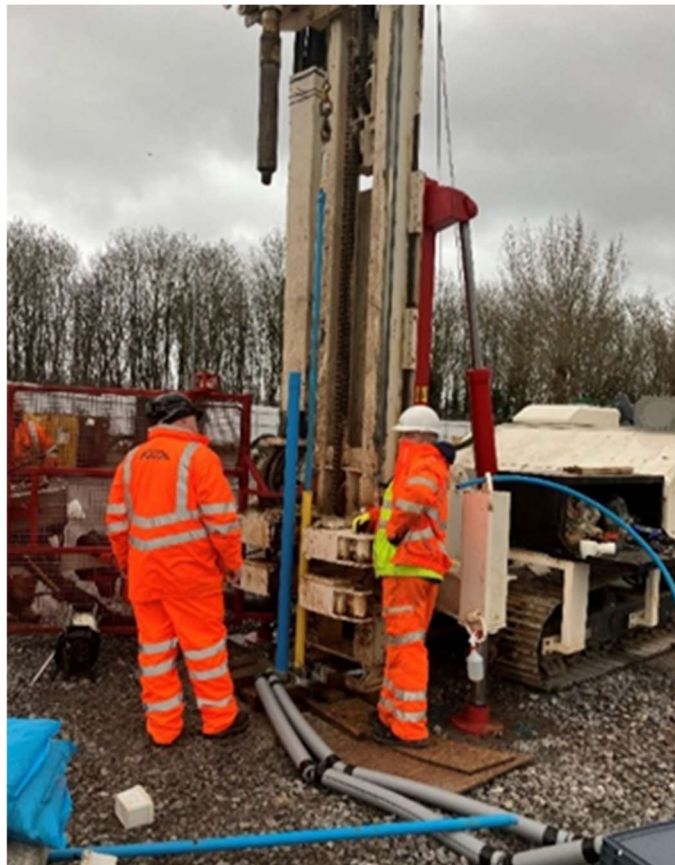
Back filling operations then commenced. See **Section 4.20.6** for the backfill materials and grout lifts undertaken. During the deployment of the filter sand and Bentonite pellets for the lower section the tremie pipe became plugged on more than one occasion. This blockage was removed by running a 30 mm pipe through the centre and constantly introducing water from surface.

Figure 111 75 mm installation pipe run. 30 mm tremie (blue) being run through the 60 mm tremie (yellow) to push through a Bentonite blockage during back filling operations.

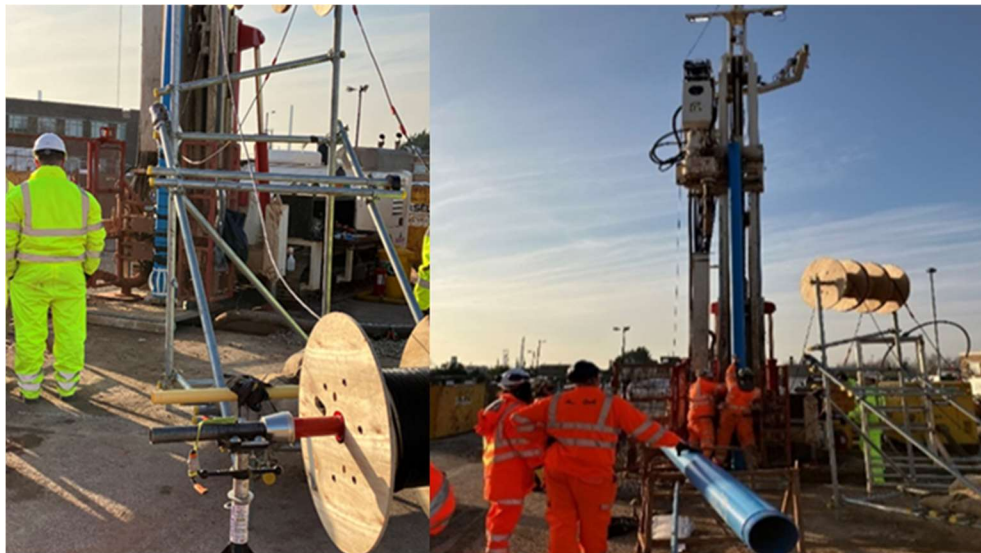
The permanent PVC intermediate (200 mm OD x 180 mm ID) casing was run to 15.0 m (0.2 m off bottom) with both ERT and fibre optic cables attached to the outside. The casing was centralised in the well with plastic centralisers and once on depth checked using the crosswire technique for verticality.

Figure 115 Installation of the 200 mm OD intermediate casing string

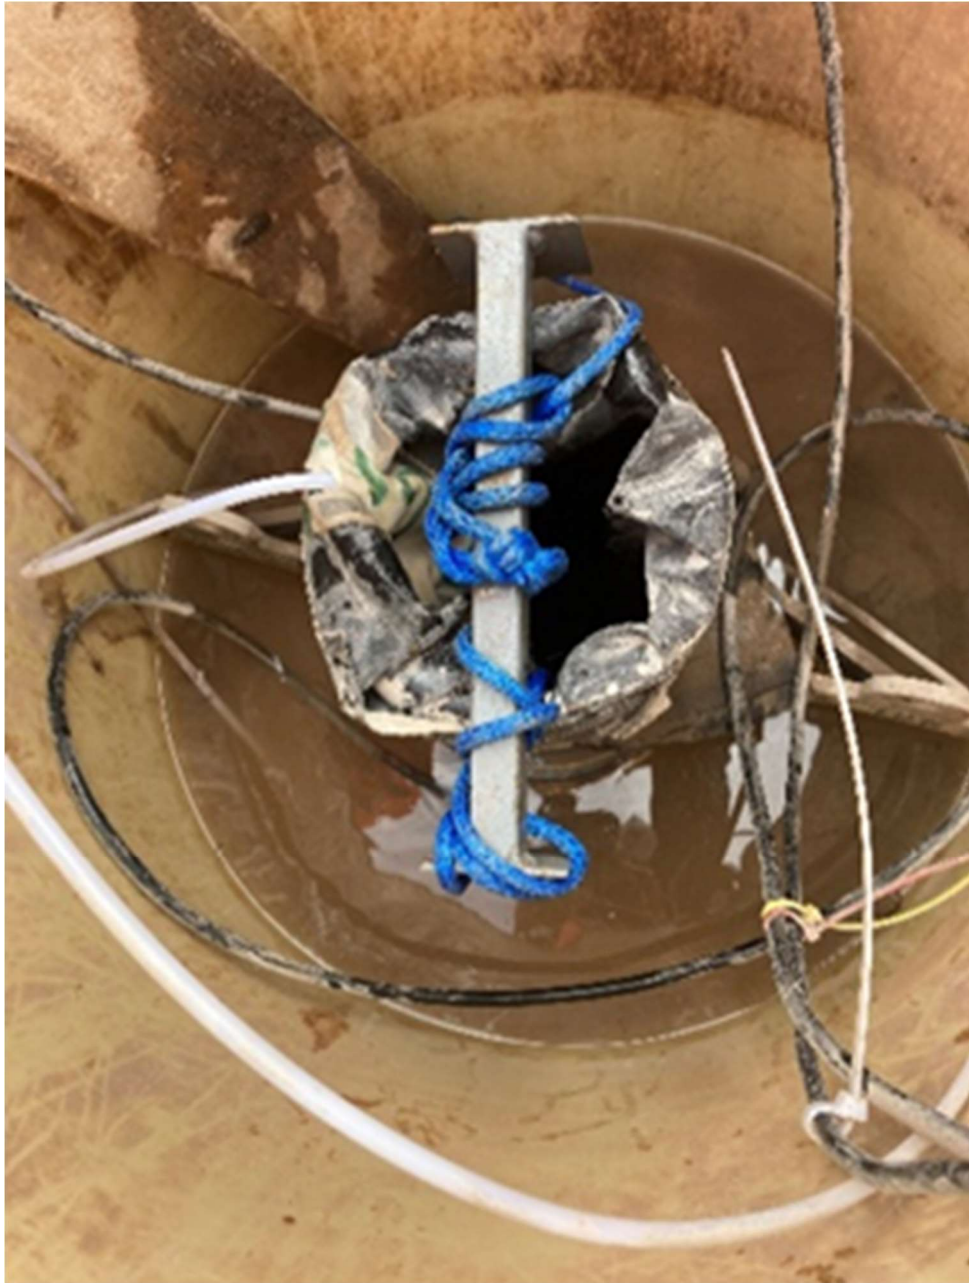
The Green Machine and associated equipment needed for the deployment of the liner was rigged up and a toolbox talk with all parties held before commencing. The FLUTE liner was installed without issue as per the manufacturer's instructions to 99.86 m. The liner and tether were secured at surface before making the well safe and rigging down.

Figure 117 FLUTe liner deployment into TH0404

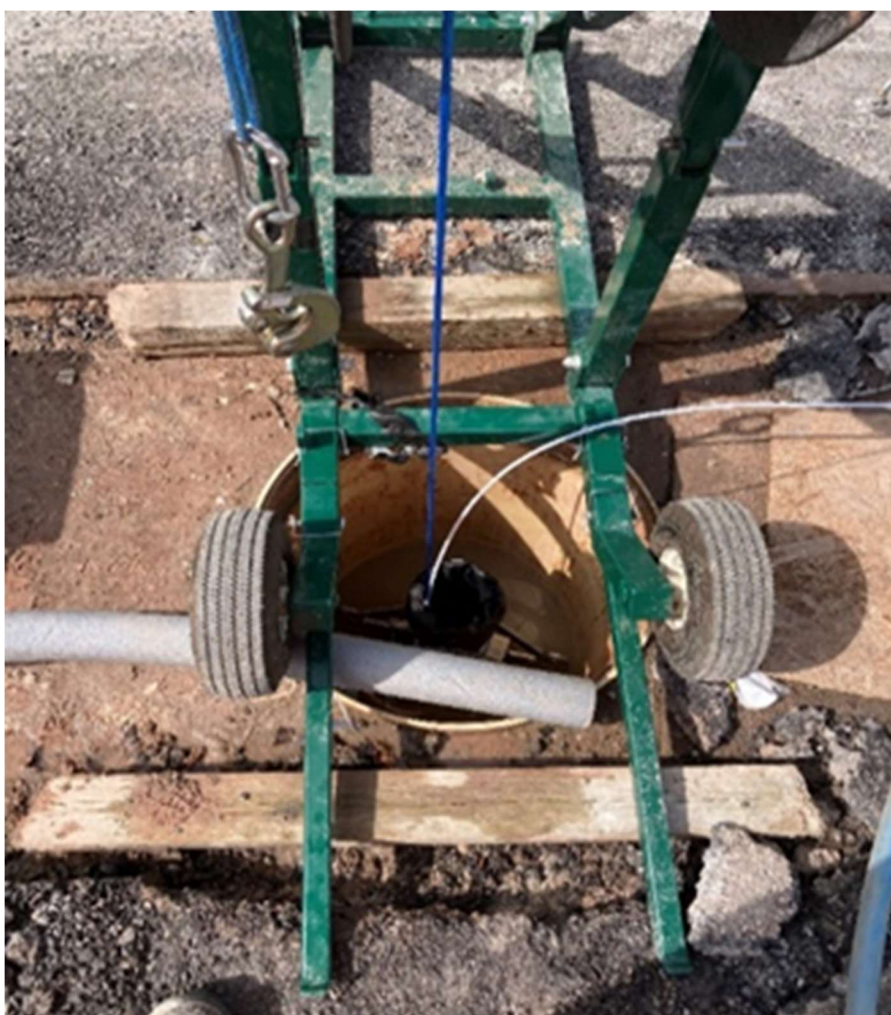
The Green Machine and associated equipment needed for the deployment was rigged up and a toolbox talk with all parties held before commencing. Bentonite was introduced into the well to bring the base of the borehole up to 100.0 m. The FLUTe liner was installed without issue as per the manufacturer's instructions to 100.0 m. The liner and tether were secured at surface before making the well safe and rigging down.

Figure 123 Green machine installed over the well during FLUTe liner deployment.

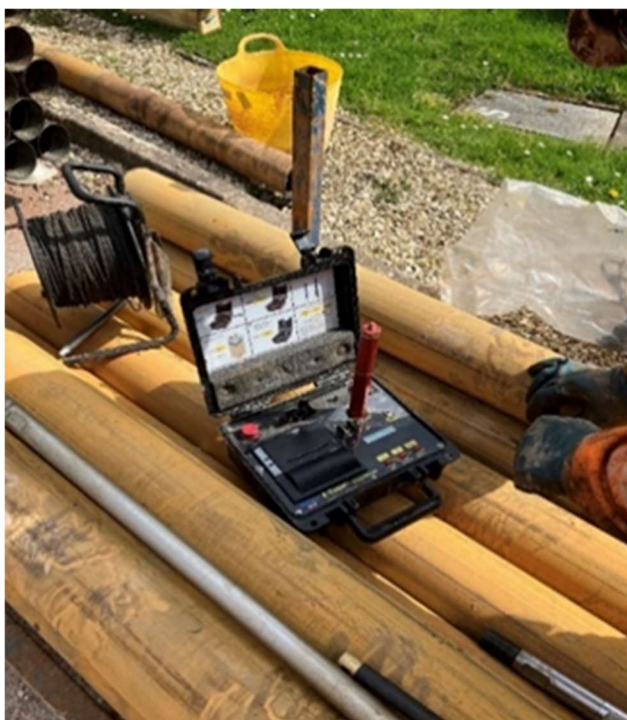
The rig was moved back over TH0415 on the 20th April 2023 and a rotary assembly was RIH to drill out the shoe track (cement plug pre-installed in the shoe joint). Once through the assembly was recovered and the 152 mm Geobore S coring assembly was made up and RIH. The well was advanced coring ahead to 100.4 m with returns being lost at 23.9 m and higher inclinations readings from 60.0 m which were above the set tolerance. No drilling issues, overpulls or tight spots were reported.

Figure 127 E-Totoc survey being taken

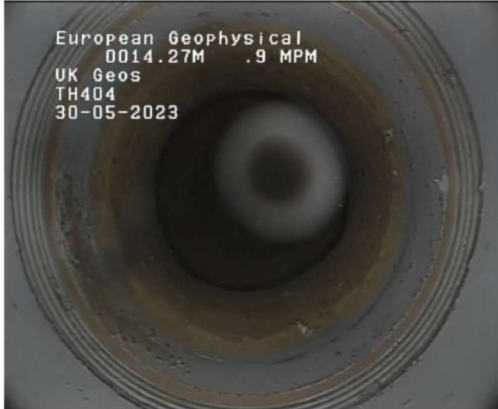
<p>TH0404</p>

<p>Casing shoe partially backed out / detached, grout plug preset inside casing remains, no cement below.</p>

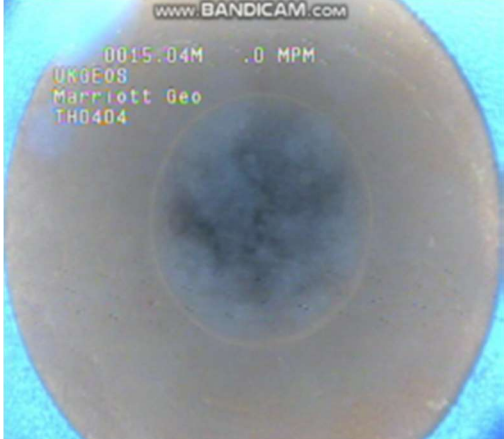
<p>Sleeve casing run into socket made with drag bit, sleeve casing 165 mm x 155 mm ID.</p>
<p>TH0405</p>

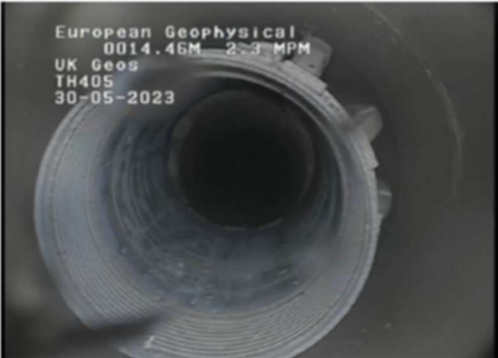
<p>Casing fully detached and dropped,</p>

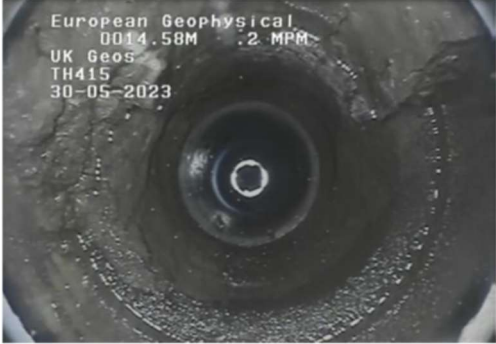
<p>Casing shoe attached, grout partially present with evidence of detached blocks of grout / poor shoe.</p>
