# Thermal imaging techniques to map ground disturbances in a former Nottinghamshire coal mining area

Internal Report IR/02/007

G J Ager, A D Gibson, D A Gunn, M G Raines, S H Marsh, A R Farrant, D J Lowe, A Forster, and M Culshaw

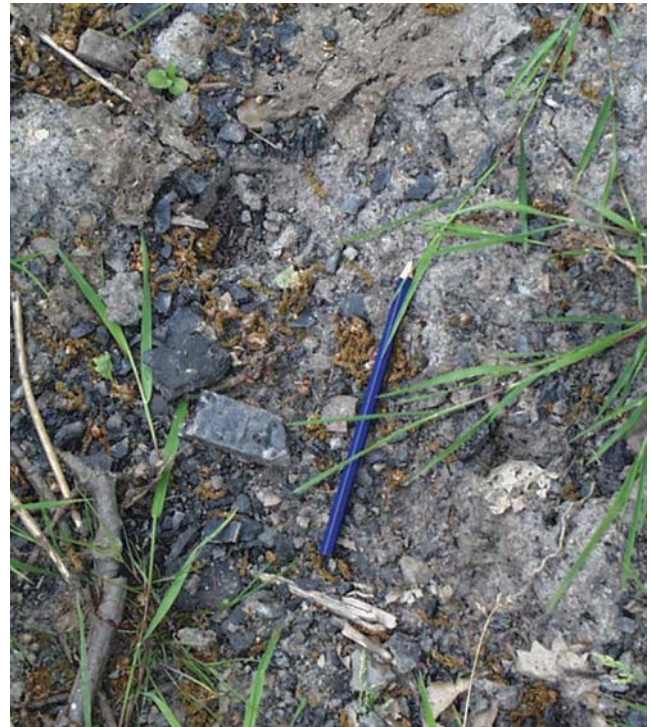
**Figure 2.3** Example of the coal/soil mixing at Chilwell Dam Farm, (NGR 451225, 342275).

It was also noted that in one location NGR 451035 342775, there was a significant proportion of weak, fissile light to medium grey mudstone, thought to be Coal Measures Mudstone (Figure 5.8), usually associated with increased coal content (Figure 2.3).

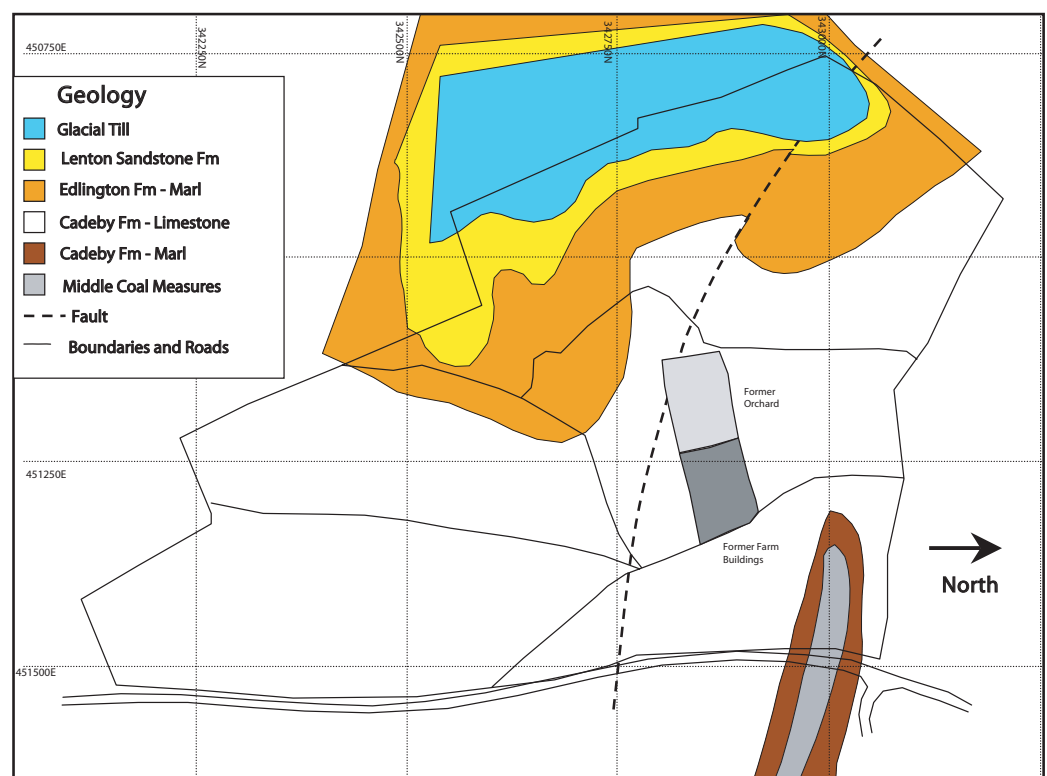
**Figure 3.1** Geology of the Chilwell Dam Farm study site.

Some topographic variation in the site is attributable to geological factors. The boundary between the Lenton Sandstone and the Edlington Marl (Figure 3.1) is observed as a break in slope from the steeper gradient of the Lenton.

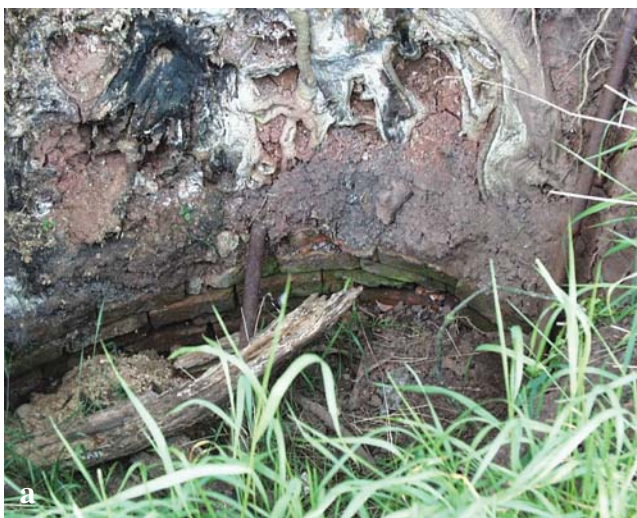
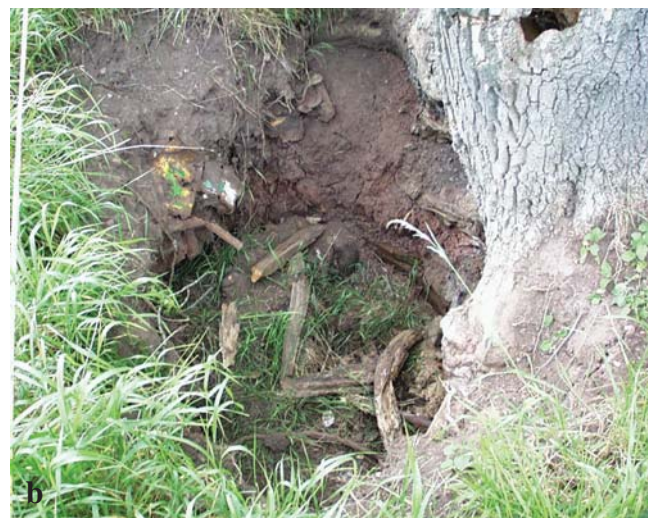
**Figure 3.4** Brick-lined mineshaft on Chilwell Dam Farm, (NGR 51285, 42342), mineshaft No. 32 in Appendix A.

approximately 2 m in diameter, that was observed on the Chilwell Dam Farm site at NGR 51285, 42342 (mineshaft no.32 in Appendix A). The lining is of dry-stacked red-brick and its collar is within 1.5 m of the ground's surface (Figure 3.4a). The growth of algae is restricted on the bricks, which suggests that until very recently there was a fuller soil cover over the shaft (Figure 3.4b). A recent collapse of the cover may have been caused by a slump in the infill materials, which appear to be of soil, logs and metal objects. Other infill materials include the soft light grey Coal Measures mudstones

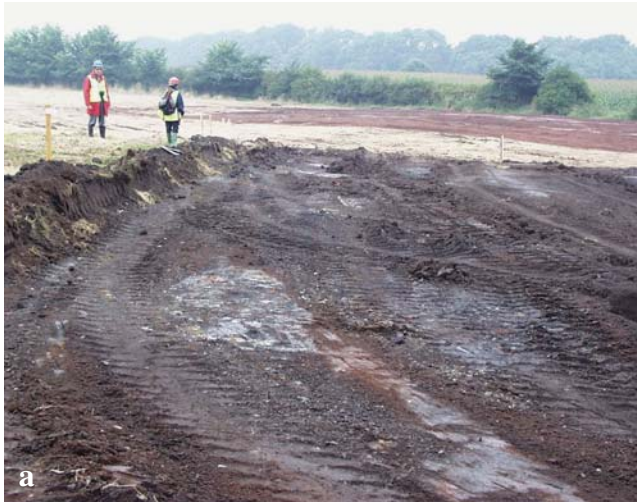
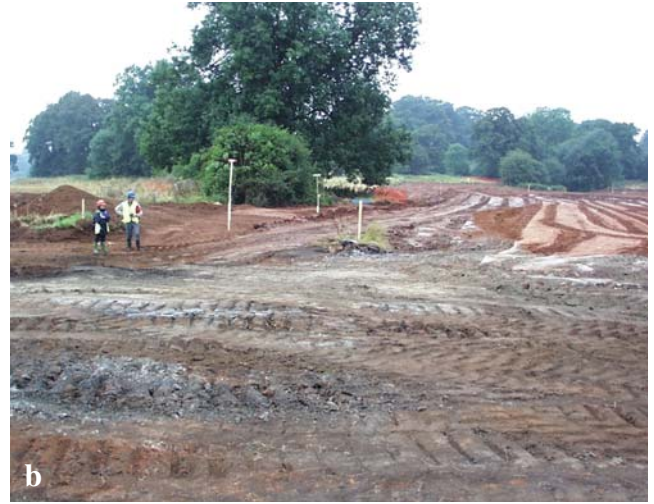
**Figure 3.5** Evidence of mineshafts in the stripped soil at Chilwell Dam Farm.

**a** Soil lightening by Coal Measures mudstones, (NGR 451114, 343017).

and coal spoils. These were observed causing localised soil lightening or darkening in several areas after the topsoil was stripped away (Figure 3.5). However, topsoil stripping involved the removal of the upper 0.3 to 0.5 m of surface materials and it is possible that shaft linings could still be concealed beneath the surface.

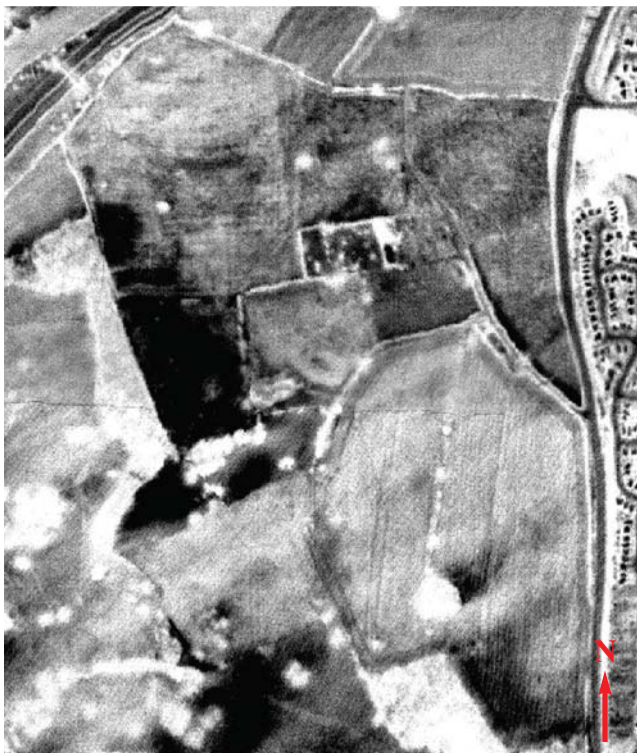
**Figure 4.1** Thermal Image of the Chilwell Dam Farm Site.

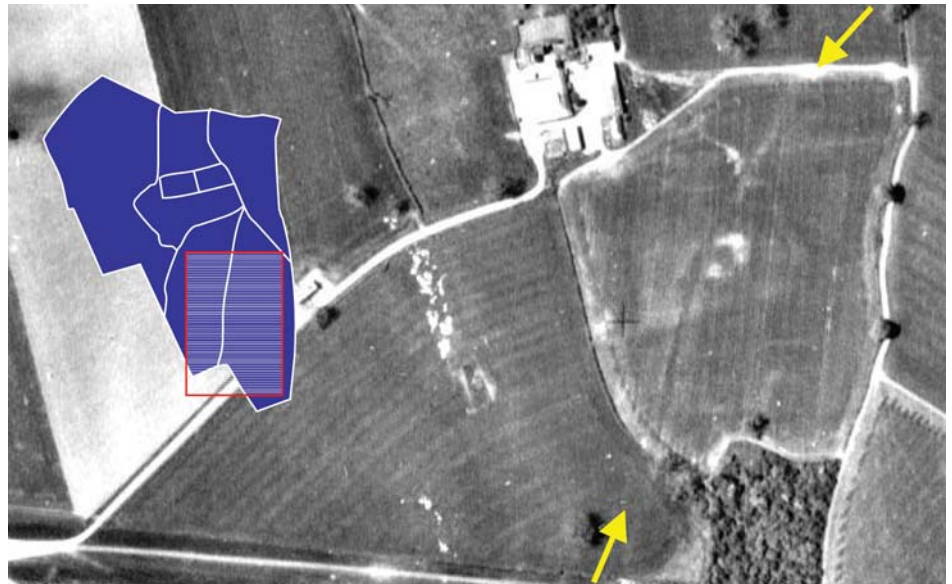
**Figure 4.6** Tonal contrast within a conventional black and white aerial photograph were useful indicators of disused workings. The track of the Kimberly Colliery Tramway is indicated between two arrows whilst the remnants of other man-made features are also visible.

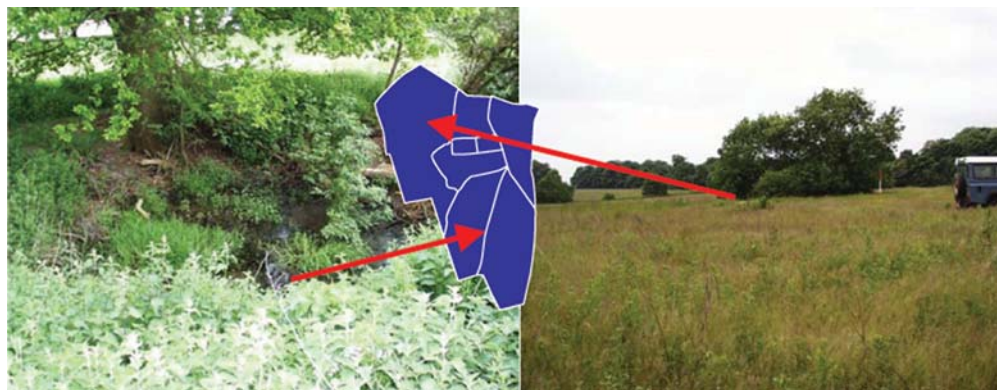
**Figure 5.3** Two examples of water filled topographic depressions, both of which were obscured by tree cover. Both locations are marked as known mineshafts on Coal Authority records.

Although no other open shafts were located during the walkover survey, six locations were identified where one or more trees were found in association with a depression in the ground; in four cases the depression was filled with standing water. In one case (Figure 5.3a), the location of the shaft was obscured by the activities of shallow quarrying which had taken place to exploit the dolomitic limestone near to the surface. The largest pool of standing water was found at NGR 450911 342997 where a near-circular pond of 10 m diameter was found (Figure 5.3b, Table 5.1).

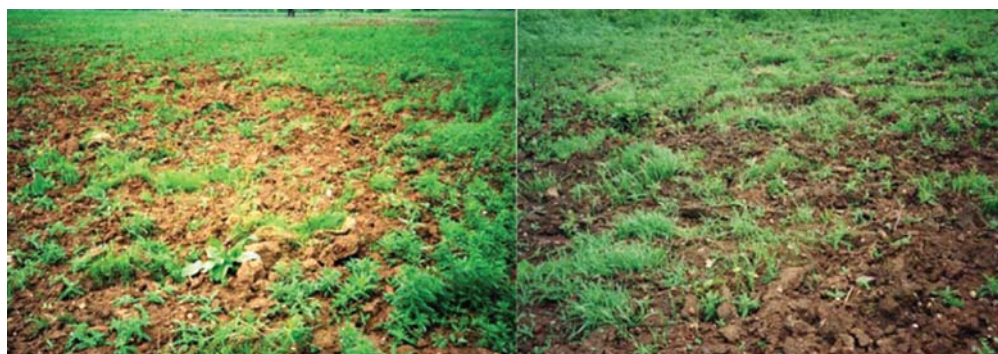
**Figure 5.5** Typical appearance of the red silt soil type, with (right) and without (left) a significant fraction of coal.

In many locations it was noted that the ‘clean’ soil (a reddish brown silt with clay occurring in the north-western areas of the site and a light to medium brown sandy silt occurring elsewhere) contained a significant proportion of lignitic material, making the overall appearance of the soil surface darker (Figures 5.5 and 5.6).

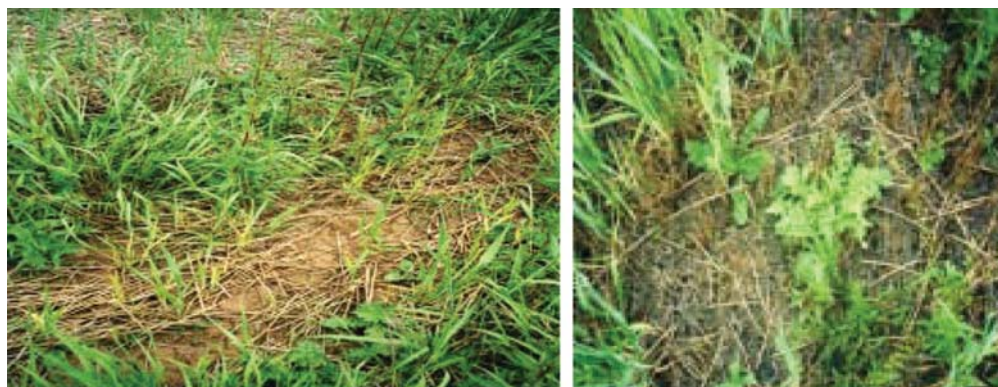
**Figure 5.6** Typical appearance of the light to medium brown sandy silt with (right) and without (left) a significant coal fraction.

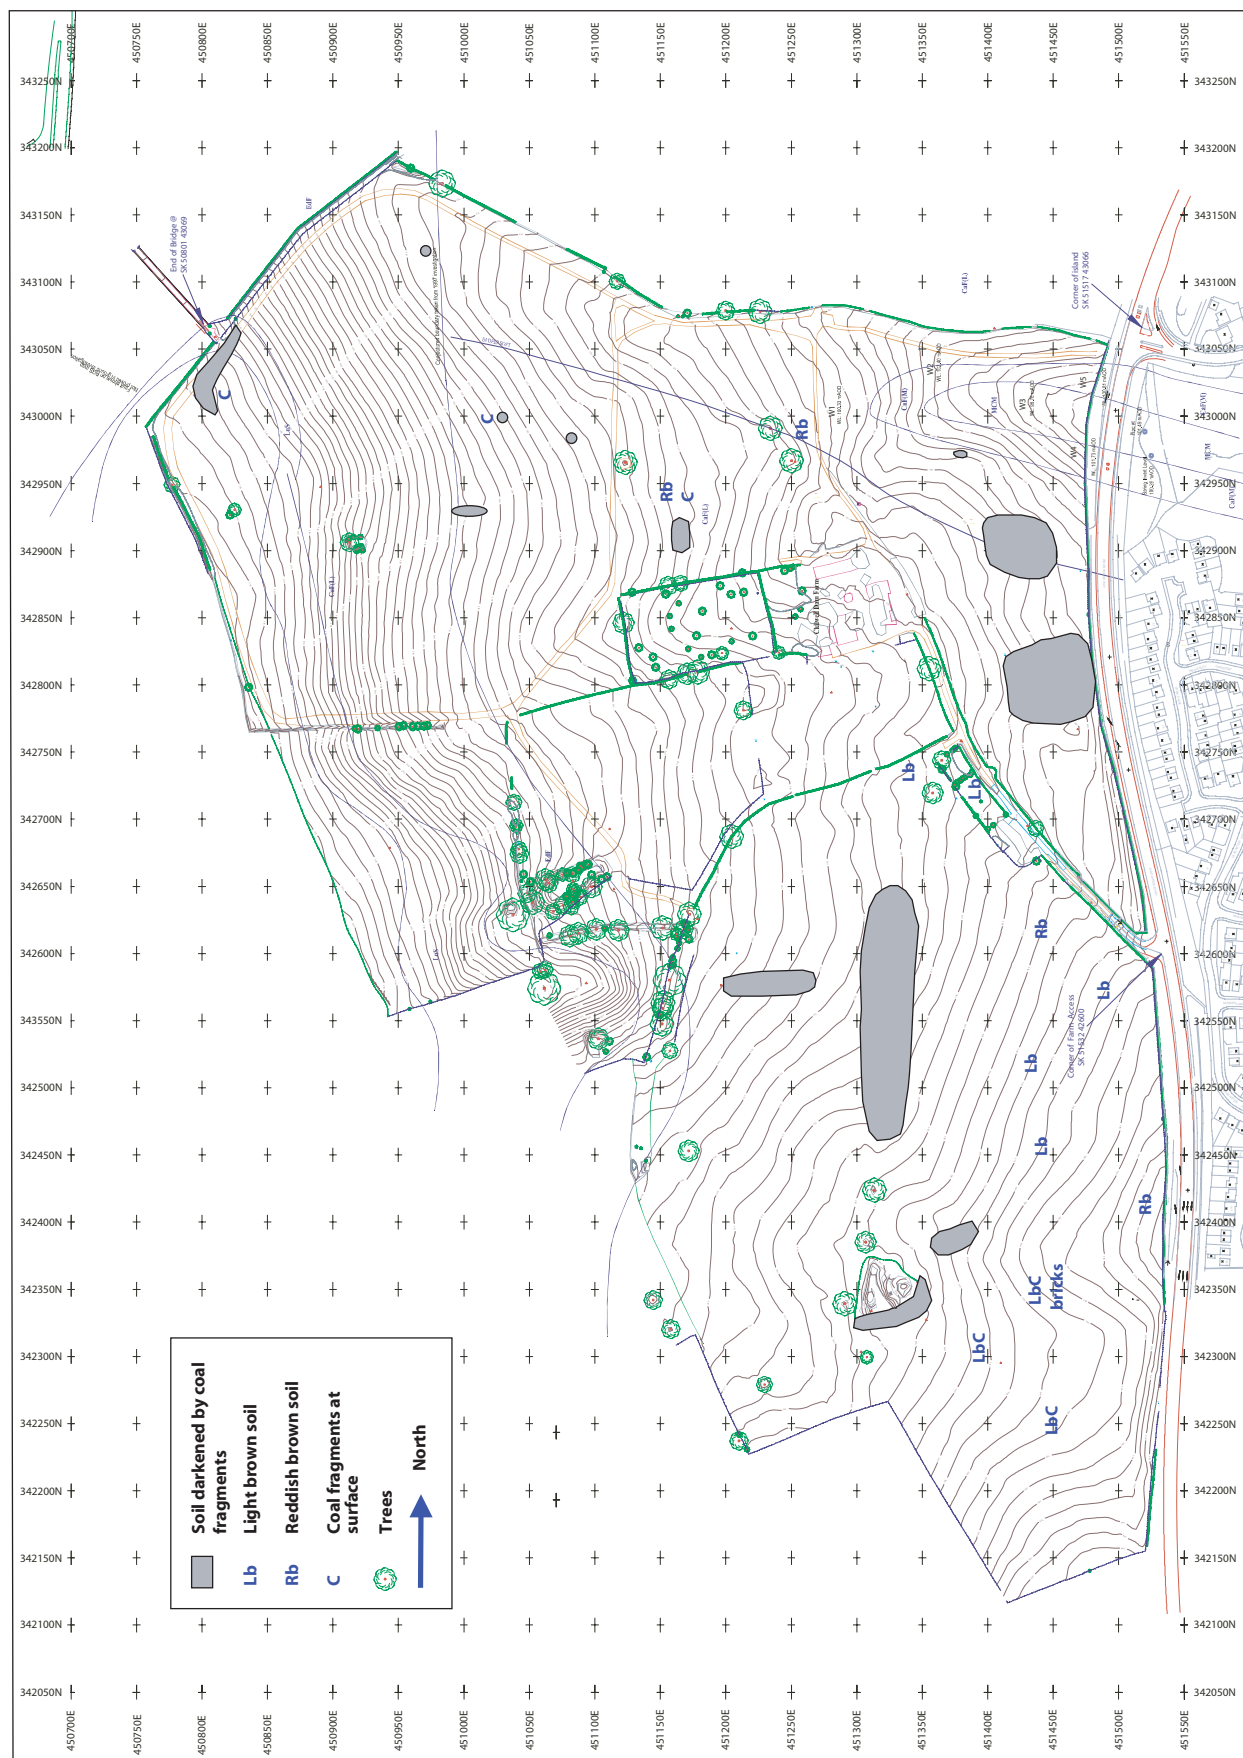
**Figure 5.7** Map of the survey area showing the location of patches of darkened soil.

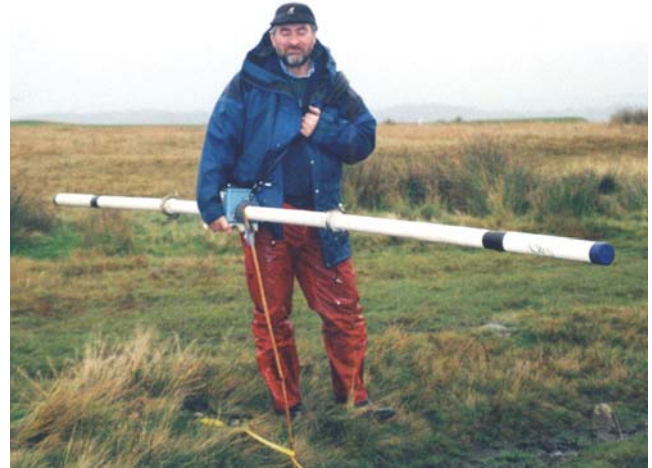
**Figure 6.4** Geonics EM 31 system with an inter-coil spacing of 3.66 metres.

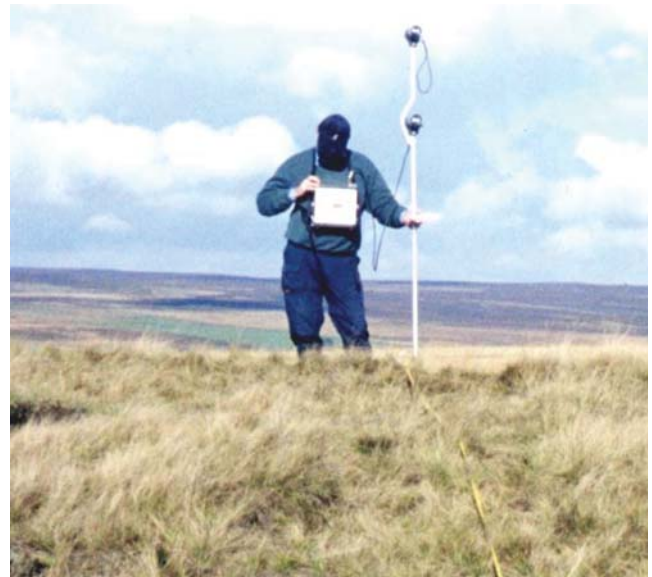
**Figure 6.7** The Scintrex IG-2 field magnetometer equipment. (The staff has two proton precession units at approximately 1.5 m and 2.0 m above the ground.)

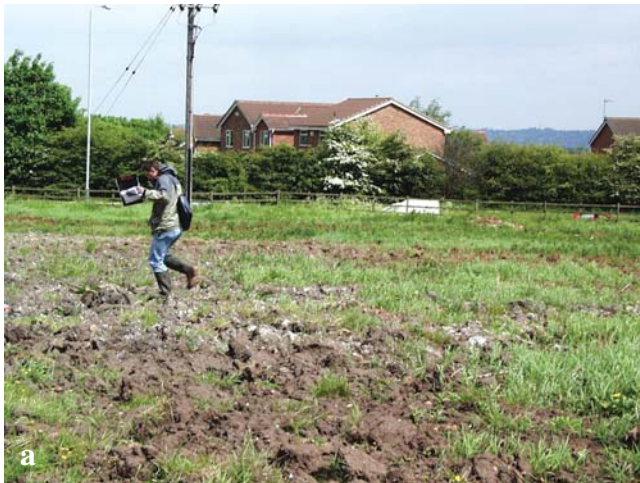
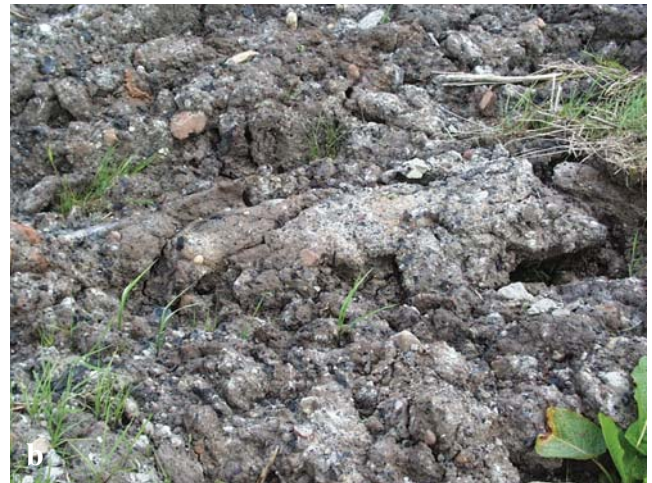
**Figure 6.21** Soil disturbances over mineshafts at Chilwell Dam Farm, (NGR 451430, 42890).

NGR 451430, 342880, (no.10) and one at NGR 451395, 342955, (no.4). A mound of approximately 20 m diameter of disturbed ground with fragments of coal and grey mudstone is located at NGR 451455, 342790, and lies just south of the shaft pair. A thermal anomaly and an associated vegetation change with an increase of clovers and nettles also occurs at this site, as shown in Figure 2.5a. Another thermal anomaly coincides with an area of approximately 25 m diameter of discoloured ground due to fragments of limestone, grey mudstone and coal (up to cobble sizes), located at NGR 451430, 42890 near the mineshaft at NGR 451430, 342880, (Shaft 10) as shown in Figure 6.21. A small mound coincides with the shaft at NGR 451395, 342955 (Shaft 4).

a Soil discoloration over an area of approx. 25 m diameter.

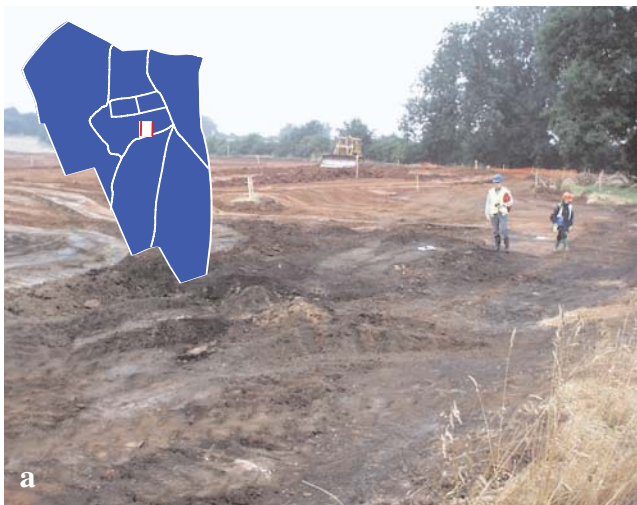
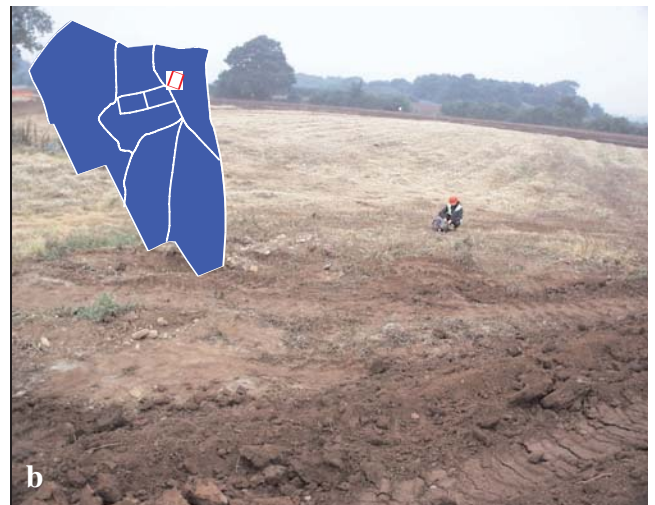
**Figure 7.4a** Soft ground at NGR 451255 342730 denoted by a series of ruts caused by the passage of site vehicles. Note the sharp boundary between 'clean' soil in the upper part of the image and darker, coal enriched soil in the foreground.

**b** Rutting of the ground at NGR 451325 342975 caused by the passage of site vehicles.

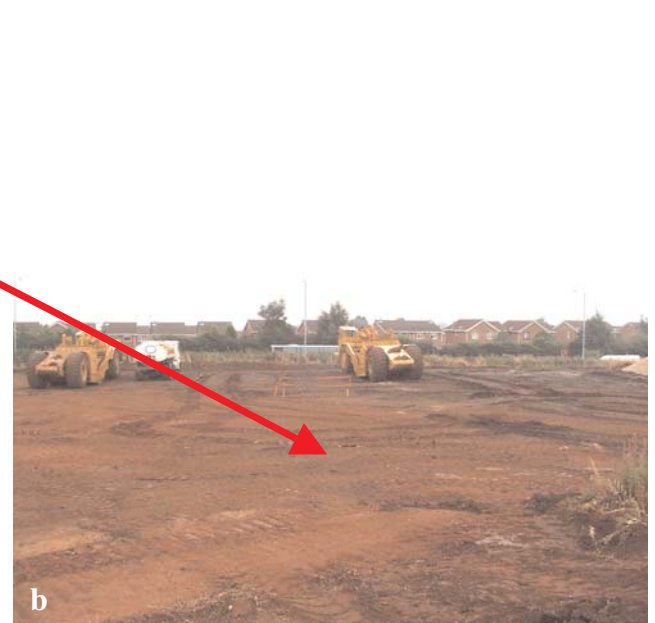
**Figure 7.5** The effects of stripping on soil colour within the site; both images are of the same location.

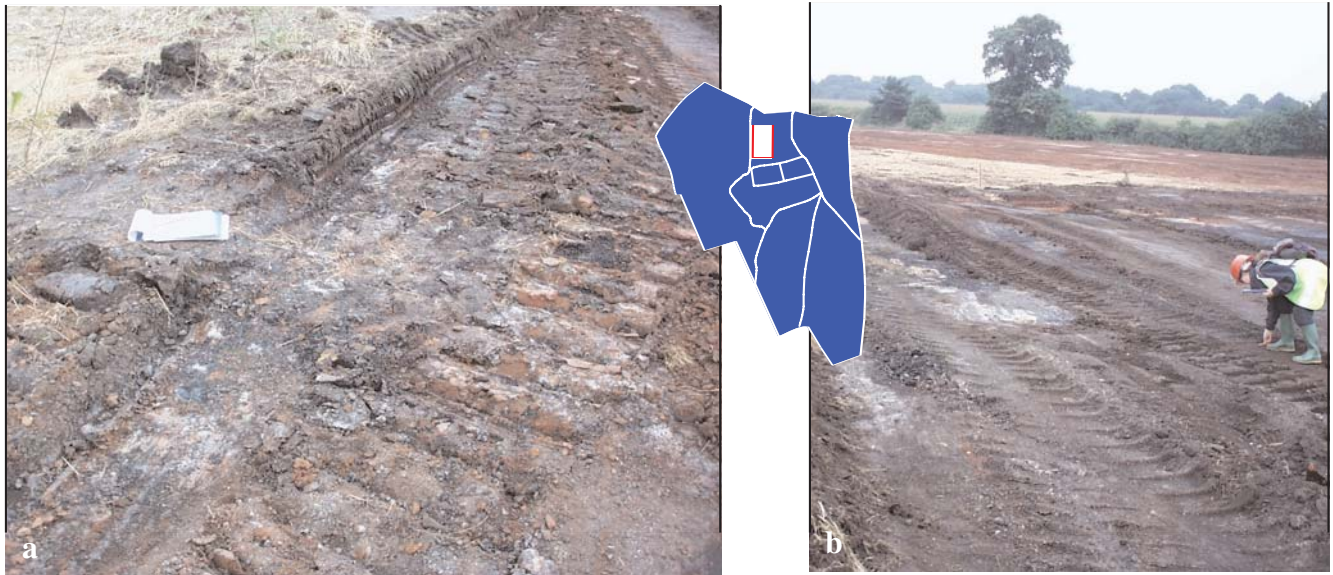
**Figure 7.6** Stripped surface showing increased levels of Coal Measures mudstone, coal and brick fragments at NGR 451120 343000. The area was also identified as an area of soft ground.

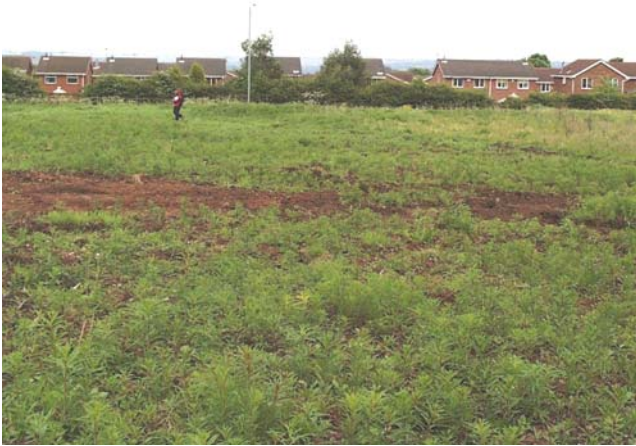
**Figure 8.2** The general red colour of the soil within the north-east field compared to the grey coloured soil at Shaft 15.

Shaft 15 had a striking appearance in the field, being a mound, approximately 30 m across with a slight depression in the centre. The vegetation was different to the surrounding vegetation, with nettles around the edge and clover, dandelions, and broad-leaved weeds in the central core (Figure 2.5a). The soil was a dull grey colour with gravel-sized coal spoils, compared to the general red colour of the field (Figure 8.2). Shaft 15 was located close to 16, but the surface expression was not as apparent, perhaps masked by the mound of Shaft 15. Mudstone was detected around Shaft 15 and 16 post-soil stripping, indicating the presence of a mineshaft, and the geophysics along line AA–BB confirmed the presence of a mine-shaft in the vicinity of Shafts 15 and 16.

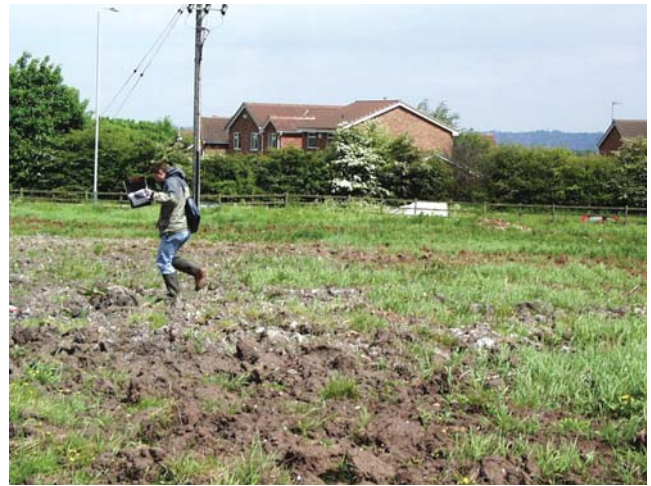
**Figure 8.3** Soil colour change over Shaft 10.

At Shaft 10 there was a marked change in soil colour from red, silty soil to white grey soil over the shaft, perhaps due to mine-waste of coal and ash, or limestone (Figure 8.3 and Figure 8.4). The lighter soil covered an oval shaped area approximately 30 m by 25 m diameter. The geophysics along line AA–BB indicated the presence of a mineshaft.

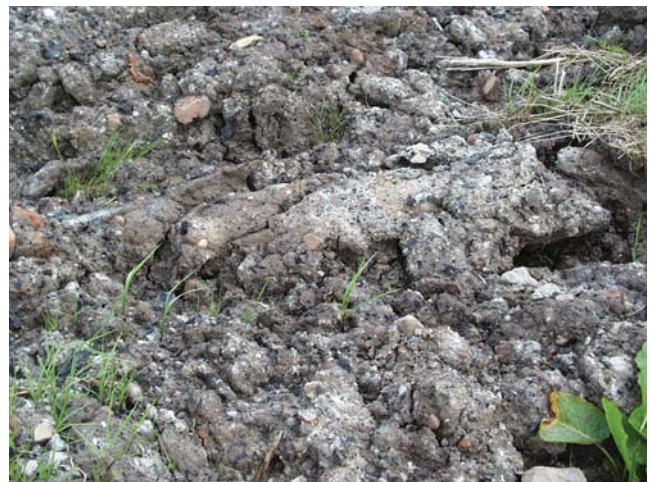
**Figure 8.4** White grey soil over Shaft 10.

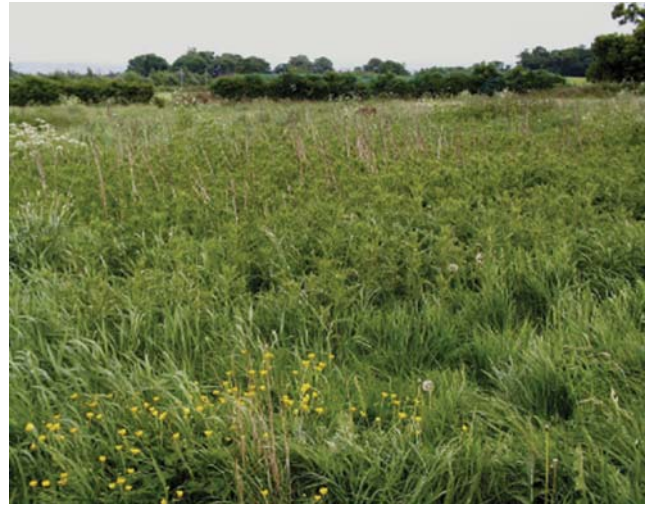
**Figure 8.7** Depressed surface and vegetation change over V2.

At V2 there was both a pronounced depression and vegetation change to thistles (Figure 8.7). Further

investigation revealed that the location corresponded with that of a former trial pit. Hence the thermal anomaly related to a trial pit rather than a mineshaft.

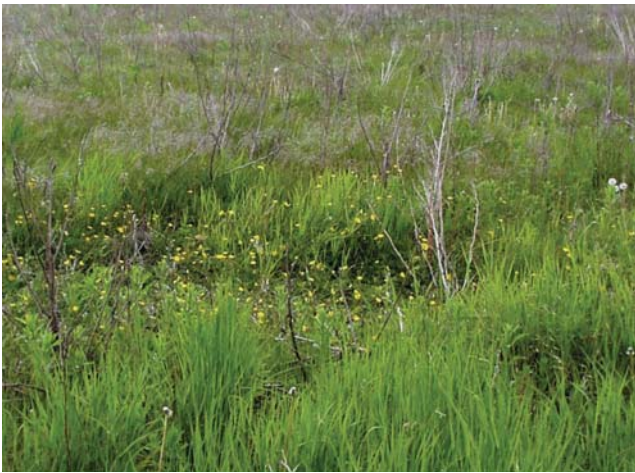
**Figure 8.6** Area of buttercups and weeds at the location of Shaft 9.
