INSTITUTE  
OF  
HYDROLOGYTHE DESIGN, OPERATION AND CALIBRATION OF THE  
PERMANENT FLOW MEASUREMENT STRUCTURES IN  
THE PLYNLIMON EXPERIMENTAL CATCHMENTS

REPORT NO 42

September 1977

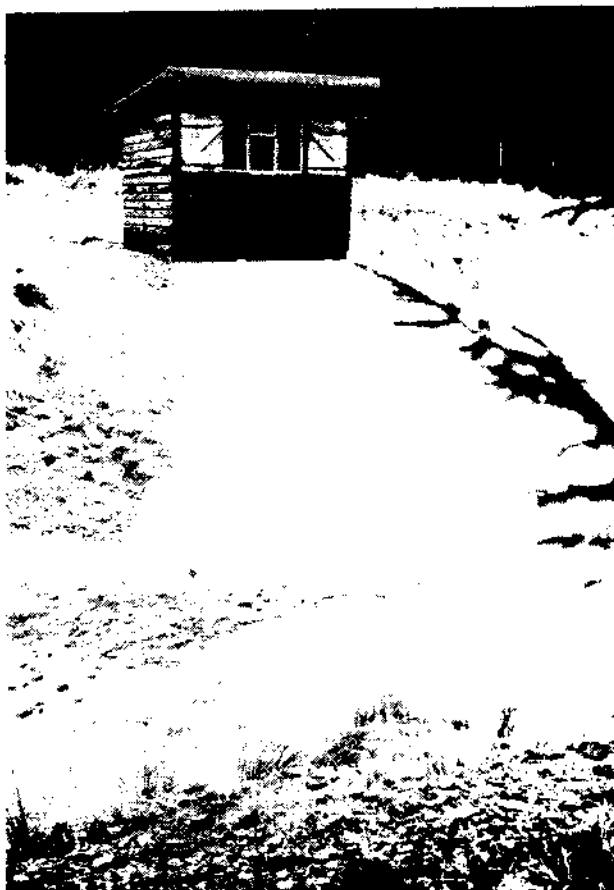
PLATE 1

It soon became apparent that large quantities of bed load were moving through the structure with a shoal in the reach immediately above the flume constantly changing its shape and dimensions. At worst, the shoal extended into the approach section (see Plate 1), thereby reducing the cross-sectional area and increasing the velocity of the water. This error reduced the stage recorded in the stilling well.

Sediment shoal building up  
in entrance to Severn trapezoidal  
flume

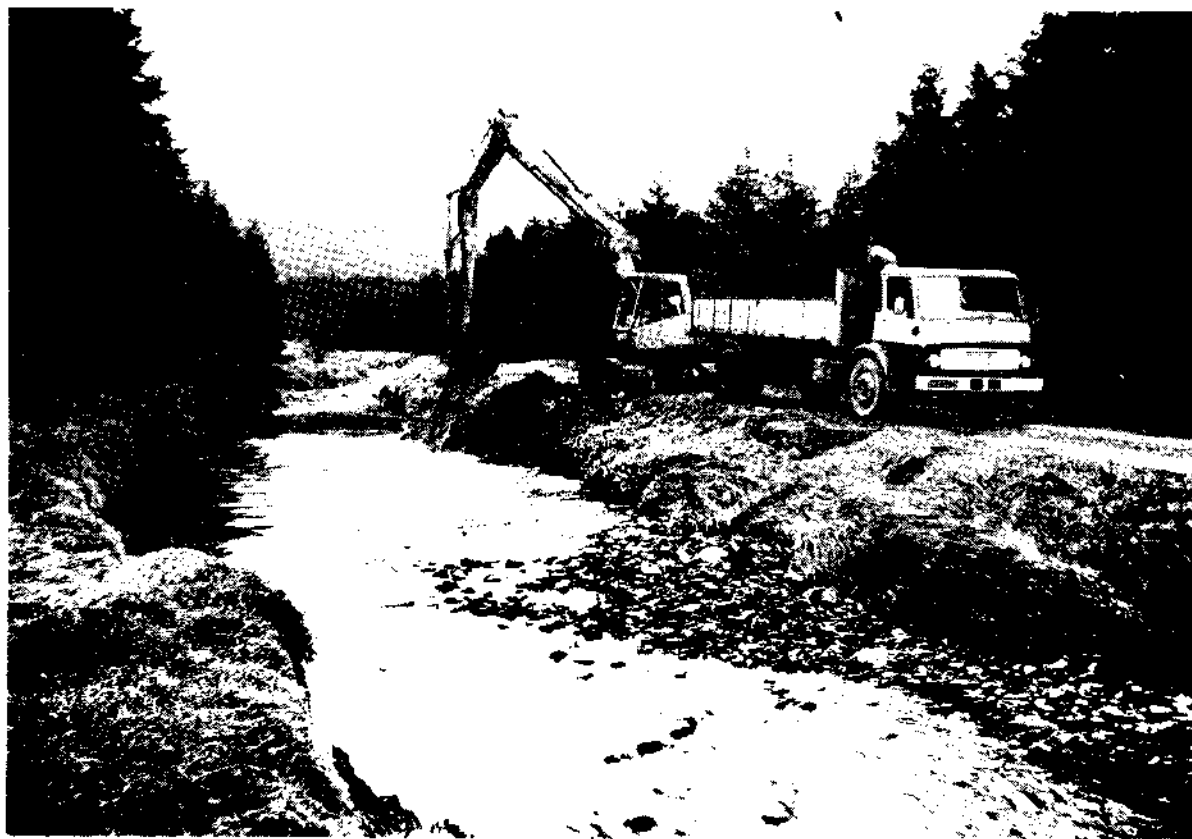
PLATE 2

Excavation of sediment trap  
in River Severn, upstream of  
trapezoidal flume

Although the return-to-datum conditions could readily be achieved, the presence of sediment in the flume approach affected records on the recession limb of a flood hydrograph. It was thought that the construction of a sediment trap might alleviate the difficulty. However, nothing was known about the amounts of sediment in movement. An estimate<sub>3</sub> of 312 tonnes/year was made by HRS (equivalent to approximately 155 m<sup>3</sup>). In three separate operations three traps were excavated; (i) the shoal and pool immediately upstream of the flume, (ii) the stilling pool behind the old sharp-crested weir 0.4 km upstream (70 m<sup>3</sup> capacity) and finally, in December 1974 (iii) 160 m<sup>3</sup> trap 0.5 km upstream cut in glacial clay on the stream bed (Plate 2). The cumulative capacity has been adequate to trap the bed load in all floods experienced since their construction and no further problems of deposition in the approach to the flume have occurred since December 1974.

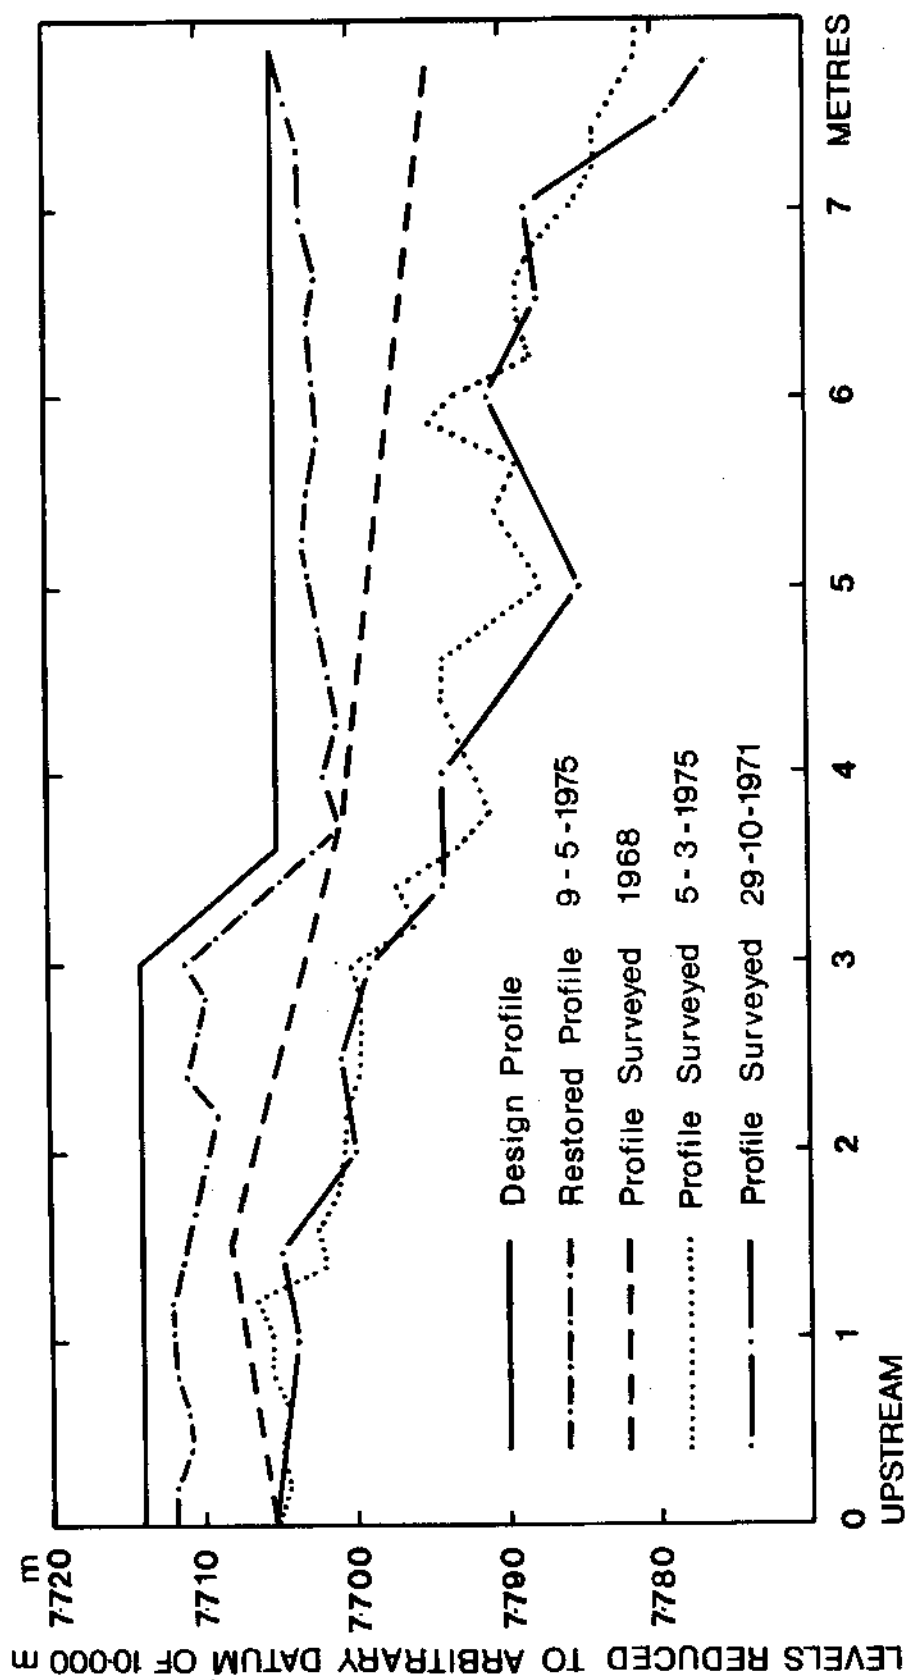
Figure 1 SEVERN TRAPEZOIDAL FLUME  
Longitudinal profiles surveyed along centre line of invert

The movement of large quantities of angular fragments through the flume eroded the concrete invert and the base of the side slopes, the first signs of which were evident in May 1969. This developed into pot-holing and repairs were attempted by plugging the sides with a mastic compound that hardened under water. However, the concrete continued to erode around the mastic.

In October 1971 a longitudinal profile was surveyed along the invert and the extent of the erosion could be seen by comparing it with the profile drawn using six spot heights surveyed after construction in 1968. In March 1975 the bypass channel was constructed, the flume drained and a second profile was surveyed prior to the restoration of the invert using metal tiles. On completion of the restoration work the profile was resurveyed and the combined results of the surveys are shown in Figure 1.

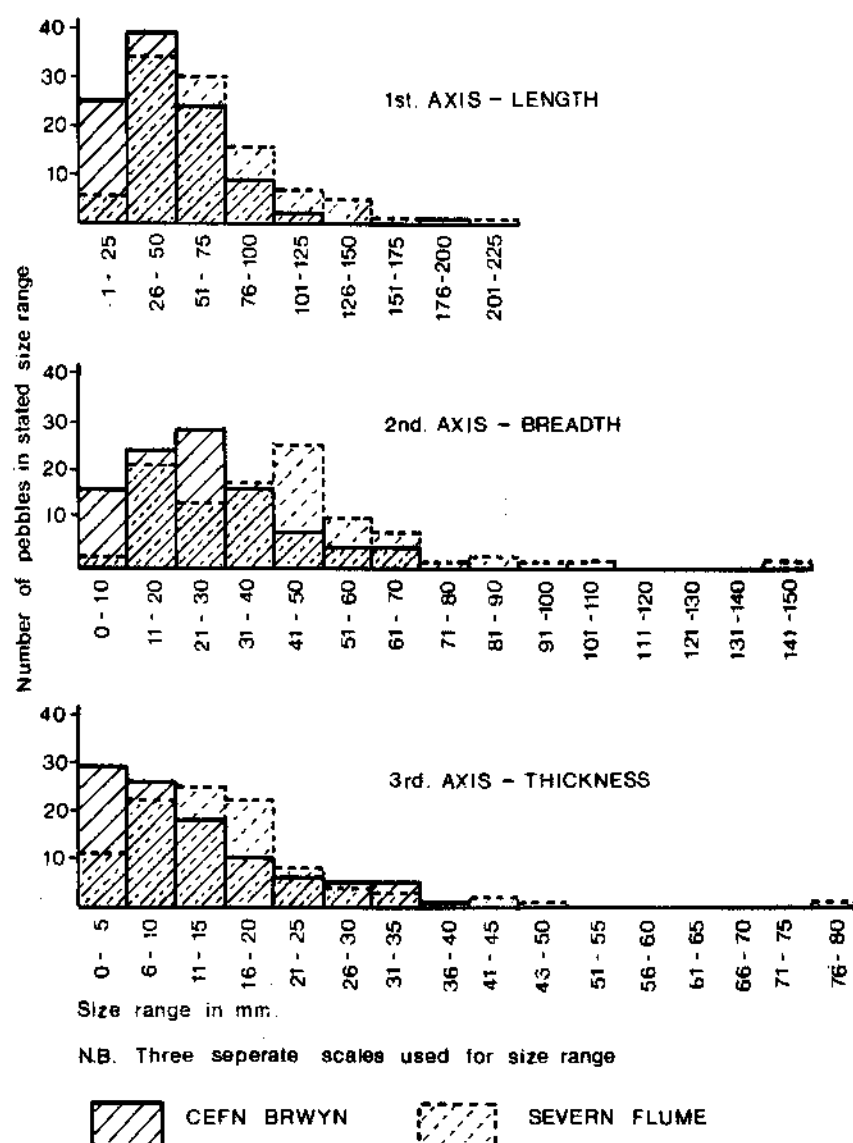
FIGURE 2 Comparison of pebbles found in settling pools of Severn flume and Cefn Brwyn weir by measurement of three axes.

One hundred pebbles were picked at random from each stilling pool and their axes measured. This sampling was carried out on the same day in both pools. The results are given as histograms in Figure 2. Although these results substantiate what is obvious on site, ie that the particles moving through the Severn flume are bigger than those moving through Cefn Brwyn, the actual sizes given should be treated with caution. More work would be essential to verify that the sizes of the pebbles sampled did not merely reflect a transport characteristic of the last flood.

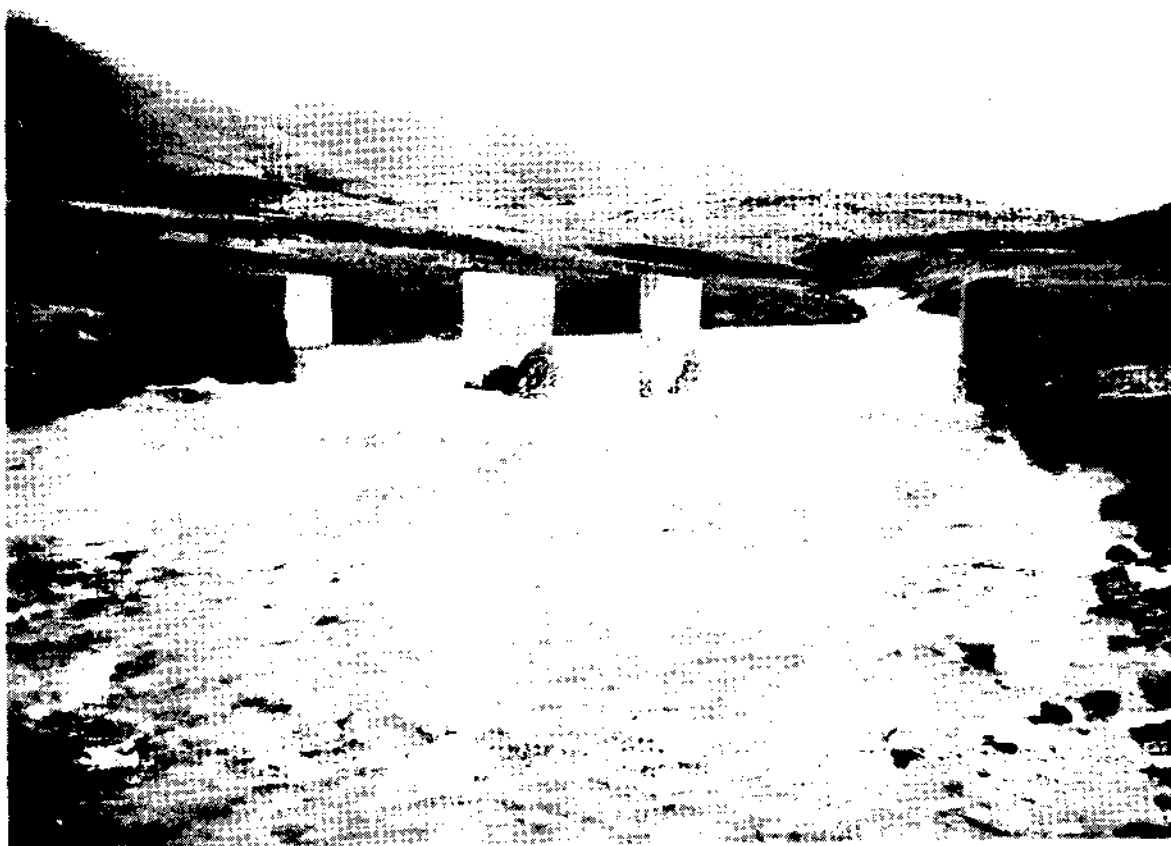
PLATE 3 The compound Crump weir on the River Wye at Cefn Brwyn

The existing weir on the Wye at Cefn Brwyn was redesigned by the Hydraulics Research Station into a modified Crump Weir (Plate 3) to gauge discharges from a catchment at the head of the Wye. The modifications were completed by the Wye River Authority in 1968. The design criteria were as follows:

The weir was constructed in concrete with twin piers separating the centre crest which is at a lower level than the two flanking crests. The crests are made of gunmetal. Stage levels are measured in a stilling-well connected by a pipe to the left side of the structure with the inlet set in the apron floor at approximately the same level as the centre crest. As in the Severn trapezoidal flume, both Leupold and Stevens and Fischer and Porter recorders were installed initially. The layout, dimensions and section through the crests are shown in Appendix I.

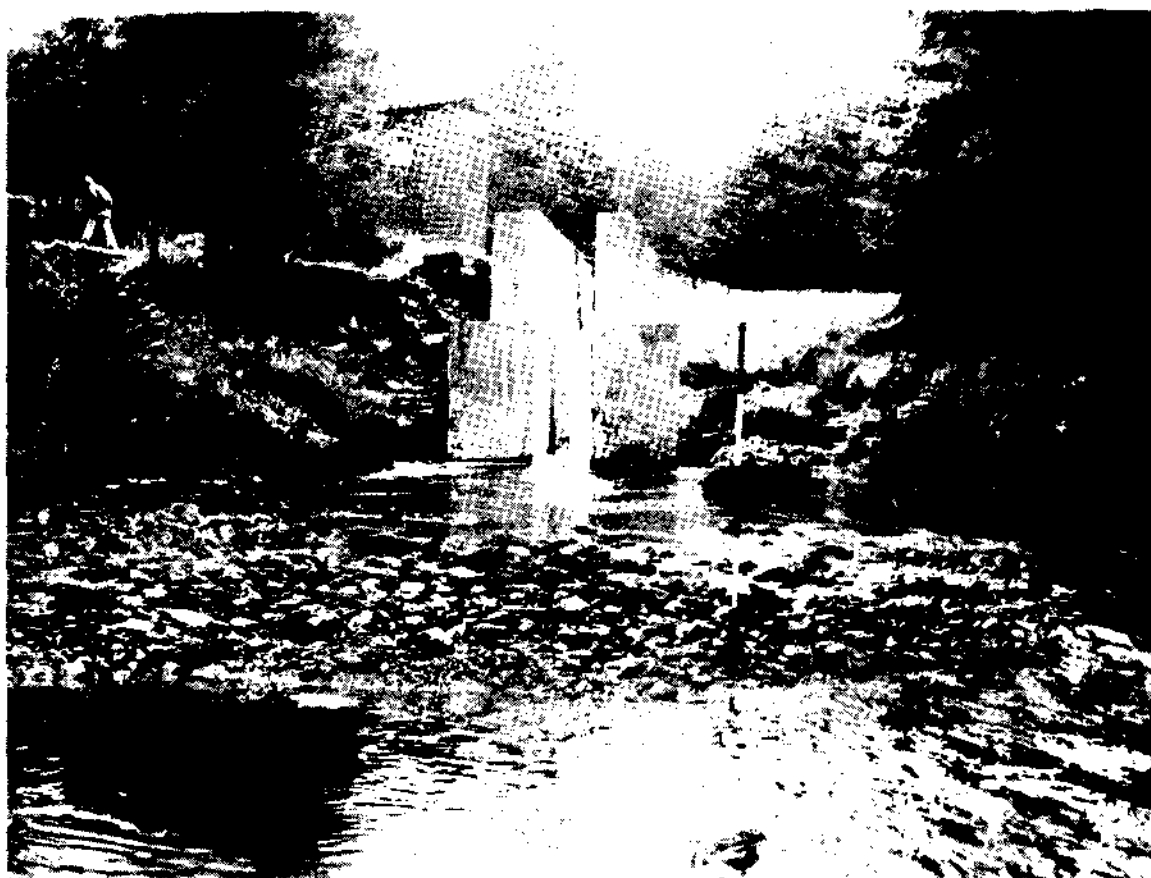
PLATE 4      Downstream drowning of the Hafren flume by shoal of cobbles and gravel.

In all cases, the velocity of the water leaving the structure on its way downstream is dramatically reduced leading to the formation of shoals. Under extreme conditions these can build up in a single flood and drown the structure (see Plate 4). Normal vigilance prevents accumulations.

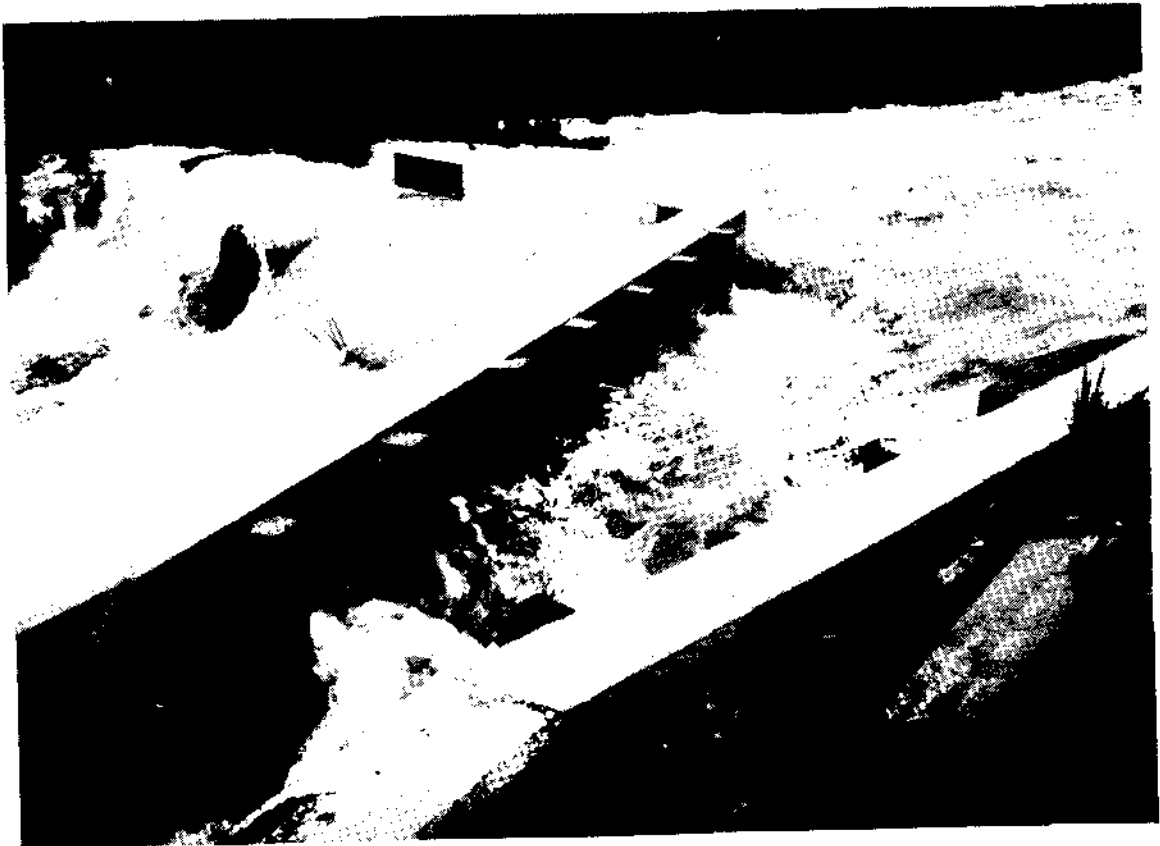
PLATE 6 Flume over-topping during storm

High flows Extreme high flows exceed the capacity of the flumes. All structures have been overtopped, notably on 5/8/73 when a flood with a return period of approximately 1:100 years occurred\*. Overtopping is known to have occurred on a number of other occasions at the flumes (Plate 6)\*\*.

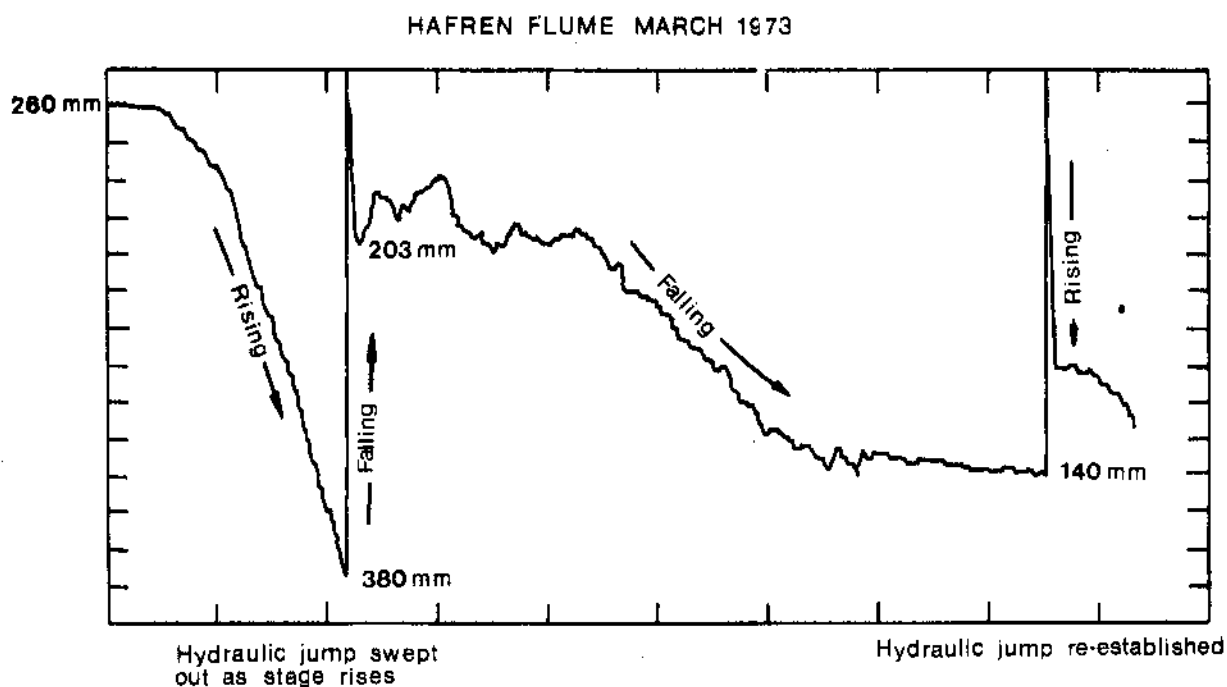
FIGURE 3      Diagram of Leupold & Stevens recorder chart showing disruption in hydraulic jump. /Note: this recorder has a device by which the recording pen reverses in direction when it reaches the margin of the chart./

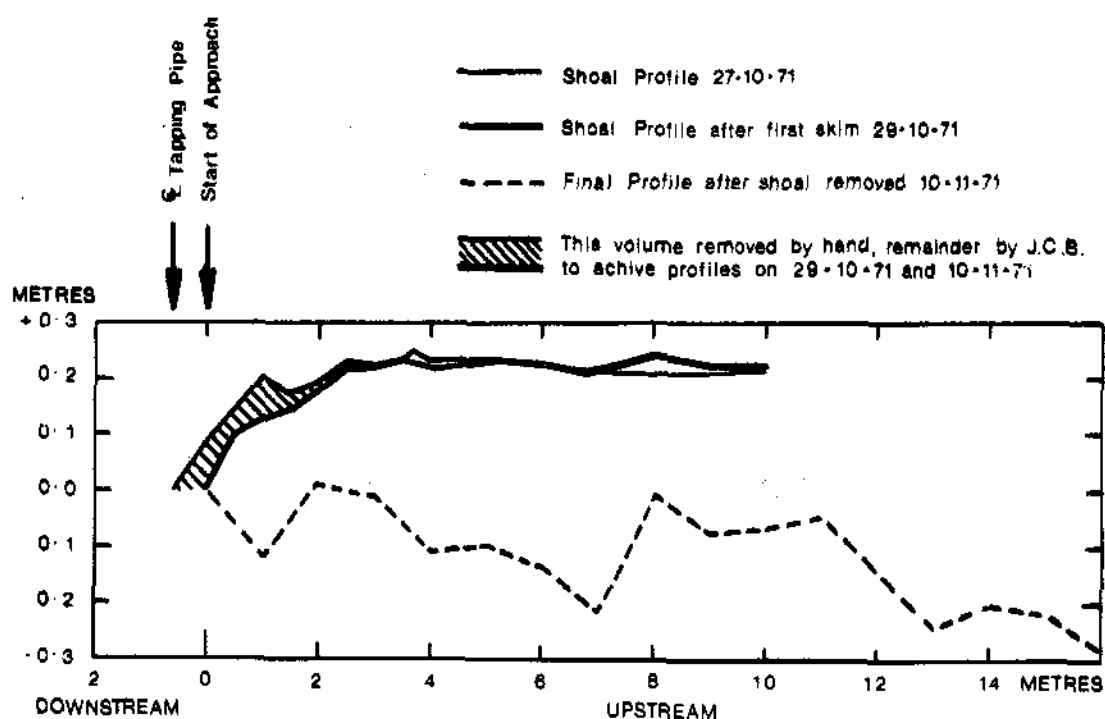
FIGURE 4 SEVERN TRAPEZOIDAL FLUME - EFFECT OF SHOAL ON STAGE

First skim caused rise in stage of 32 mm ) Total rise in "  
Final profile caused further rise of 58 mm ) stage when shoal  
removed, 90 mm

This broad analysis of what happens to the stage when a shoal forms in the approach to the flume was substantiated on two separate occasions, in October and November 1971, and is shown graphically in Figures 4 and 5. In October 1972 the area between the approach walls was concreted at approximately invert level. In June 1974 the shoal re-established itself in the approach and the opportunity was taken to clear the shoal front back progressively and note the effect on the stage. The results shown in Figures 4, 5 and 6 suggest that although the stage was sensitive to the shoal geometry, the magnitude of the effect was not very significant.

Notes: The invert at the tapping plate was used as the datum for levels.  
First skim caused rise in stage of 32 mm, removed by hand.  
Final profile achieved by removing shoal with J.C.B., caused  
further rise in stage of 58 mm.  
Total rise caused by removing shoal - 32 + 58 = 90 mm.

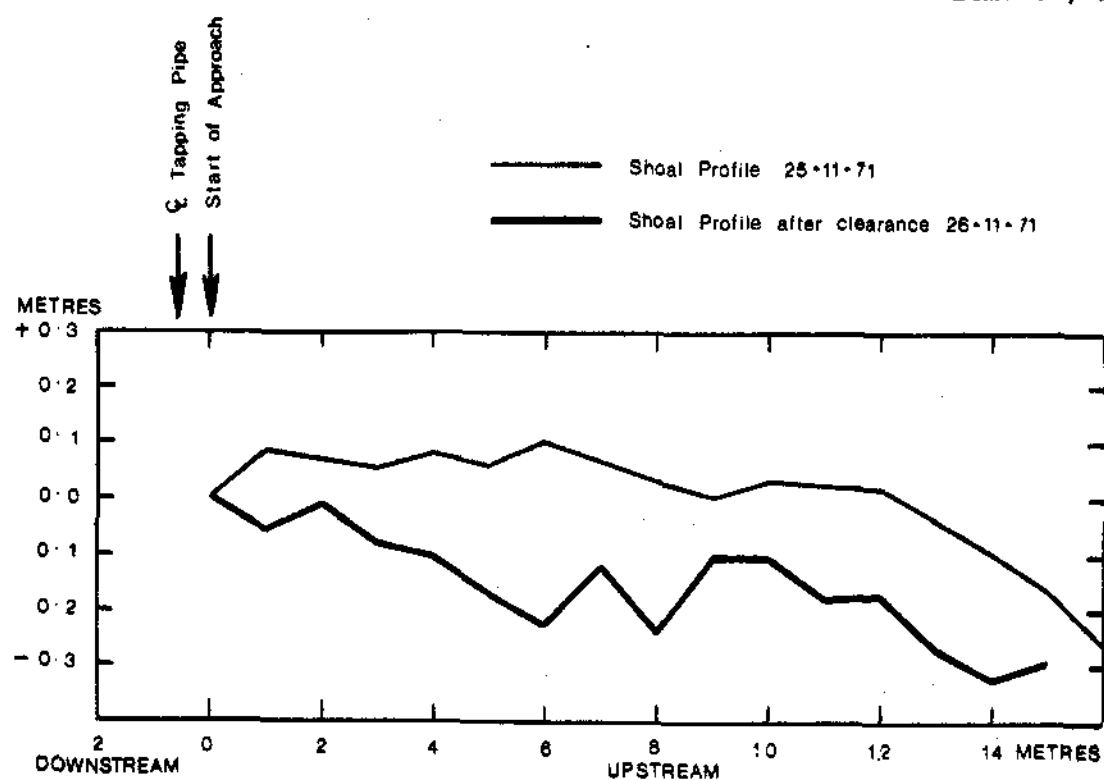
FIGURE 5 SEVERN TRAPEZOIDAL FLUME - EFFECT OF SHOAL ON STAGE

Removal of shoal caused rise in stage of 9 mm

Notes: The invert at the tapping plate was used as the datum for levels.  
Removal of shoal caused rise in stage of 9 mm.  
On 25.11.71 the tapping pipe was partially blocked with gravel/  
sand. This was flushed by filling well and releasing. This  
caused a rise in stage of 6 mm.  
Effect of cleaning pipe and shoal - 6 + 9 = 15 mm rise in stage.

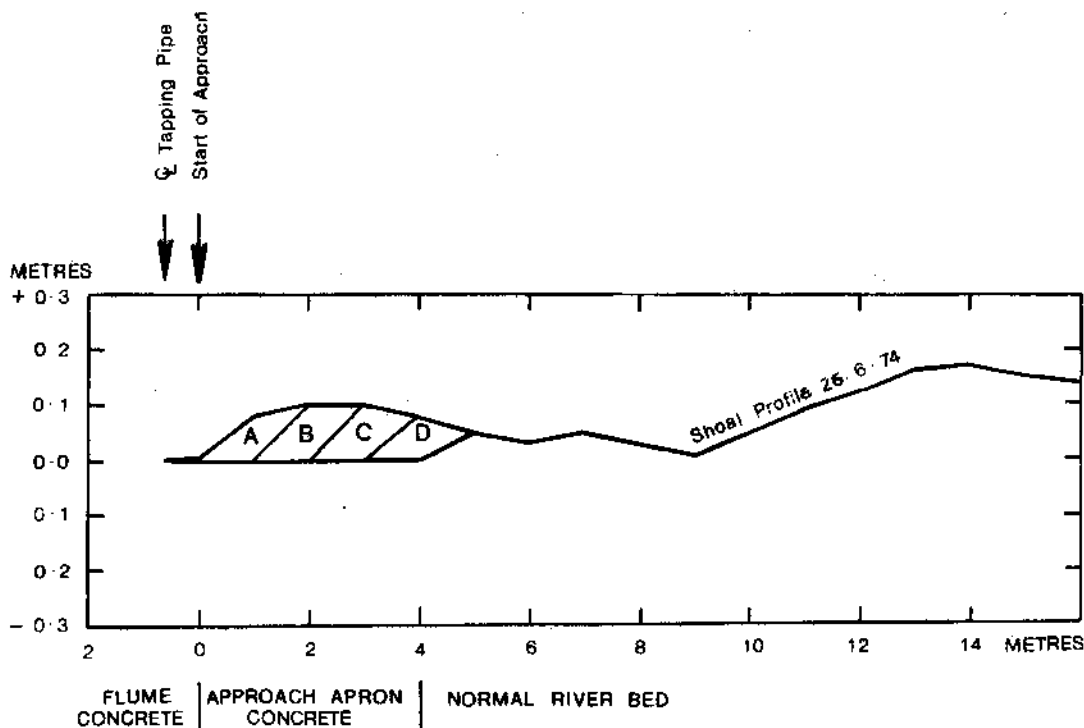
FIGURE 6 SEVERN TRAPEZOIDAL FLUME - EFFECT OF SHOAL ON STAGE

When A was removed, stage dropped 8 mm  
 B was removed and pipe cleaned, stage rose 5 mm  
 C was removed, stage rose 5 mm  
 D was removed, stage dropped 2 mm  
 remainder of shoal removed 1.7.74, stage dropped 6 mm.

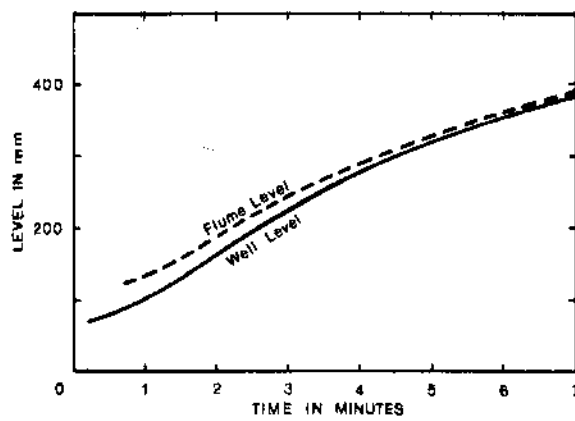
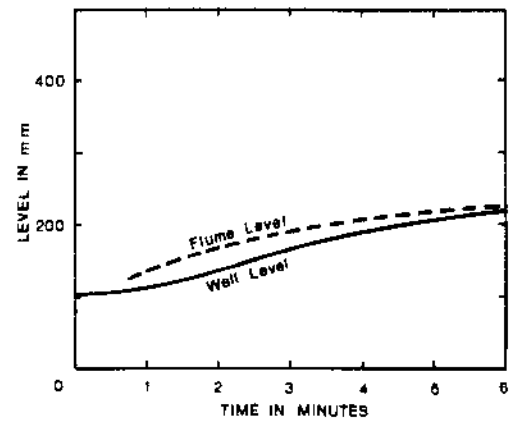
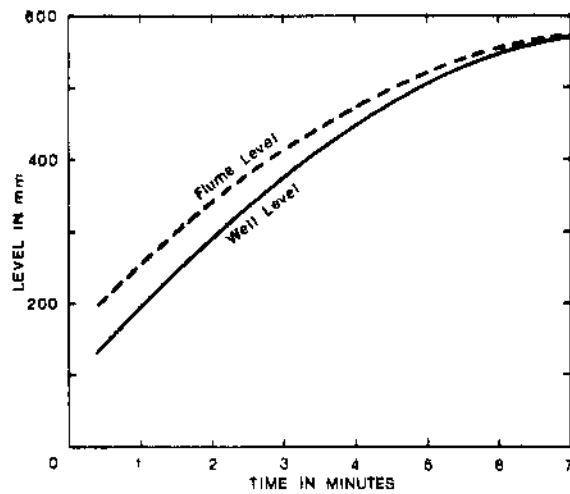
FIGURES 7-10

Well response tests on the Tanliwyth, Iago, Cyff and Gwy flumes.

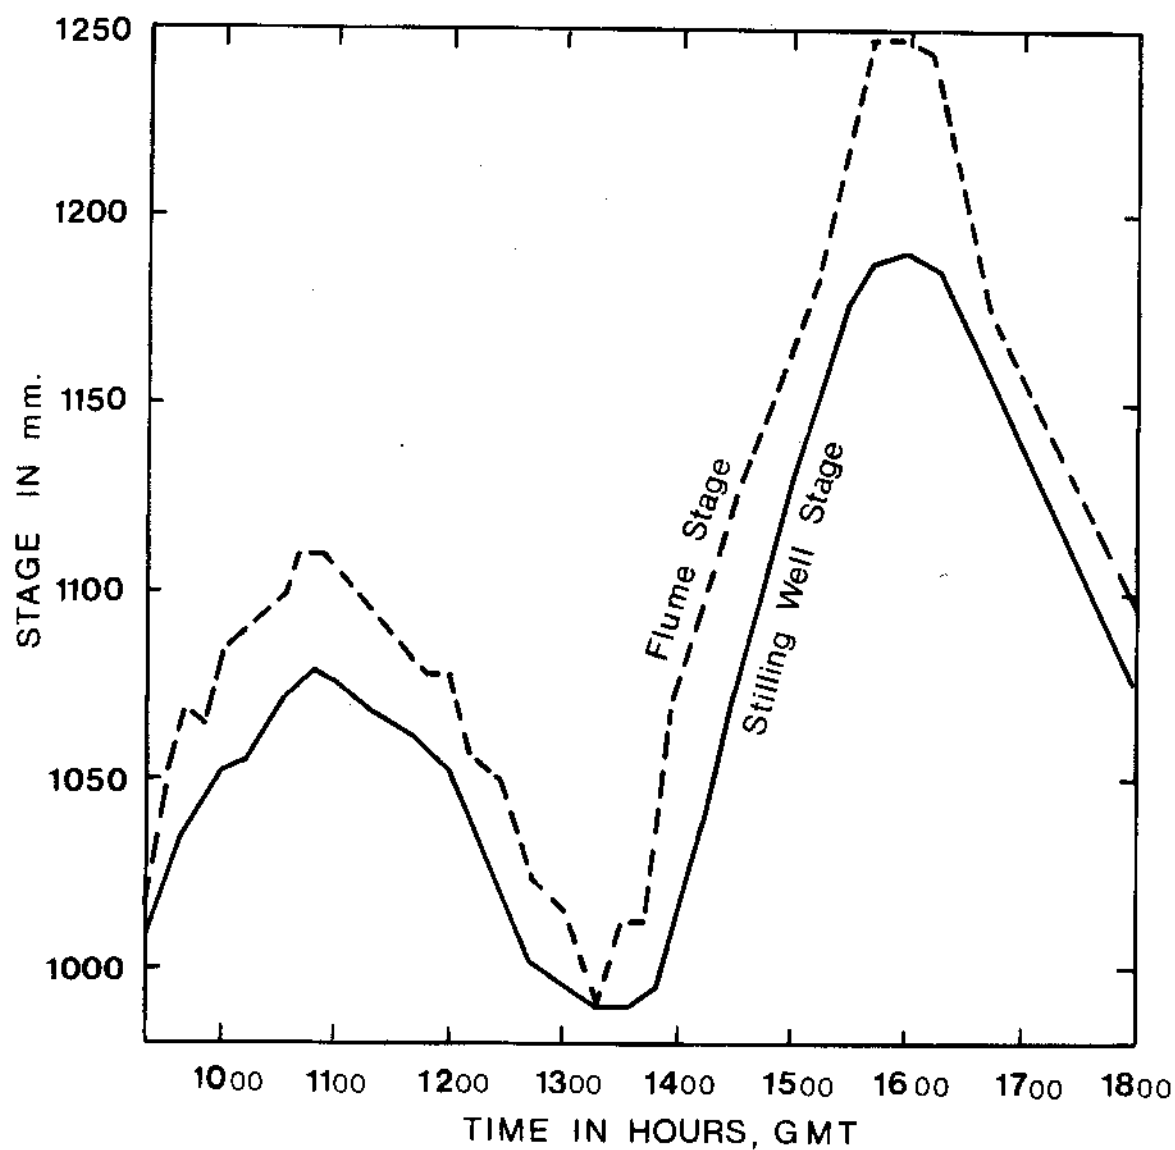
FIGURE 11

HOPE FLUME - monitoring of well and stage levels, 15.10.76.

The possibility that the well does not always reproduce flume levels was investigated by taking weekly measurements of the water surface in both flume and well. These were combined with more intensive observations through specific storms. This dual technique ensured that results did not reflect a freak condition occasioned by sediment deposition, for example.

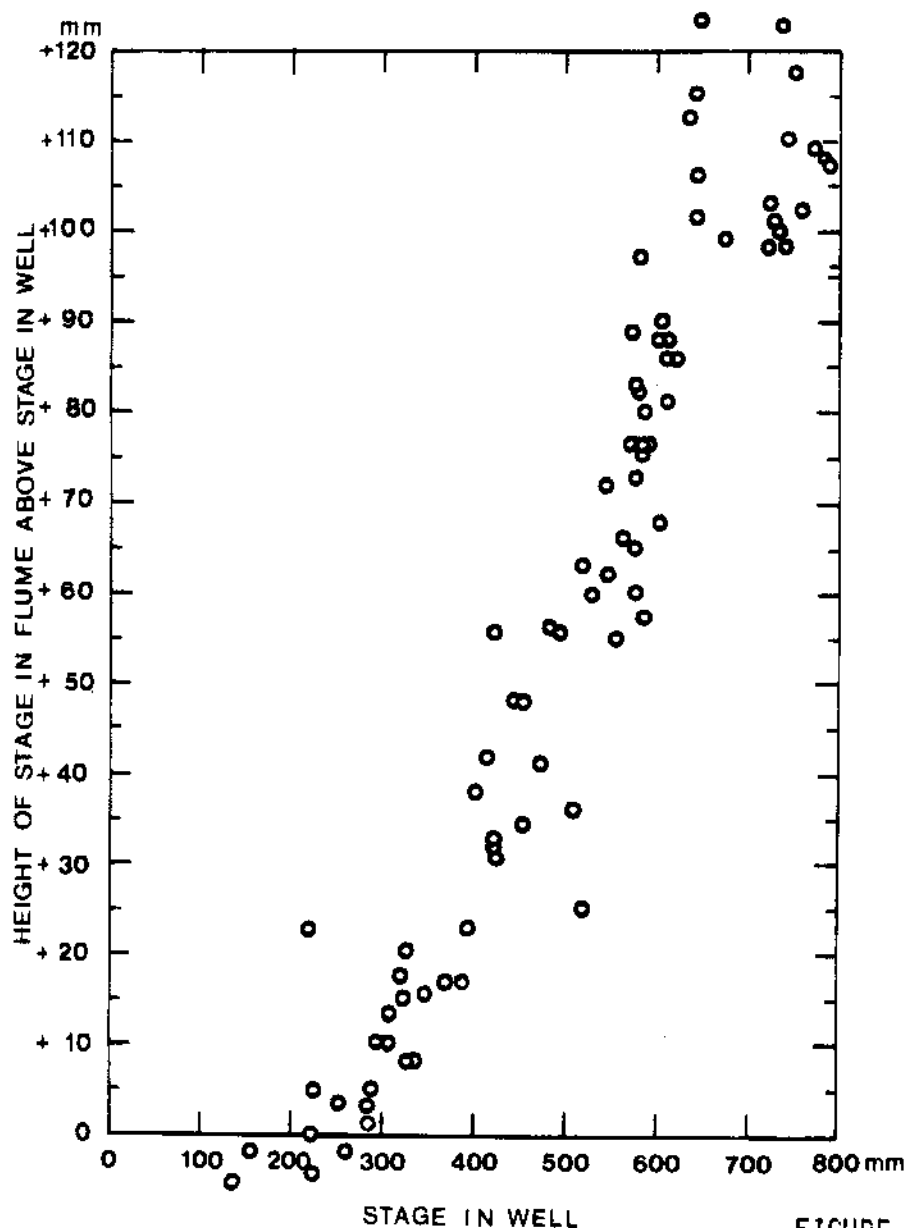
FIGURE 12

Discrepancy between  
well and stage levels,  
Hafren flume

The discrepancy between the two levels was plotted against the observed well level. Comprehensive results are not available for all flumes (by April 1977) but those obtained for the Hafren are reproduced in Figure 12.

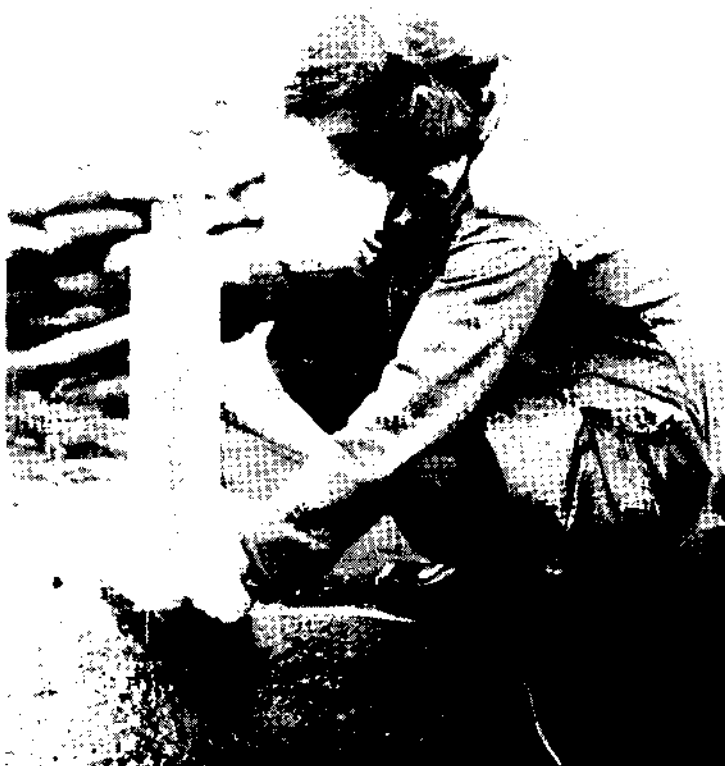
PLATE 8

Manometer in use in  
flume

The stage recorders must therefore be related to the datum and a manometer<sup>2</sup> was designed which sat in the throat of each structure. This was linked to a pipe bung which was fixed into the flume end of the tapping pipe. The manometer and well were thus connected as a 'U' tube. The reading by point gauge of the water surface in the manometer standing over the datum point in the invert could therefore be transferred via the well water surface to the trace on the recorder, and any setting or adjustment made to the recorder (Plate 8).

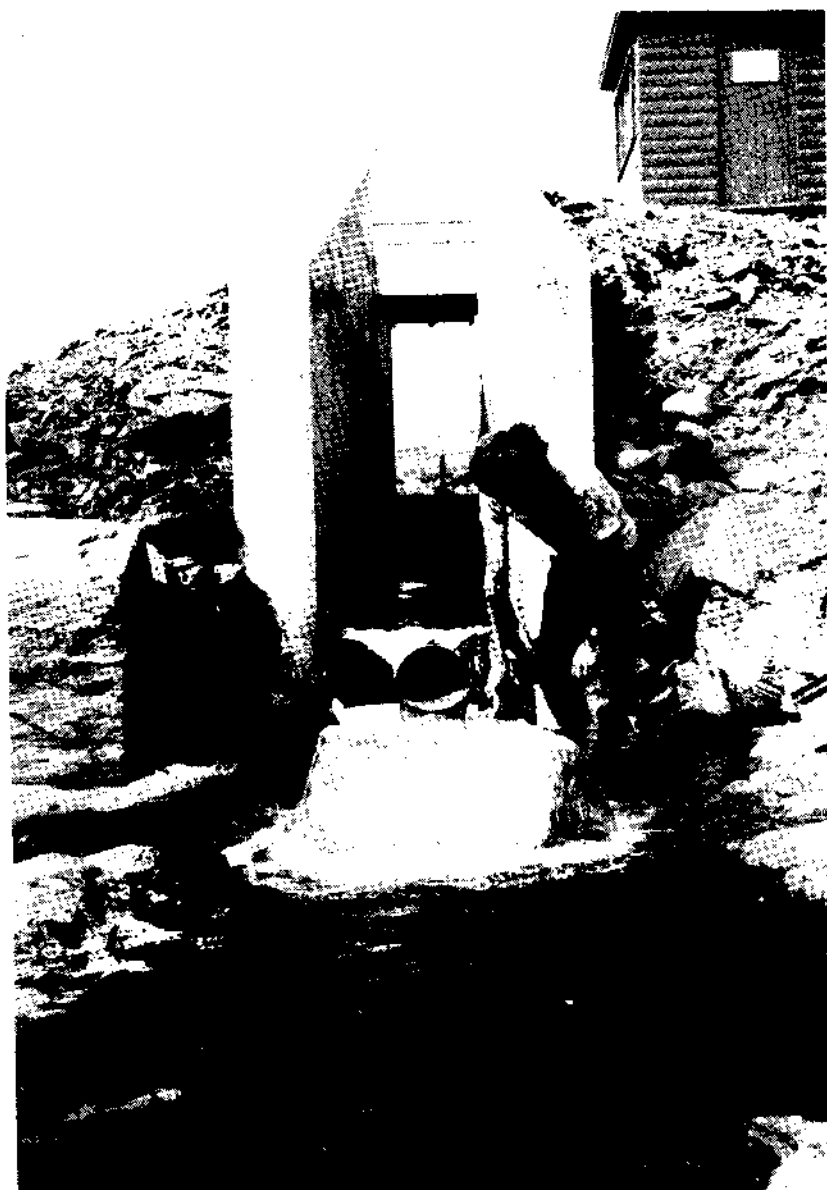
PLATE 9

Manual volumetric  
measurements of  
discharge, 1976

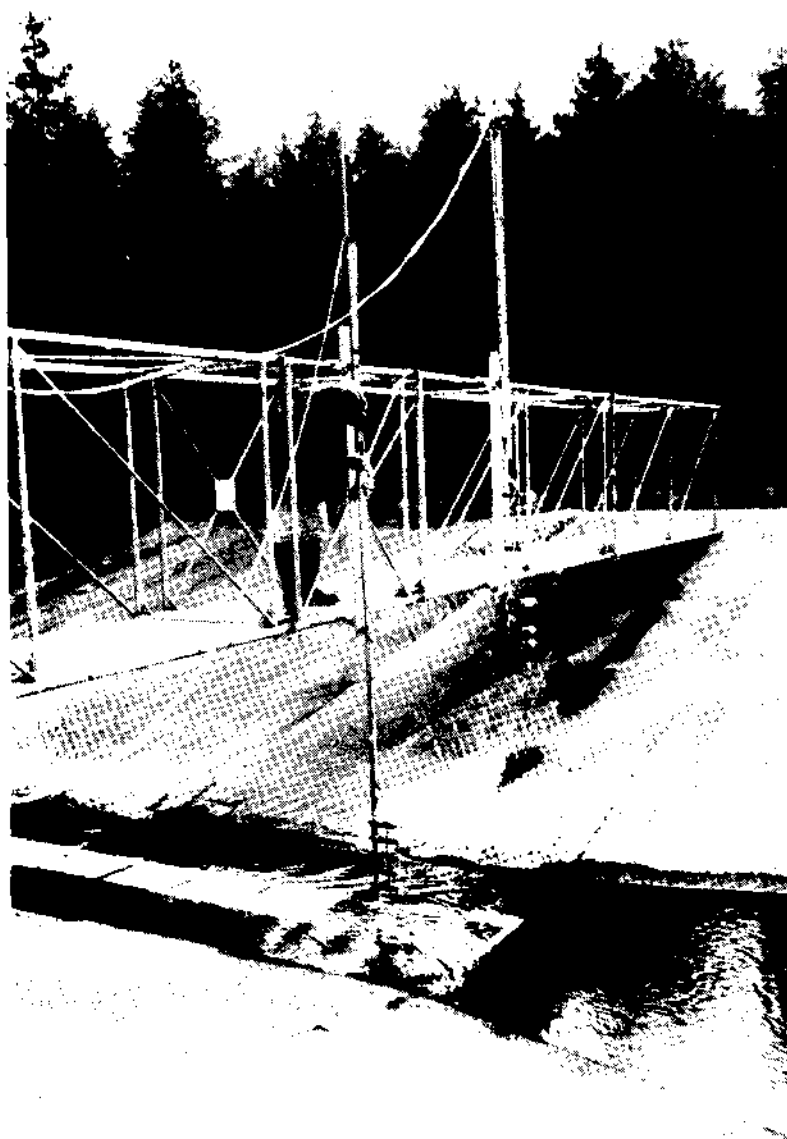
PLATE 10

Portable bridge  
for current metering  
River Severn

All the equipment described above was loaned for the calibration period by the Hydraulics Research Station. For the steep stream structures the Institute designed and made a system of sectionalised rods and clamps which was easily portable and could be adapted to fit across each gauging structure. It consisted of a metal bar across the flume with 75 mm graduations engraved along it; it was levelled and secured

to two metal base plates, one on each wall of the flume and the graduations centred. The meter rod was attached to a sliding clamp on the metal bar; near the base of the flume the rod was supported and the metering positions located by means of a horizontal line of plastic "cotton reels" centred and corresponding to the graduations on the metal bar at the top of the flume. The line of "cotton reels" was held in position by a hydraulic jack. As with the Severn trapezoidal flume the meters pointed directly upstream and were opposite the tapping pipe (see Plate 11). The operator stood on a metal support platform behind the meter rod. There were 11 meter positions across the steep stream structures except for that in the Gwy in which there were 15. Average time for a complete metering traverse was 25 minutes for the flumes with 11 positions and 35 minutes for the Gwy flume.

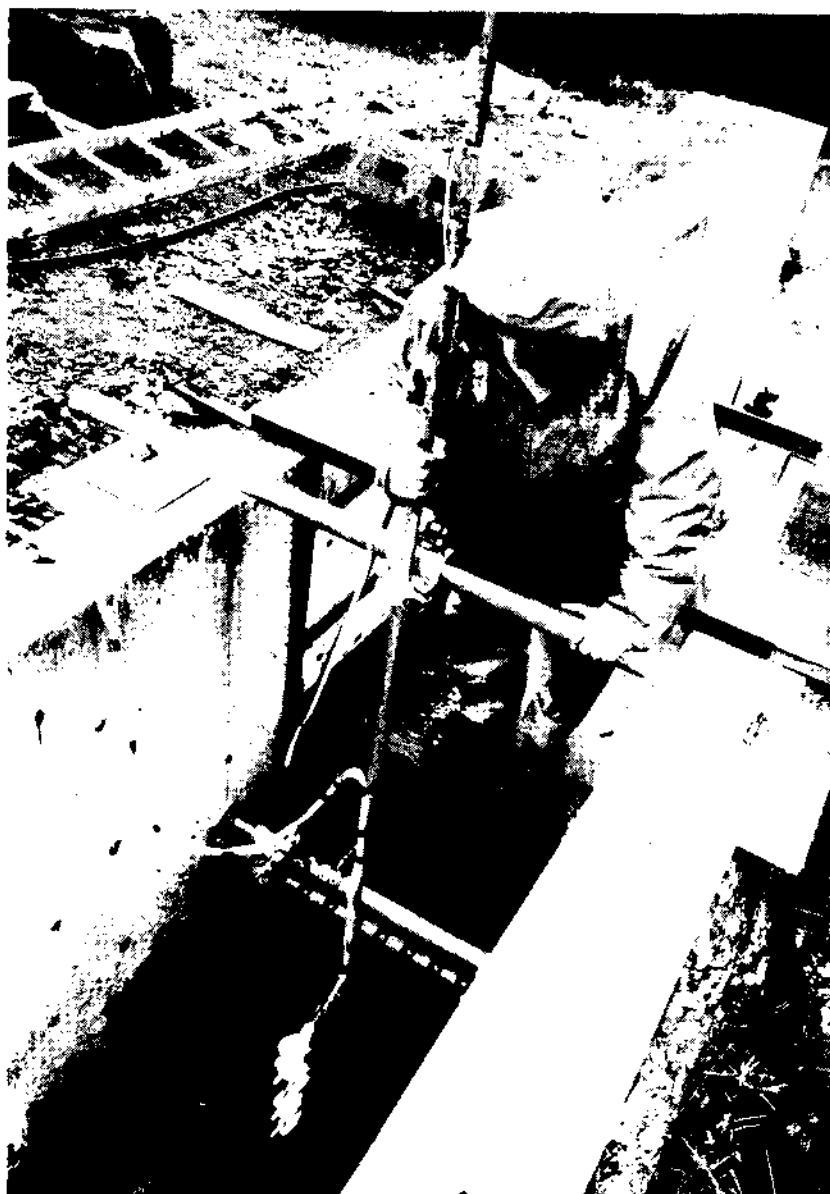
PLATE 11

Current metering in  
flume

Flow velocity was measured in the Severn trapezoidal flume and in each of the six steep stream flumes using Braystoke current meters fitted with 63.5 mm diameter propellers. Five meters were mounted on a 25 mm diameter metal rod at distances of 0.1, 0.2, 0.3, 0.4 and 0.5 m above the bed, while another five meters were mounted on an identical rod at greater intervals for flood flows, namely 0.1, 0.2, 0.4, 0.8 and 1.2 m above the bed. The meters were connected to five counters controlled as a group by an adjustable electronic timer. The output of both timer and counter are pulsed and assumed to be accurate to one count at all readings. Operational guide lines set a minimum time interval of 100 seconds and a minimum meter count of 100. The meter rod was clamped vertically with the meters pointing directly upstream. In the case of the Severn trapezoidal flume the meter rod was clamped to a portable bridge (see Plate 10) across the flume positioned such that the metering positions were opposite the tapping pipe. To locate the metering positions accurately across the stream the bridge was marked out in .125 m intervals. At high stages metering was done at .250 m intervals, the criterion for interval choice being the requirement of at least 15 verticals in the cross section, whilst gauging traverse time does not exceed approximately 45 minutes if the stage is changing rapidly. The average number of verticals used was 14 with an average traverse time of 35 minutes.

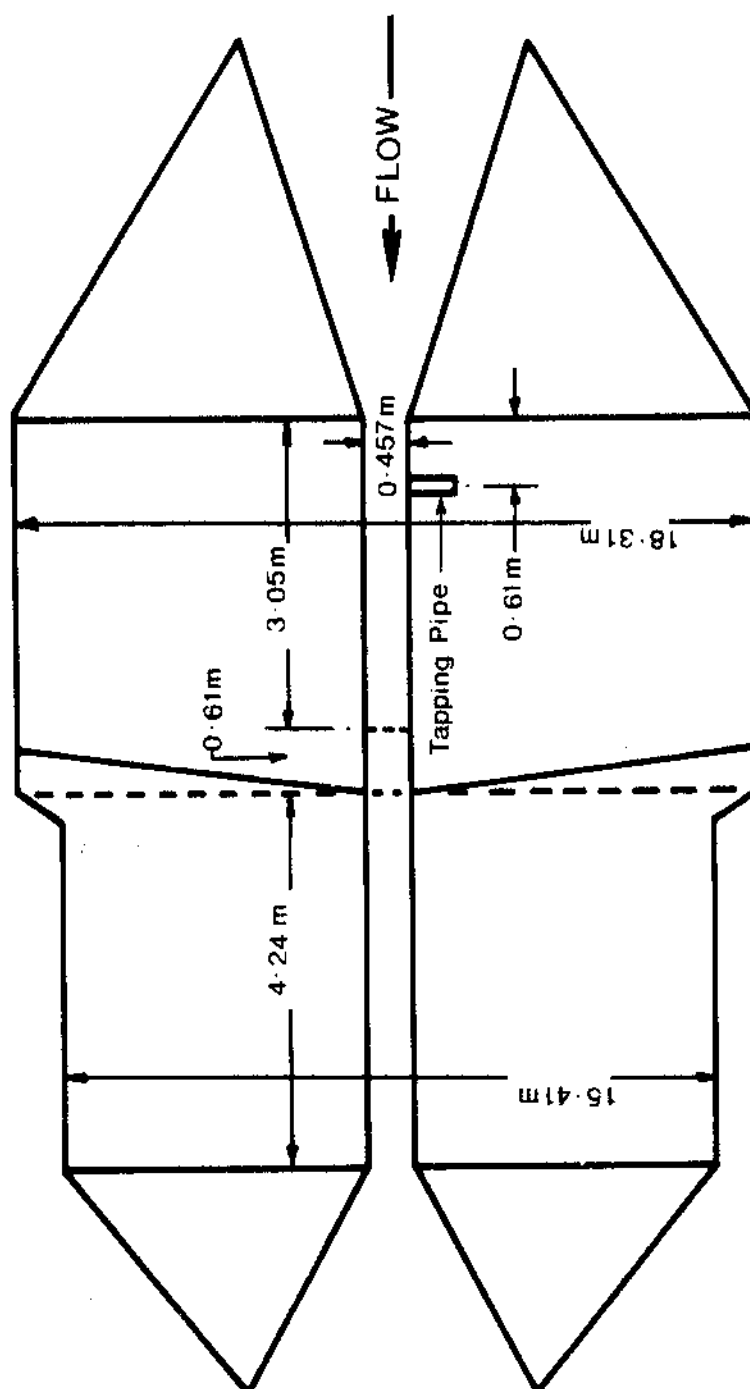
PLAN OF SEVERN TRAPEZOIDAL FLUME

Lengths:	Approach section	3050 mm
	Throat section	4240 mm
Invert width:	Approach	457 mm
	Throat	457 mm
	Step height	-10 mm in 610 mm*
Side slopes:	Approach - left	1 : 3.85
	right	1 : 3.90
	Throat - left	1 : 3.27
	right	1 : 3.20
Materials	Invert and first 150 mm of side slope aluminium alloy; remainder in concrete

*\*Step of 10 mm down from approach to throat  
achieved between 3.050 and 3.660 mm,  
measured from start of approach section.*

The flume, as built, is a critical depth flume of trapezoidal section. It has a flat invert, 457 mm wide, with a 9 mm step down into the throat achieved over a 610 mm long transition section. The side slopes in the approach are 1 : 3.90 and 1 : 3.25 in the throat. Transition from the approach to the throat section is achieved by two cylindrical surfaces, the axes of the cylinders passing through the entrance to the throat. Stage levels are measured in a stilling well connected by a pipe to the side of the flume at the invert level of the approach section. The plan dimensions and layout of the flume are shown in Appendix I.
