INSTITUTE  
OF  
HYDROLOGYTHE DESIGN, OPERATION AND CALIBRATION OF THE  
PERMANENT FLOW MEASUREMENT STRUCTURES IN  
THE PLYNLIMON EXPERIMENTAL CATCHMENTS

REPORT NO 42

September 1977

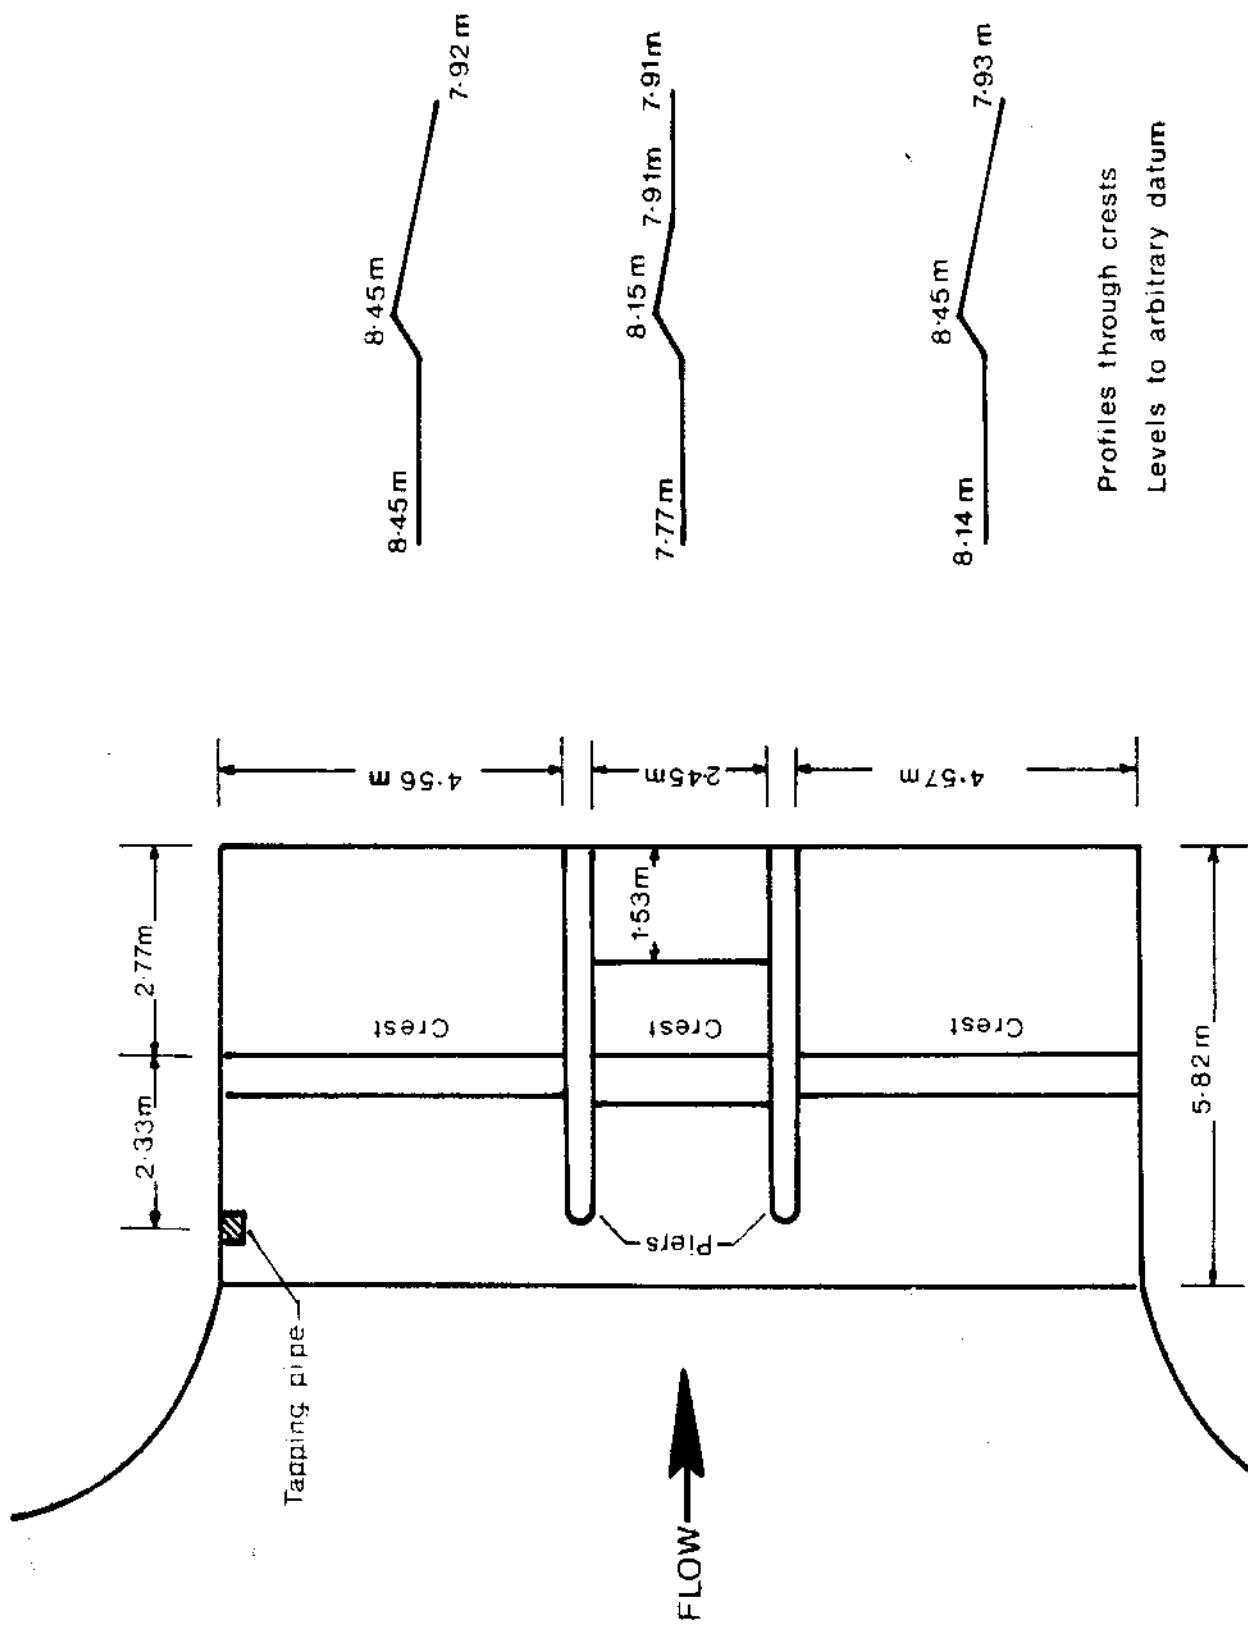
CEFN BRWYN WEIR

Crest widths	Left bay	4560 mm
	Centre bay	2450 mm
	Right bay	4575 mm
Crest levels	Left bay	+ 377 mm
	Centre bay	0
	Right bay	+ 378 mm
Crest slopes	Left - upstream	1 : 1.839
	downstream	1 : 5.226
	Centre - upstream	1 : 1.737
	downstream	1 : 5.167
	Right - upstream	1 : 1.645
	downstream	1 : 5.327
Materials	Concrete; gun-metal crests

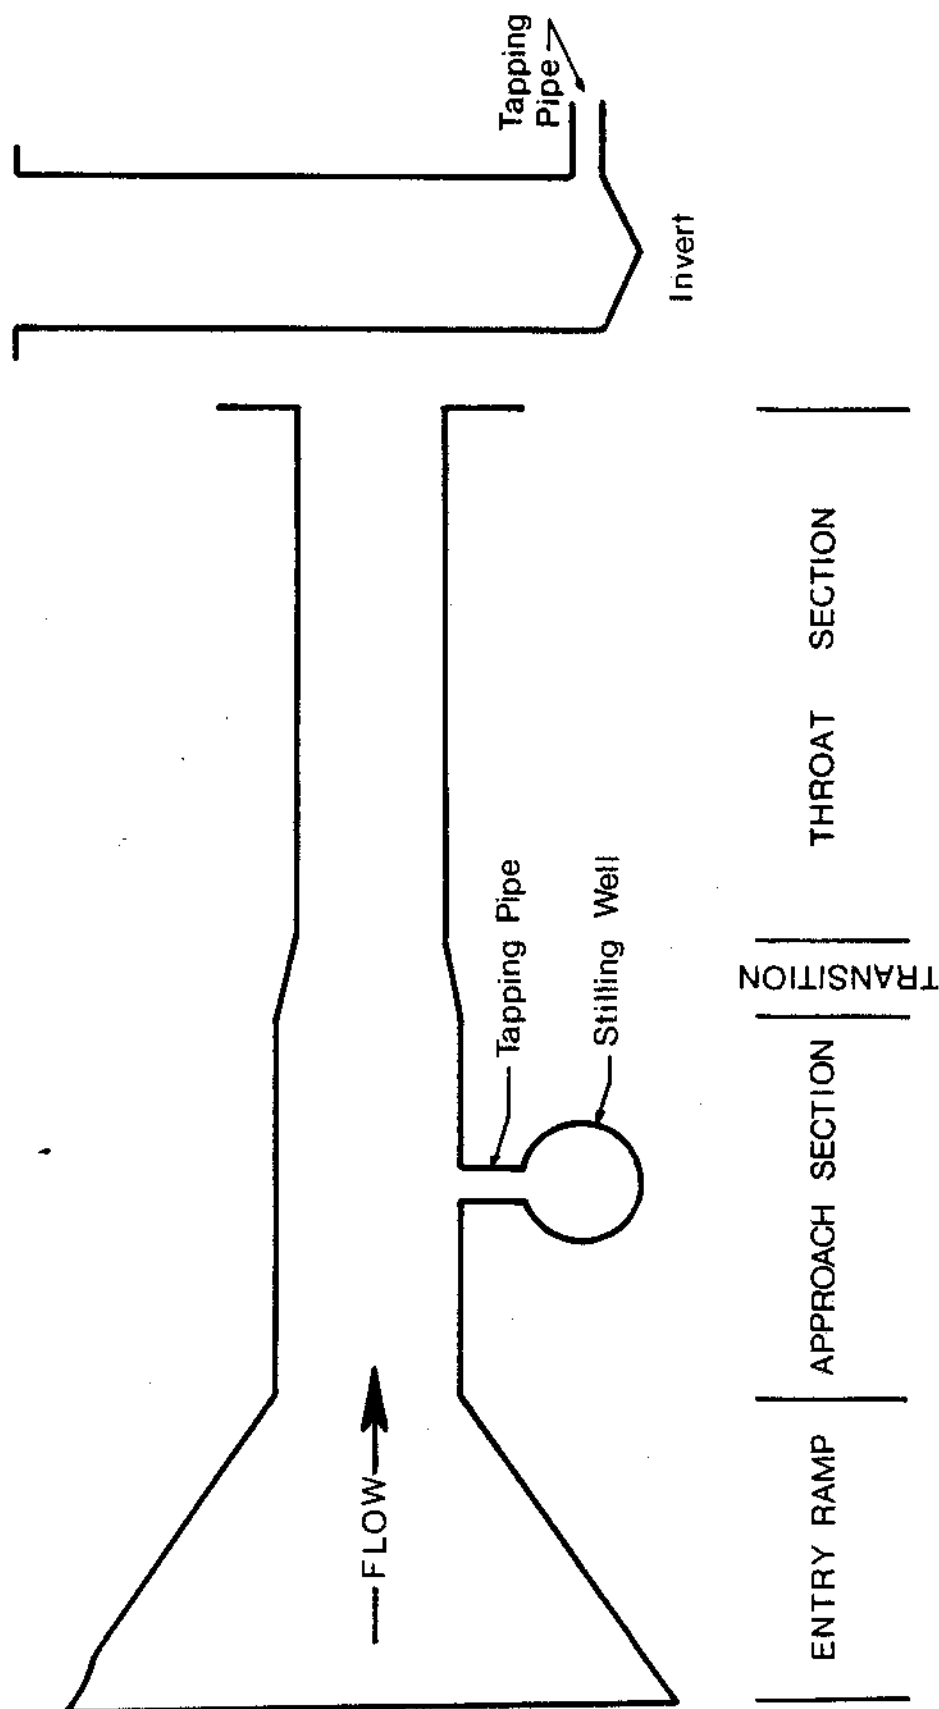
# PLAN OF STEEP STREAM FLUMES

Lengths, mm			Distance between vertical walls, mm			Construction material			
	Catchment area km <sup>2</sup>	Design flood Q cumecs	Design drought Q cumecs	Approach	Transition	Throat	Approach sect. at tapping point	Step height up in throat mm	Approach walls & invert	Throat walls
HAFREN	3.67	10.19	0.009	5480		5890	913	682	glass fibre	aluminium alloy
TANLLWYTH	0.89	2.26	0.003	3660	610	3660	916	701	glass fibre	Al. alloy
HORE	3.08	14.15	0.011	8160	1040	6860	916	701	concrete	concrete concrete
IAGO	1.02	3.96	0.003	3660	610	3660	912	759	glass fibre	Al. alloy
GWY	3.98	17.83	0.014	6640	1000	5500	1214	938	concrete	concrete concrete
CYFF	3.13	9.91	0.009	5600	920	4730	982	759	concrete	concrete concrete
