**British
Geological Survey**

Mineralogical investigations of the interaction between iron corrosion products and bentonite from the NF-PRO Experiments (Phase 1)

Commissioned Report CR/07/116^N

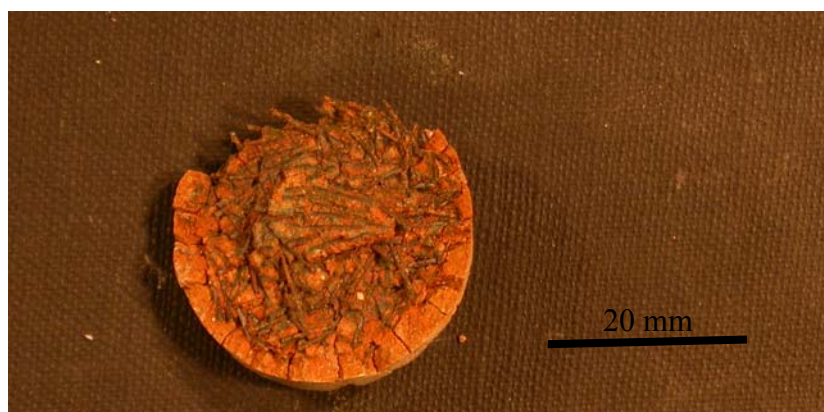
Figure 4. Photograph of subsample 12c sliced from the centre of the steel wire region of the compacted bentonite. The corroded wire surfaces are coated with a black iron oxide corrosion product, surrounded by narrow haloes of reddish-brown iron oxide alteration product. The adjacent bentonite matrix is strongly stained orange-brown. Note that shrinkage and cracking of the bentonite has occurred around the wire-free margin of the slice, whereas, the centre of the disc contaminating the wires displays markedly less shrinkage cracking. Experiment NFC12.

Closer examination of freshly broken fragments (after vacuum drying) taken from the corroded wire zone region of the bentonite cylinder showed that the surfaces of the steel wires were coated with a very thin film of very dark brown to black oxide corrosion product, surrounded by a halo of dark reddish-brown colouration of the adjacent bentonite that becomes a more diffuse and lighter orange to light reddish brown stain in the bentonite matrix beyond about 0.1-0.5 mm

distance from the wire surface (Figure 4). Fragments of the dark brown to black oxide corrosion product display ferromagnetic properties and could be attracted to a strong hand magnet. A similar black corrosion product recovered from the surface of corroded wires in Experiment 17 was found by XRD analysis (see Section 4.2.2.1) to contain magnetite [Fe_3O_4]. Therefore, it seems likely that the black oxide product seen on the surfaces of the corroded steel wires in Experiment NFC12 is probably also magnetite.

It was noticeable that the shrinkage behaviour of the bentonite matrix on drying was different between the heavy iron-stained central part of the steel wire-bearing region and the margins of the bentonite that were free of steel wires. The heavily iron-impregnated areas from the centre of the zone with abundant corroded steel wire displayed much less shrinkage and cracking after vacuum-drying than the margins of the zone that were free of corroded steel wires (Figure 4).

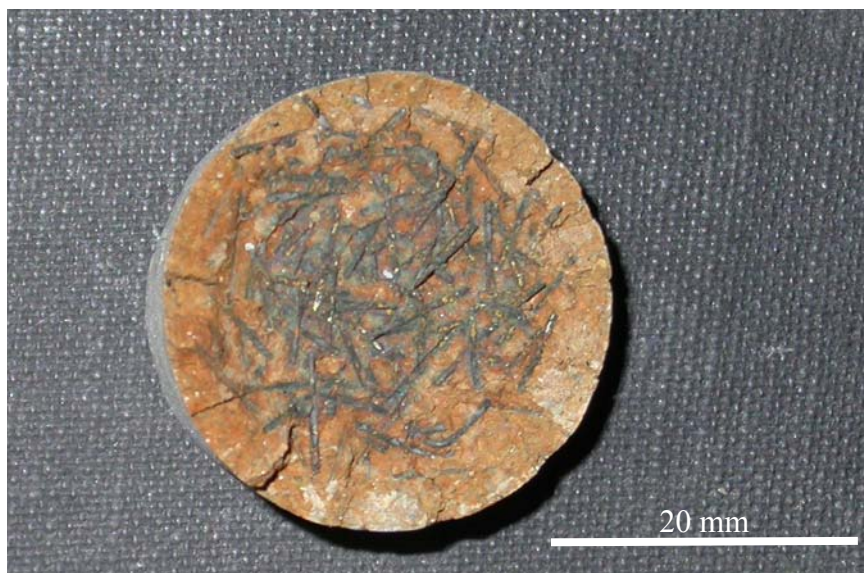
Figure 15. Photograph of subsample 16a showing the surface of the interface between bentonite and ‘bentonite with steel wire’ region. Reddish brown staining permeates the matrix of the bentonite between the steel wires but locally there are patches of iron-stain-free bentonite. The surfaces of the steel wires can be seen to be coated with a black oxide alteration product. Experiment NFC16.

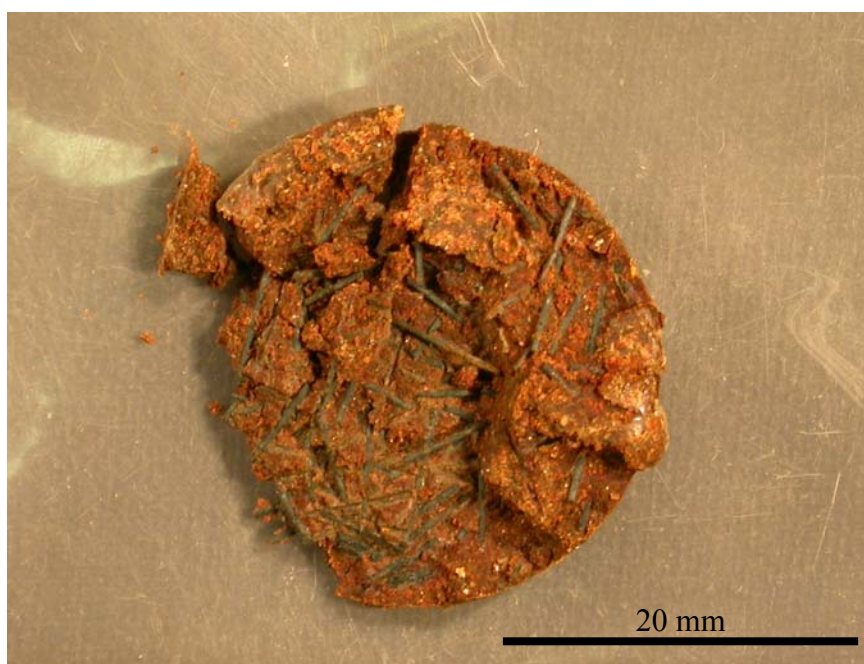
Figure 20. Photograph of bentonite with corroded steel wires from the centre of the steel wire-bentonite zone. The steel wires are covered by a surface film of black iron oxide. The bentonite matrix between the wires is heavily stained an orange to reddish brown colour. Experiment NFC17.
