# Slope Dynamics Project Report: Norfolk Coast (2000 - 2006)

Research Report OR/08/018

Norfolk, coastal, landslides, erosion, cliff recession, Happisburgh, Sidestrand, Weybourne, glacial deposits, slope stability, slope dynamics project.

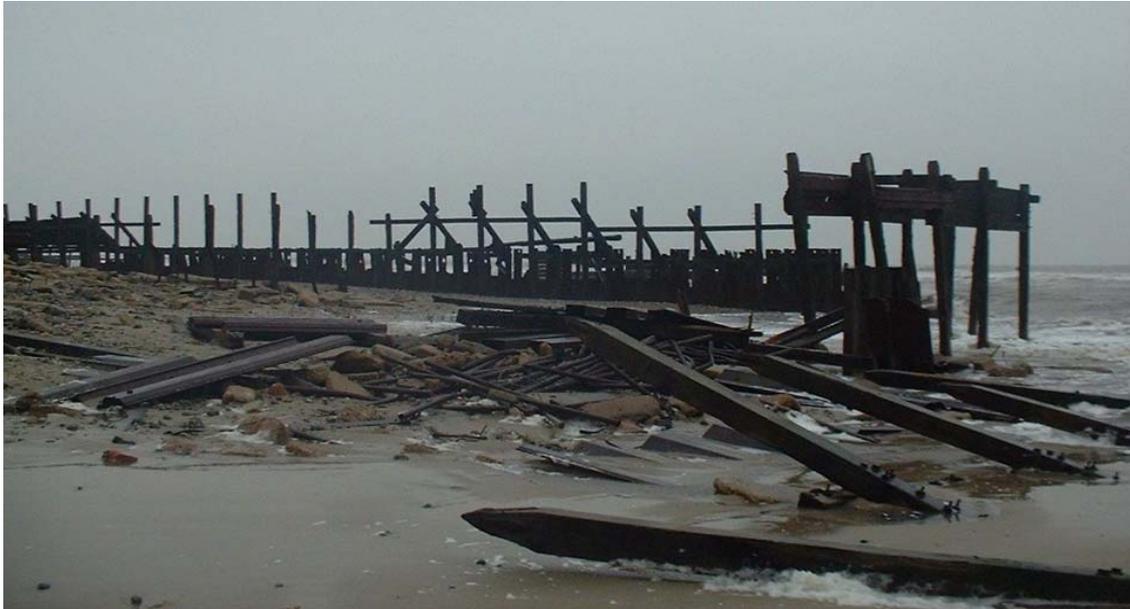
**Figure 2-1 Failing defences at Happisburgh in 2004.**  
**Most of this section of wooden palisade defences has now been removed. A small rock bund now replaces part of this section.**

During recent years, some sections of coastline which were previously defended, such as at Happisburgh, have been subject to defence failure (Figure 2-1). Where the structures have not been repaired/maintained, there has been rapid cliff erosion as the cliff line attempts to realign to a more natural position. It should be borne in mind that even where protected by defences, the cliffs are still subjected to sub-aerial erosion processes and landslide.

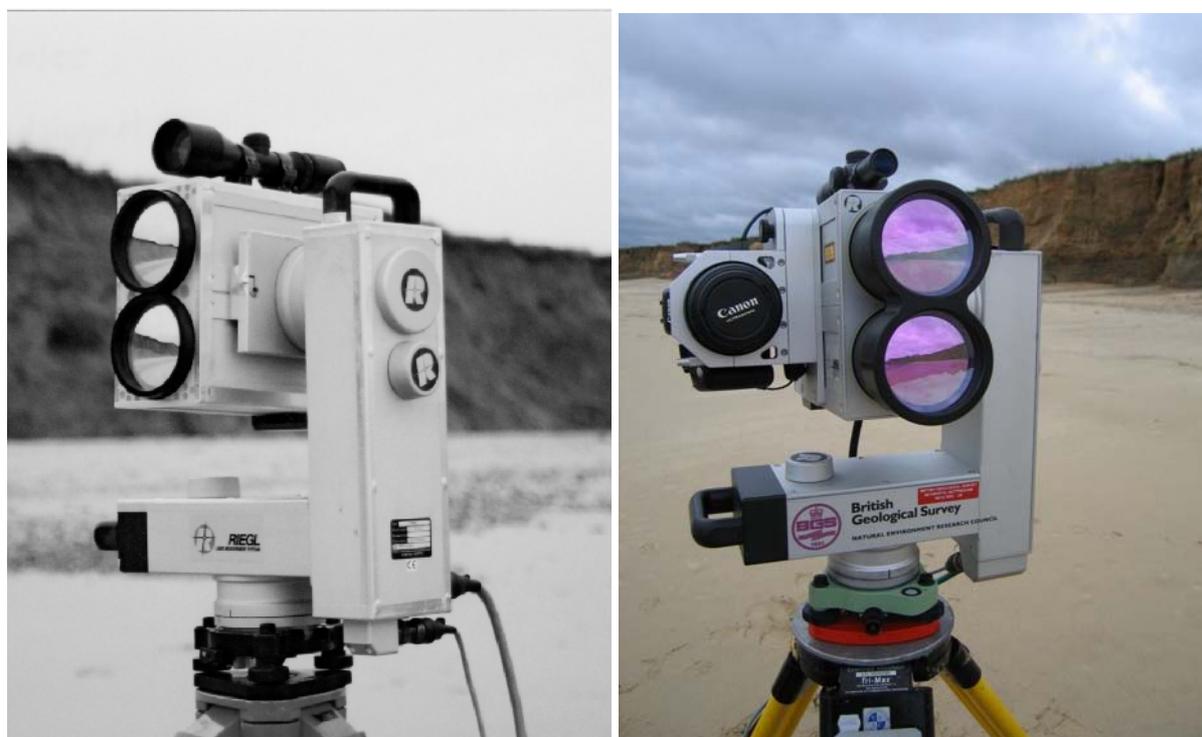
**Figure 3-1 Riegl LPM2K mobile terrestrial laser scanner (left); Riegl LPM-i800HA mobile terrestrial laser scanner with camera (right).**

The range-finding accuracy is quoted as 50 mm for the Riegl LPM2K and 25mm for the Riegl LPMi800HA laser scanners, though repeatability is considerably better. It was found that baseline distances of 50 to 100 m were capable of re-measurement to 0.5 mm (1 in 500,000). These values are largely unaffected by range if atmospheric conditions are ignored. With regards to scanning capability the pan/tilt mount is quoted as having a stepper motor accuracy of 0.009°. This represents a movement of 16 mm per 100 m range (Figure 3-3). The quoted laser beam divergence for the LPM2K and LPMi800HA scanners is 0.8 mrad. This is equivalent to an 80 mm increase of beam width per 100 m range (Figure 3-4). Other ranges are linearly proportional in each case. The significance of this is that where a scan involves large distances, those far objects will be less well defined in terms of position and form than close objects. For example, at a range of 500 m, the laser footprint is about 0.4 m in diameter. This factor particularly affects objects inclined at an acute angle to the direction of the laser beam, i.e. not face-on. An estimate of the improvements in the overall positional accuracy of the combined ‘scanner + GPS’ system during the project is shown in Figure 3-5, showing how accuracy has improved during the project life from around 2.5 m to <20 cm in the later scans. These improvements have been largely due to equipment upgrades.

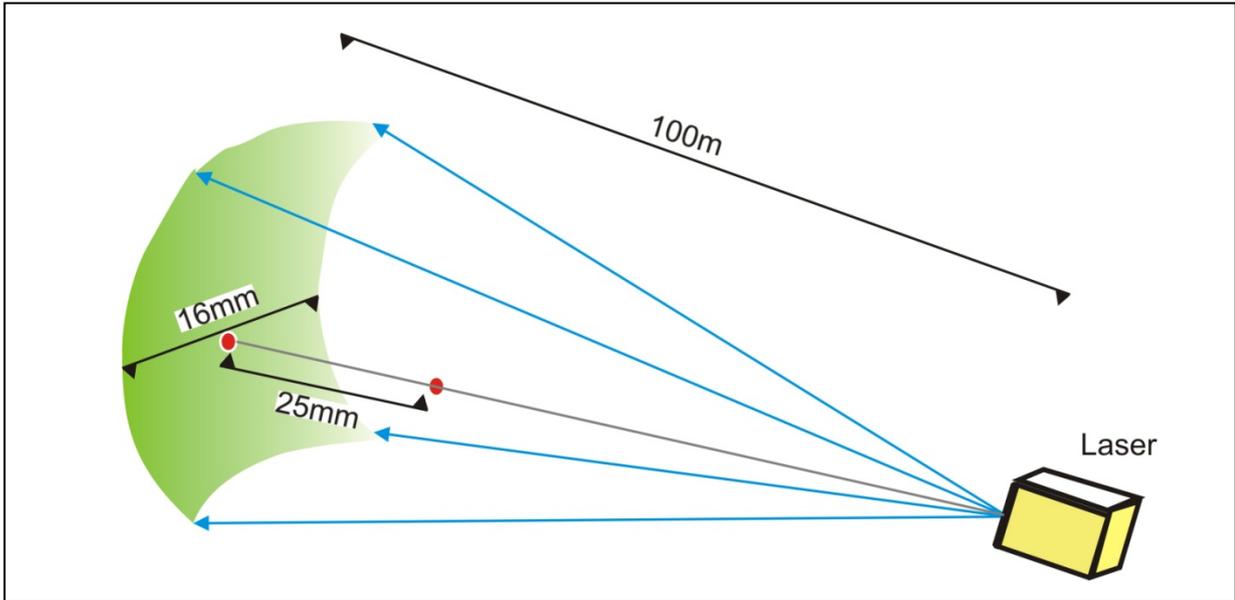
**Figure 3-3 Schematic illustrating accuracy of angular (green) and range (red) components of laser scan (xyz) data**

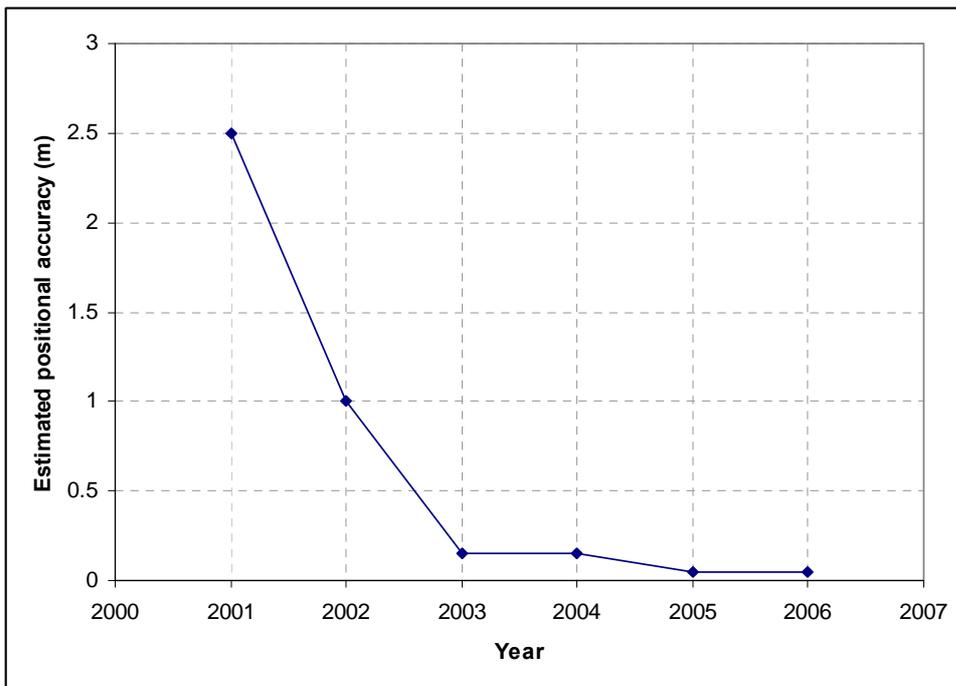
**Figure 3-5 Estimated development of model (scanner + GPS) positional accuracy during project**

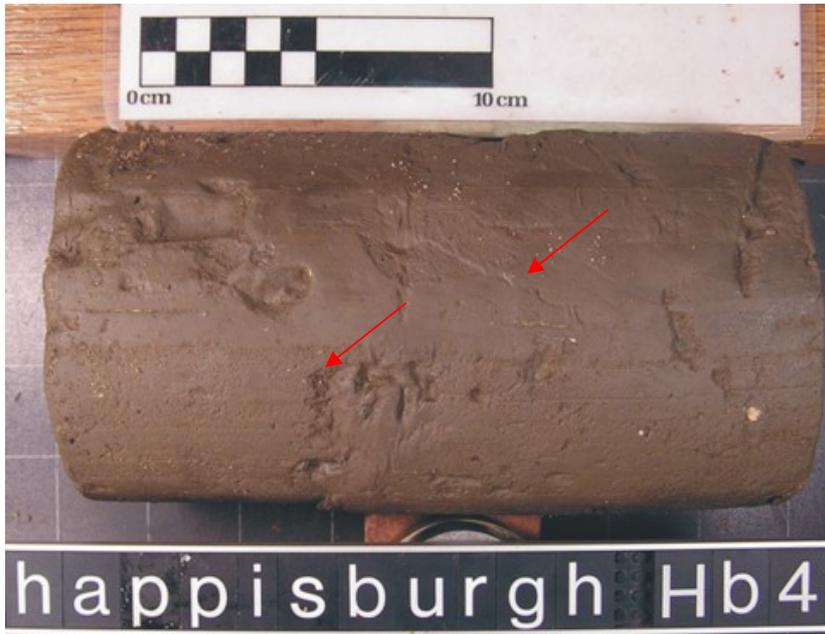
**Figure 3-8 Post-failure triaxial test specimen** (principal shear surface shown by red arrows)

The laboratory *mechanical* testing programme consisted of triaxial testing using a GDS 100 mm stress-path system. The test used was the multi-stage ‘consolidated isotropic undrained’ (CIU) with pore pressure measurements (Head, 1996), allowing ‘peak’ effective strength parameters to be measured at effective average stresses of 100, 200 and 400 kPa applied to a single specimen. The specimen size was 102 mm diameter with a target length to diameter ratio of 2:1. Top, bottom, and side drains were used to facilitate consolidation. The specimen was saturated, prior to stage 1 isotropic consolidation, by staged ramping-up to an elevated (back) pressure; the final value being determined by the ‘B-test’ (i.e. pore pressure response to applied load increment). Axial compression was applied in the undrained state following each consolidation stage, with pore pressures measured at either end of the specimen. Stages 1 & 2 of axial compression were discontinued when the stress ratio reached a peak, whereas the stage 3 axial compression was continued beyond shear failure. A post-failure specimen is shown in Figure 3-8.

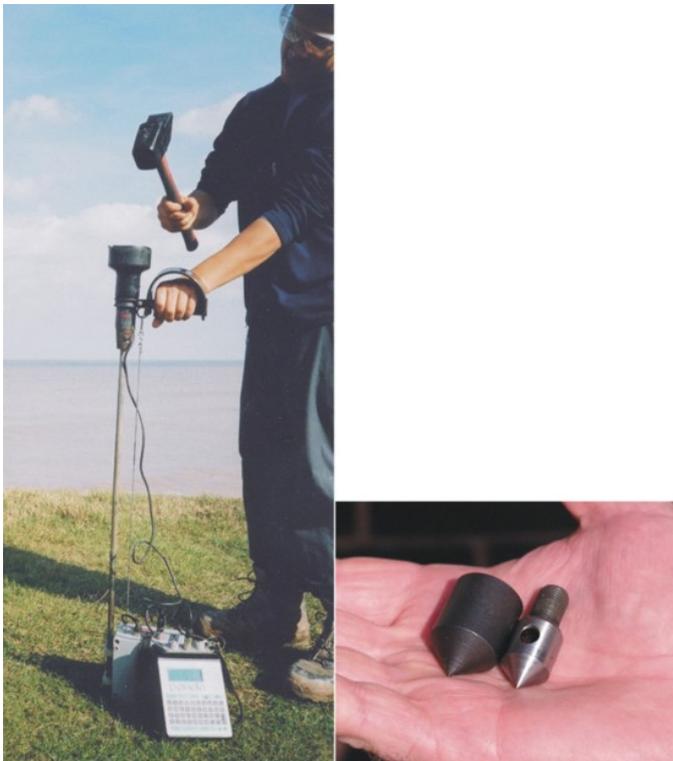
**Figure 3-9 Panda™ ultra-lightweight penetrometer (Type 1)** Note: alternative cones (right)

Field testing consisted of cone penetrometer tests on the cliffs using the Panda (Types 1 & 2) ultra-lightweight penetrometer apparatus (Figure 3-9 and Figure 3-10). The principal difference between these is that the Type 2 has a solid state accelerometer in the anvil, whereas the Type 1 has a plunger and transducer. The hammers for the two types also differ whilst the cones and rods are identical.

The Panda is an ultra-lightweight hand-operated cone penetrometer with variable energy input, capable of penetrating soil and other unbound material to 10 m depth and very weak rock to a depth of about 2 m. In the Type 2 PANDA, the anvil at the top of the rod train contains an accelerometer which measures the speed of the hammer impact. A retractable tape measures the penetration produced by each blow. Each of the half-metre length rods weighs 0.58 kg, whilst the small and large cones 0.033 kg and 0.062 kg, respectively. From these data the energy at the cone tip is calculated.

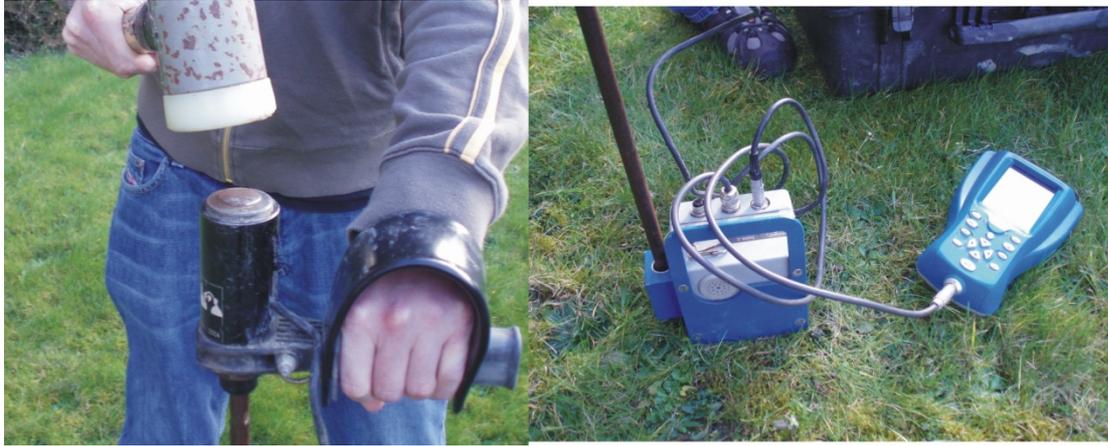
**Figure 3-10 Panda™ ultra-lightweight penetrometer (Type 2)**

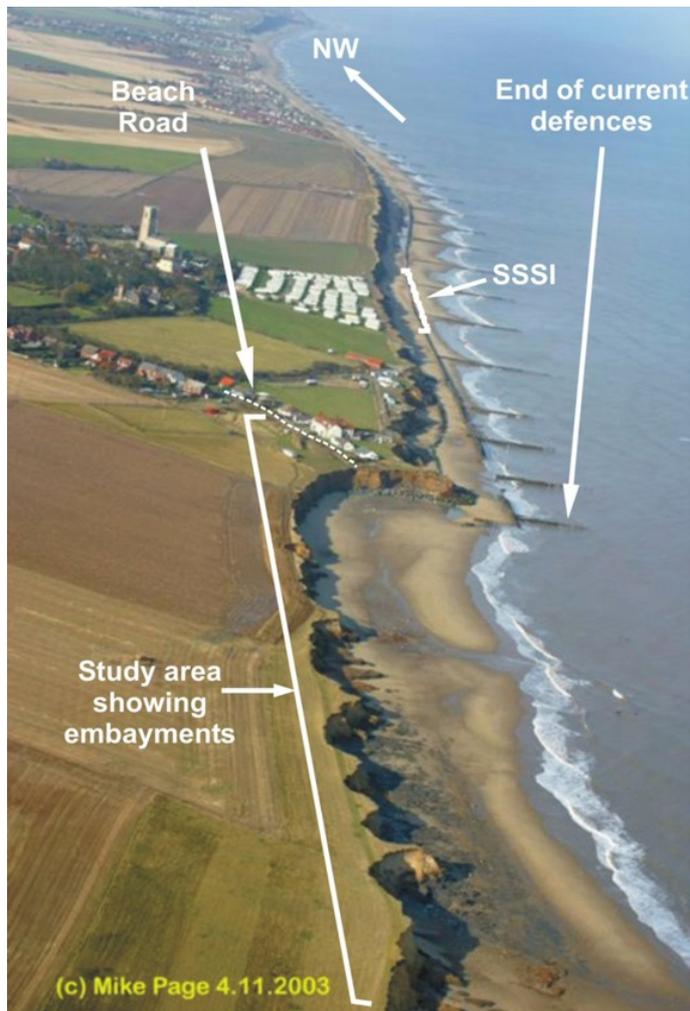
Figure 4-1 Aerial photograph at Happisburgh taken in 2003, facing north, showing the point where the sea defences have failed and been removed.

Earlier publications on this work using data from 2001-2004 (Poulton *et al.*, 2006), show that where the defences have failed and been removed, and where the cliffs are exposed (Figure 4-1), average recession rates of the cliff top range between 8-10 m/yr at Happisburgh. The subsequent surveys update this figure to 6-8 m/yr for 2001 – 2006.

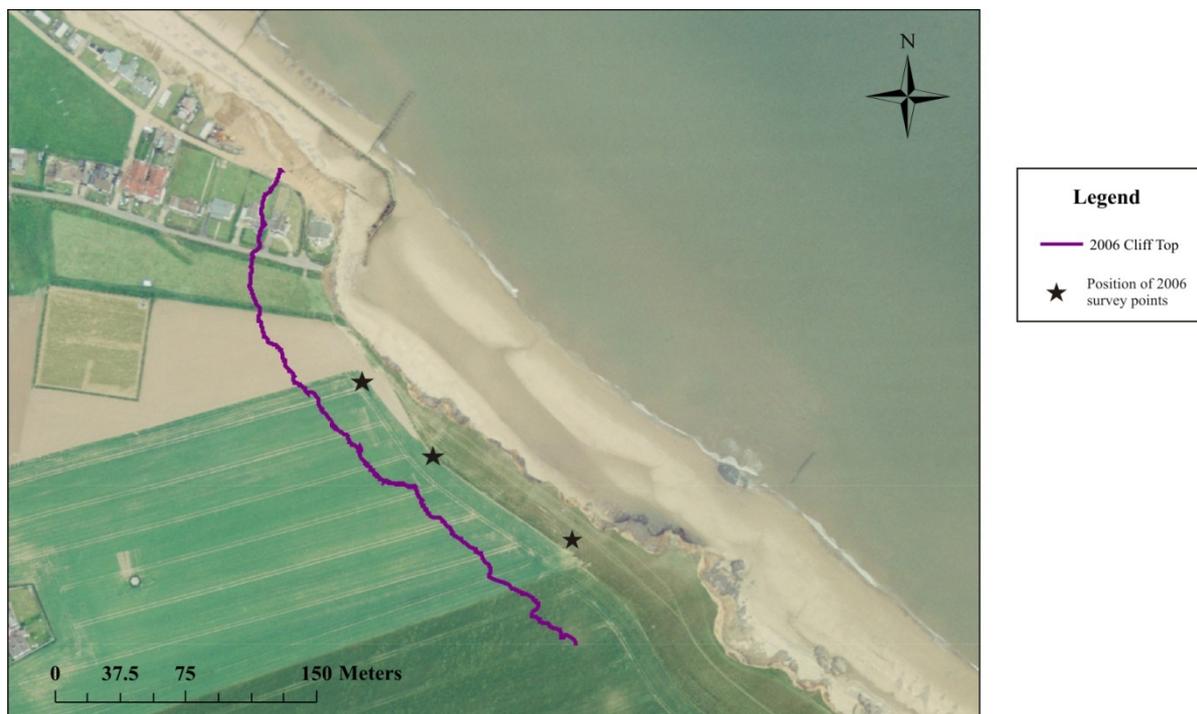
**Figure 4-2 Location of 2006 scan positions relative to the 2006 cliff line at Happisburgh**  
(NOTE: aerial photo 1999). Scan positions NGR: 638621, 330778. 638659, 330743. 638720, 330692.

The position of scans taken in 2006 at the Happisburgh site is shown in Figure 4-2.

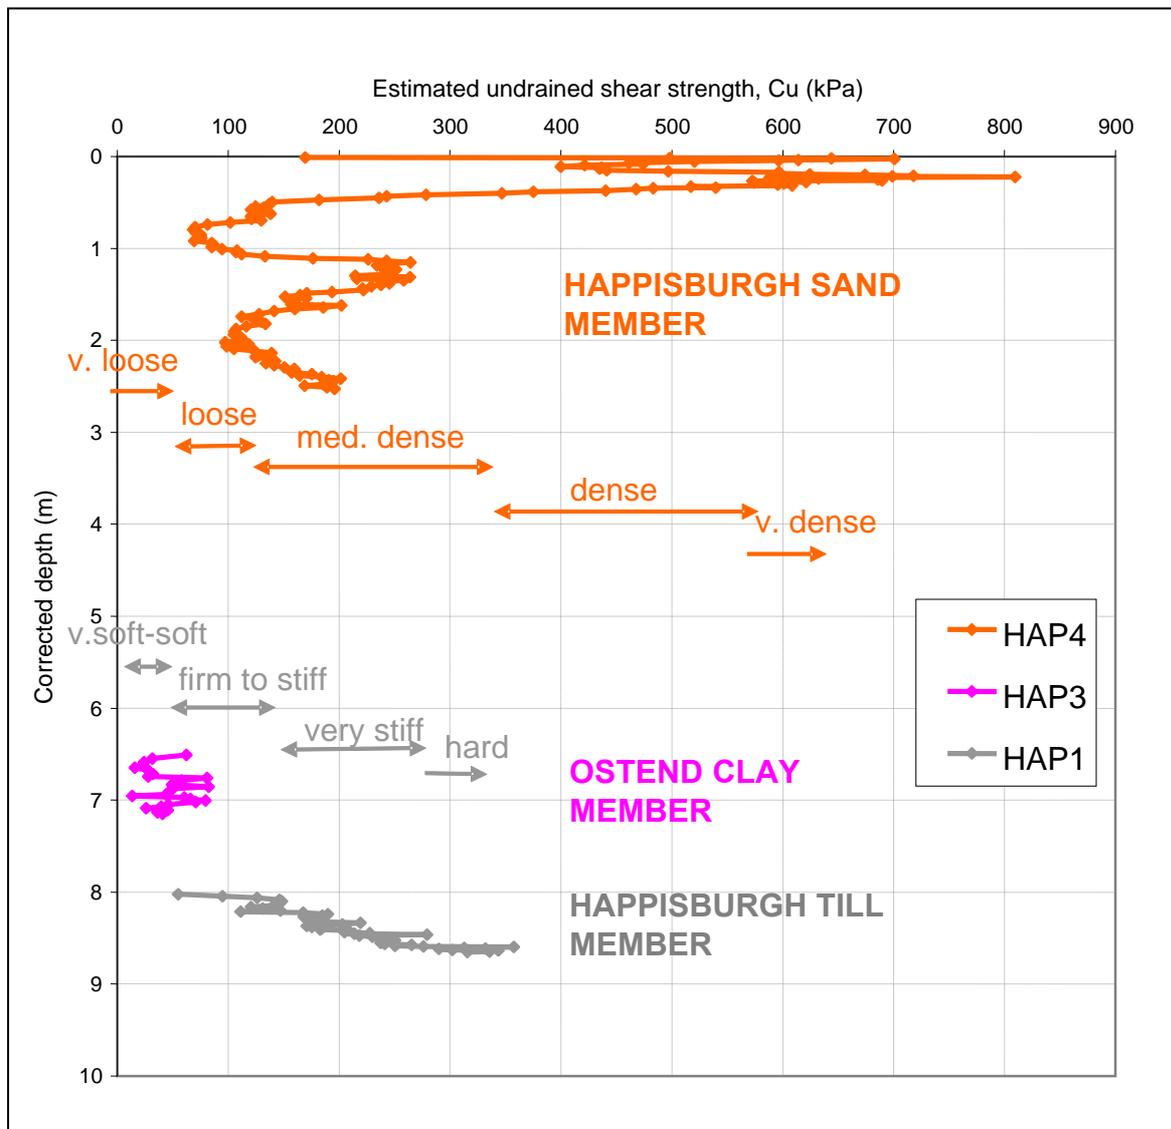
**Figure 4-5 Composite shear strength (partial) profile (from depth-corrected Panda profiles, refer to Table 4-3 for explanation of geology names)**

A number of in-situ Panda ultra-lightweight penetrometer tests were carried out at Happisburgh at different lithostratigraphic horizons on the cliff and platform (Table 4-3). The resulting profiles were combined to form a partial synthetic profile of undrained strength of the cliff and platform, as shown in Figure 4-5. The profile is notable in that there is a marked decrease in strength within the Happisburgh Sand Member from the cliff-top to a depth of 2.5 m. The member varies from ‘very loose’ to ‘dense’ in consistency with two distinctive weaker/looser horizons at 0.9 and 2.0m. The remainder of this member was not tested. The high values near the cliff-top are due to a stony layer beneath the topsoil. However, the Ostend Clay Formation, though thin, constitutes a distinct weak zone with ‘very soft’ to ‘soft’ consistencies. The variation in stiffness may distinguish the silt, clay and sand rich laminations and beds. Within the underlying Happisburgh Till Member there is a rapid strength increase with depth. The weakening of material may be due to the effect of surface weathering and stress release, and changes in water content with depth.

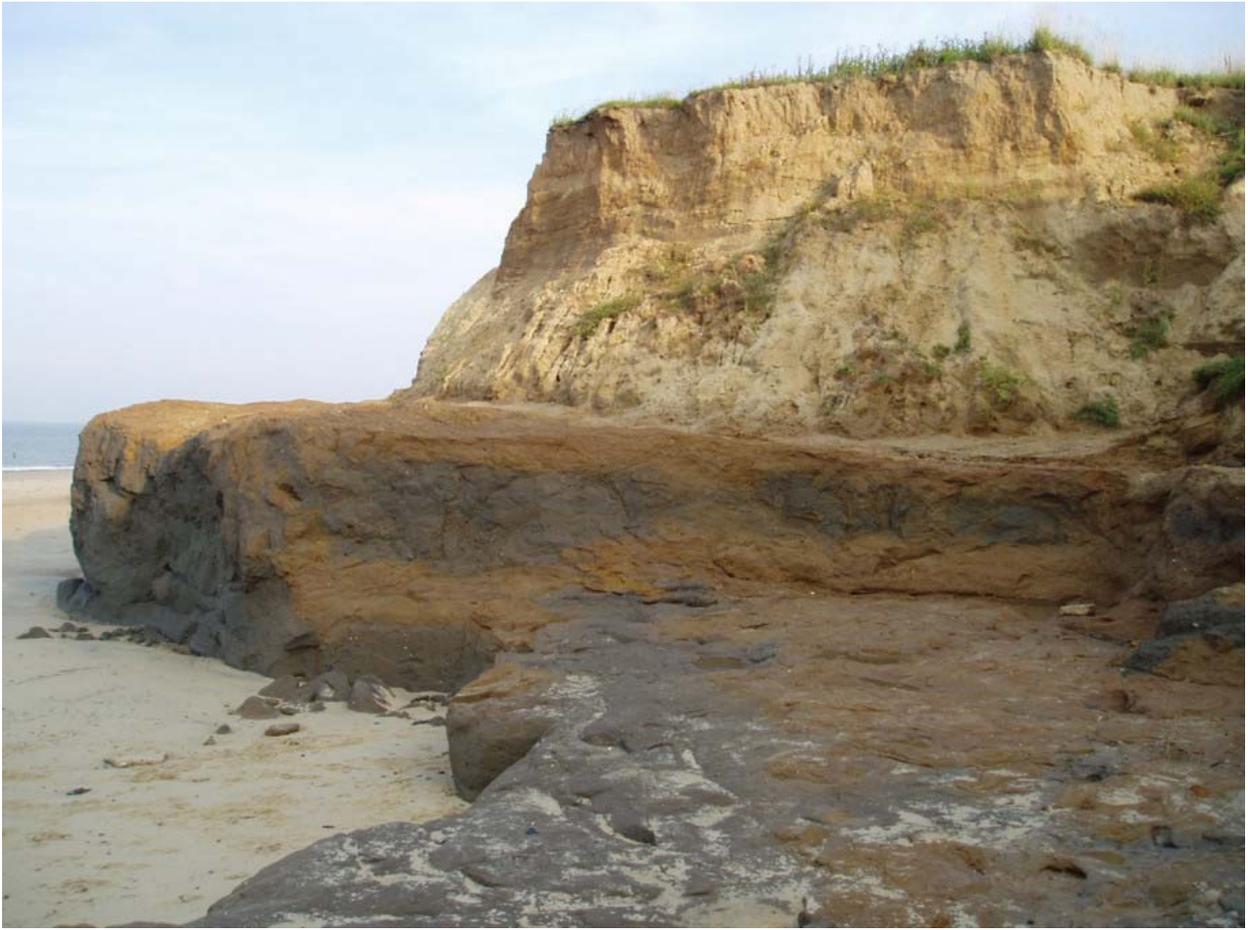
**Figure 4-7** Cliff face at Happisburgh showing the Happisburgh Till Member (grey)

The cliffs at Happisburgh typically range from 6 to 10 m within the study area, consisting largely of sands of the Happisburgh Sand Member, underlain by a distinctive bench of Happisburgh Till Member (Figure 4-28). The intervening Ostend Clay Member outcrops intermittently where it produces a spring line between the Happisburgh Sand Member. A notable feature of cliffs in these materials is the erosion of the sand lithologies, apparently by ground water. This extends several metres landward of the cliff in the form of narrow gullies, presumably produced by field run-off during heavy rain. This non-uniform erosion process is reflected in the cliff surface profile (Figure 4-7), with the formation of embayments in the upper cliff. The landsliding process involves rock/block falls and topples (Figure 4-8), mudflows and running sand.

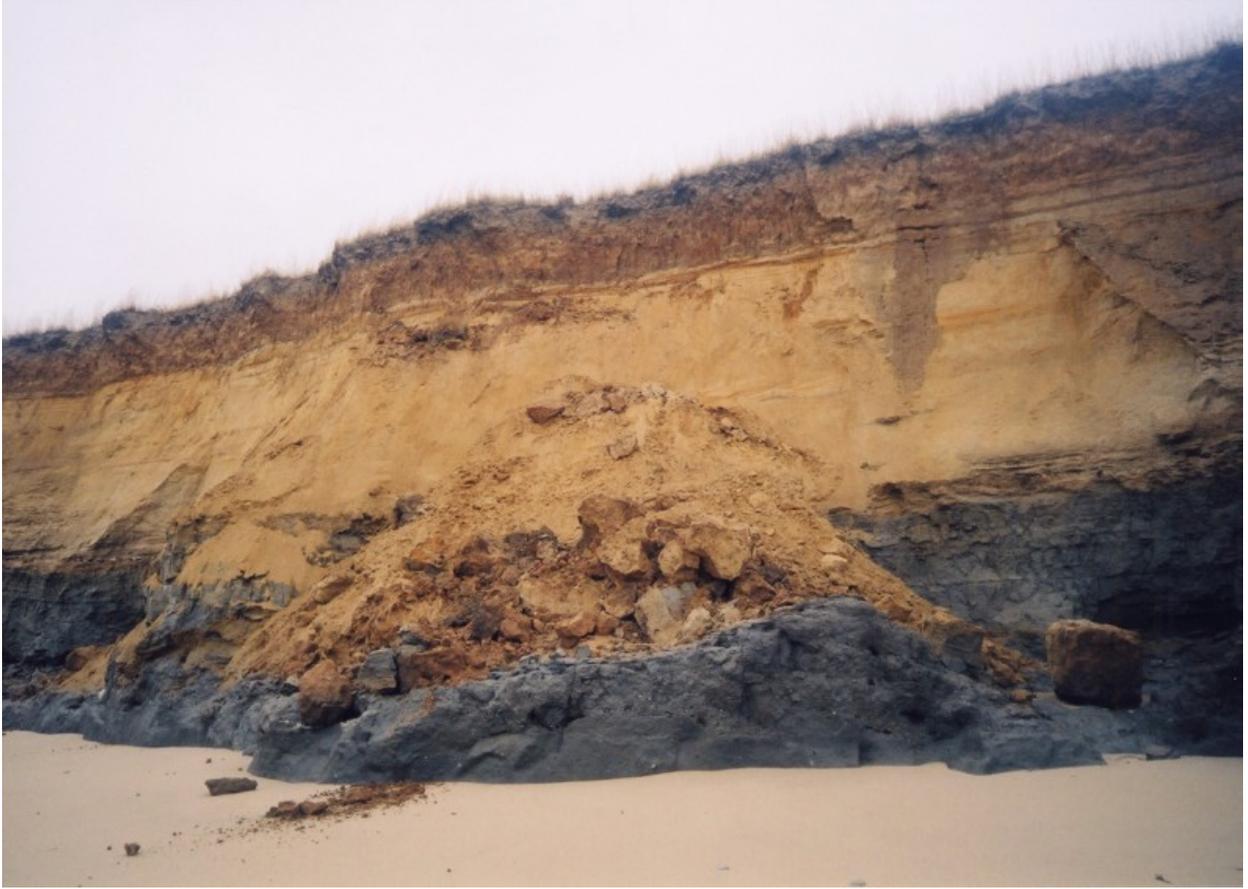
**Figure 4-8** Landslide (fall) at the Happisburgh test site

The landsliding processes typically observed in the section at Happisburgh are small scale (<1 to 10 m<sup>3</sup>) and on a rapid timescale. Landslide types include topples (Figure 4-8,

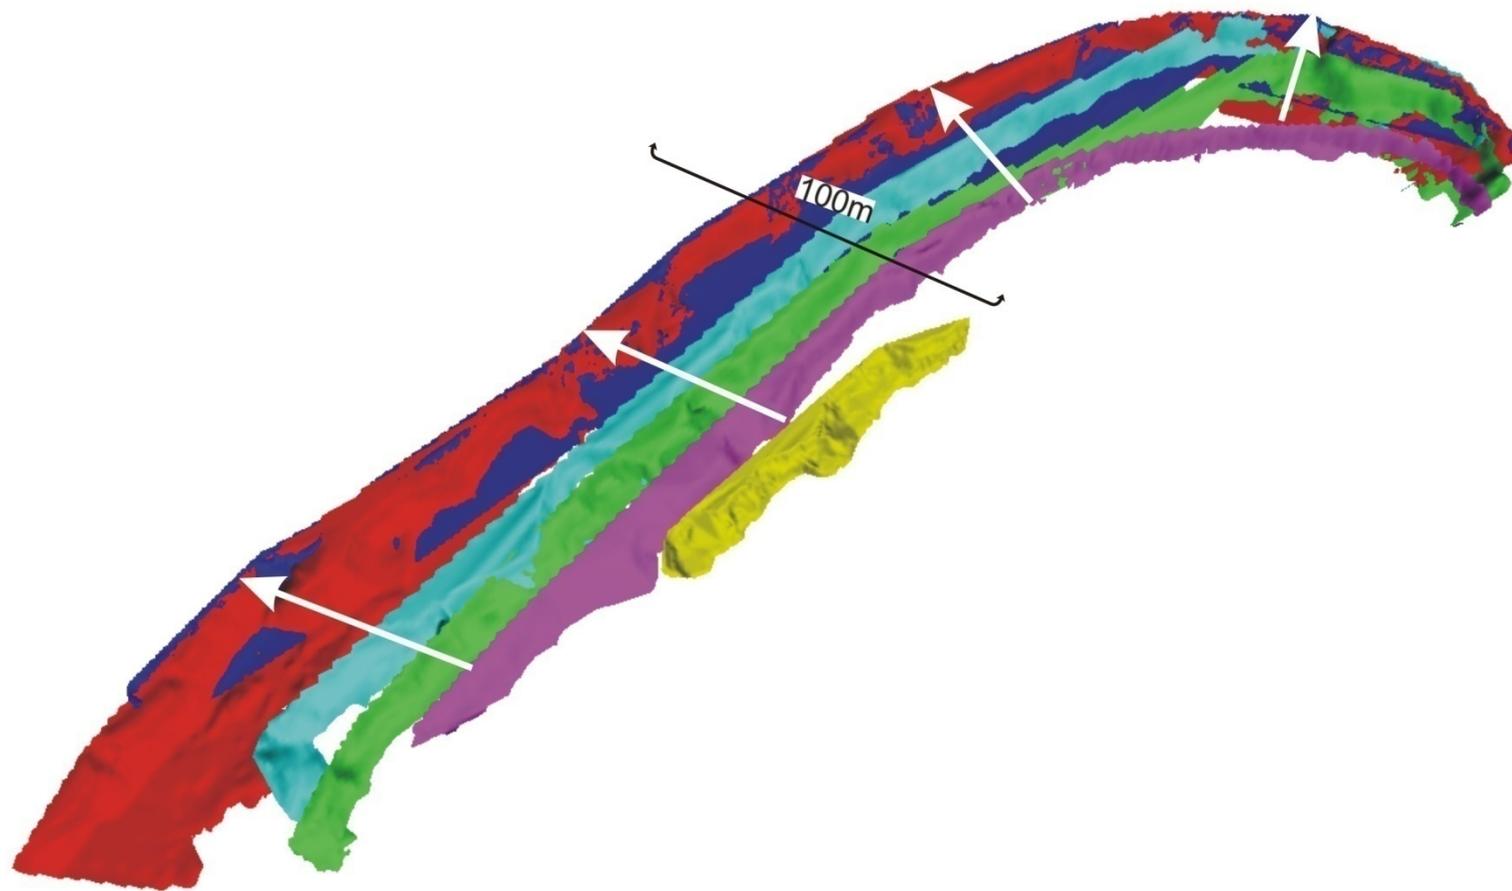
**Figure 4-10 3-D laser scan solid models for 2001 to 2006 at Happisburgh**  
yellow=2001, magenta=2002, green=2003, cyan=2004, red=2005, blue=2006; white arrow=direction of recession

The overall 3-D model for the monitored cliff recession at Happisburgh is shown in Figure 4-10. During the scanned period (2001-2006) the loss of land was approximately 45 m, an average of 6-8 m/yr. The notable hiatus in recession between 2005 and 2006 is in contrast to the large recession exhibited between other epochs (the 2005-2006 hiatus has resulted in the 'speckled' effect in Figure 4-10 where small errors in the scans have alternately brought each to the foreground). The recession between the other epochs are relatively consistent.

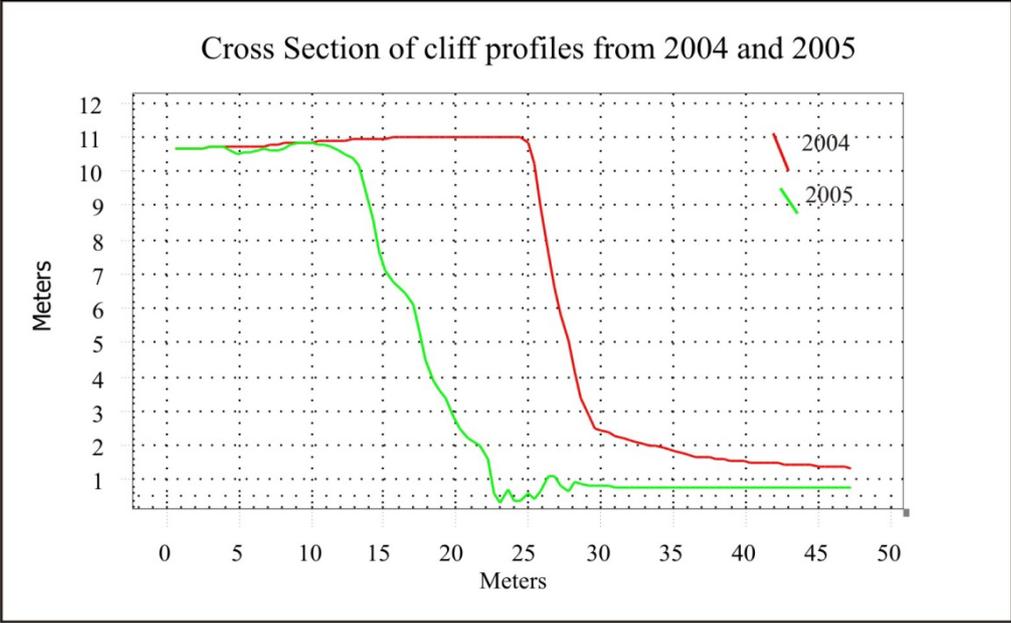
Figure 4-12: Cross sections of cliff profiles from Happisburgh extracted from scanned data for the 2004 and 2005 epochs

Cliff profiles from 2004 and 2005 show how significant the recession of the coastline is, between these two epochs 36,785 m<sup>3</sup> of material was lost along 200 m of this cliff line with a total recession of 12 m. From the cliff profile cross sections of 2005 and 2006 (Figure 4-12 and Figure 4-13) it can be seen that only a small amount of material compared to previous years was lost at the top of the cliff, approximately 2 m, whilst towards the base the beach appears to be up to 1 m higher, this could account for the perceived increase in stability.

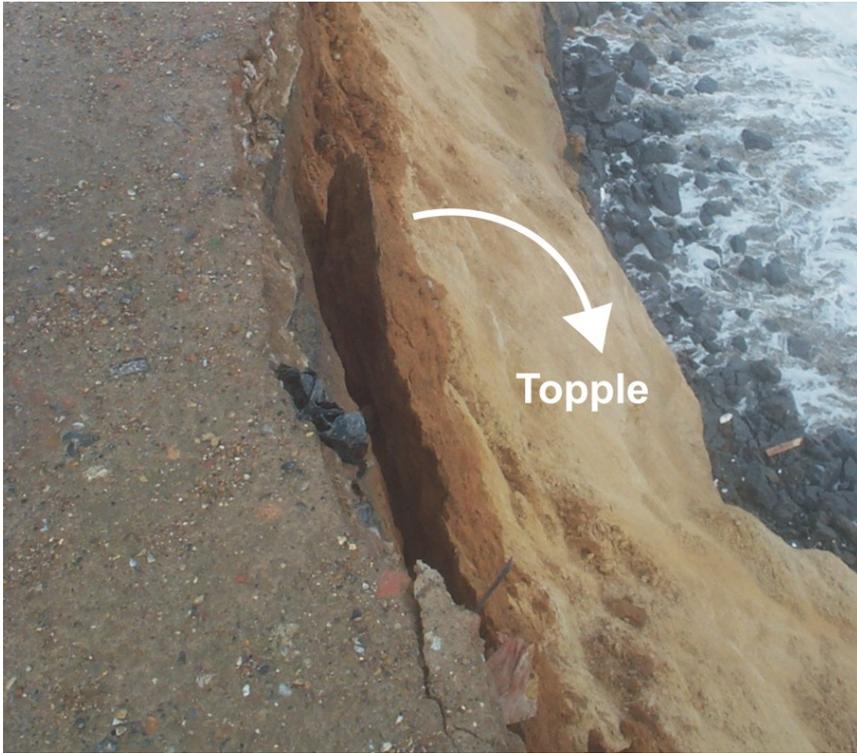
**Figure 4-14 Example of a 'topple' at Happisburgh in 2003**

Figure 4-14), falls (Figure 4-15) and rotational slumps (Figure 4-16). The landslide deposit at the toe of the cliff remains until removed by the next high tide. It is, therefore, impossible to detect all such small and rapid landslides on an annual monitoring cycle. Observations during fieldwork in stormy weather conditions and at high tide have shown that considerable volumes of sediment are released from the cliffs by direct mechanical erosion by wave action (Figure 4-15).

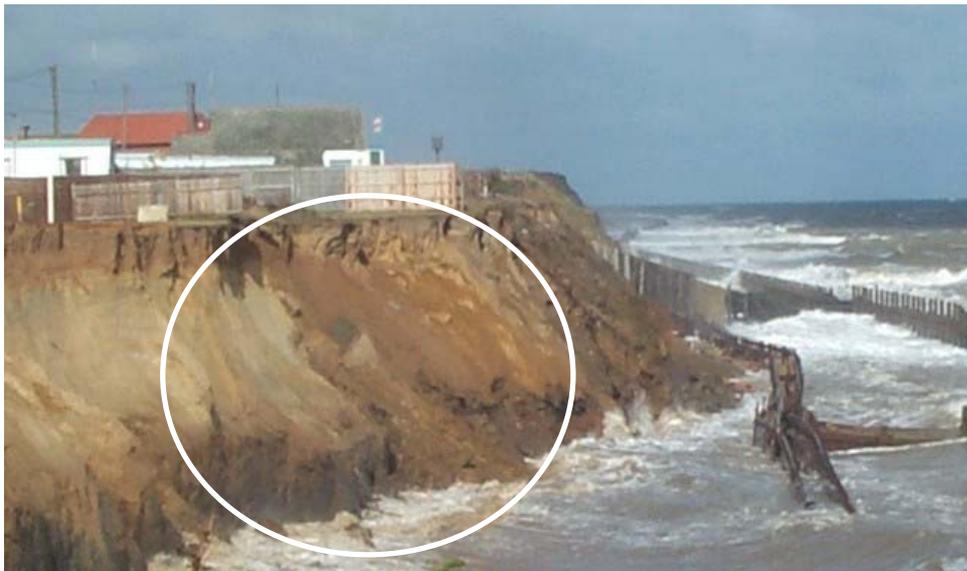
**Figure 4-15 Example of a 'fall' landslide in action during high tide at Happisburgh in September 2002.**

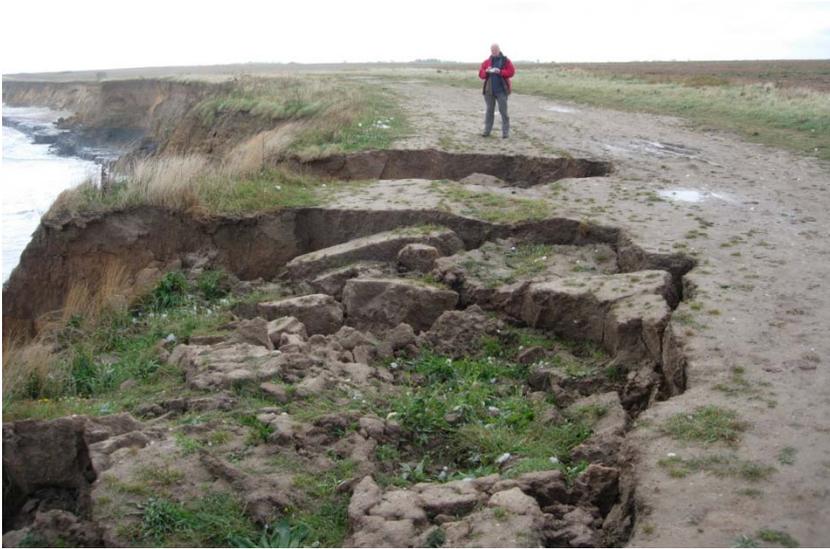
Figure 4-16 Rotational ‘slump’ landslides, Sep 2007.

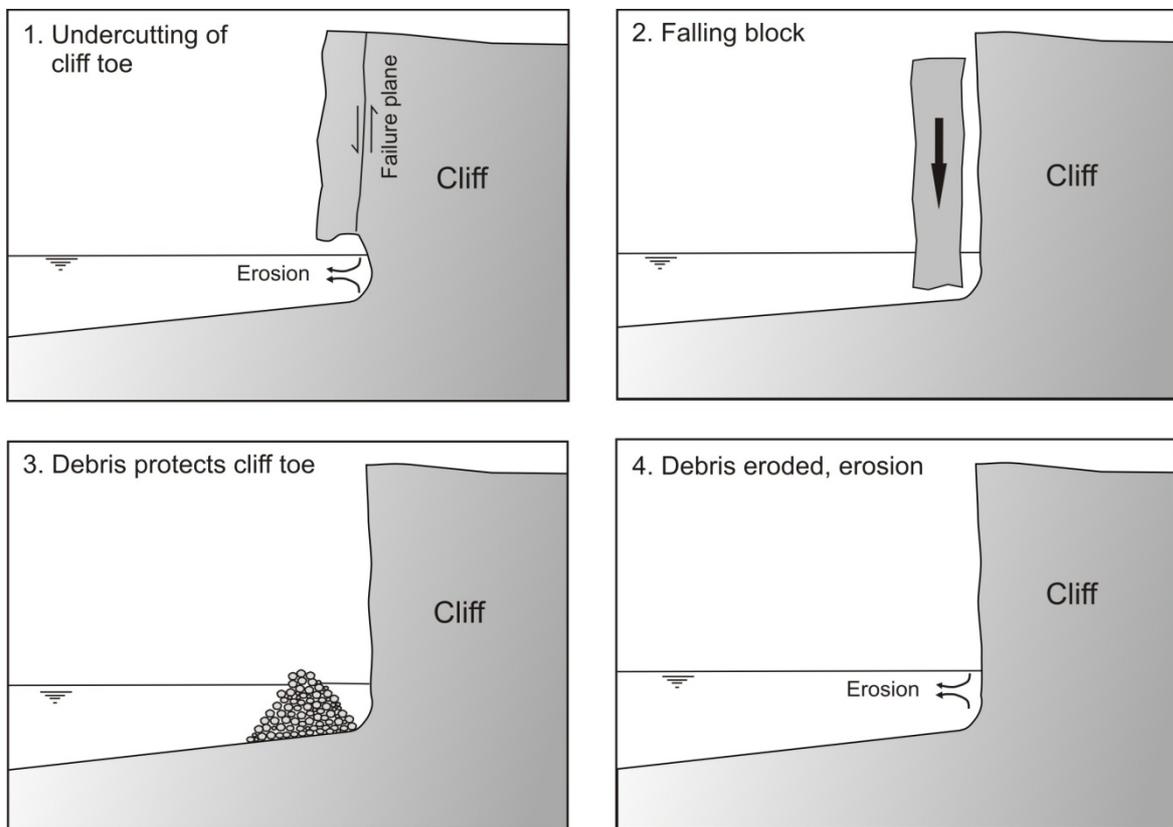
Figure 4-17 A conceptual toe erosion model based on Ohl *et al.* (2003).

1. basal undercutting of the intact toe by wave action, leading to steepening of the cliff profile and a reduction in slope stability;
2. cliff failure, involving failures of blocks of material;
3. deposition of debris at the base of the cliff, protecting the cliff toe;
4. removal of debris from the foreshore by wave action, leading to the onset of basal undercutting (stage 1 above).

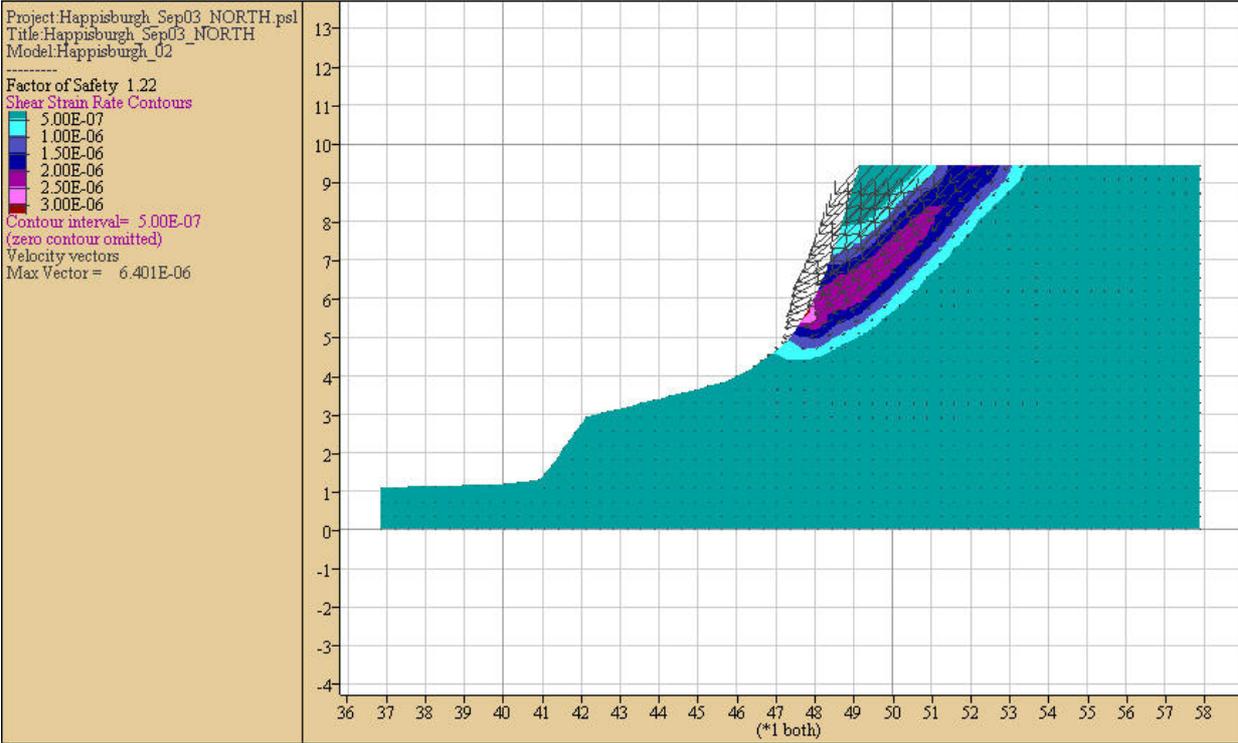
Figure 4-20 Example of displacement strain contour/vector diagram: Happisburgh, North, Sep 2003

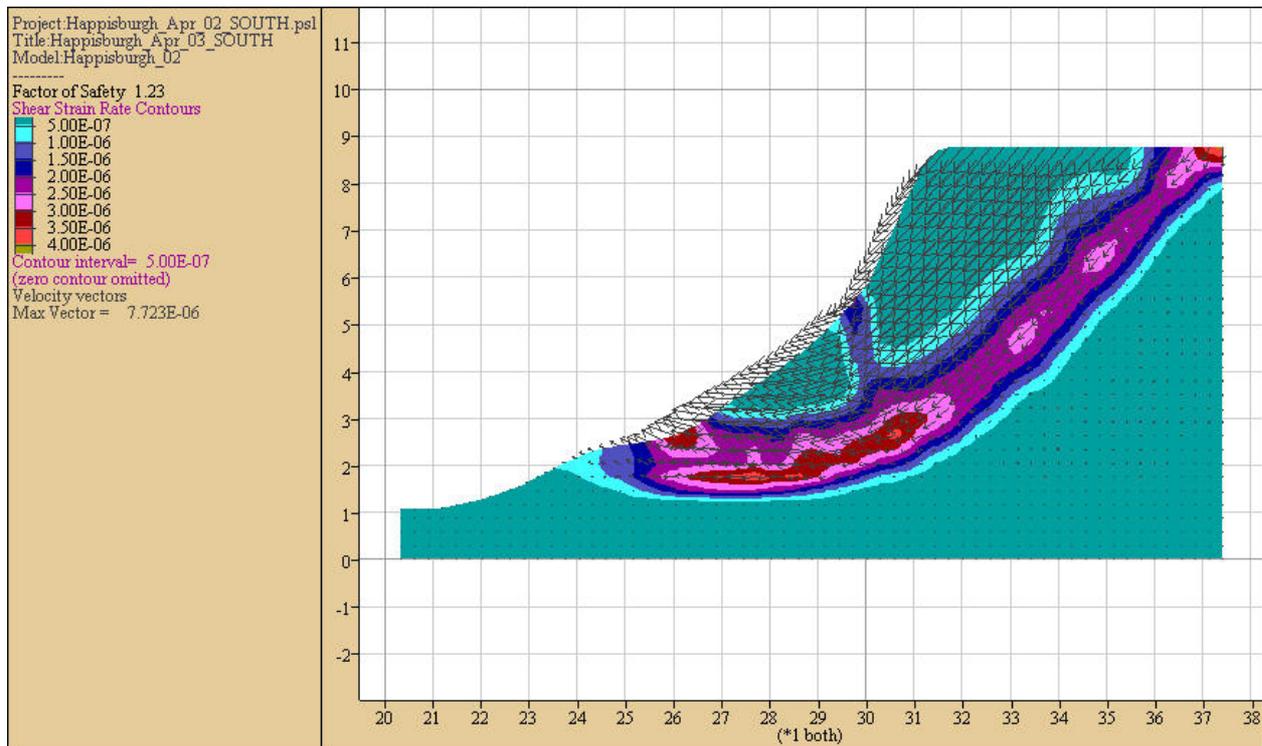
Figure 4-21 Example of displacement strain contour/vector diagram: Happisburgh, South, April 2002

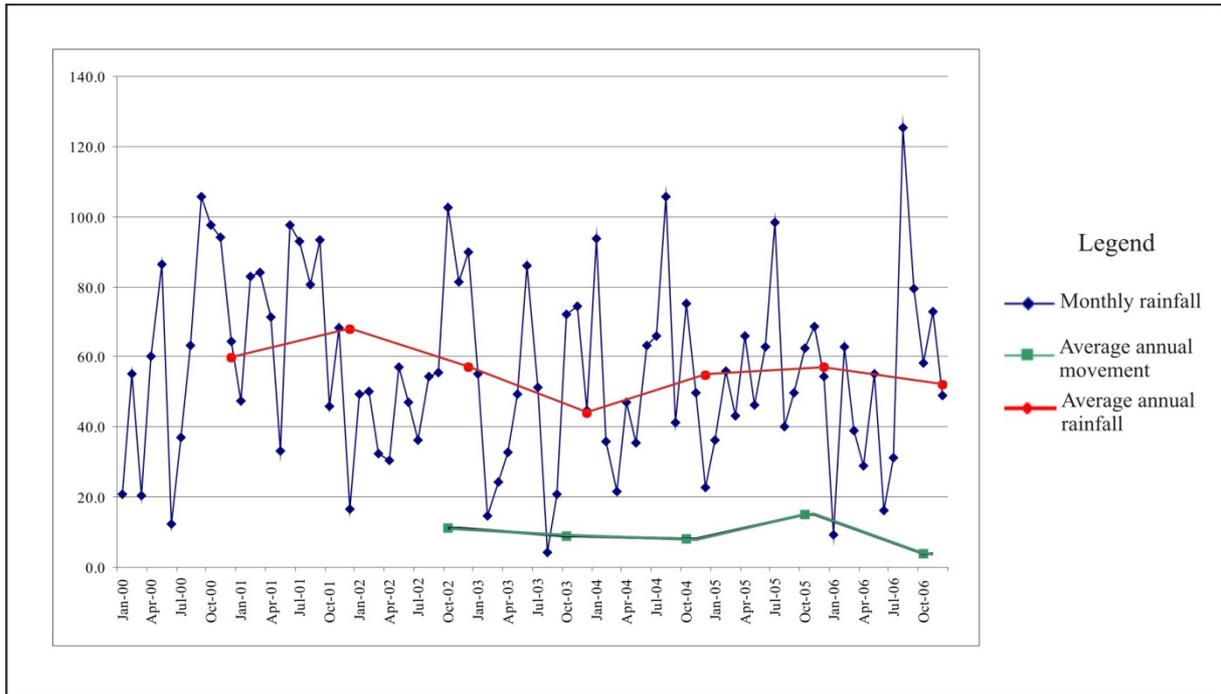
**Figure 4-23 Annual average rainfall (2000 – 2006) compared to annual average movement in 2002-2006**

Average annual recession of 6-8 m/yr remained relatively constant in the years 2002, 2003 and 2004; however this rate increased significantly in 2005 followed by a year of below average recession in 2006. Possible reasons for the acceleration and following decrease in erosion have been assessed. One possible reason for yearly changes in recession rate is the amount of rainfall, which appears to show a correlation when plotted as annual average rainfall against annual average movements. Figure 4-23 shows how the pattern of annual average rainfall is matched by annual average movement in 2002, 2003 and 2004. Increases in rainfall in 2005 are accompanied by increases in the recession rate in 2005. However the subsequent decrease in rainfall is not matched in scale by the significant drop in recession rate in 2006. The rise in beach height in 2006 is probably a key factor here.

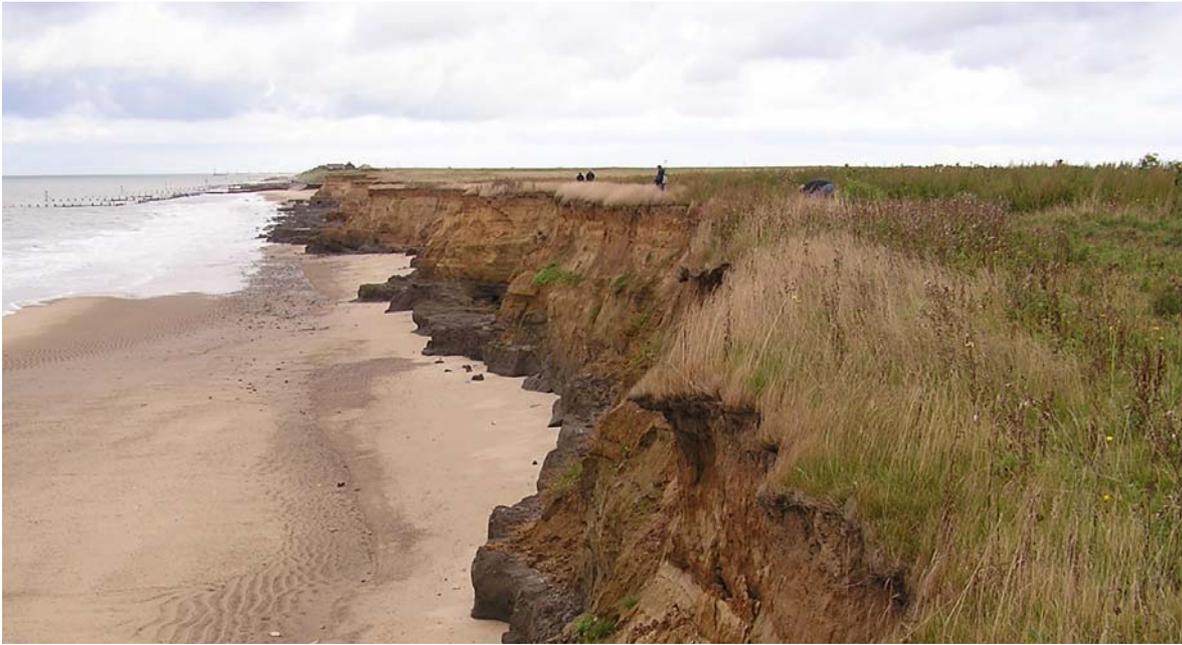
**Figure 4-24 Exposure of the lower cliff in 2003 at Happisburgh**

Beach height and exposure of the base of the cliff was observed to change annually (Figure 4-24 to Figure 4-27). The base of the cliff is more extensively exposed in years of high recession when the beach was correspondingly low. In 2005 the beach level was lower than in previous years. In 2006 the base of the cliff was much less exposed with corresponding higher beach level. This increase in beach thickness correlates to the reduction in recession observed between 2005 and 2006. However, these observations were made at the point of scanning and do not necessarily represent the conditions experienced for the year as a whole.

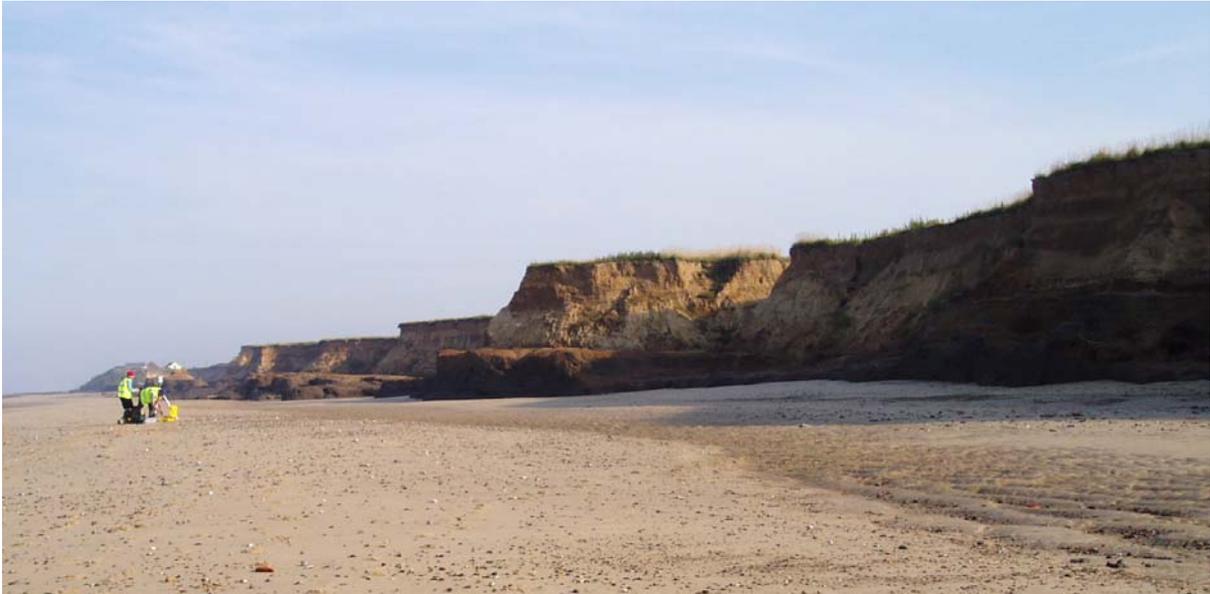
**Figure 4-25 Exposure of the lower cliff in 2004 at Happisburgh**

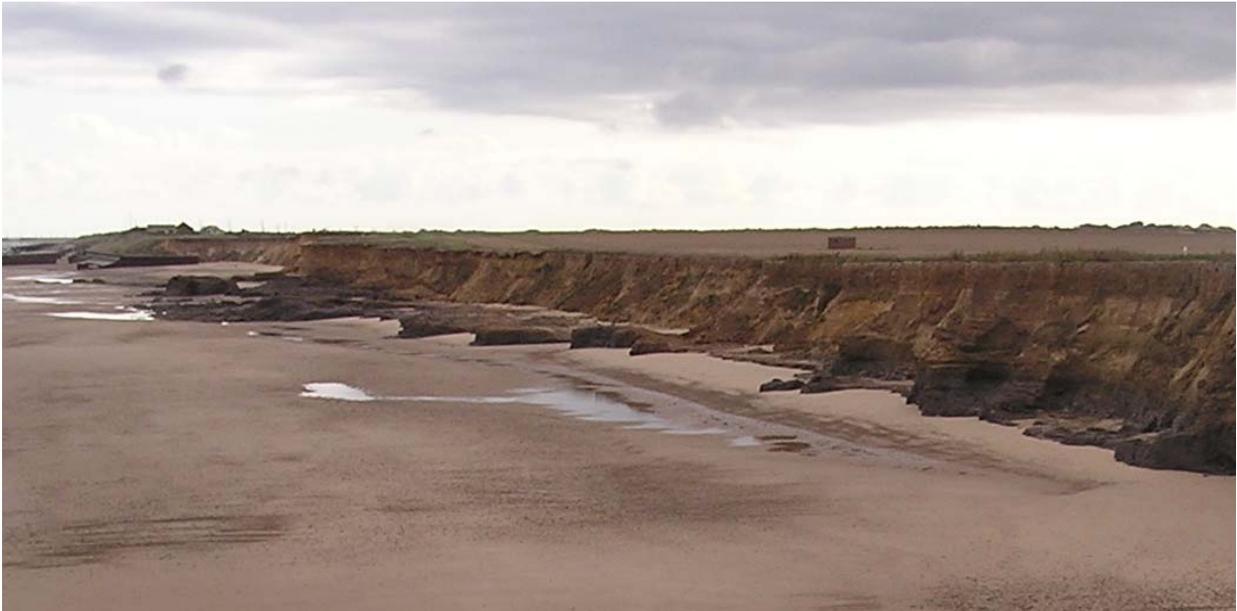
**Figure 4-26 Exposure of the lower cliff in 2005 at Happisburgh**
