# Slope Dynamics Project Report: Norfolk Coast (2000 - 2006)

Research Report OR/08/018

Norfolk, coastal, landslides, erosion, cliff recession, Happisburgh, Sidestrand, Weybourne, glacial deposits, slope stability, slope dynamics project.

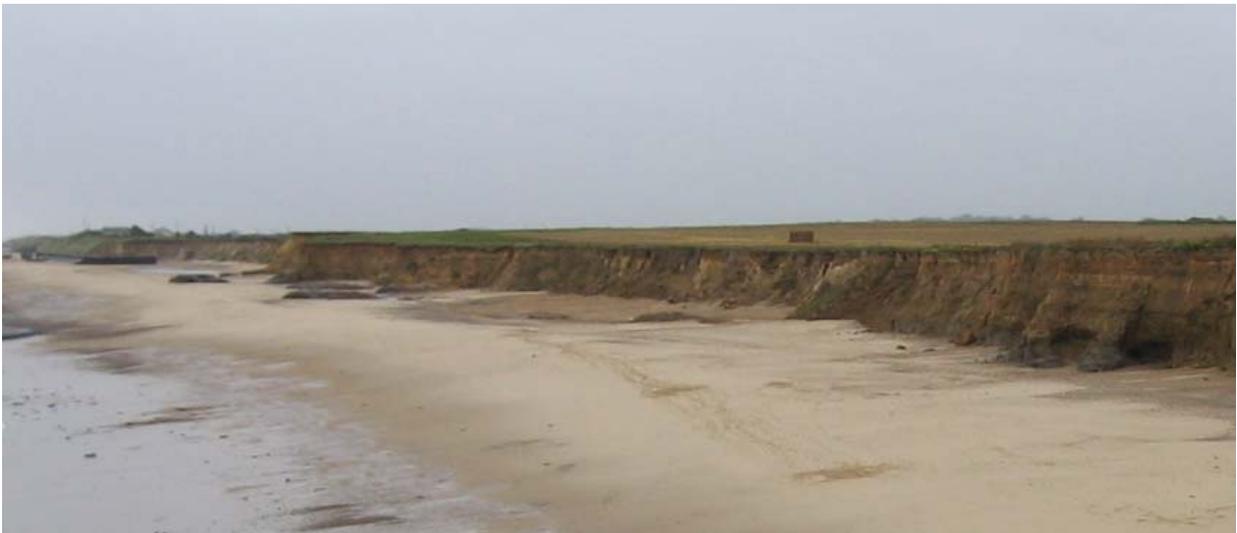
**Figure 4-27 Exposure of the lower cliff in 2006 at Happisburgh**

Beach height and exposure of the base of the cliff was observed to change annually (Figure 4-24 to Figure 4-27). The base of the cliff is more extensively exposed in years of high recession when the beach was correspondingly low. In 2005 the beach level was lower than in previous years. In 2006 the base of the cliff was much less exposed with corresponding higher beach level. This increase in beach thickness correlates to the reduction in recession observed between 2005 and 2006. However, these observations were made at the point of scanning and do not necessarily represent the conditions experienced for the year as a whole.

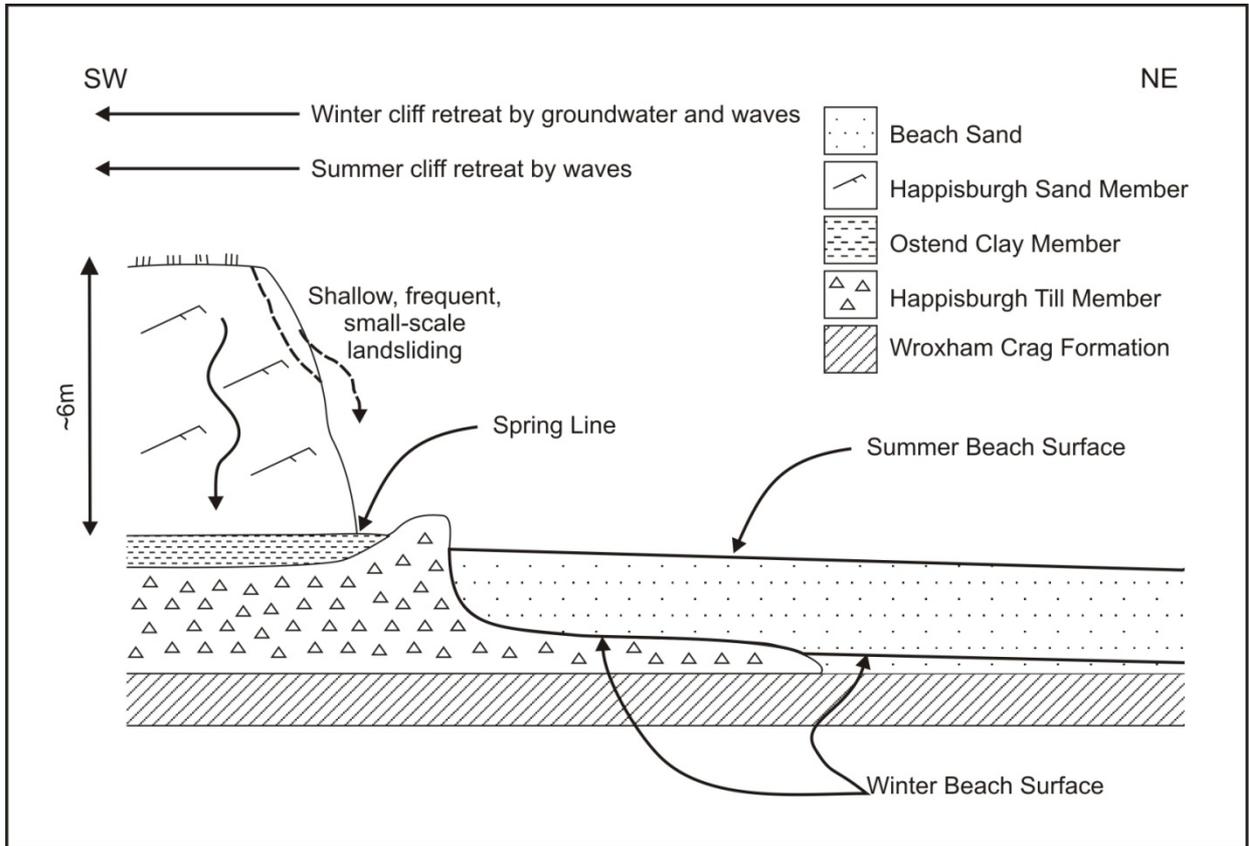
Figure 4-28 Cross-section at Happisburgh, showing cliff and platform stratigraphy (Poulton *et al.*, 2006)

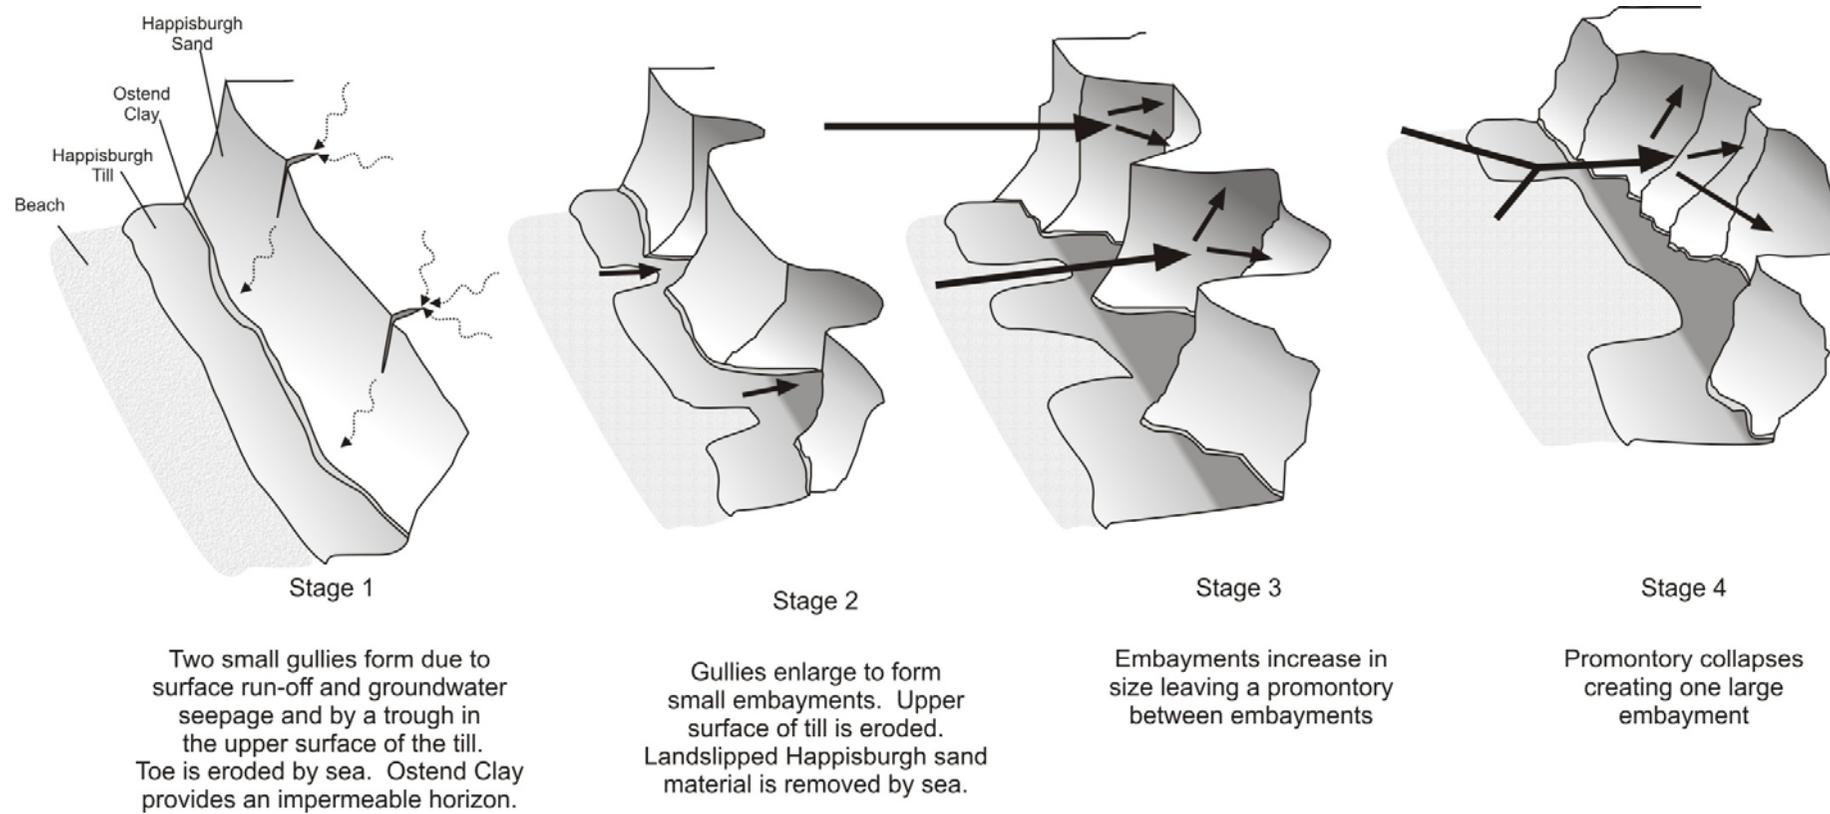
Figure 4-29 Diagram to represent embayment formation process in the cliffs at Happisburgh within the Happisburgh Sand Member (based on Poulton *et al.*, 2006)

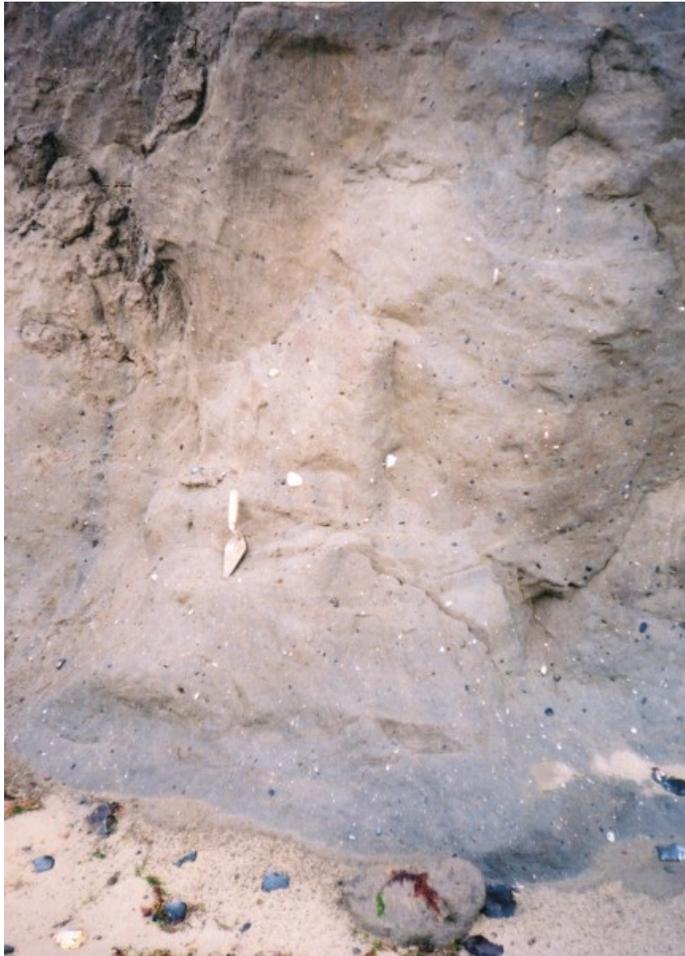
**Figure 5-8 Happsburgh Till Member fabric (toe of cliff, unslipped) (08/08/01). Trowel for scale.**

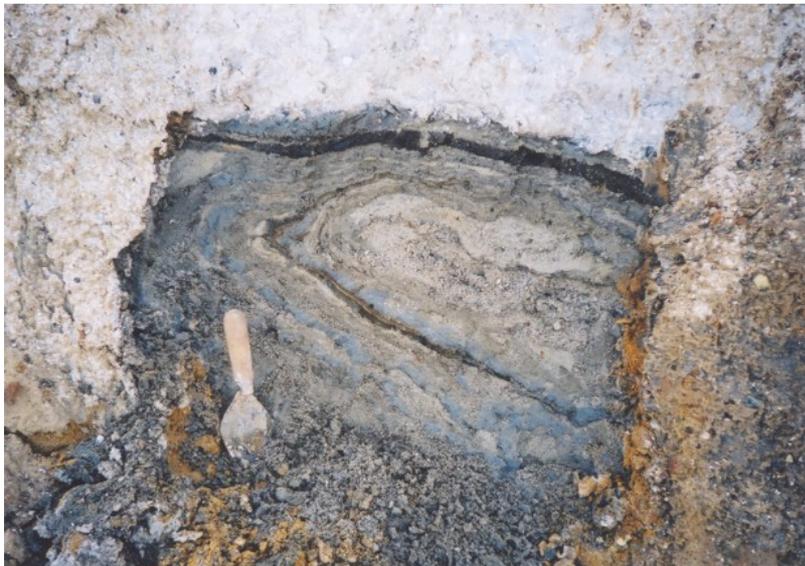
**Figure 5-10 Contorted, laminated, variegated clay/silt/sand (Trimingham Clay Member) beneath chalk till (Weybourne Town Till Member) (mid-cliff, unslipped) (08/08/01). Trowel for scale.**

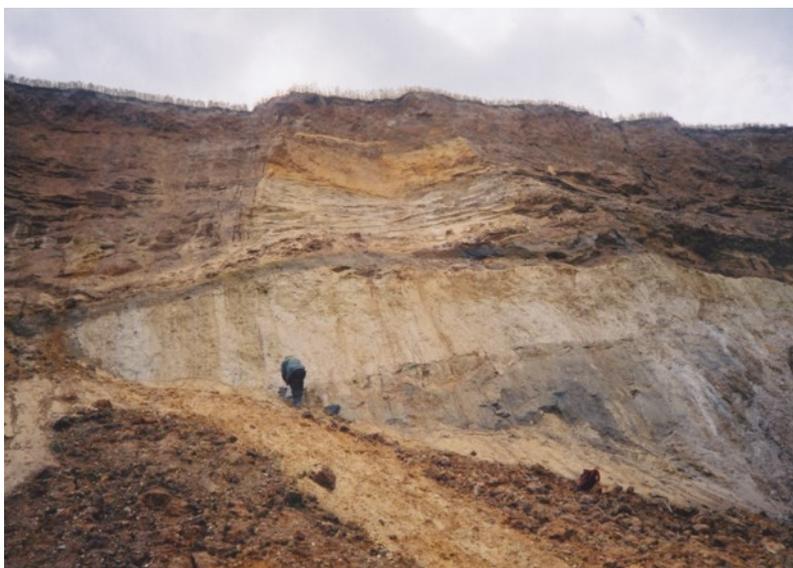
**Figure 5-11 Trimingham Clay Member (TCM), Weybourne Town Till Member (WM), and Stow Hill Sand & Gravel Member, SHM (SD3, top of cliff, unslipped) (08/08/01)**

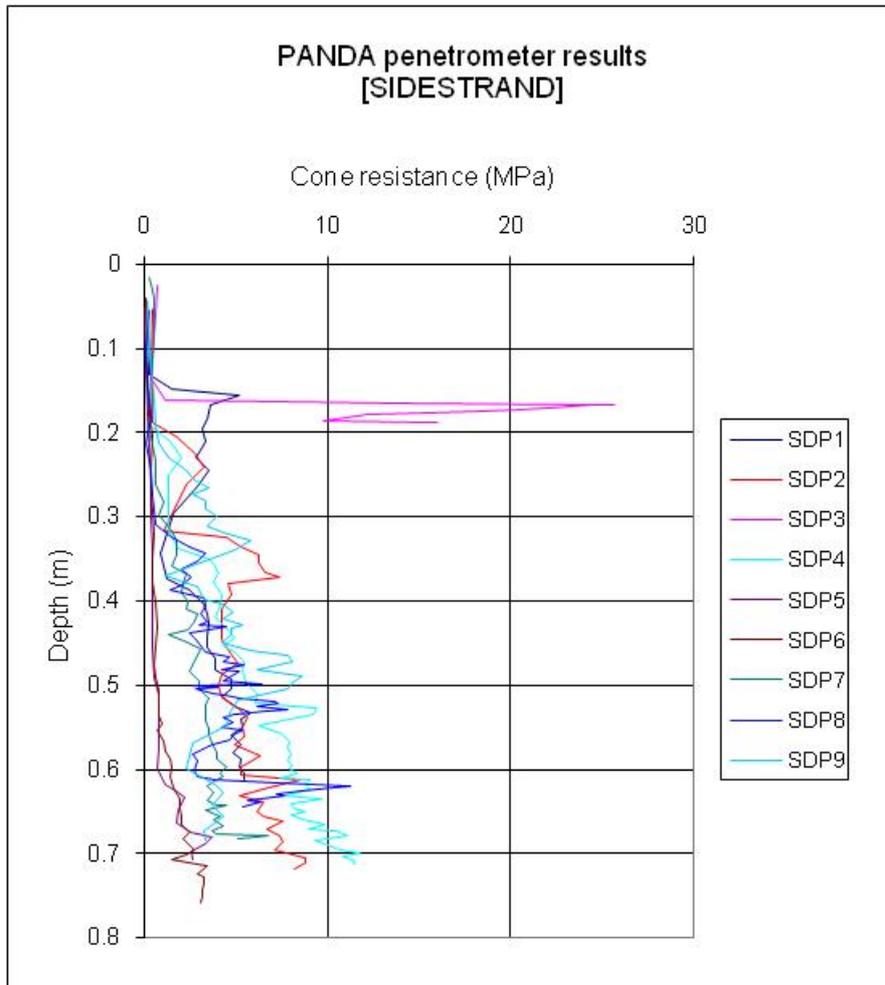
Figure 5-13 PANDA penetrometer results for landslipped material at Sidestrand.

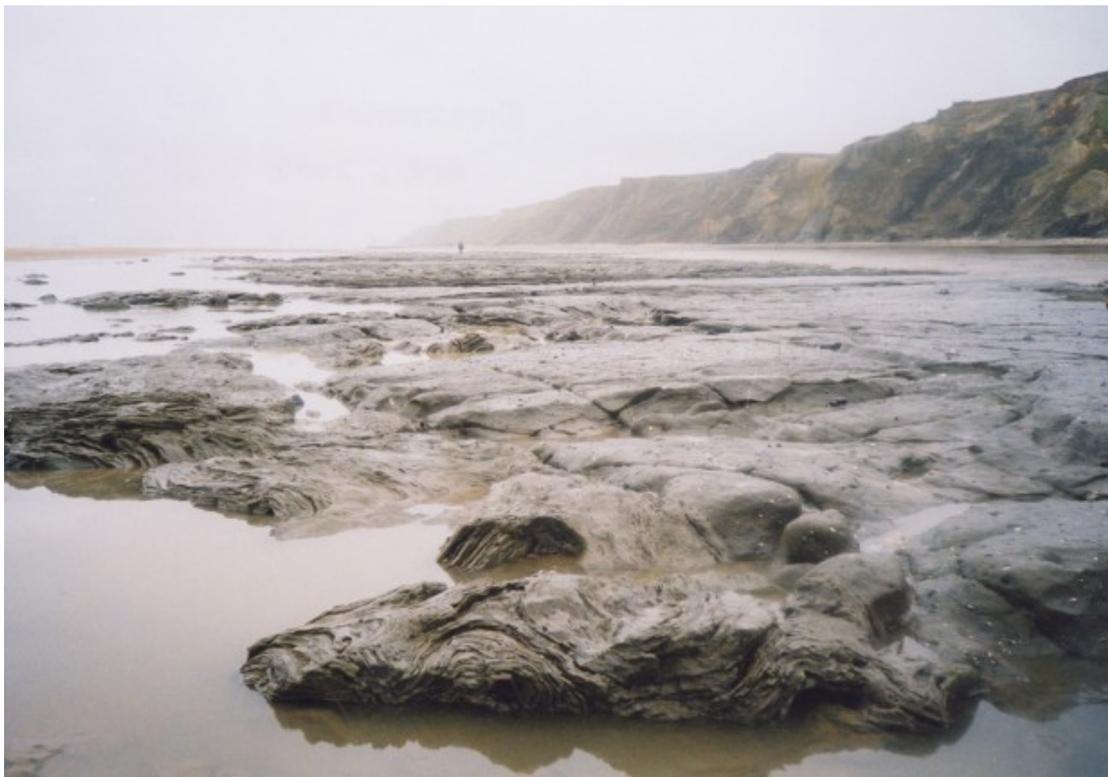
**Figure 5-15 Platform at Sidestrand test site (Happisburgh Till Member) at SD2**

Note: micro-folding and jointing

Part of the solid platform exposed beneath the beach at low tide is shown in Figure 5-15. This represents the base level to which the beach can reach during the seasonal cycle of beach lowering. As at Happisburgh, platform exposure typically varies from summer to winter, dependent on beach level, although a significant cover of beach material was observed at the Sidestrand site during all fieldwork epochs, with the platform only intermittently exposed at around the low water level during spring tides. Small-scale or micro-folding is shown (foreground), and some jointing is also shown (mid-ground). The former indicates a north-south thrust direction, whilst the latter trend is approximately east-west. The folding matches that seen at the cliff toe (Figure 5-9).

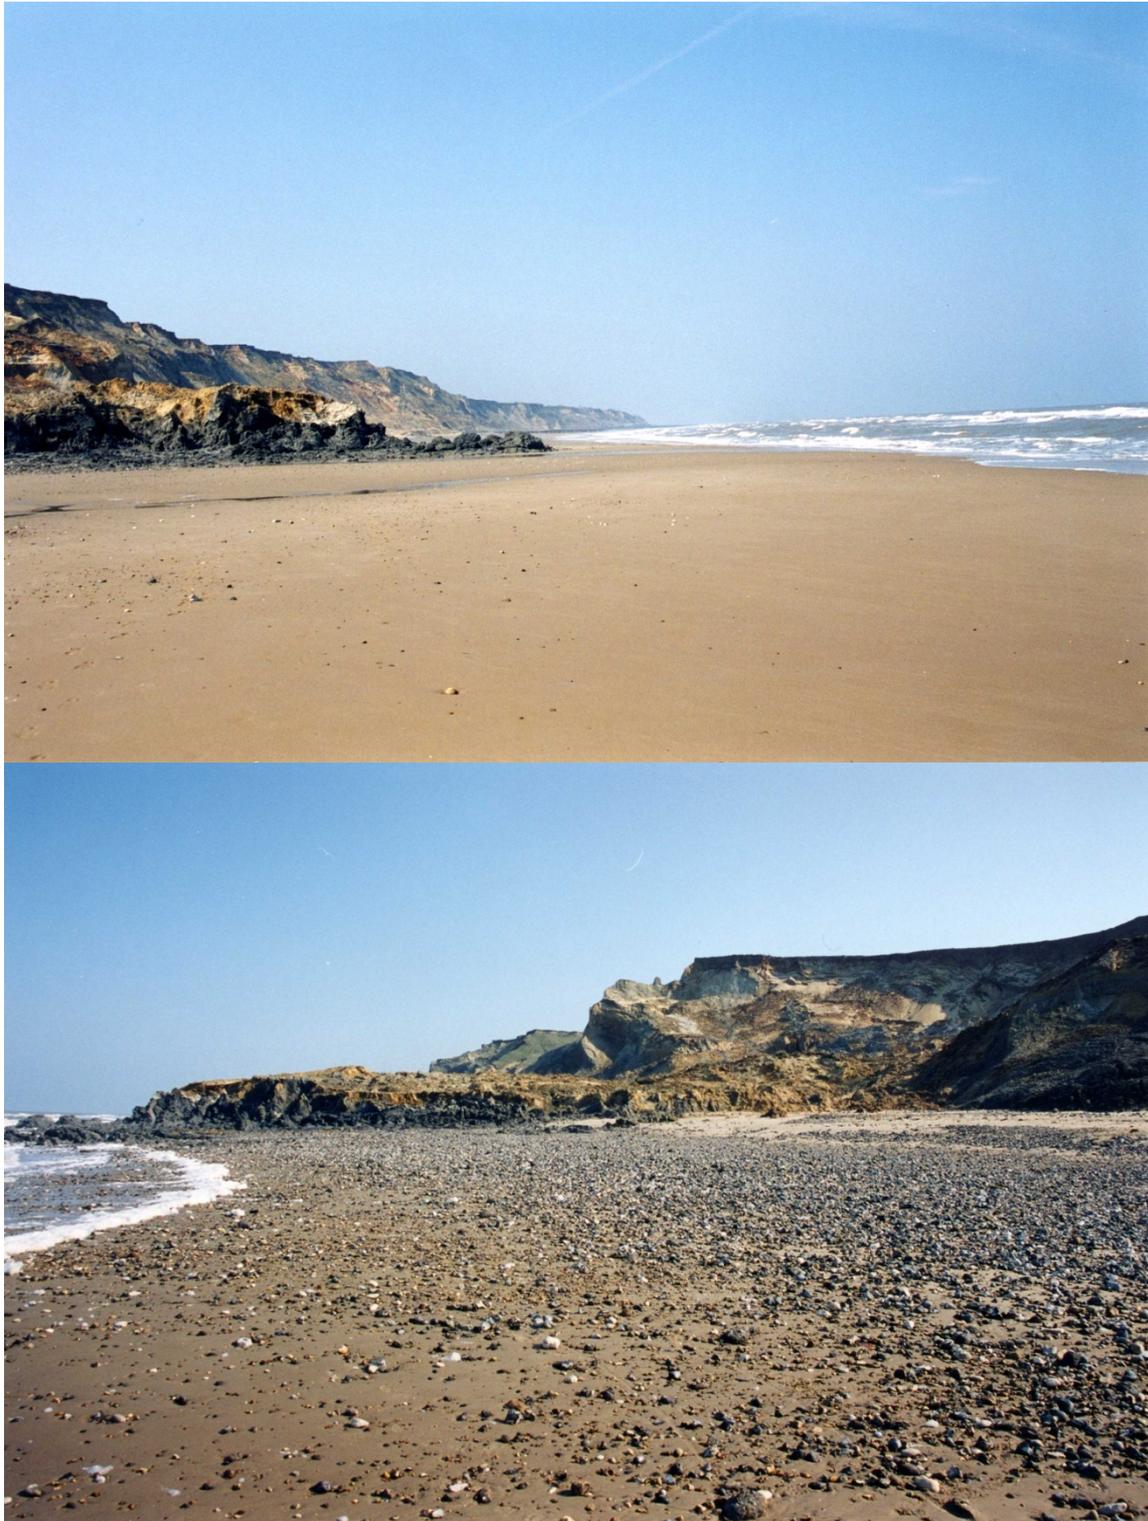
**Figure 5-16** Contrasting beach sediment type over a short distance of coast either side of the main landslide at Sidestrand.

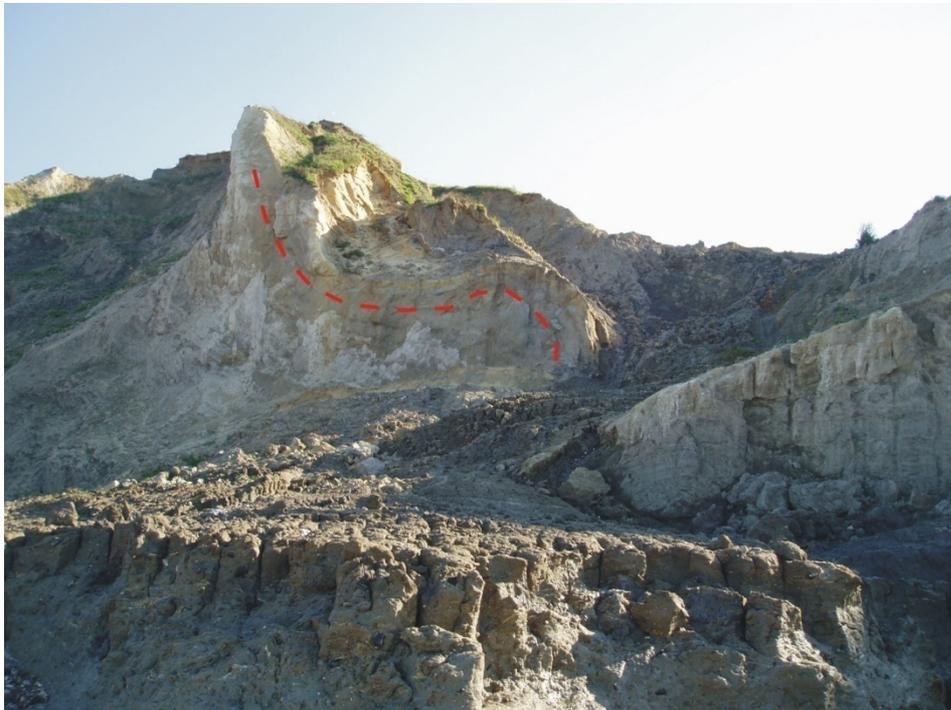
**Figure 5-17 Promontory between embayments SD1 and SD2 showing thrust-affected folding (red line) of Ivy Farm Laminated Silt Member (Sep 2004).**

Note: debris flow in foreground. Approximate height of promontory = 20m.

Embayment formation at Sidestrand might be expected to be controlled largely by landslides. Evidence gathered during the monitoring period supports this. However, there is likely to be a more fundamental controlling factor; that is, the underlying geological structure itself which is determining the shape and size of the embayments. This in turn affects the nature of the landslide activity. This is illustrated by the images in Figure 5-17 which shows the thrust-affected marls of the Ivy Farm Laminated Silt Member, and Figure 5-18 which shows folding within the underlying Ostend Clay Member. These are folded in such a way that the upturned limbs act as resistant zones and tend to form promontories, whereas the lower and flat-lying parts form a trough within which landslides can develop and travel. Also the low-lying zones feature thicker deposits of overlying weak sands which are more prone to instability. Embayment SD3 is a much broader feature due to the generally flat-lying form of the Ivy Farm Laminated Silt Member in this section. As a result the landslide processes are different here. The structural features illustrated are more often than not obscured by landslides deposits and slopewash.

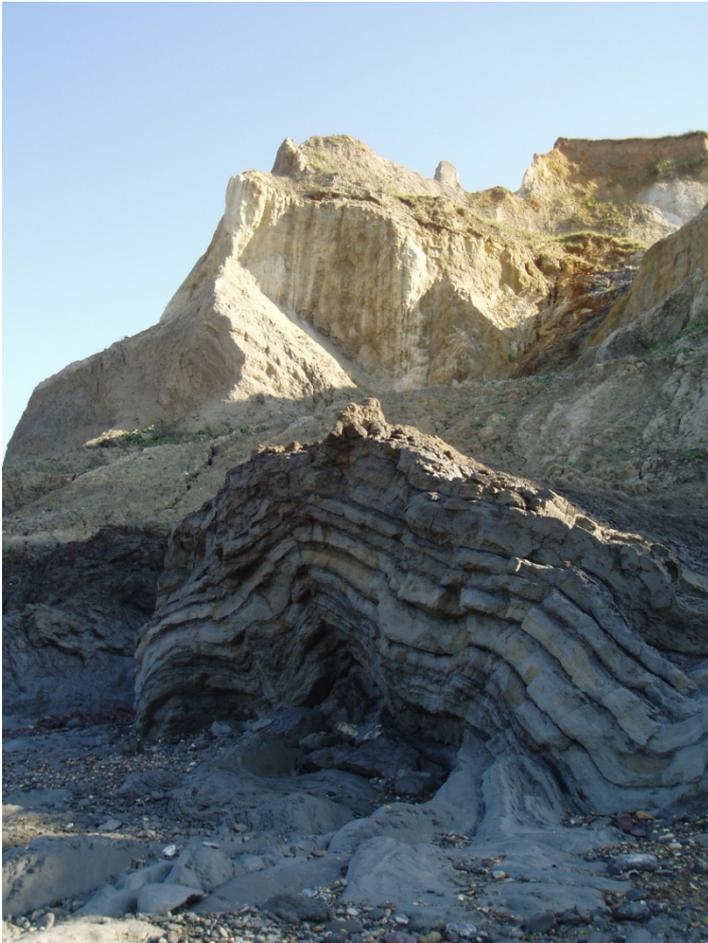
**Figure 5-18 Folding in Ostend Clay Member between embayments SD2 and SD3 (Sep 2004).**  
Approximate height of foreground mass = 2m

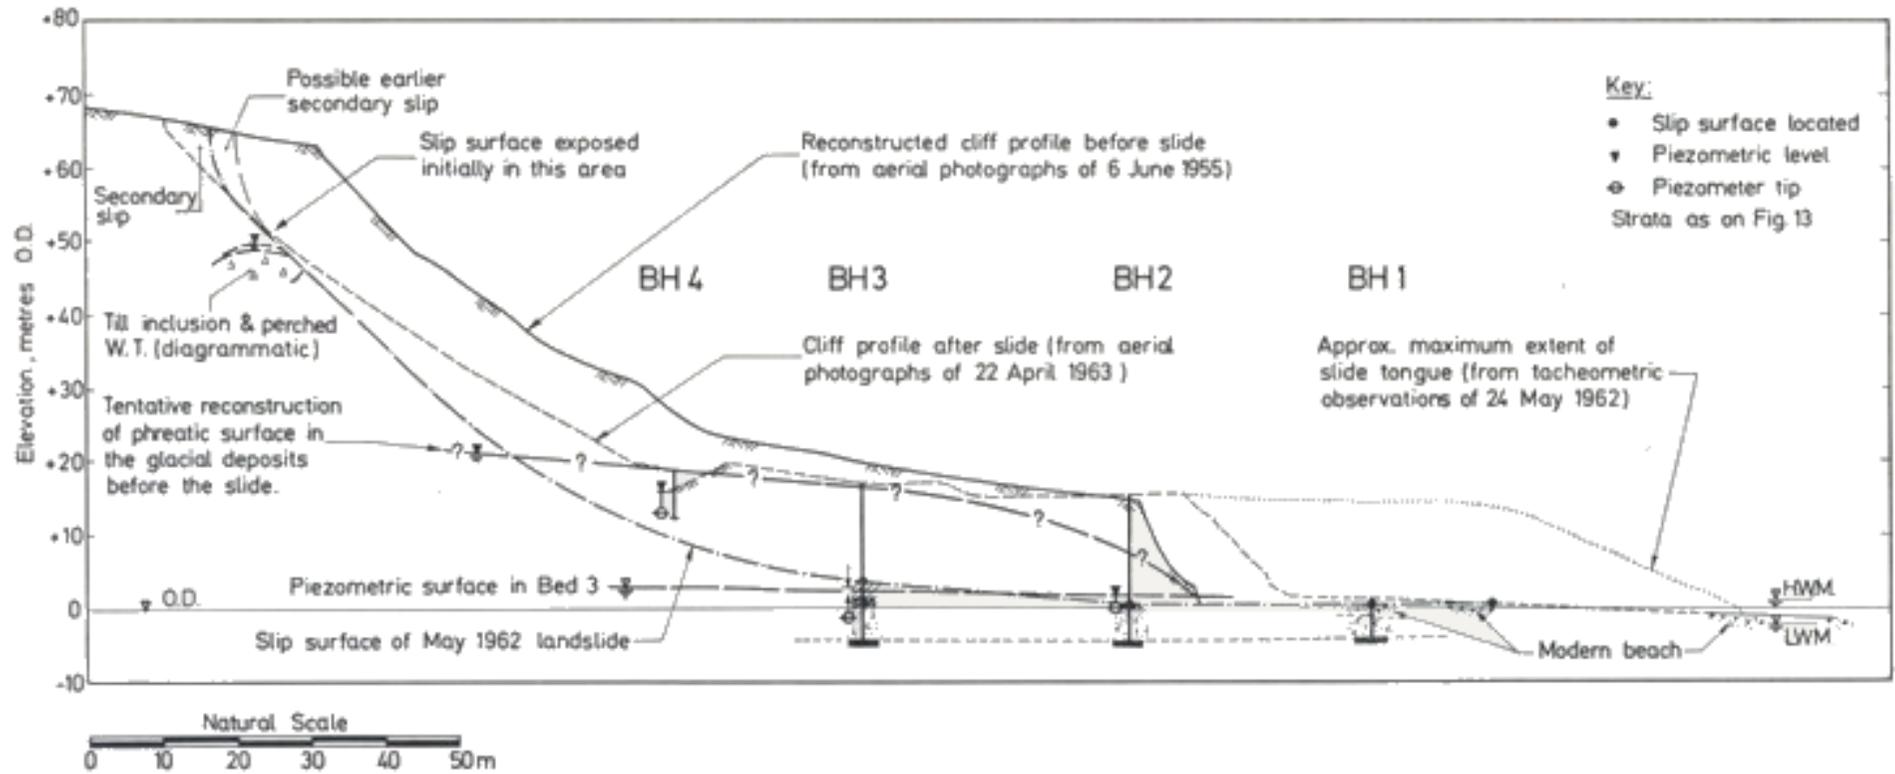
Figure 5-19 Cross-section of May 1962 landslide at Cromer golf course [TG236415 approx.] (Hutchinson, 1976)

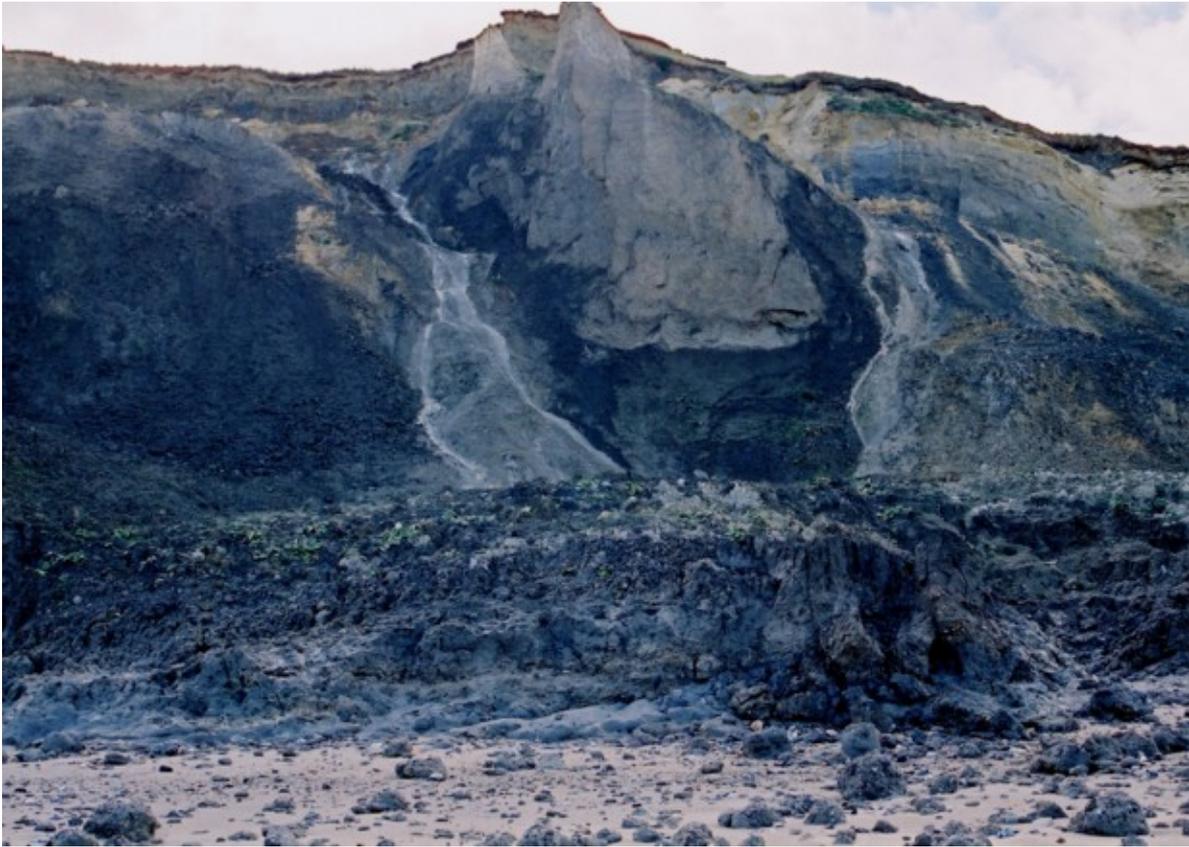
**Figure 5-20 Chalk till buttness separating SD1 and SD2.**  
 Note: very active till-rich mudflows, debris flow covering beach deposit (26/10/00).

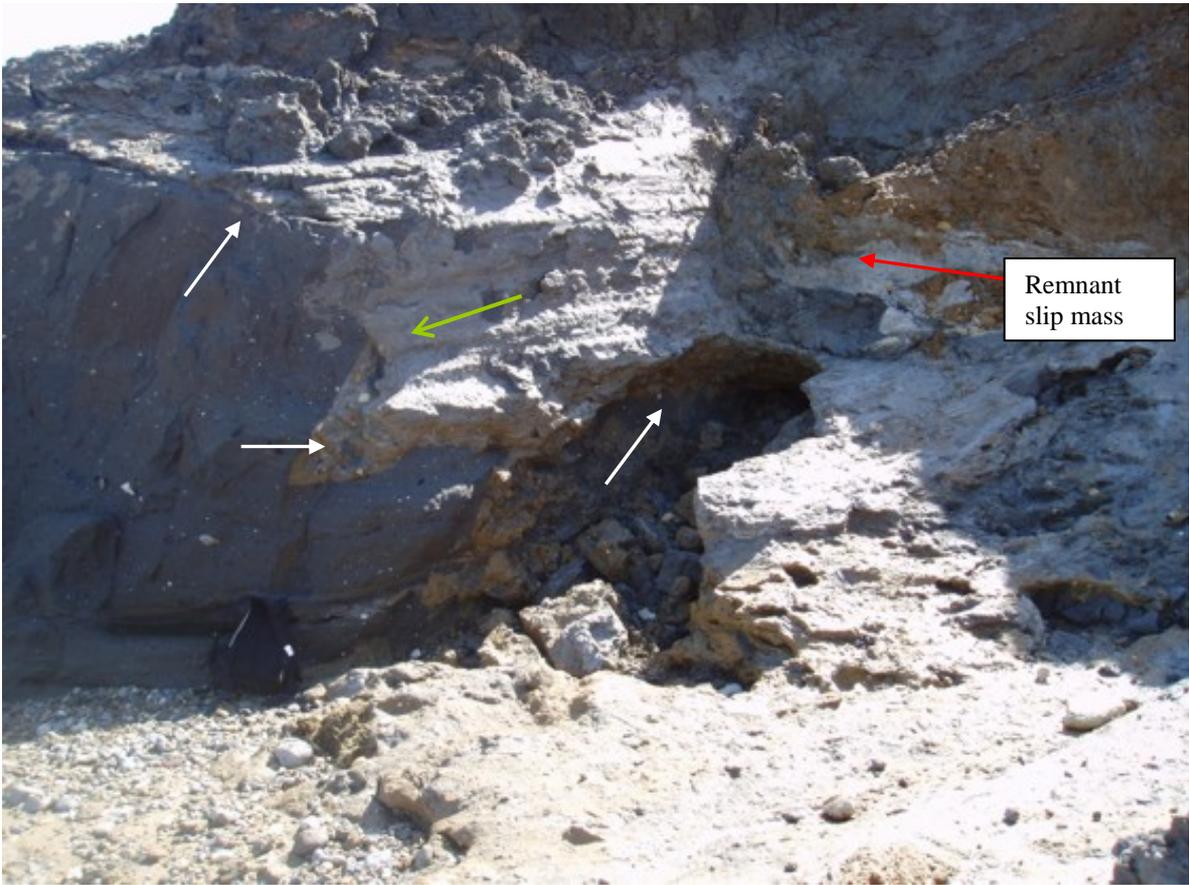
**Figure 5-21 Exposed undulose slip surface (white arrows) at base of former debris flow/mudslide on grey till at cliff toe, SD3.**  
 Note: Horizontal slickensides & striations – slip direction: green arrow. (Sep 2004).

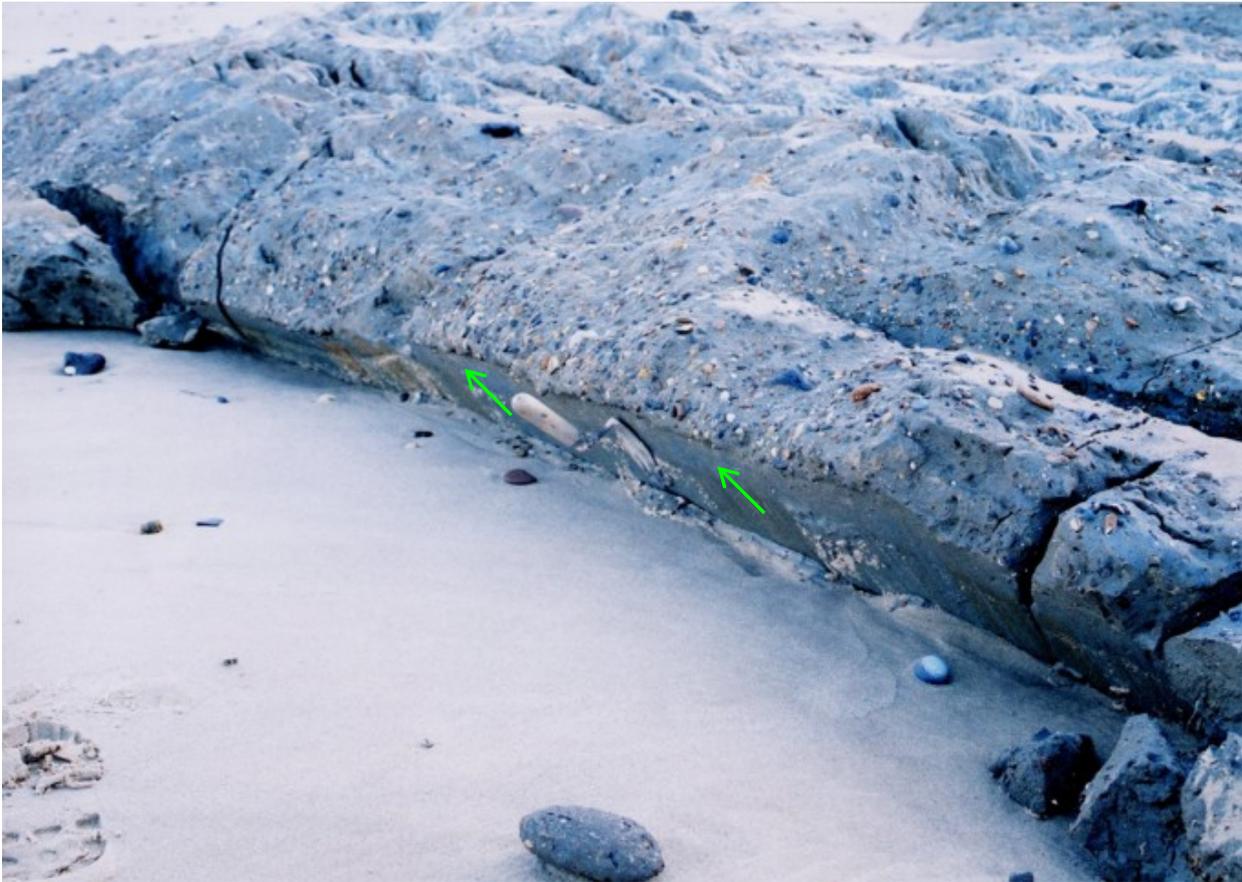
**Figure 5-22 Actively rotating slip mass rising from beneath beach level at SD3.**  
Note: base of slip plane exposed, direction shown by green arrows (26/10/00). Note trowel for scale.

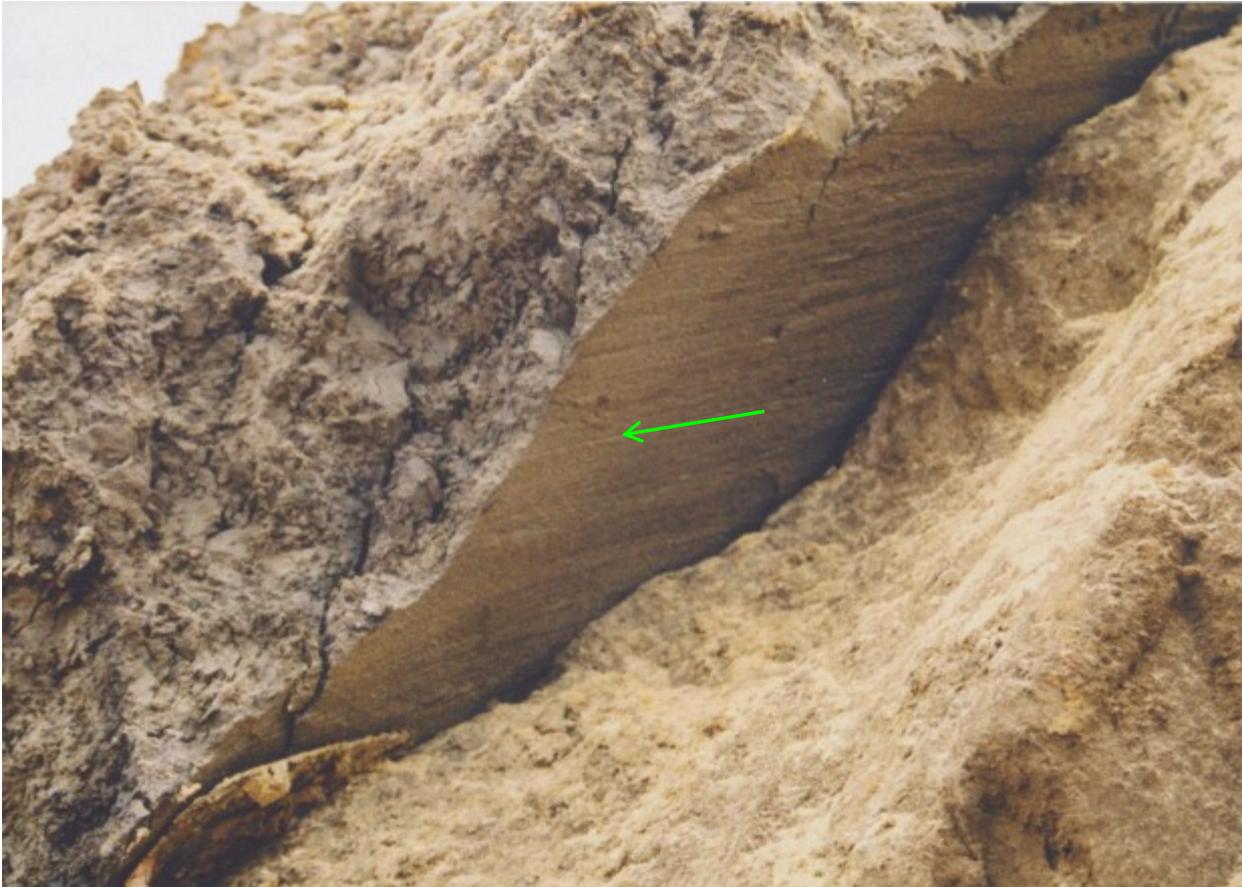
**Figure 5-23 Exposed base of desiccated mudslide mass showing inclined slickensided slip plane, SD2**  
Note: Direction of movement shown by green arrow (Oct 2000). Approximate length of arrow = 10cm

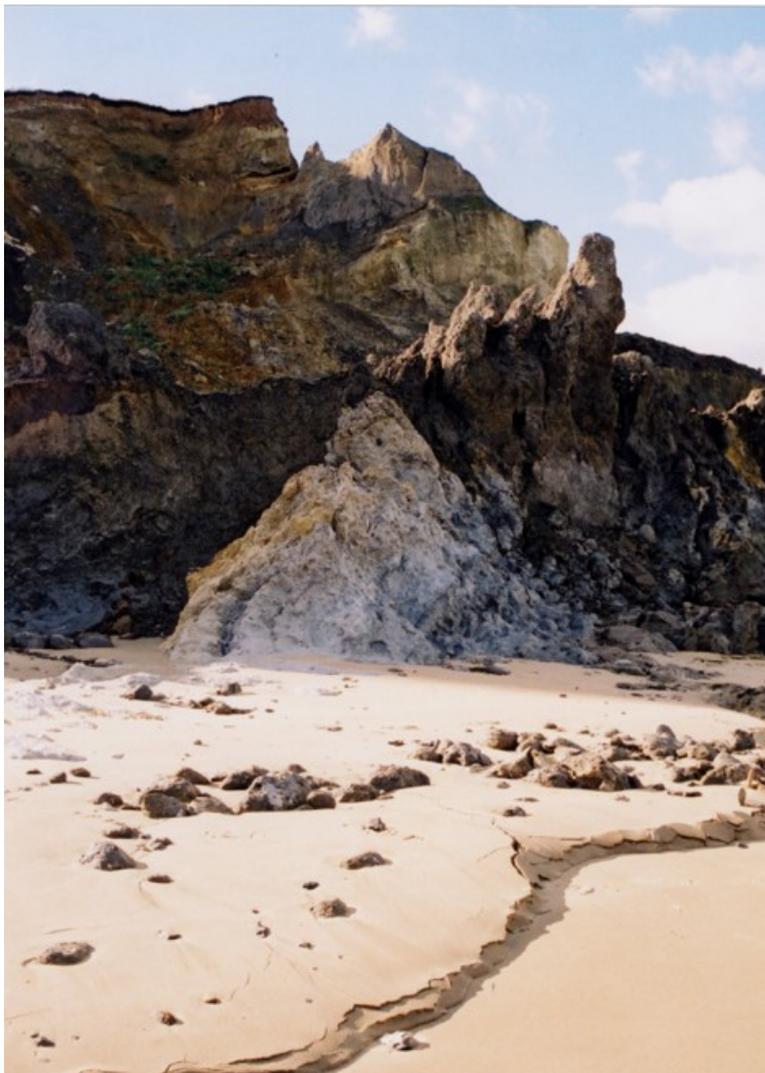
**Figure 5-26 Active thrusting of beach deposits as a result of deep-seated landslide movement in SD3.**  
Note: uptilted tills (mid-ground) (26/10/00)

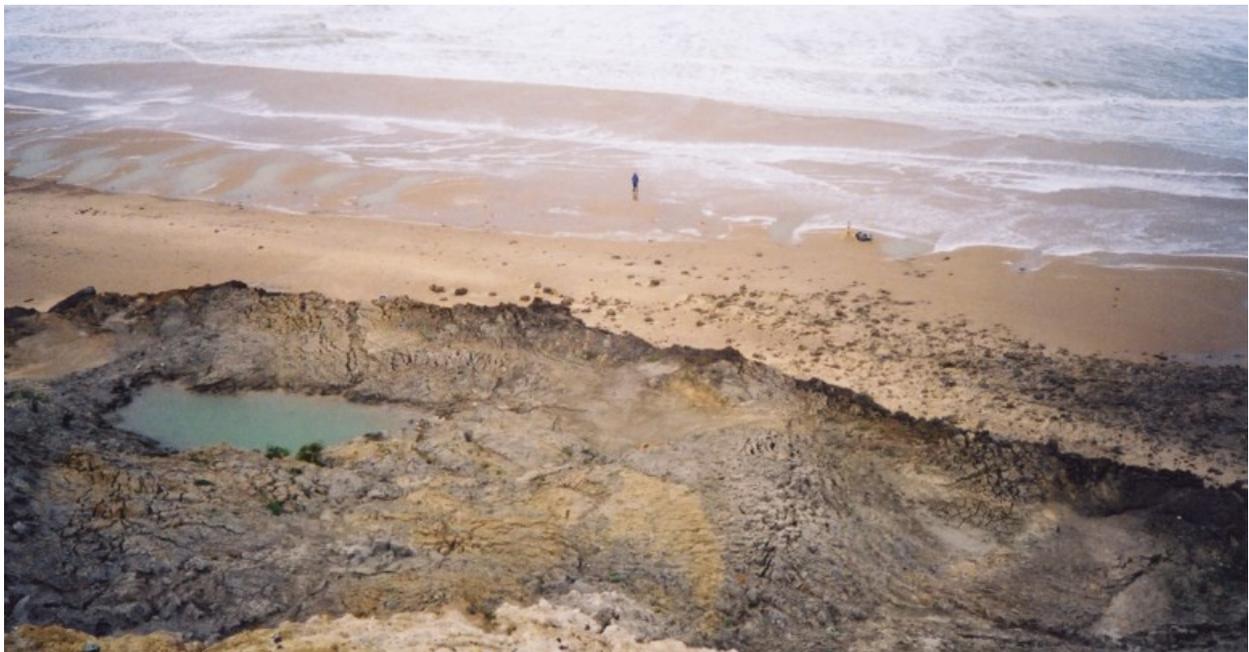
**Figure 5-28 Lower section of large landslide in SD3**

Note: active condition, ponding, compression ridges, desiccation cracks (05/09/01)

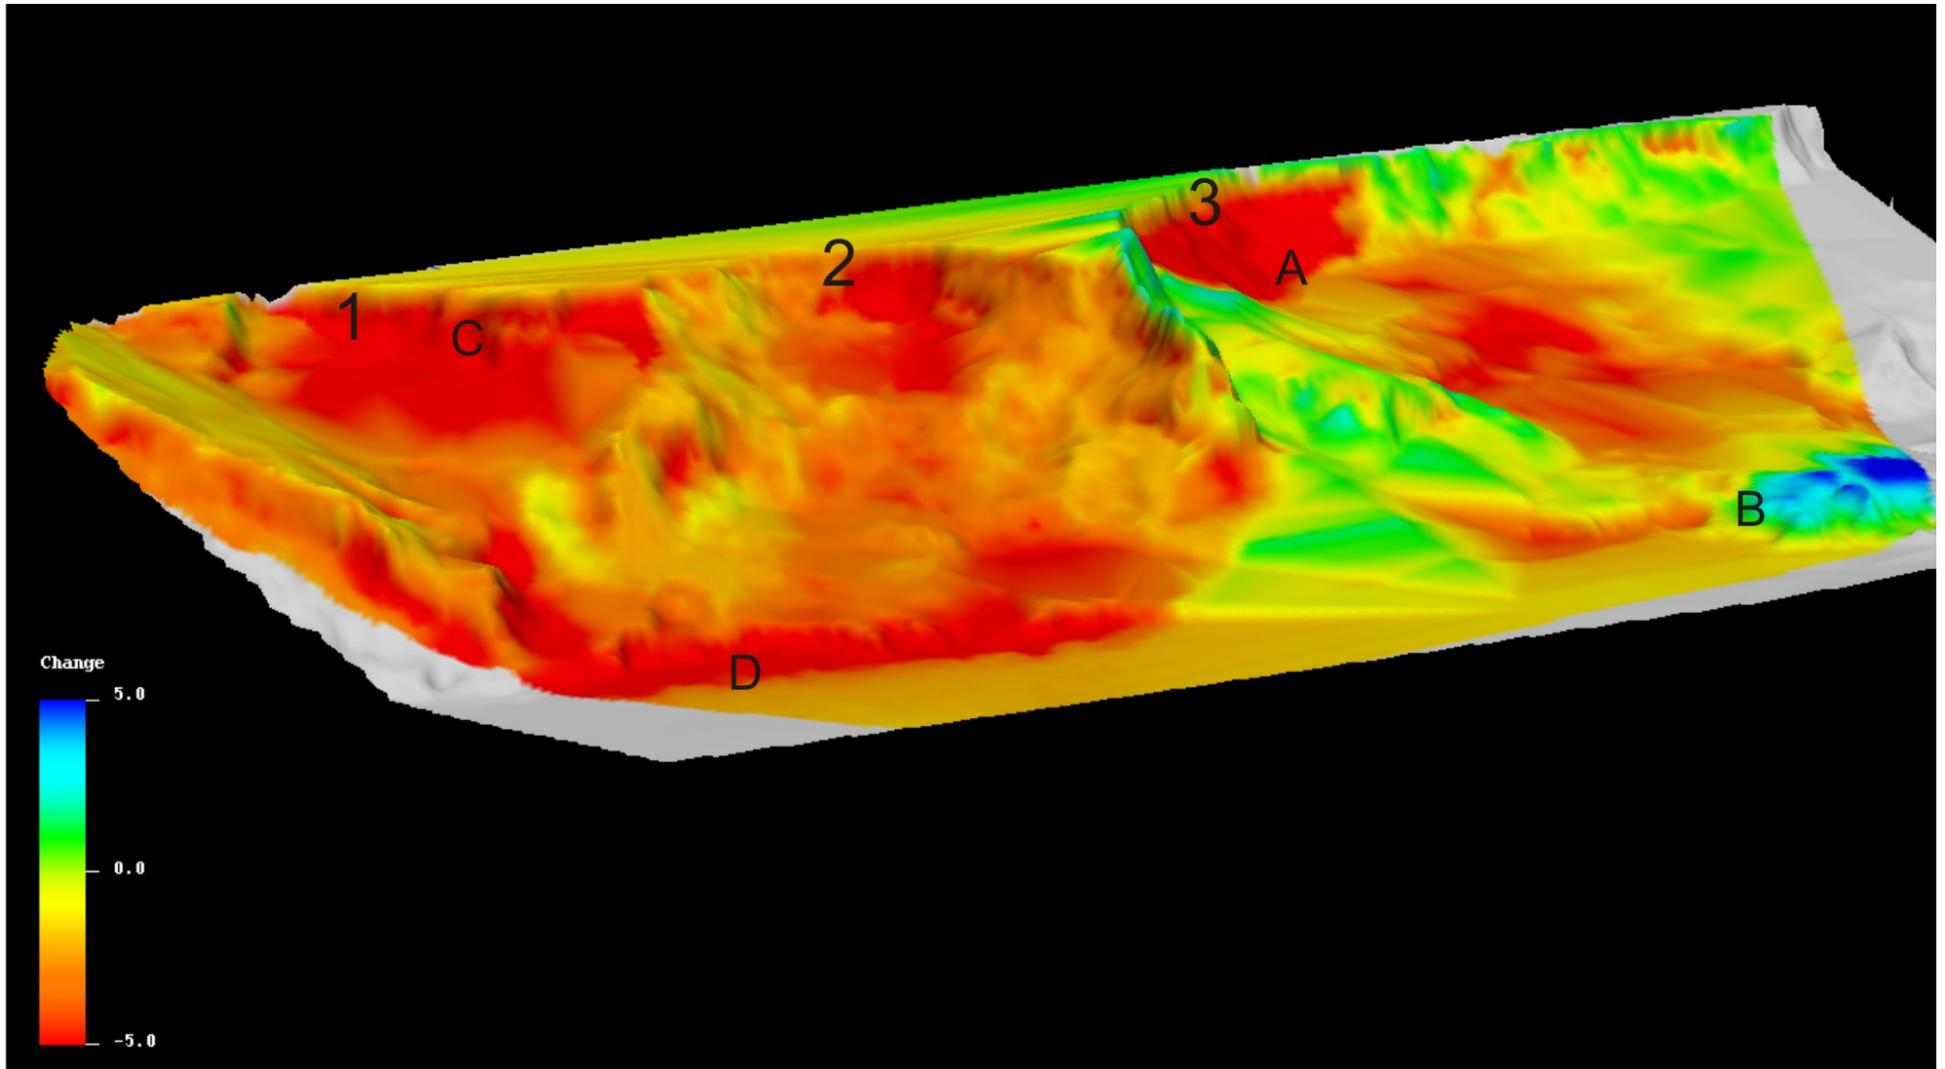
**Figure 5-29 Height change model for the 01/02 scanning season**

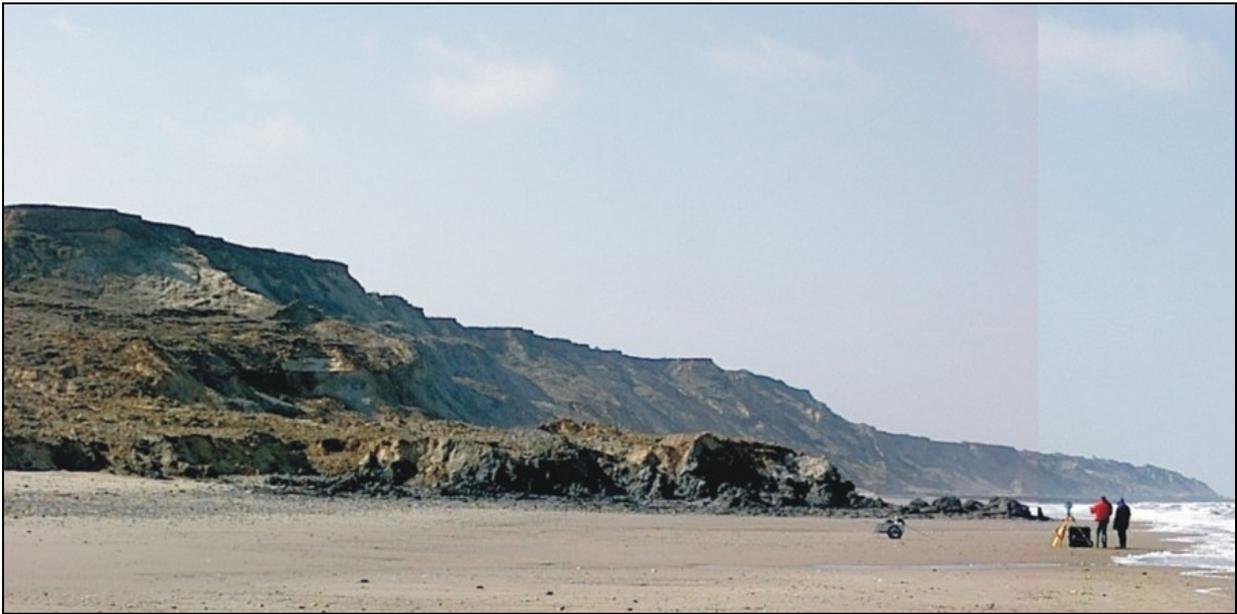
**Figure 5-30 Large debris flow of winter 2001/02 at SD3 (11/04/02)**

A combination of field notes, photographic evidence and change models produced from scan data allows us to assess the levels and distribution of activity of landslides within the three embayments. From the change model in Figure 5-29 it is evident that during the period 2001-2002 a large debris flow (A) occurred at the eastern end of embayment SD3 (Figure 5-30). The eastern edge of embayment SD3 in Figure 5-29 shows a clear loss of material whilst there is an increase in height at the base of the slope as a consequence of the toe being built up (B). The morphology of the landslide toe is clearly shown in Figure 5-28 and Figure 5-29. The debris flow emanated from the easternmost corner of the embayment’s backscarp and spread down the slope and about 30 m across the beach to a thickness of about 7 m. It took over 18 months for the debris to be eroded away by the sea back to its pre-flow position.
