# Slope Dynamics Project Report: Norfolk Coast (2000 - 2006)

Research Report OR/08/018

Norfolk, coastal, landslides, erosion, cliff recession, Happisburgh, Sidestrand, Weybourne, glacial deposits, slope stability, slope dynamics project.

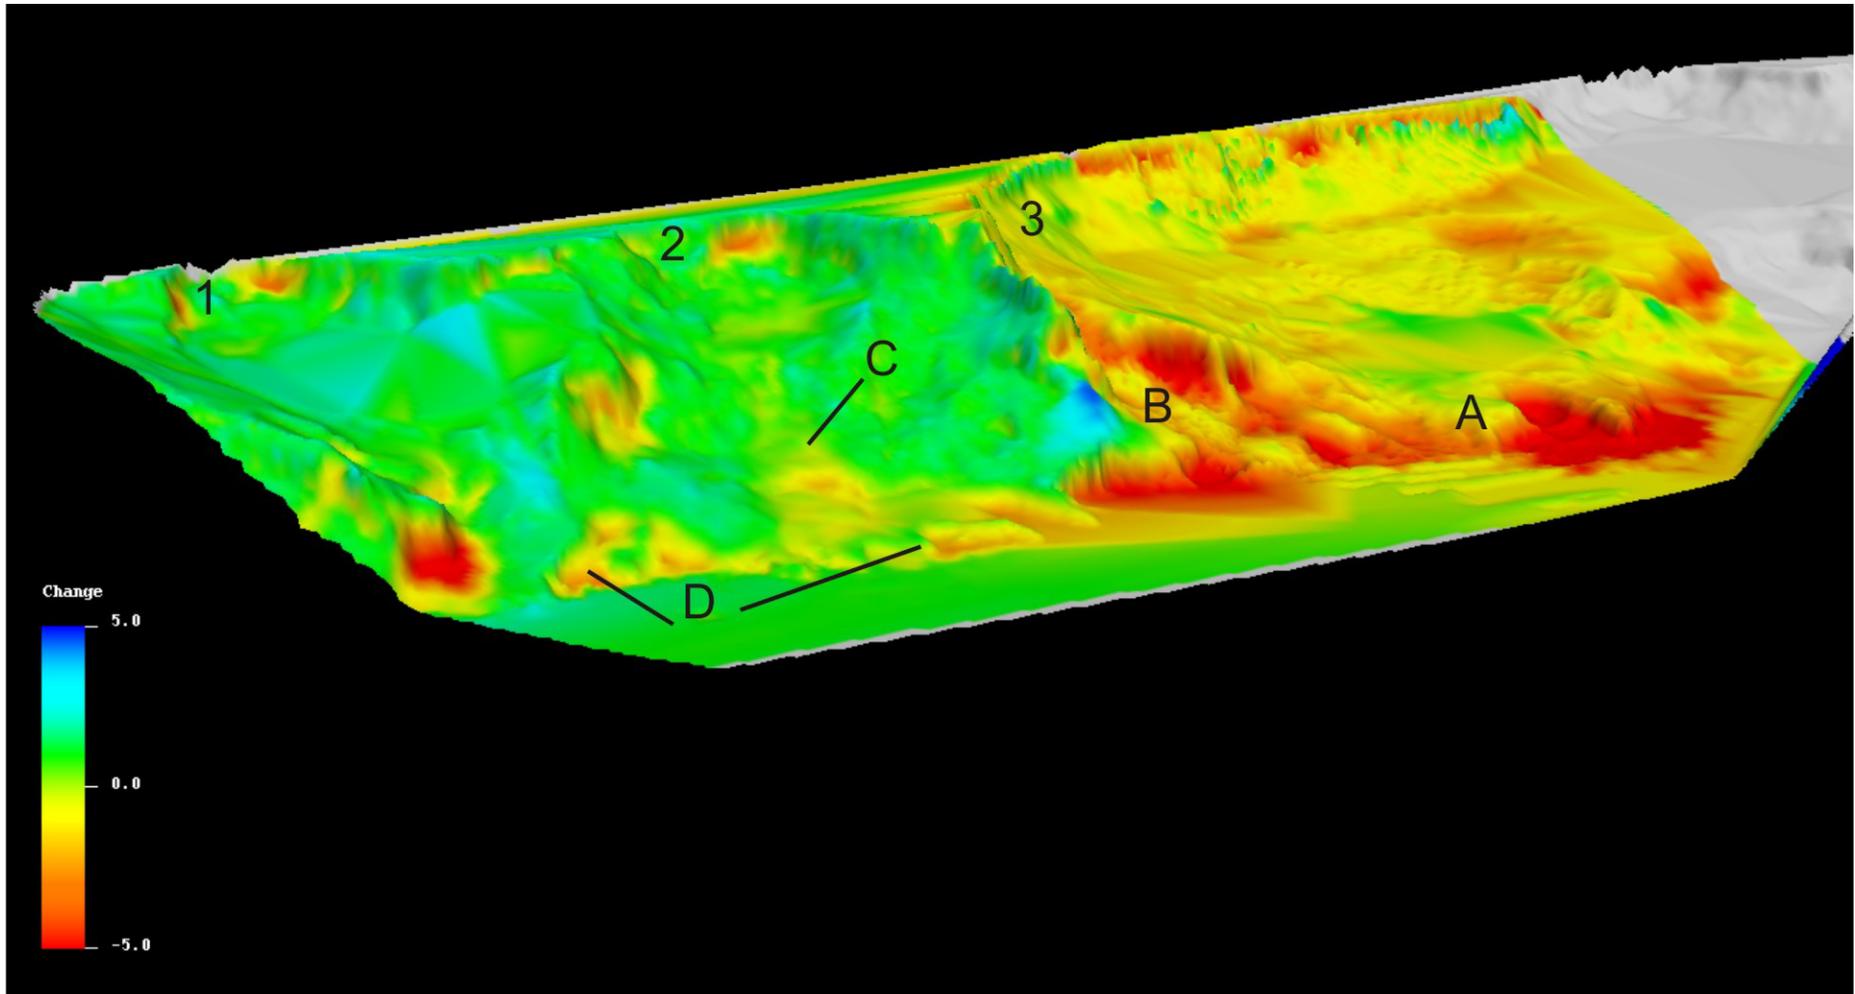
Figure 5-31 Height change model for Sidstrand for the period 2002-2003. Length of section approximately 370 m.

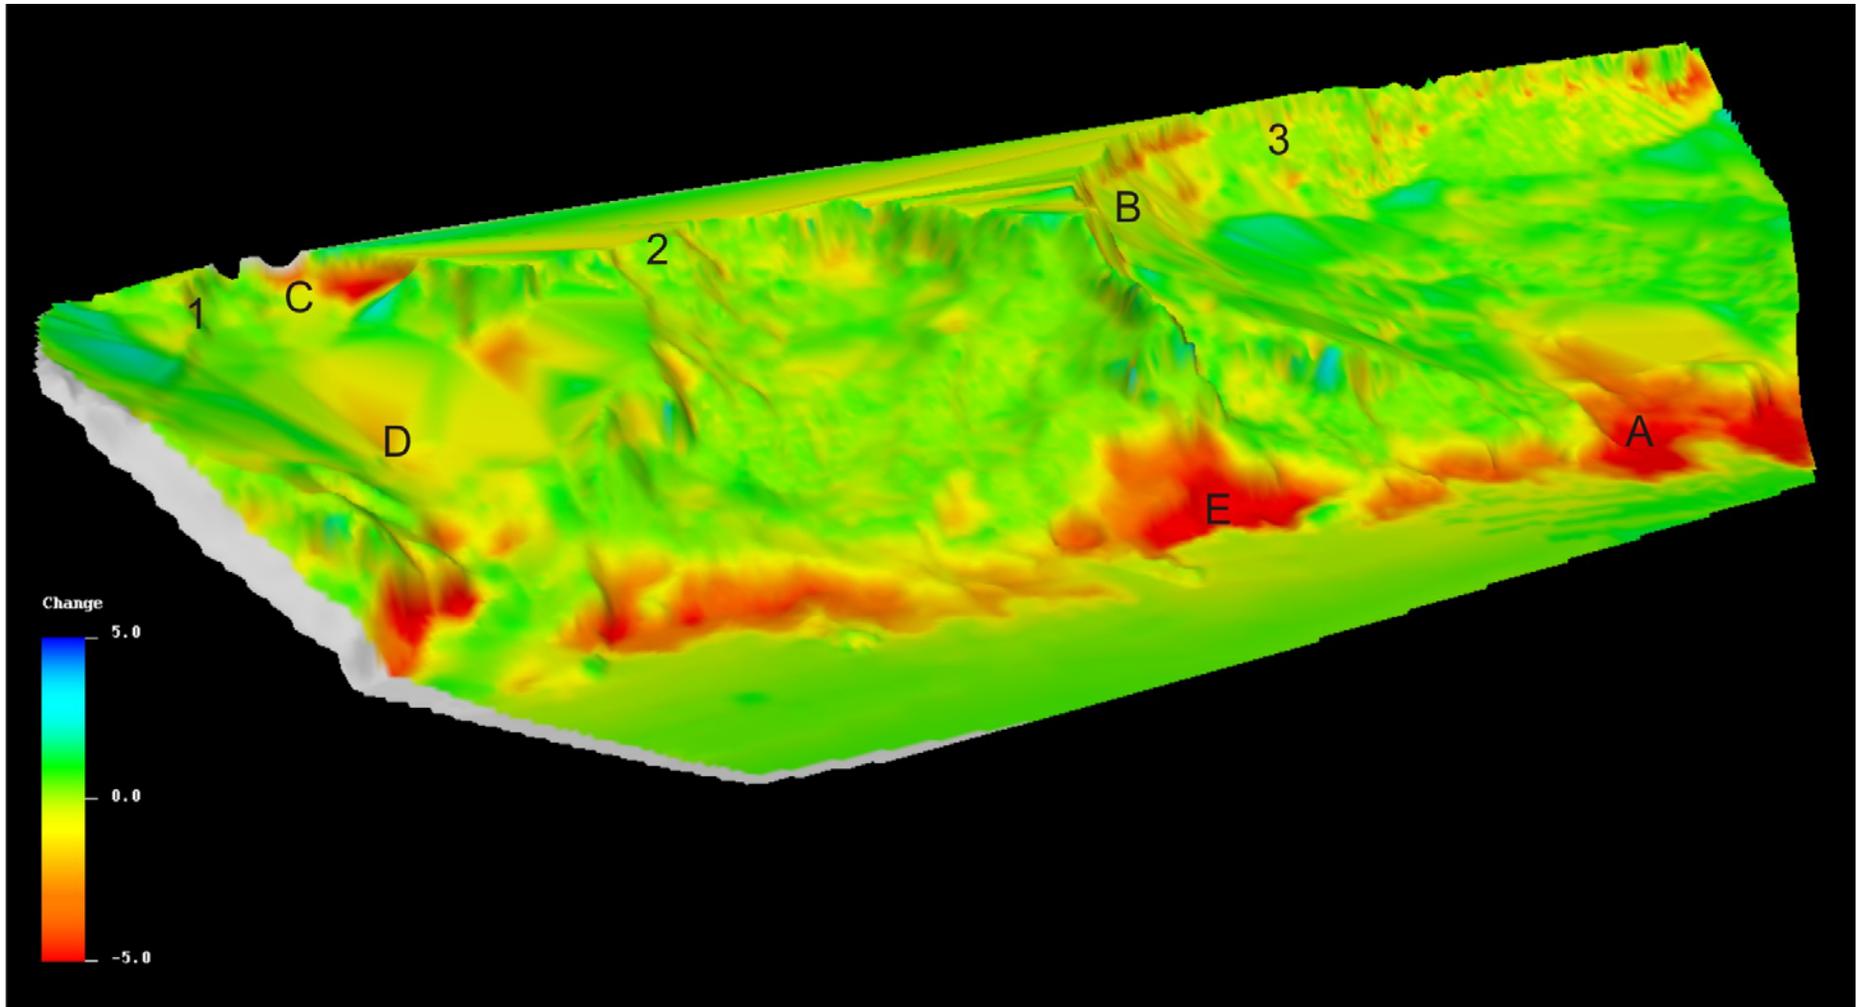
Figure 5-32 Height change models of Sidestrand for the period 2003-2004. Length of section approximately 370 m.

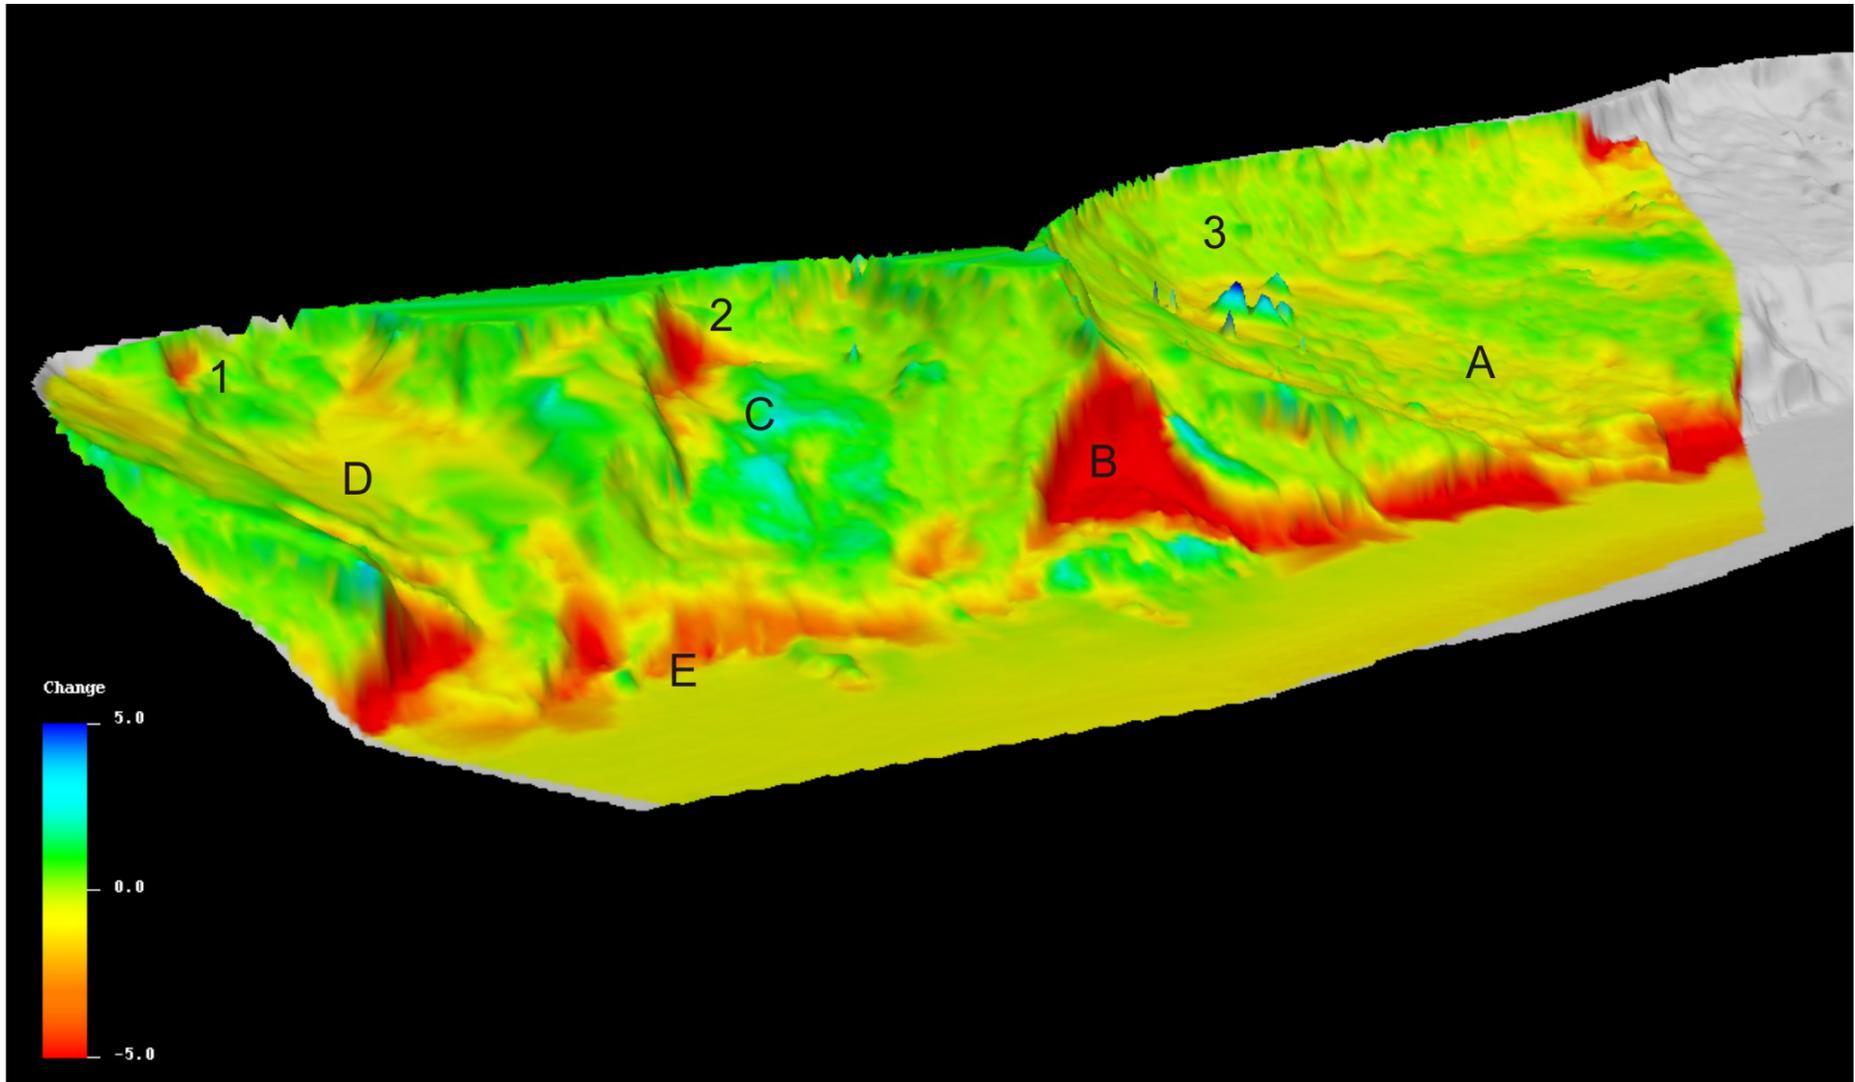
Figure 5-33 Height change models of Sidstrand for the period 2004-2005. Length of section approximately 370 m.

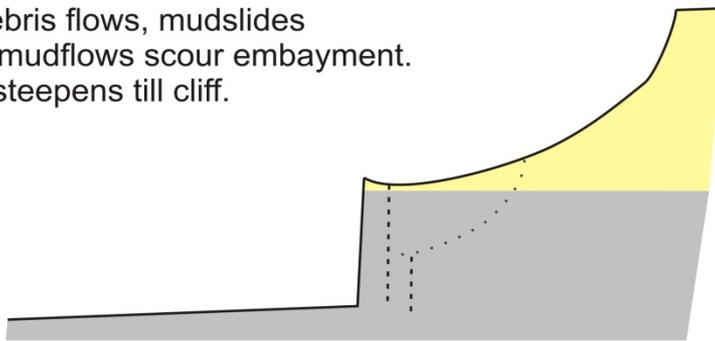
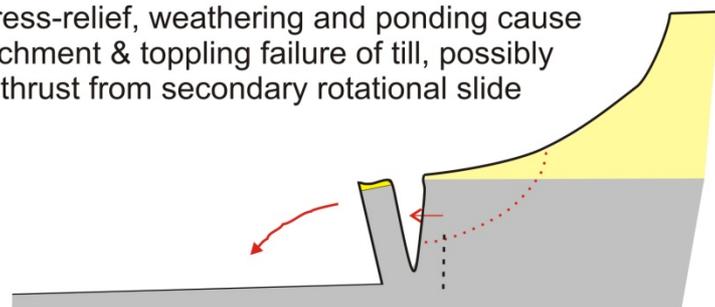
c) Stress-relief, weathering and ponding cause detachment & toppling failure of till, possibly with thrust from secondary rotational slide

**Figure 5-34 Conceptual model for landslide events observed on 28<sup>th</sup> September 2006.**  
For discussion of this event see Section 5.8.1.6.

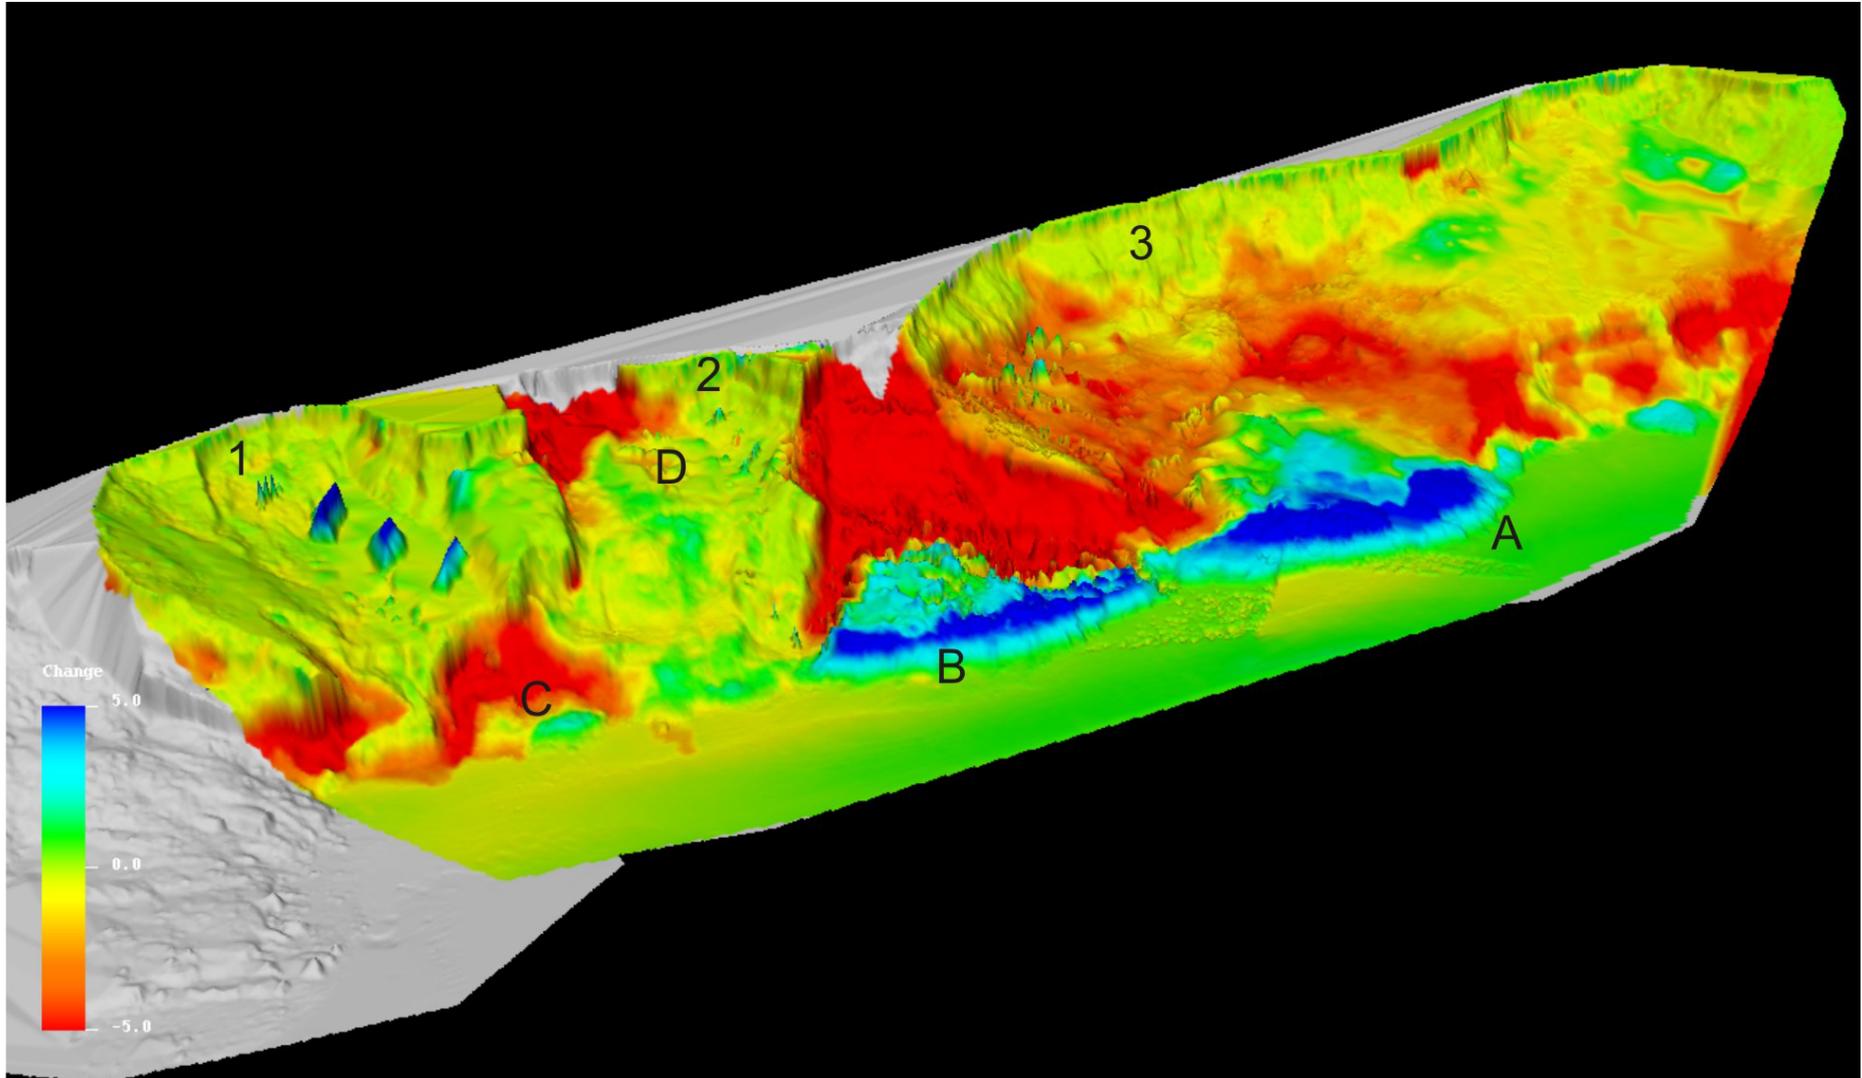
Figure 5-35 Height change model for Sidestrاند between 2005 and 2006. Length of section approximately 370 m.

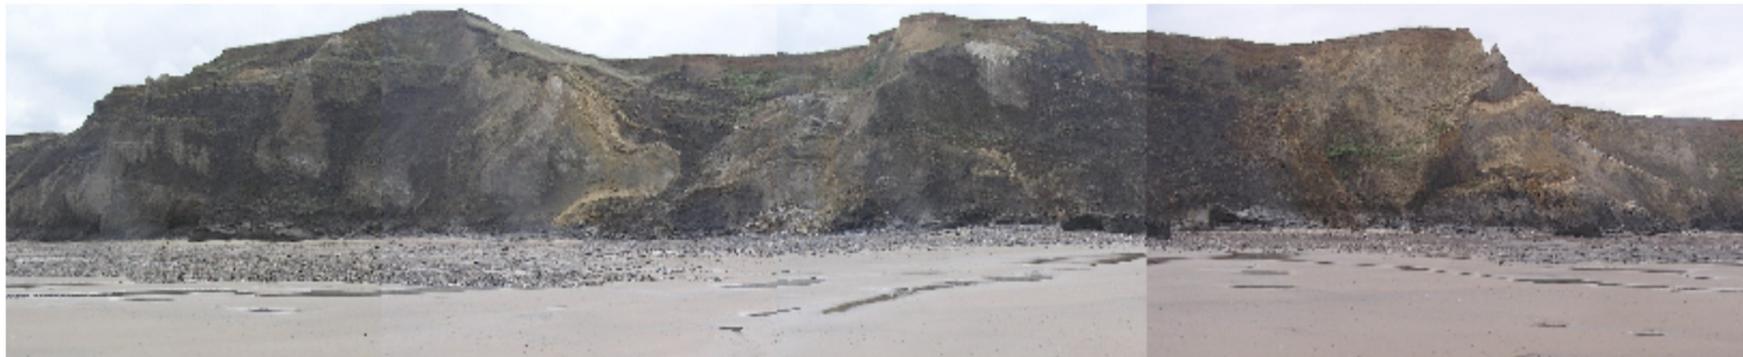
**Figure 5-36 : Field sketch and associated panorama photograph for Sidestrand, October 2005.**  
Length of section approximately 250m.

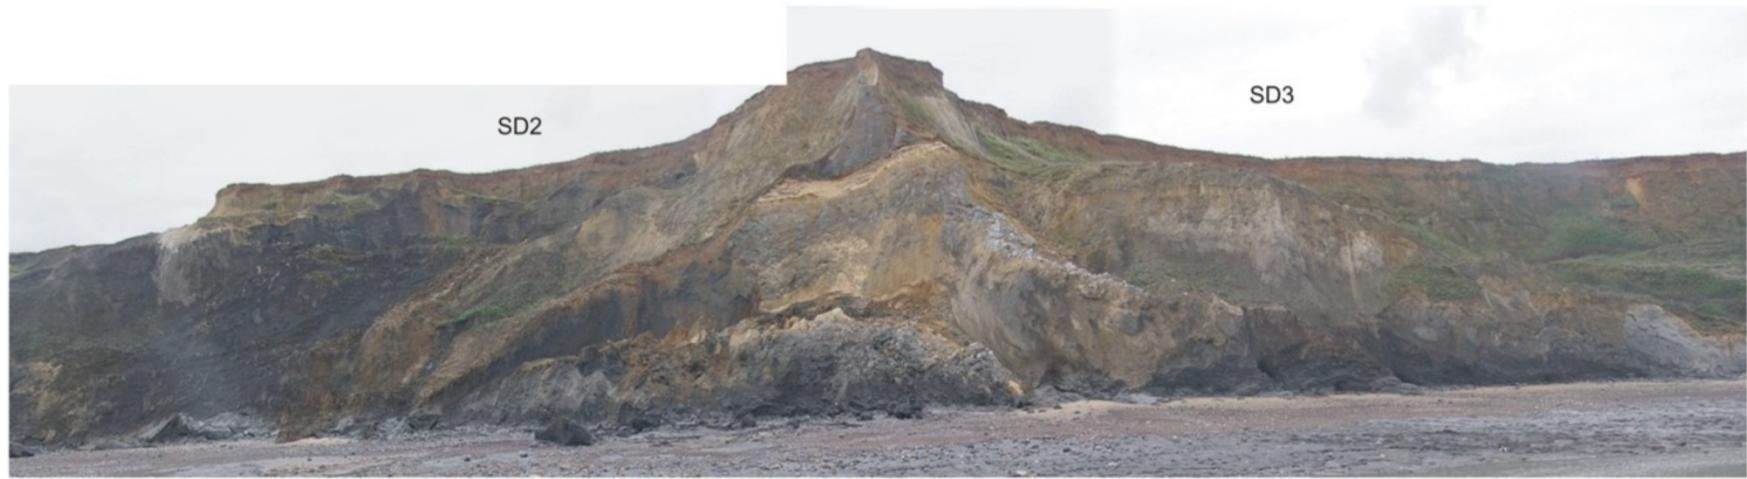
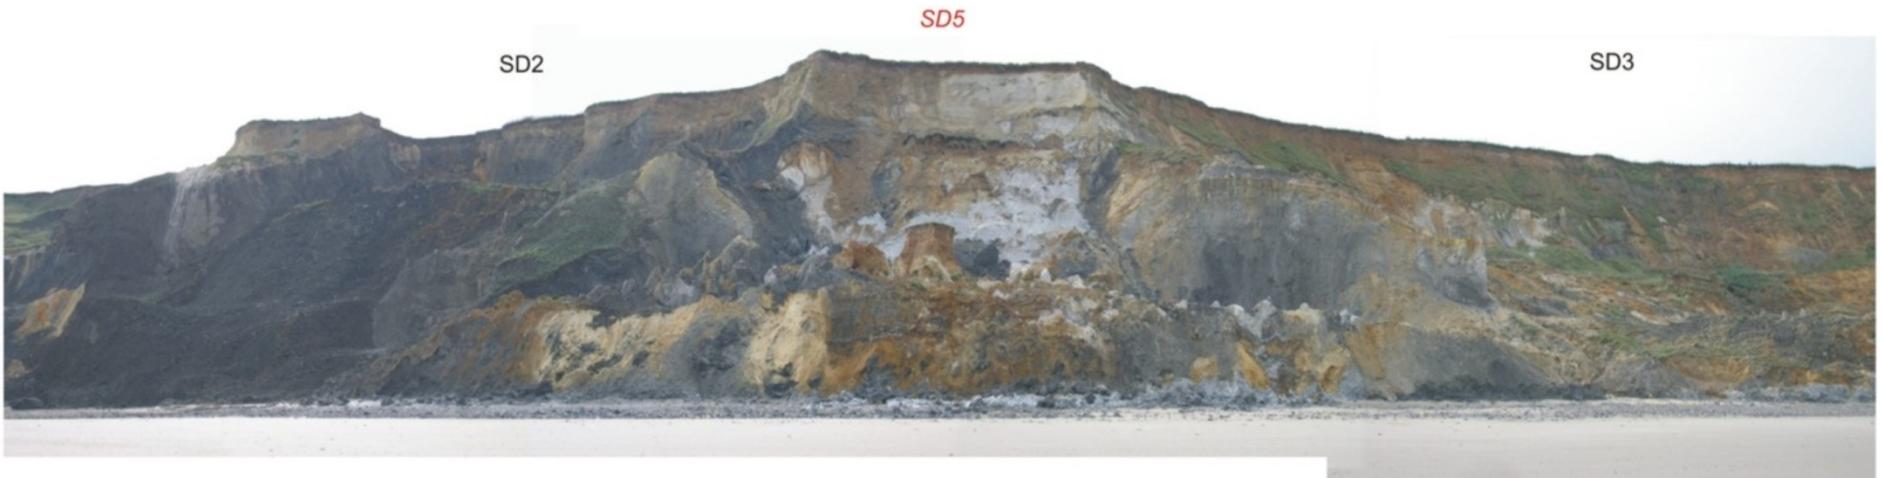
Major landslide activity occurred  
09.30 Thursday 28th Sept. 2006

**Figure 5-38 Comparative panoramas of the central part of the Sidestrand test site taken in 2005 and 2006 (red arrow = westward). Length of section approx 200m.**

The panoramic photos taken as part of the survey (Figure 5-38 and Figure 5-39) show the major changes and landslide movements which are indicated in the change models. The first of these was a major rotational movement involving almost the entire cliff height producing a large debris apron on the beach, and its own embayment (referred to as SD5 and marked by a red arrow). This movement had already initiated in the lower cliff prior to the 2005 panorama, either in the form of slumping or toppling (or both), thus destabilising the upper cliff and preparing it for the September 2006 movement. The movement has revealed the shapes and extents of chalk till deposits within the cliff. The movement appears to occupy a 'syncline' defined by the pale-grey/white marls of the Ivy Farm Laminated Silt Member, the 'limbs' of which have remained un-slipped, and the precise geometry of which had been obscured prior to the movement. The western limb of the syncline has remained largely intact since the first survey in 2000. The movement has also brought down chalk till material from the upper part of the cliff, along with sand. This new feature was scanned and lies within the 2006 laser-scan model. In addition, further movements in the upper and eastern part are noted as having caused significant regression of the cliff top at this point, with debris cascading over the lower cliff, and a narrowing of the promontory between SD1 and SD2.

The second was a major landslide, possibly of progressive type which mobilised a previously unslipped, near-vertical section of the lower cliff but also regressed in the upper cliff. Though largely unaffected by the 2006 movements, embayment SD1 illustrates clearly the importance of the more resistant marls in the mid and upper cliff in determining the precise geometry of the landslides and resulting embayments. The freshly-exposed, apparently synclinal (and micro-folded) Ivy Farm Laminated Silt Member feature at SD1 has resulted in funnelling action for landslide debris and flows from the upper cliff and a buttressing action to the promontories at either flank. *This new feature was scanned as part of the 2006 model but only from the west side, and cannot be compared in full with scans from previous years as it is beyond the test site.*

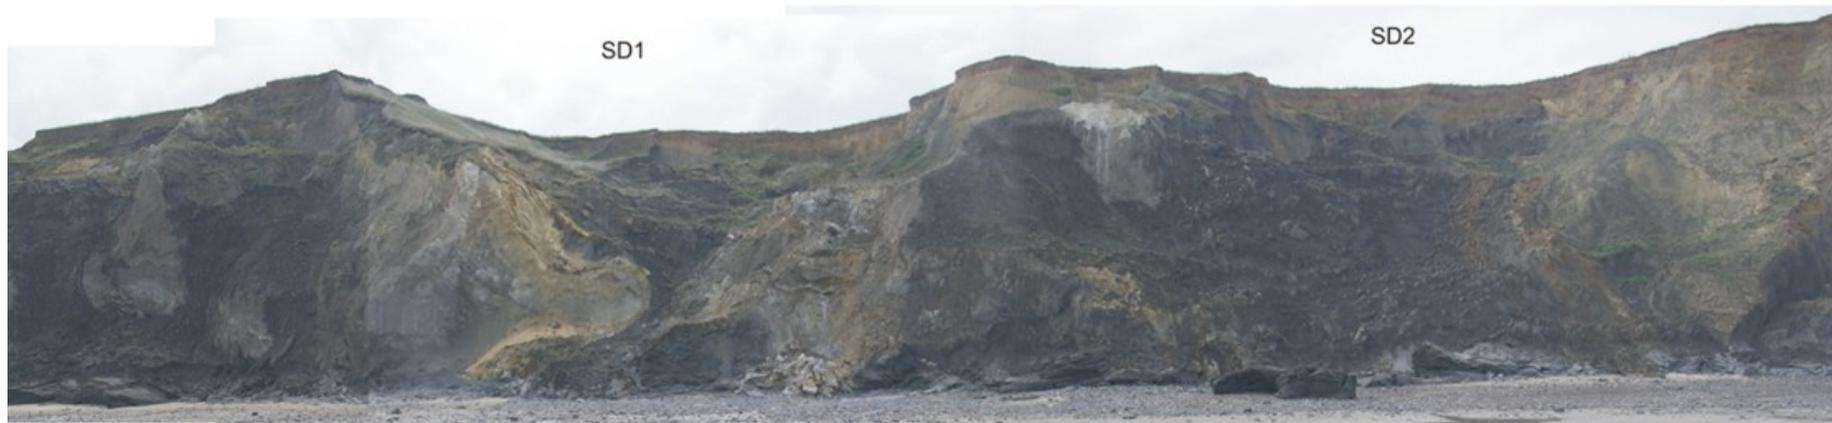
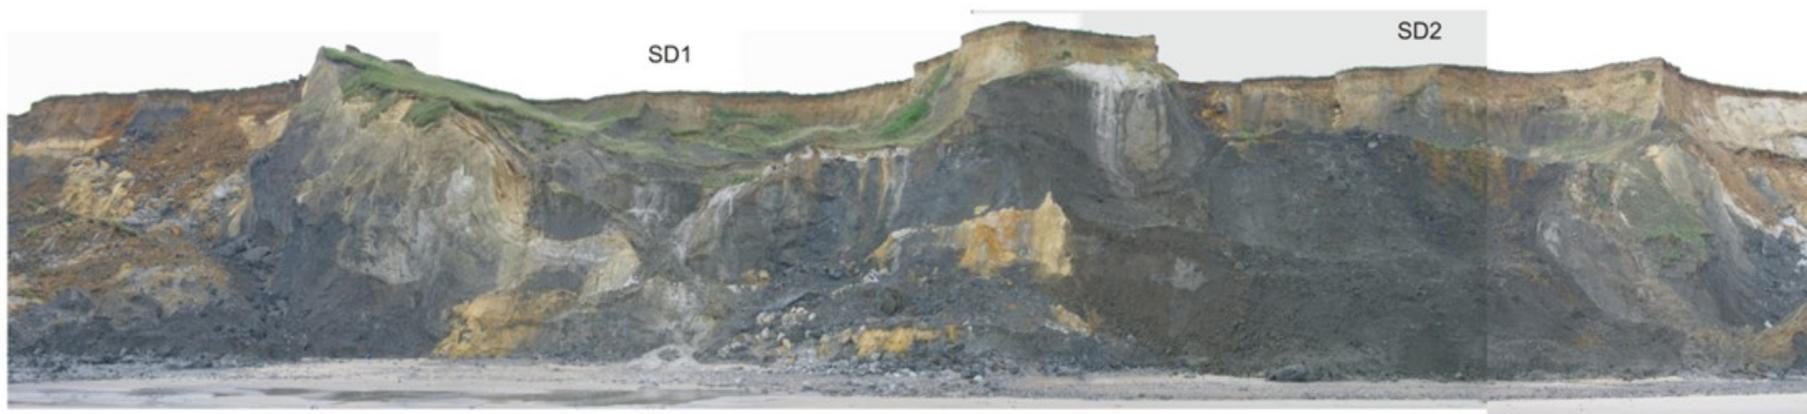
Major landslide activity occurred  
09.30 Thursday 28th Sept. 2006

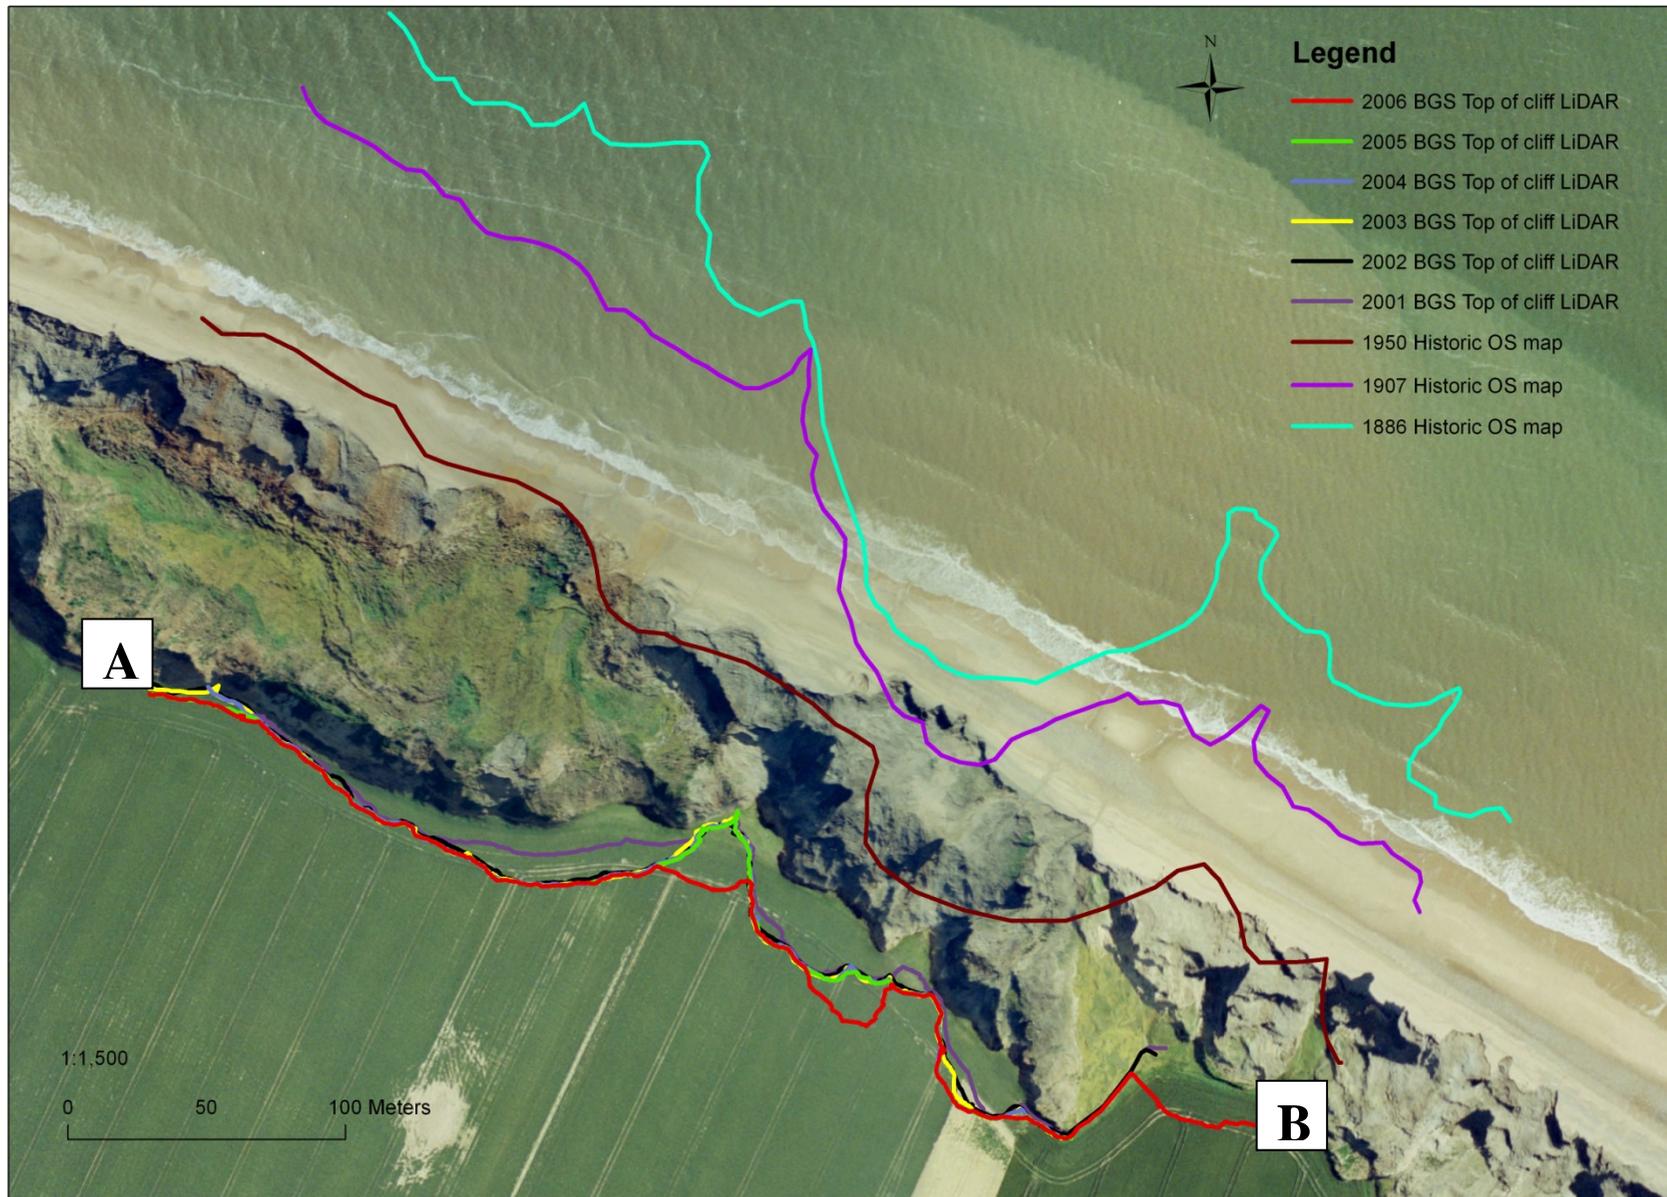
**Figure 5.36: Recession of the Sidstrand cliff line between 1886-2006 on 1999 aerial photograph. 1886-1950 historic OS maps. 2001-2006. BGS LiDAR survey. Grid Reference of A (626650, 339623) and B (627049, 339465).**

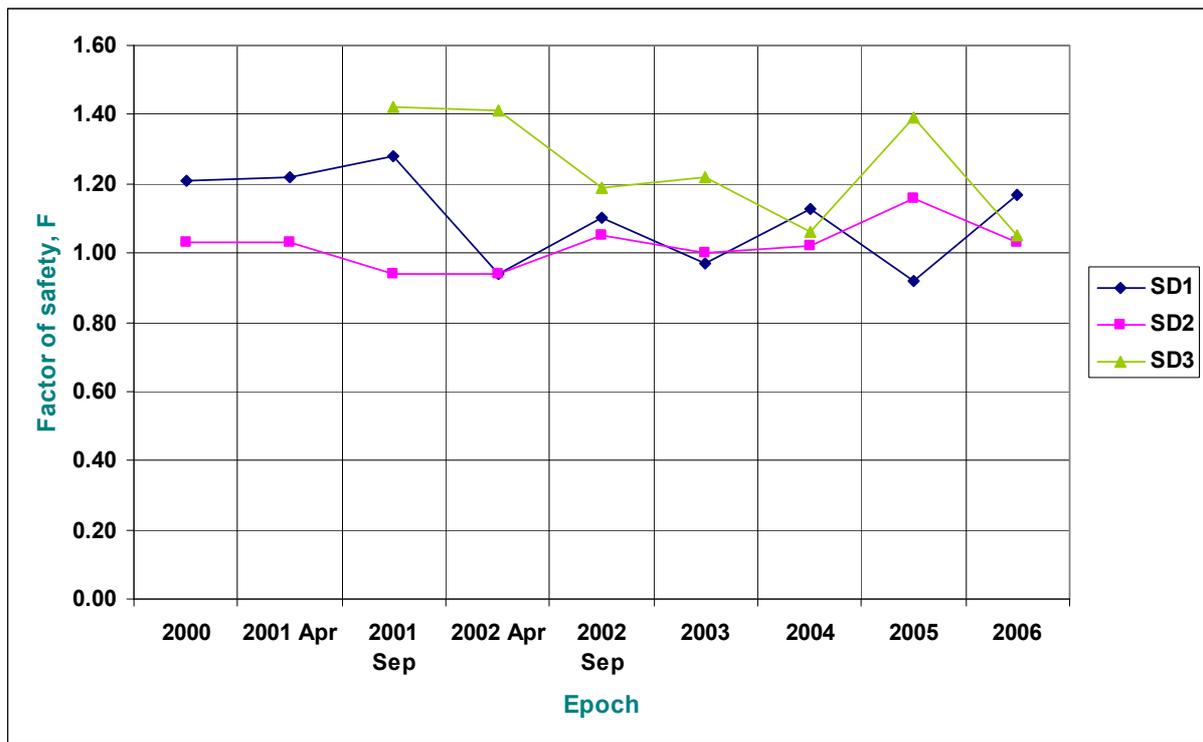
**Figure 5-41 Plot of factors of safety (FLACslope, v.4) for Sidestrand embayments SD1, SD2, & SD3**  
Refer to Appendix 4

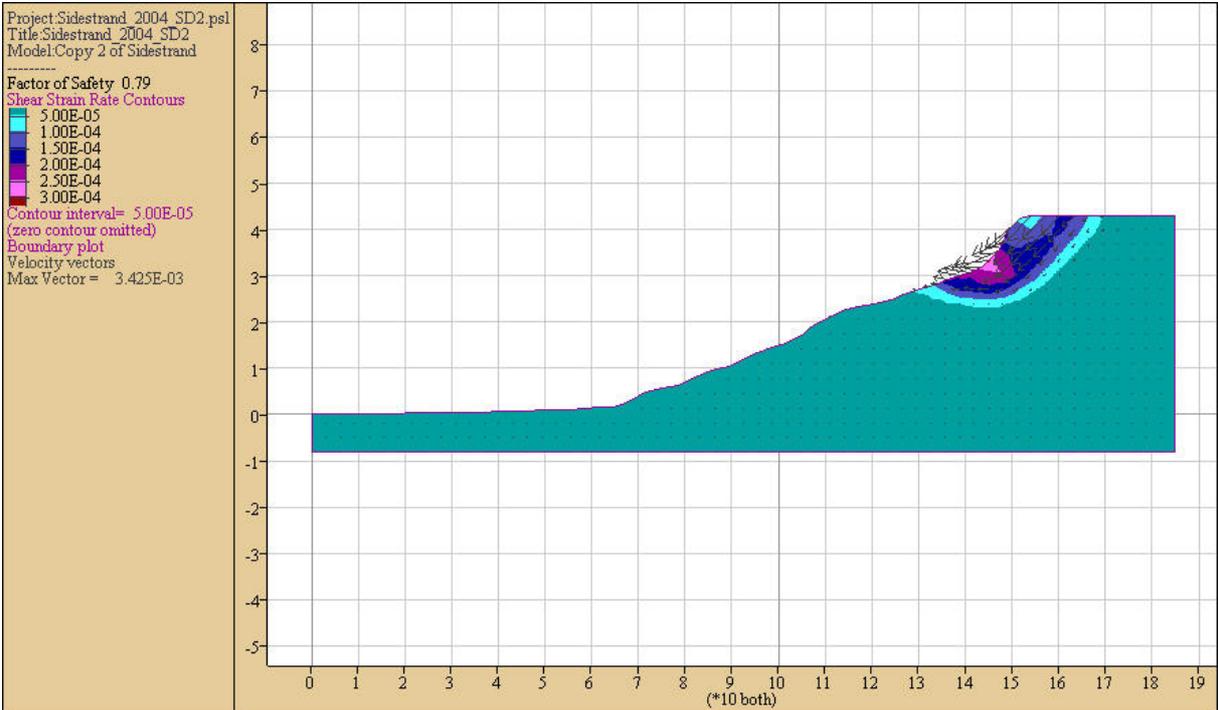
Figure 5-42 Example of displacement strain contour/vector diagram: Sidestrand, SD2, Sep 2004

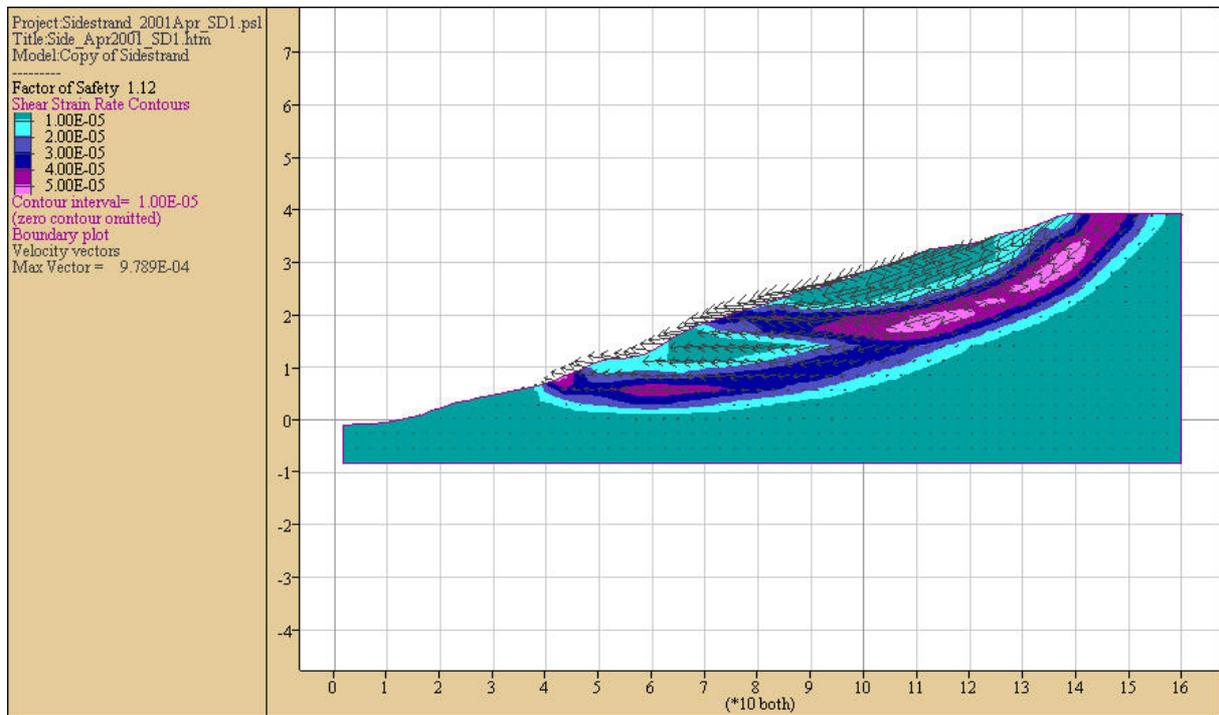
Figure 5-43 Example of displacement strain contour/vector diagram: Sidestrand, SD1, Apr 2001

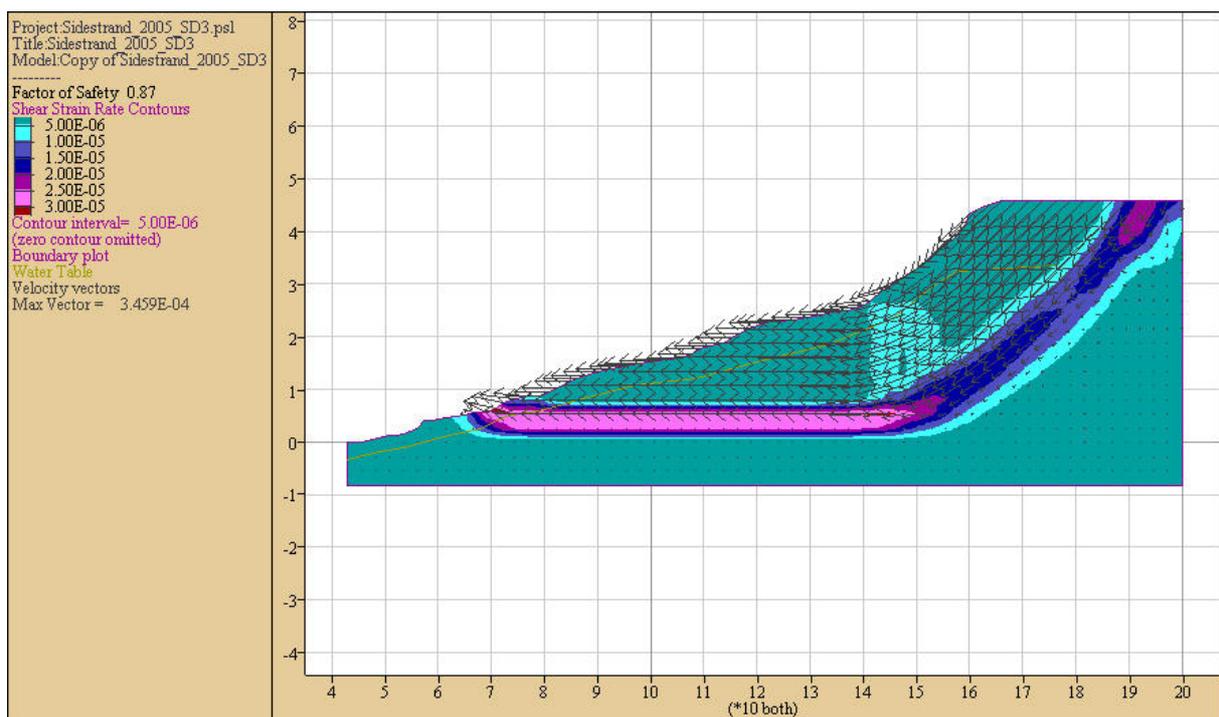
Figure 5-44 Example of displacement strain contour/vector diagram: Sidestrand, SD3, Sep 2005

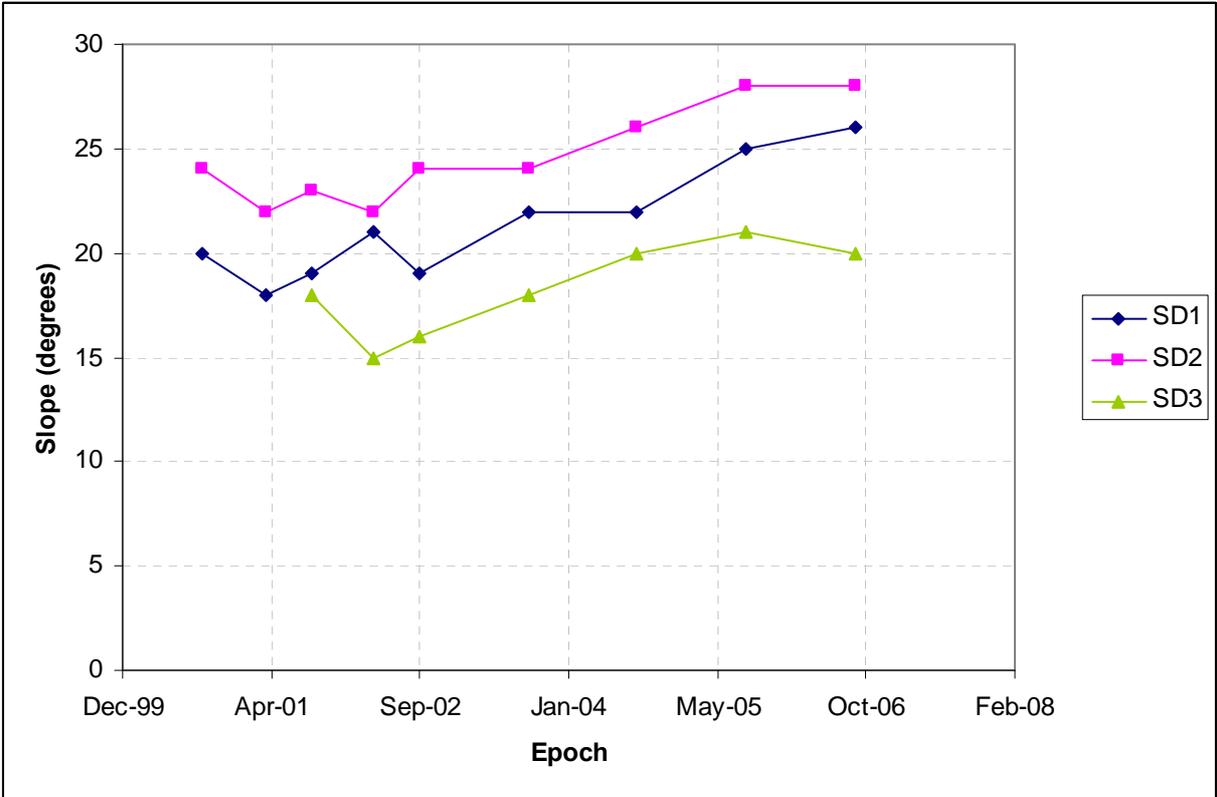
Figure 5-45 Overall slope angle against epoch for Sidestrand

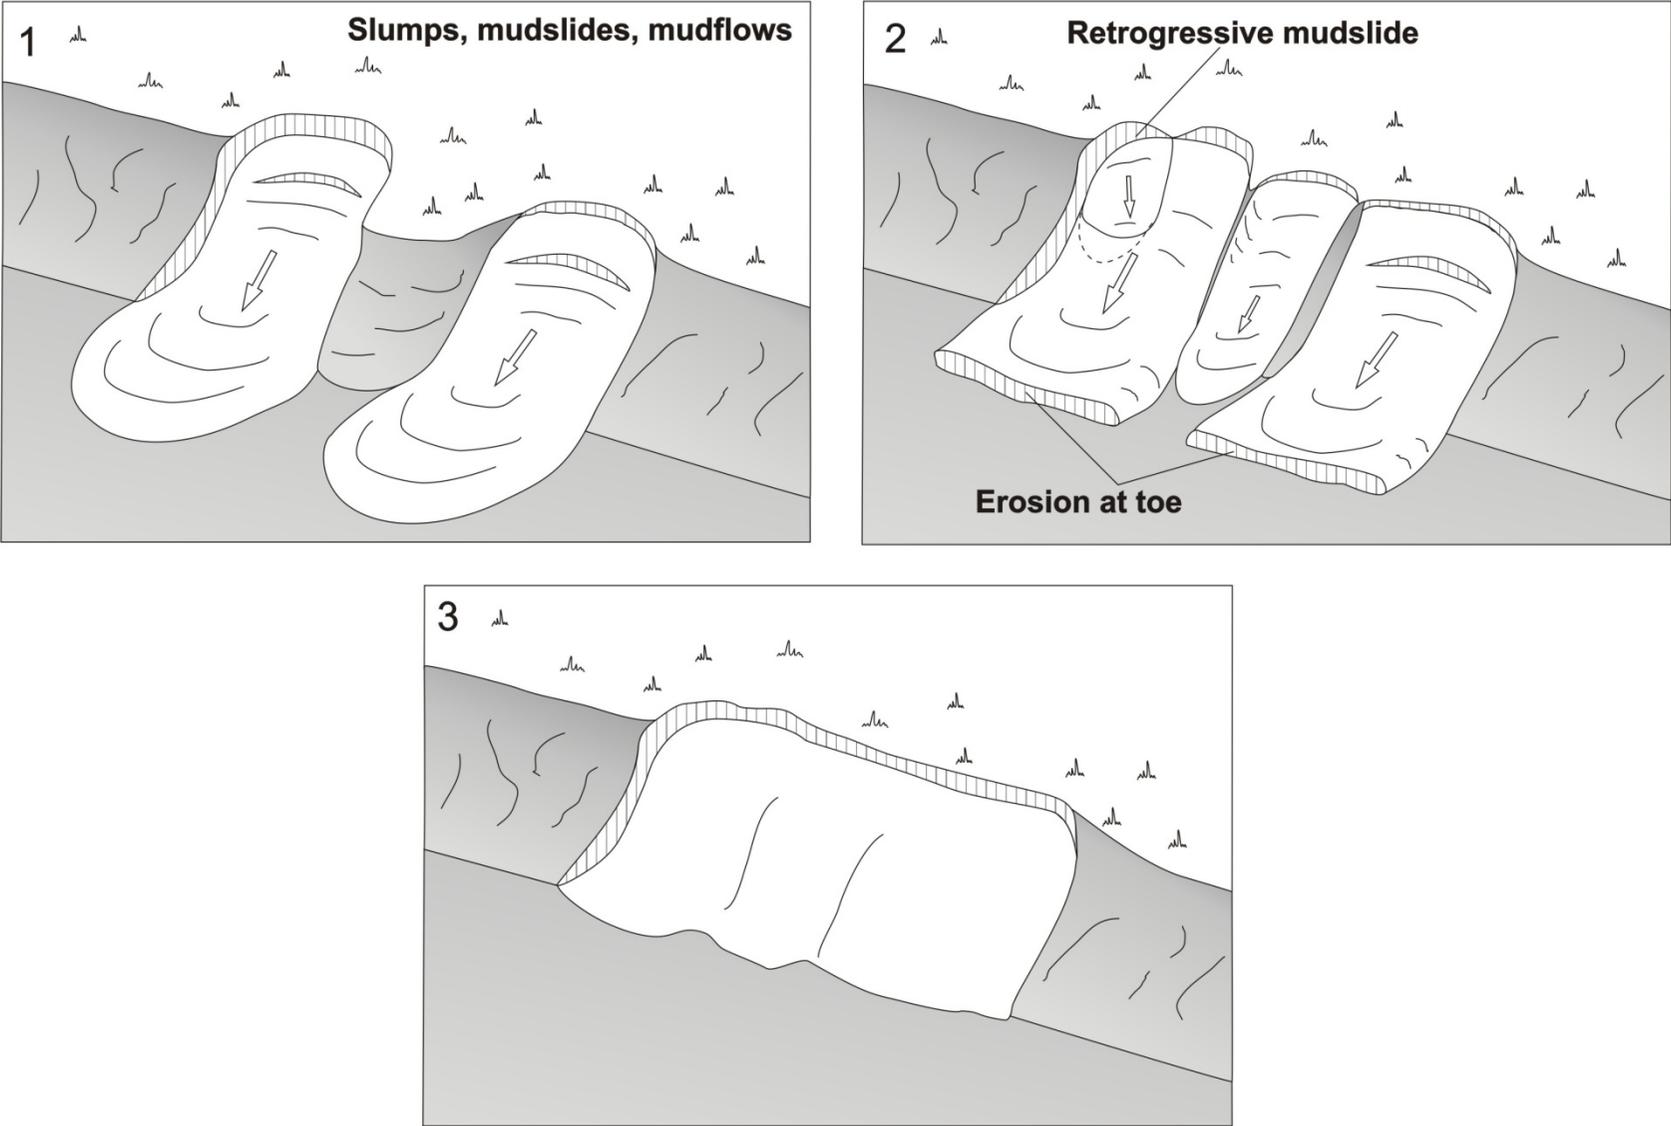
Figure 5-46 Conceptual Model A for embayments SD1 and SD2 at Sidestrand.

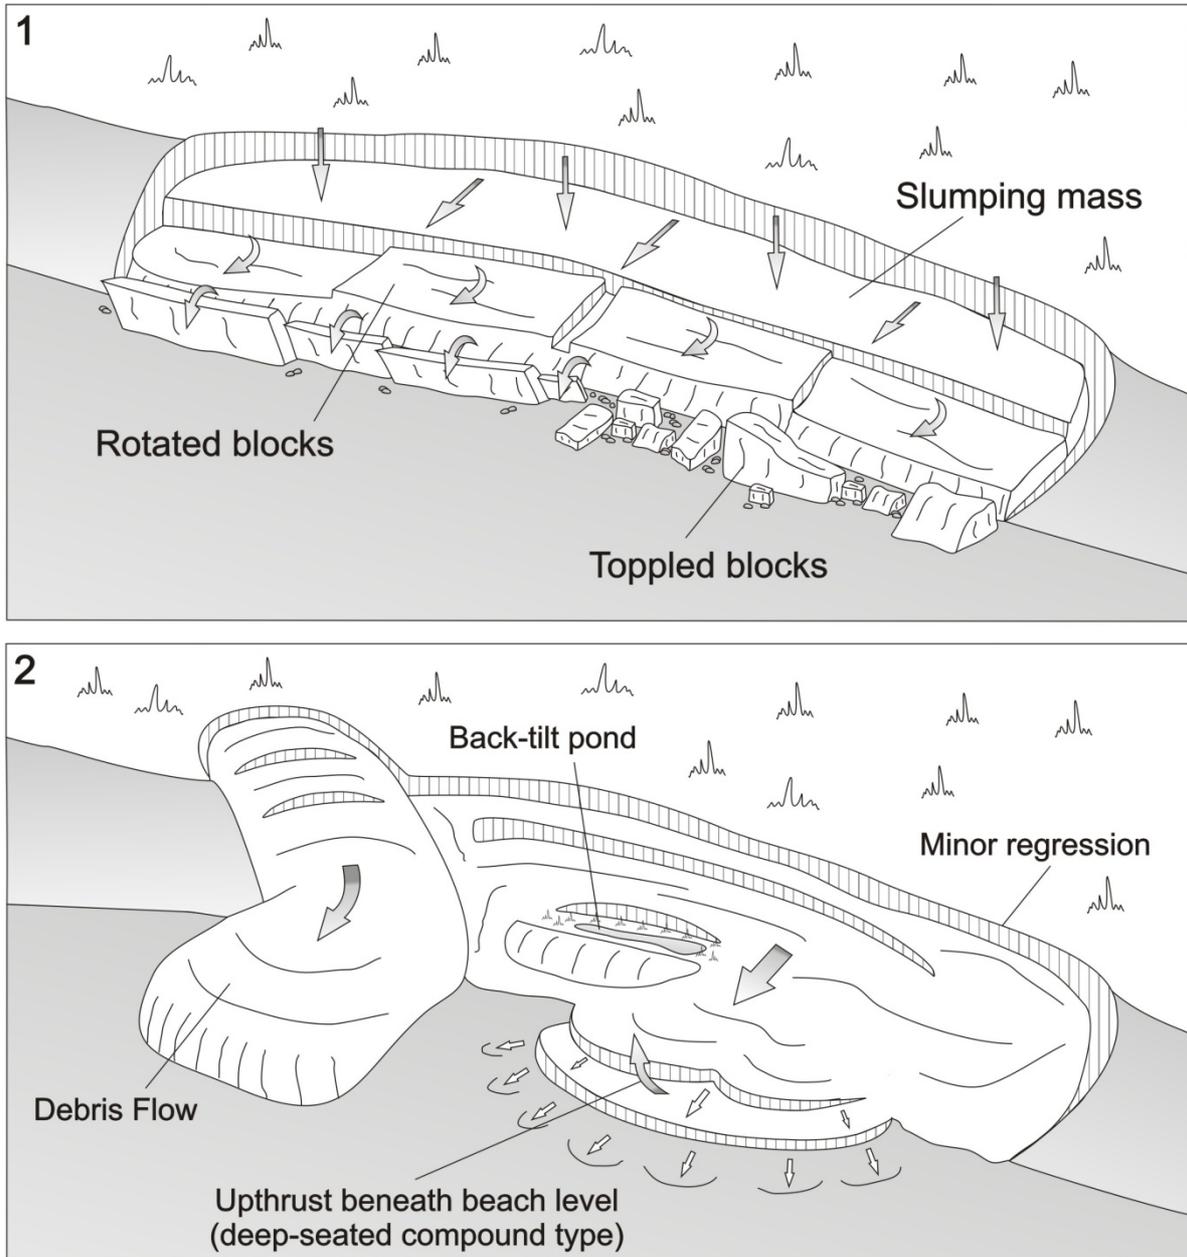
**Figure 5-47 Conceptual Model B for the embayment SD3 at Sidestrand.**
