# Slope Dynamics Project Report: Norfolk Coast (2000 - 2006)

Research Report OR/08/018

Norfolk, coastal, landslides, erosion, cliff recession, Happisburgh, Sidestrand, Weybourne, glacial deposits, slope stability, slope dynamics project.

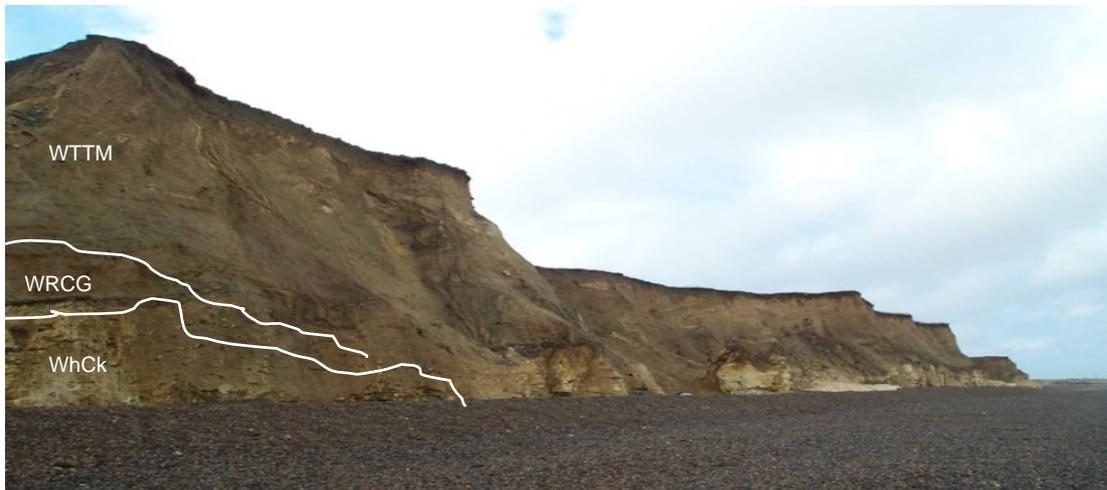
Figure 6-1 View westward of part of test site showing chalk (White Chalk Subgroup, WhCk), sands (Wroxham Crag Formation, WRCG) and Weybourne Town Till Member (WTTM).

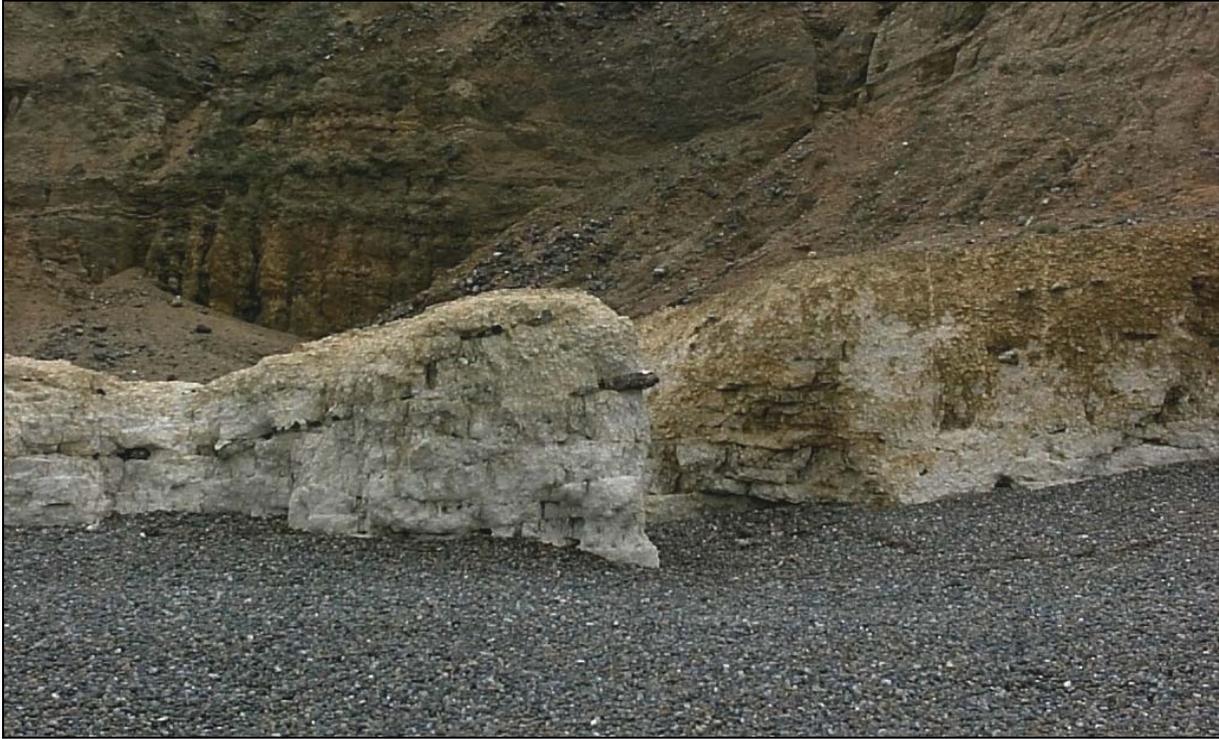
**Figure 6-4 Chalk exposed at base of cliff (Weybourne Chalk)**  
Height of exposure (foreground) approx 1m.

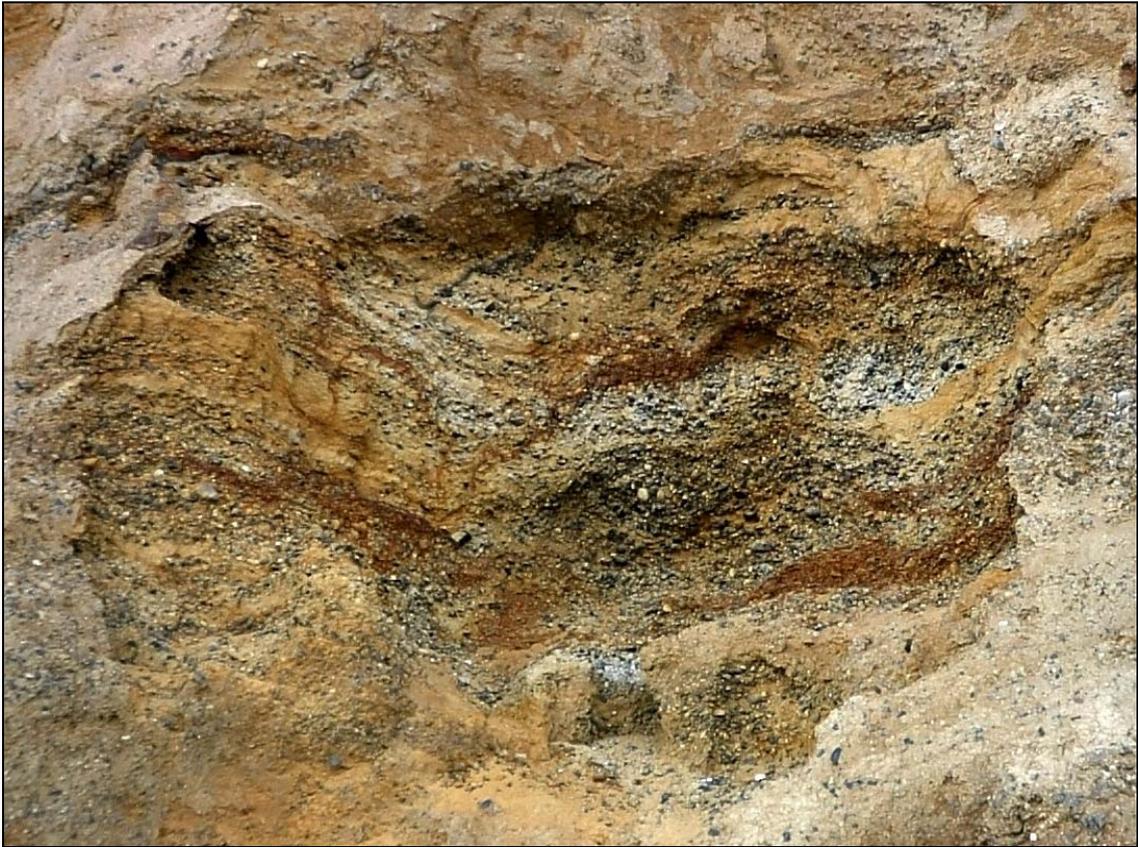
**Figure 6-5 Thinly bedded, laminated, and folded sand and gravel layers (Wroxham Crag Formation)**  
Height of section approx 1m

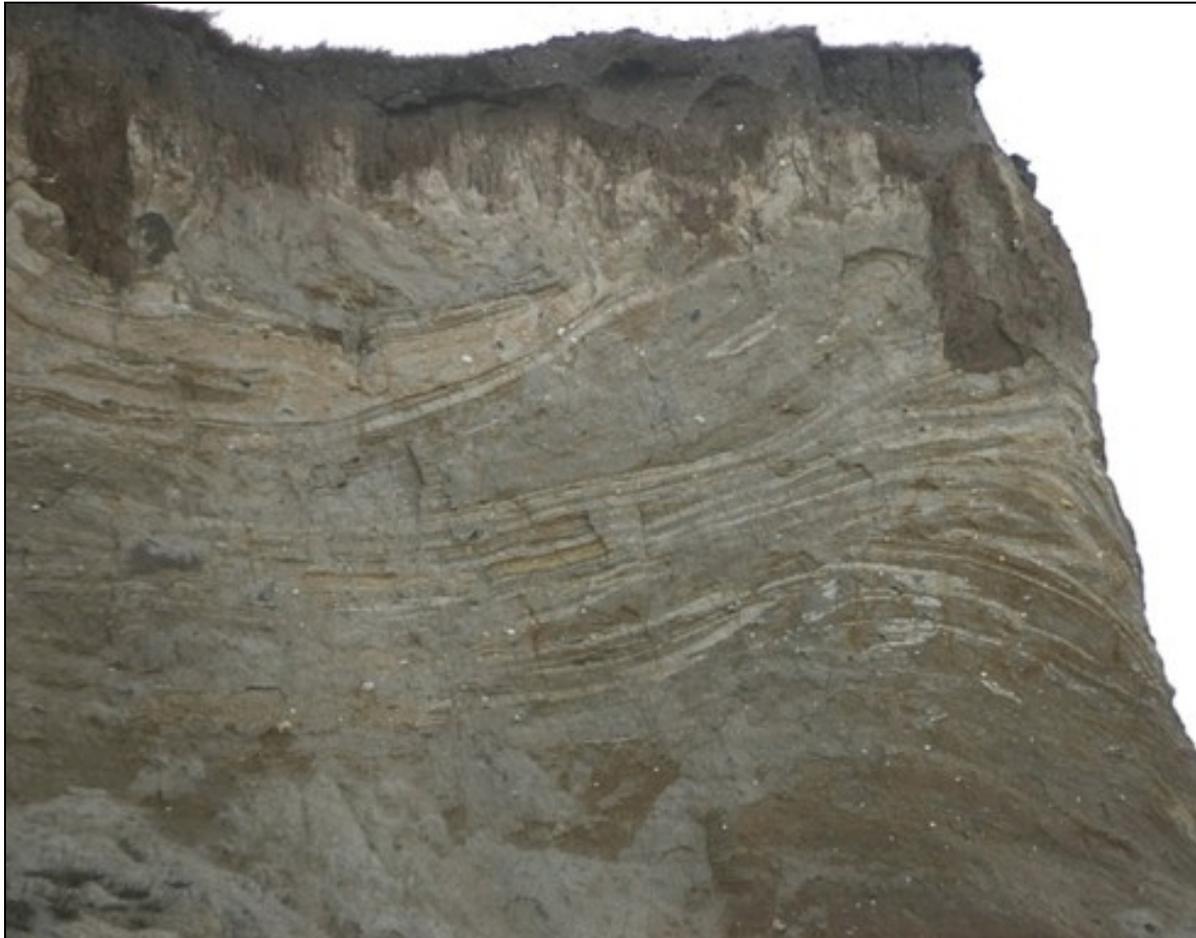
**Figure 6-6 Highly contorted melange of brown sandy till and chalky till that from the Weybourne Town Till Member of the Sheringham Cliffs Formation**  
Height of section approx 7m.

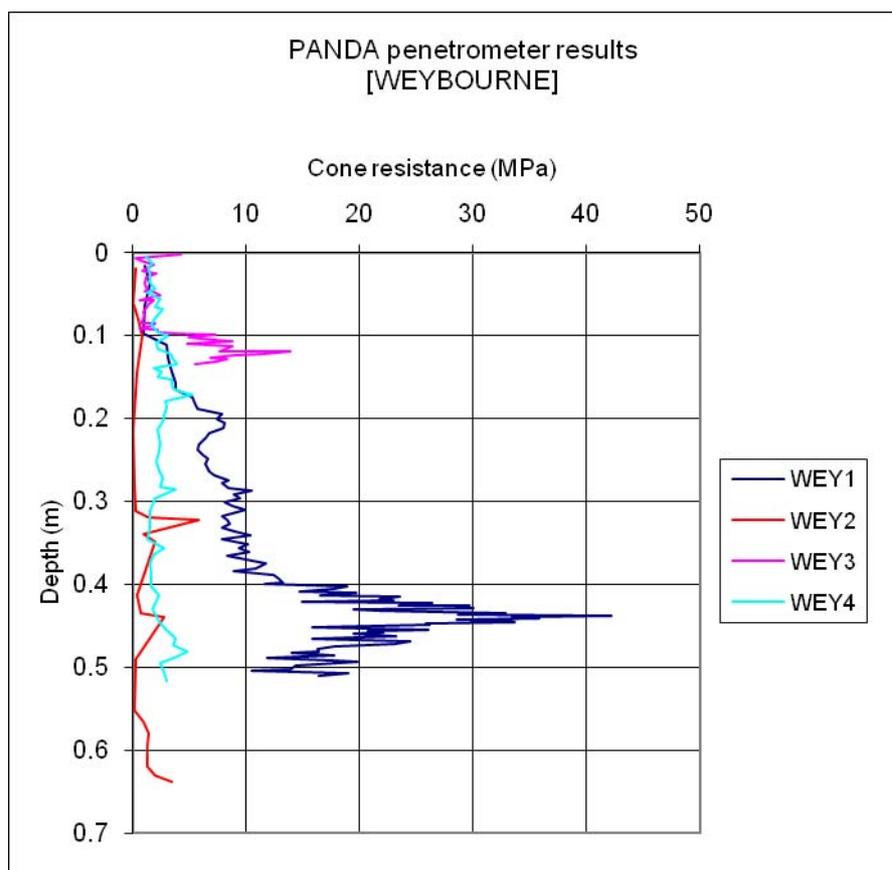
**Figure 6-7 PANDA penetrometer profiles for Weybourne** (refer to Table 6-2)

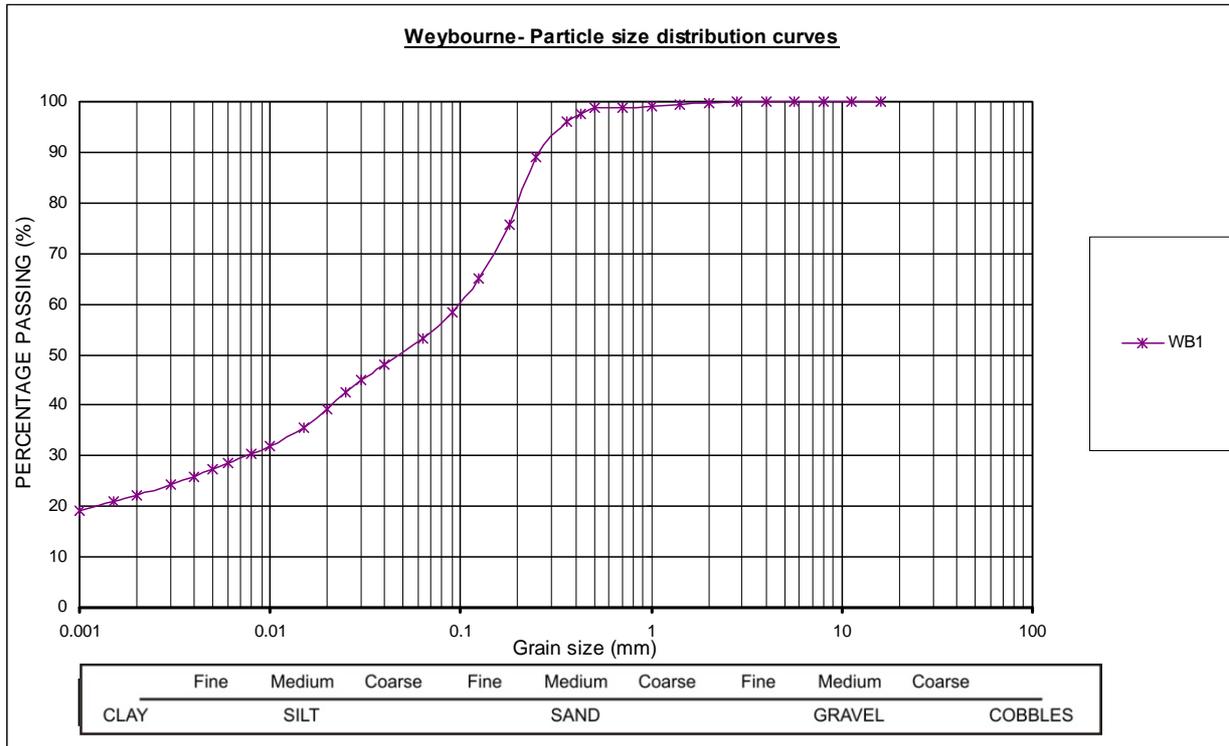
Figure 6-8 Particle-size distribution curve for sample WB1, Briton’s Lane Sand & Gravel Member (Briton’s Lane Formation)

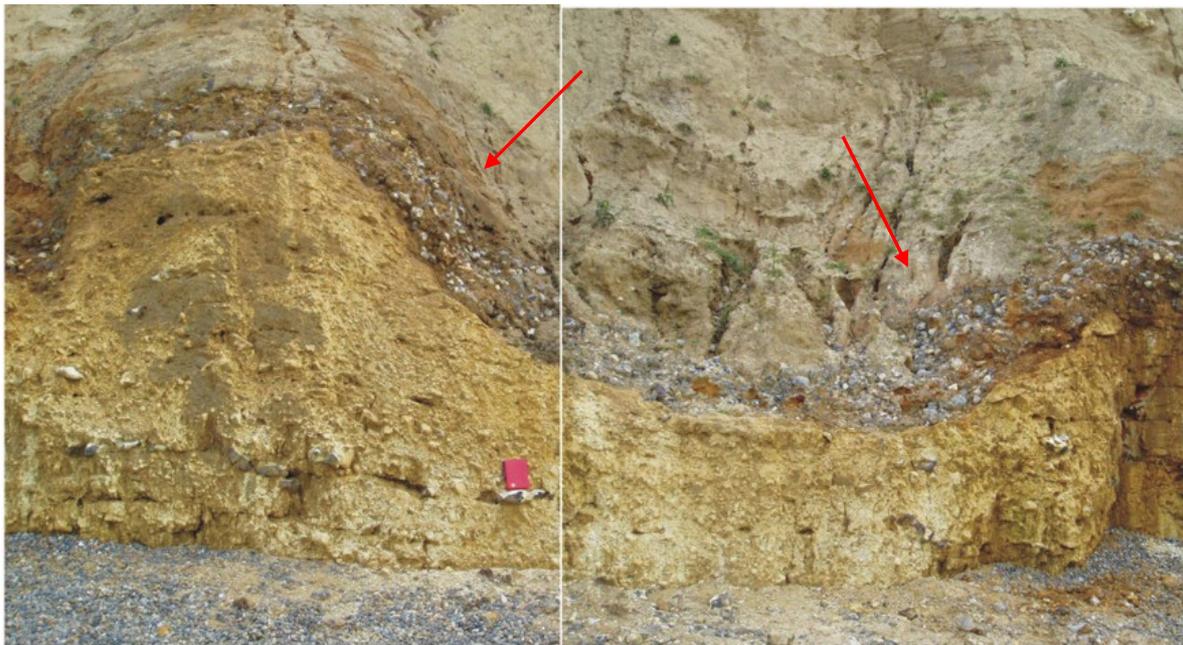
**Figure 6-9 Wroxham Crag Formation gravels (arrowed) separating White Chalk and Sheringham Cliffs Formations.**

Height of section approx. 2.5m

The majority of the cliff is cut into unconsolidated glacial sands and gravels, which in places include large chalk erratics (Figure 6-9). Chalk is exposed as a resistant platform at the base of the cliff, compared with the glacial sands above it (Figure 6-10). The form of the cliff profile is influenced by the relative thicknesses and erosion resistance of the formations, the most resistant being the Chalk, followed by the Crag sand/gravel. The sands above and below the Crag are much less resistant to erosion. The Chalk outcrops at Weybourne provide a potential source of flint to the beach, but this is only likely in small quantities. The chalk platform dips eastwards and to the east of Weybourne it is only present within the intertidal zone.

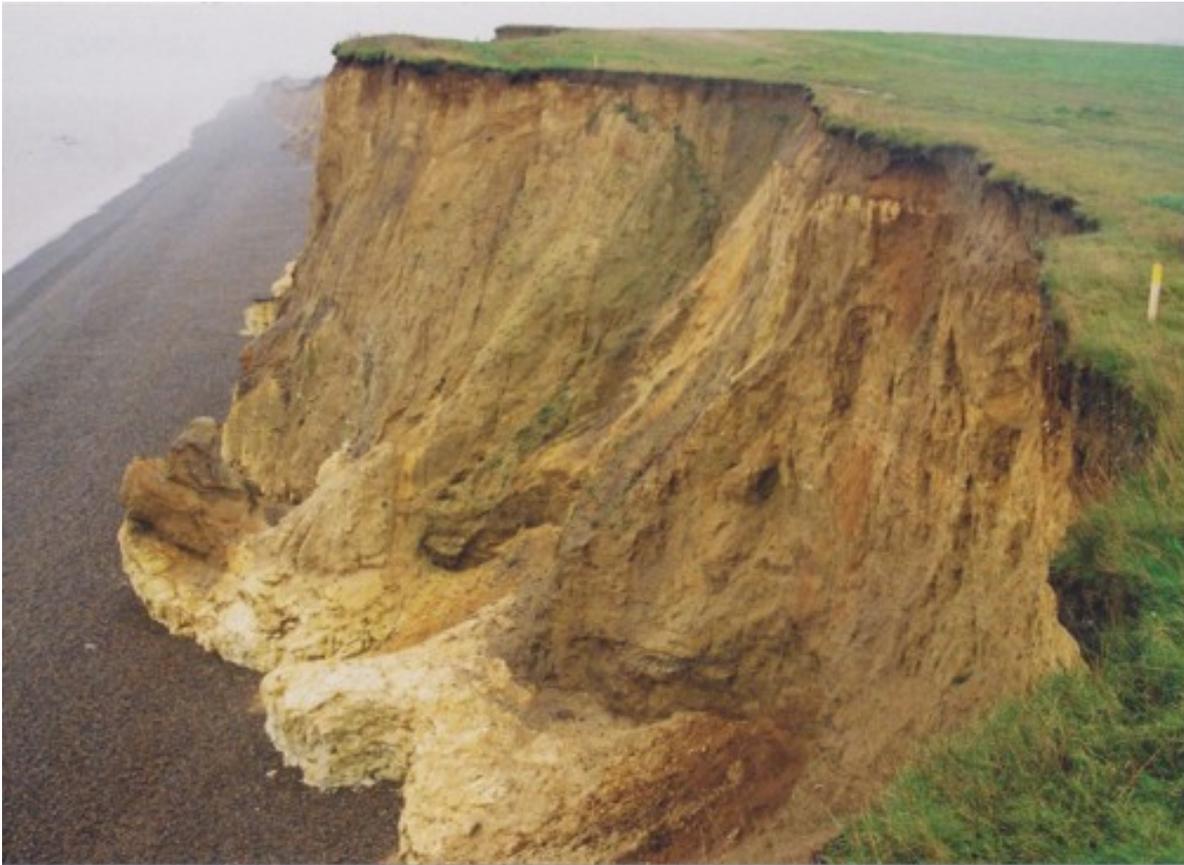
**Figure 6-10 View of cliff looking eastward**

Whilst the landslides at Weybourne are not particularly prominent, at least in comparison with the other two Norfolk test sites, the cliff is distinctly embayed (Figure 6-10). Removal of landslide debris is relatively rapid. The principal mechanism appears to be sand runs from the

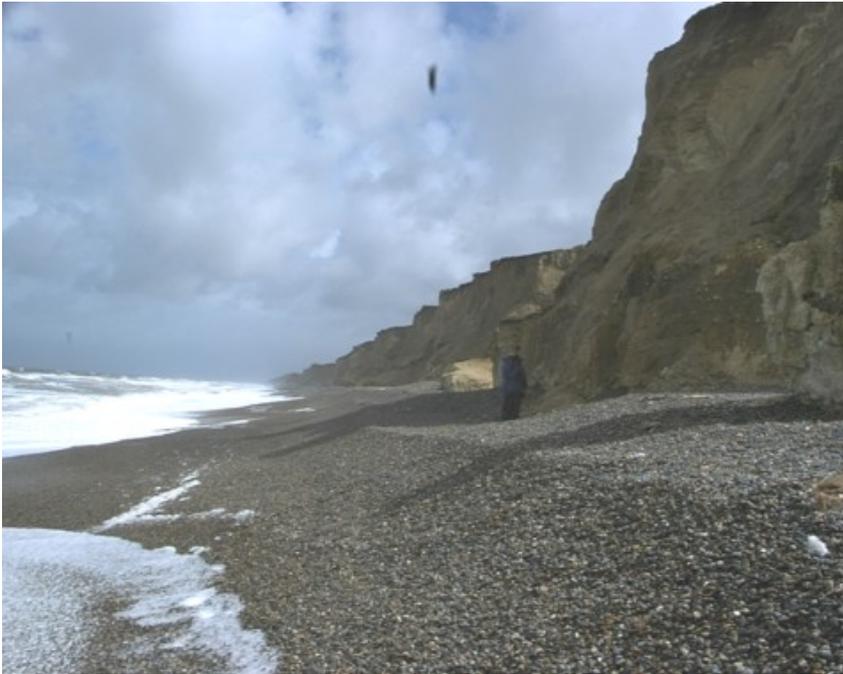
**Figure 6-11 View of shingle beach looking eastward**

The chalk platform underlies a substantial and persistent beach and has not been visible during the survey. The steeply-sloping beach consists of graded pebbles, predominantly of flint (Figure 6-11), which become increasingly coarse-grained towards the top of the beach. Much of the beach gravel is relict, with small amounts being added to the beach at present. The fine-grained sediment derived from the cliffs is largely washed offshore and represents an important source of sediment for subtidal areas (Halcrow 2002). The profile of the beach varies seasonally, but typically exhibits two distinct foreshore berms. These represent the limits of high tide swash action during spring and neap tidal cycles. The beaches are highly mobile due to the high onshore-offshore wave energy. The steepness of the beach profile serves to dissipate the high wave energy, but this energy is sufficient along this shoreline to both attack the cliffs and remove eroded material, meaning that the beach volumes do not continually increase, with rapid movement of beach material alongshore. There is a net drift of beach sediment eastwards, but this can vary in both direction and rate (Halcrow, 2002). The volume of gravel diminishes eastwards towards Sheringham, where the lower beach becomes progressively sandier.

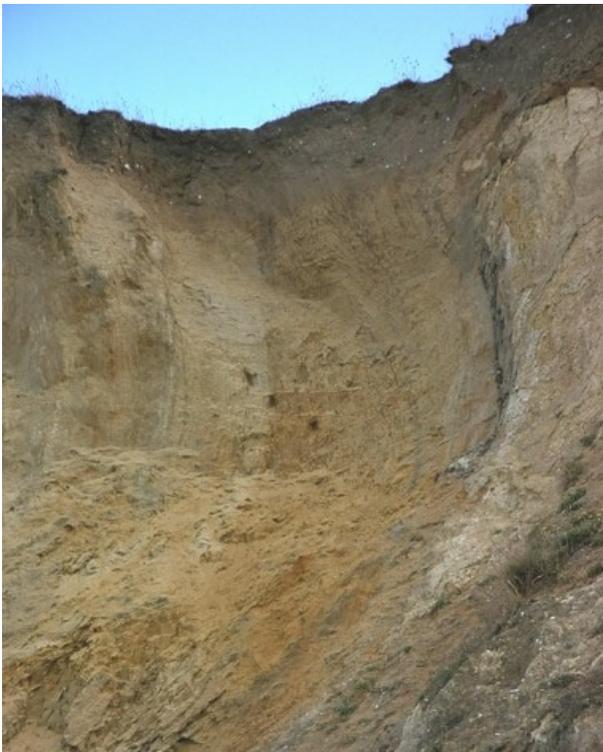
**Figure 6-12 Sand run from the Sheringham Cliffs Formation within embayment (Note: upturned bedding)**

Sheringham Cliffs Formation (Figure 6-12). Some of this activity is probably promoted by ground water seepage. Occasionally, a narrow slump is observed in the upper part of the cliff, but this is probably not the main landslide process. The chalk forming the bench tends to be brecciated and erodes by mechanical erosion, accompanied by dissolution from seawater rainwater and groundwater. Small block falls, controlled by bedding thickness and joint/fracture spacing, also occur. The flint beds provide some ‘reinforcement’ to the chalk against the direct mechanical erosion by the sea.

As shown in Figure 6-15 the only recession event of any significance took place between September 2002 and September 2003 at one embayment location (Figure 6-12, Figure 6-14) within the test site. This location appeared to be affected by the structural conditions of the dominantly sand-rich formation locally in the mid and upper-cliff. The chalk forming the lower cliff was unaffected by slope instability but has undergone erosion over the monitoring period.

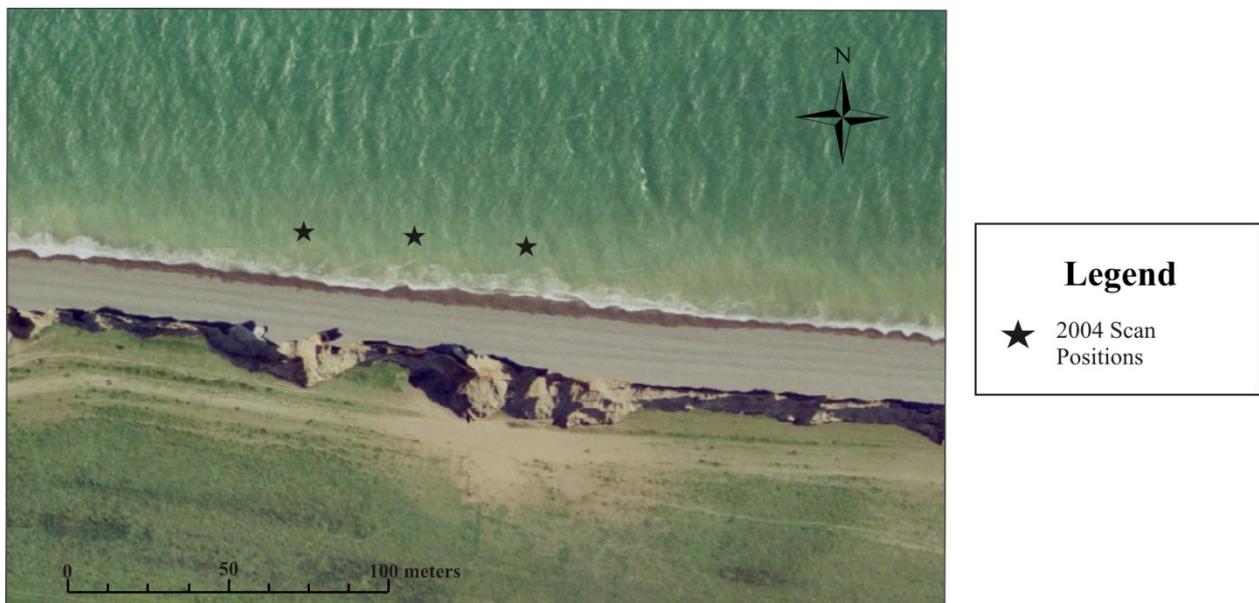
**Figure 6-13 Plan of scan locations at Weybourne test site**

(NOTE: aerial photo 1999). Scan positions NGR: 611381, 343678. 611349, 343683. 611320, 343684.

The rate of erosion at the test site at Weybourne has to date been monitored in 2001, 2002, 2003, and 2004 (Appendix 2) using the laser scan (terrestrial LiDAR) system combined with GPS. Figure 6-13 shows the position of the scan locations and target points from the 2004 survey.

The position of scans taken in 2006 at the Happisburgh site is shown in Figure 6-13.

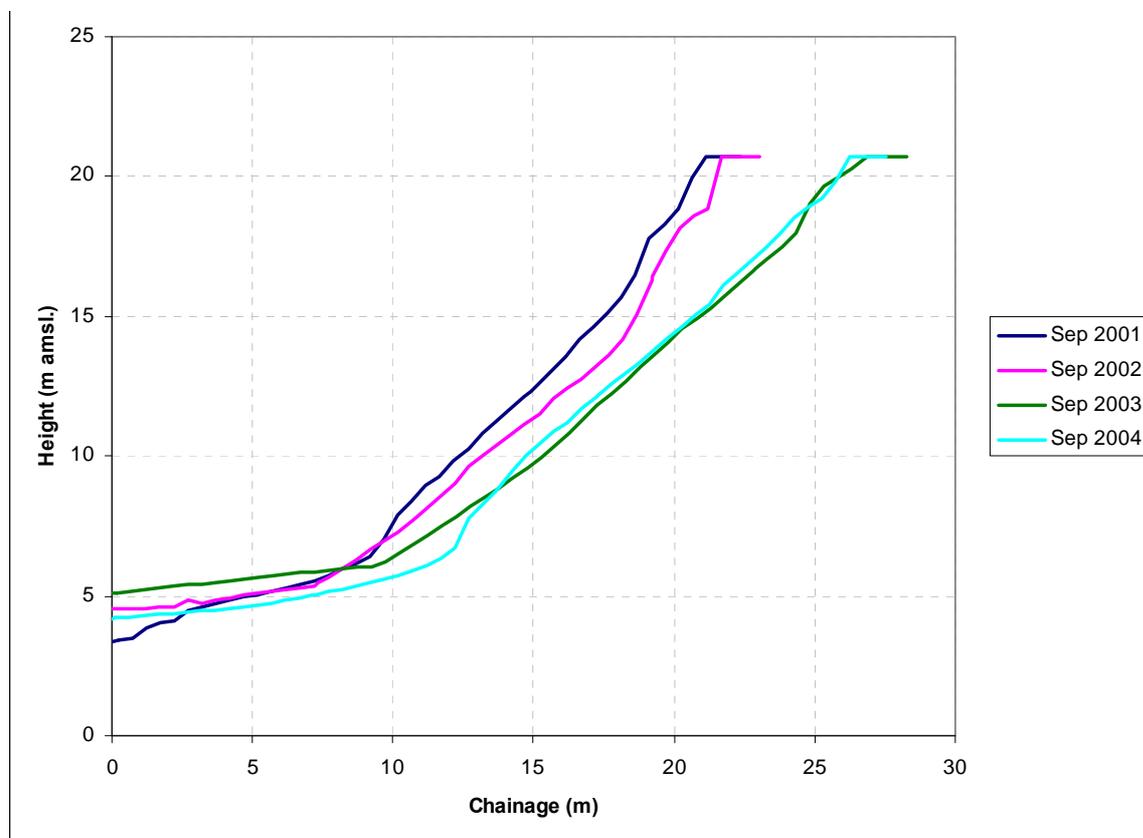
**Figure 6-15 Cross-sections, Weybourne, 2001-2004**

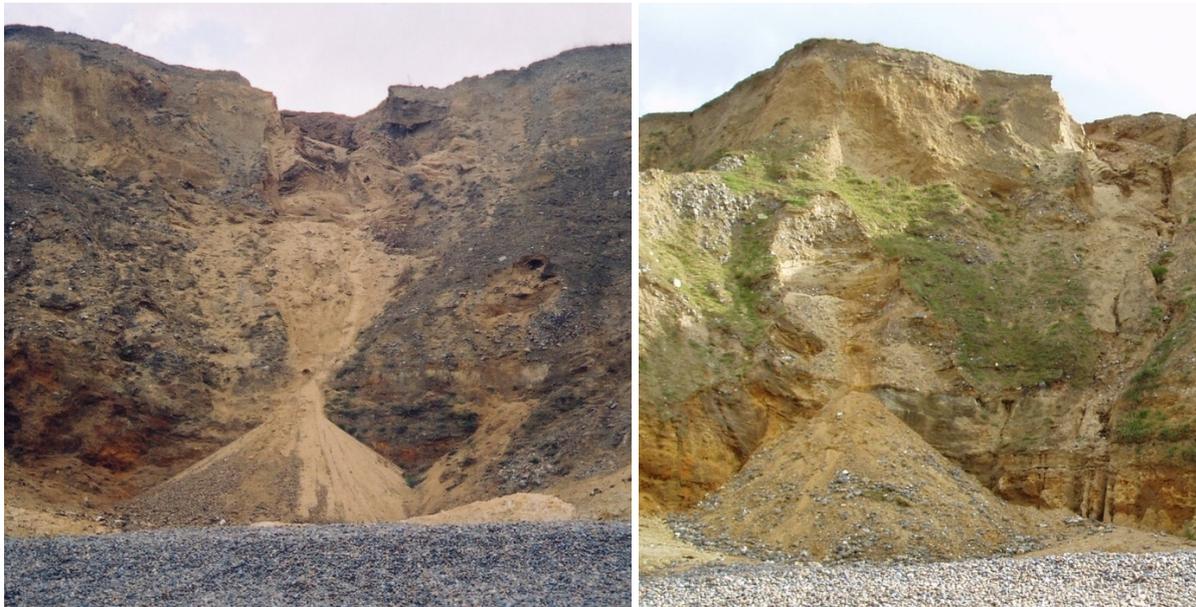
**Figure 6-18** Examples of sand runs at Weybourne in 2003 (left) and 2004 (right)  
Section heights approx. 20m
