# BGS cruise to Rockall-Hatton-Faroes region Project 06/02 RRS Charles Darwin CD180 Operations Report

Marine Coastal and Hydrocarbons Programme

Internal Report IR/06/076

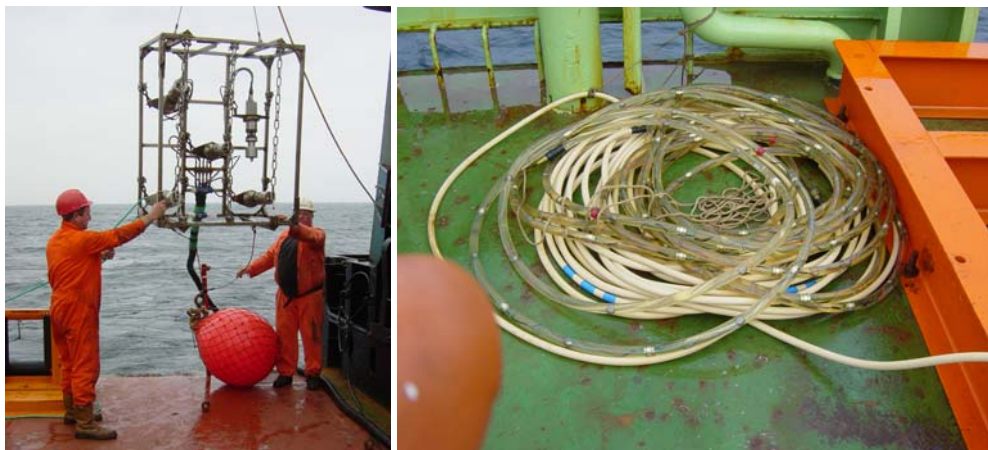
**Source:** An array of 5 x 40 cu inch Bolt 600B airguns with waveshape kits and time break solenoids was utilised as the airgun source. Routinely, up to four guns were fired simultaneously, keeping the fifth gun as a ready spare. The number of guns used varied with water depth, with a minimum of 1 being used in the shallower areas. The firing rate varied from 6 – 7 seconds depending on water depth. The airgun array firing synchronisation was achieved by monitoring the time break solenoids and manually adjusting each airgun's trigger as required. This introduces a short time delay into the system of between 25 and 38 milliseconds and thus the sea-bed return time is not an absolute measurement of depth. A 20ft compressor container belonging to BGS containing two CompAir Reavell type VHP36 compressors supplied the high-pressure air for the airguns. Air was fed from the compressors through the vessel's internal pipe-work to the aft deck and connected into the BGS airgun control panel.

Plate 1 Deployment of Airguns and 30m-hydrophone streamer

**Hydrophone:** A 4 channel SIG hydrophone summed to give a single channel 32m active length was utilised as the receiver for the airgun source.

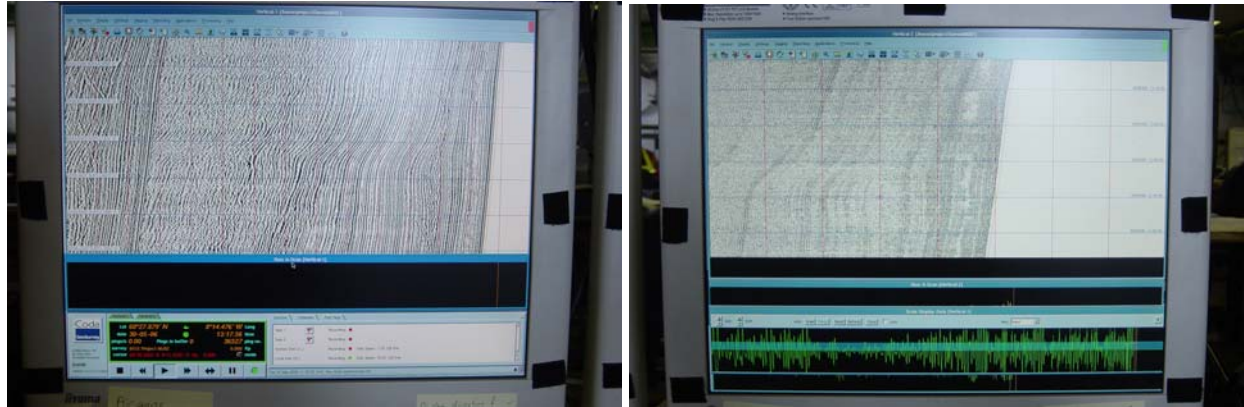
**Recording:** The BGS CODA DA200, software version 3.9.11.5L(3360) 2005 four-channel digital recording and processing system was utilised to record the raw data. The data were recorded to Flipdisks in CODA format with a sampling frequency of 3kHz, record length of 4 seconds and bandpass filter of 25-800 Hz. The start of recording was delayed in deep water to permit a minimum of 2 seconds of data below the sea-bed. The CODA system also received a navigation data string from the vessels Trimble DGPS system, and logged position, time and date for each shot.

**Plate 2 Screen images of Airgun and Sparker data**

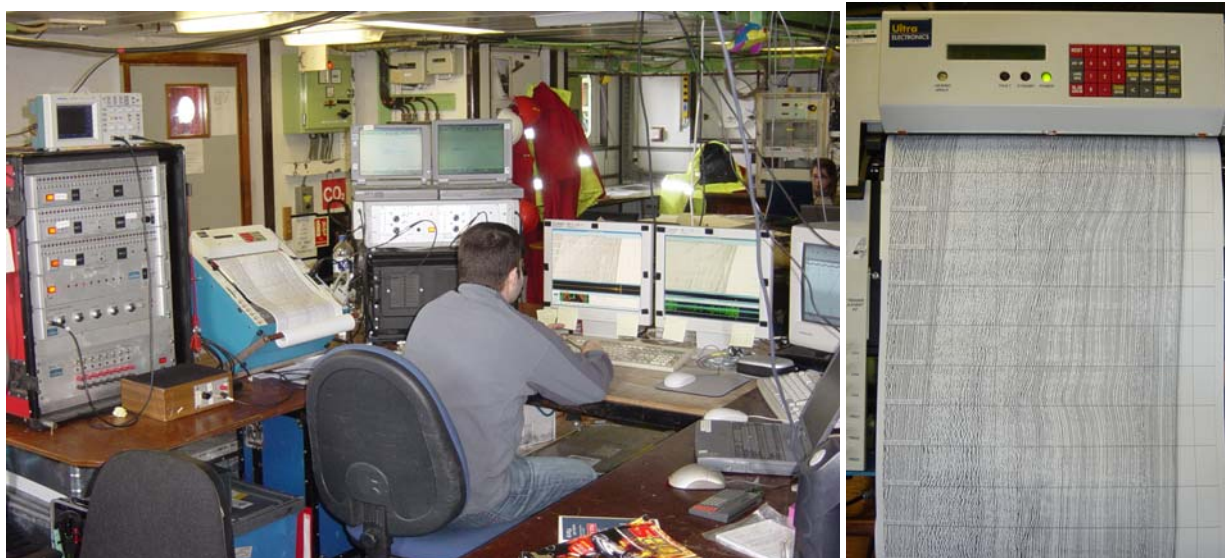
**On line processing:** In addition to the recording described above, the CODA system was also used to process the data on-line and produce a real time hard copy output on an Ultra 120 thermal printer. Processes applied were time varied gain (TVG), time varied filtering (TVF) and trace mixing and, in extremely large amplitude sea swell situations, a swell filter. Both TVG and TVF were applied from the sea-bed, which was tracked automatically. A 1.5 sec record length was used for the on-line hard copy, with a delay adjusted to give an optimum record for the water depth.

**Plate 3 Seismic reflection recording layout and hardcopy printer**

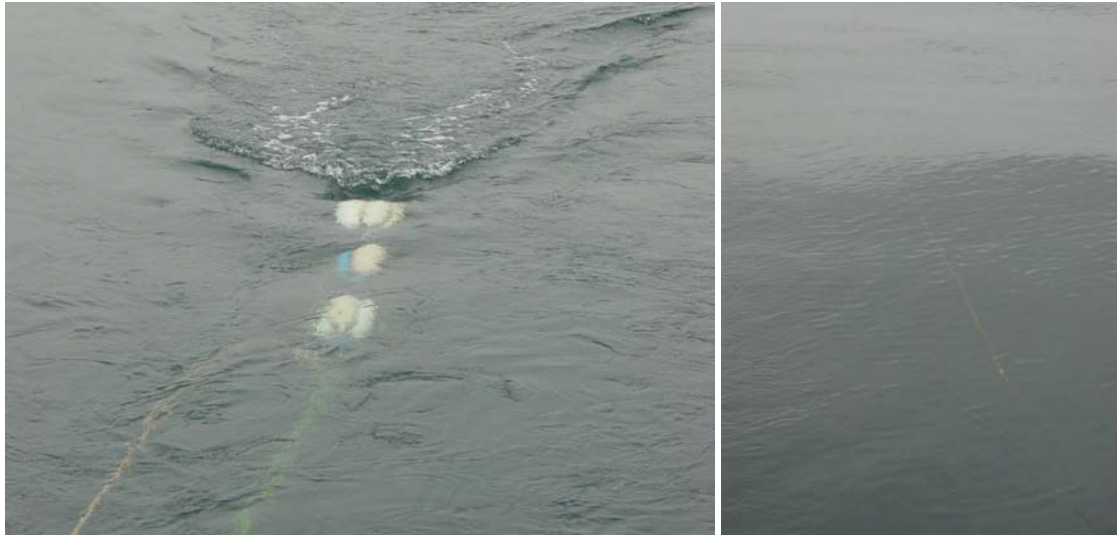
**Source:** EG&G, nine candle, multi-tip sparkarray with 135 tips was utilised as the sparker source.

**High Voltage Power Supply:** An Applied Acoustic Engineering CSP2200 capacitor charging unit. This is a single unit, powered from the ship's 240VAC supply incorporating switchable output energy up to a maximum of 2200 J. Apart from lines 2-5 (1800J) the whole survey was conducted at an output of 2200 J.

**Plate 4 Sparkarray and hydrophone 10m hydrophone streamer on an exceptional calm day**

**Hydrophone:** A seven channel Teledyne 10m hydrophone, summing on the most part, all channels to give a single output, was utilised as the receiver for the sparker source.

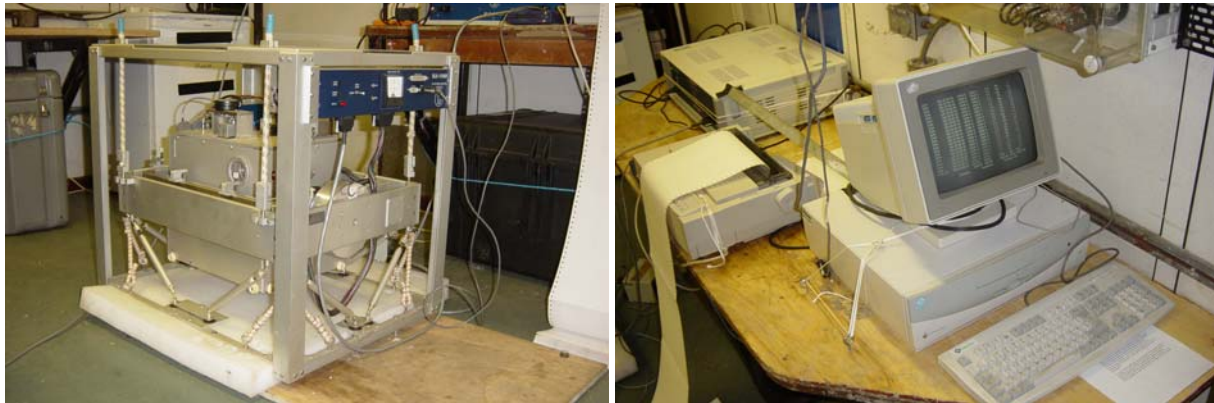
The gravity meter used was a ZLS Corporation UltraSys controlled LaCoste and Romberg sensor serial No. S75 system. This consists of a highly damped, zero-length spring type gravity sensor mounted on a gyro-stabilised platform, together with associated control and recording electronics. The sensor and control electronics were located in the 'Controlled Temperature Laboratory' adjacent to the 'Main Laboratory', this allowed easy access for observation. It was impractical to mobilise the meter in the vessel's 'Gravity Room' due to access restrictions for

both equipment and cables to main lab. Gravity was measured continuously and the gravity, spring tension and cross coupling correction values were logged at a one second interval in L&R Long Format onto the ship's logging and processing system and internally in the gravity control computer. Additional backup data storage was achieved through utilising the zip drive incorporated with the gravity control computer. Data were also output to a colour printer for QC purposes. No data processing was carried out on the vessel.

**Plate 5 Gravity meter and recording PC**

The vessel suffered two complete blackouts during the transit to the work area. This resulted in the meter losing power and having to be clamped and kept on heat using a battery powered, power supply. At the time of writing it is unknown if these two power blackouts have had an affect on the data, although this felt unlikely. However it was observed that the internal pressure within the meter varied with atmospheric pressure and this should be corrected for using the approximation of 1mGal for every 4Hpa of pressure change. This fault should be repaired before the next cruise.

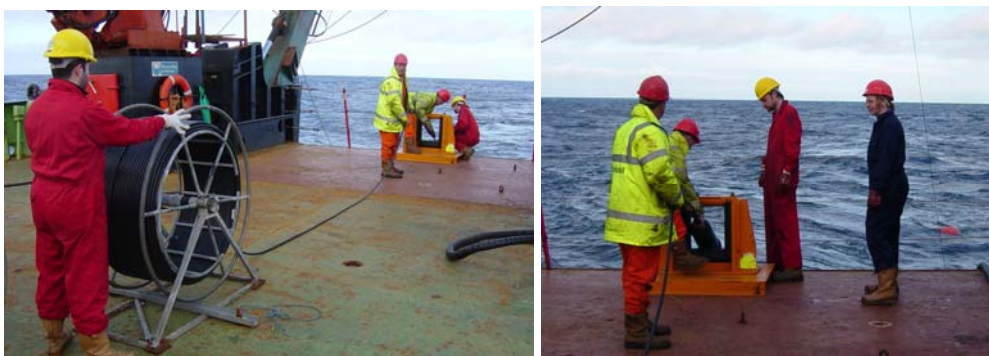
The system used was a Barringer proton precession magnetometer with a 1 gamma sensitivity. The sensor was towed 200 m astern to minimise the effects of the vessel's steel hull on the local magnetic field. The system was triggered by the seismic control system such that the sensor was polarising when the sparker fired. This eliminated electrical interference from the sparker discharge. The data were converted from parallel Binary Coded Decimal (BCD) data to serial data within a BCD to serial converter before being logged onto the ship's logging and processing system.

**Plate 6 Deployment of marine magnetometer**

This very elderly system performed as well as can be expected, though suffered from noise on some lines. Consideration should be given to the replacing this ageing system, to a system that is higher resolution and easier to interface and record the data, both hard copy and digital as paper and pens are becoming expensive and difficult to source.

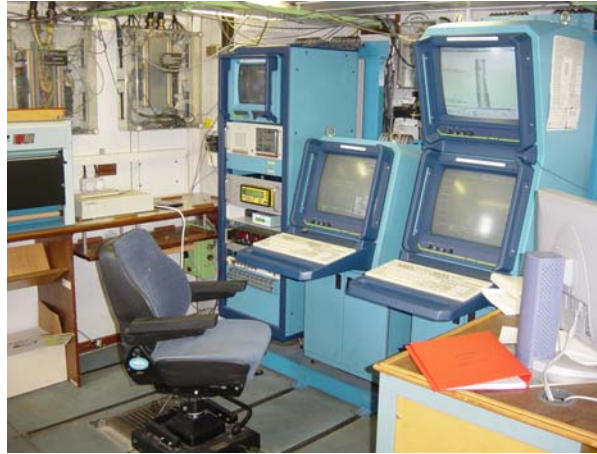
The vessel has an elderly deep water Simrad EM12 multibeam system, which was used throughout the survey. Checks of the multibeam calibration were made when the vessel arrived at Rockall Bank. Lines were run up the bank and down on a reciprocal course. Unfortunately the weather was too severe for the vessel to run an accurate reciprocal course. A further line was run back up the slope, however the data was lost when the vessel had a complete blackout. After half a day of attempting to check the calibration of the multibeam system without success, coupled with the poor weather conditions, it was decided, with advice from the multibeam operator on board that no further attempts would be made. The vessel was weathered off for next 12 hours.

**Plate 7 Simrad EM12 multibeam recording and processing**

Note: The calibration of the multibeam historically has proven to be stable and as such no recalibration was deemed necessary or was planned for this project. The attempted checks of the multibeam calibration were just that, checks.

Several sound velocity profiles were made throughout the survey, Rockall Bank, before the start of line 12 and the Faroe Bank Channel. It was noted that the Faroe Bank Channel had fresh water close to the seabed.

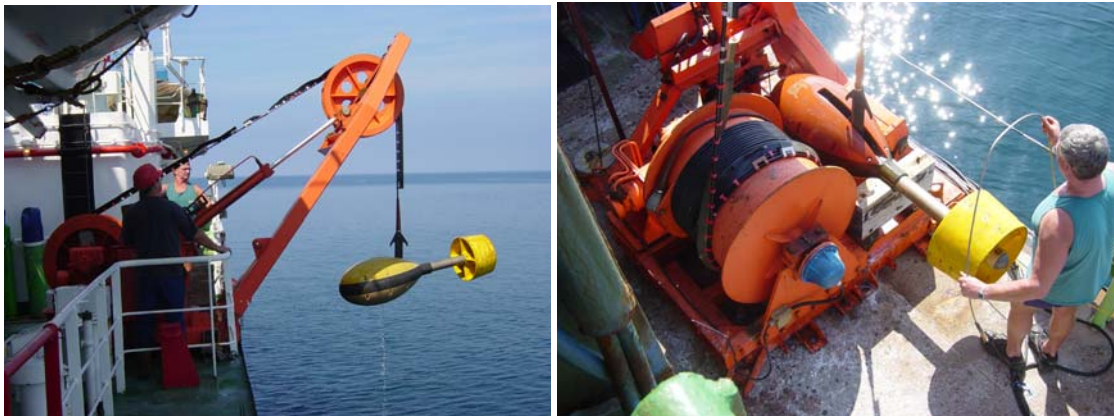
The 3.5kHz pinger is a transducer mounted in a tow fish and was towed over the starboard side. This was controlled by an IOS transceiver with the data recorded on a CodaOctopus360 acquisition system and was part of the standard shipboard equipment. The pinger gave poor sub-bottom records compared with the sparker system and was affected by the sparker especially in the St Kilda and Stanton Bank areas where the sparker was fired at the higher rate of 0.6 sec.

**Plate 8 Recovery of PES (port) and Pinger (Starboard)**

The Precision Echosounder (PES) is a 10kHz IOS transducer mounted in a tow fish and deployed off the port side close to amidships. This is controlled by a Simrad EA500 transceiver and display and was compensated for fish height with the depth recorded centrally. Paper printout was only collected for the lines around St Kilda and Stanton Bank.
