Landslide Survey of North Yorkshire: Reconnaissance Report

Internal Report IR/06/039

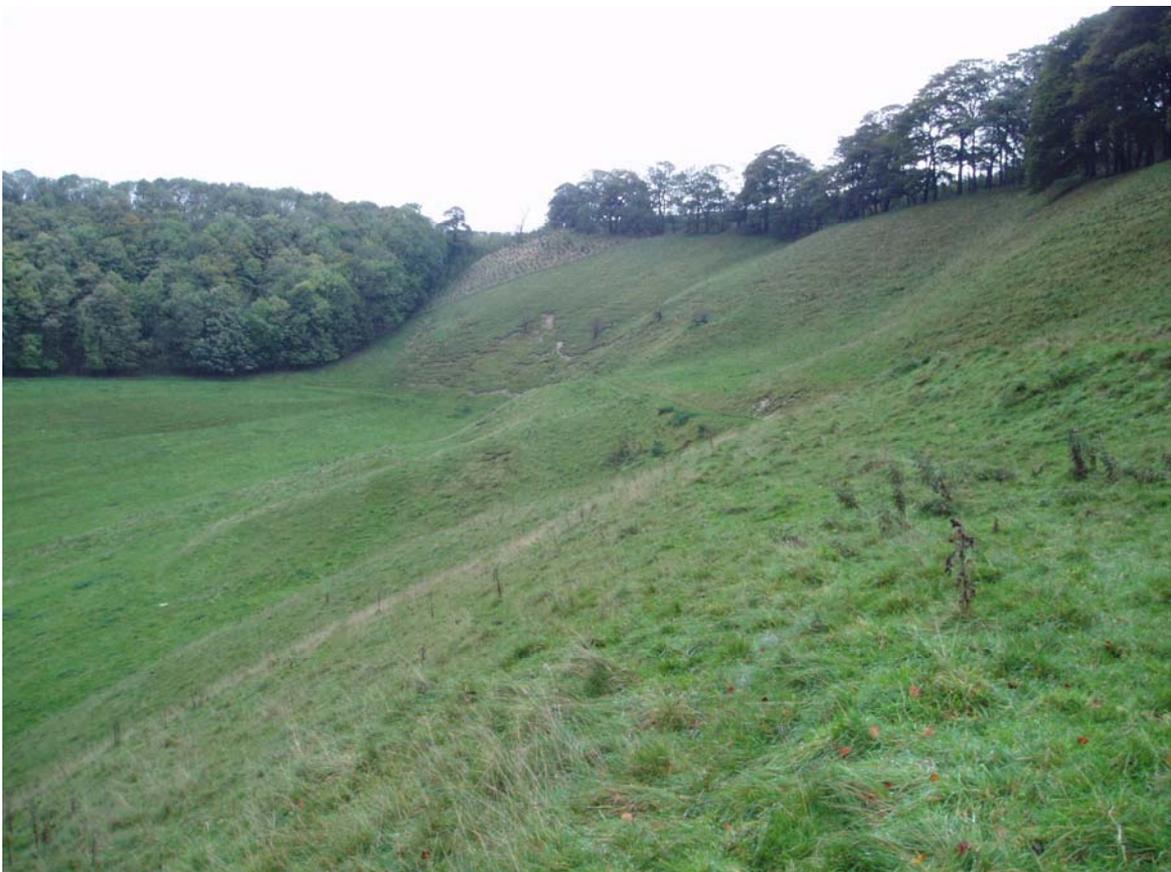
Figure 5. Slope at Uncleby displaying creep. Photograph taken from 481482 459408, orientation 060°(NE).

The slope at Uncleby (Figure 1) consists of the Whitby Mudstone Formation, overlain by the Saltwick Formation (and possibly the Leberston Member) and the Chalk Group. Local topography is characterized by the presence of a series of large steps at the foot of a steep cliff formed within the Chalk (Figure 5). It is inferred from these that the steps are actually the remains of blocks from the overlying Gristhorpe Member and Chalk that have moved downslope, most likely from weaknesses and movement within the underlying Whitby Mudstone Formation. Further evidence for slope instability is shown in the form of soil creep at the back of the photographed embayment (Figure 5).

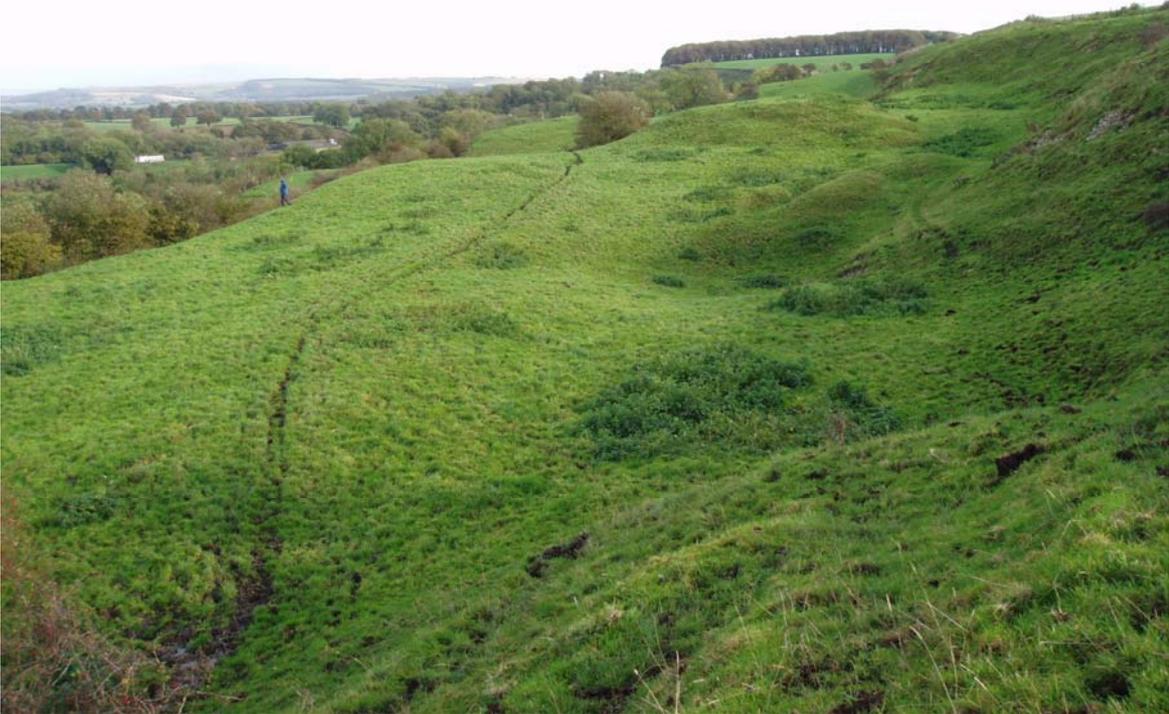
Figure 6. Slope at Leavening Brow. Photograph taken from ⁴⁷⁹⁵⁶⁵ ⁴⁶³⁴⁰⁸, orientation 070°(ENE).

The slope at Leavening Brow is composed of a complex landslide on a large scale. On the lower part of the slope, below the road, blocks of the overlying Chalk have rotated on the Kimmeridge Clay. The landslide is very large, of the order of 100's of metres in width, and its length covers the upper half of the entire slope. On the upper part of the slope, above the road, there is also possible evidence of cambering. However due to the subdued nature of the slope (a result of a long legacy of farming), key geomorphological features are difficult to distinguish.

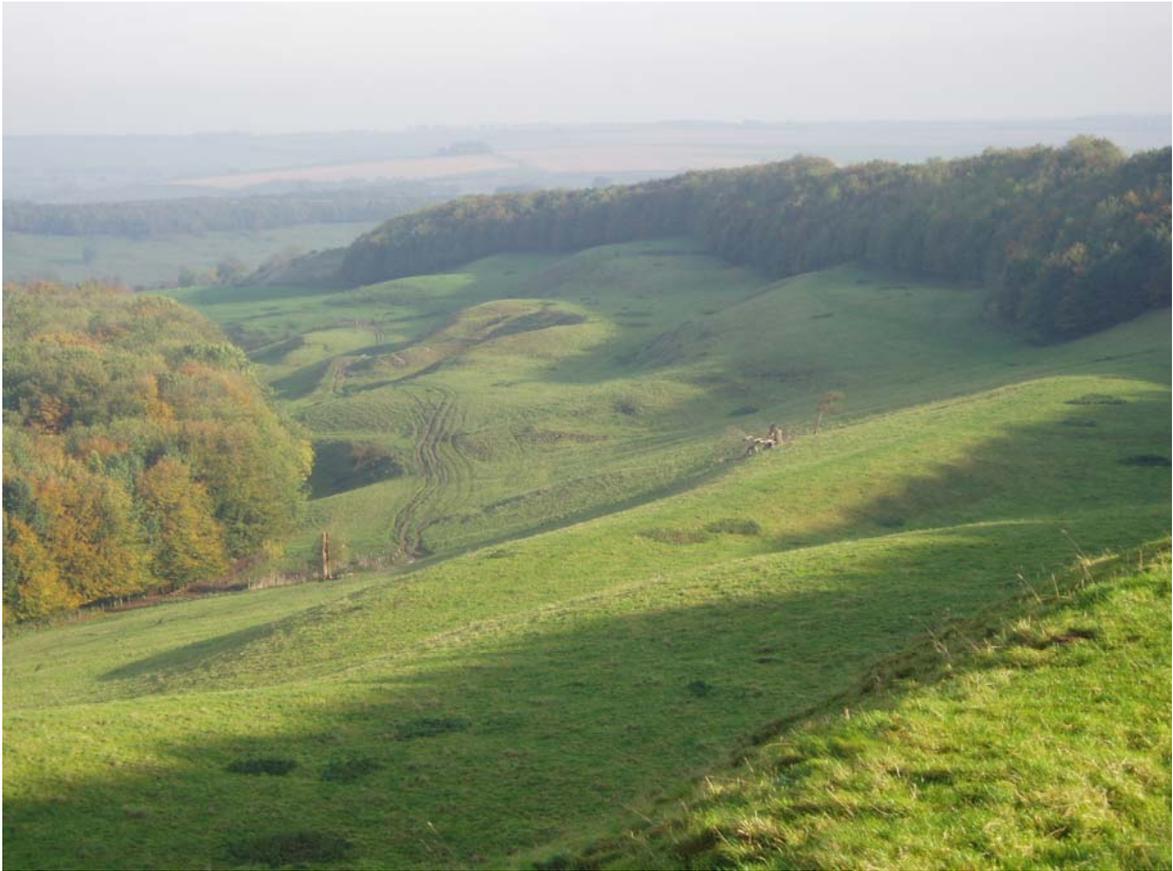
The geology at Birdsall Brow is similar to Leavening Brow, with Kimmeridge Clay underlying the Chalk. The slope is almost entirely composed of Kimmeridge Clay, with the Chalk occupying the very top of the slope. The stepped topography of the area again suggests that a series of blocks from the Chalk have failed in a rotational manner, with a failure surface within or near the Kimmeridge Clay Formation. The slope at Birdsall Brow displays a large landslide complex, with little of the slope *in situ*. There are a number of different processes and mechanisms of movement evident, and further survey is necessary to confidently categorise the nature of the landslides in detail.

Figure 7. Eastern end of Birdsall Brow. Photograph taken from $483654\ 463983$, orientation $045^\circ(\text{NE})$.

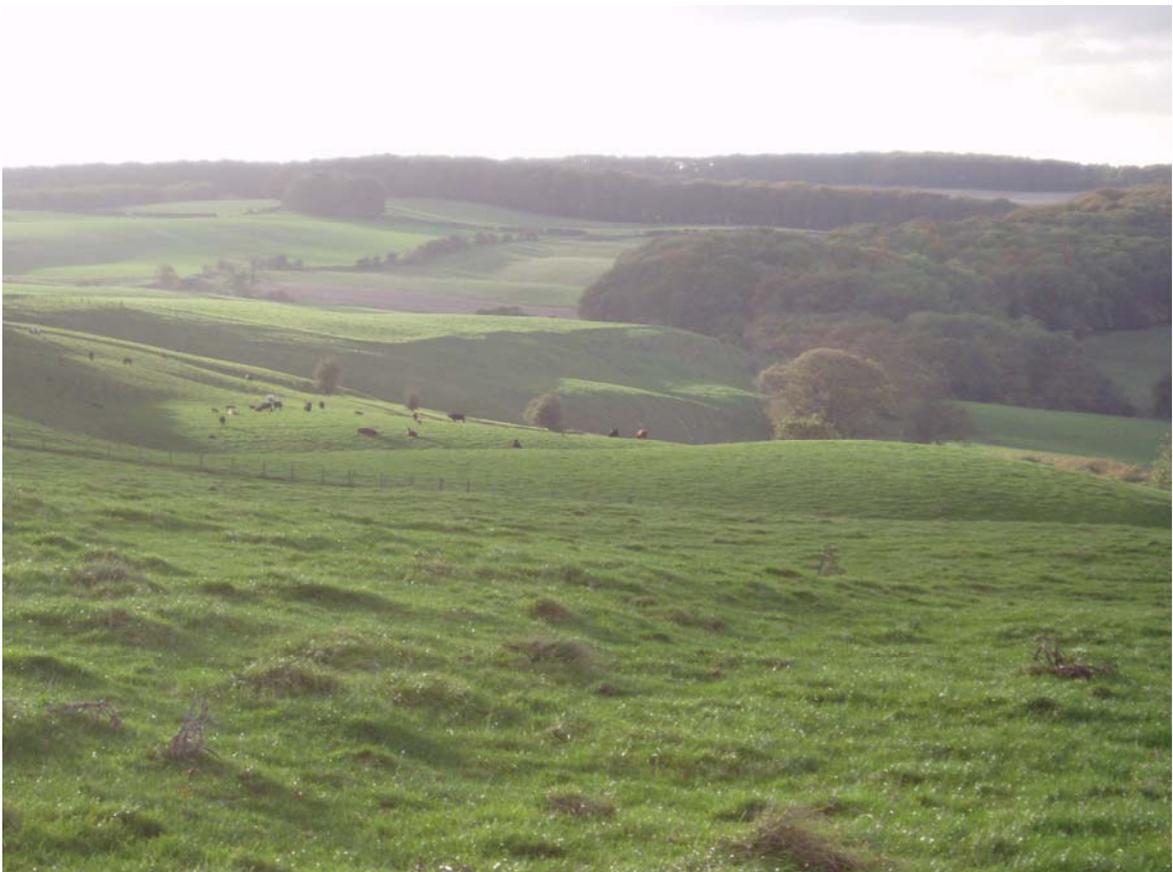
Figure 8. Western end of Birdsall Brow. Photograph taken from $483150\ 463676$, orientation $270^\circ(\text{W})$.

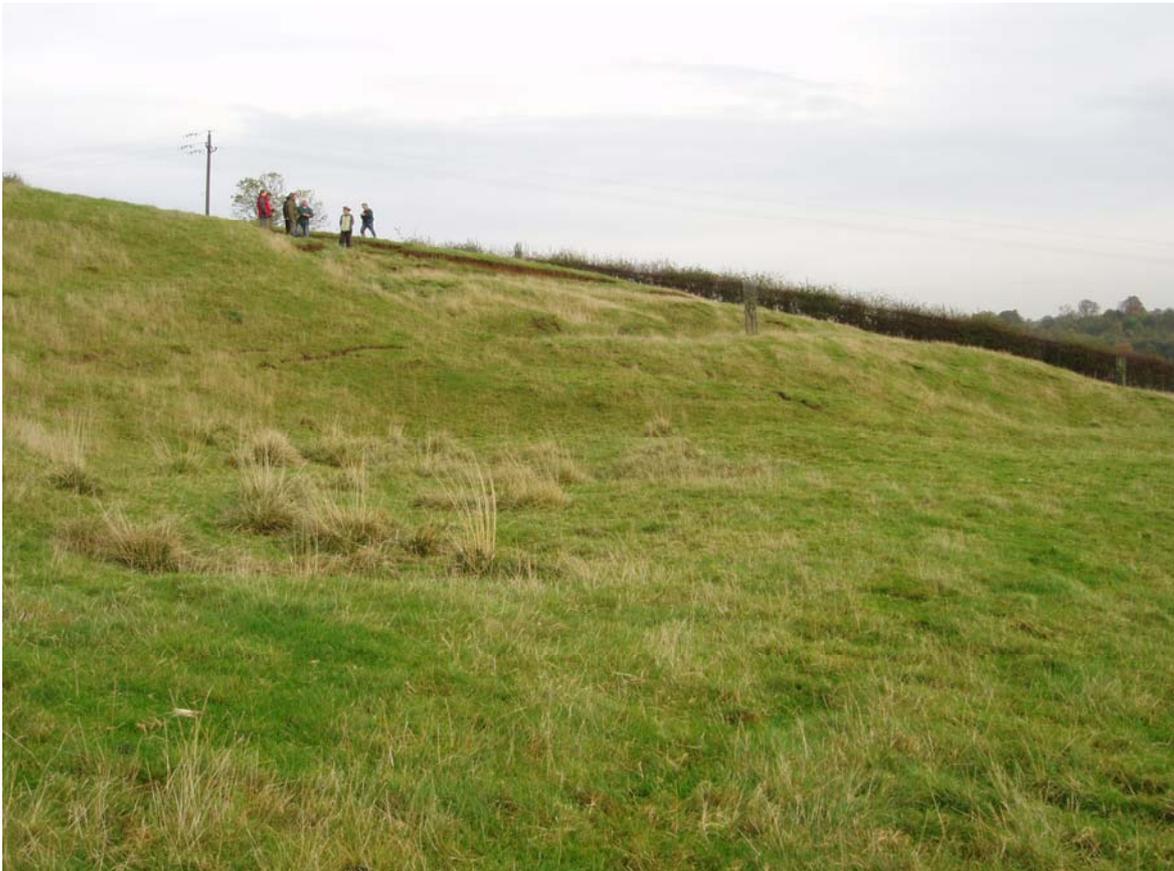
BGS was alerted to the presence of a landslide at Birkdale Farm by the landowner, Mr Stephen Gibson, who approached field survey geologist Jon Ford at a meeting of the Ryedale Vernacular Building Materials Research Group. A survey was undertaken at the farm by the landslide and mapping team during the October field reconnaissance survey. The slope at Hollin Hill consists of the Redcar Mudstone Formation (Lower Lias) at the base, with an outcrop of the Staithes Sandstone Formation and Cleveland Ironstone Formation (undivided), (Middle Lias) running across the middle section of the slope (evidenced from sandy soil excavated by badger setts). The Whitby Mudstone Formation (Upper Lias) overlies this, with the upper part of the slope composed of the Dogger Formation. Both the Redcar Mudstone Formation and the Whitby Mudstone Formation are highly susceptible to landsliding, and movement across the entire slope is facilitated by these two Formations.

Figure 9. Part of the landslide complex at Hollin Hill, Birkdale Farm. Photograph taken from $468122^{\circ}468895'$, orientation 045° (NE).

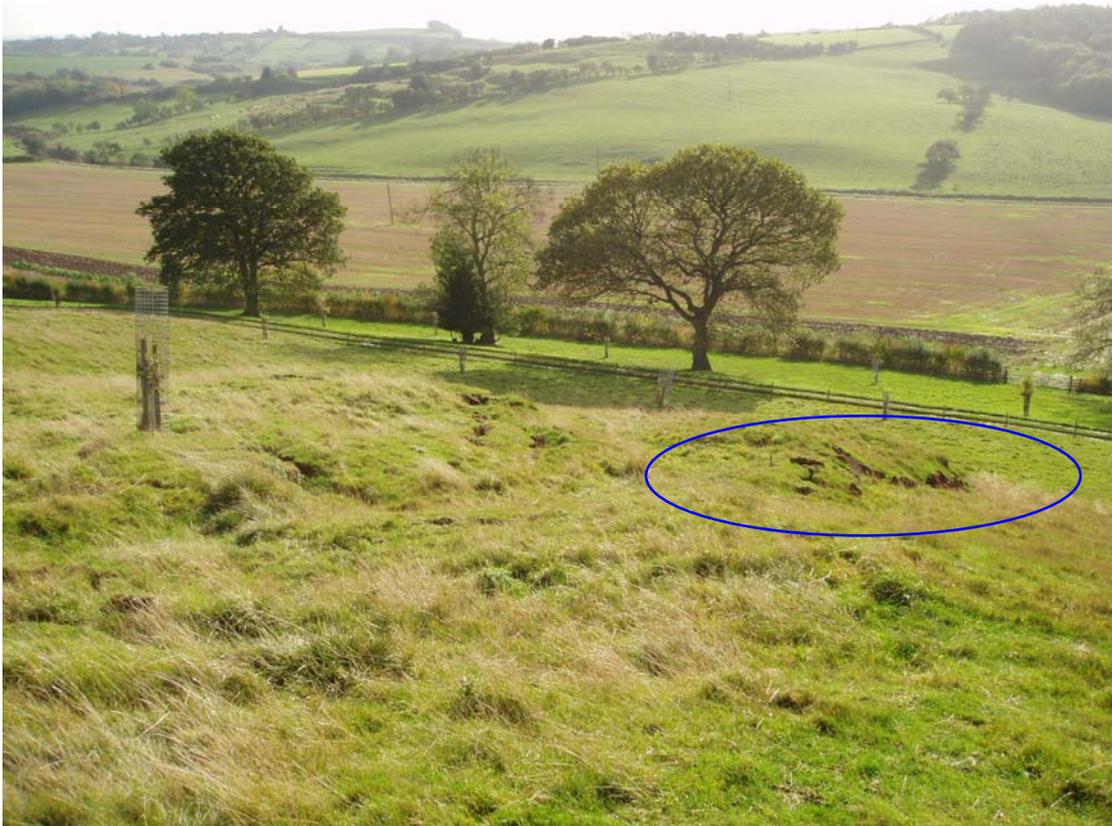
A second survey was undertaken at Birkdale Farm in March 2006 by Gareth Jenkins, Lee Jones and Mike Raines to assess the site for a terrestrial LiDAR and geophysics survey. The two photographs taken below (Figures 11 and 12) show that the site is active, with the first photograph taken in October 2005, and the second in March 2006. The later photograph displays movement, albeit on a small scale, but notable blocky failure is occurring along the failure planes of the hummock. A further survey is planned for summer 2006 to provide baseline data for future integrated monitoring of movement on the slope.

Figure 10. October 2005 view of Hollin Hill landslide. Photograph taken from $468050\ 468807$, orientation 165° (SSE).

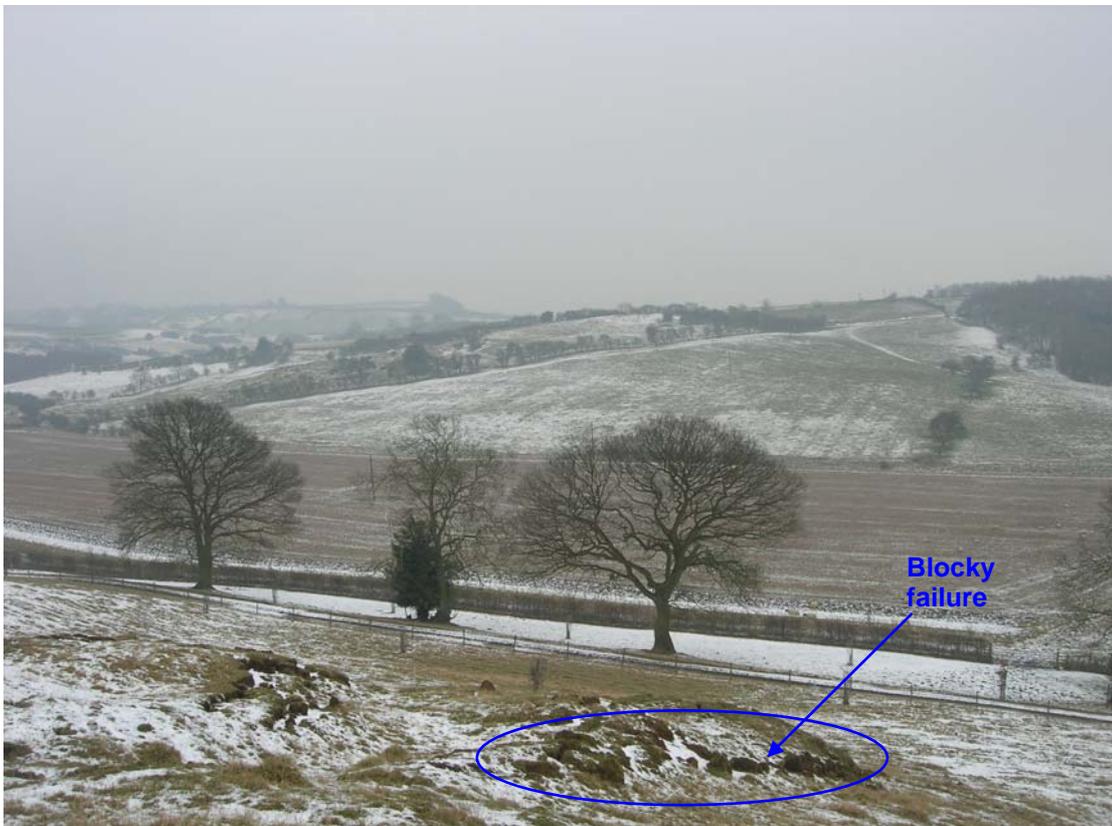
Figure 11. March 2006 view of Hollin Hill landslide. Photograph taken from $468050\ 468807$, orientation 145° (SSE).

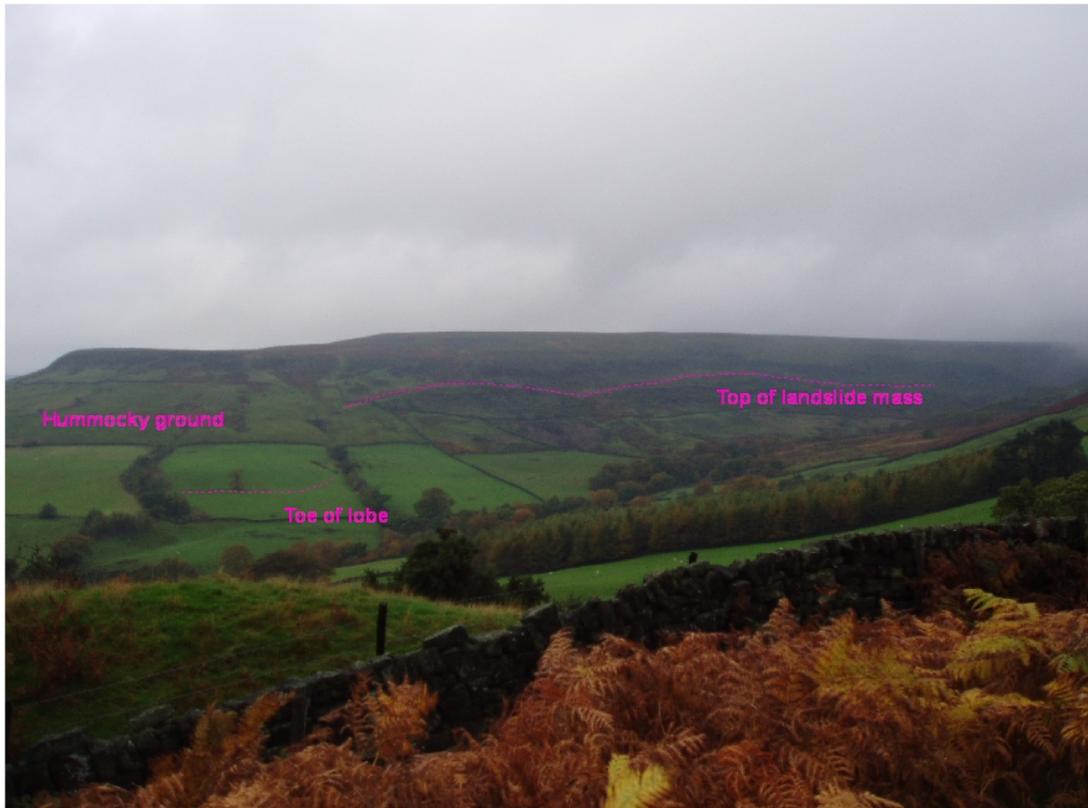
The BGS landslide team were also interested in evaluating the extent of landslide activity in the North York Moors National Park. Two sites were visited (Figure 2) based on their geology and characteristic geomorphological features identified on DTM plots of the area. The first site, at Church Houses in the central part of the moors (GR 466965 497496) provided an excellent panorama of the valley slopes, with landsliding evident in a number of locations. The valley slopes are predominantly underlain by the Whitby Mudstone Formation. It was difficult to distinguish without further inspection, which geomorphological features related to mass movement and which were *in situ* sandstone benches (Figure 12). However the majority of slopes showed some evidence of landsliding and suggested further survey of the area would yield sufficient useful evidence to produce an accurate landslide hazard map for the North York Moors.

Figure 12. Slope above Church Houses, North York Moors. Photograph taken from 467783 498526, orientation 290°(WNW).
