# Improvements to the SEPA groundwater monitoring network in the Stranraer area

Commissioned Report CR/06/004N

D F Ball and M T Graham

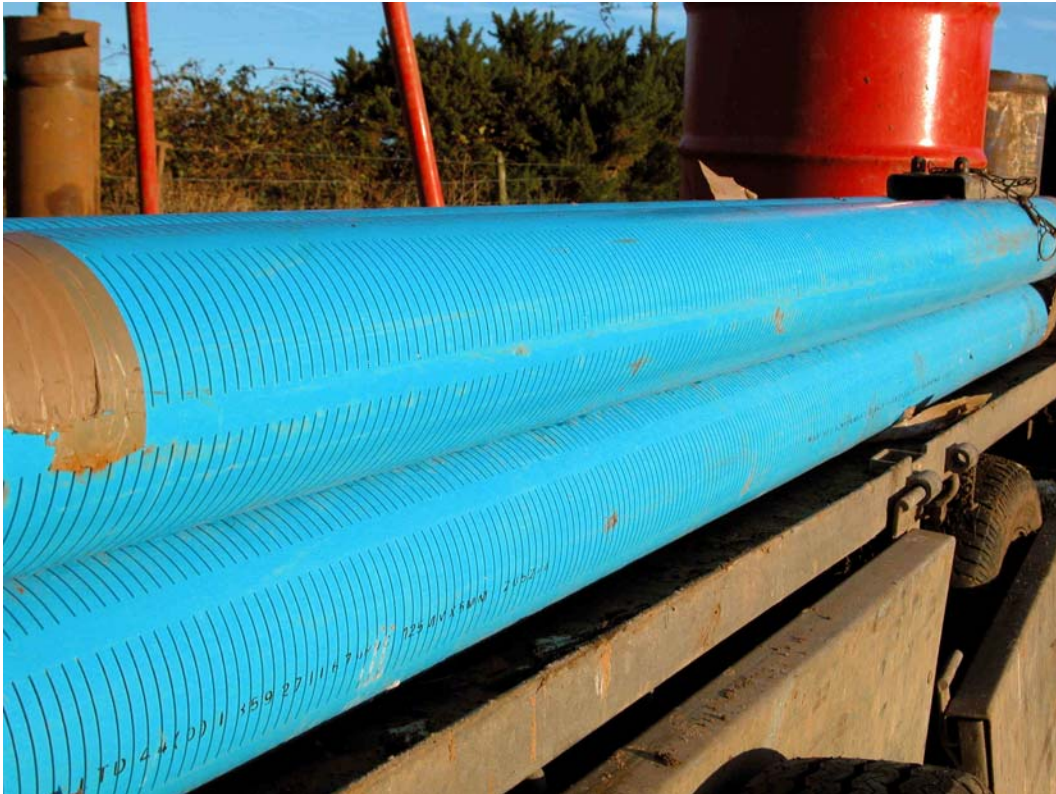
Figure 3 125 mm diameter plastic well screen was used in the boreholes

Details of the drilling specification are given in Appendix 1. The abstraction boreholes were all drilled using 350 mm diameter percussion drilling equipment. A 125 mm od diameter plastic slotted well screen (Figure 3) was installed in each borehole and a 1.9 – 2.6 mm diameter washed gravel filter pack installed adjacent to the screened section (Figure 4).

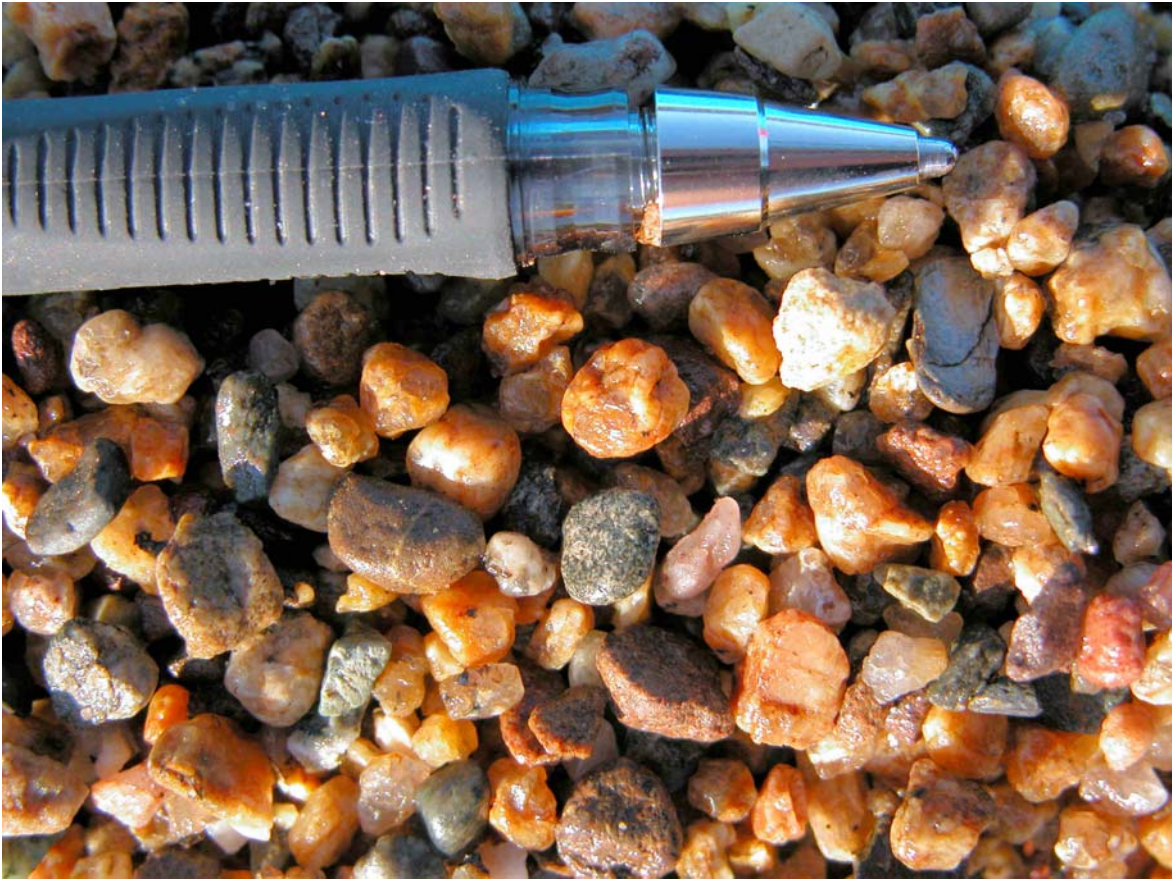
Figure 4 A 1.9-2.6 mm diameter gravel filter pack was used in all boreholes

The filter pack is approximately 80 mm thick and is designed to restrict the ingress of fine-grained sand to the boreholes. All three boreholes, upon completion, were air-lifted for a minimum of 3 hours. Each borehole was completed at ground level with a concrete chamber within which there is sufficient space to install a water pressure vessel for supply purposes (the borehole at Mark farm was fitted with such a tank during the site work). Each borehole was equipped with an electrical submersible pump, complete with cabling to the chamber. Ducting to enable water pipes and surface cables were also installed in the surface concrete plinth.

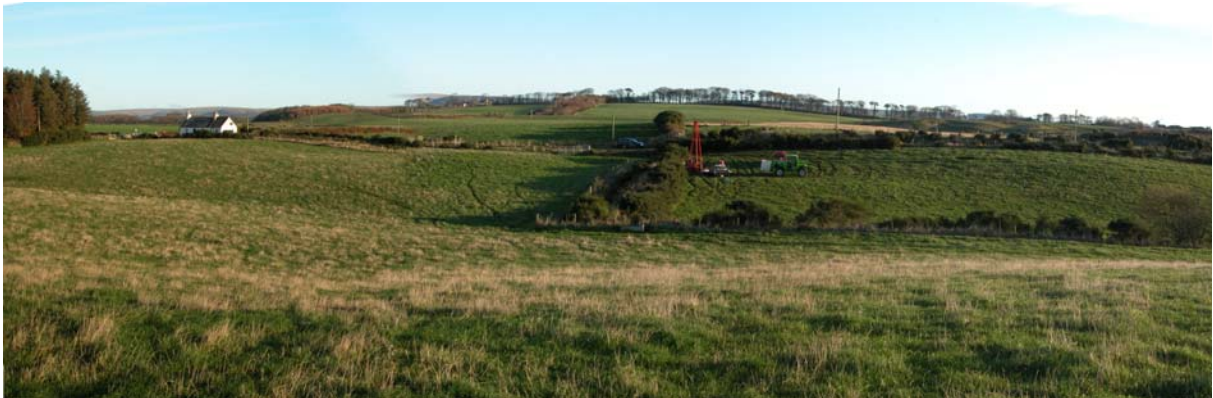
Figure 9 Culgrange borehole

Figure 9 shows the site, with the borehole near the middle of the scene. The spring is to the left of the hedge. The farm buildings are to the right of the photo.

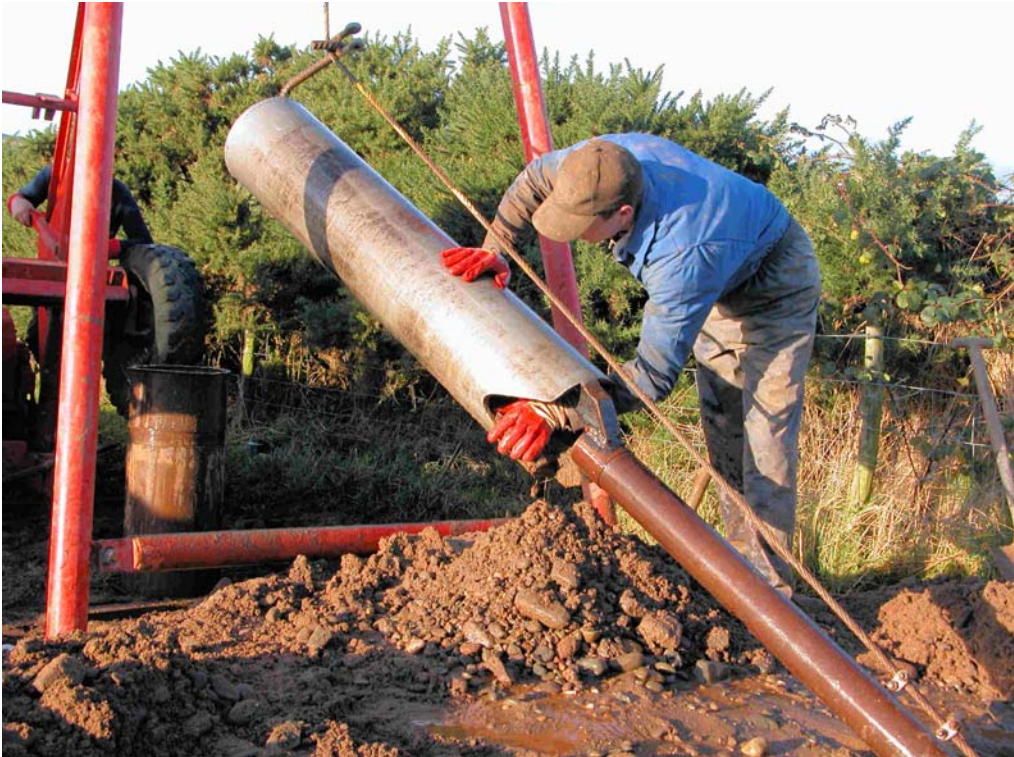
Figure 12 Emptying sand and gravel from the drill tool

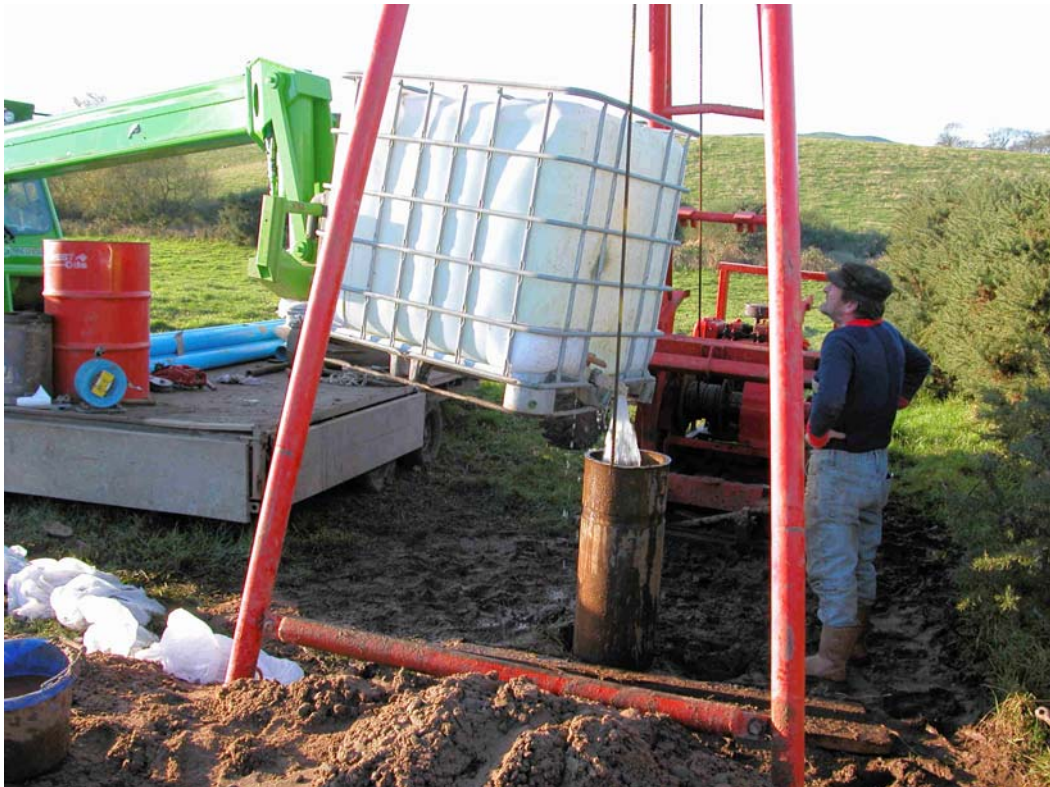
Figure 13 Adding water to aid the drilling process

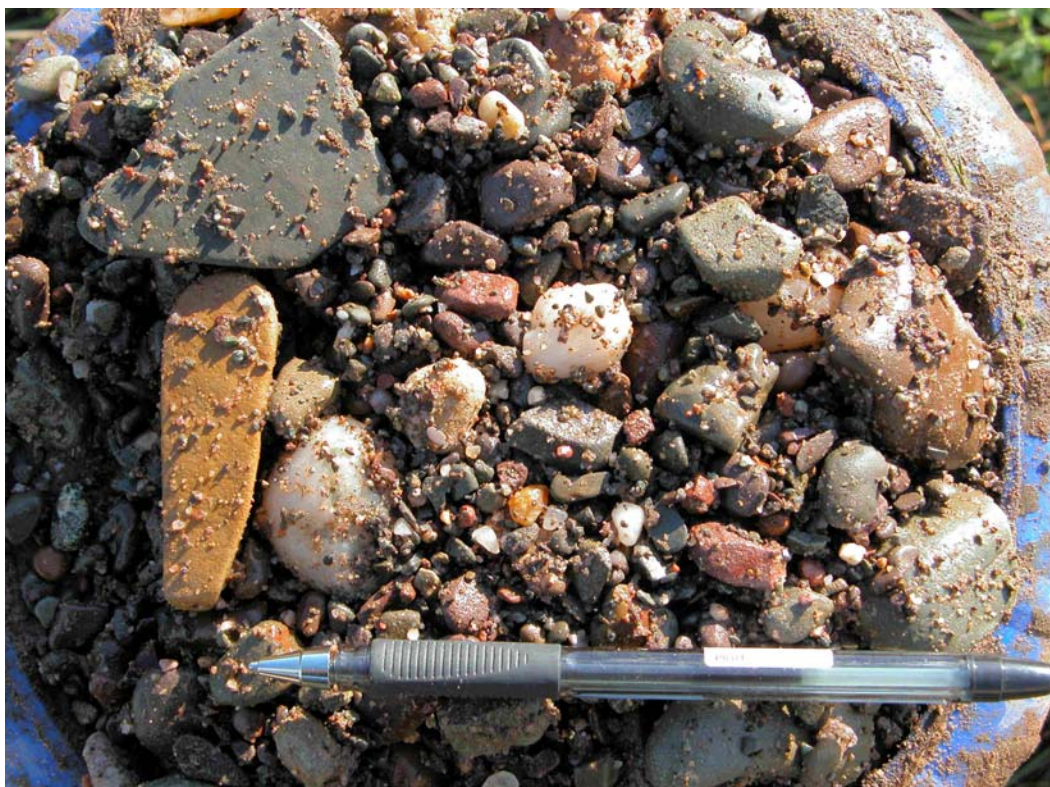
Figure 14 A sample of the aquifer material

Depth (m)	Description
0 – 2.5	Medium- to coarse-grained sand and well rounded gravel.
2.5 – 8.0	Mainly coarse-grained sand and gravel
8.0 – 9.0	Sand and gravel, becoming finer-grained with less gravel.
9.0 – 9.20	Clay, red/brown, stiff.
9.20 – 10.0	Sand, medium-grained, with occasional gravel clasts.

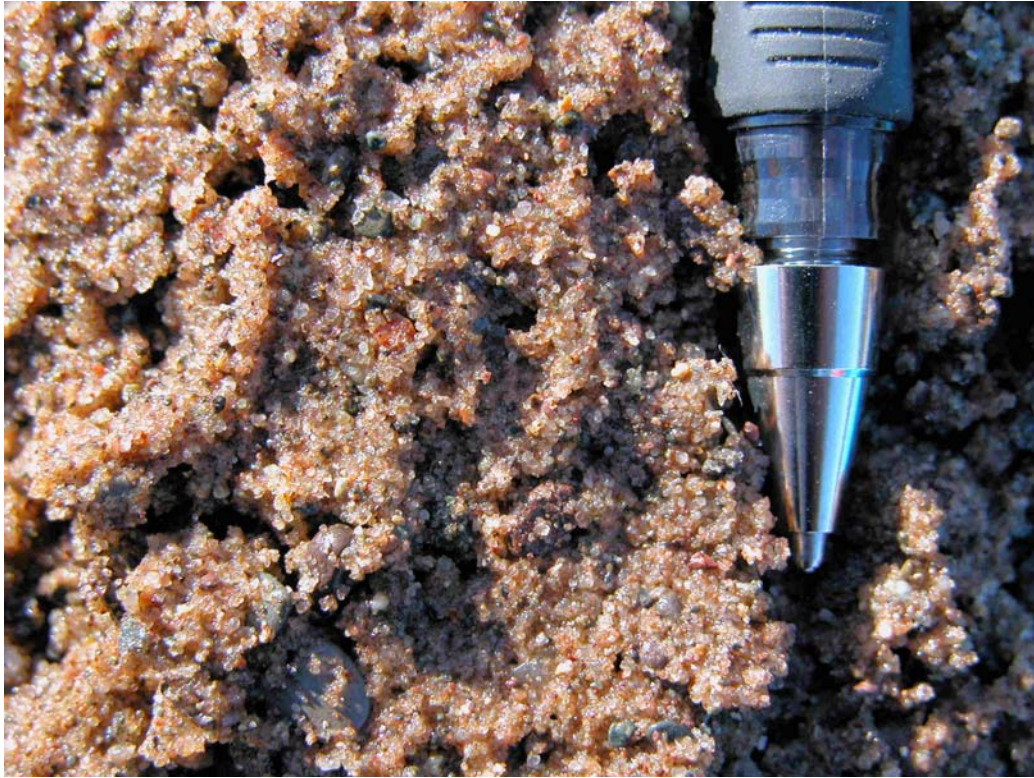
Figure 15 Culgrange sand from 9.5 m bgl

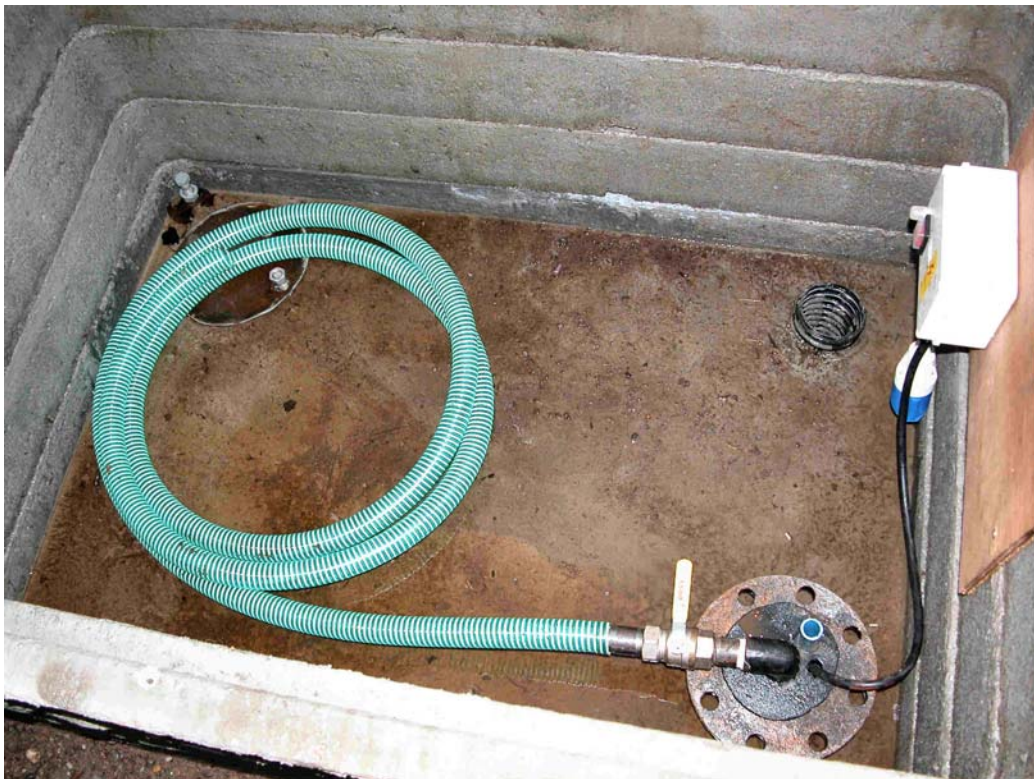
Figure 16 The completed surface chamber with the borehole in the bottom right corner

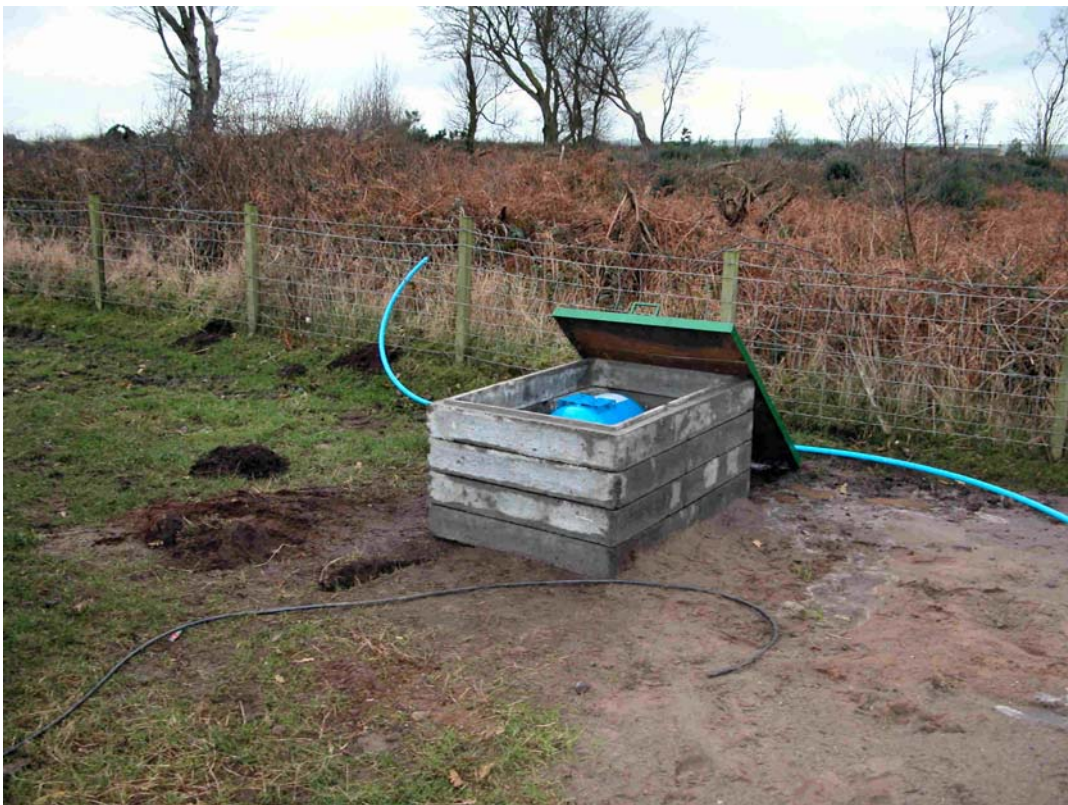
Upon completion, the rest water level was 5.20 m bgl. Figure 21 shows the surface chamber.

Figure 21 Mark Farm well head completion

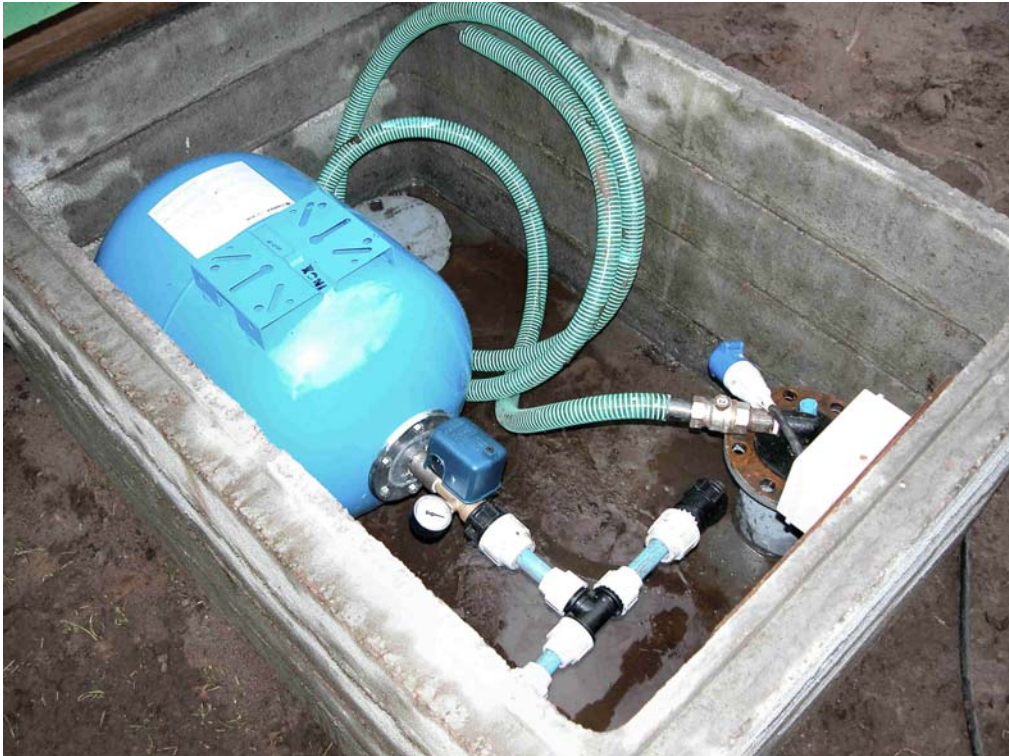
Figures 22 and 23 show the detail inside the chamber, with the farmer's pressure vessel already installed.

Figure 22 Mark Farm chamber detail, with pressure vessel

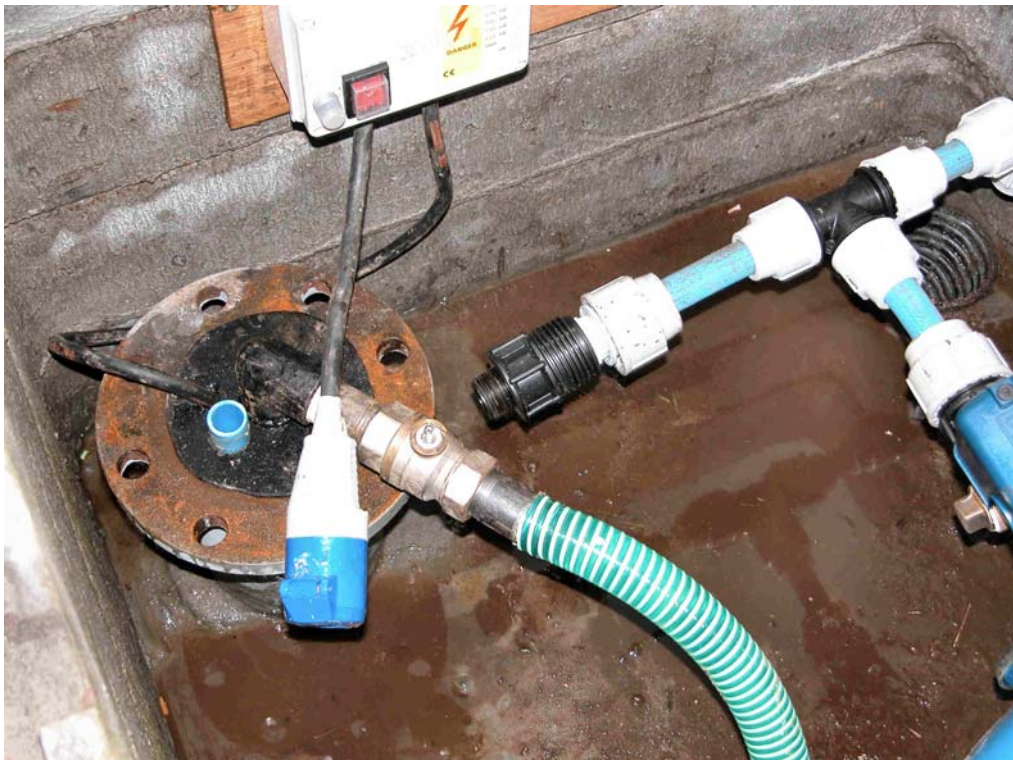
Figure 23 Mark Farm well head

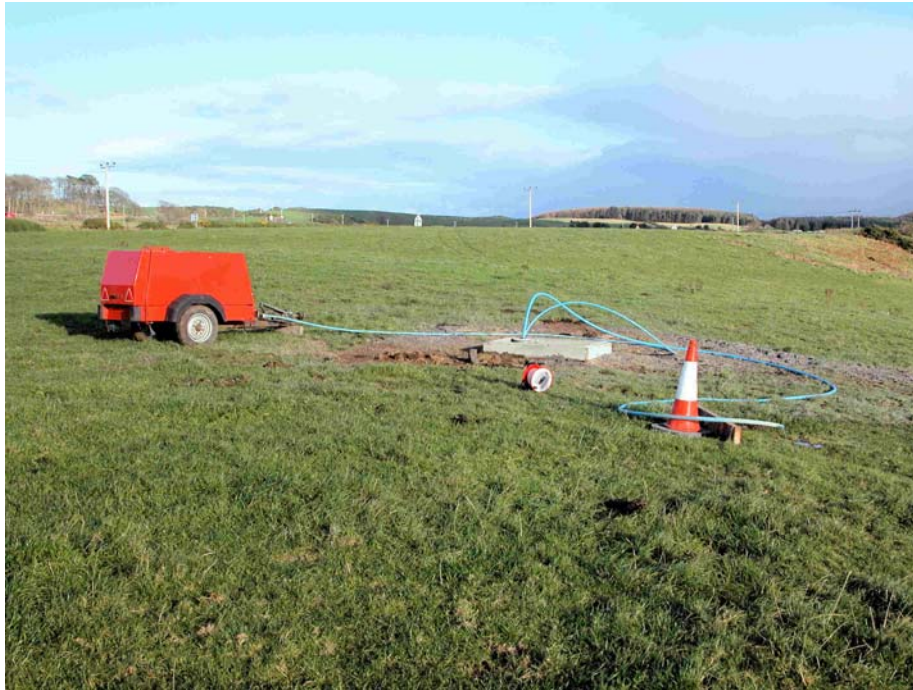
Plastic 125 mm casing was installed to 10.5 m bgl. 125 mm diameter screen is present from 10.5 m to 12.0 m bgl. Figure 27 shows the air-lifting arrangements at Whitecrook Farm, whereby sand and silt is flushed out of the borehole using an air compressor.

Figure 28 Whitecrook Farm borehole air-flush arrangement

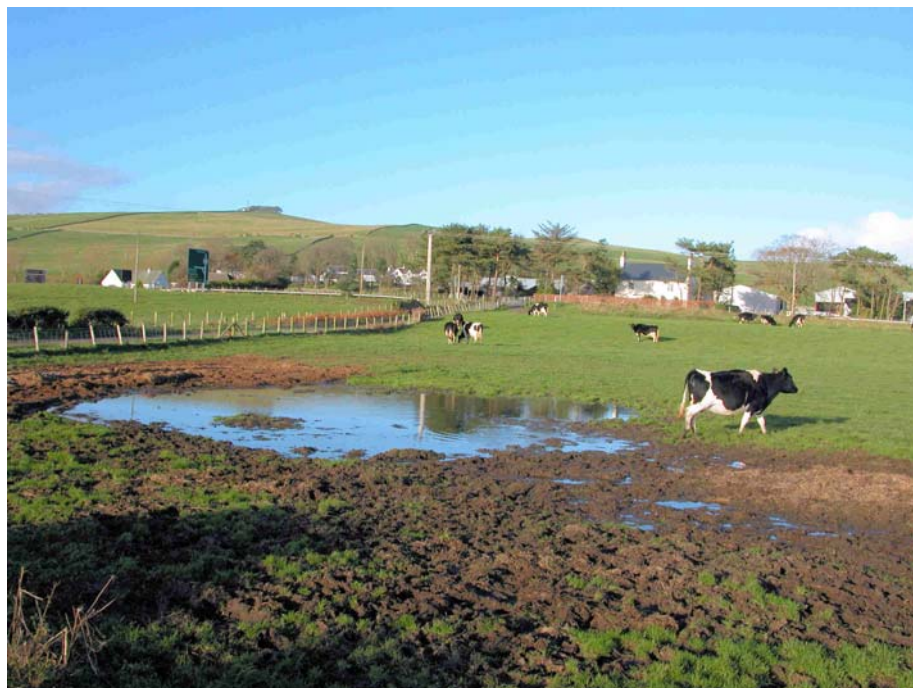
Figure 29 shows the trough area near the old well which has returned consistently high nitrate concentrations. Figures 29-33 show general scenes at Whitecrook and the new well head.

Figure 29 The waterlogged trough area at Whitecrook Farm

The new borehole is approximately 55 m north-east of the original SEPA monitoring well at Whitecrook which has consistently returned very high nitrate concentrations, thought to be due to polluted surface water flowing overland from a cattle trough (Figure 26). Cattle slurry was regularly deposited on the field in which both water sources are situated, but it is not known whether the very high nitrate concentrations found in the well will be present in the new borehole which is not affected by trough run-off.

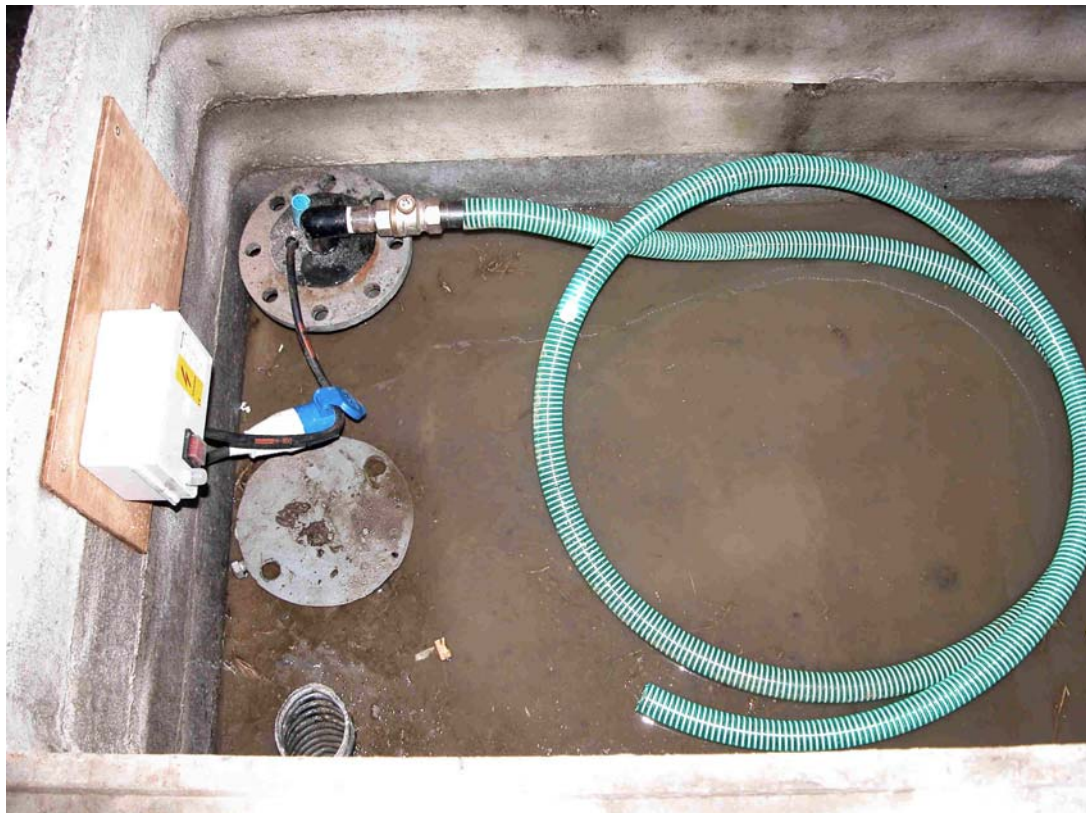
Figure 34 Whitecrook Farm well head with sampling tube ready for SEPA

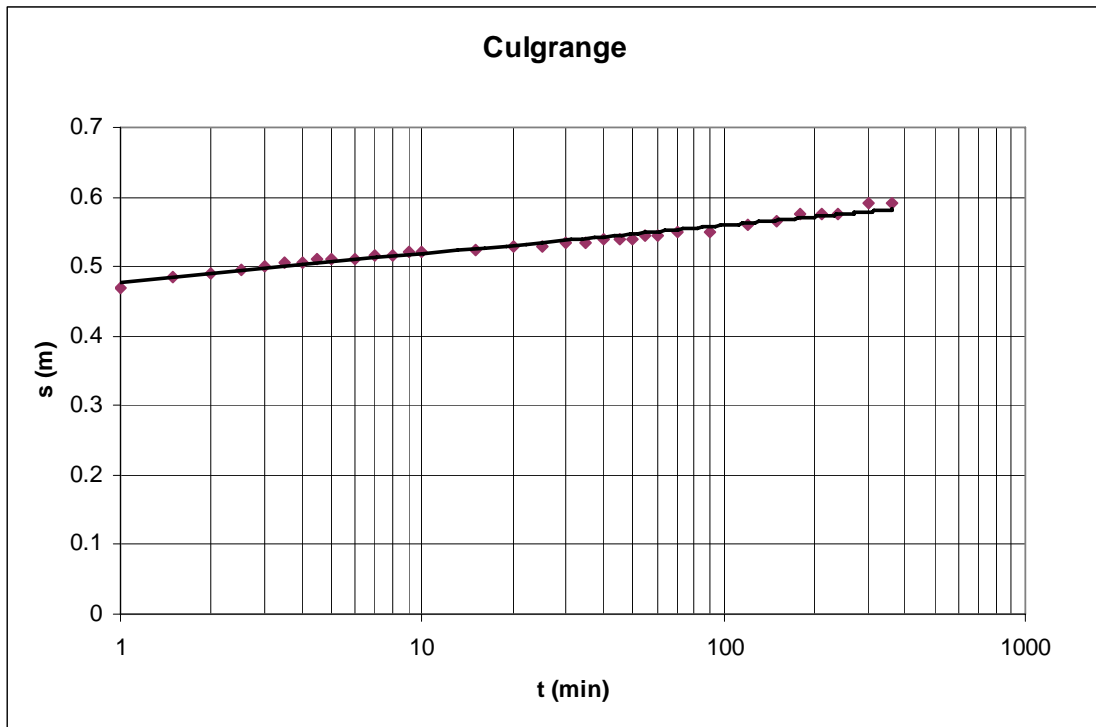
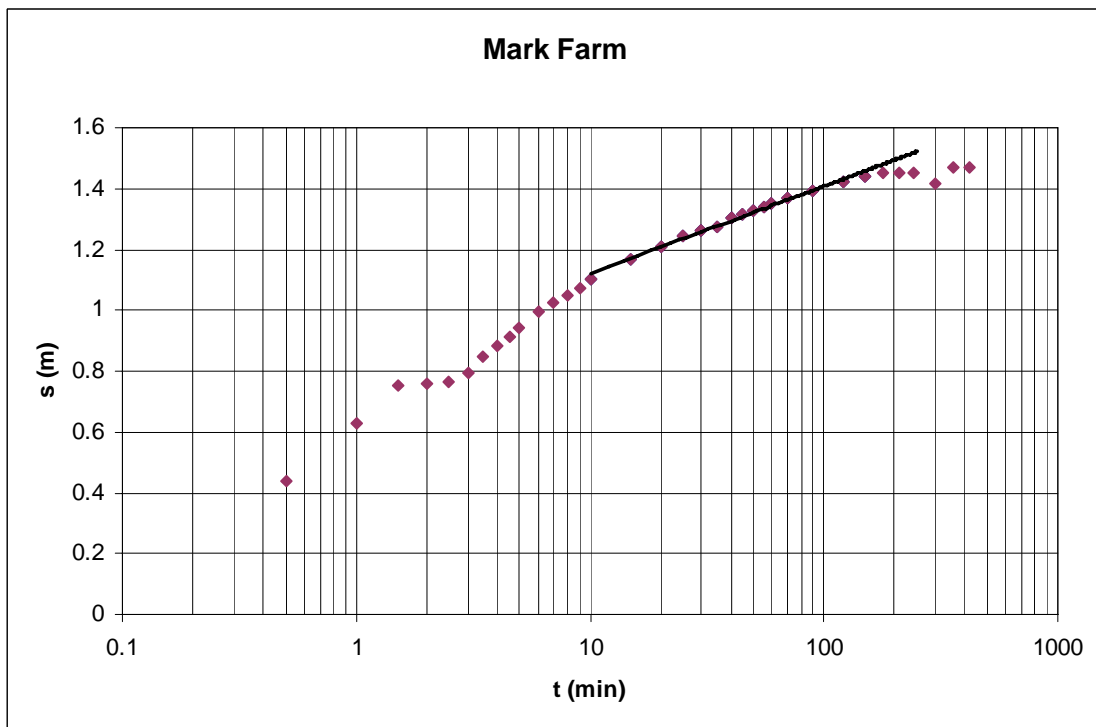
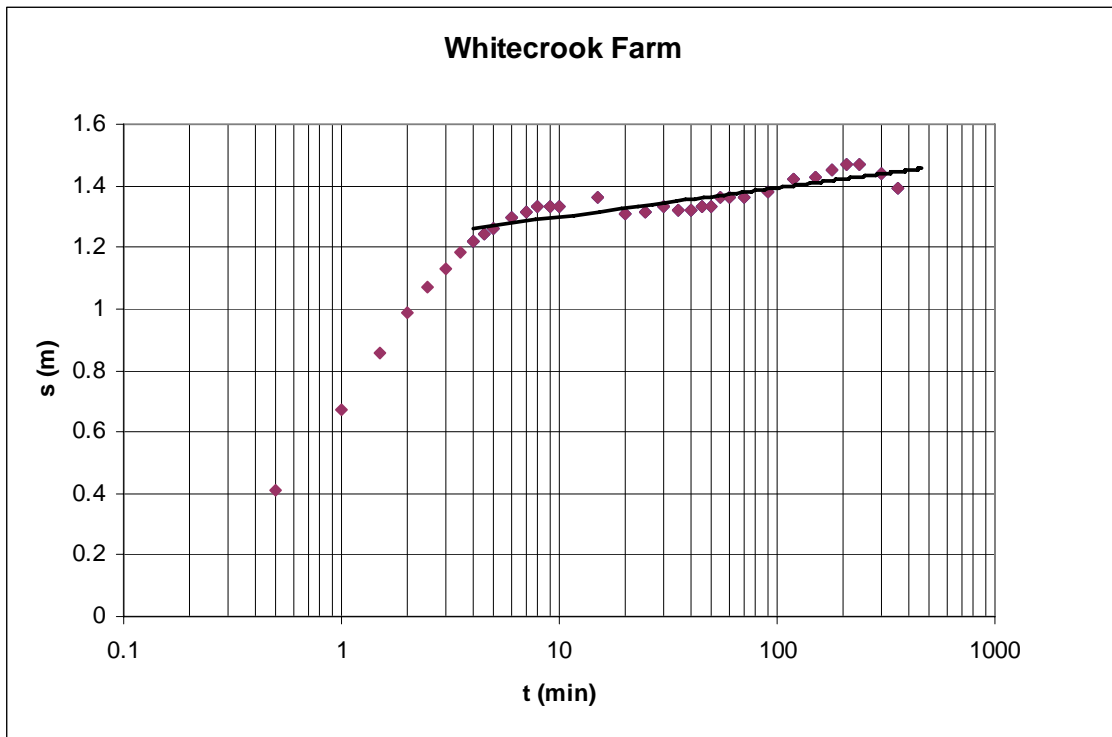
## **Pumping test results**

**Test flow rates:** Culgrange - 0.5 l/s  
 Mark Farm – 0.26 l/s  
 Whitecrook – 0.21 l/s

Time (min)	s (Culgrange)	s (Mark Farm)	s (Whitecrook Farm)
0	0	0	0
0.5	0.34	0.44	0.41
1	0.47	0.63	0.67
1.5	0.485	0.75	0.855
2	0.49	0.76	0.985
2.5	0.495	0.765	1.07
3	0.5	0.795	1.13
3.5	0.505	0.85	1.185
4	0.505	0.885	1.22
4.5	0.51	0.915	1.245
5	0.51	0.945	1.26
6	0.51	0.995	1.295
7	0.515	1.025	1.315
8	0.515	1.05	1.33
9	0.52	1.075	1.33
10	0.52	1.1	1.33
15	0.525	1.17	1.365
20	0.53	1.21	1.31
25	0.53	1.245	1.315
30	0.535	1.26	1.33
35	0.535	1.275	1.32
40	0.54	1.305	1.32
45	0.54	1.315	1.33
50	0.54	1.33	1.335
55	0.545	1.34	1.36
60	0.545	1.35	1.36
70	0.55	1.37	1.36
90	0.55	1.395	1.38
120	0.56	1.42	1.42
150	0.565	1.44	1.43
180	0.575	1.45	1.45
210	0.575	1.45	1.47
240	0.575	1.45	1.47
300	0.59	1.415	1.44
360	0.59	1.47	1.39
420		1.47

Of the three pumping tests carried out, the test at Culgrange shows the highest value of transmissivity (T), at 194 m<sup>2</sup>/d. The dominant lithology here is sand and gravel, with a small band of clay (0.2 m) at around 9 m below the surface. The borehole depth of 10 m gives a likely hydraulic conductivity of close to 19 m/d, which appears reasonable for deposits of this type. The drawdown curve fails to reach a steady state over the period of the test (6 hours), thereby preventing the specific capacity of the borehole from being determined. The final drawdown recorded during the test constrains it to a maximum value of around 73 m<sup>2</sup>/d, with an abstraction rate of 43.2 m<sup>3</sup>/d.

Mark Farm shows a much lower value of T (14 m<sup>2</sup>/d). The Mark Farm borehole passes through 12 m of sands and gravels, with a higher proportion of sand than was encountered at Culgrange. The overall hydraulic conductivity of the deposits reflects this, with a likely value of around 1 m/d. The test appears to show a steady state drawdown of around 1.6 m at later times, giving a specific capacity of 14.1 m<sup>2</sup>/d (with an abstraction rate of 22.5 m<sup>3</sup>/d).

The test at Whitecrook Farm appears to have suffered from significant well storage, which has affected the early time data. Nevertheless, it was possible to determine a T of 35 m<sup>2</sup>/d from the rest of the curve. The borehole was drilled to 12 m depth, passing through dominantly fine sands, with some gravels and lesser amounts of clay and peat. These deposits have an overall hydraulic conductivity of close to 3 m/d.

The drawdown appears to equilibrate more rapidly than the other boreholes tested, although the possible influence of tides makes interpretation of late-time data more difficult. This borehole is particularly close to the sea, leading to significant oscillations in the time-drawdown curve. Faster equilibration may be due to an increasing proportion of gravel with depth - a pattern shown by the borehole log - which may lead to a more ready supply of water at later times. Assuming a final drawdown of 1.6 m, a specific capacity of 11.3 m<sup>2</sup>/d is obtained (with an abstraction rate of 18.1 m<sup>3</sup>/d).
