# An appraisal of Underground Gas Storage technologies and incidents, for the development of risk assessment methodology.

Sustainable and Renewable Energy Programme  
Open Report OR/07/023

**Volume Two – Figures and Tables**

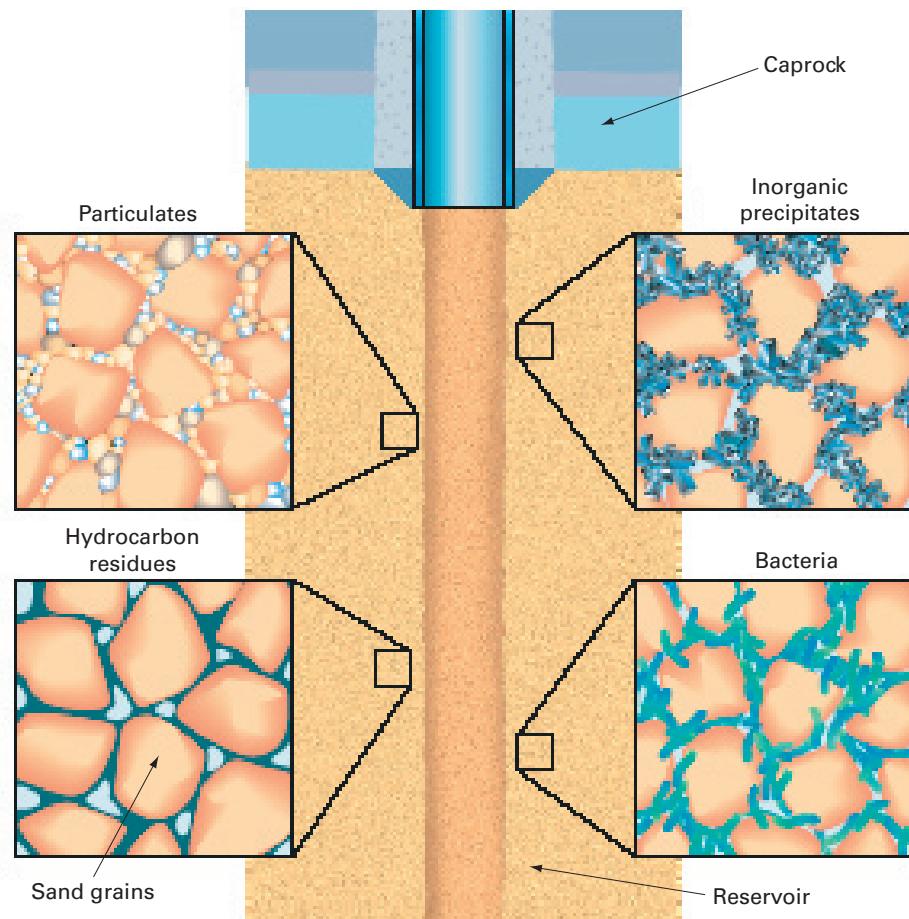
**Figure 3. The main mechanisms leading to the choking/blocking of pore spaces that cause damage to, and loss of performance in, reservoir rocks and gas storage wells (after Bary et al., 2002 and courtesy of Schlumberger).**

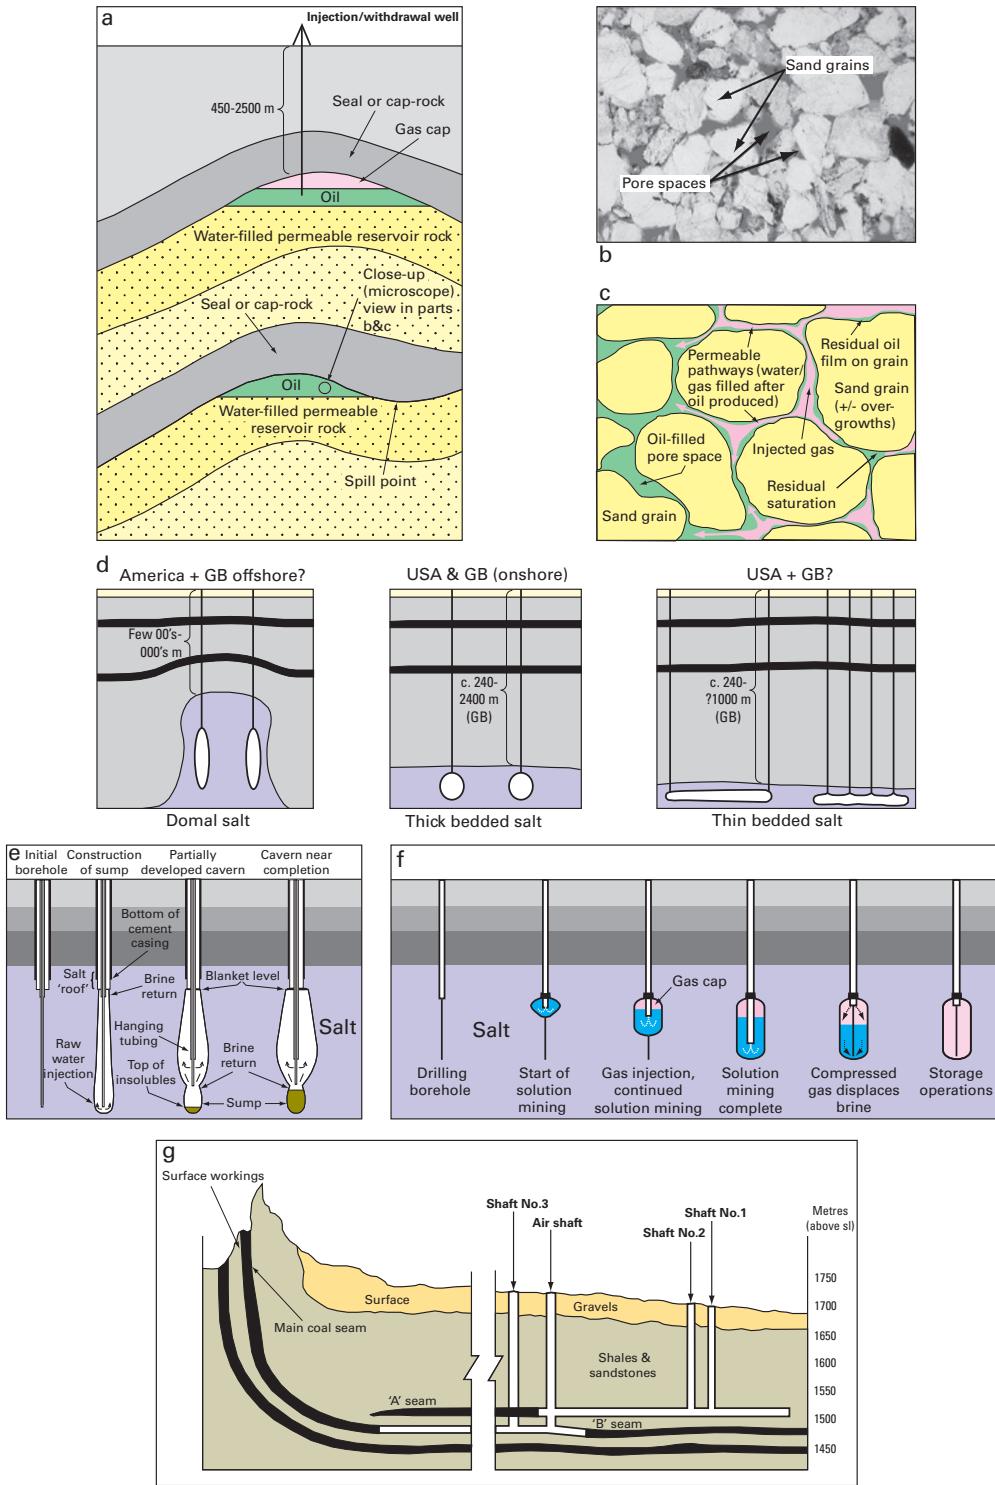
**Figure 4.** Schematic diagram illustrating the concepts of underground gas storage in depleted oil/gasfield (pore), salt cavern and abandoned mine scenarios. a) typical anticlinal traps for oil and gas b) microscope view of sandstone reservoir, c) cartoon illustrating injection of gas into pore spaces from which oil has migrated, or displacing residual oil in pore spaces, thereby enhancing oil recovery, d) the various types of salt bodies in which salt cavern might be constructed (note: the concept of injection and storage of gas in aquifers is the same as in parts a-c, with the exception that the pore spaces are filled with saline water, rather than oil), e) solution mining process for a salt cavern, f) abandoned coal mine storage (based upon Leyden Mine, Canada; after Raven Ridge Resources, 1998).

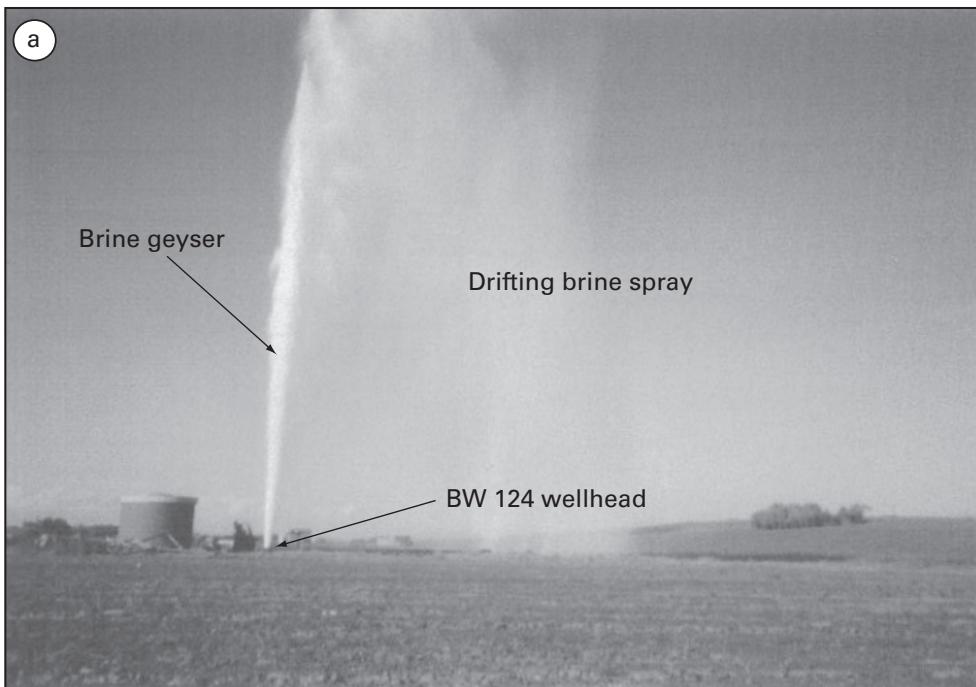
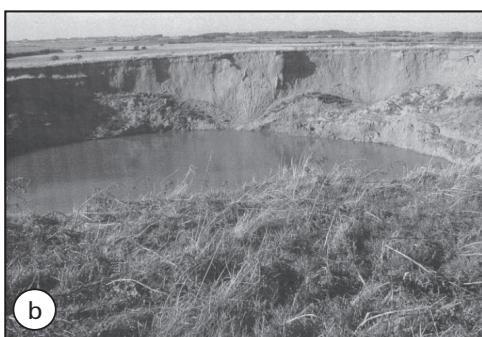
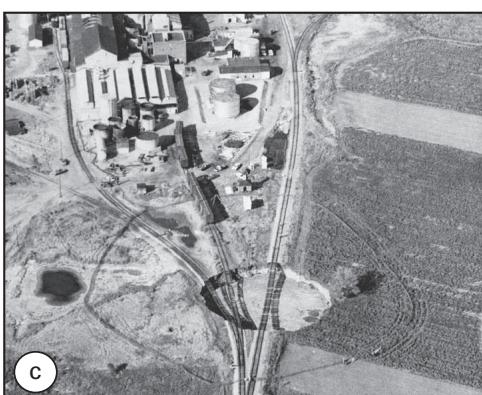
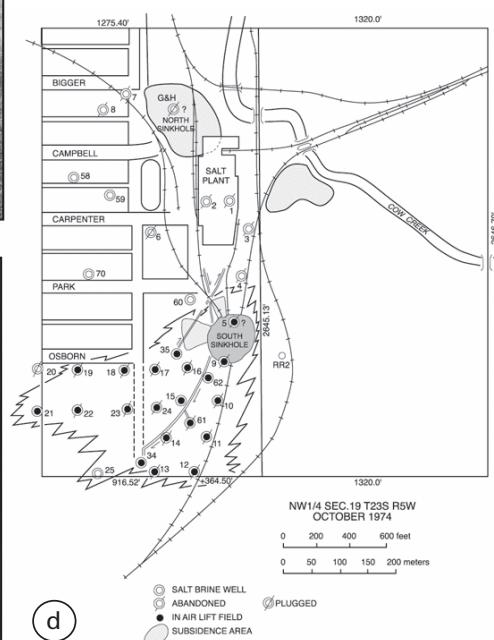
**Figure 5. Photographs of salt brining related incidents and features. a) Brine gusher from ICI well BW 124 at Preesall, near Fleetwood, Lancashire, b) collapse crater associated with previous salt brining activities in the Preesall Saltfield (from Jackson, 2005; reproduced by permission of D.S. & M.J. Jackson), c&d) photograph and map of south sinkhole developed at Cargill, Kansas, November 12, 1974 showing development and loss of infrastructure (railway lines) above location of brine well/cavern (from Walters, 1978 and courtesy of Kansas Geological Survey).**

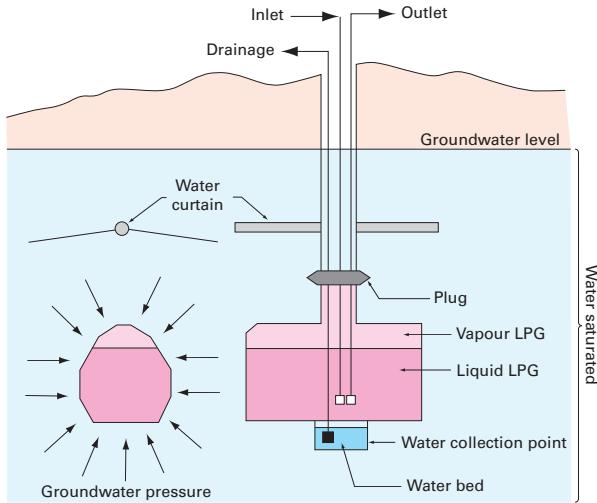
**Figure 7. Concept of underground LPG storage caverns with water curtains preventing the release and migration of stored product (gas), after Yamamoto & Pruess (2004).**

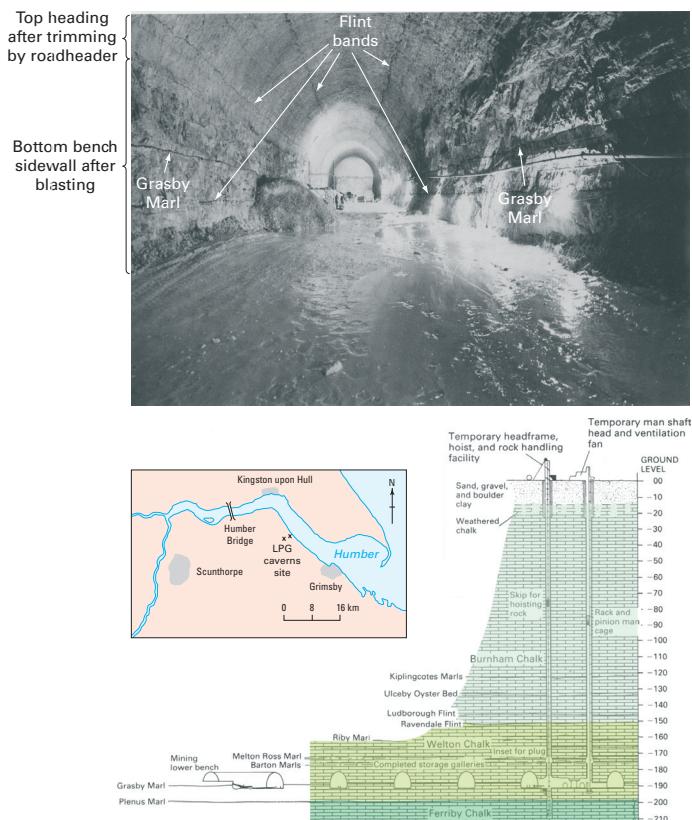
**Figure 8. Photograph, location map and sketch section showing the Chalk cavern storage facility at Killingholme. Photograph is of one mined gallery, with the sketch section detailing the geology, Chalk stratigraphy, storage horizon and mining technique of an upper and lower 'bench', as described in the text (far left of line drawing). Line drawing reproduced by permission of the Geological Society; photograph by permission of David Lee Photography Ltd., Barton upon Humber and the Geological Society, London.**

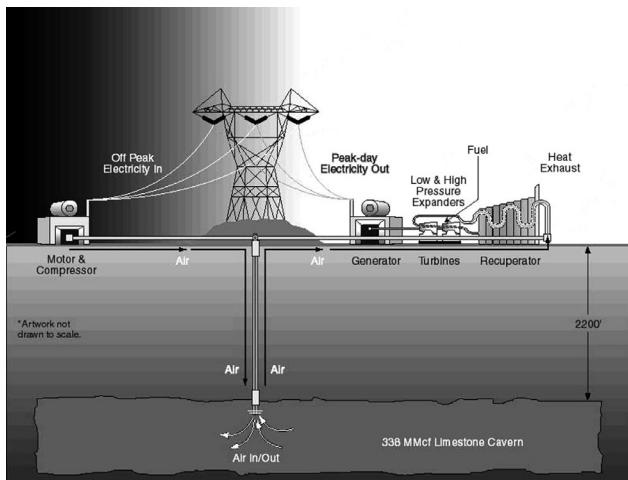
**Figure 9 Diagrammatic representation of the proposed Norton CAES plant at Norton, Ohio (black and white image reproduced by permission Sandia and CAES Development Company LLC: <http://www.caes.net/cycle.html>).**

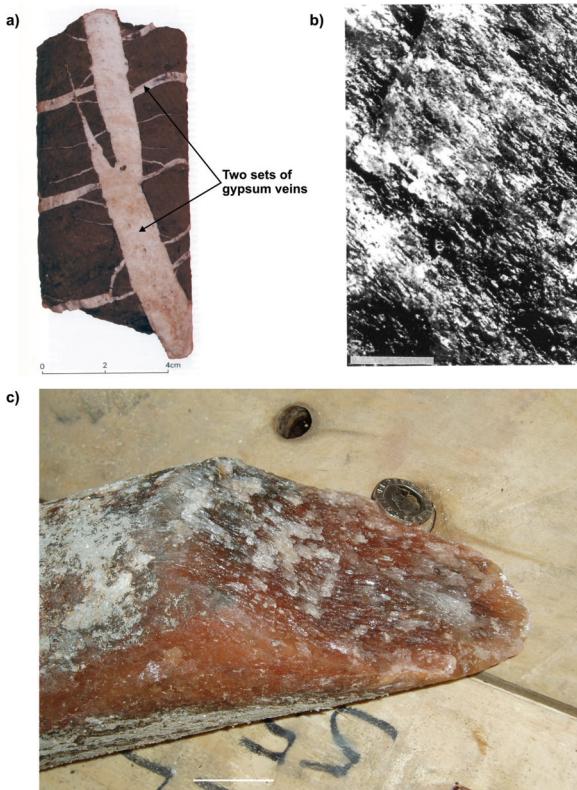
**Figure 10. Fractures in halite sequences and linear schistose (possibly mylonitic) fabrics developed in UK halite beds. a) gypsum filled veins representing two sets of infilled fractures in the Breckells Mudstones (caprock) at Preesall (NW England, from Wilson & Evans, 1990), b) strongly flow linedated Boulby Halite on subconcordant core break from depth of 336.7 m (after Smith, 1996; courtesy of the Geological Society, London). Scale bar 10 cm, c) linear crystal fabric that has developed on the curved surface of a break in the core in Preesall Halite (depth 538 m). The break and linear features in the halite has been interpreted by some as slickensides related to brittle faulting in the halite, but may be a ductile flow fabric similar to part b (photograph courtesy of Canatxx Gas Storage Ltd).**

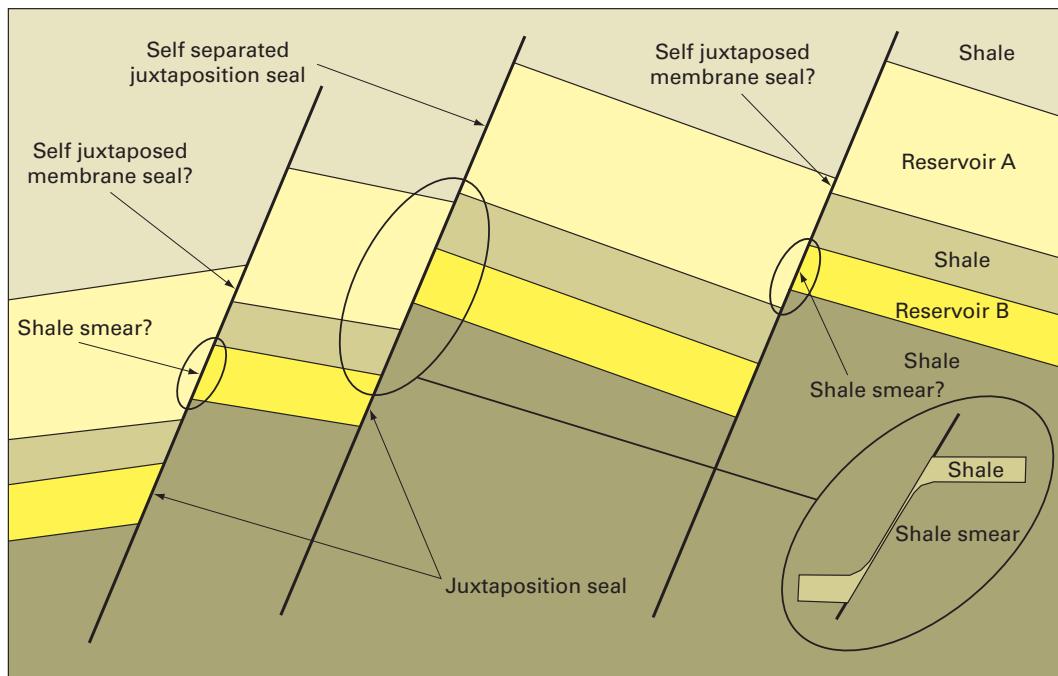
**Figure 16. Schematic illustration of faulted sand-shale sequence and terminology of fault offsets and sealing configurations referred to in the text (after Færseth, 2006). Where reservoir A and reservoir B are juxtaposed across faults, the shale interval stratigraphically between the two reservoir units may be smeared along the fault to form a seal that hydraulically separates the sandstones.**

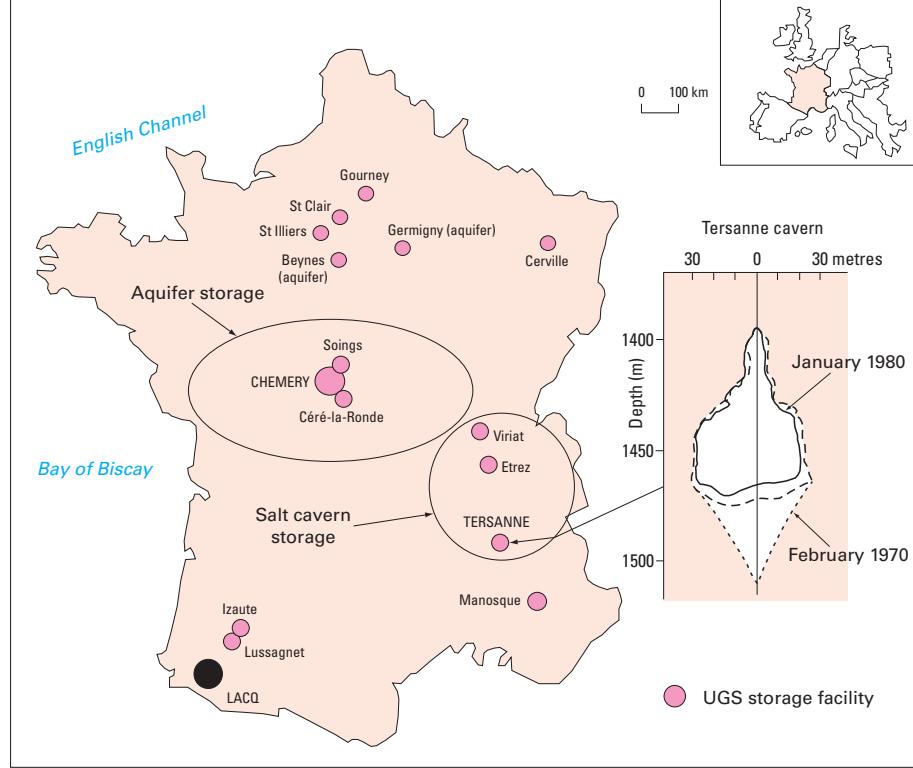
**Figure 21. Location of French UGS sites referred to in the text and details of the Tersanne cavern dimensions prior to and following salt creep (after Bérest & Brouard, 2003).**

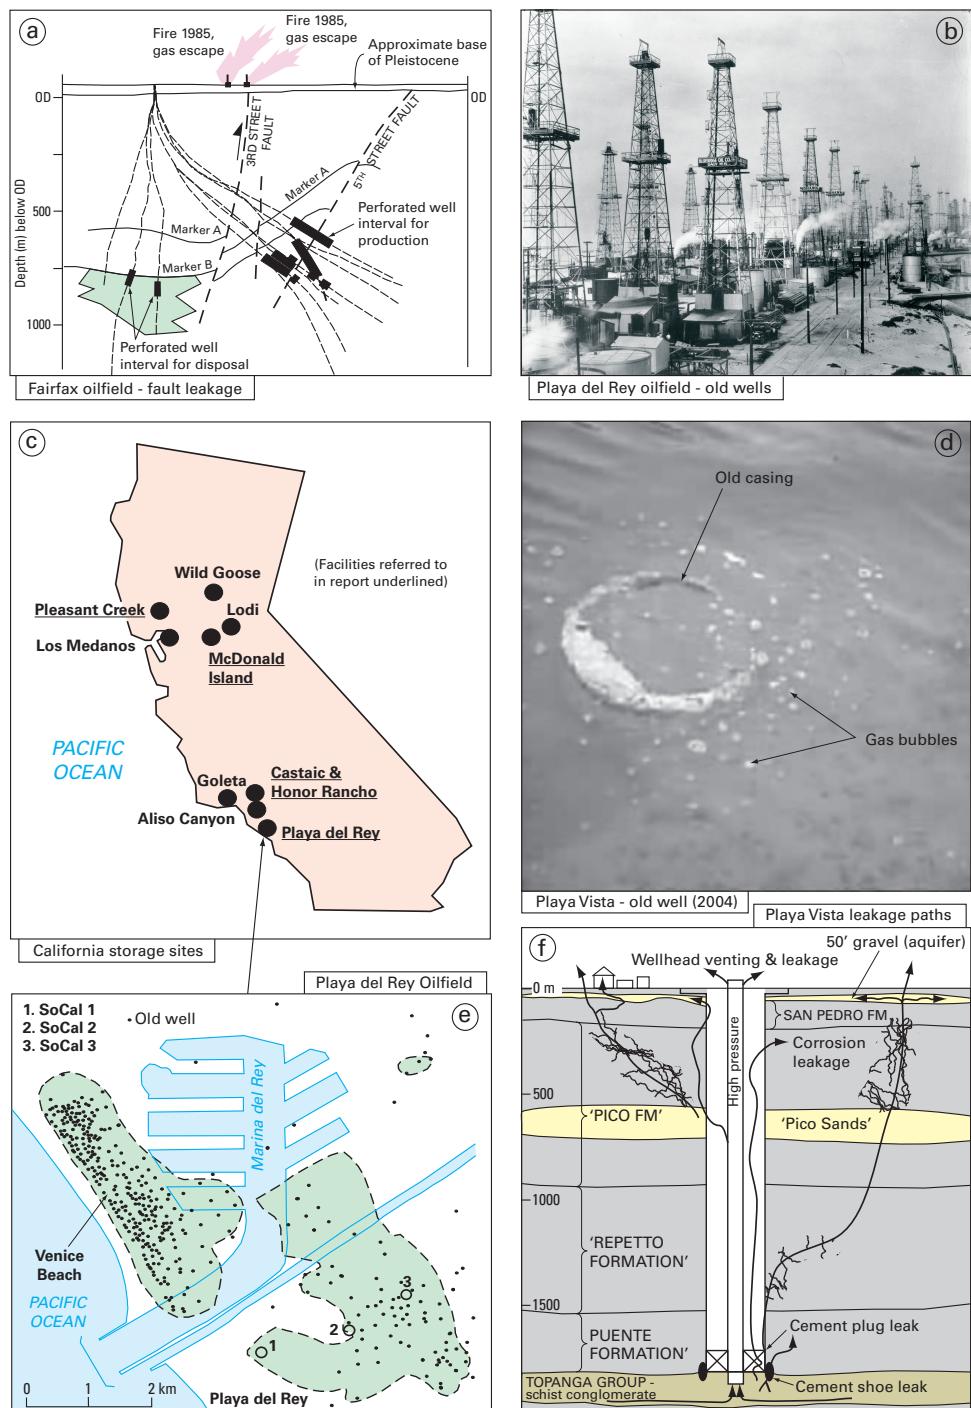
**Figure 22. Details of Californian oilfields.** a) cross section of the leakage scenario at the Fairfax Oilfield (after Hamilton & Meehan, 1992), b) skyline of oil derricks at the Playa del Rey Oilfield (after Seaver Center for Western History Research, Los Angeles County Museum of Natural History), c) general location map of depleted gasfields and gas storage sites in California and referred to in the text, d) gas bubbling up old leaking well in shallow water pond, Playa del Rey (courtesy Jeanette Vosberg, Save Ballona Wetlands).

See <http://saveballona.org/techpages/well.html>), e) map of the Playa del Rey and Venice Beach oilfields with known well locations, f) schematic section of Playa del Rey Oilfield showing gas leakage paths.

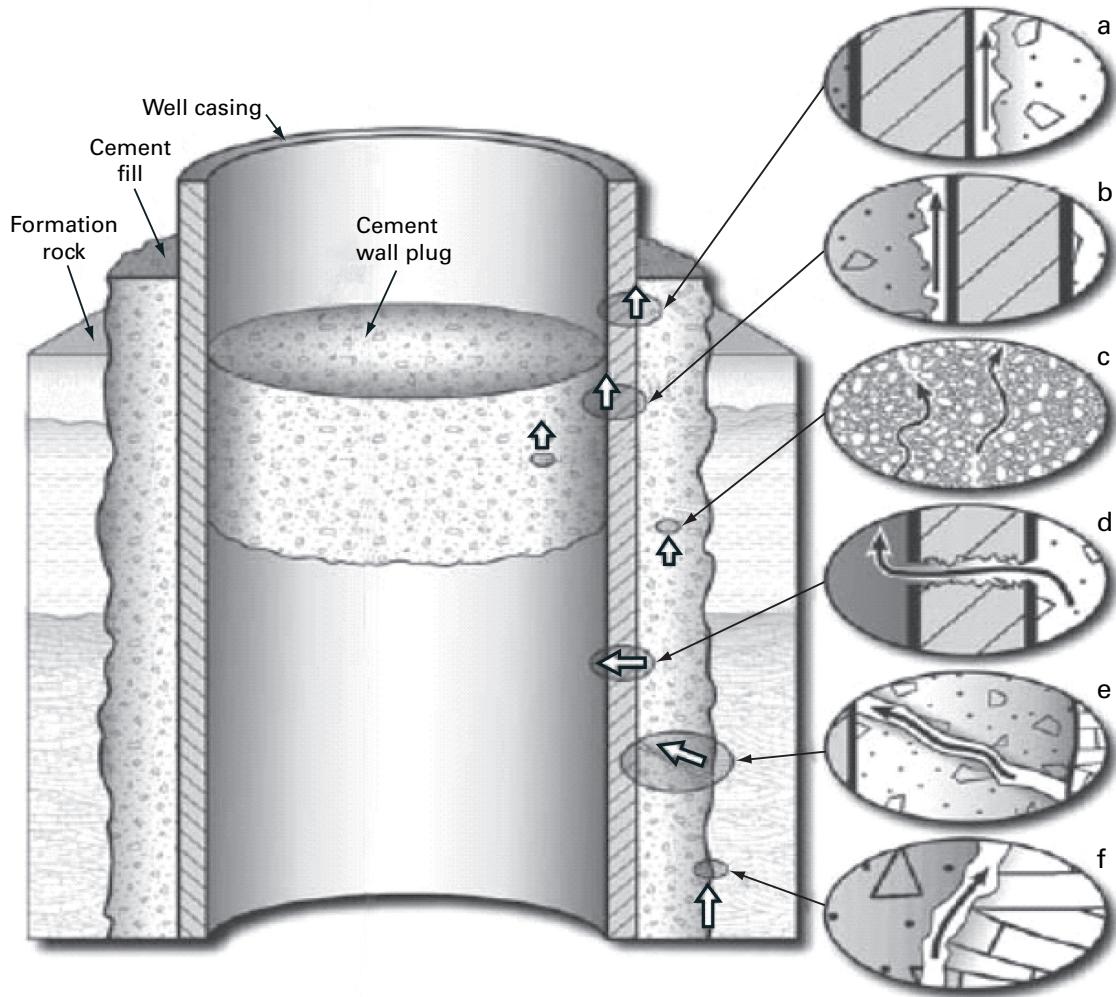
**Figure 28.** Schematic illustration of possible leakage pathways through an abandoned well: a) between casing and cement, b) between cement plug and casing, c) through the cement pore space due to cement degradation, d) through well casing as a result of corrosion, e) through fractures in cement, f) between cement and rock. (Figure from Scherer et al., 2005; reproduced from Environmental Geology, by permission of ©Springer Verlag).

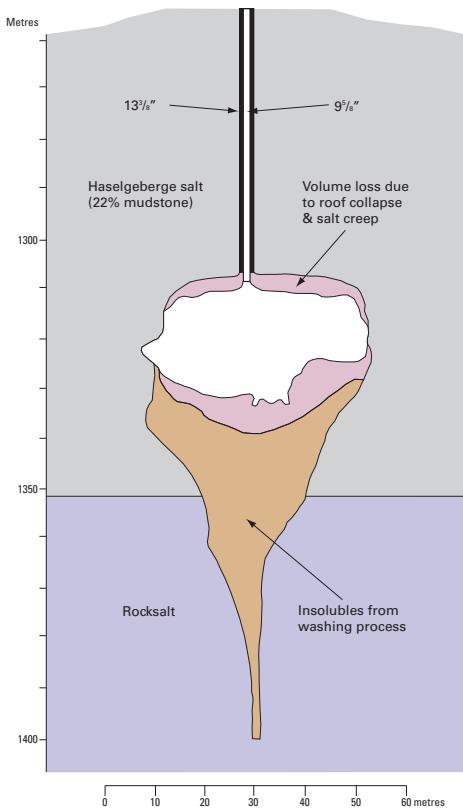
**Figure 31. Detail of the Kiel storage cavern in Germany, illustrating volume loss due to insolubles, roof collapse and salt creep (after Bérest & Brouard, 2003).**

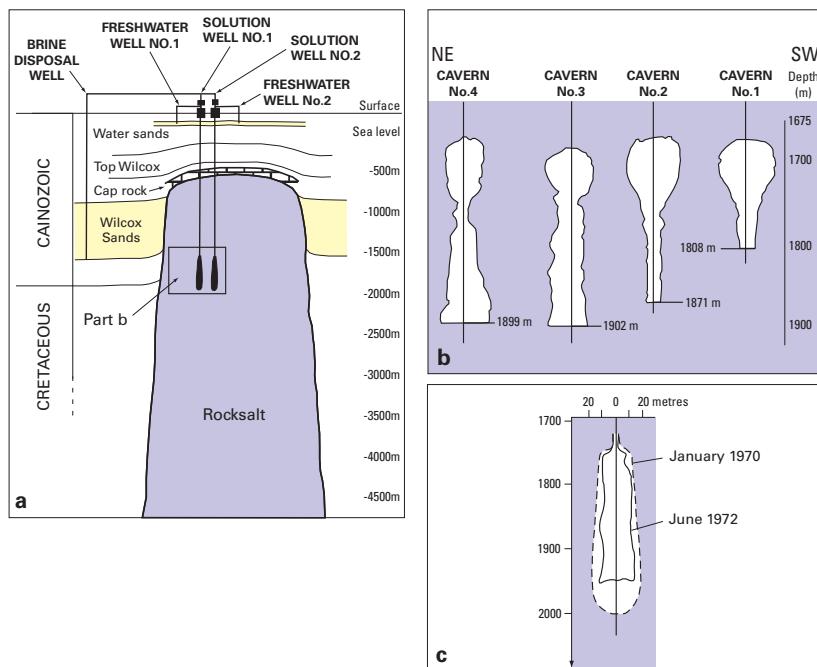
**Figure 32. Details of the Eminence salt dome and storage facility (based upon Allen, 1972). a) cross-section of the salt dome with depth of caverns, b) detail of the depths and shapes of the four caverns constructed at Eminence c) illustration of the extent of salt creep and decrease in cavern size.**

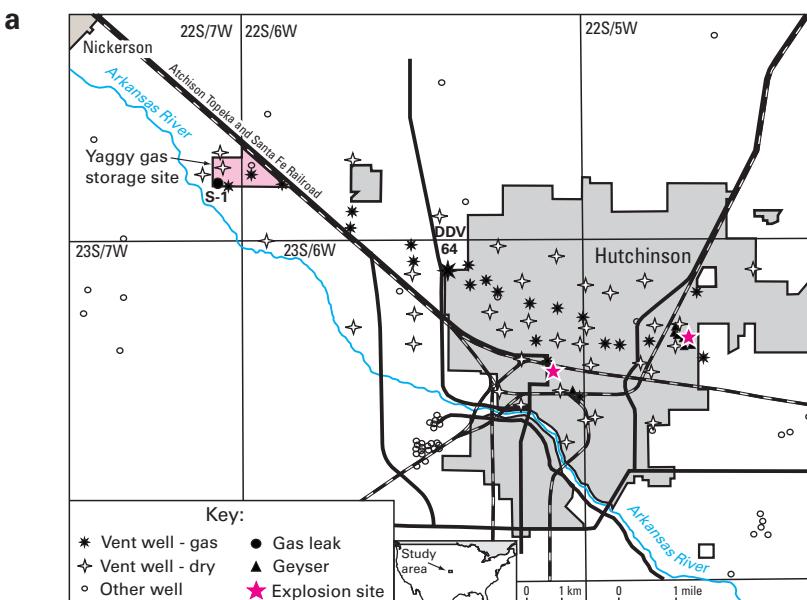
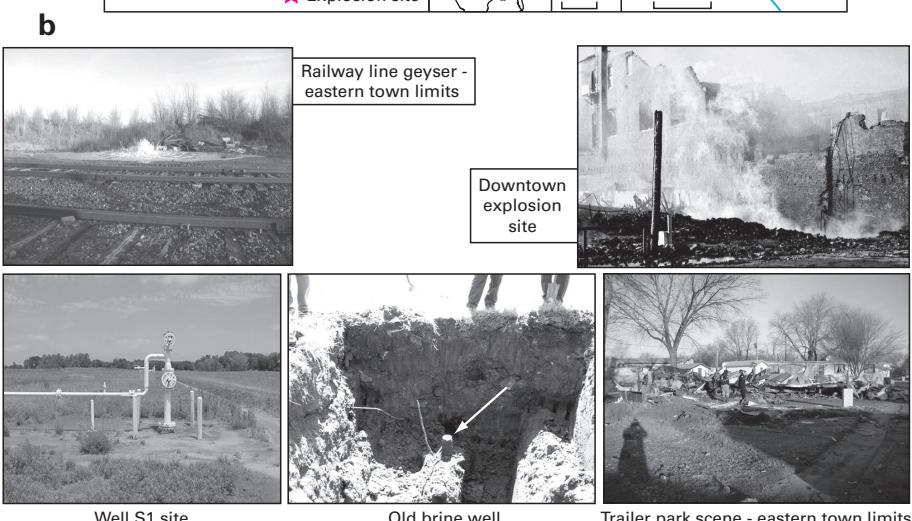
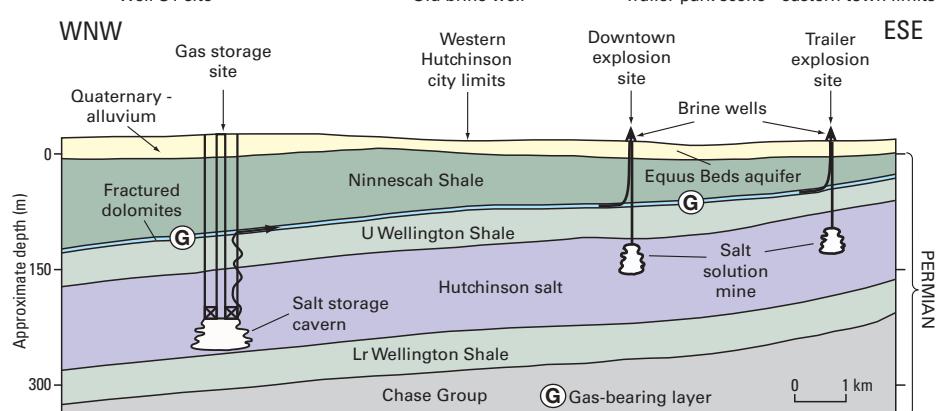
**Figure 35. Details of the Hutchinson incident. (a) location map illustrating the site of the storage facility circa 11 km (7 miles) NW of the town of Hutchinson (b) WNW-ESE cross section showing the stratigraphy and structure of the area and the route taken by the gas from the storage cavern to the town (after Kansas Geological Survey). Images shown courtesy of Chief Forbes, Hutchinson Fire Department; Kansas Geological Survey; Kansas Department of Health and Environment, CUDD Drilling and Shannon Pope of RPC Inc.**

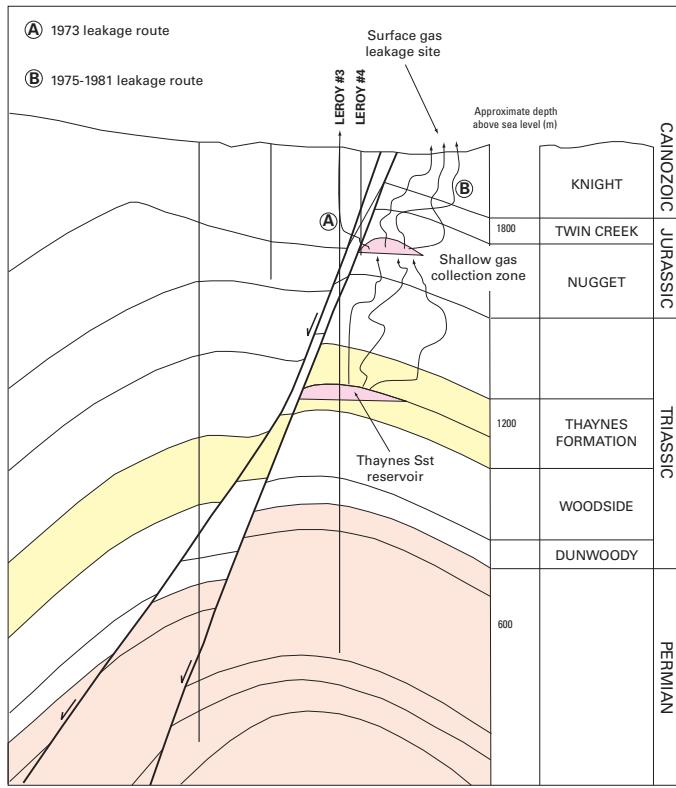
**Figure 38. Stratigraphy, cross-section and leakage paths from the Leroy Gas Storage Facility, Wyoming (after Araktingi et al., 1984).**

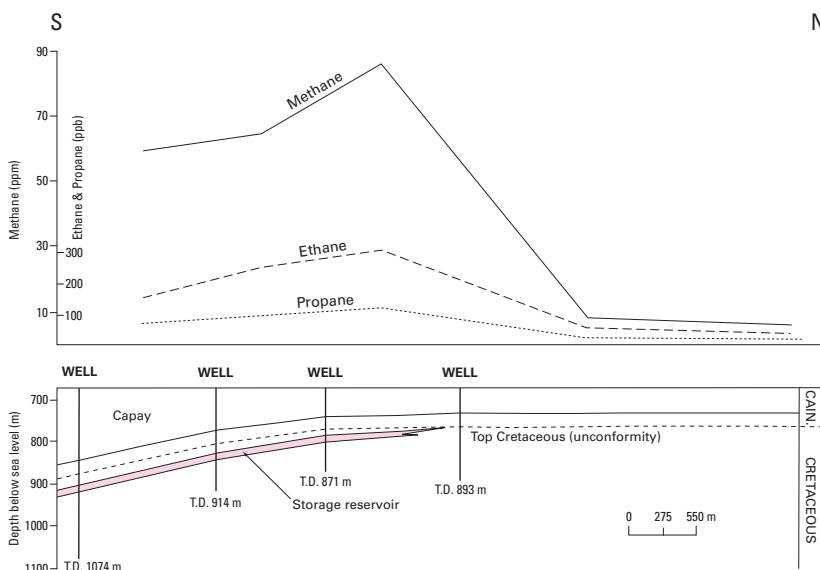
**Figure 40. Cross-section of the Pleasant Creek gas (aquifer) storage facility in California (after Jones & Drozd, 1983). Also shown the soil-gas profiles showing leakage of the aquifer caprock.**

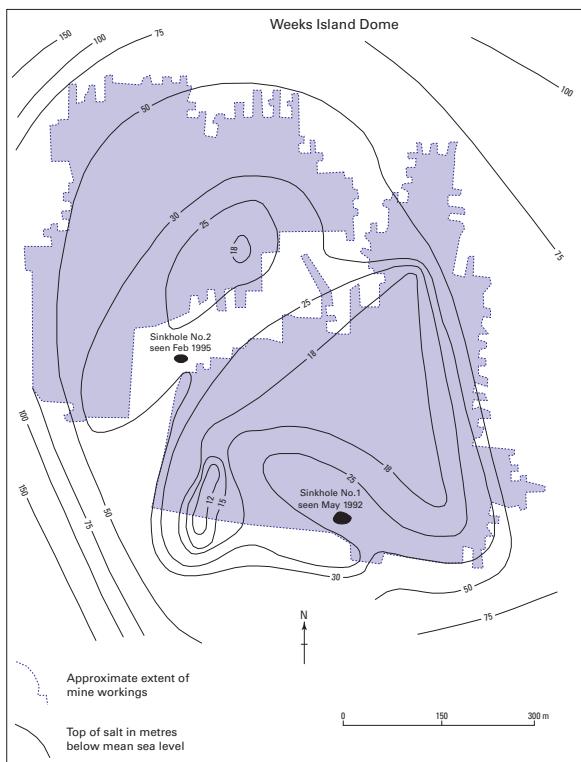
**Figure 42.** Structural contour map of the Weeks Island salt dome, Louisiana, illustrating the sites of the two sink holes in relation to the extent of salt mine workings (after Warren, 2006).

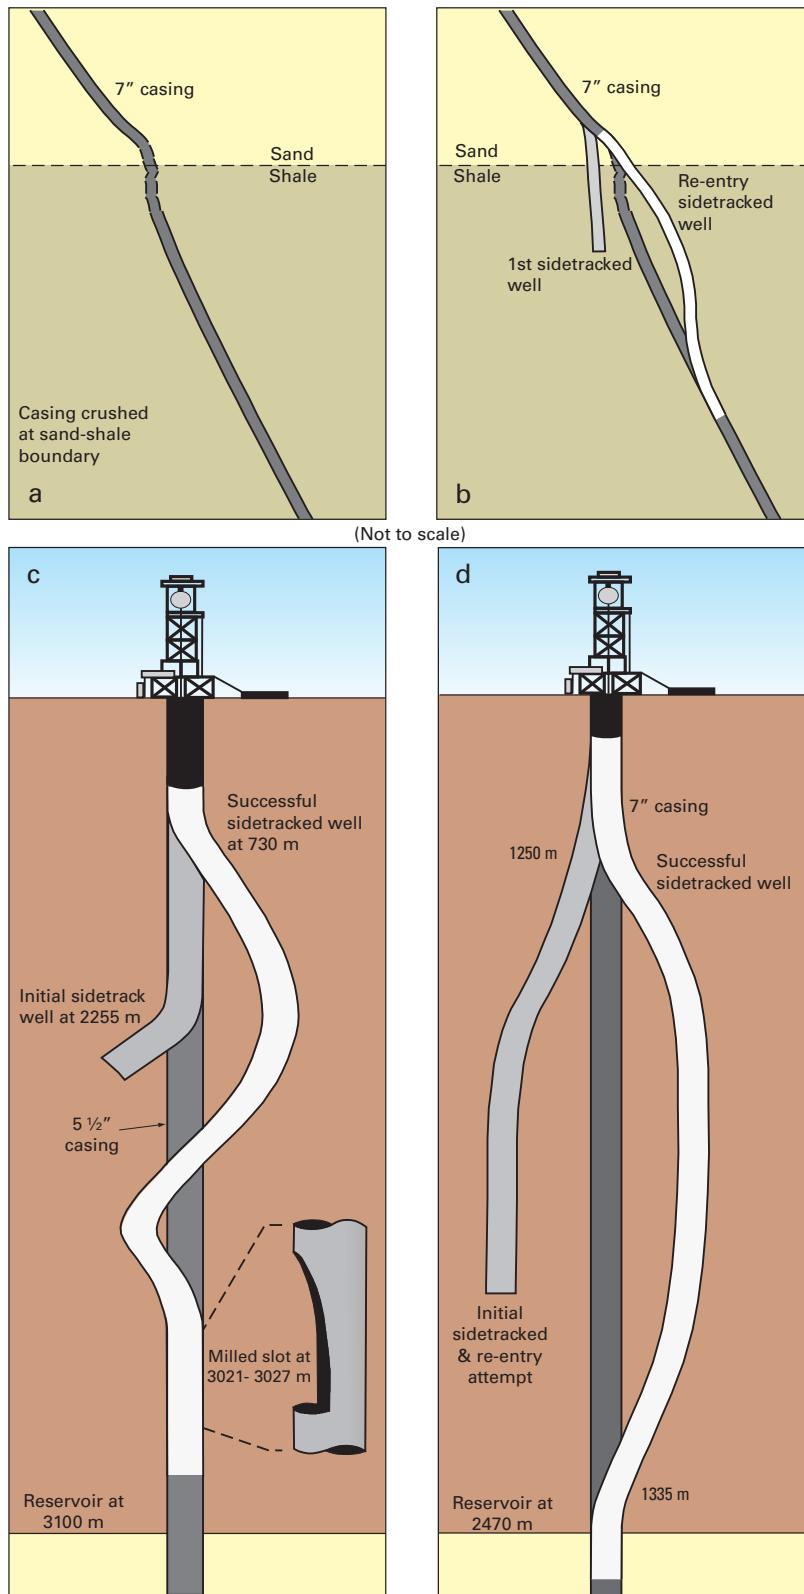
**Figure 46. Sketch diagrams showing problems with and the repair of gas storage wells in California (after Vector Magnetics: [http://www.vectormagnetics.com/Case\\_HistoryO&G.html](http://www.vectormagnetics.com/Case_HistoryO&G.html)). a) and b) damage following an earthquake, c) inadvertent sidetracking of a well, d) inadvertent sidetrack due to corroded casing.**

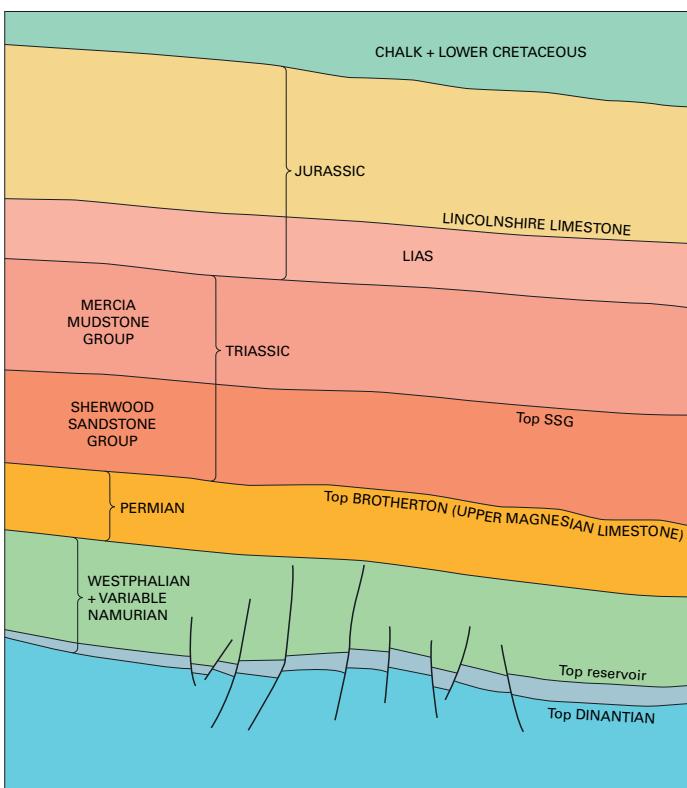
SALTFLEETBY SCENARIO

**Figure 47. Sketch section illustrating the geological conditions likely to represent the ‘Saltfleetby scenario’ (based upon Hodge, 2003).**

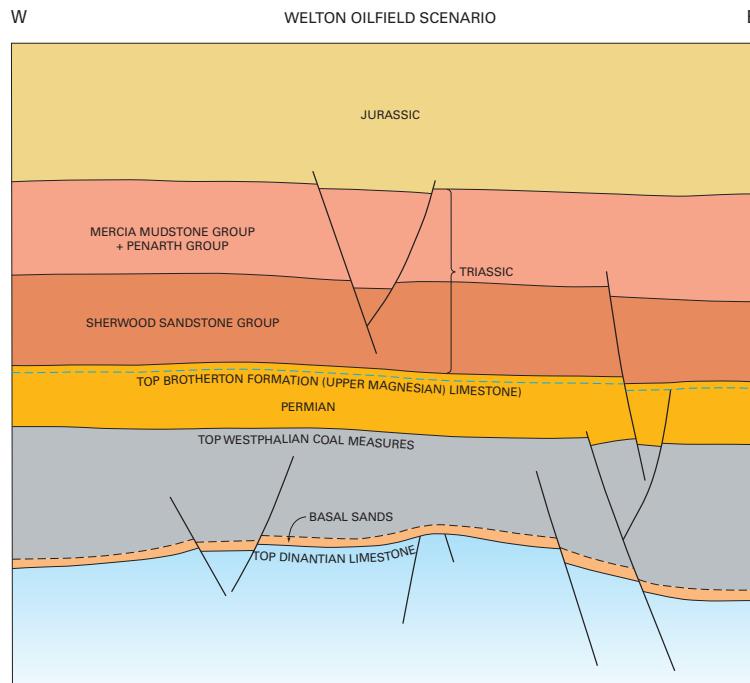
**Figure 48. Sketch section illustrating the geological conditions likely to represent the ‘Welton scenario’ (based upon Rothwell & Quinn, 1987).**

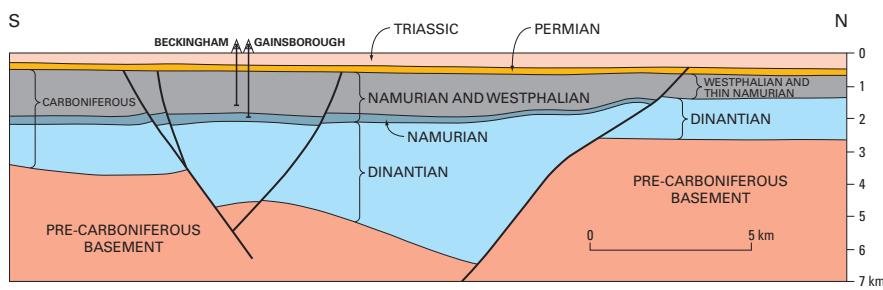
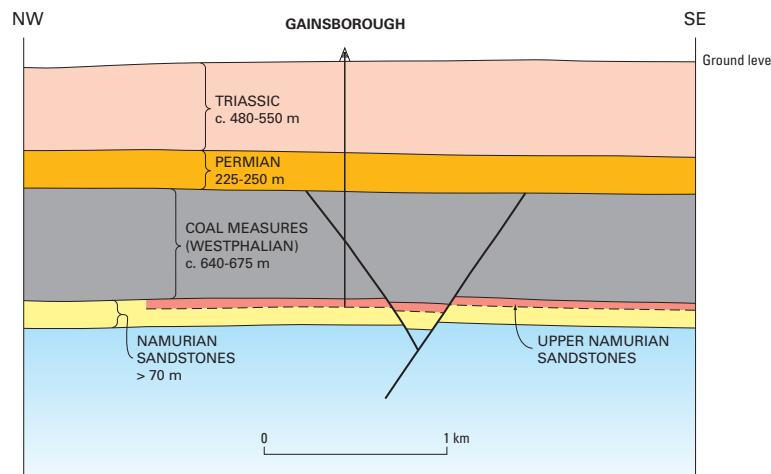
**Figure 49. Sketch section illustrating the geological conditions likely to represent the ‘Gainsborough-Beckingham scenario’ (based upon Brunstrom, 1963; Fraser & Gawthorpe, 1990, 2003).**

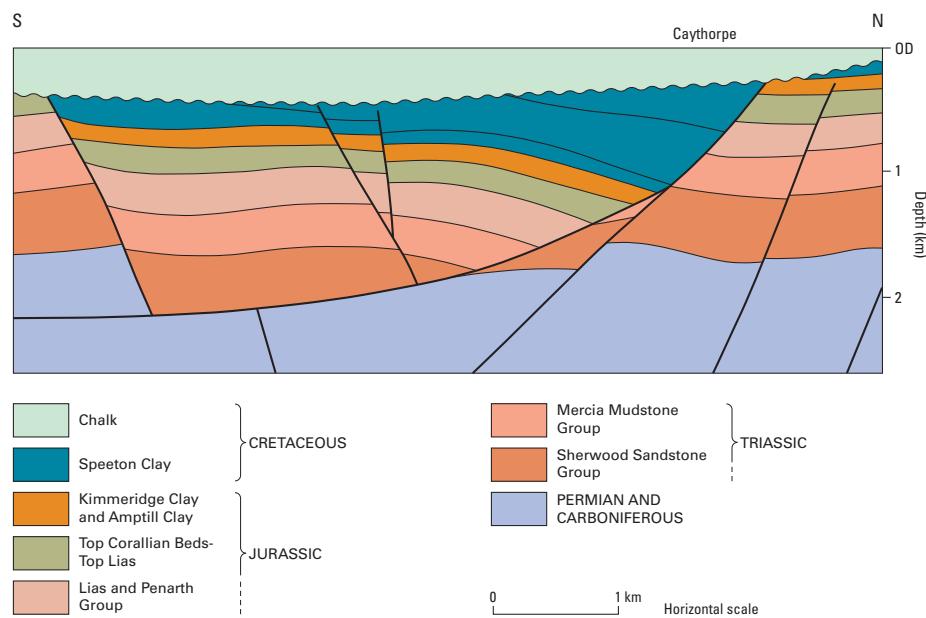
**Figure 50. Sketch section illustrating the geological conditions likely to represent the ‘NE England scenarios’ (e.g. Caythorpe and Kirby Misperton gasfields – based upon Kirby & Swallow, 1987).**

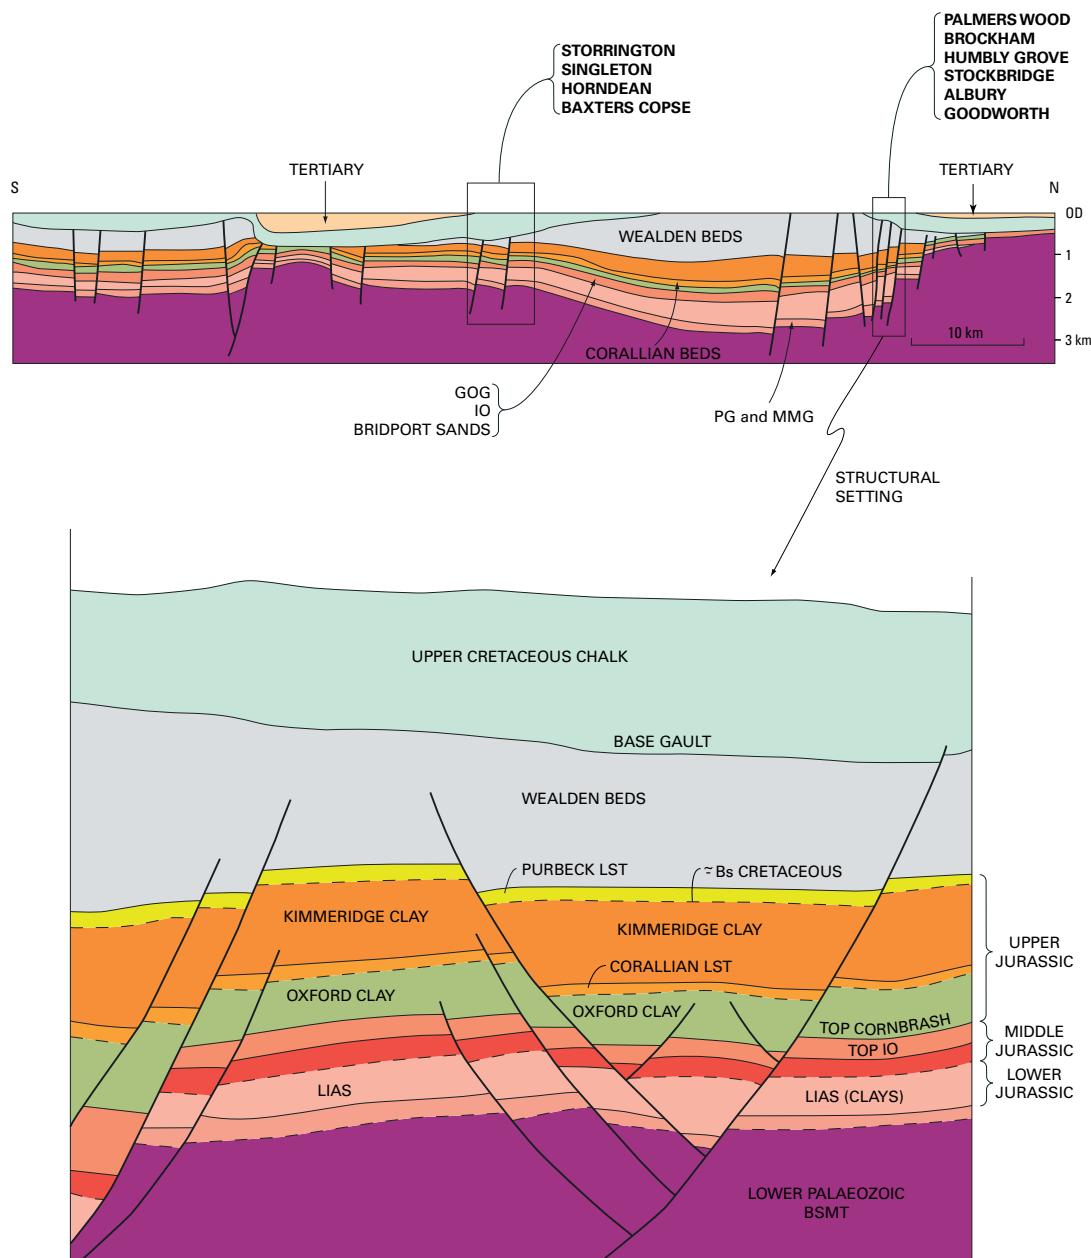
WEALD BASIN SCENARIO

**Figure 51. Sketch section illustrating the geological conditions likely to represent the 'Weald Basin scenarios' (e.g. Humbly Grove and Storrington – based upon Hancock & Mithern, 1987).**

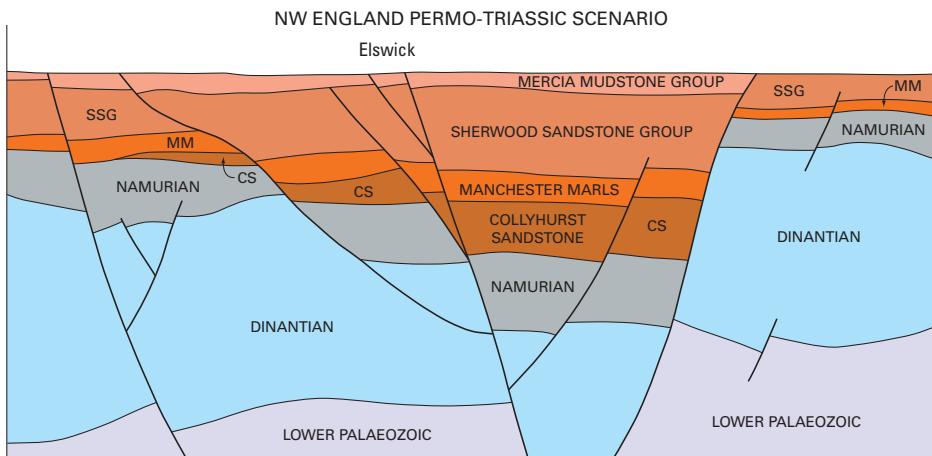
**Figure 53.** Sketch section illustrating the geological conditions likely to represent the 'NW England (Elswick) scenario' (based upon Aitkenhead et al., 1992).

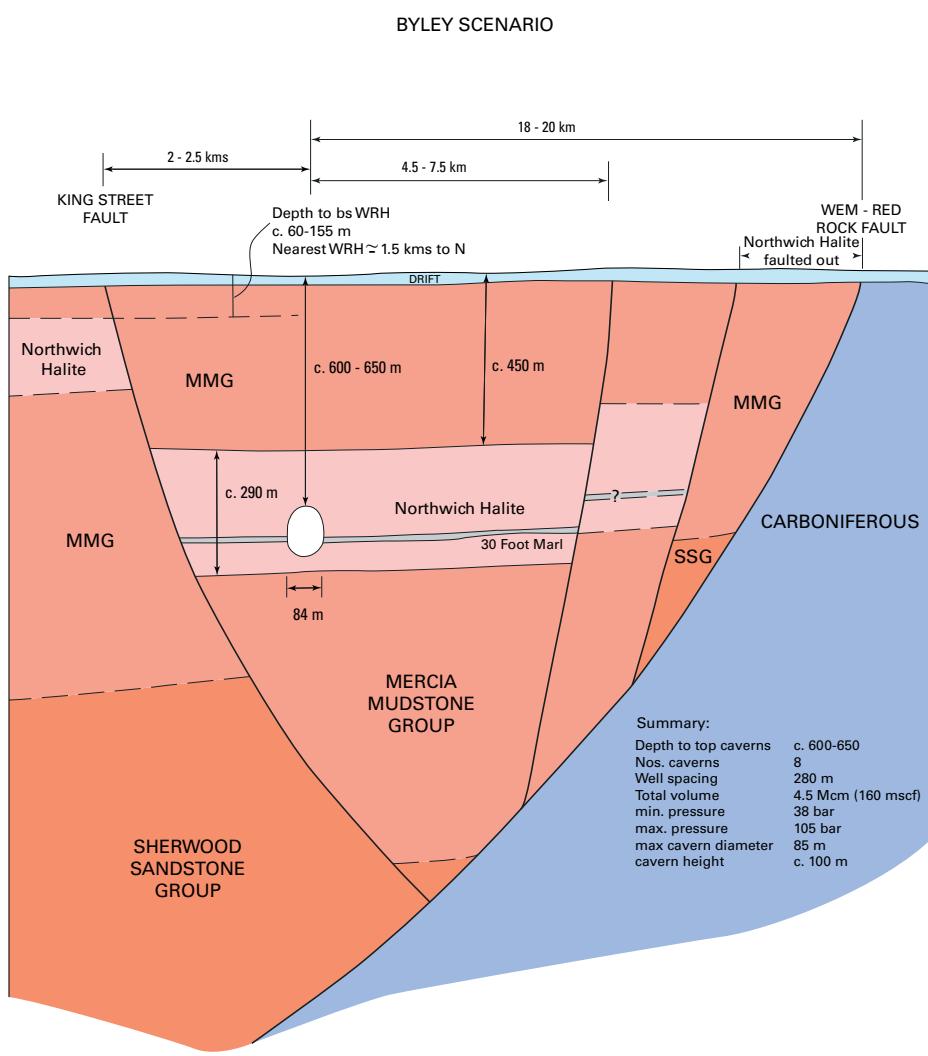
**Figure 54.** Sketch section illustrating the geological conditions likely to represent the 'Cheshire Basin scenario' – relating to the Byley, Hole House, King Street and Stublach sites.

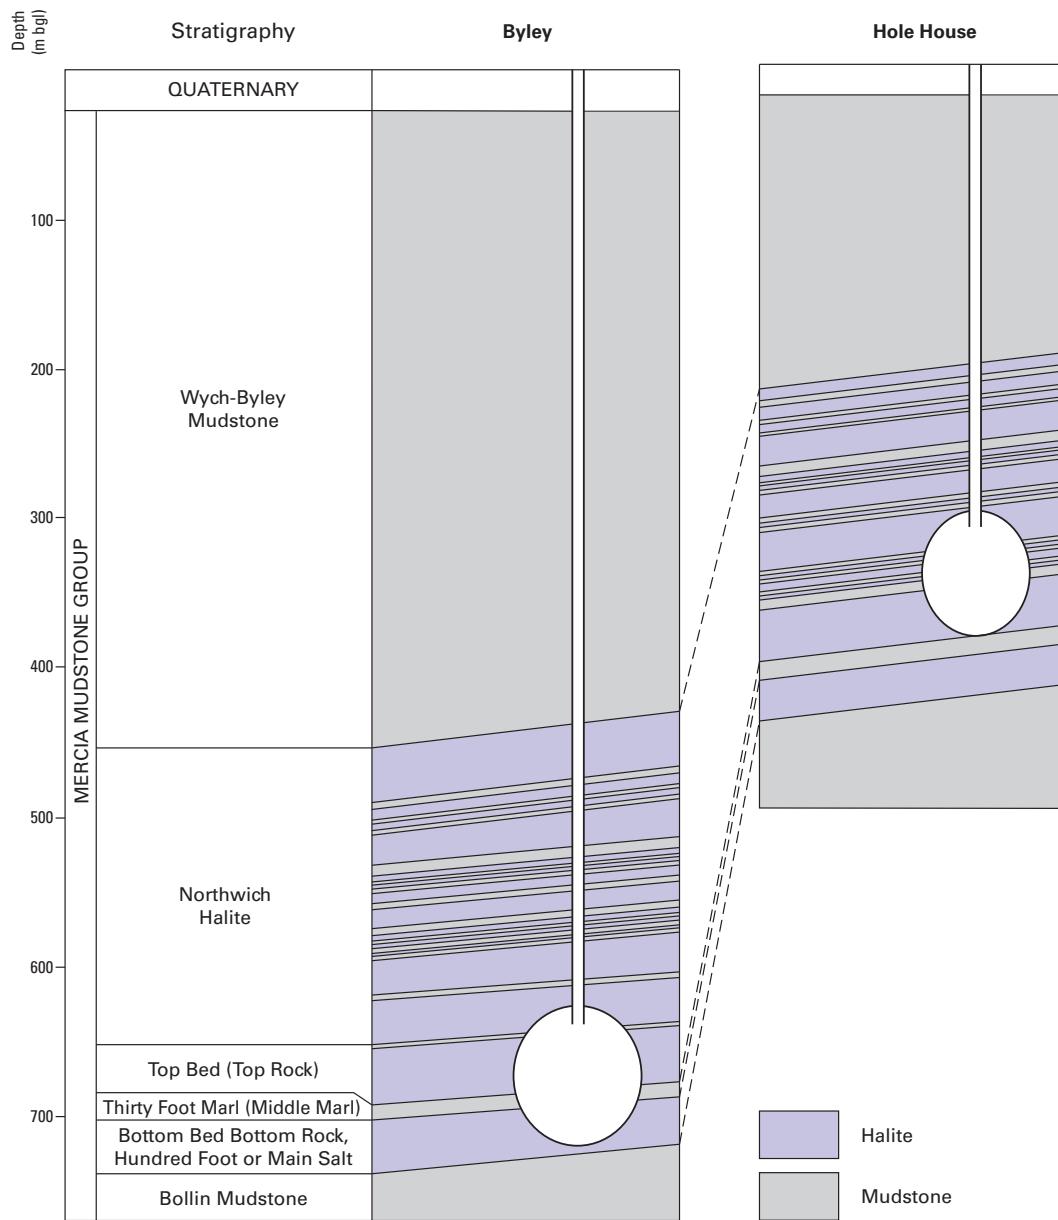
**Figure 55.** Sketch section illustrating the geological conditions likely to represent the 'Bley and Hole House scenarios'.
