# An appraisal of Underground Gas Storage technologies and incidents, for the development of risk assessment methodology.

Sustainable and Renewable Energy Programme  
Open Report OR/07/023

**Volume Two – Figures and Tables**

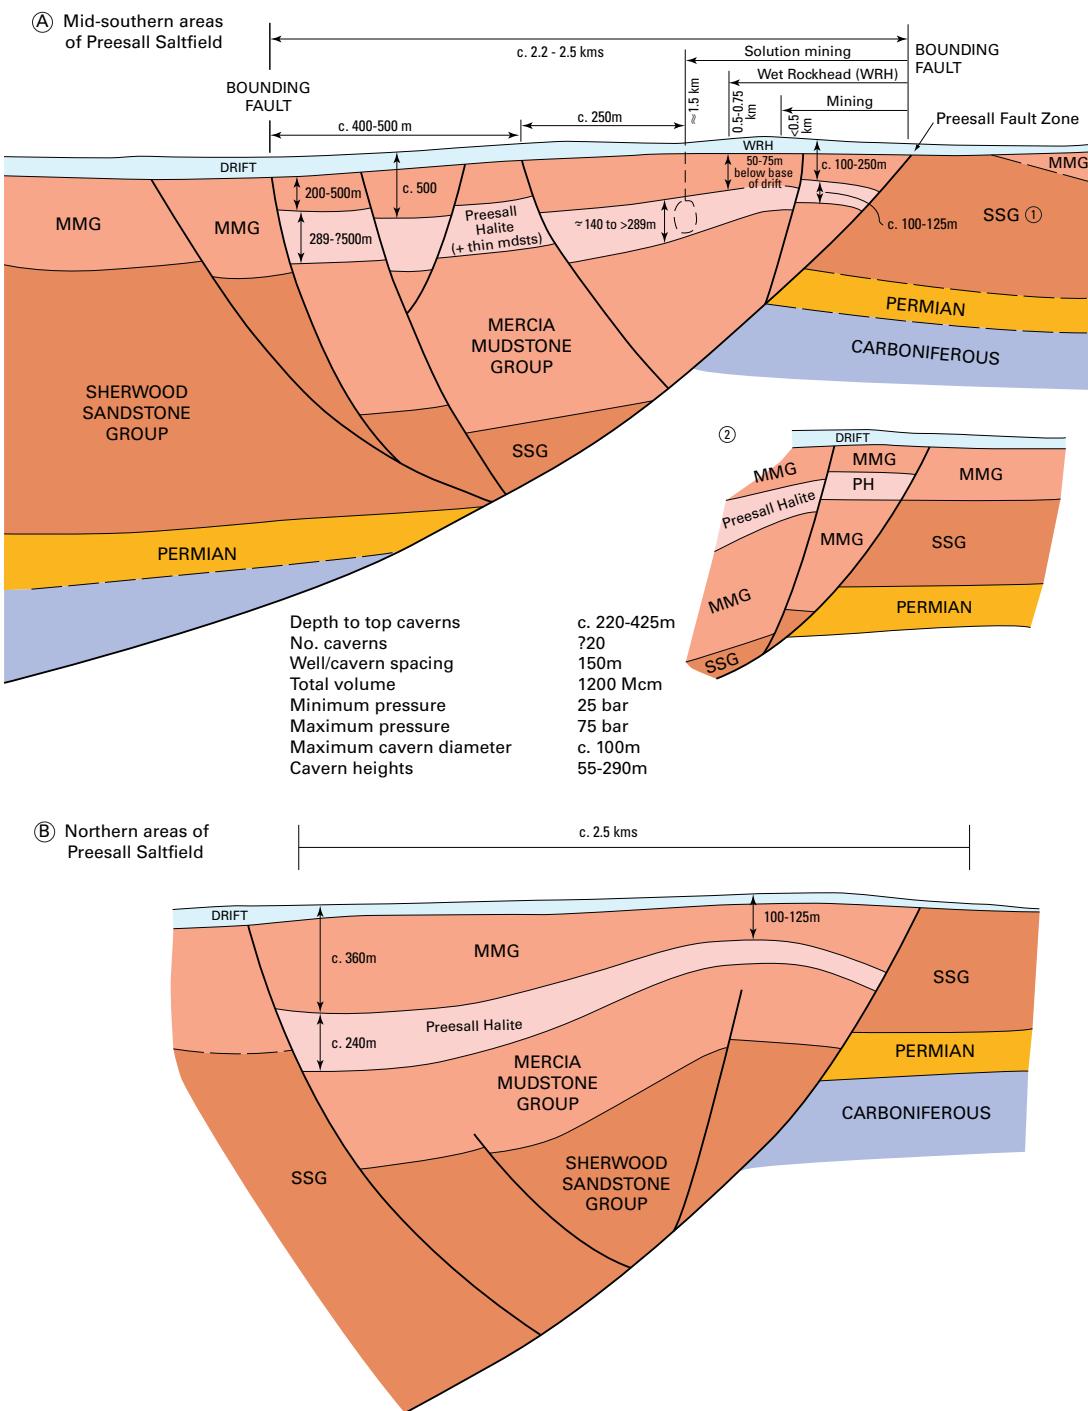
**Figure 56.** Sketch section illustrating the geological conditions likely to represent the ‘Preesall saltfield scenario’. a) the southern areas of the saltfield (more intragrabenal faults), b) the northern areas of the saltfield (fewer intragrabenal faults).

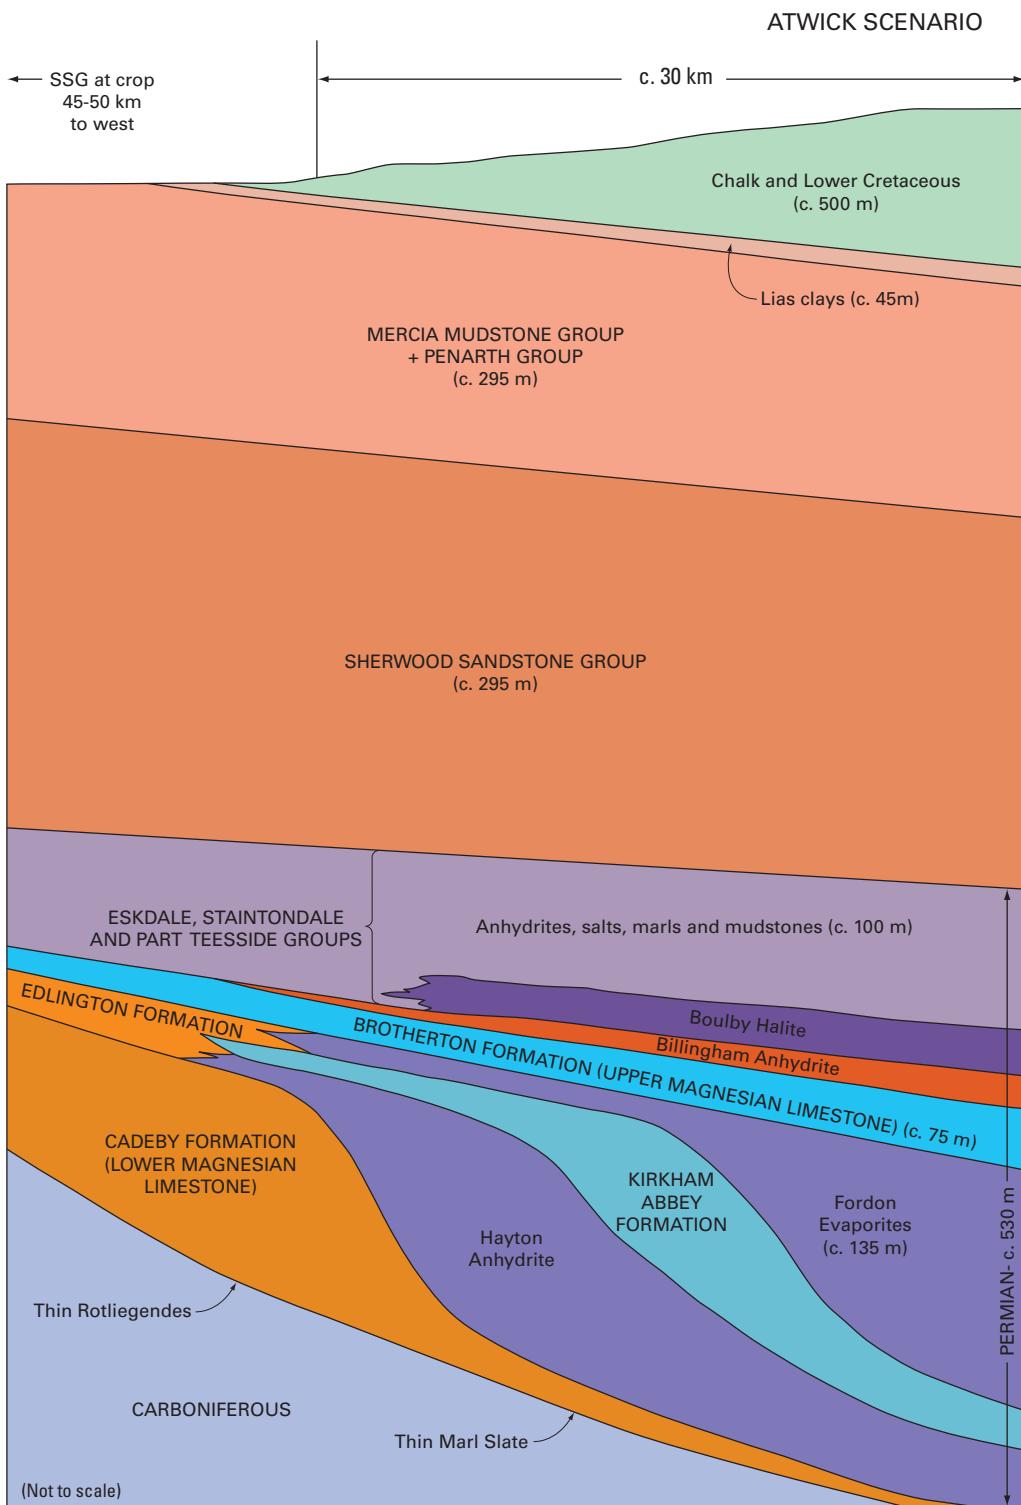
Depth top caverns	c. 1670 - 1900 m	Minimum pressure	c. 120 bar
Nos of caverns	9	Maximum pressure	c. 270 bar
Spacing	not known	Maximum cavern diameter	not known
Total volume	c. 420 Mcm	Cavern heights	c. 60 - <100m

**Figure 58. Sketch section illustrating the geological conditions likely to represent the 'NE England Permian scenario' (e.g. Hornsea/Atwick, Aldbrough).**
