TECHNICAL REPORT WC/95/28
Overseas Geology Series

RAPID METHODS OF LANDSLIDE HAZARD MAPPING: FIJI CASE STUDY

A report prepared for the Overseas Development Administration under the
ODA/BGS Technology Development and Research Programme, Project 92/7

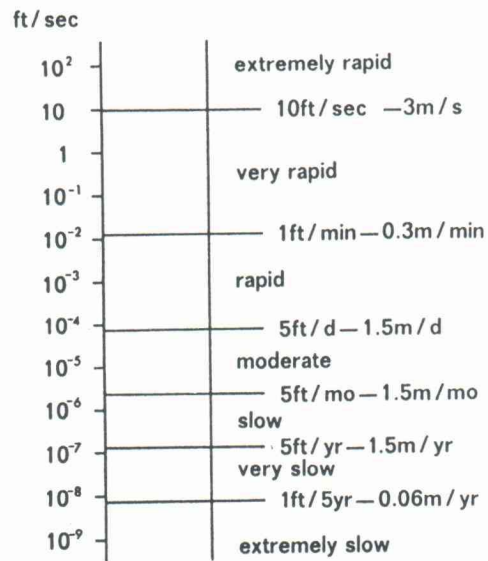
Figure 2.6 Rate of movement scale.
(after Varnes, 1978)

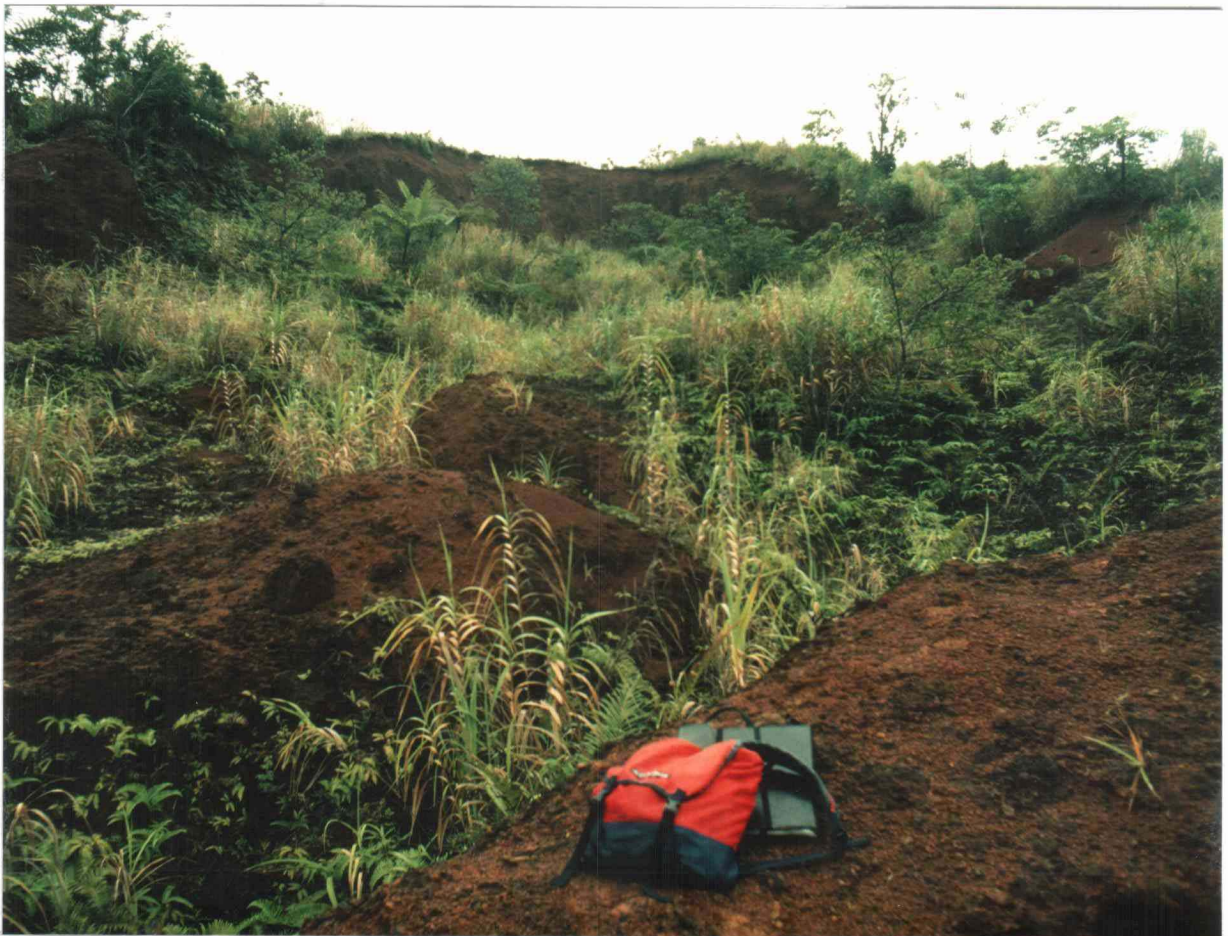
Figure 2.7 Multiple rotational slump in residual soil on unforested slope. The slump masses below the steep backscarp are rapidly degrading to rounded hummocks and attaining a vegetation cover. (Location: Serua Hills area)

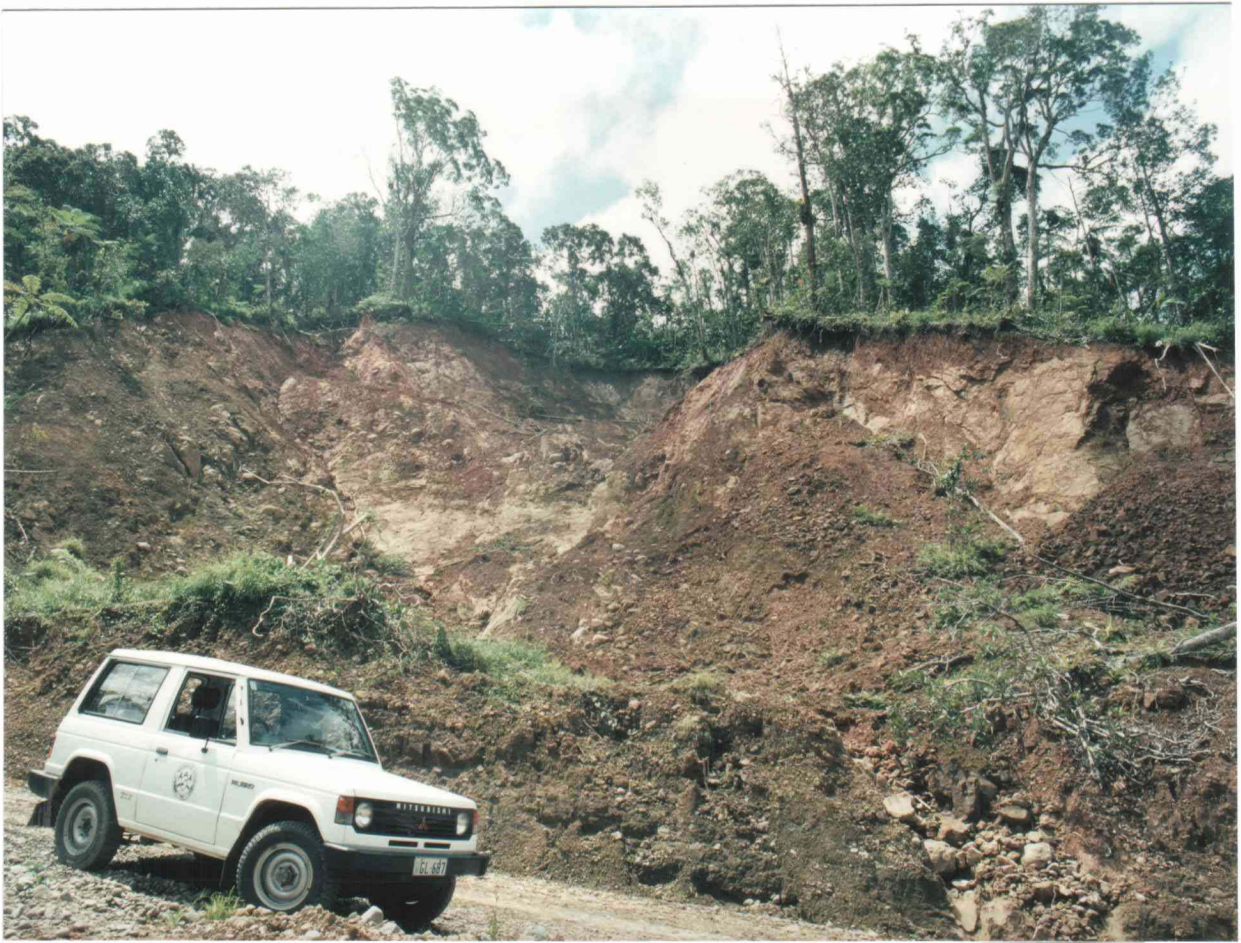
Figure 2.9 Translational debris slide with movement initiated along steeply dipping planar discontinuities in highly weathered bedrock. (Location: Nambukavesi-Namosi road in Waindina River catchment)

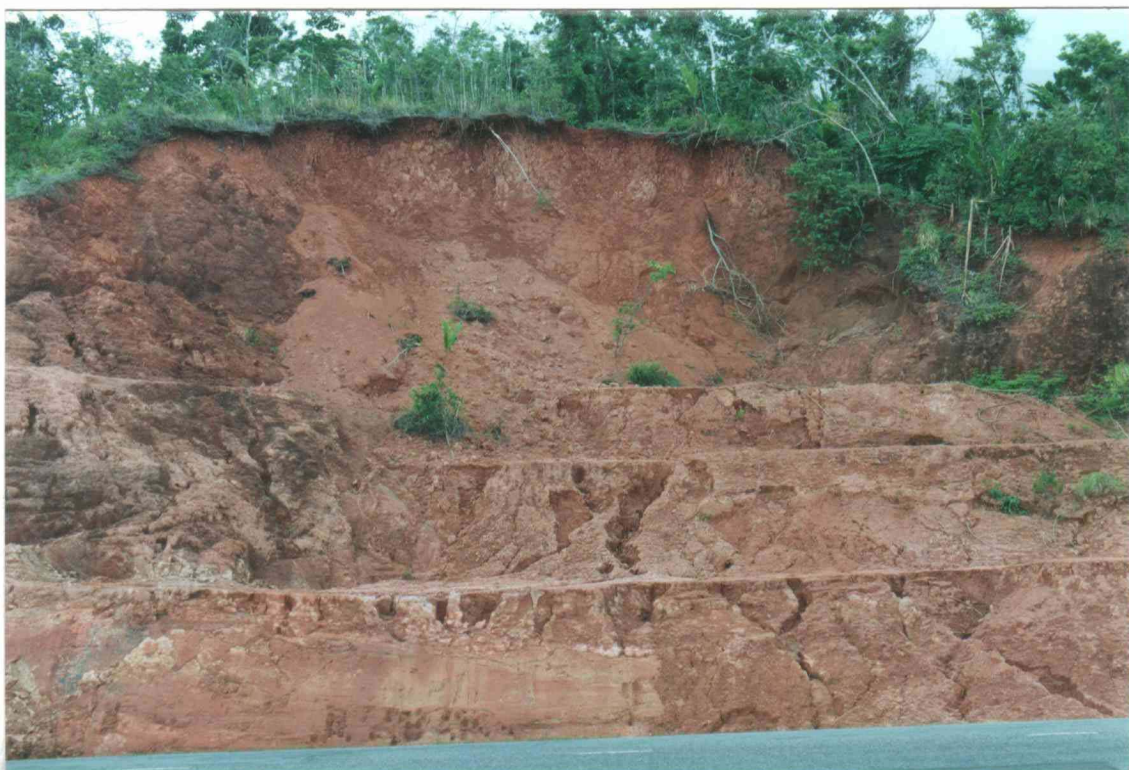
Figure 2.10 Unstable road cutting near Galoa on the Suva-Nadi Highway. Failure is translational, involving residual soil sliding along an irregular, steeply-dipping interface with underlying weathered bedrock, and compounded by shallow rotational movements in the displaced debris mass.

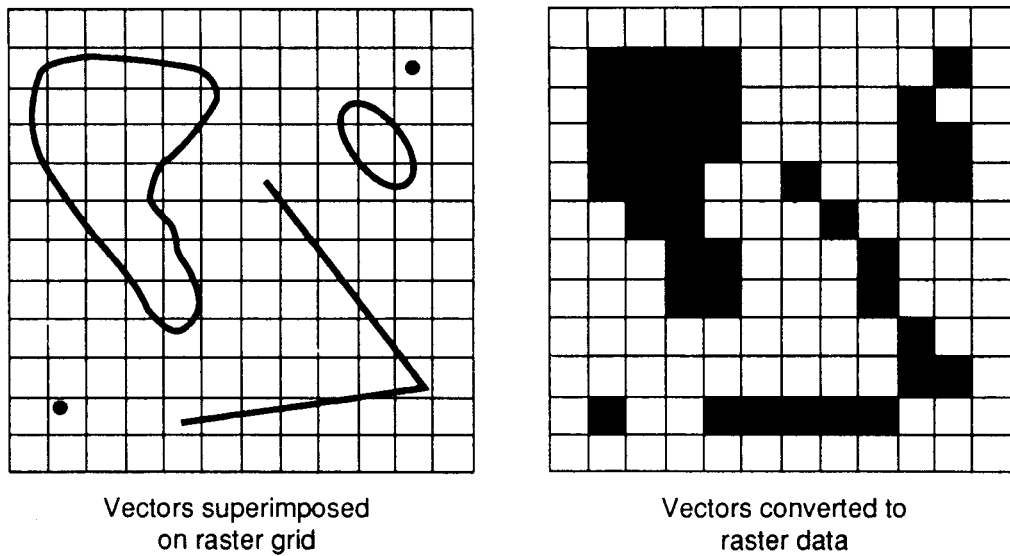
Figure 4.1 Concepts of vector and raster representations of points, lines and polygons.

raster systems, the map area is divided into a mesh of grid cells (also called 'pixels') each of which records the value of the parameter. Raster data require more storage than vectors since every pixel must have a value, even if it is a code to indicate the absence of information. They also produce less elegant map output. Their main advantage is they are better suited to analyzing spatial relationships between parameters over continuous areas.

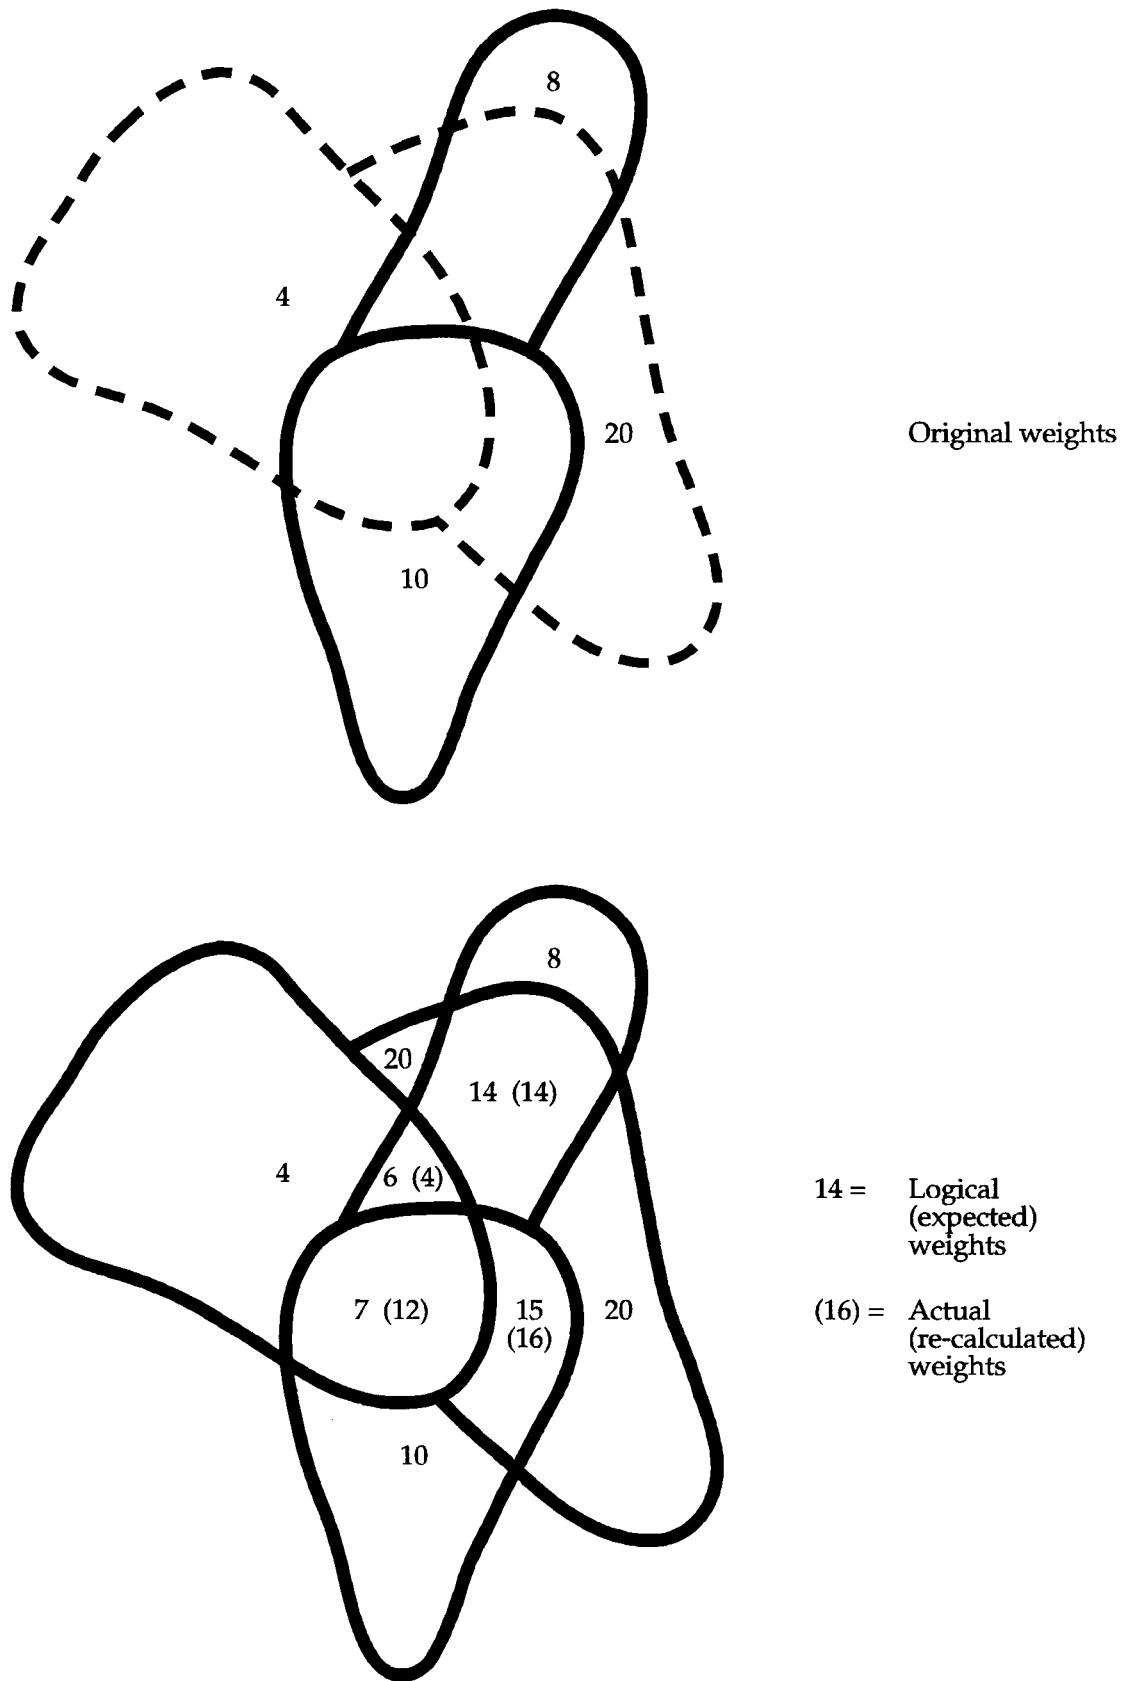
Figure 5.2 The upper diagrams show 2 variables each consisting of 2 weighted classes. In the lower diagram, summation of the 2 variables produces new ‘logical weights’ for the new polygon areas. However, the ‘re-calculated weights’ (in brackets) do not necessarily match the logical weights.
