A Building Stone Audit for Kilmarnock

Surveying, matching and sourcing stone for the built heritage

OPEN REPORT OR/09/002

A Building Stone Audit for Kilmarnock: Surveying, Matching and Sourcing Stone for the Built Heritage

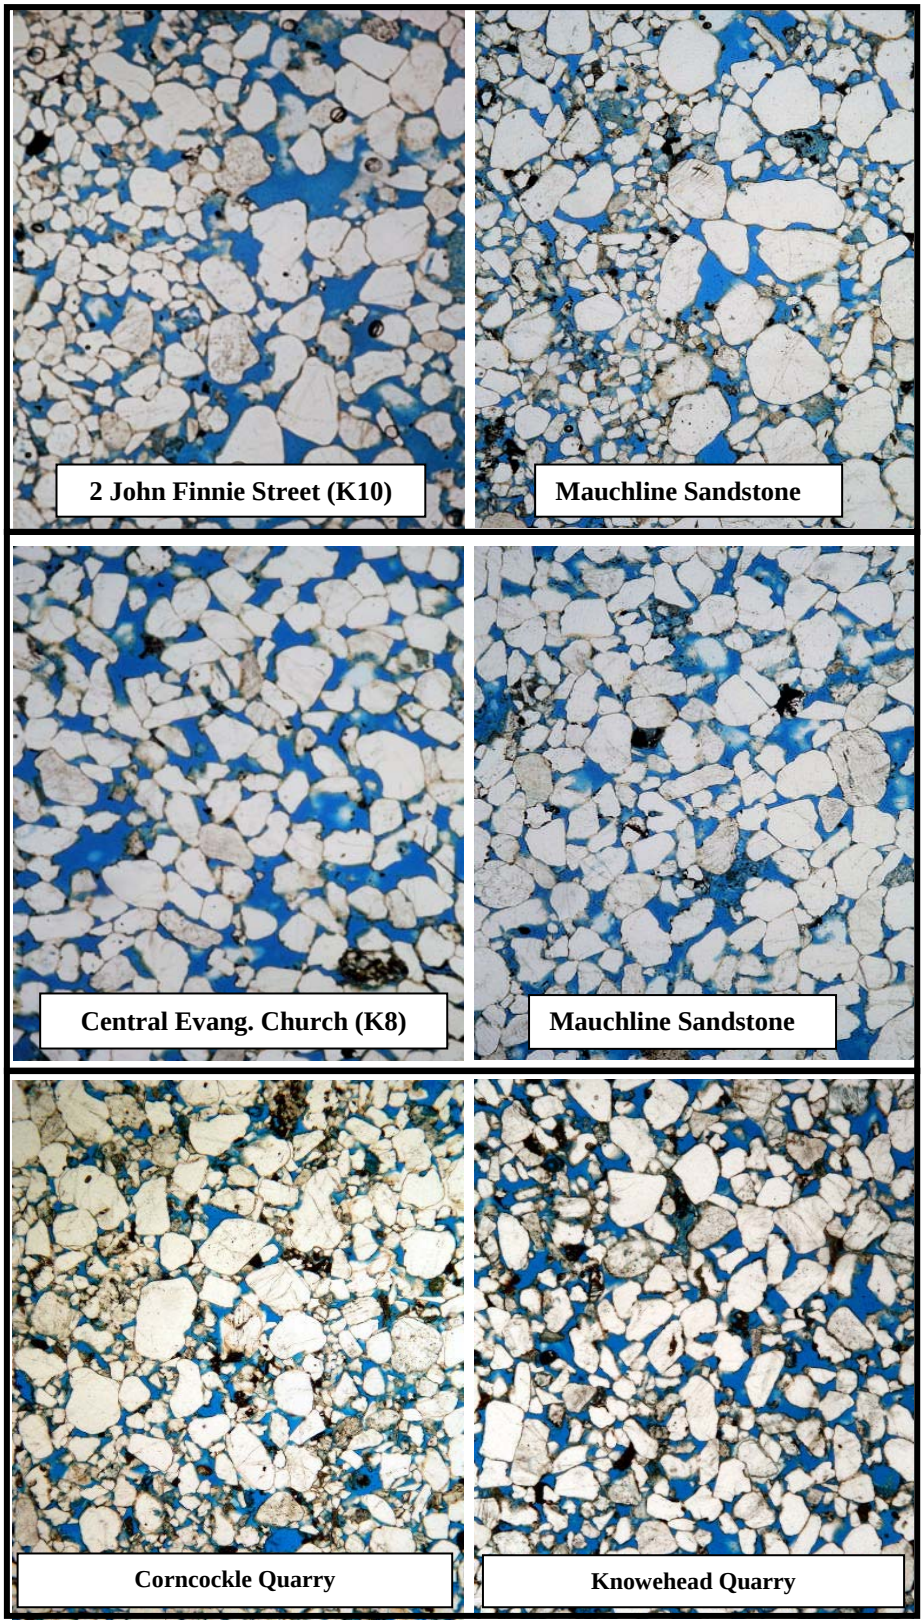
Of the thirty-two samples analysed, twenty-one are Permian red sandstone. These represent late 19th and early 20th century buildings mostly associated with John Finnie Street. As there are no Permian red sandstones in the immediate vicinity of Kilmarnock, this stone type has undoubtedly been imported into the town. Comparison of the samples with quarry specimens held in BGS collections shows that most of the red sandstone is of a type found in the Mauchline basin (located approximately 15 km southeast of Kilmarnock) (Fig. 8). The Mauchline sandstone is distinctive in that it has a bimodal grainsize distribution, but with a variable texture ranging from strongly bedded to uniform. All of the sandstone quarries in the Mauchline basin are now closed.

Fig. 8. Comparison of microscopic thin section images of red sandstone from Kilmarnock buildings with known quarry sources. The top-left and centre-left images are from buildings K10 and K8, and have been 'matched' to sandstones from quarries in the Mauchline area (top-right and centre-right). The closest matching currently-available sandstones are shown bottom-left and right, from Corncockle and Knowehead quarries in Dumfriesshire. All images are c.3mm across; viewed in plane polarised light; and blue dye impregnated to highlight porosity.

None of the sandstone quarries in the Mauchline basin are open today, so that the original sandstone used for the majority of the surveyed buildings is unobtainable (see Chapter 6 for detailed discussion of the former quarries and the potential for their reopening). The samples identified as Mauchline sandstone from the surveyed buildings were compared to specimens from active red sandstone quarries from throughout the UK in order to identify the closest currently available stone types for repairs. Sandstone from Corncockle quarry (Dumfriesshire) is the most similar to the Mauchline sandstones in terms of petrographic and visual characteristics (Fig. 8), and this is recommended as the closest matching replacement stone for most red sandstone buildings (Table 2). The reddest varieties of sandstone from Knowehead quarry (Dumfriesshire) are also similar to the Mauchline sandstone, and have been recommended for a number of buildings (Fig. 8; Table 2). Locharbriggs sandstone typically has a distinctive more pinkish colour compared to the deeper orange-red colour of the Mauchline sandstones. Only the more red varieties of Locharbriggs sandstone are considered to be a suitable substitute for Mauchline stone (Table 2).

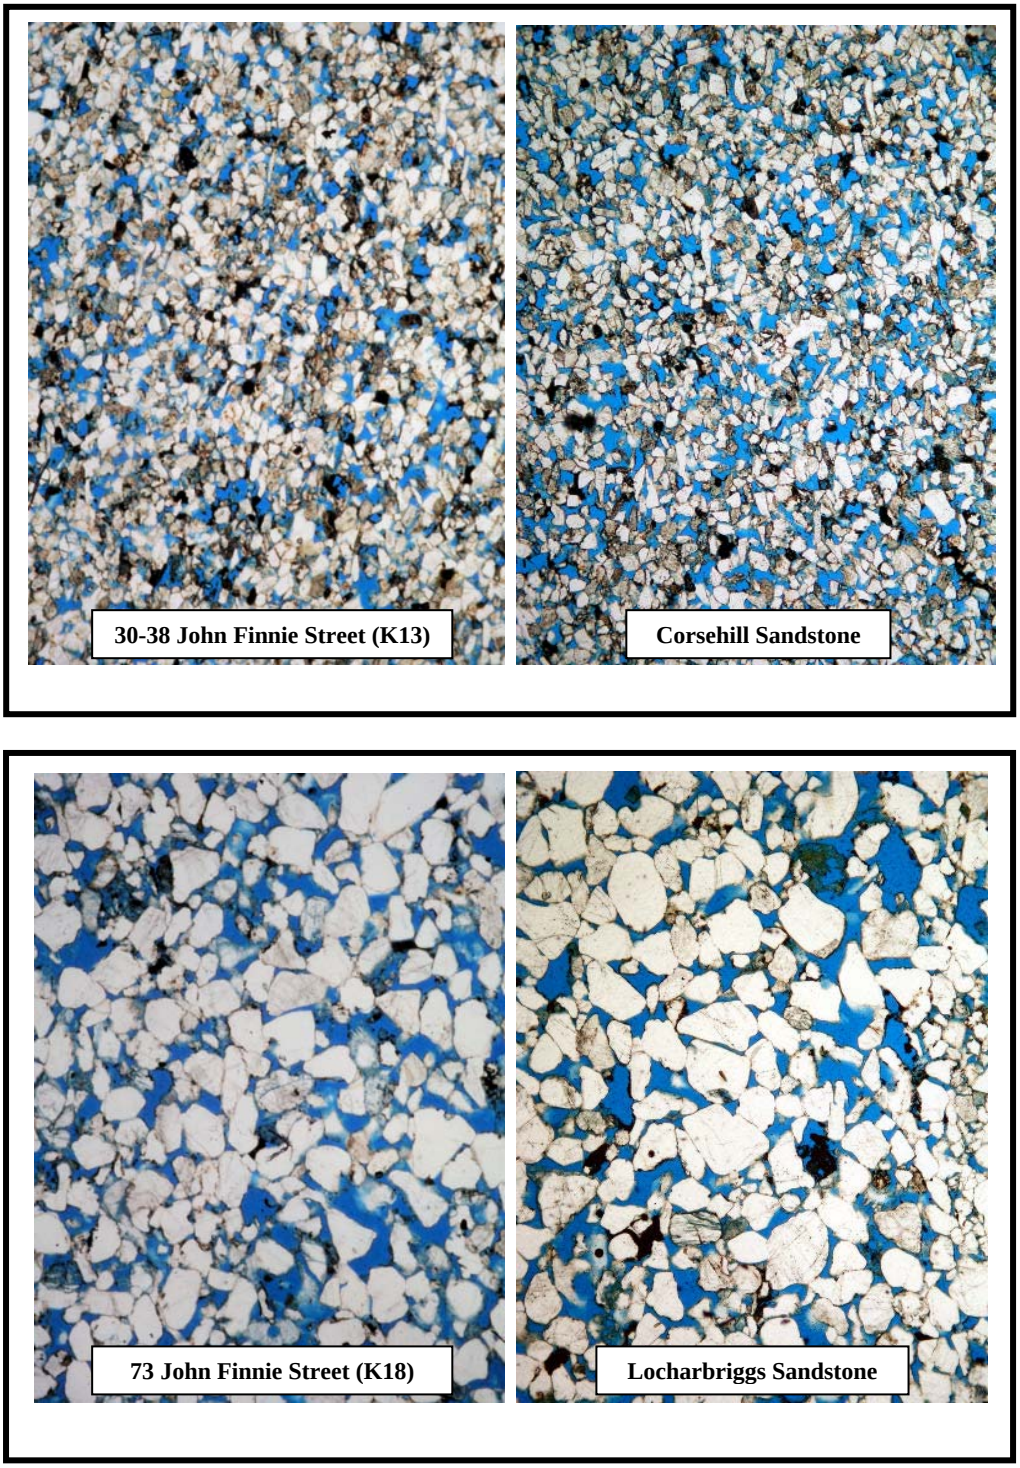
Three samples from Kilmarnock buildings are a much finer grained red sandstone, similar to Corsehill sandstone (from Annan in Dumfriesshire (Fig. 9). It is possible that this stone is a finer grained variety of red sandstone from one of the Mauchline quarries, but it is not typical of the Mauchline red sandstones. This finer grained red sandstone is found in only three buildings; Whites (K1), Kilmarnock Standard (K5), and the west elevation of 36 John Finnie Street (K13). A third type of red sandstone with has been identified in the Post Office building (K18), which has a different shade of colour (lighter orange-pink) and distinct petrographic characteristics (coarser grained), very similar to Locharbriggs sandstone from Dumfriesshire (Fig. 9).

Fig. 9. Microscopic thin section images of red sandstone from two Kilmarnock buildings which match sandstones from the Corsehill and Locharbriggs quarries. All images are c.3mm across; viewed in plane polarised light; blue dye impregnated to highlight porosity.

The few buildings containing other red sandstone types (Corsehill and Locharbriggs) can be matched using stone from these quarries, both of which are still active (Fig. 9). The stone matching recommendations for each building are summarised in Table 2, and more detail is given in the Sample Description Sheets for each building.

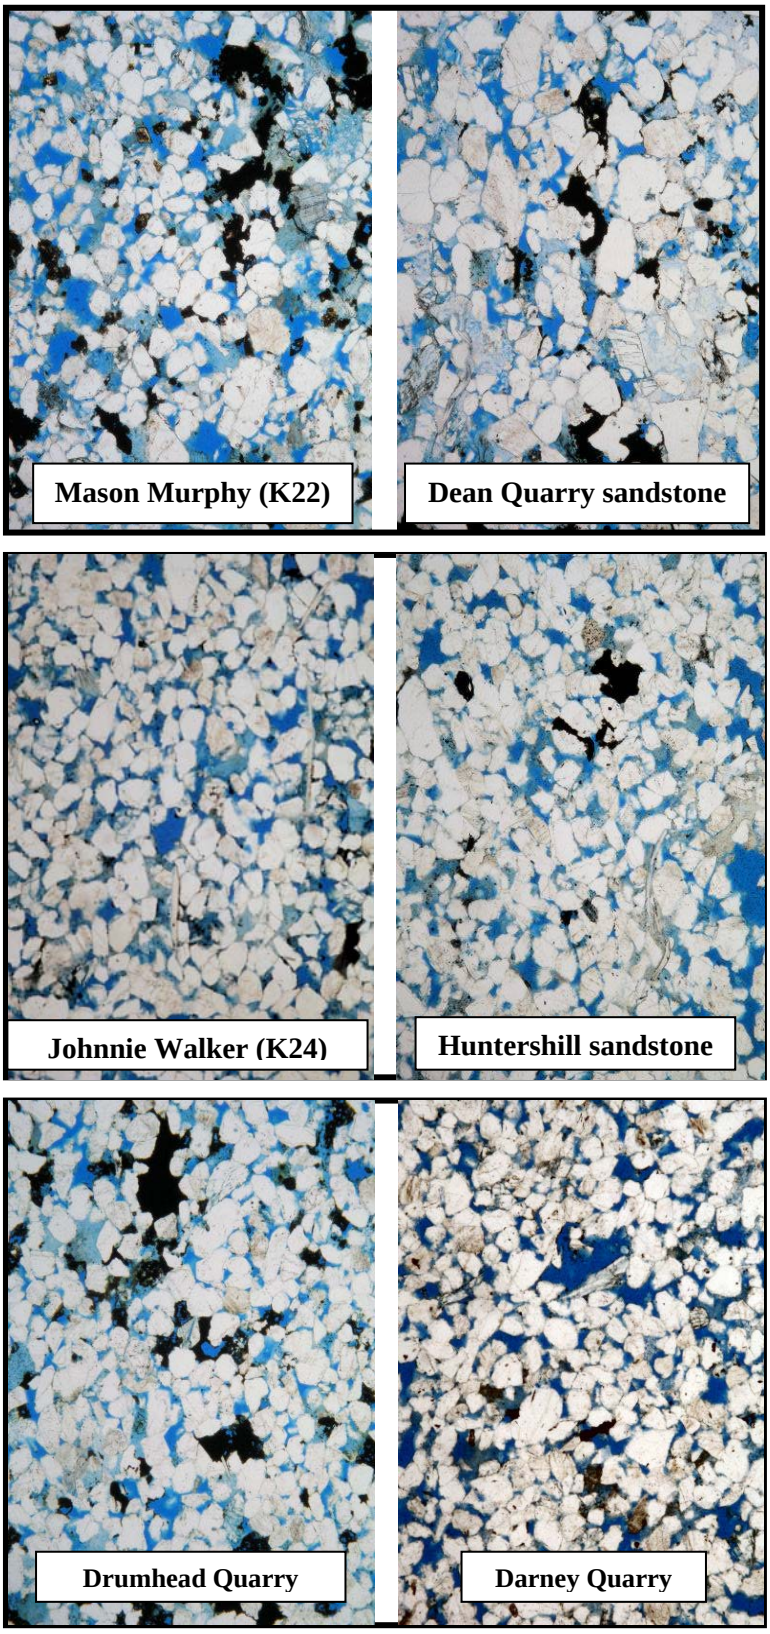
Fig. 10. Microscopic comparison of blonde sandstones from Kilmarnock buildings with known quarry sources. Top images: Sample from Mason Murphy (left) compared to Dean Quarry sandstone (right), showing that the stone for this building almost certainly came from this quarry. Centre images: Sample from Johnnie Walker building (left) showing similarity to sandstone from Huntershill (Bishopbriggs) near Glasgow; Bottom images are the closest matching available stone types; Left: sandstone from Drumhead quarry (near Falkirk), similar to the Dean Castle sandstone; Right: sandstone from Darney quarry (Northumberland), similar to stone from the Johnnie Walker building. Images c.3mm across; plane polarised light; blue dye impregnated to highlight porosity.

It is difficult to find a currently available matching stone type for the local Kilmarnock blonde sandstone. All the building stone quarries in the Kilmarnock area are closed (discussed in Chapter 6), and there are no quarries in the UK supplying sandstone of exactly this type. Comparison with specimens in the BGS collections has identified a number of quarries which produce stone which has some similarities to the original Kilmarnock blonde sandstone (Table 2 ; see also individual Sample Description Sheets for each building). The most commonly recommended stone types are Drumhead (Doghillock) sandstone (Fig. 10), Northumberland Buff, Bearl and Catcastle Buff. These sandstones are generally pale in colour, relatively coarse grained (or variably grained) and have a banded or bedded texture. The recommended stone types show a range of characteristics, including some which have a more buff brownish colour (rather than 'blonde') which may replicate the weathered appearance of the original blonde sandstone in a building. A number of more uniform currently available sandstones are also suggested (e.g. High Nick and Birchover) should a less banded texture be required (e.g. for reproducing carved or moulded details). Because the original Kilmarnock blonde sandstone can be variable, it is recommended that prior to specification of replacement stone for a particular building, a range of the recommended samples are obtained for on-site comparison, so that the most suitable stone type for the particular job is obtained.

Comparison of the high quality 'imported' blonde sandstone with stone from currently active quarries has identified a number of available stone types with similar petrographic characteristics. These are mostly from northeast England where most of the sandstones have a stronger buff (variable orange-brown-yellow) colour. The recommended sandstone types which are closest to the original stones used in Kilmarnock are Darney, Blaxter, High Nick, Birchover, Dunhouse Buff, Black Pasture and Hazeldean (Fig. 10). Table 2 lists the recommended stone types for each particular building (discussed in more detail in the Sample Description Sheets). As stated above, samples of the recommended stone types should be obtained prior to specification to allow on-site comparison with the original stone.

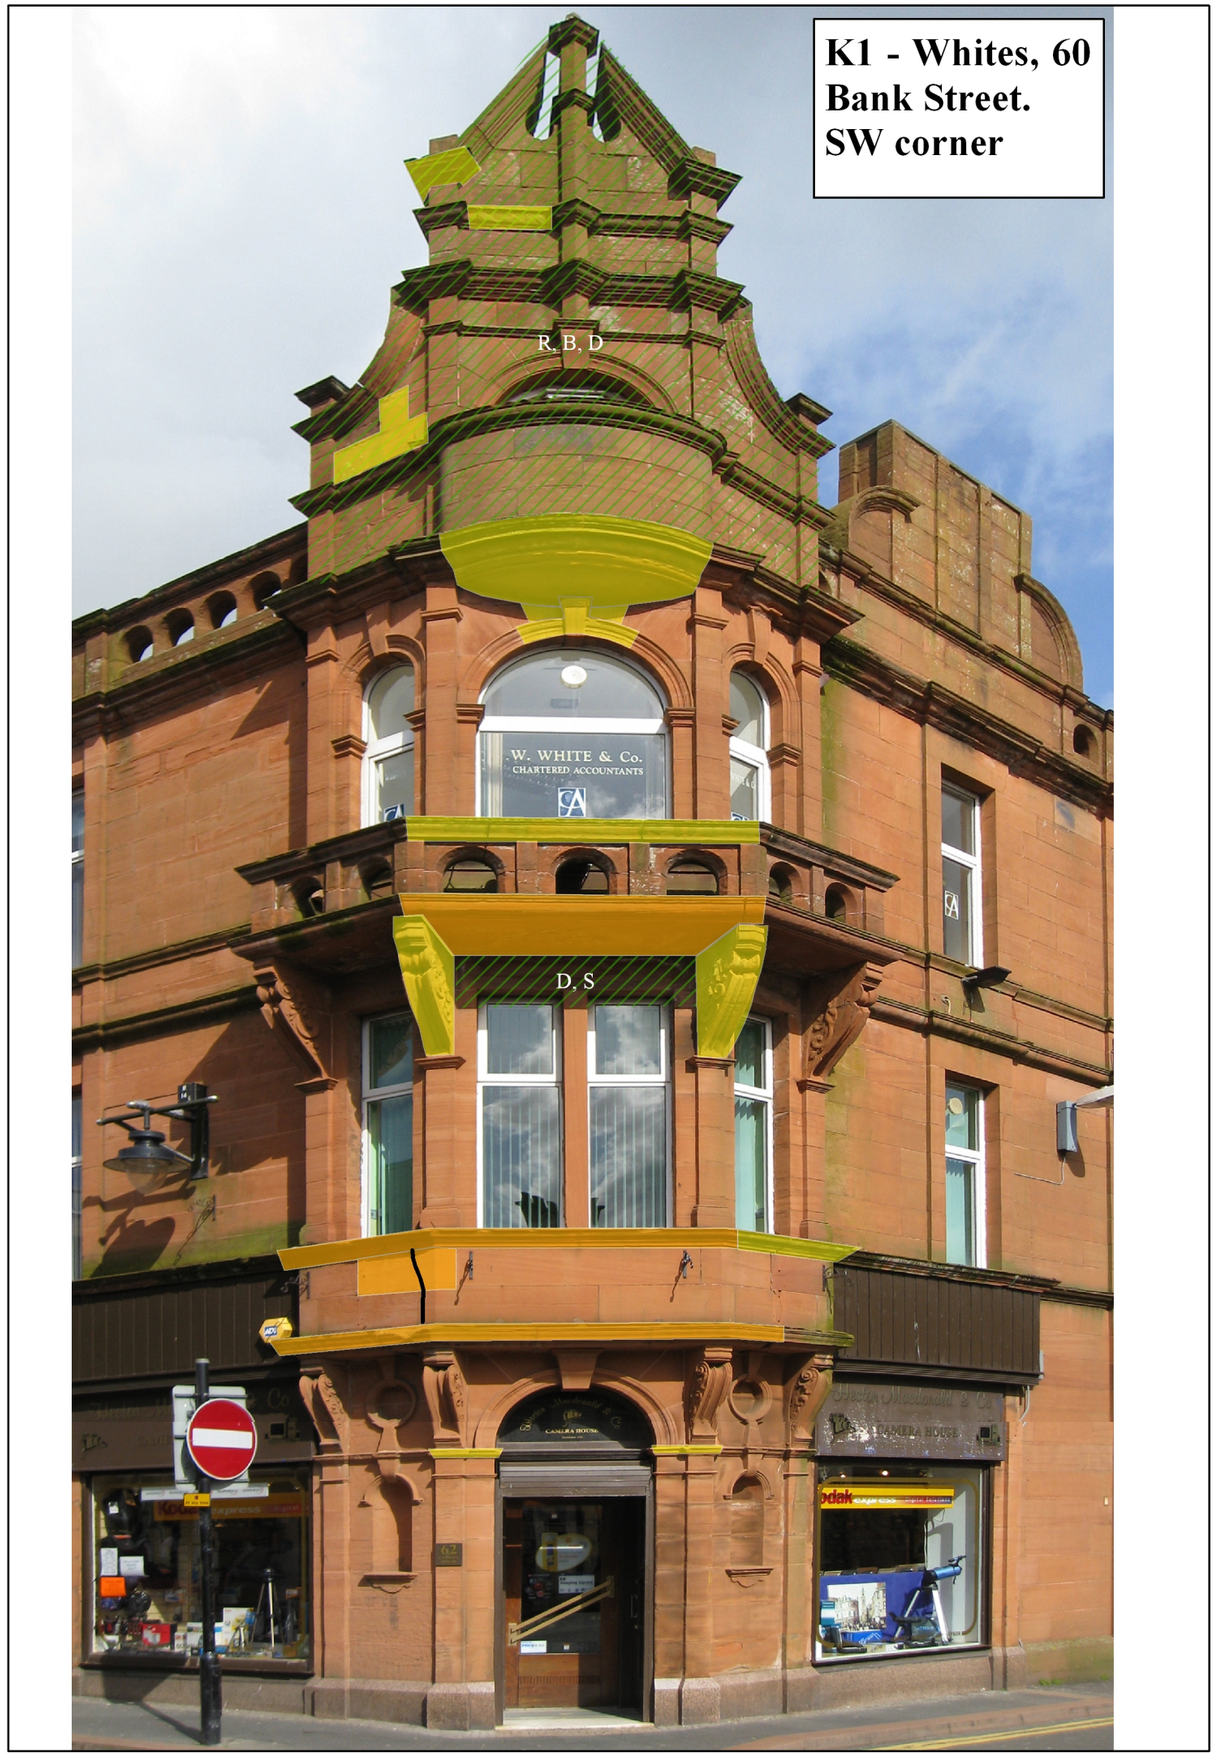
Note: This survey is intended to highlight areas of stone decay/damage as a guide for stone repairs/replacement and to draw attention to maintenance requirements. Surveys were carried out from ground level, and closer inspection may be required to assess the precise repair requirements. The survey does not include roofing materials; nor missing/removed architectural details. It does not constitute a structural survey. For full details please consult the project report.

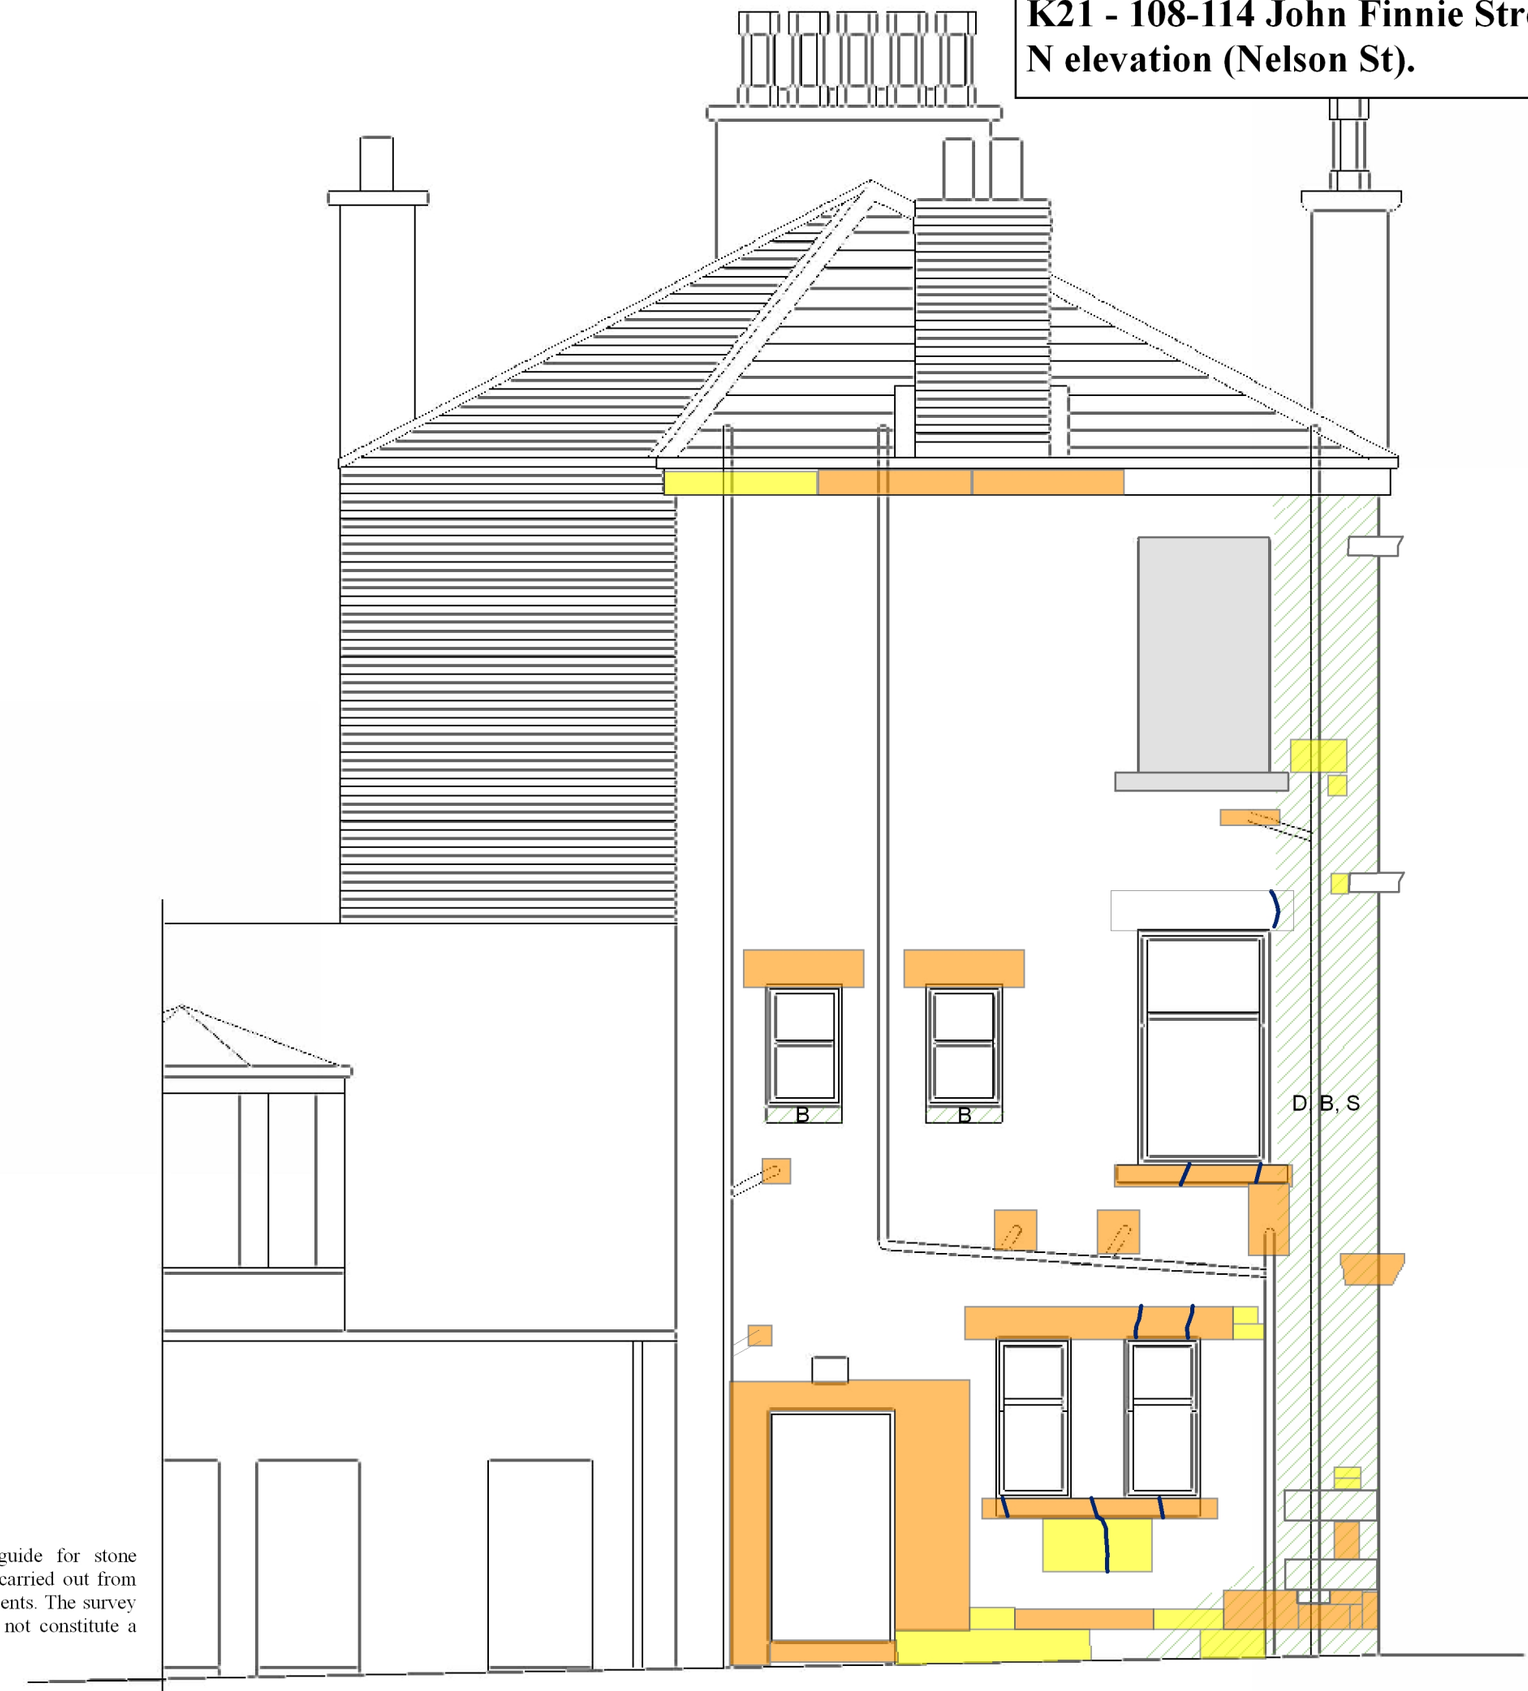
R = Repointing required
D = Water penetration/damp
C = Cement mortar/patches or other coatings
S = Salt/splash
B = Organic growth/deposits
O = Other (see façade survey sheet)

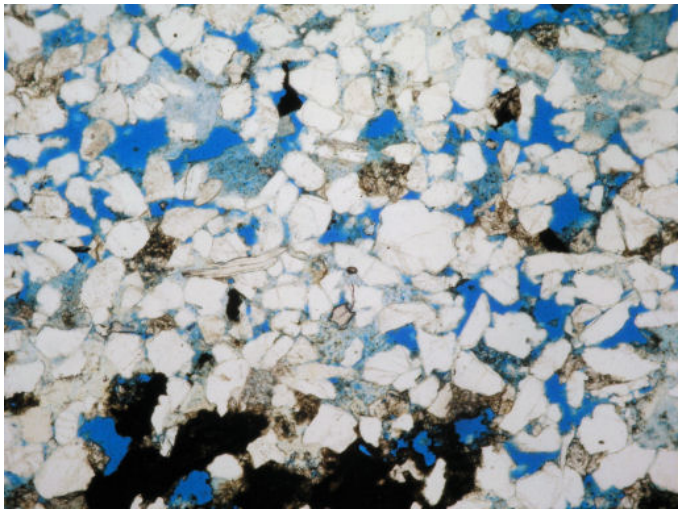
In this report the survey results for each building or structure are presented as an A3 size digital image with colour overlays showing the areas of stone which require repairs (Appendix 2). Related issues such as maintenance requirements are also highlighted. Each image is accompanied by a Façade Survey Sheet (Appendix 1), which describes the main types and causes of stone decay, and suggested actions and intervention needs. The information given represents observations made at the time of survey as shown on the Façade Survey Sheet.

3.2 Survey methodology and categories of damage

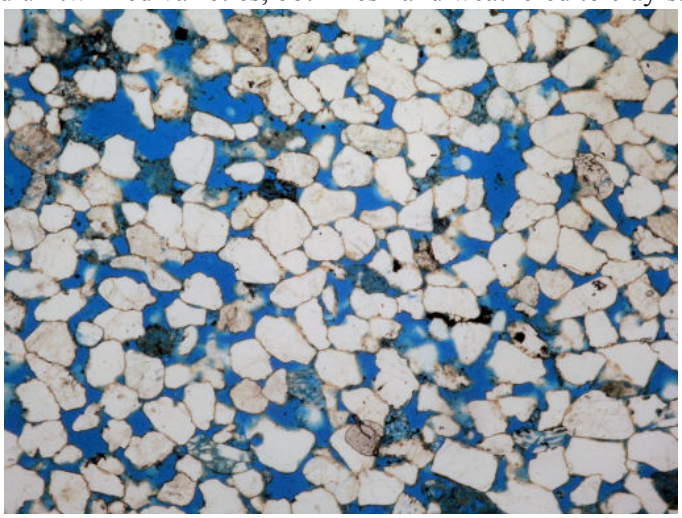
3.2.2 Stone likely to require replacement (orange colour)
Stone masonry shows decay or damage to a degree that it is affecting the ability of the masonry element to perform its function (e.g. decay of water shedding features such as string courses, cornices, window surrounds etc.). Also included are elements where further decay could result in future instability (e.g. decayed dentils and projecting mouldings). This category also includes stonework which is decayed to the extent that it causes significant disruption of the architectural or aesthetic value of the building. It is considered that the stone identified in this category is likely to require replacement in forthcoming repair works.

3.2.3 Damaged stone not necessarily requiring replacement (yellow colour)
Stone which shows superficial decay or damage, but which is not causing impairment of the structural or functional aspect of the stone, and/or which is not significantly disrupting the overall appearance of the building. It is recommended that stone identified in this category is given a more detailed inspection during the course of the repair works or planning stages in order to confirm whether replacement is considered necessary or not. The stone is highlighted for future consideration and may require immediate maintenance to prevent further decay. In some cases the decay is such that the stone surface may be redressed or dressed back to sound stone. Further details and recommendations for each building are given in the Façade Survey Sheets, and summarised in Table3.

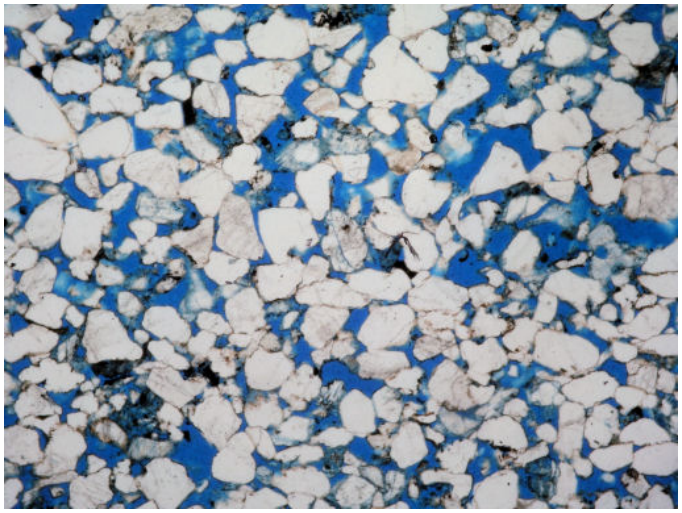
For each surveyed building and structure a standard pro forma survey sheet ('Facade Survey Sheet') was completed to ensure systematic collection of information in the field. For buildings where significant differences occur between different facades more than one sheet was completed. The information recorded was used in the production of the digital survey images and summarised in the facade survey sheets that accompany each of the building surveys in this report. Each sheet gives a summary of the masonry style and stone type, and an overview of the main findings of the stone survey including intervention needs. A 'Comments' section gives details of the main types and causes of stone decay and other issues relating to the building and its repair needs. An example of a field survey sheet is shown in Fig. 7.

3.4 Criteria for decision-making and constraints of the stone surveys

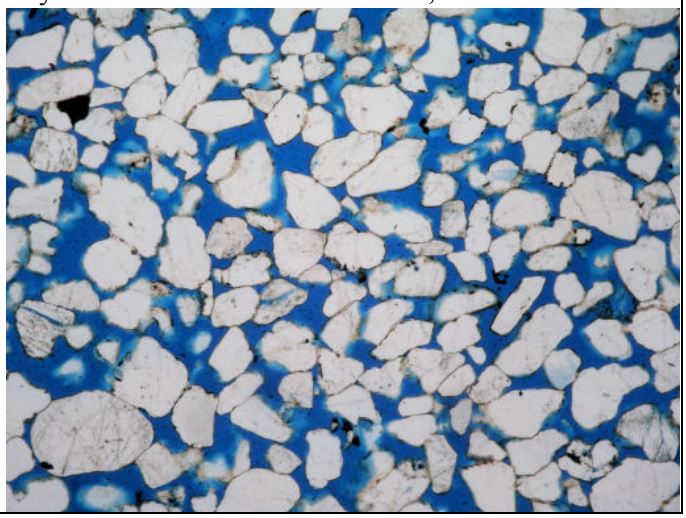
- Stonework is decayed or damaged such as to have a significant impact on the aesthetics and architectural value of the facade, including requiring the reinstatement of missing masonry and carved details.

- Where it is judged that the stone is so badly damaged that deterioration will occur over the next few years that will result in any of the above factors.

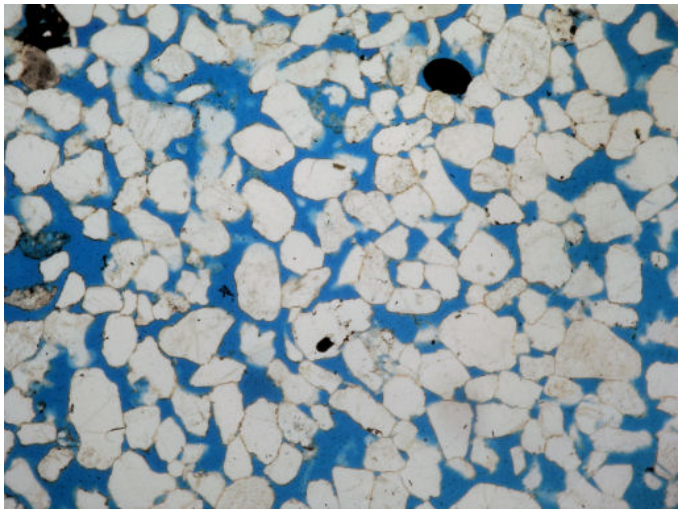
Masonry Style (Oriental) Ashlar w. simple carvings. Papa & A&H mostly plain ashlar w. some pitted rubble.

Stone Description (type/location/grainsize/colour/texture/others)
