Physical factors contributing to rural water supply functionality performance in Malawi

UPGro Hidden Crisis Research Consortium

<u>Version date</u>
07 February 2020

<u>Bibliographical Reference</u>
Mwathunga E, Fallas HC, MacAllister DJ, Mkandawire T, Makuluni P, Shaba C, Jumbo S, Moses D, Whaley L, Banks E, Casey V, MacDonald AM. 2019. UPGro Hidden Crisis Research Consortium, Technical Report – Malawi. *British Geological Survey (BGS) Open Report*, OR/19/057, pp 25.

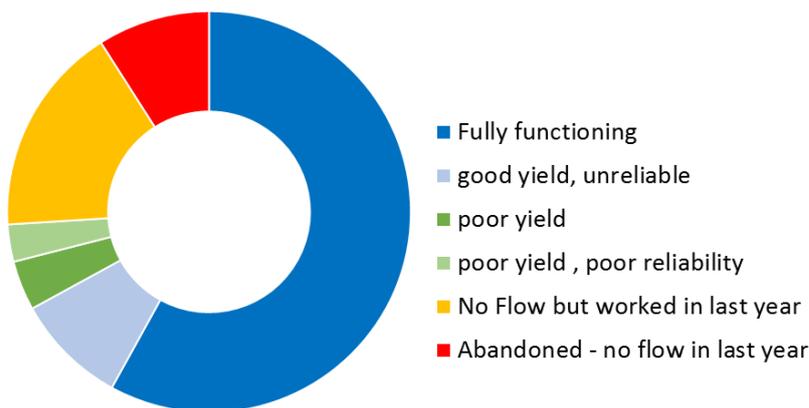
- 67% of HPBs provided the design yield of 10 litres per minute
- 58% provided adequate yield and reliability (<1 month downtime within a year).
- 41% of HPB's had adequate yield and reliability, and also passed WHO guidelines of water quality indicators (TTCs and inorganic chemistry) – see Table 2.

Figure 1 - Functionality performance assessed for boreholes equipped with handpumps within Malawi. The functionality criteria used were: sufficient yield (>10 L/min) on day of survey; and less than 30 days downtime reported for the past year.

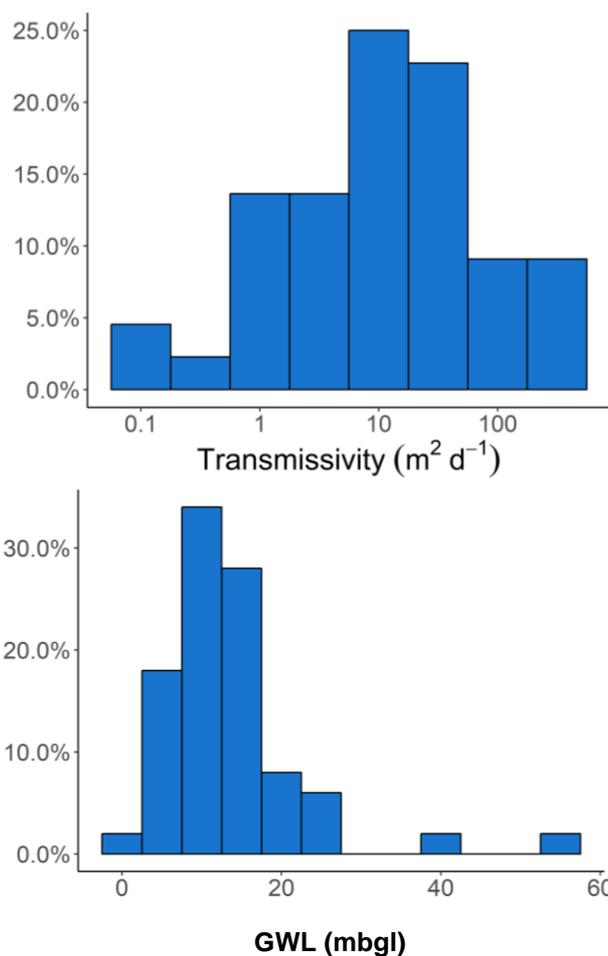
Aquifer transmissivity is measured to be relatively high across the four districts, but with significant variability between sites – likely reflecting both the heterogeneity of the aquifer resource. The median and mean transmissivity is 8 m^2/d and 39 m^2/d, respectively – Figure 3. Overall, 85% of the sites are assessed to have sufficient aquifer transmissivity (approximately >1.5 m^2/d) to be able to meet the demand of community water supply.

Depth to groundwater (GWL) was generally quite shallow across the districts – mean and median depth to groundwater being approximately 13 metres below ground level (m bgl), which is optimal for the operation of handpump mechanisms.

Figure 3 – (Top) Aquifer transmissivity values calculated from pumping test data collected at each of the 50 boreholes; (Bottom) Depth to groundwater (m bgl), measured at each site. The water levels represent a rest water-level following 18 hours of no pumping.

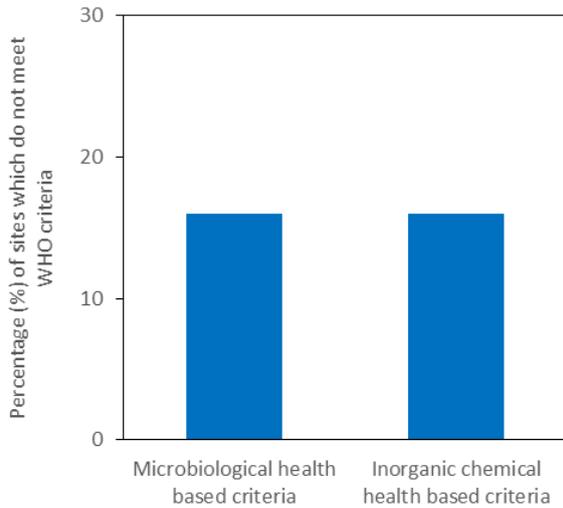
Water Quality. Inorganic water quality is shown to be good across the majority sites with only 16% of sites failing WHO standards of water quality indicators – Figure 4. Pathogen contamination also affected 16% of sites, however improved well construction and completion could help improve this issue – Figure 4.

Figure 4 – Proportion of water points in Malawi where water quality exceeds WHO drinking water criteria.

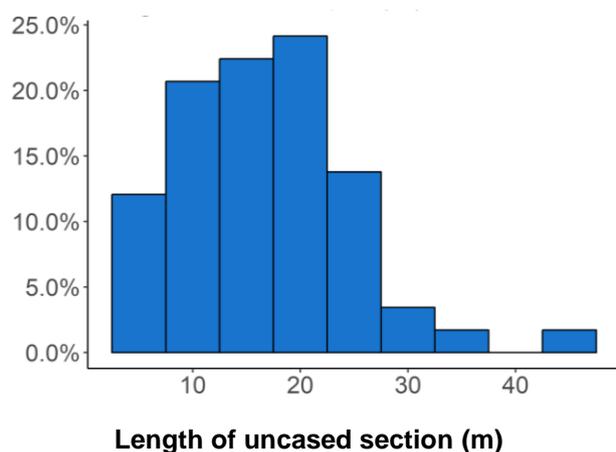
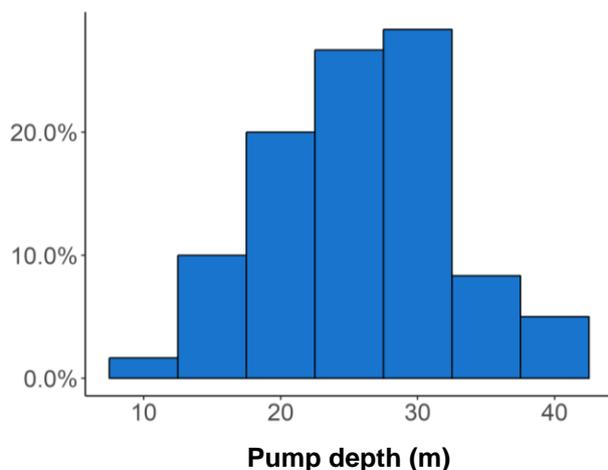
Average **borehole depth** is 35 m, and the average **length of screen or uncased section** observed across the sites ranges from 10 to 25 m, in line with normal rural water supply well design – Figure 5. Approximately 13% of HPBs were observed to have a screen or uncased section length of less than 3 m, but with no significant impact observed to functionality performance.

Pump depth are generally between 20 to 30 m bgl (average 27 m bgl), corresponding to the shallow depth to groundwater observed across the sites. Where the pump depth is greater than 40 m bgl, the depth to groundwater is generally still less than 20 m bgl. These operational conditions are within the handpump specification and capacity – Figure 5.

Figure 5 – (Top) the distribution of pump depths in HPBs observed across the four districts in Malawi; (Lower) the typical length of screen or uncased sections in HPB construction.

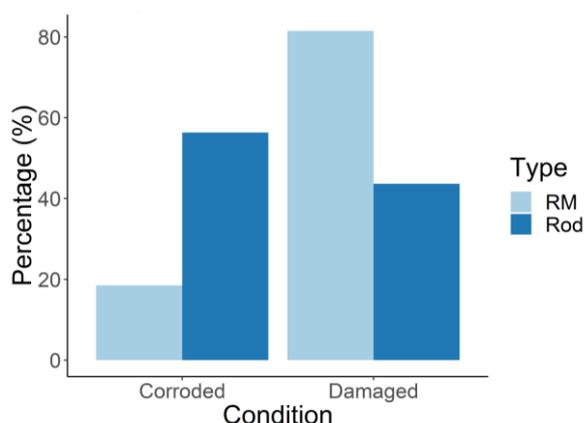
Corrosion and general damage affected handpump components in over 75% of the HPBs surveyed. Pump rods were shown to be significantly affected by corrosion, with over 50% being in poor condition across the sites. Damage to rising main sections (mostly uPVC) was observed in 80% of HPBs, however this may only have materially impacted performance in a small number of cases – Figure 6.

Figure 6 – Percentage of Rising Main (RM) or pump rods which were observed to be damaged or corroded in HPBs in Malawi. Damage was defined to include evidence of significant wear – for example components which were bent, cracked, or worn.

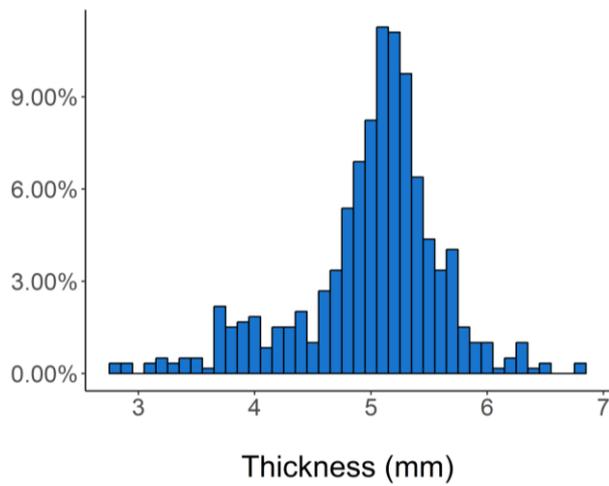
Handpump components were found to have variable material competency (either as a result of corrosion, or manufacturing variability) with variable thickness of rising main sections – Figure 7. Around 20% of the handpumps surveyed had a rising main thickness less than the Afri Dev hand pump specification (4.7 mm ±0.8 mm), and a further 20% had a rising main thickness greater than this specification.

Figure 7 – Distribution of Rising Main section thicknesses measured in Afri Dev hand pumps in Malawi.
