Birmingham Airport Link Pipeline
Environmental Assessment of Watercourse Crossings
Initial Report with reconnaissance surveys

Project leader: F.H. Dawson
Report date: 6 September 1990
Report to: RSK Environment Ltd (for Esso Petroleum Co Ltd)
Contract No: Letter of 21.5.90
IFE Report Ref: T04053s1/1
TFS Project No: T04053s1

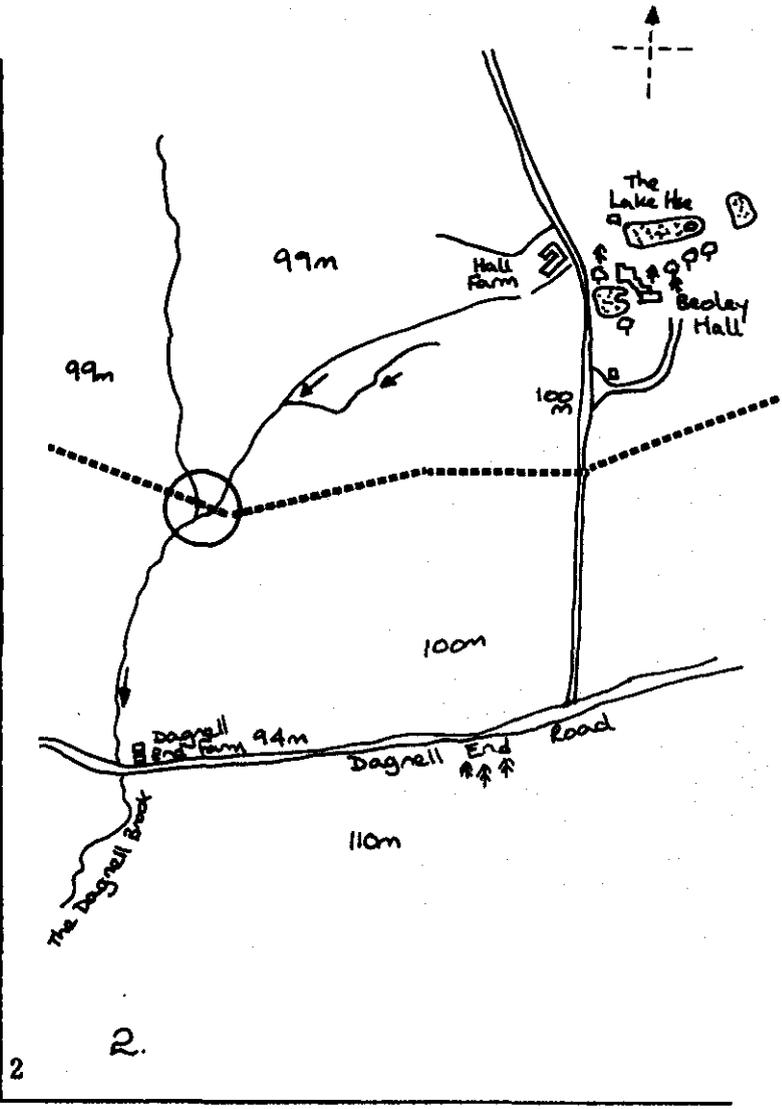
Ion balance 9.78 : 8.65 m equiv.
 Assessment:
 high calcium low nutrient water

ADJACENT FEATURES etc.
 Land use shelter belt in cereal fields
 Upstream shelter belt
 Downstream shelter belt and farm
 Maintenance nil
 Fishery interest low-nil

PHYSICAL Maintenance Factor +2
 Shallow stream in broad valley with 5-10m high sides. Proposed crossing above confluence with tributary.

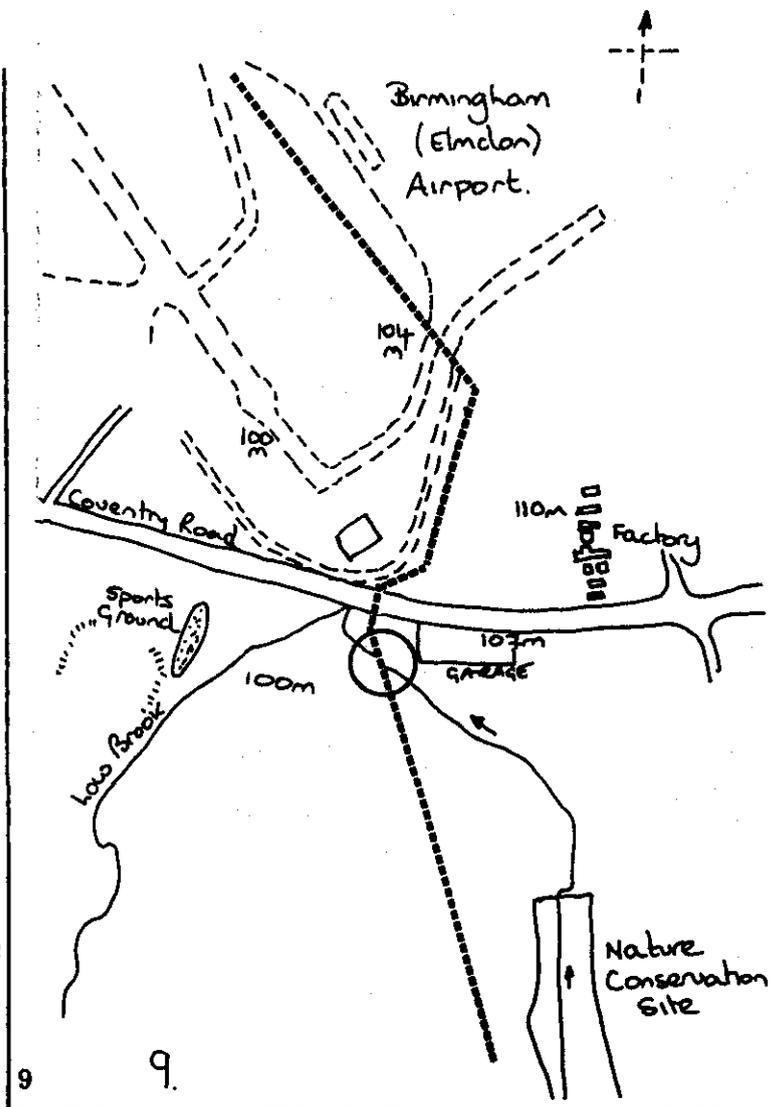
Ion balance 10.08 : 9.00 m equiv.
 Assessment: nitrate-rich clear water
 (evaporative concentration?)

Land use grazing, adjacent landing lights
 Upstream pasture
 Downstream dual carriageway, airport
 Maintenance minimum
 Fishery interest nil

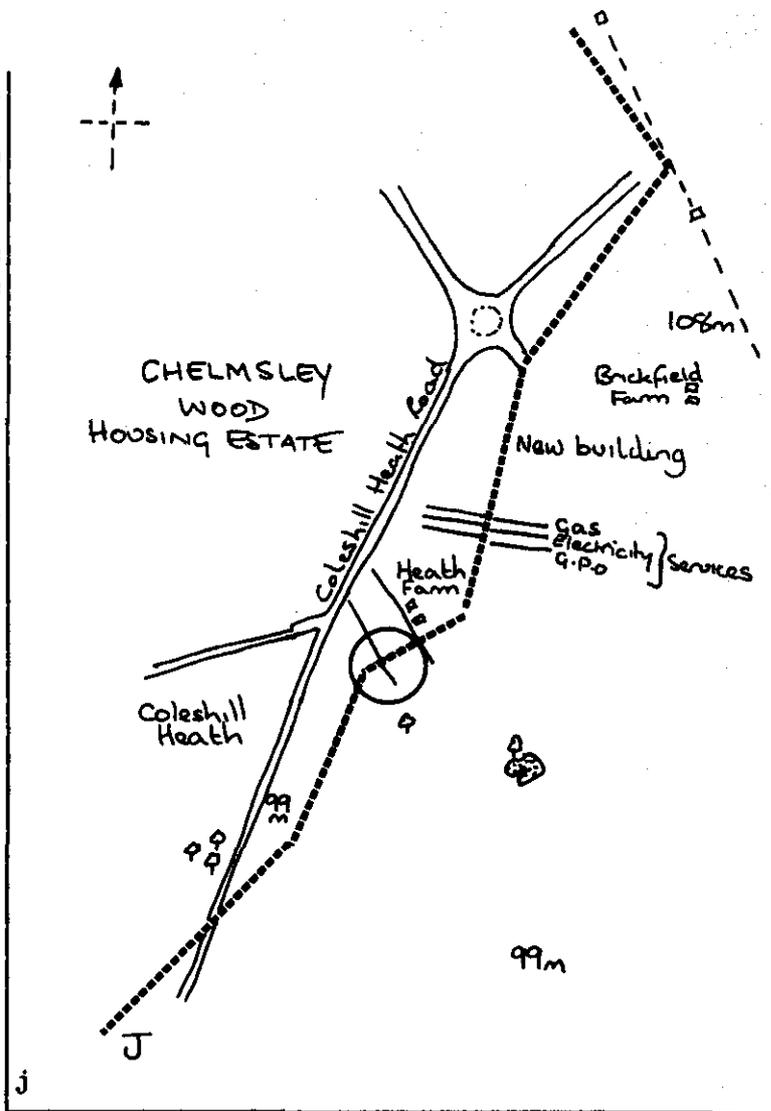
River Cole, nr Chelmsley Wood
 week of 2.7.90 SP 187 877
 km from source 30 Altitude 90 m
 Lat 52° 29'N, Log 1° 44'W

ANIMAL Score 3
 Only 5 taxa were found at this site. Filamentous algae covered the stony substratum. Chironomidae were extremely abundant and Asellidae was common. The sparse fauna indicates a polluted site.
