Cruise Report No. 03

RRS Discovery Cruise 360

19 JAN-02 FEB 2011

Trials of the Autosub LR AUV, HyBIS, PELAGRA,
Ellsworth Camera and MYRTLE-X Lander systems

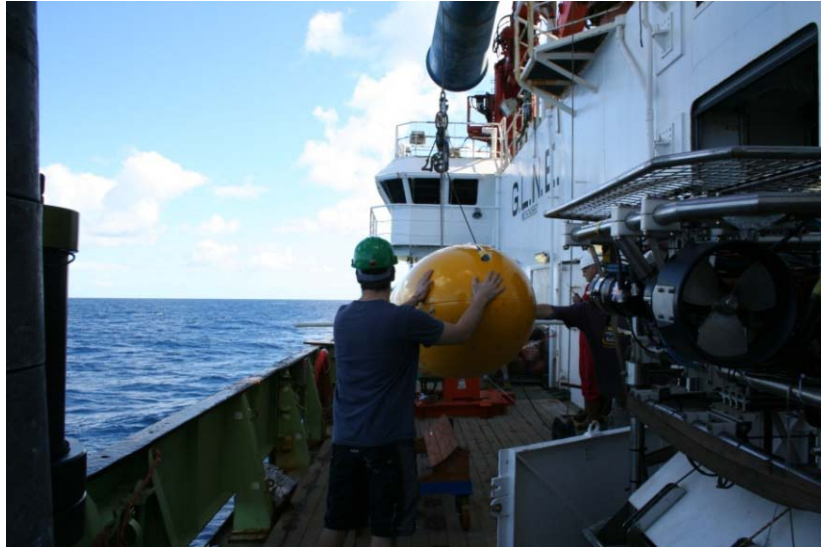
Discussions took place before the cruise when it was agreed to use the Rexroth driven ‘Rotzler’ winch on the ships’ CTD gantry frame. However, inspection of the winch during mobilisation showed there was not sufficient gap to winch through the Boss Hook connecting the ALR recovery line and the winch line. The plan was changed to utilise a 1.6Ton LeBus GP deck and a diverter block fixed to the deck.

Figure 4. Deck arrangement, Diverter block (by feet of Steve McPhail on right) and 1.6T orange winch in the background

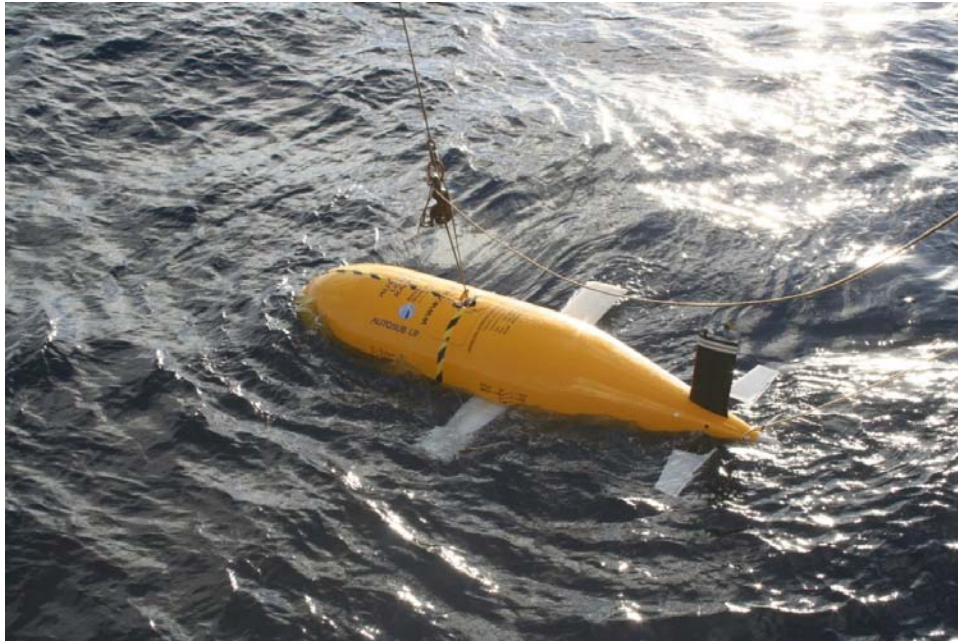
Figure 5 Autosub LR lowered into the water for its first deployment in the Atlantic Ocean. Note the sea catcher release system, and the line on the tail, used to control the AUVs heading during launch (this is snapped off with a sharp tug).

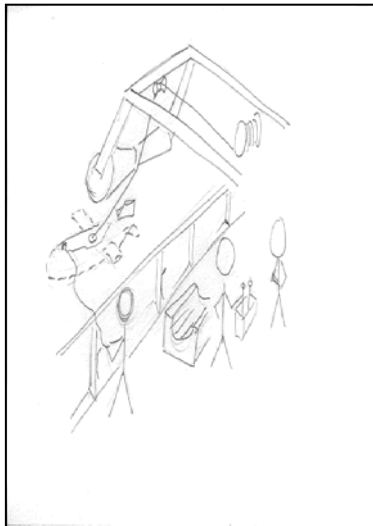
Fig 6. Schematic of the recovery once the ALR recovery lines have been attached to the winch line. Note the winch line passed over the FAR side of the roll to keep the ALR at some distance from the ship, not the near side as drawn.

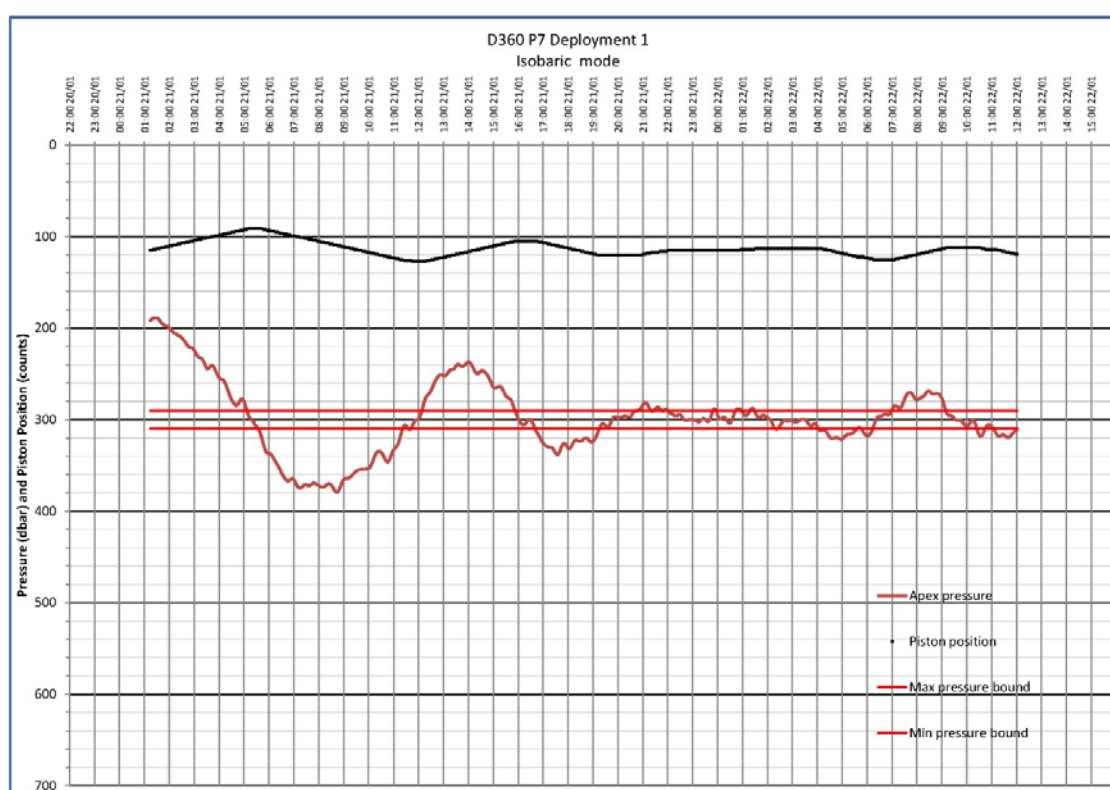
1900h P7 recovered at 24.263°N, 20.382°W. The sample cups were found to have opened but not closed. Depressor weight and end-of-mission abort weights were both absent and the over-depth abort weight was in place as expected. No significant sediment was collected probably due to wash-out on ascent.

On inspection, P7's APEX float was found to have terminated its profile and initiated ascent 5 hours early. This erroneous behaviour has been seen before and will be investigated. Sample cup operation was subsequently checked on deck and found to be trouble free; it is not clear why they did not close during the mission.

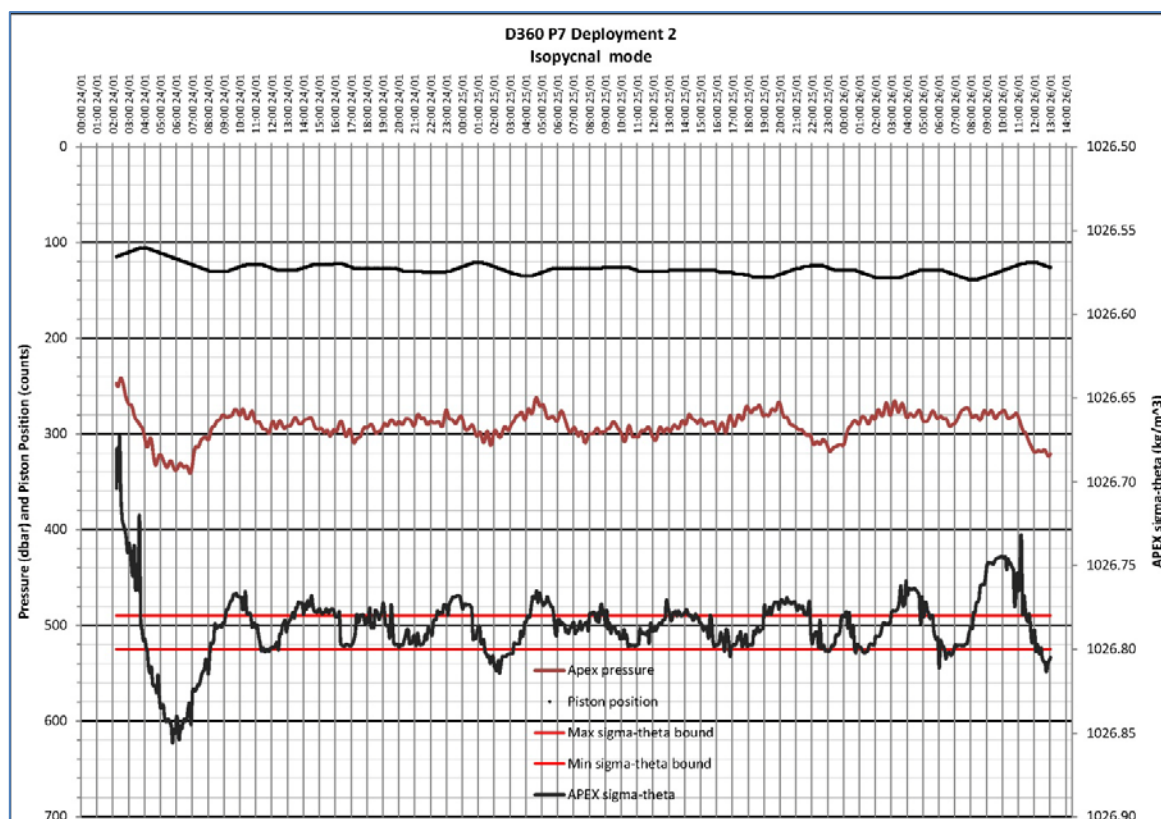
2003h P7 recovered at 23.795°N, 20.308°W. The sample cups were found to have opened but not closed. Depressor weight and end-of-mission abort weights were both absent and the over-depth abort weight was in place as expected. No significant sediment was collected probably due to wash-out on ascent.

Base of trap suffered major strike on ship's rail during swing but appears to be undamaged. On inspection, P7's APEX float was found to have terminated its profile and initiated ascent 5 hours early as in Deployment 1. On inspection it was thought that the driving worm was a little tight to the worm-wheel so the gearbox position was adjusted.
