Survey of Broad Haven Primary School and adjacent land, Haverfordwest, Pembrokeshire, Wales

Open Report OR/08/063

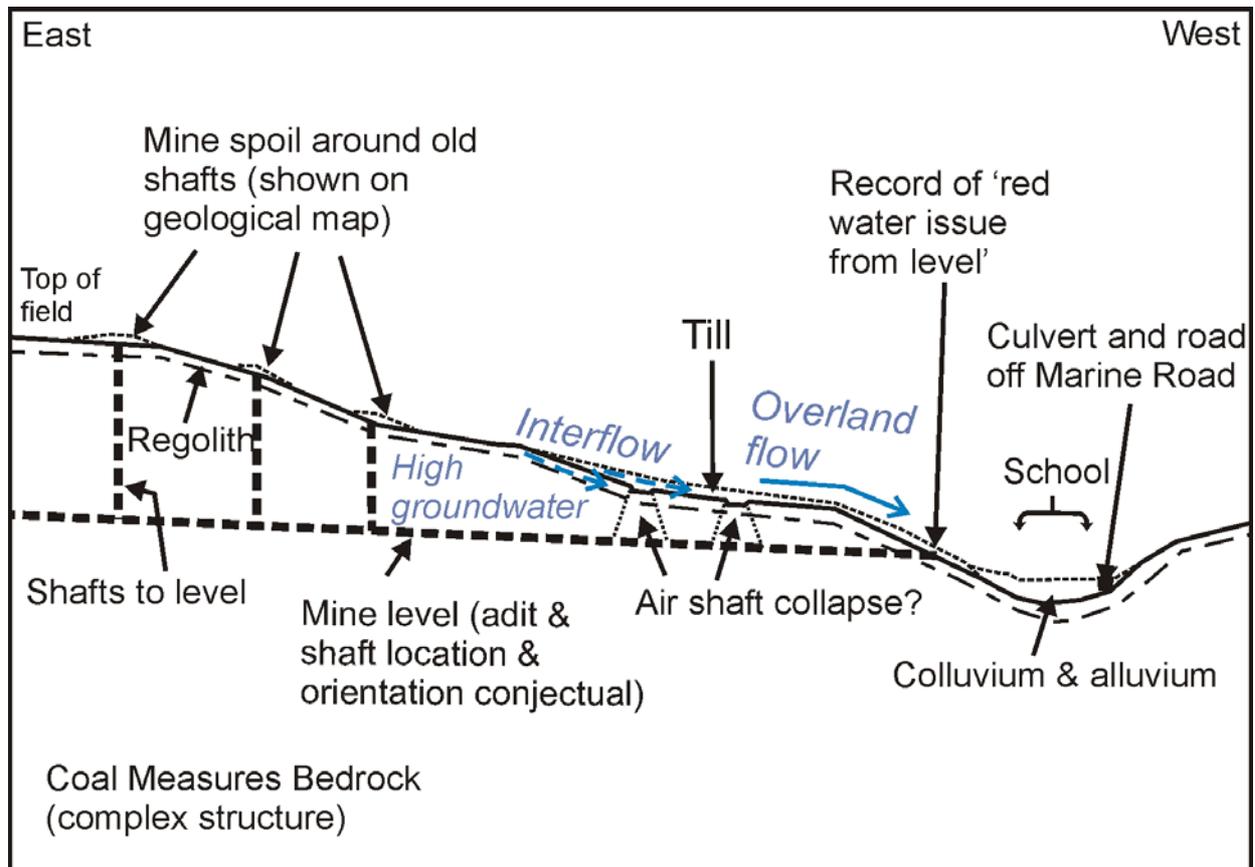
Several mine-related hazards were identified by the survey. One is the possibility of mine shaft collapse, which could lead to the migration of a void to the surface, or subsidence where the material filling the shaft was loaded, for example by heavy farm machinery. An additional hazard is that of mine water discharge through the adit (Fig 4), especially if water had backed up in the level or workings; in extreme circumstances, this could cause an outburst. The potential for such mining hazards to exist warrants further investigation. The use of non-intrusive ground investigation techniques (e.g. shallow geophysics) could be used to locate shallow subsurface voids, and may be used to map the extent of any mine workings.

Figure 4. Schematic cross-section through the survey area showing the general relationships between slope morphology, geological units, water conditions and mine features. Not to scale, for illustrative purposes only.
