**ENVIRONMENTAL BASELINE STUDY
OF
DAMAGED GROUND
AT
CAIRNGORM ESTATE**

by
Dr Adam Watson

April 1994

Produced for Highlands & Islands Enterprise, 1994

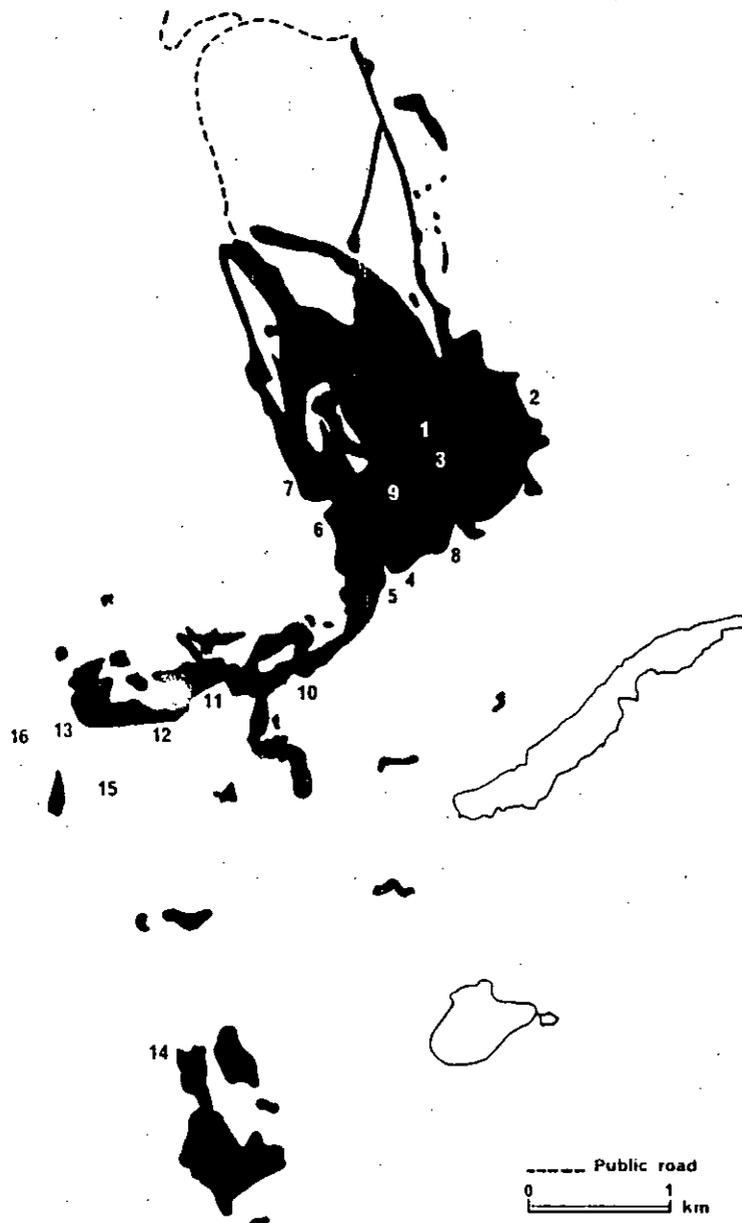
Fig. 2. Transect locations (numbers) and ground disturbed by man-induced soil erosion (solid). Areas with different scores could be plotted clearly at 1:10 000 scale but not when reduced as here. Paths are omitted, as well as patches of undisturbed ground in disturbed areas unless the patch covered an area of > 1 ha.

Disturbed ground (Fig. 2) covered 403 ha, 83% in the Glen More Forest Park and 17% in the Cairngorms National Nature Reserve. Areas with scores of 1, 2 and 3 for lateral erosion (Table 1) comprised 14, 84 and 3% of the disturbed land in the Park and 19, 75 and 6% of it on the Reserve.

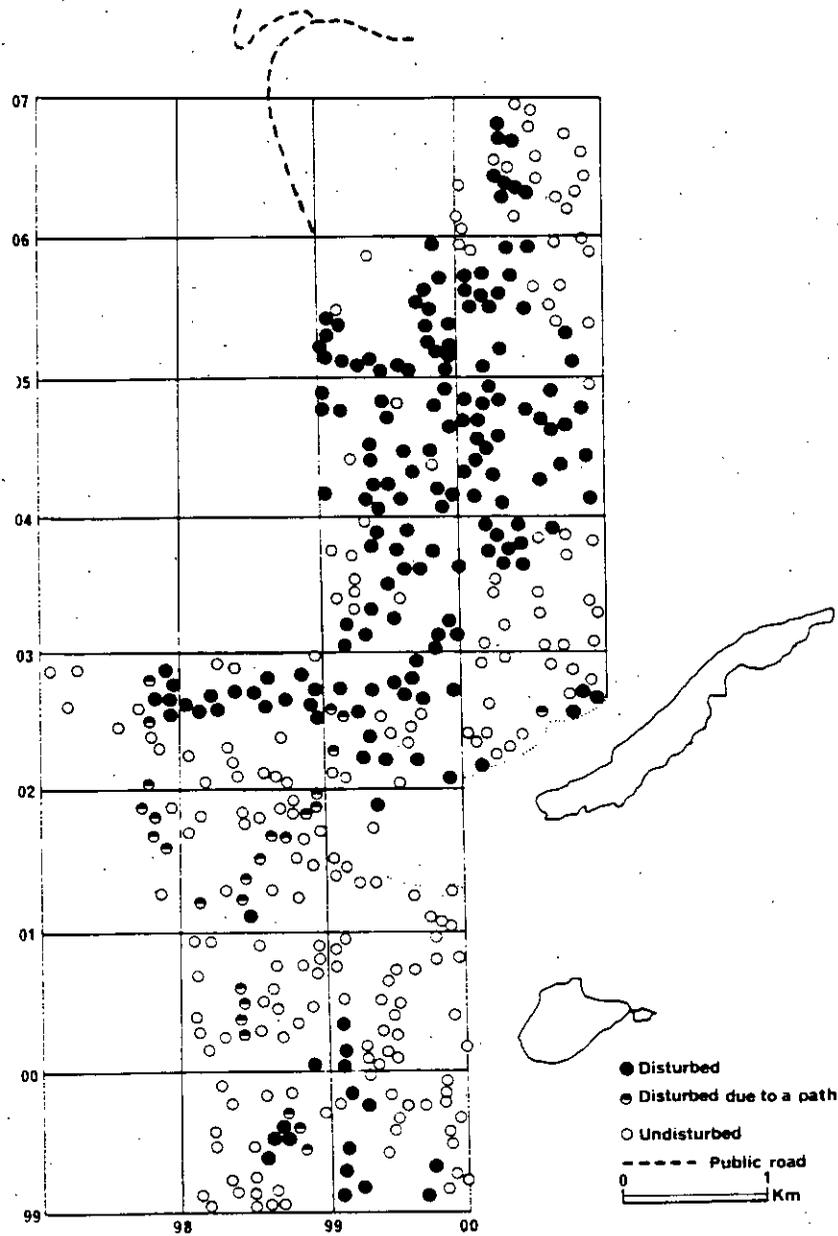
Fig. 3. Disturbed and undisturbed ground, based on 25 randomly selected points in each 1 km square of the Ordnance Survey national grid. Four squares (see Table 2) had <25 points as they included ground outside the study area, and the squares which included the public road-ends were not surveyed.

Score 4 applied only to small patches, each less than 1 ha. Disturbed land occurred mostly on and near ski grounds, but with some patches along the main visitor routes west to Cairn Lochan and south to Ben Macdui up to 6.2 km away. Data at random points within each 1 km grid square confirmed this pattern (Fig. 3).

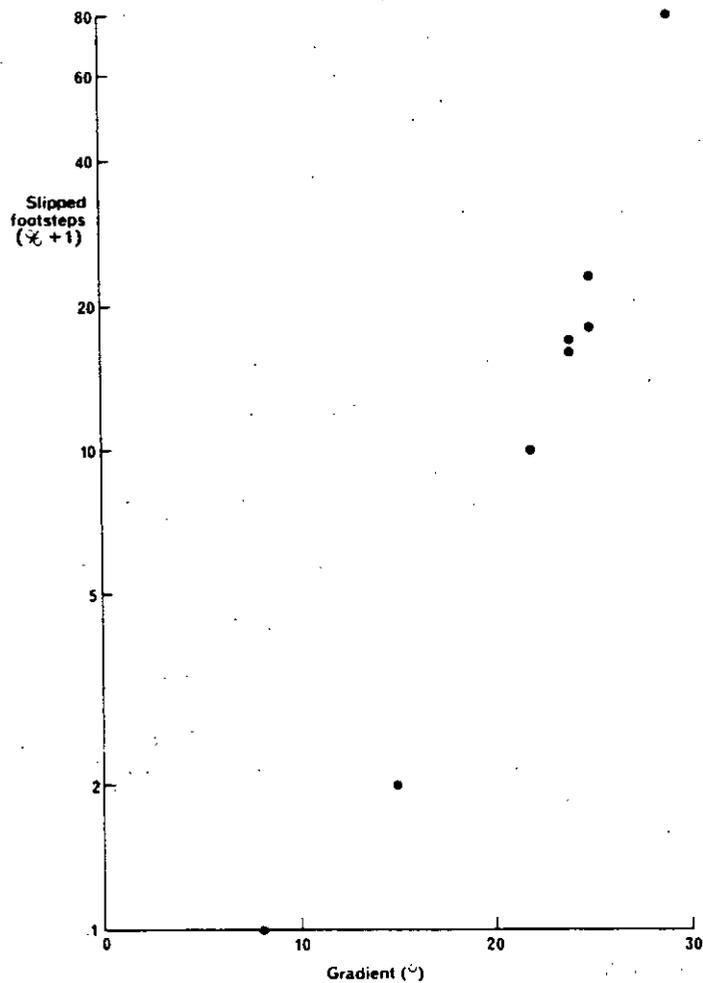
On gradients $< 15^\circ$, my footsteps did not slip on either disturbed or undisturbed ground (Fig. 4). They slipped increasingly on disturbed areas the steeper the gradient up to 29° , but not on nearby undisturbed ground at the same gradient. The rate of slipping on disturbed ground increased logarithmically with the rise in gradient (\log_{10} slipping rate versus gradient, regression equation $y = 10.3 + 10.8x$, $r = 0.978$, $p < 0.0005$). Not only were disturbed slopes unstable, but it was obvious while doing the measurements that slipped footsteps caused still further loosening of soil and vegetation.

Fig. 4. Percentage of slipped footsteps in 100 steps at different gradients on disturbed ground (on transects 10, 11, 13, 3, 1, 6, 14 and 9 in order of gradient). No slipped footsteps occurred on transects on nearby undisturbed ground at these gradients (χ^2 , $p < 0.0005$ in each of the steepest five, < 0.005 in sixth steepest).

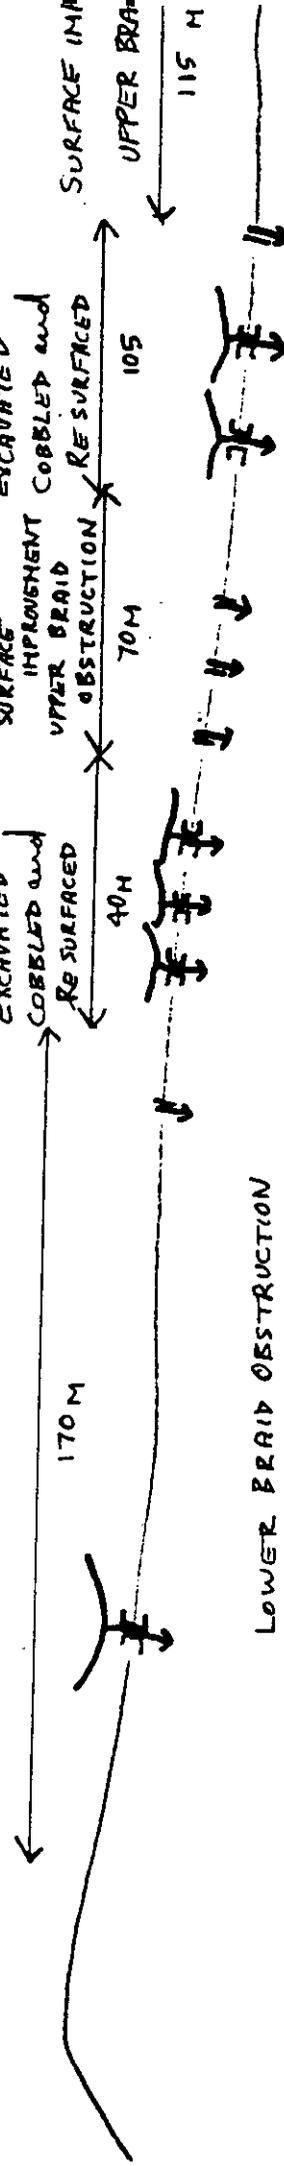
PATHWORKS CHALAMAIN GAP PATH OS 36 GR 983 067 - 976 065

SURFACE IMPROVEMENT
UPPER BRAID OBSTRUCTION

LOWER BRAID OBSTRUCTION

X DRAINS 15
WATER BARS 15
