THE INTERPRETATION OF VAN DE  
CASTEELE DIAGRAMS

G. W. LENNON

1966

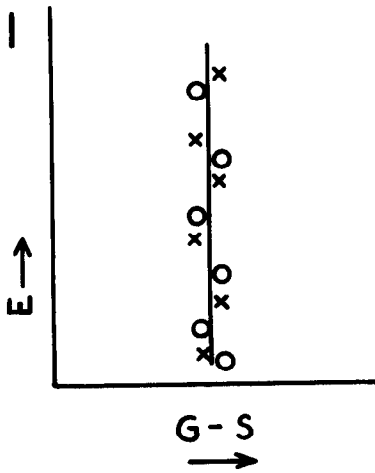
G = Tide gauge reading  
 S = Well-sounding converted to elevation above datum.  
 E = Tidal elevation  
 → = Direction of increasing magnitude  
 Rx indicates rising tide  
 Fo indicates falling tide.

NOTE: Ordnance Survey plot a quantity defined as "Zero in feet below Contact Point". Changes in this quantity are of same magnitude and of same sign as in G-S. Above indicates perfect gauge. If sounding has been carried out accurately none of plots show a displacement left or right of line in excess of 0.01 ft.
