**British
Geological Survey**

Slope Monitoring at the Glan Ebbw Landslide, Blaina, South Wales: January to April 2016

Internal Report IR/16/015

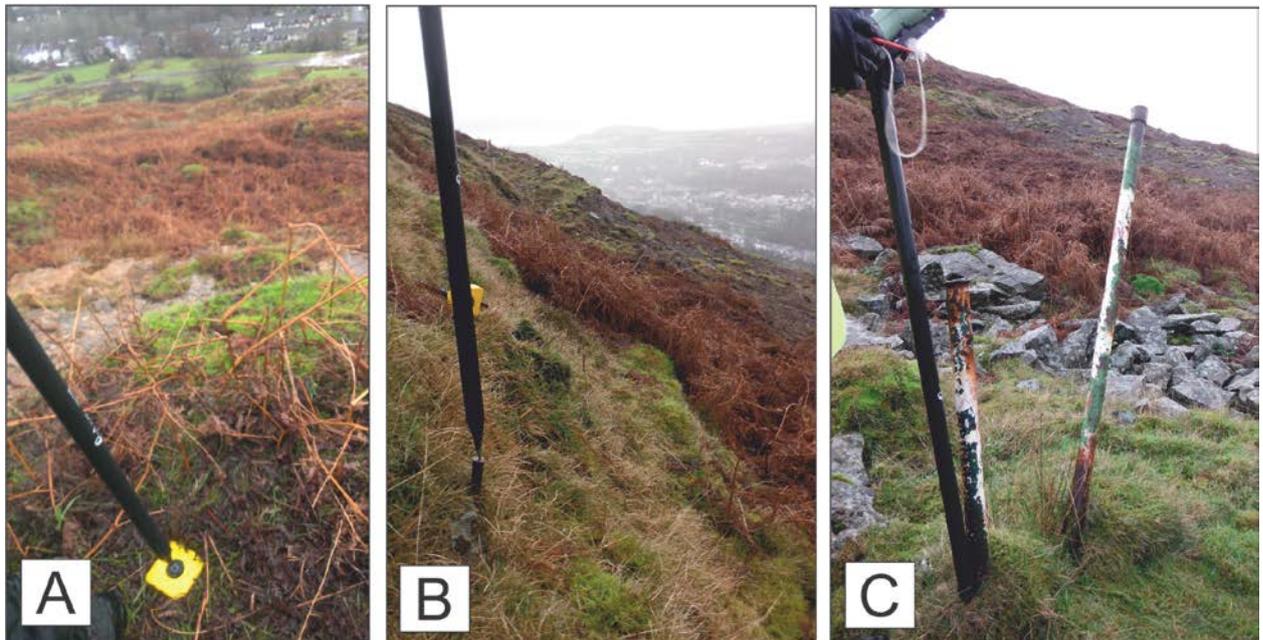
During the first site inspection seven ground survey pins were installed by the BGS. These were a mixture of Ground Mark type 300 mm or 500 mm pins (Figure 3 A). During the installation four pre-existing steel pins and an old steel pole were discovered (Figure 3B & C). These items were also surveyed to provide additional monitoring points to the ground pin network. The presence of the existing steel pins suggests previous slope monitoring work has been undertaken on the slope, but the Council has no record of this.

Figure 3 Ground pin types and survey method. A: new 300 mm long pins with yellow cap; B: old steel pins; C: old steel pole. Note: GPS device Leica Viva GS14 used with 2 m long survey pole with tip positioned aligned in the centre of the top of the ground pins, except P11 which was measured from the ground surface on the south side of old painted steel pole as shown in C.

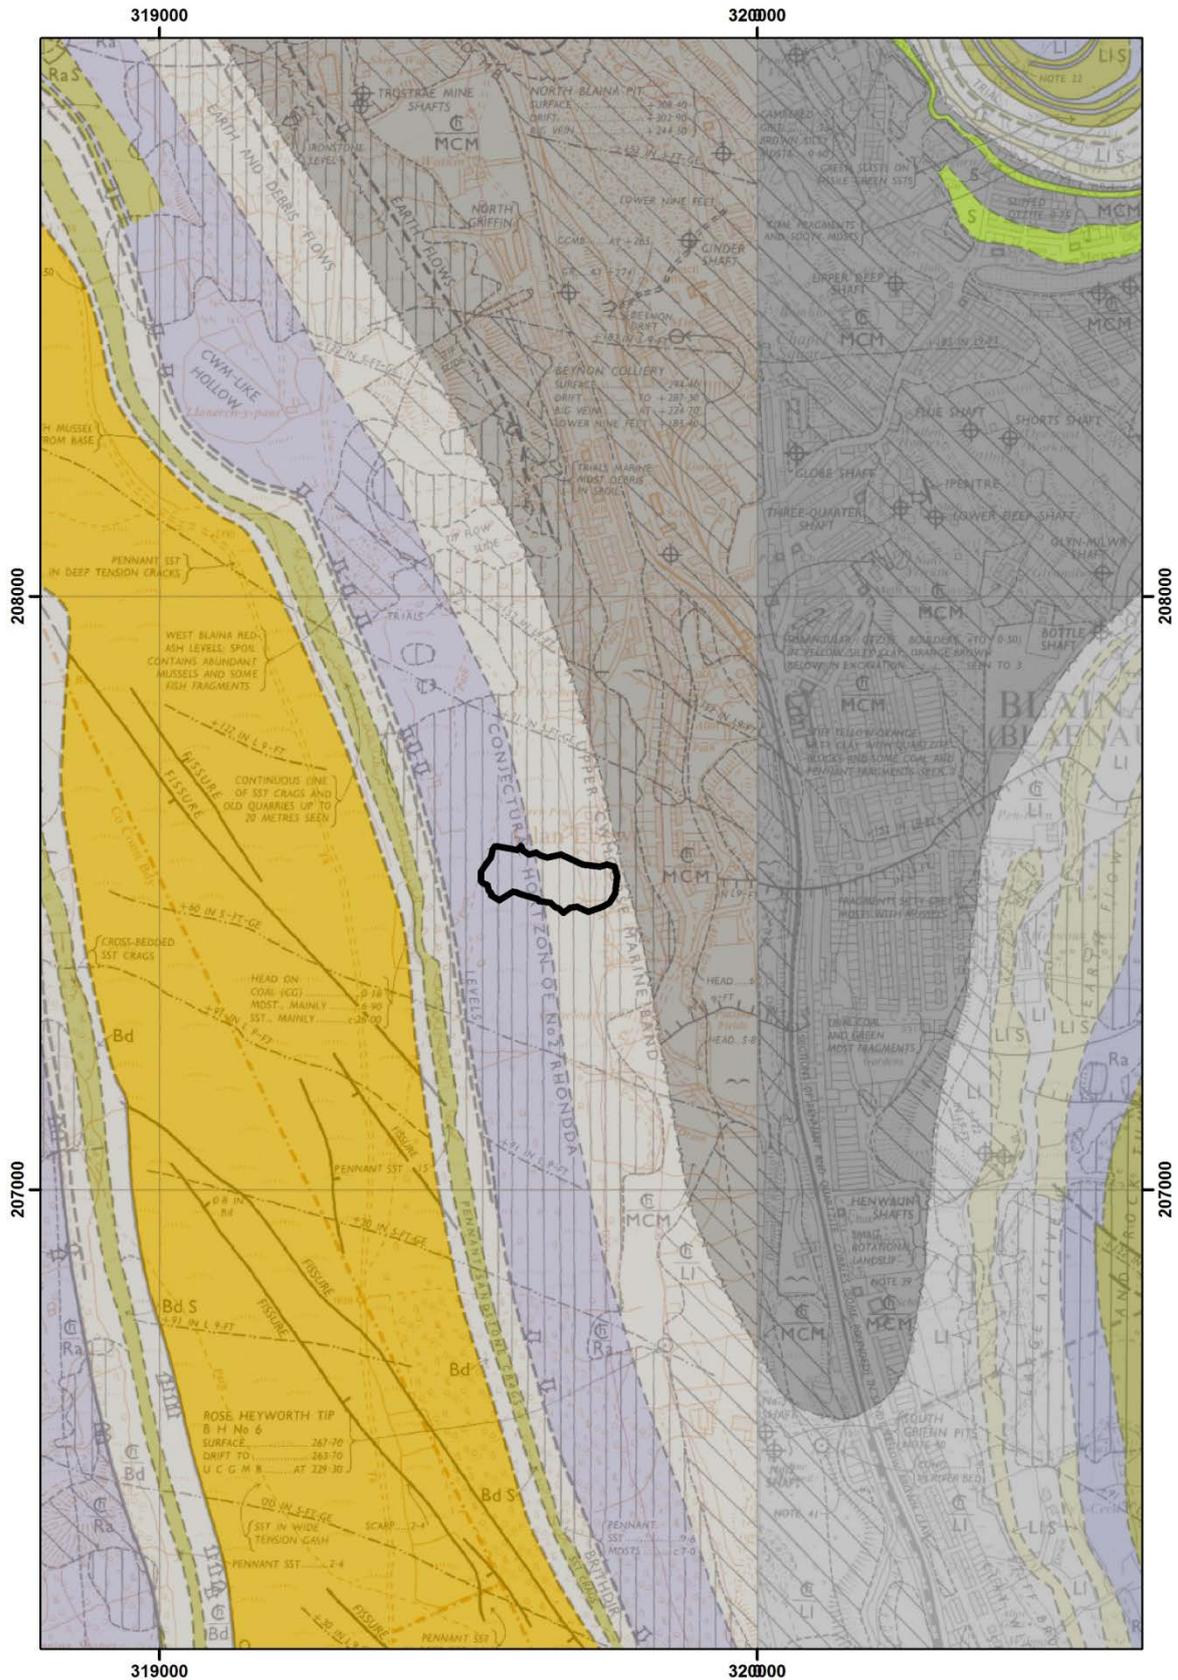
During the site visit it was noted that the slope is mantled by several metres of landslide deposits (observed in the field to be typically gravelly sandy CLAY), head (possibly some soliflucted till), colluvium and quarry spoil. Extensive shallow and deep coal mining took place under the hill and in the valley (ARUP, 1985). There was no clear evidence of mine spoil on the landslide, though this would have certainly been disrupted by the mass movements. The Gwaelod-y-gelli farm house, located approximately 100 m to the south of the active part of the landslide, was built on undisturbed ground.

Figure 4 Extract from 1:10 000 geological map (sheet SO10NE, surveyed 1979). Bedrock Legend: MCM South Wales Middle Coal Measures Formation; LI Llynfi Member; Ra Deri Formation; Bd Brithdir Member. The black outline shows approximate footprint of the active landslide as of 8 April 2016. *Geological map* © BGS/NERC 2016. All rights reserved. Map grid coordinate system is British National Grid.

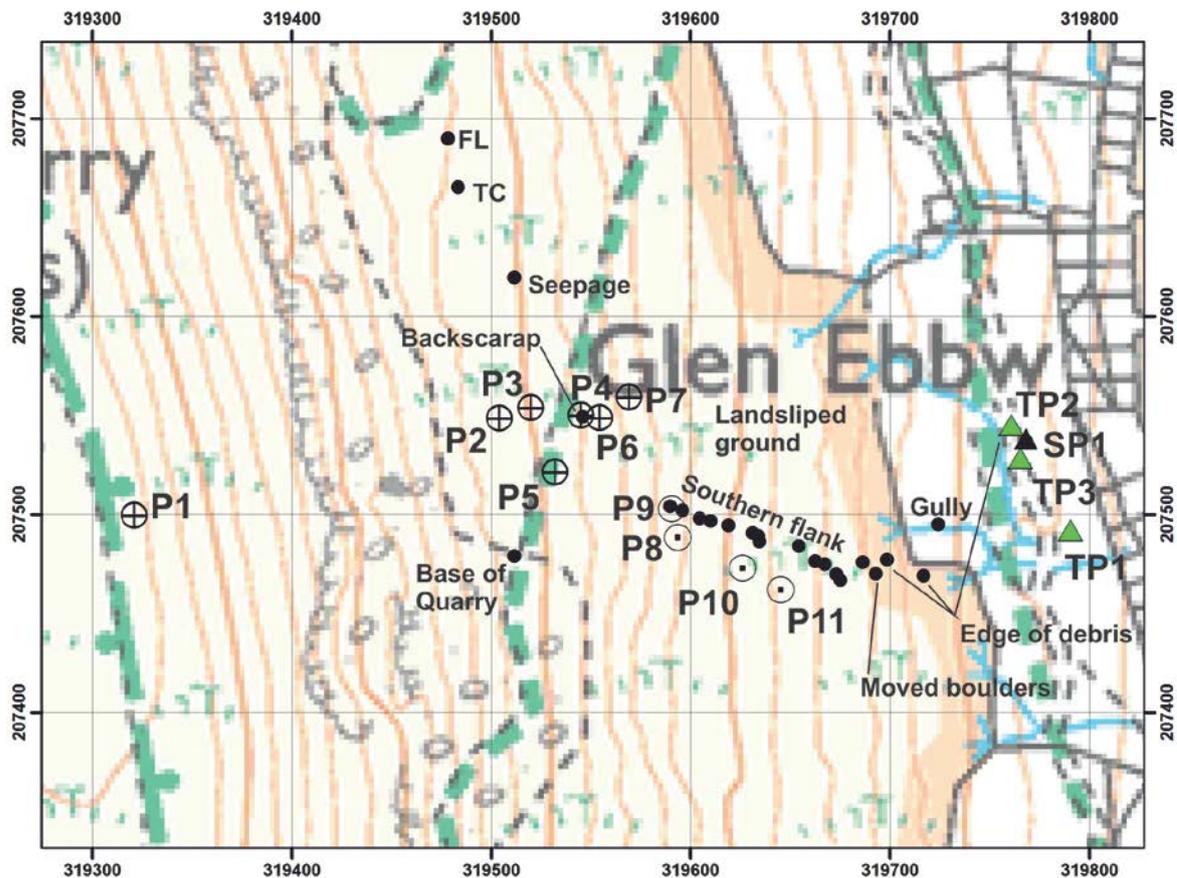
The southern flank was inspected on foot on 28 January 2016. Ground levels were surveyed at several locations using a dGPS device to delineate the southern edge of the land-slipped ground, or southern flank, as shown in Figure 5. Major landslide morphological features, including the landslide backscarp and toe were noted and photographed. The northern flank was not inspected closely due to time restraints and safety concerns as the landslide was clearly active at this time and the ground was very wet, very soft and impassable across the mudflows. The GPS survey data (x,y,z) is provided in Appendix 1.

Figure 5 Map showing location of ground pins installed 28 January 2016 and dGPS points (Survey 1). P1, P2, P3, P4, P5, P6, P7 are 300mm long or 500mm long steel yellow capped pins. P8, P9, P10, P11 are old steel pins or poles discovered by chance whilst on site. Other observed features are also shown, such as FL=fence line, TC=tension crack, water seepage point, gully, backscarp, landslide flank, base of old quarry with spoil heap of angular Pennant Sandstone boulders, downslope edge of debris, and recently moved boulders. SP1 is the TLS position and TP1-3 denote ‘Tie Point’ reference positions. Full dGPS point coordinates are included in Appendix 1. *Contains Ordnance Survey data © Crown Copyright 2016.*

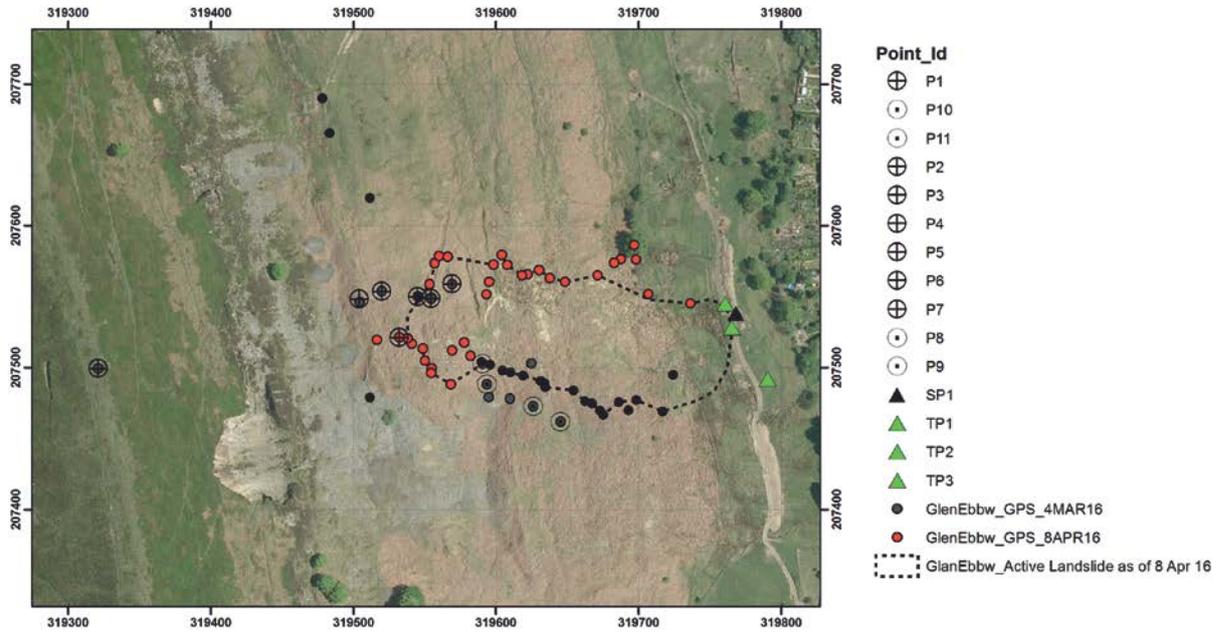
Figure 8 shows the GPS and observation data points collected over the survey overlaid onto a recent colour aerial photograph. Figure 9 shows the main area of unstable ground inferred based on interpretation of this primary data.

Figure 8 Plan of GPS survey points collected throughout study, overlaid on pre-event aerial photograph (c. 2010 vintage). RGB Aerial Photography – ©GeoPerspectives.

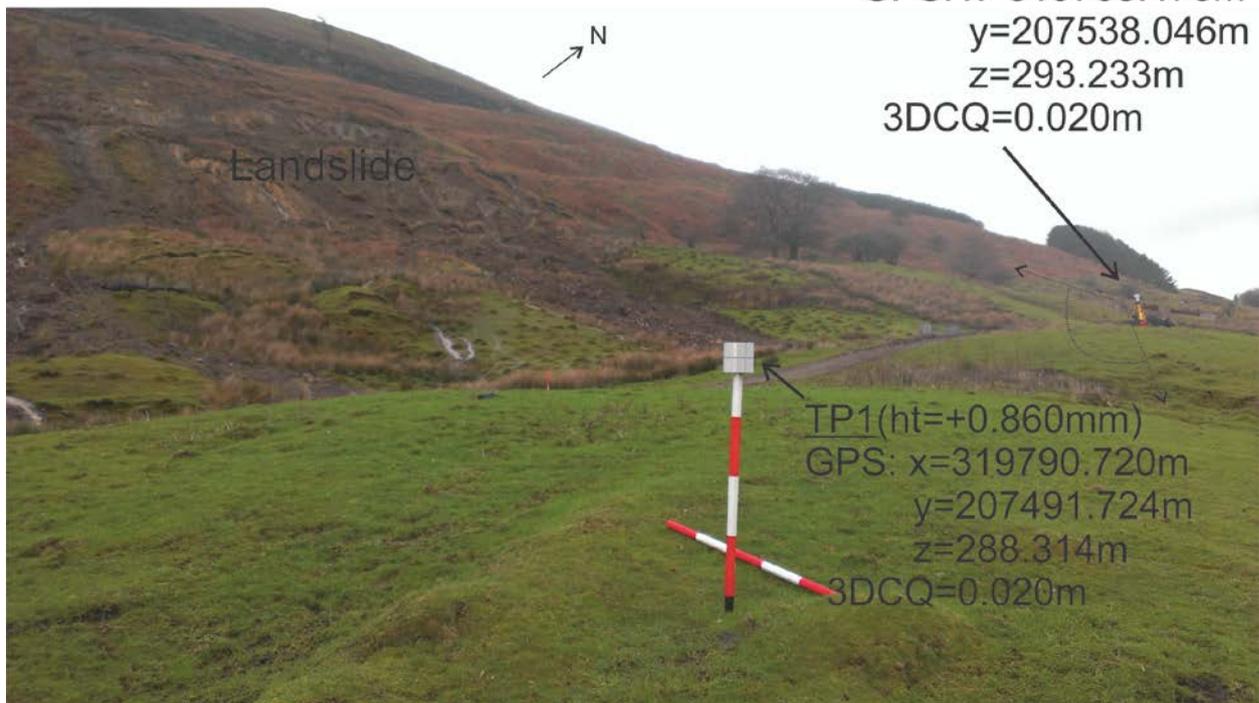
Figure 10 Annotated photo showing laser scan set up relative to the landslide-affected slope and tie point. Scanner position (SP1) and reflector 'tie point' position (TP1) were located at the foot of the slope.

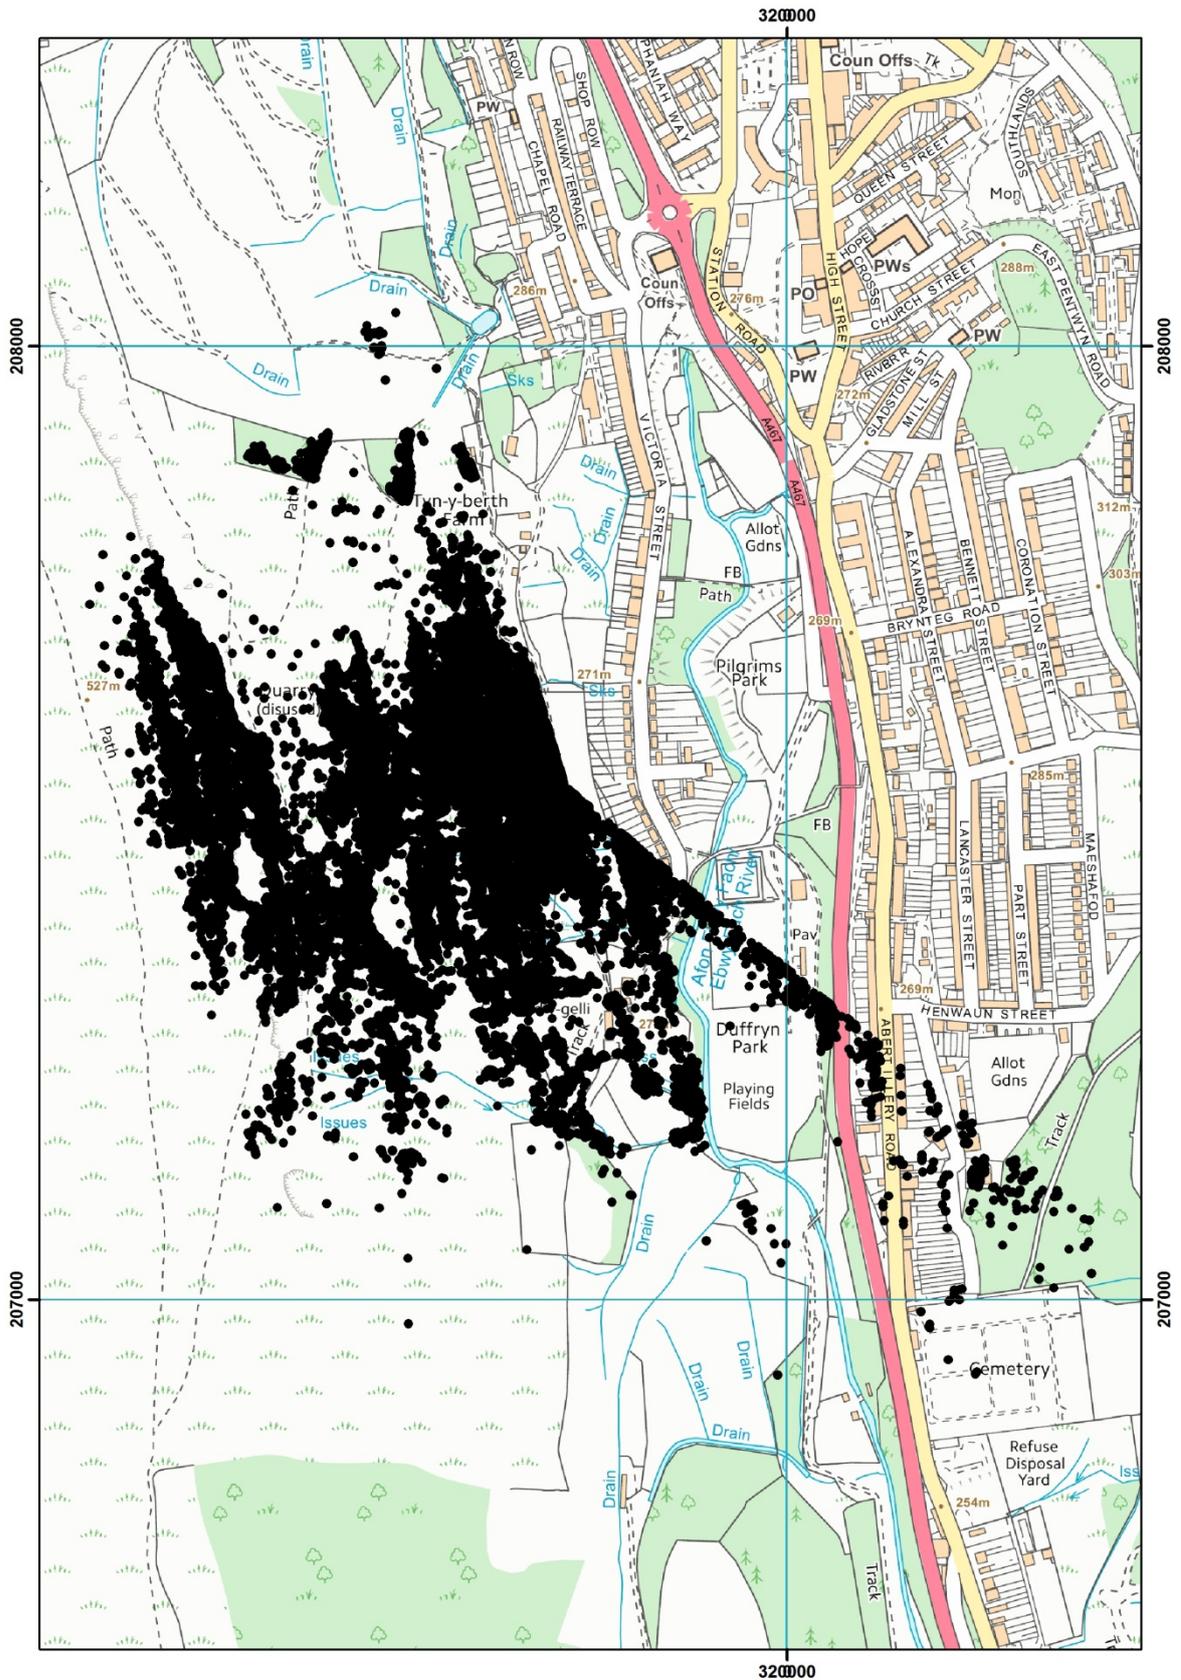
The TLS survey produces topographic point data (or ‘point cloud’) with centimetre accuracy. LiDAR points were captured across much of the active landslide area and surrounding ground, as shown in the map in Figure 11. The range of the laser beam on the day was just over 500 m. This range was sufficient to capture the active part of the slope. The resulting dataset was of sufficient quality and point density to enable a variety of reliable derived information products to be generated for slope monitoring and communication purposes, including:

Figure 11 Distribution of TLS survey points (the point cloud) surveyed 28 January 2016. Contains Ordnance Survey data © Crown Copyright 2016.

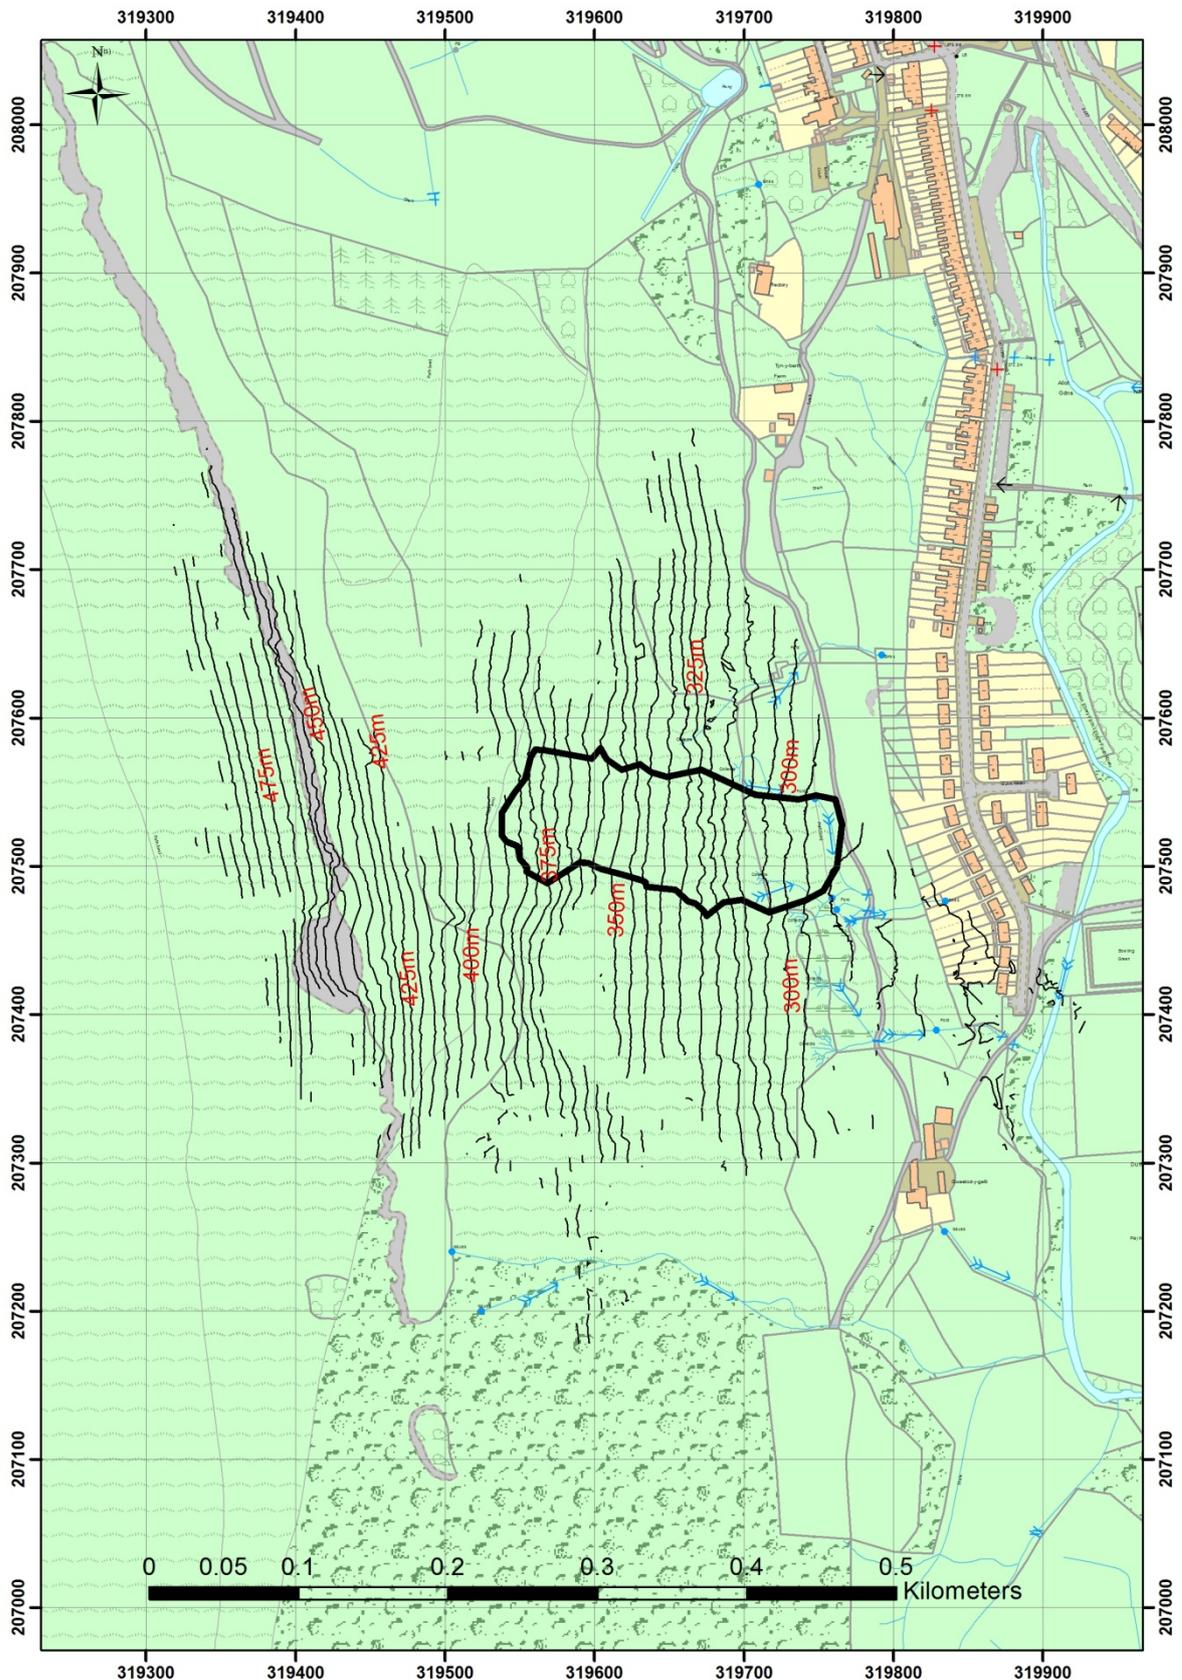
Figure 12 Map of 5 m topographic contours at Glan Ebbw derived from TLS data and draped on OS MasterMap2015 base map for context. Contains Ordnance Survey data © Crown Copyright 2016.

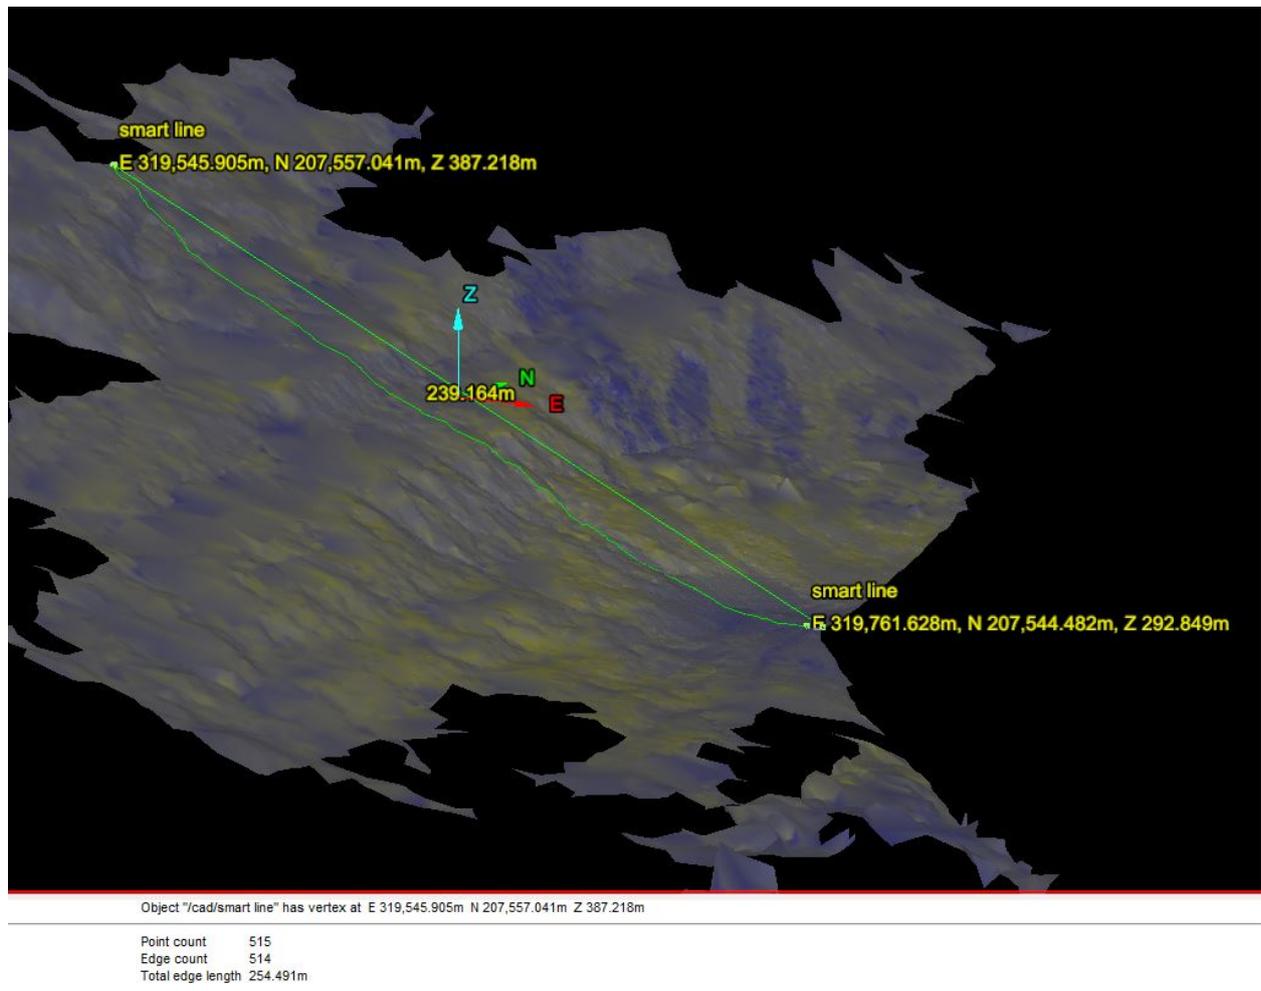
Figure 13 3D visualisation of the digital terrain model derived from triangulation of the TLS data points. Virtual field measurements on the terrain surface were made using Maptec data visualisation software. This allowed analysis of slope metrics, such as landslide dimensions, length, area and volume, and slope angle, as well as providing a virtual visualisation environment for interpretation of landslide features and processes. Data points were selected along the centre line of the landslide mass by defining a ‘smart line’, which is an analysis function of the Maptec software.
