# Recent fissuring in the Magnesian Limestone at Houghton-le-Spring, City of Sunderland

Research Report RR/02/03

B Young and D J D Lawrence

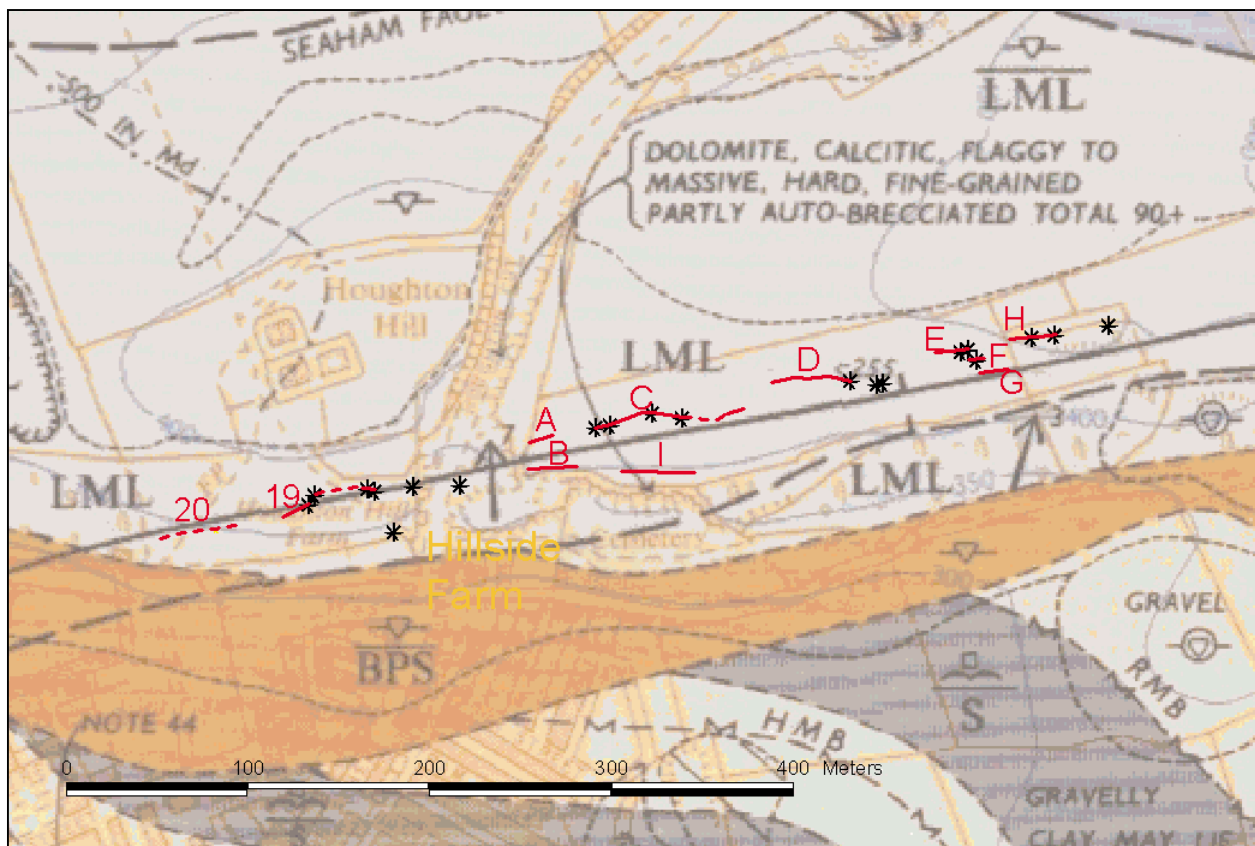
**Figure 2** Geological map of the Houghton-le-Spring area. (Extract from BGS 1:10 560 scale sheet NZ 35 SW). The position of the main fissures, open holes and depressions, described in this report are shown. Letters and numbers refer to Tables 1 and 3.

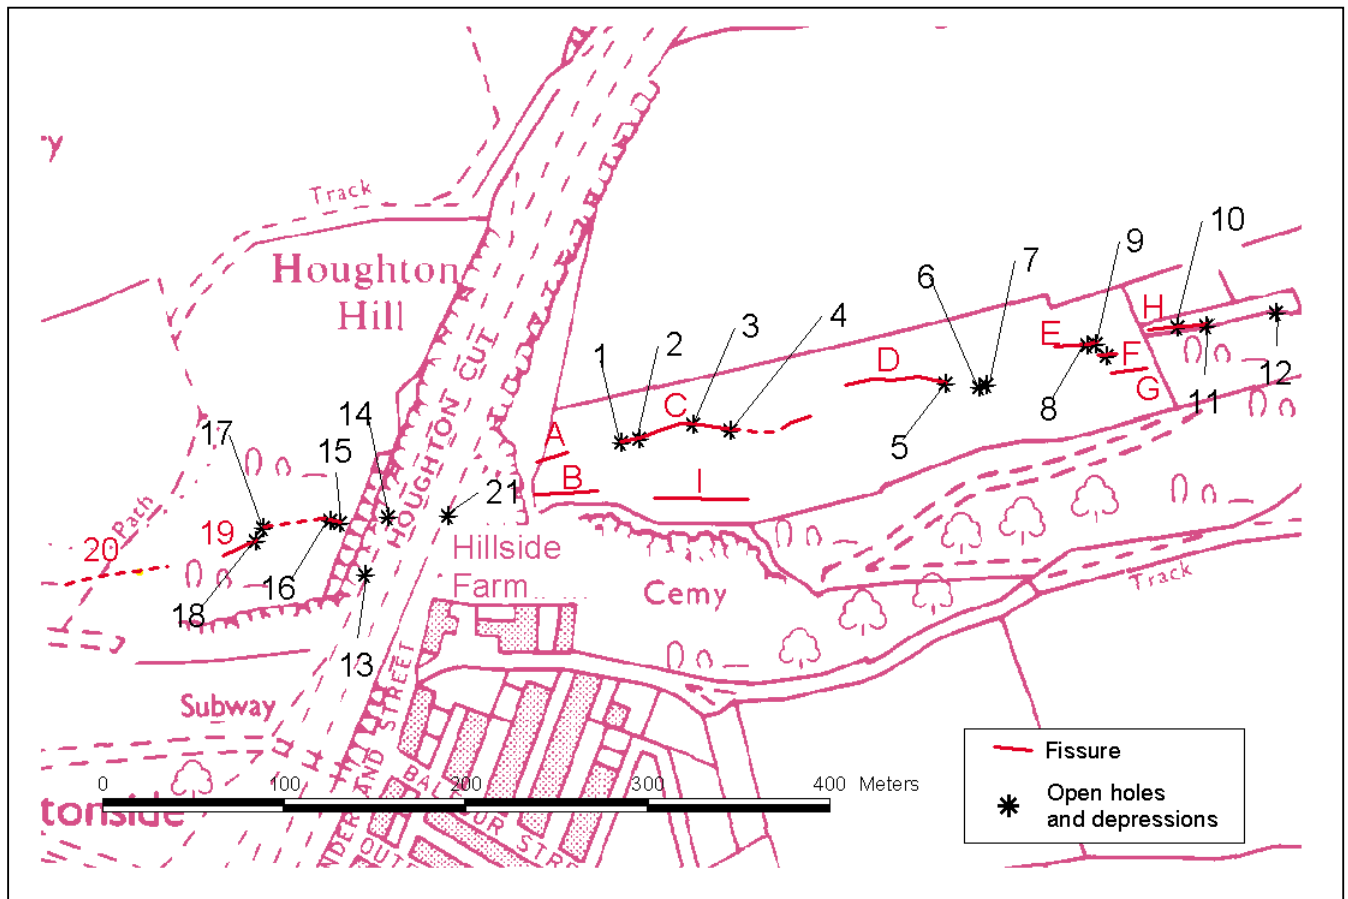
**Figure 3** Sites of fissures described in this report.  
Linear fissures (letters refer to descriptions in Table 1.)

<b>Letters and numbers refer to sites shown on Figure 3.</b> <b>Letters refer to linear subsidence features; numbers refer to open holes.</b>		
A	NZ 34462 50497	Linear depression up to 0.75 m across and approximately 0.5 m deep. Appears to be surface expression of continuation of 1.0 m wide open fissure exposed in limestone cliff immediately west of field. No evidence of recent movement. Appears unchanged from when seen in June 2000.
B	NZ 34458 50479–NZ 34492 50481	Long linear depression up to 0.75 m wide and approximately 0.5 m deep. Abundant evidence of very recent collapse in form of fresh scars in turf and topsoil on either side of depression forming graben-like feature. Observed during June 2000 investigation as a line of linear depressions up to 0.3 m across and 0.5 m deep.
C	NZ 34505 50508–NZ 34609 50521	Long, rather sinuous linear depression up to approximately 1.0 m wide and generally approximately 0.5 m deep. Connects several discrete open holes. Brick rubble locally towards eastern end suggests filling from previous collapse. Not observed during June 2000 investigation.

Substantial evidence of very recent ground movements along the full length of the linear fissure, described by Young and Culshaw (2001), was noted. The investigation in June 2000 revealed evidence of significant dilation of the northernmost fissure exposed at locality 15 in Figure 3. Whereas the present investigation showed little or no further widening of this joint at this point, very substantial recent movement was evident between here and the western edge of Houghton Cut. The fissure here is up to 1.1 m wide, dipping steeply to the south, with freshly exposed walls of limestone and limestone rubble. Over much of this length the fissure is up to 1.3 m deep. However, at the extreme eastern end, immediately above the western wall of the cut an open hole over 1.0 m wide extends to a depth of several metres, though it proved impossible to gain safe access to undertake accurate mea-

At locality 16 in Figure 3 a newly opened linear fissure at least 4.0 m long and up to 1.0 m wide is partially concealed beneath shrubby vegetation. The fissure has clean vertical sides in solid limestone and is floored at a depth of approximately 2.5 m with limestone rubble and very recently collapsed blocks of newly grown turf (Figure 16). At its western end the fissure continues downwards beneath the present collapse to depths which could not be accessed.

<b>Numbers refer to sites shown on Figure 3.</b>		
13	NZ 34364 50435	Cracking of tarmac surface of north-bound carriageway of A690 road. Observed during June 2000 investigation. Crack more conspicuous May 2001.
14	NZ 34377 50467	Site of subsidence of footpath. Active movement on adjacent fissure recorded during June 2000 investigation. Sudden collapse of hole up to 0.5 m across and approximately 0.75 m deep in May 2001; minor injuries to pedestrian.
21	NZ 34408 50467	Gap between kerb stones widened and with evidence of vertical displacement.

Numbers refer to sites shown on Figure 3.		
15	NZ 34350 50464	<p>Prominent gully extending several metres west from western edge of cutting. Open fissure up to 1.1 m wide and up to several metres deep at its eastern extremity immediately above cutting. Paired fissures separated by approximately 1.0 m of limestone.</p> <p>Clear evidence of very recent collapse with disrupted soil, turf and displaced mature hawthorn bush.</p> <p>Substantial collapses since June 2000 investigation.</p>
16	NZ 34345 50465	<p>Prominent linear fissure approximately 4.0 m long, up to 1.0 m wide and at least 2.5 m deep. Fissure exhibits clean vertical sides.</p> <p>Adjoining topsoil and turf freshly broken giving clear evidence of very recent collapse.</p> <p>Although this fissure lies along course of depression recognised during June 2000 investigation, this prominent open fissure was not observed at that time.</p>

\* Open holes and depressions  
(numbers refer to descriptions in Tables 2 and 3.)

The open fissures to the west of Houghton Cut have been fenced by Sunderland City Council.
