# Walkover survey of a landslide on the A57 (Snake Pass) road at Cowms Moor, Derbyshire in January 2008.

Open Report OR/08/006

D P Boon & H M Evans

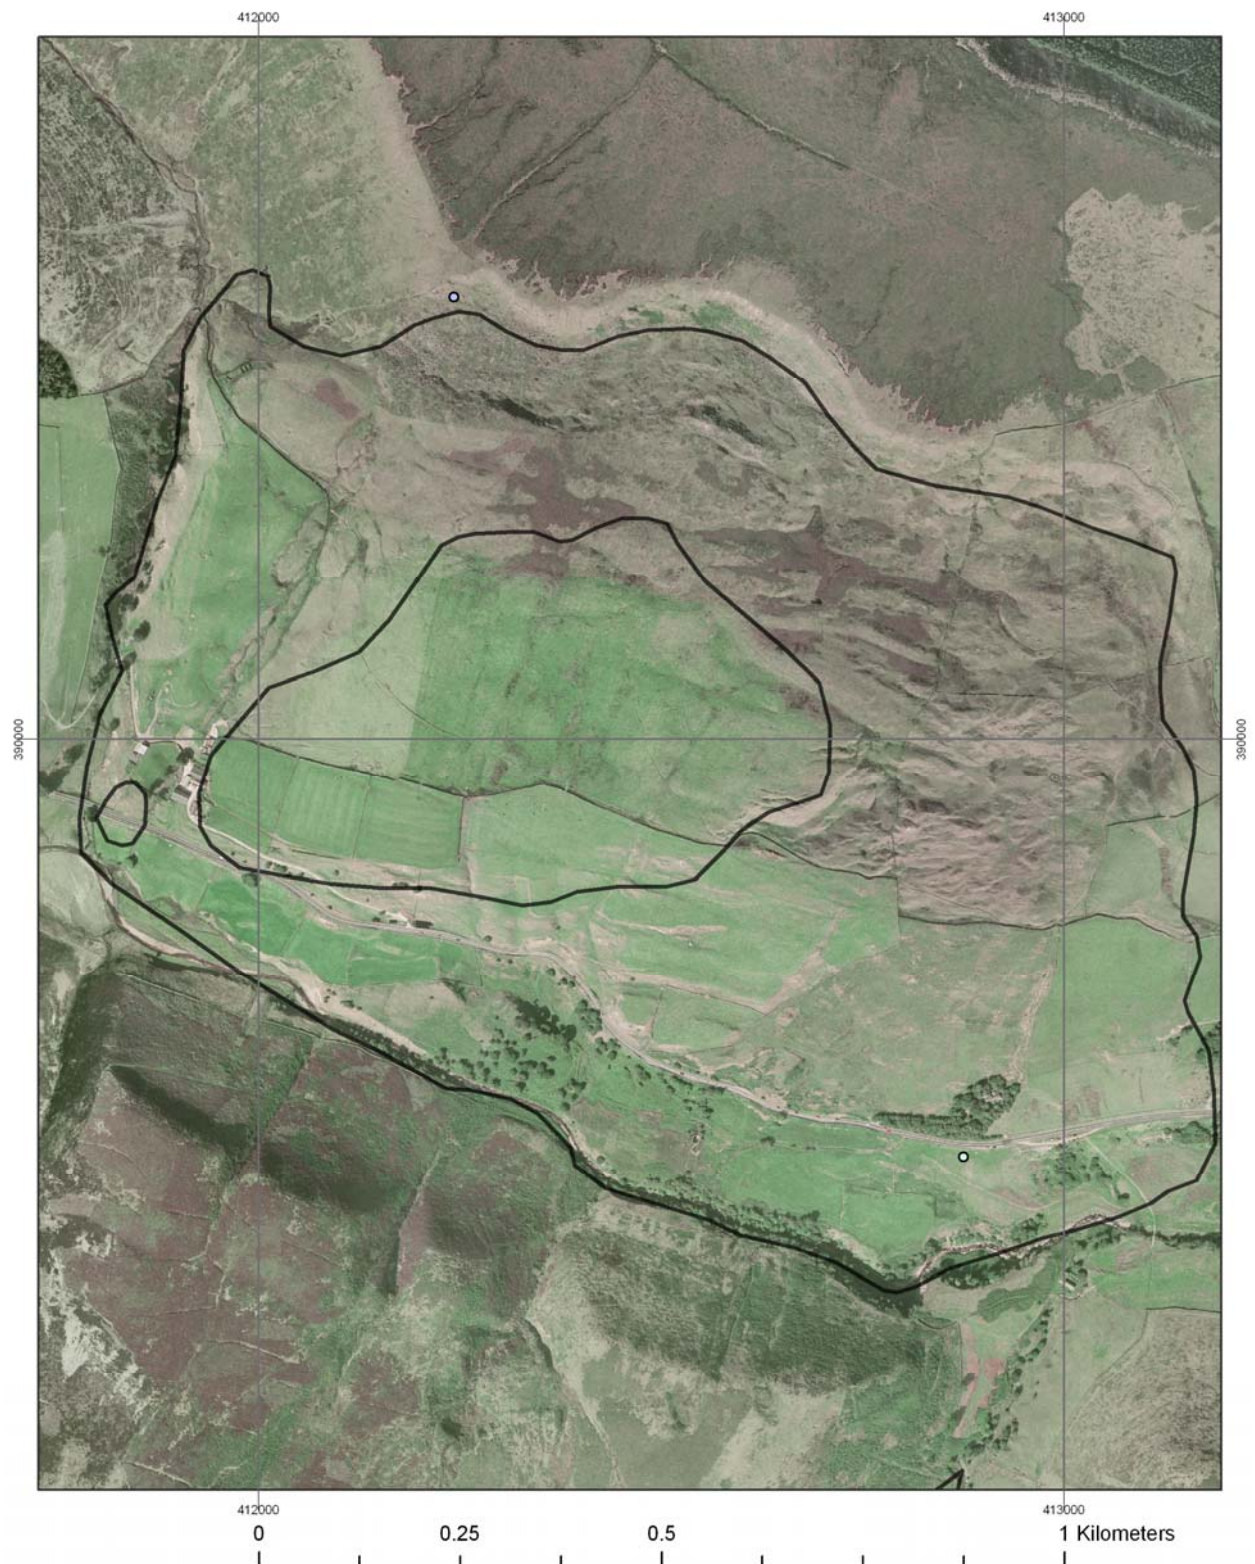
The aerial photograph shown in Figure 2 shows the undulating ground surface in the area of the mapped landslide. In Figure 2, several distinct morphological zones can be identified. The far west of the landslide is characterised by narrow lobes (possibly mudflows), the central area has a

more uniform smooth surface and is mapped as an insitu block of bedrock. The north eastern area has linear degraded scarps and bench features with either brown peat formed in the mini basins or ponding of water. The central eastern area has fresher, narrower, scarps and benches than in the north, and the south and south eastern area has subdued and isolated scar and bench features including degraded scarps. The steep sided river valley, gentle slopes and some flat topped terraces characterise the base of the valley.

**Figure 2** Air Photograph (c. 2000) of Cowms Rocks landslide complex, Derbyshire. White point (bottom, right) marks the location of new landslide event detailed in this report. The white point (top, left) indicates the existing database point [ID 5470] for the Cowms Rocks Landslide held in the BGS National Landslide Database. The outer black boundary marks the extent of the mapped Cowms Rocks landslide (see Mass Movement).

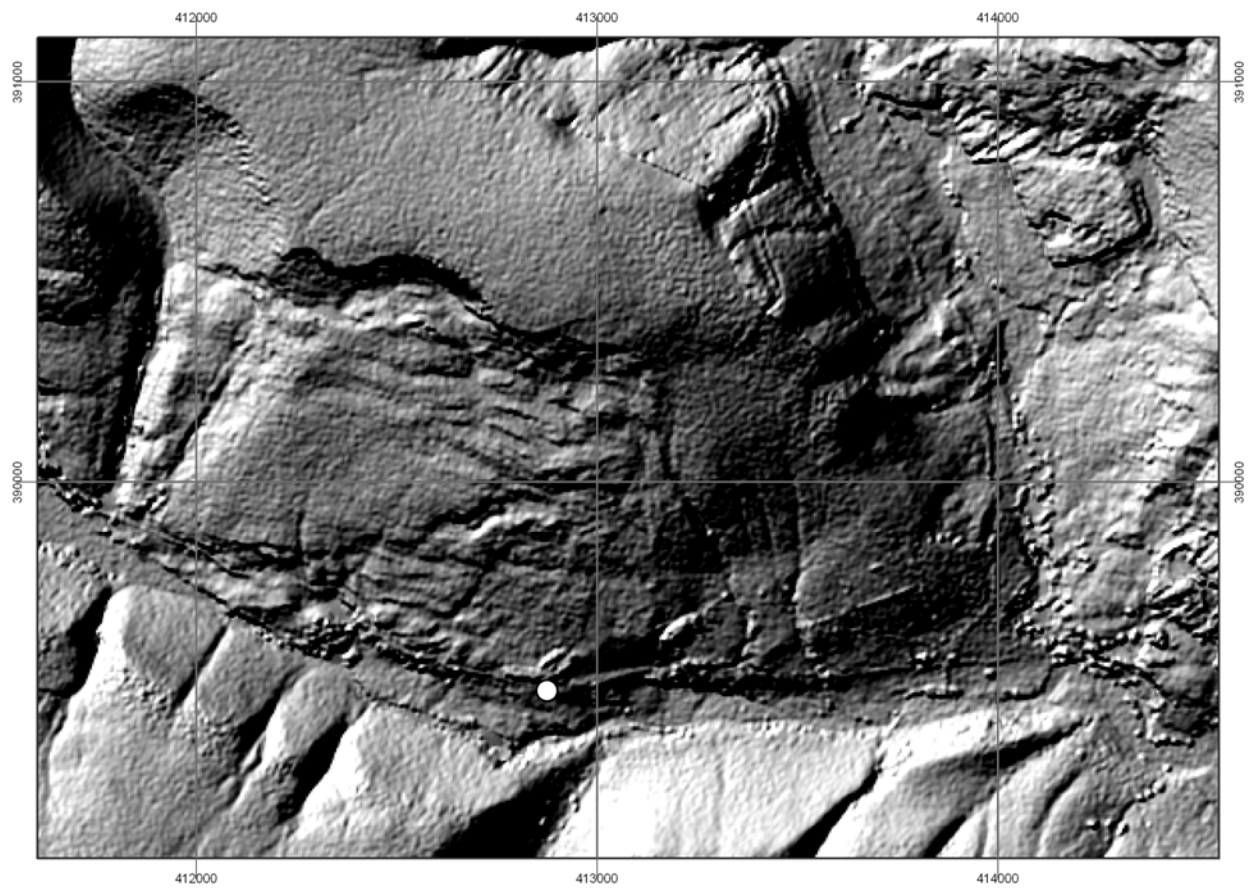
The Next Map™ Digital Terrain Model (DTM) shown in Figure 3 shows the position of the landslide affecting the A57 and shows the wider scale features associated with the Cowms Rocks landslide complex.

**Figure 3 NextMap50 Digital Terrain Model showing the northern side of the Ashop valley. The white point (bottom, centre) marks the location of the reported landslide.**

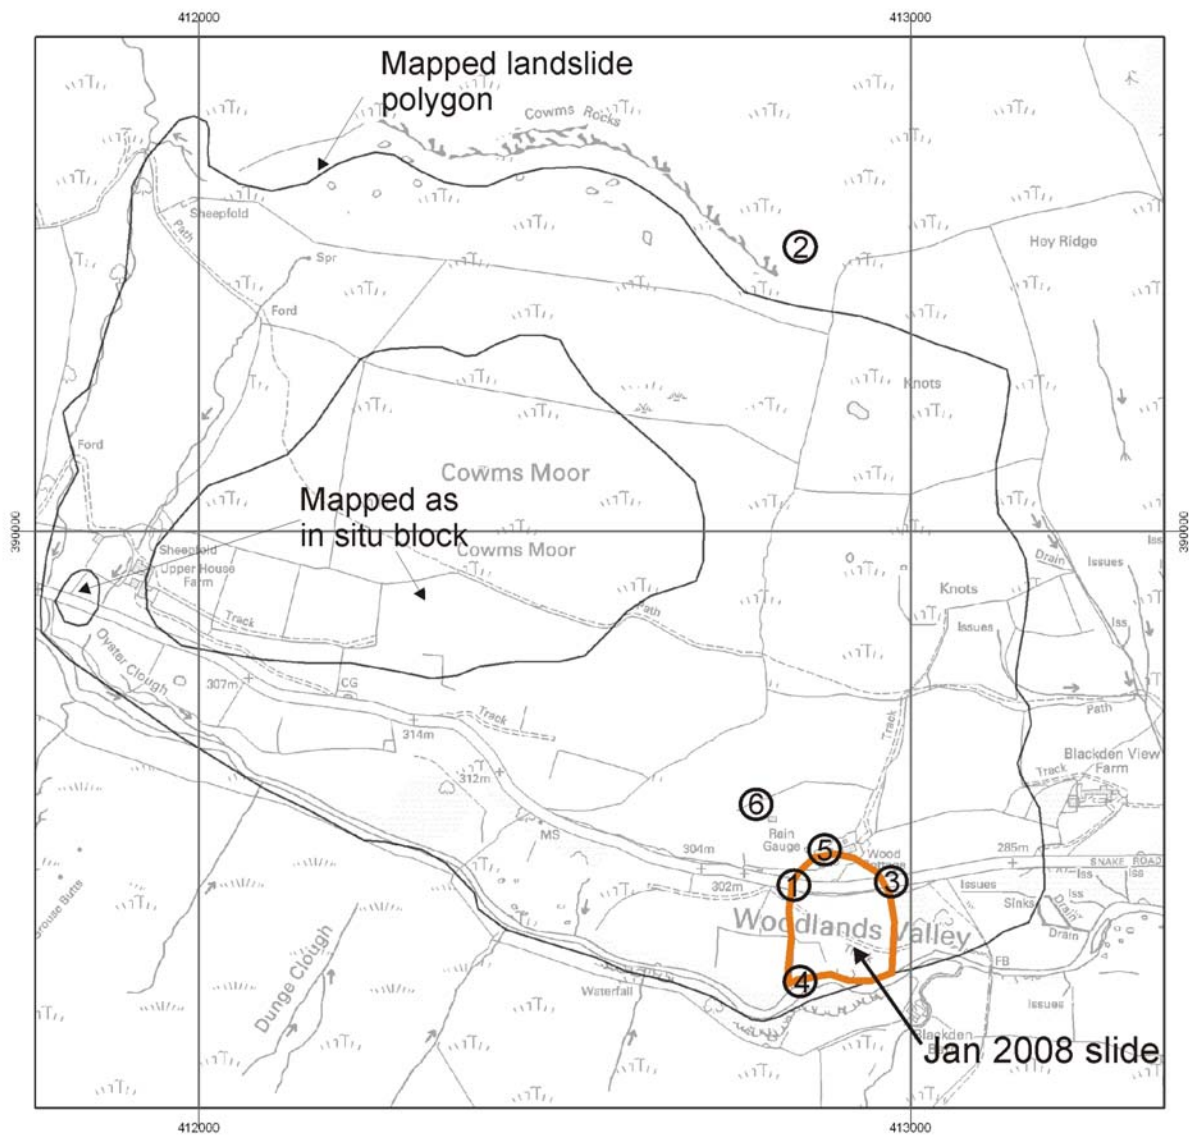
During a rapid walkover survey the following field observations were made. Observation numbers relate to the locality numbers on the map given in Figure 5. Additional information, including anecdotal evidence, is summarised separately under Additional Information.

**Figure 5** Location map showing locality numbers, extent of the reported January 2008 landslide event (red outline), and the BGS mapped landslide (black outline).
