## **OBSERVATIONS AND IMPLICATIONS OF DAMAGE FROM THE MAGNITUDE $M_w$ 6.3 CHRISTCHURCH, NEW ZEALAND EARTHQUAKE OF 22ND FEBRUARY 2011**

Sean Wilkinson, Damian Grant, Elizabeth Williams, Sara Paganoni, Stuart Fraser, David Boon, Anna Mason, Matthew Free

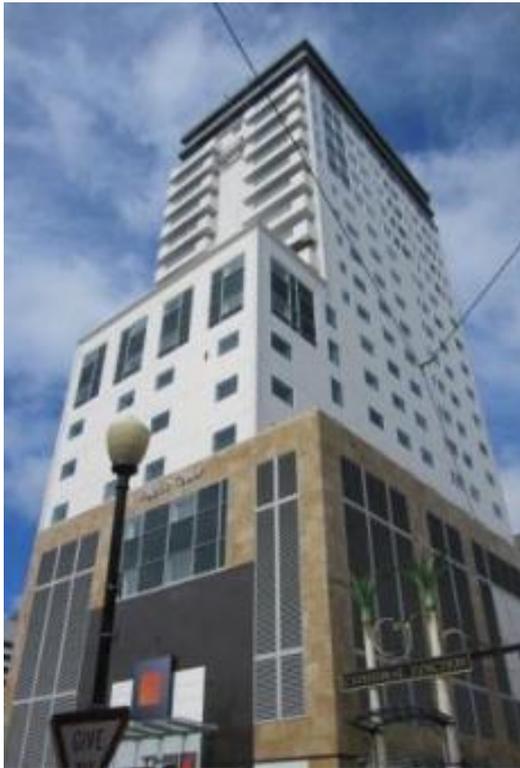
Figure 11- 22-storey steel EBF/Moment Frame building, Pacific Tower, 2010.

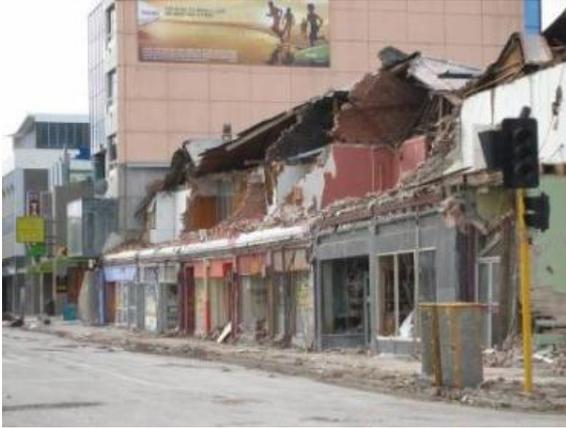
(a)

1. Two-storey commercial row brickwork buildings (Figure 13a);
2. Large commercial and residential brickwork buildings either detached or built in rows (Figure 13b);
3. Churches (Figure 13c);
4. Other typologies of buildings with either public or industrial use, such as the old University colleges, old stonework mills, etc. (Figure 13d).

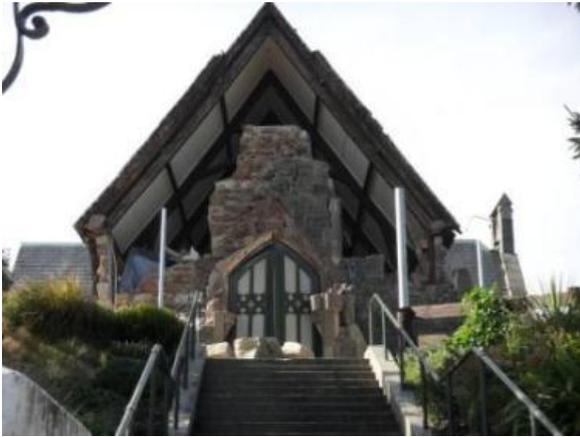
(c)

1. Material quality. Churches and public buildings (Figure 13c, Figure 16c and Figure 16d) generally had multi-leaf or rubble cavity walls with an outer wythe of cut stone blocks, while the brickwork of the other types of URM structure was made of frogged fired bricks laid with lime mortar. It is likely that the majority of important buildings had undergone grouting, as stonework masonry displayed a good cohesion. Instead, the extended collapse of large portions of brick masonry panels was probably determined by the weakness of the bond deriving from the poor quality of mortar and possibly from the use of strong bricks with a vitrified superficial finish.
