East Cliff Landslide, Bournemouth

Last updated 15:00, 07/06/2016

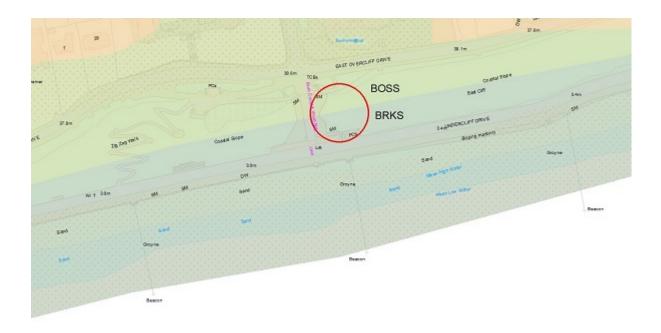
Geological map showing Boscombe Sand Formation (BOSS) and Branksome Sand Formation (BRKS). Contains Ordnance Data © Crown Copyright and database rights 2013. Ordnance Survey Licence no. 100021290.

The geology of the cliffs at East Cliff comprise a sequence of generally very weak sandstones and mudstones from the Mid-Eocene, belonging to the <u>Boscombe Sand Formation</u> and the underlying <u>Branksome Sand Formation</u>.

The intimate juxtaposition of sand and clay, characteristic of the Branksome Sand Formation, allows rapid movement of water through the rock mass and exposure of the clay component to water and hence swell/shrink deformation and cracking. These conditions are likely to have contributed to the development of a landslide shear plane within the Branksome Sand Formation, which has migrated upward to the cliff top forming a continuous surface.
