# Nedern Brook Wetland SSSI Phase 1 hydrological monitoring

Open Report OR/15/038

Gareth Farr

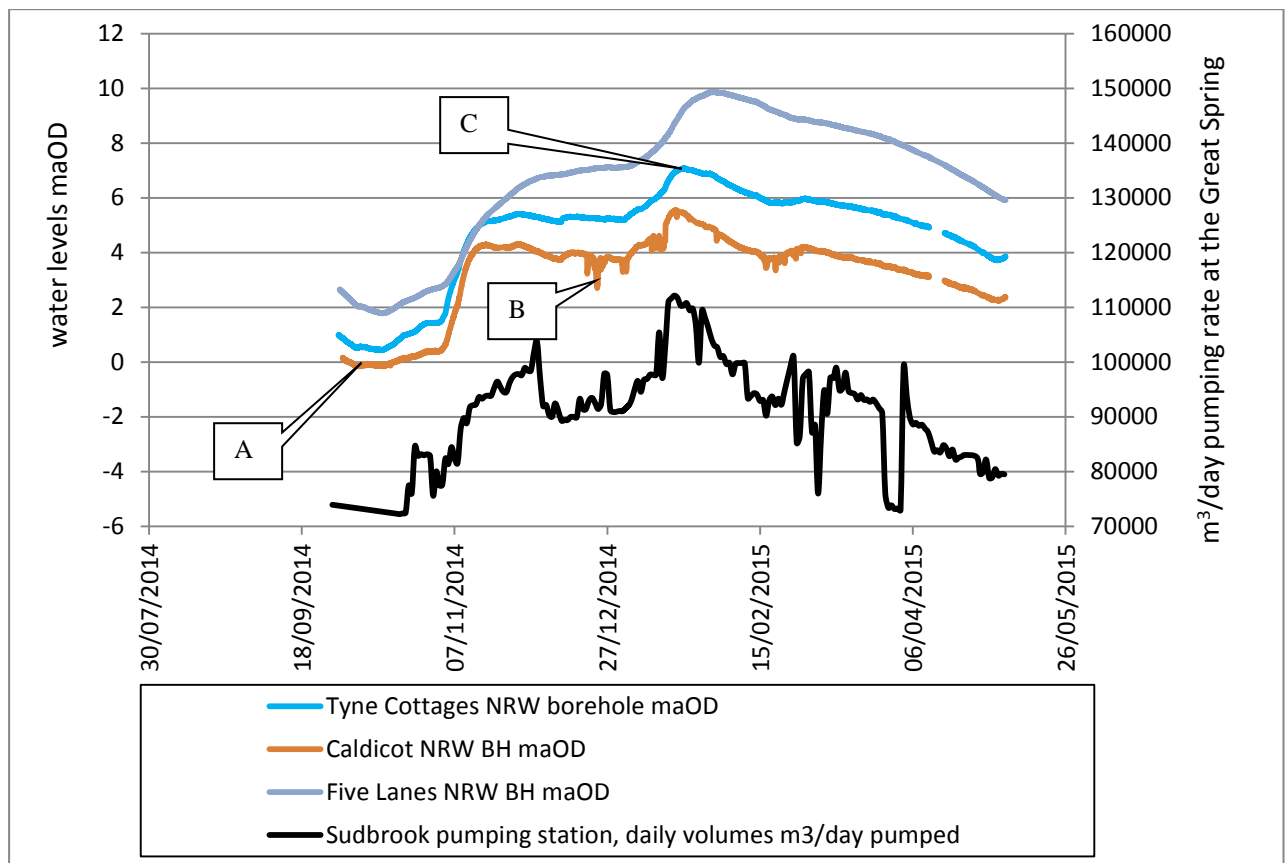
Groundwater in the underlying Carboniferous Limestone aquifer is monitored by NRW as part of routine monitoring within the Great Spring Source Protection Zone (SPZ). The general overall trend of groundwater levels (Figure 6) within the limestone aquifer is very similar. There is a significant groundwater abstraction at the 'Great Spring', located about 2 km to the south east. The Great Spring is a dewatering operation to keep the Severn Tunnel from flooding. It is monitored by Network Rail (Figure 6). Pumping at the Great Spring has to respond to increasing groundwater levels in order to maintain groundwater at a set level within the tunnel and thus also shows a similar trend to the groundwater hydrographs. Figure 6-A illustrates groundwater levels in the Caldicot Country Park borehole, during September when groundwater levels are  $<0$  maOD. Groundwater levels would not normally be  $<0$  maOD under natural conditions and it is prosed this is a dewatering effect of the Great Spring. Small changes in the same hydrograph (Figure 6-B) are also possible responses to pumping at the Great Spring. The Tyne Cottages borehole, Figure 6 C, is geographically closest to the wetland and has a range of nearly 6 m.

**Figure 6 Groundwater levels in the Carboniferous Limestone aquifer compared to pumping rates at the Great Spring**

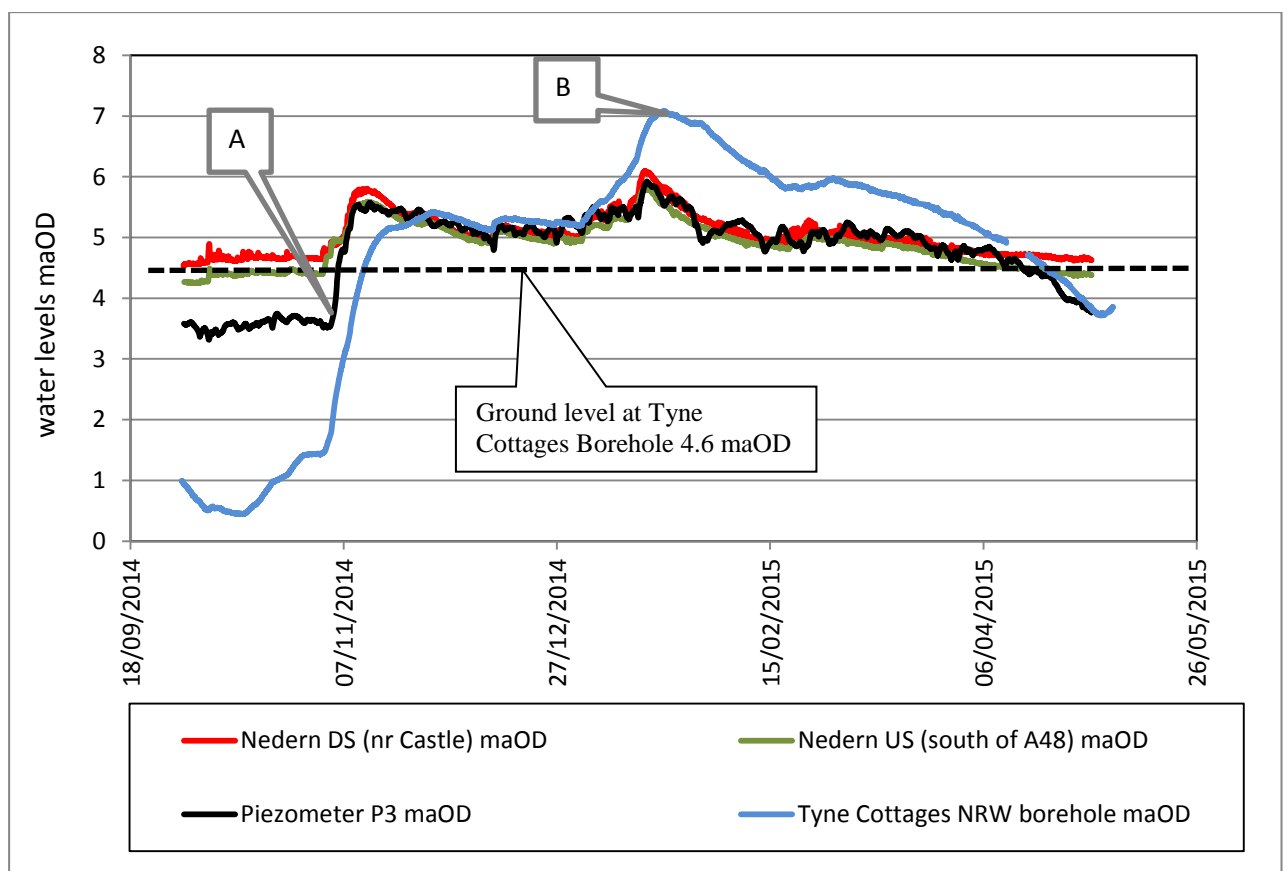
**Figure 7 Groundwater and surface water levels in the wetland.**

Groundwater levels recorded from a piezometer ‘P3’ located within the wetland are plotted against surface water levels collected from the stilling wells on the Nedern Brook and groundwater levels from the NRW Tyne Cottages borehole (Figure 7). Tyne Cottages is the closest bedrock borehole to the wetland that monitors the underlying Carboniferous Limestone aquifer (Figure 7). The ground level near the dipwells and piezometers, approximately 4.6 maOD, is marked by the black dashed line (Figure 7 and Figure 8). The rapid rise in groundwater levels within the limestone aquifer, in response to precipitation, is reflected by a rise in Piezometer P3 (Figure 7 A) and also the stage readings within the Nedern Brook US and DS monitoring points. During the flooding period the piezometric head in the limestone aquifer (Tyne Cottages borehole) is lower than that of the flood water in the wetland suggesting that there is a limited vertical movement of groundwater from the limestone during the initial flooding period. This could highlight that springs and seepage from shallower sources such as the River Terrace Gravels (which are not instrumented) are in part responsible for initial flooding within the wetland. However in late November the piezometric head in the limestone aquifer reaches 7 maOD (Figure 7 B), higher than the ground level within the wetland and greater than the flood waters within the wetland, suggesting that vertical flow of water upwards into the wetland might be possible if a low permeability pathway (such as a sand or gravel horizon) exists. The flood depth reaches about 1.5 m in the vicinity of the dipwell and piezometer nests and covers an area of over 30 ha (see Appendix 5 field maps for the 1<sup>st</sup> January 2015).

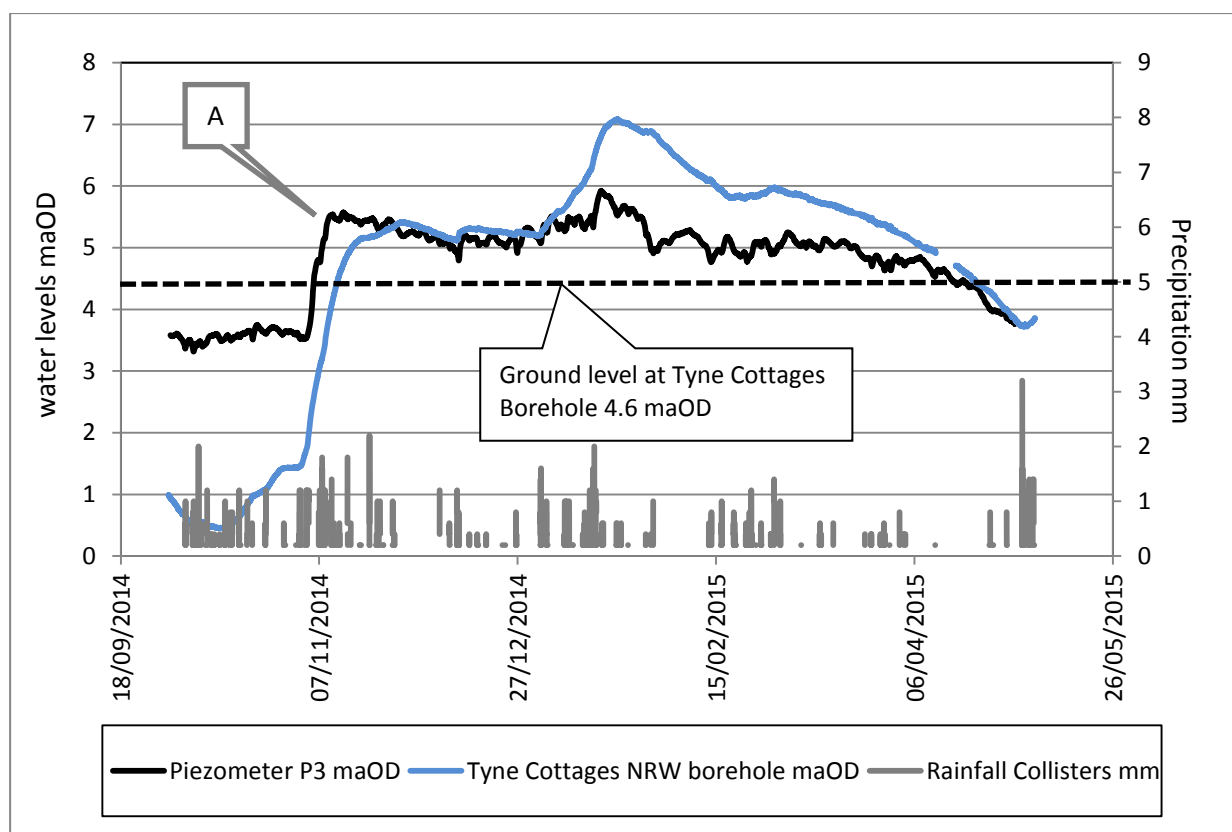
Precipitation at Collister Pill gauging station is compared to groundwater levels in the Carboniferous Limestone (Tyne Cottages Borehole) and flood levels in the Nedern wetland, Piezometer P3 (Figure 8). The black dashed line represents ground level within the wetland next to the piezometer, and not at the Tyne Cottage borehole. It is clear that flooding in the Nedern Wetland occurs before the piezometric head in the limestone aquifer is great enough to cause surface flooding (Figure 8 A), suggesting either an input from another source such as the overlying river terrace gravels or impediment of downwards flow by low permeability infill within the Nedern Brook Wetland.

**Figure 8 Rainfall compared to flood depth in the wetland (P3) and groundwater levels in the Carboniferous Limestone (Tyne Cottages).**

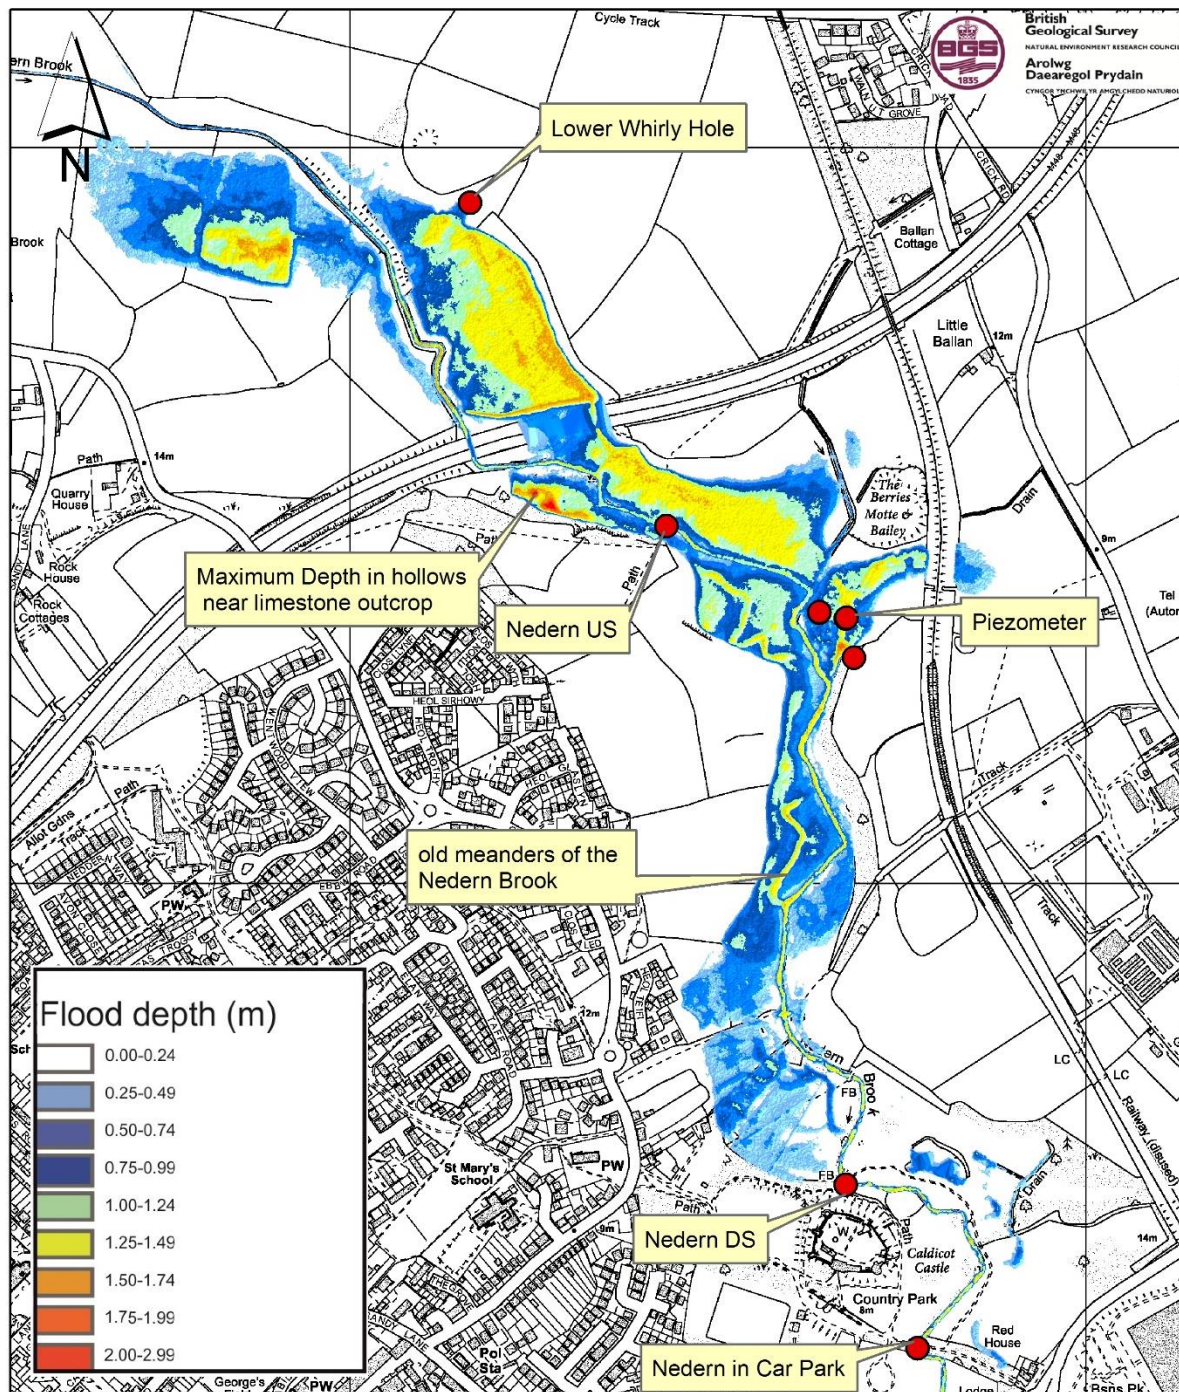
The following flood depth maps were produced to illustrate the maximum and mean flood depths during the monitoring period (Figure 9; Figure 10). The existing and historic meanders of the Nedern Brook are clearly visible, the deeper areas tend to be those that flood first and retain water longest.

**Figure 9 Maximum Flood levels based on 5.92maOD elevation of maximum flood depth between 30/09/2014 and 1/05/2015**

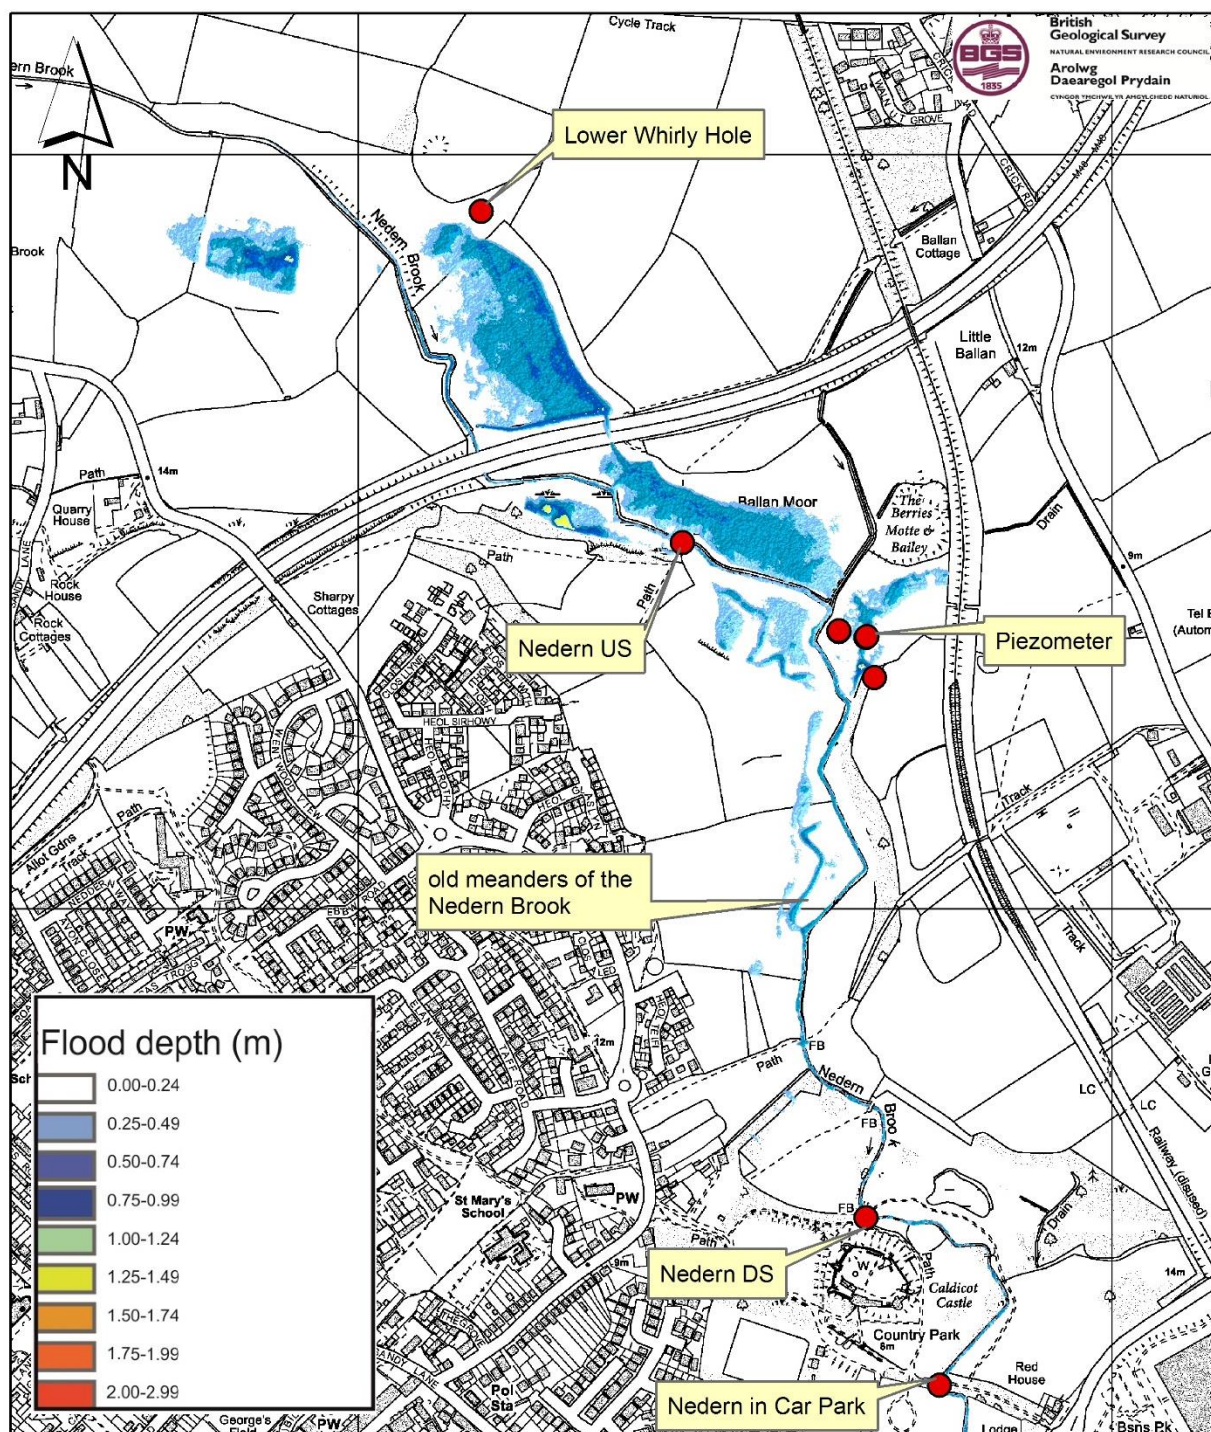
**Figure 10 Mean flood depth, based on 5.15m AOD elevation of average flood during between 30/09/2014 and 1/05/2015**

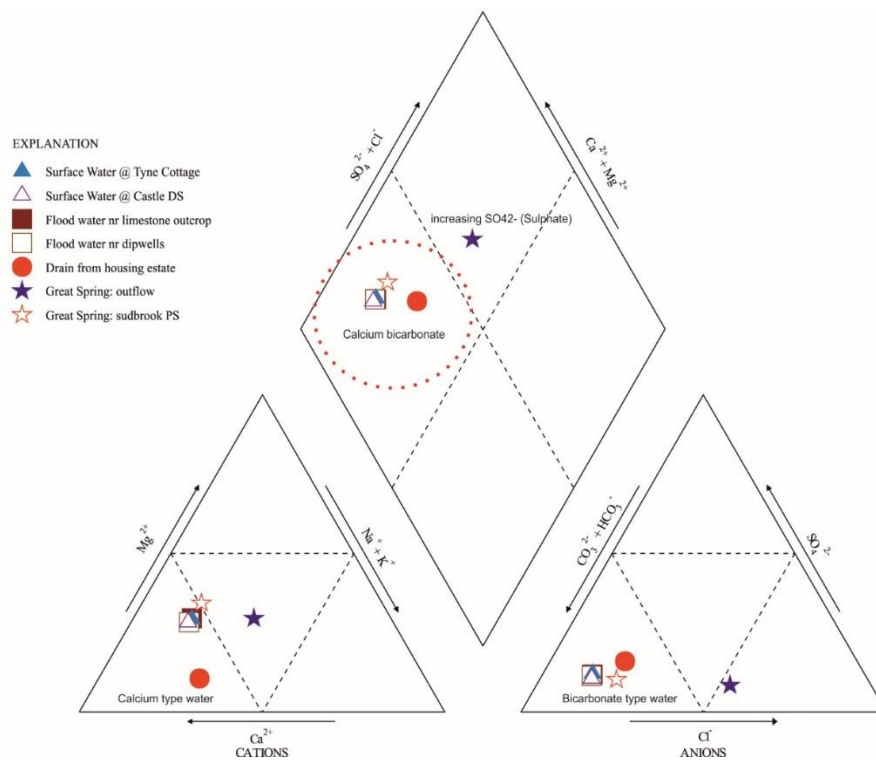
Calcium bicarbonate dominates the water types, however the Great Spring outflow, that represent groundwater from the Carboniferous Limestone aquifer, has higher levels of sulphate especially when sampled at the outflow to the River Severn. The groundwater from the Great Spring is more mineralised that the waters in the Nedern Brook and the wetland, however this could be representative of a longer residence time of groundwater within the Carboniferous Limestone aquifer before it reaches the Great Spring. In the upper part of the Nedern Brook (nr Caldicot Castle) nitrate (5.45mg/l) concentrations reflect that of local groundwater in the Great Spring (5.61mg/l), which may reflect the high amount of baseflow that the upper course of the brook receives from the underlying limestone aquifer. The effects of dilution, from direct precipitation or from groundwater from the river terrace gravels are not understood.

**Figure 11 Major ions of water samples taken from Table 1, shown in a ‘Piper Trilinear Diagram’. Most samples are of CaHCO<sub>3</sub> type as highlighted by the red dashed circle in the upper triangle.**

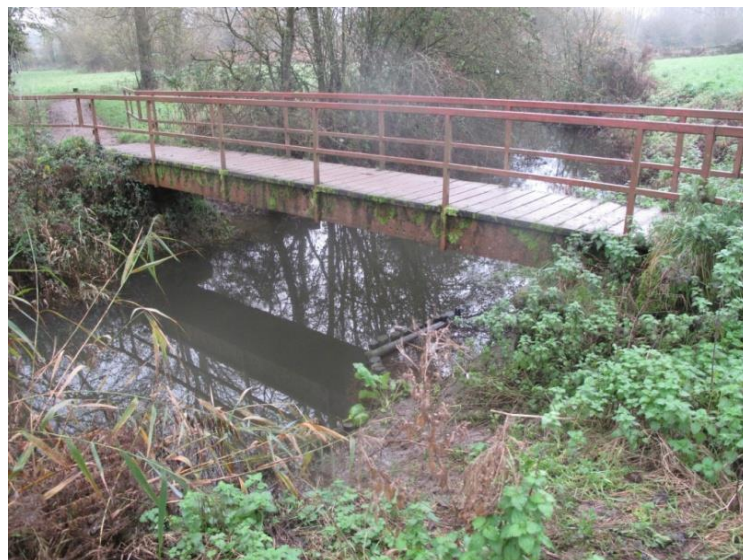
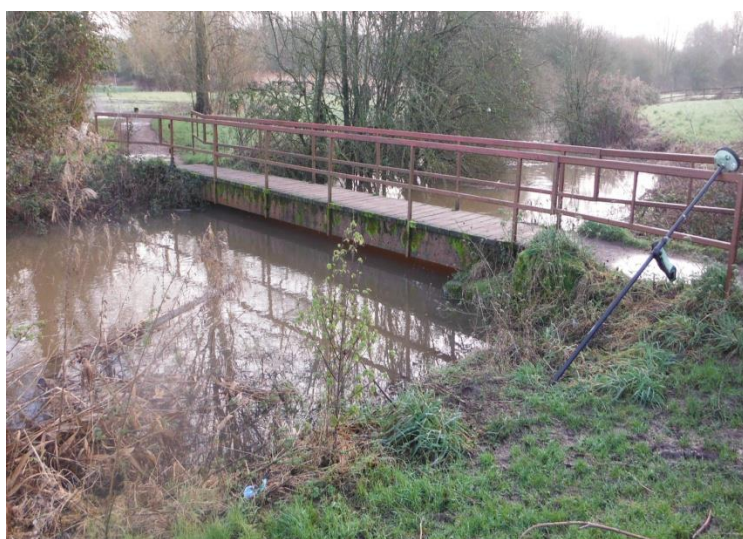
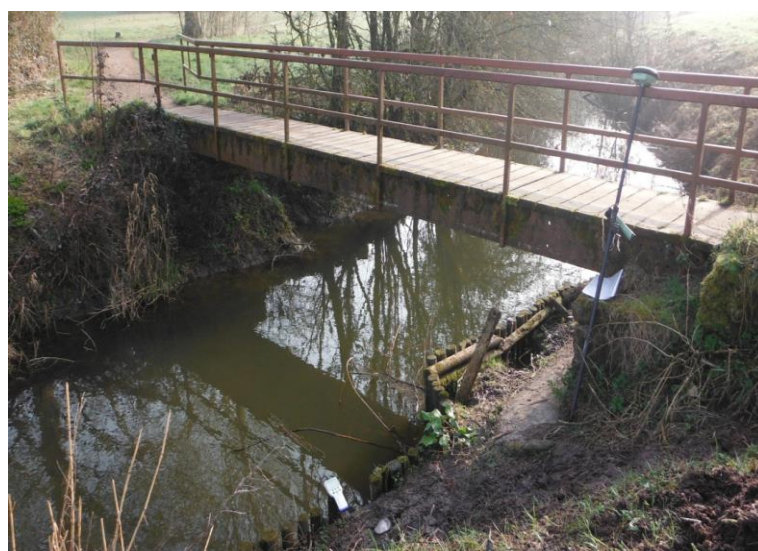
**Figure 14 Nedern Brook DS Monitoring Point under variable flow conditions © BGS NERC.**

27.11.2014 (top), 16.1.2015(middle) & 18.3.2015 (bottom)

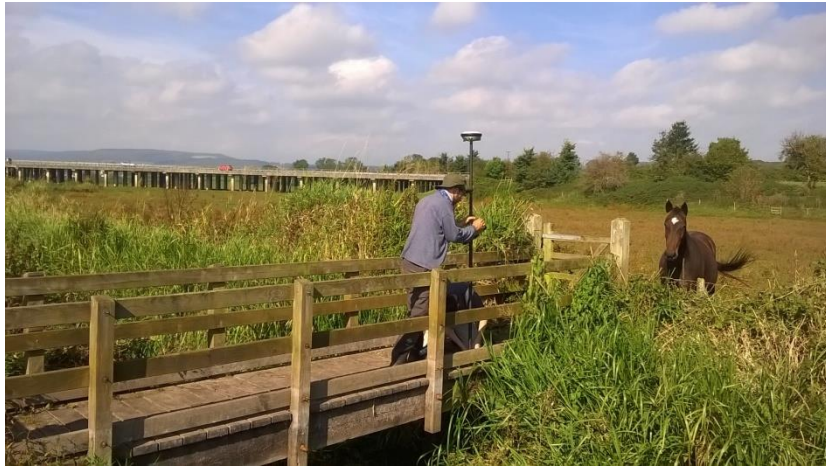
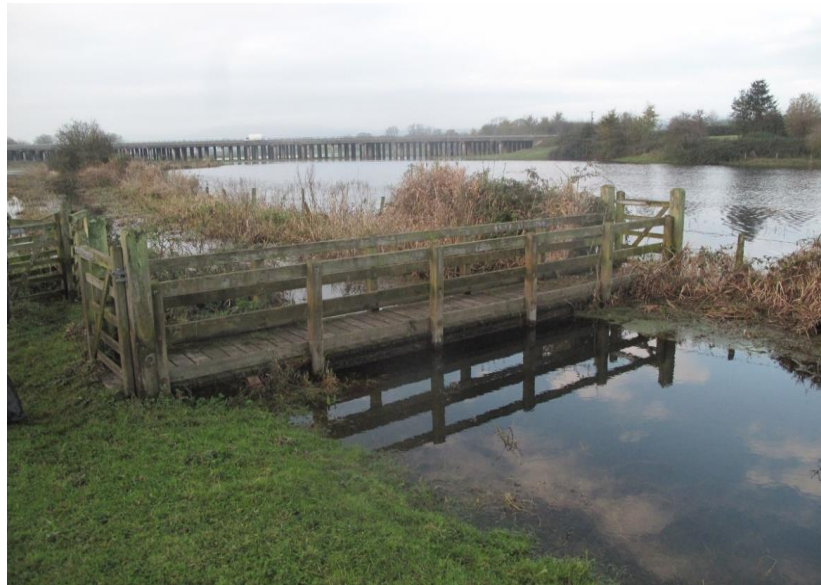
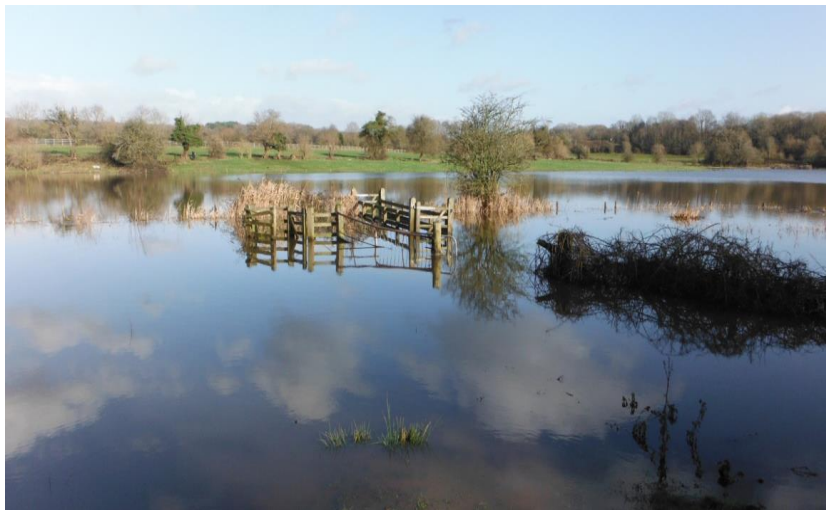
**Figure 15 Nedern Brook US Monitoring Point under variable flow conditions © BGS NERC.**

30.09.2014 (top: dry), 27.11.14 (middle: dry view north towards the road bridge), 16.1.15 (bottom: wet view east).

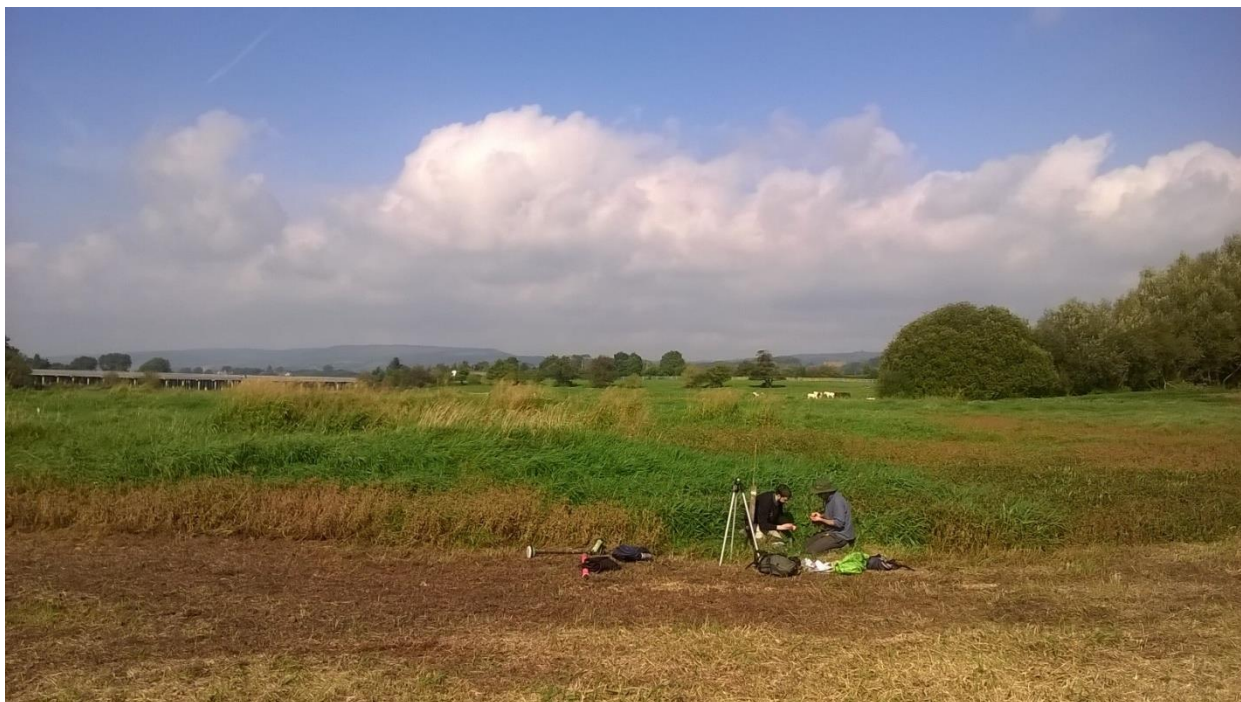
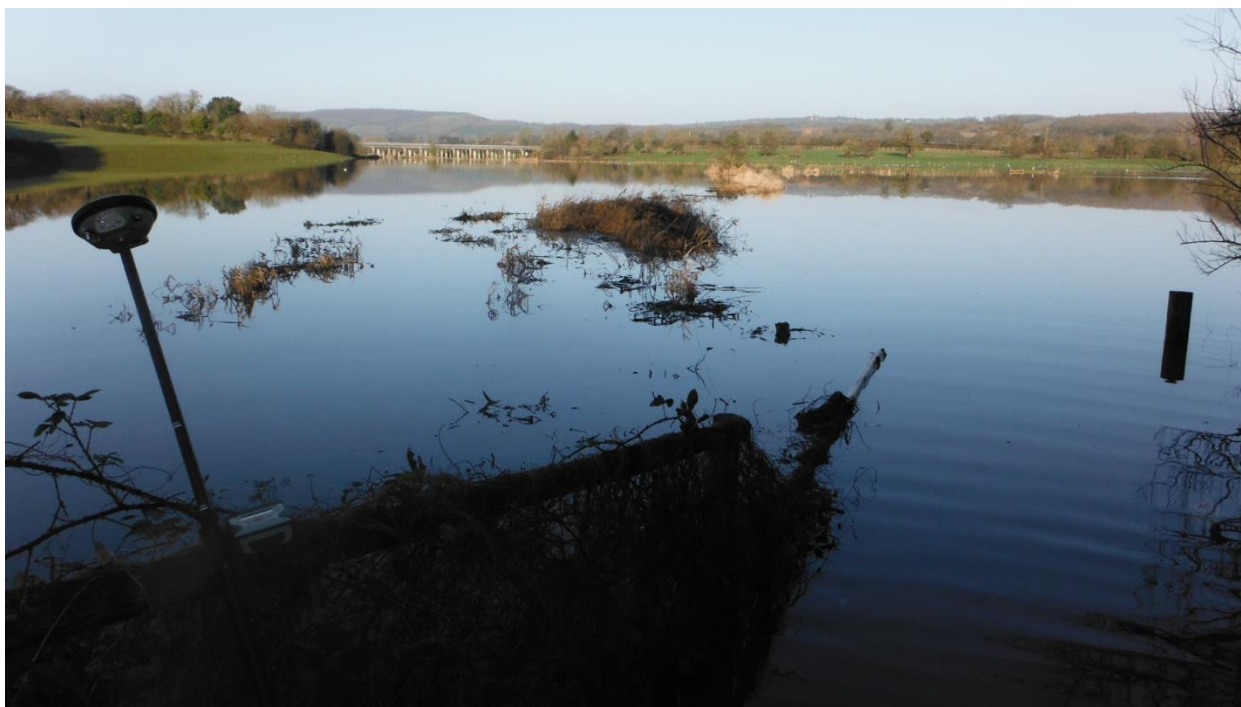
**Figure 16 Dipwells and Piezometers (P3) in dry and flood conditions © BGS NERC.**

30.09.2014 (top: dry install and survey view north towards M48) and 16.01.2015 (bottom: wet similar view)

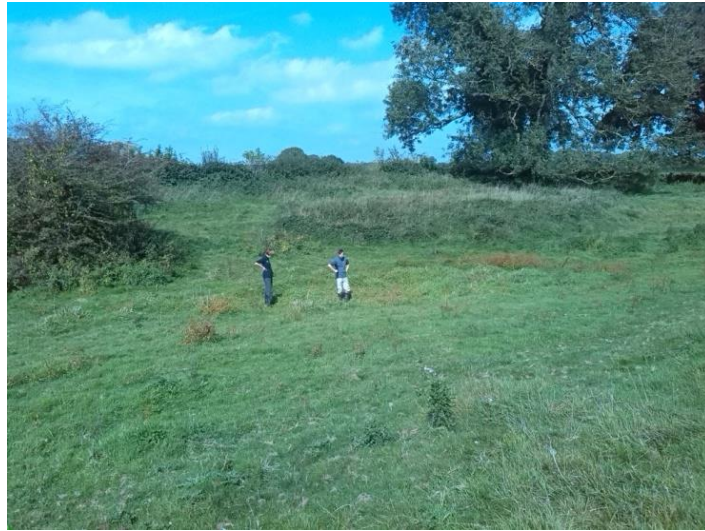
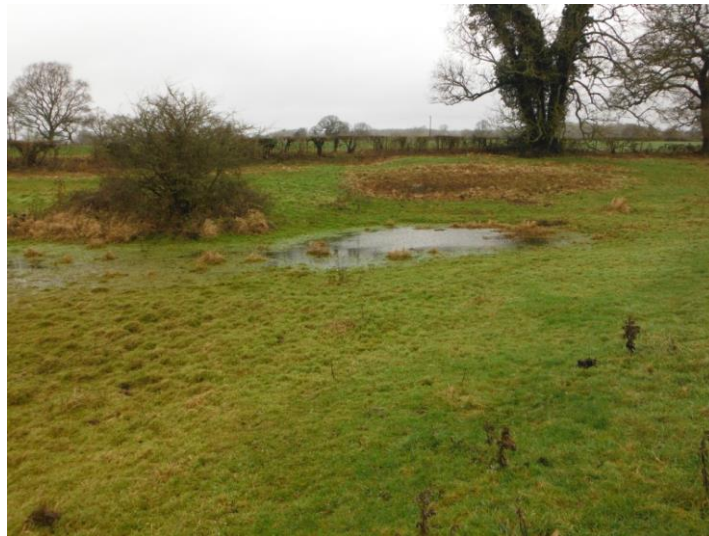
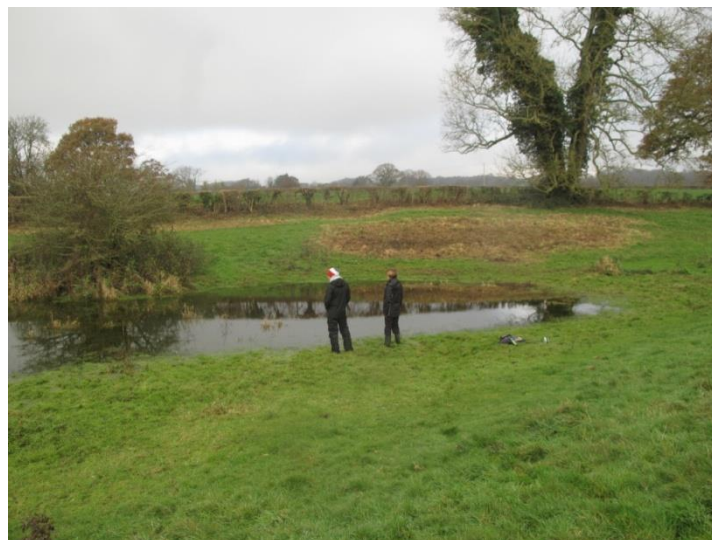
During the walk over surveys it was possible to observe areas where groundwater was discharging into the wetland, the key areas are illustrated on Figure 5. The Lower Whirly Hole was actively discharging groundwater for most of the monitoring period and during recession other small seepages and springs appeared nearby. The electrical conductivity of the spring water was 580 - 670  $\mu\text{S}/\text{cm}$ , indicative of groundwater. A large spring head/seepage area can be found in a woodland area just to the north of the Lower Whirly Hole however it was only actively discharging water during very high flood levels, remaining dry for the majority of the monitoring period.

**Figure 17 Lower Whirly Hole in variable flood conditions © BGS NERC.**

30.09.2014 (top), 18.12.2014 (middle), 27.11.2014 (bottom)

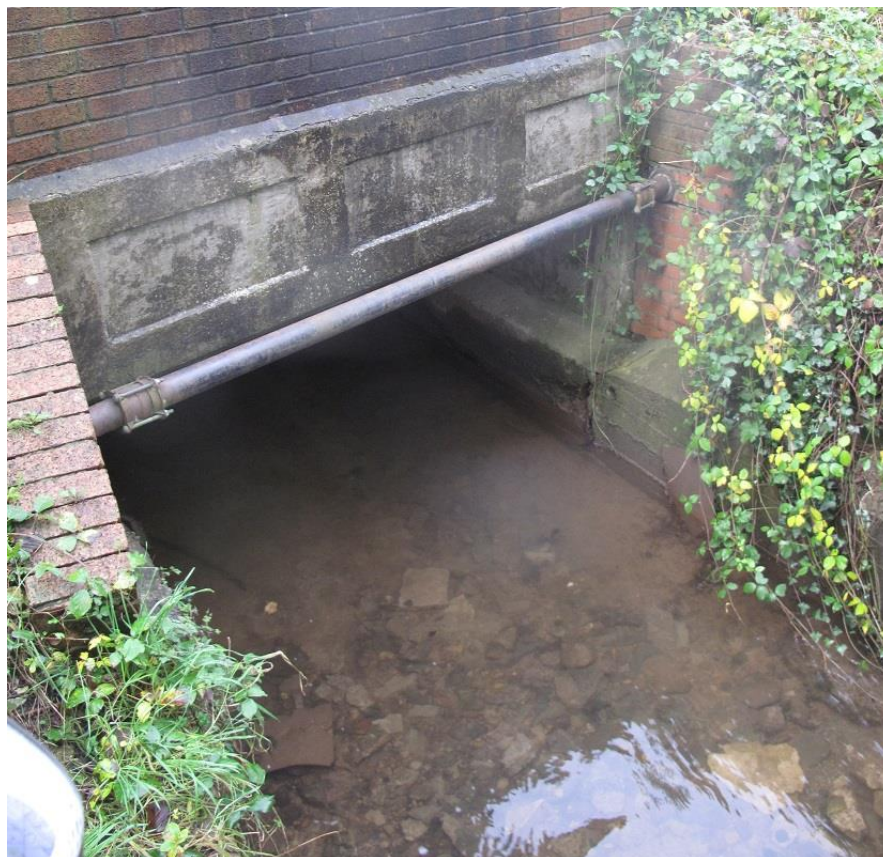
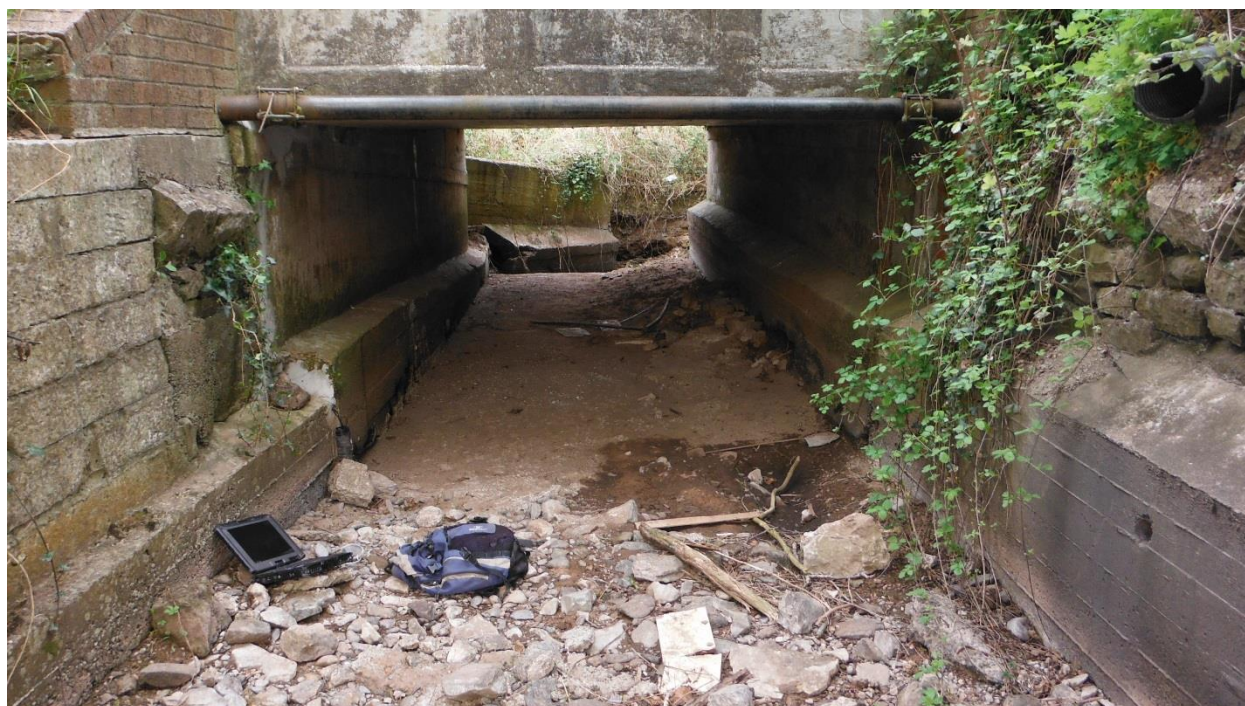
**Figure 18 Nedern Brook at Tyne Cottages in variable flow conditions © BGS NERC.**

27.11.2014 (top) and 1.05.2015 (below)
