Initial report on the Scroggs Cleuch landslide, Lockerbie, December 2006

Internal Report IR/06/138

N R Golledge

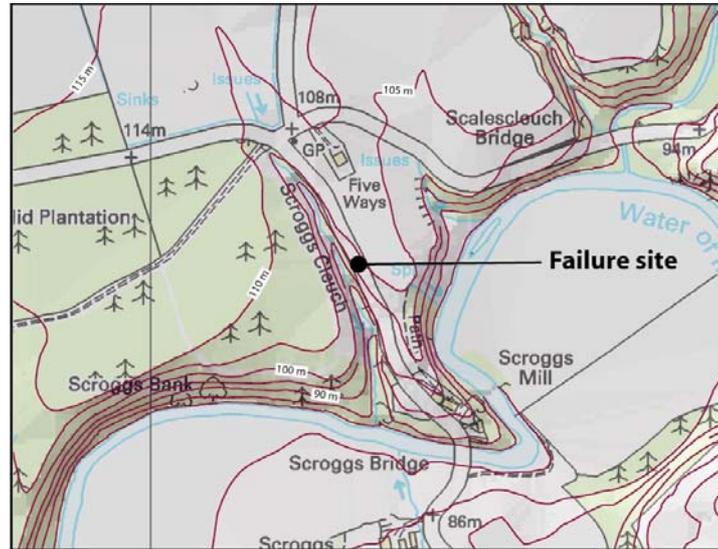
The failure took place at [NY16212 81353], on the eastern bank of Scroggs Cleuch. The burn has incised a c.10 m deep gully with steep sides. Slope aspect is 245° (SW). The B7068 runs NNW-SSE along the top of the eastern bank where the failure occurred.

Figure 2. Detail of landslip site.

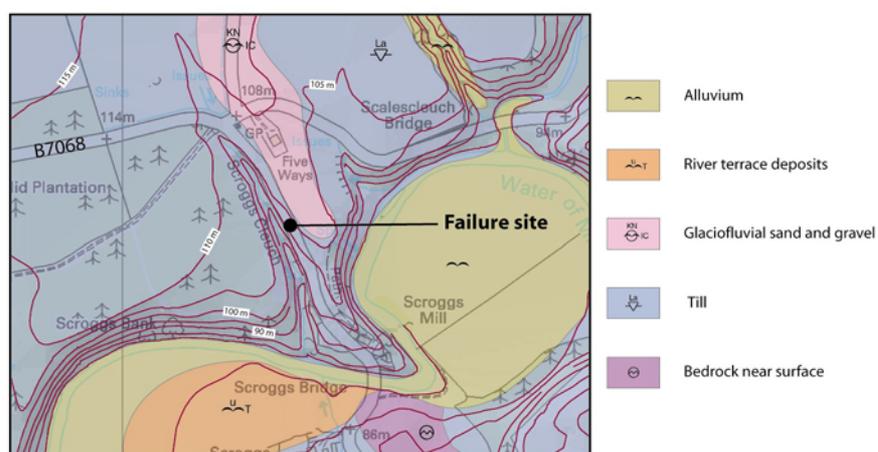
Recent field mapping and interpretation of 1:24 000 aerial photographs of the surrounding area combined with existing data from earlier geological surveys has identified an area of sand and gravel immediately to the east and north of the failure site (Fig. 3). This deposit is likely to be glaciofluvial in origin, and although no exposures have been logged, is likely to be composed of variable amounts of silt, sand and gravel. These components may form discrete beds or may be massive. Clasts are likely to be rounded or subrounded and may range from gravel to cobble grade. The deposit overlies the red, cohesive diamicton that forms the majority of the area. This is interpreted as subglacial till of the Langholm Till Formation, which typically has a firm to very firm matrix of silt and sand, and contains subangular to subrounded cobbles. These cobbles are chiefly Lower Palaeozoic greywacke sandstone and siltstone. The fine grain size of the matrix produces a ‘sticky’ deposit when wet, and a semi-cohesive slurry when saturated.

Figure 3. Geological map of the area surrounding the failure site, based on BGS 1:50 000 scale Solway East Special Sheet
