The Horncliffe landslide, Berwick-upon-Tweed, December 2008

Open Report OR/08/071

N R Golledge

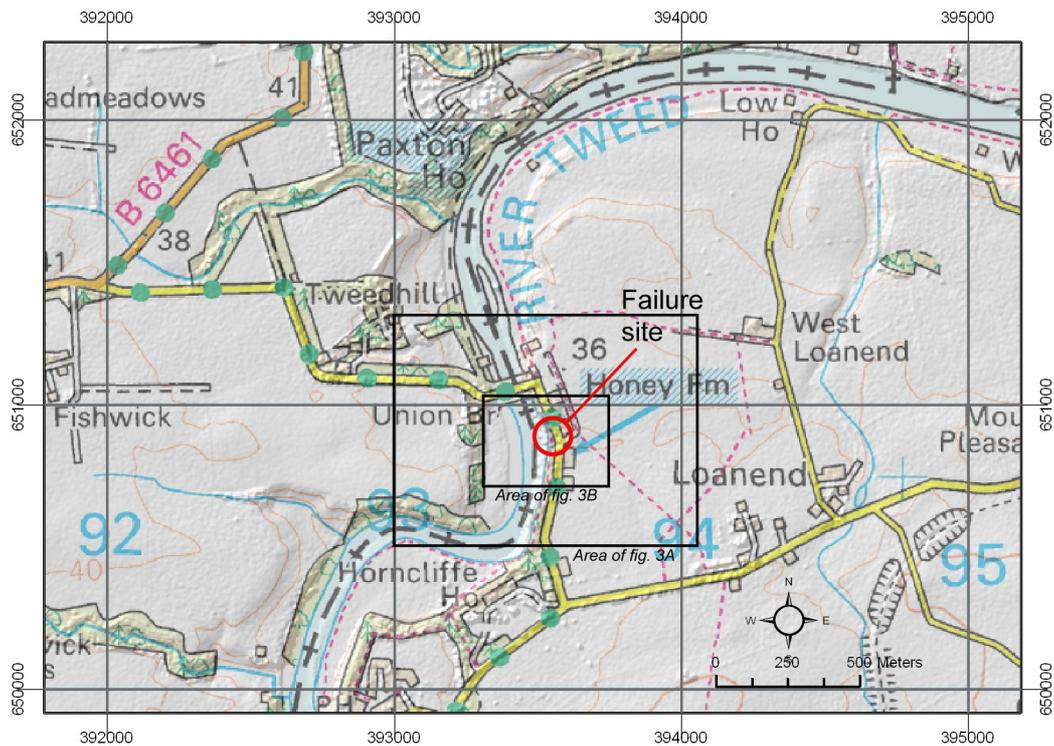
The failure took place at [NT93543 50854], on the eastern bank of the River Tweed between the Honey Farm and the Union Chain Bridge that crosses the Scotland – England border. There were reportedly maintenance works carried out to a fractured water main at the site 6 weeks prior to the failure, and evidence seen during the site visit suggested that repair had been effected and the hole backfilled with a coarse gravel aggregate. Locals also informed us that a culvert was thought to flow beneath the road at this location, though it was unknown whether or not it was still functional. During the site visit, a small stream was seen emerging beneath slumped and in situ material near the top of the failure gully, which may be the one reported to have been previously culverted.

Figure 2. Detail of landslip site.

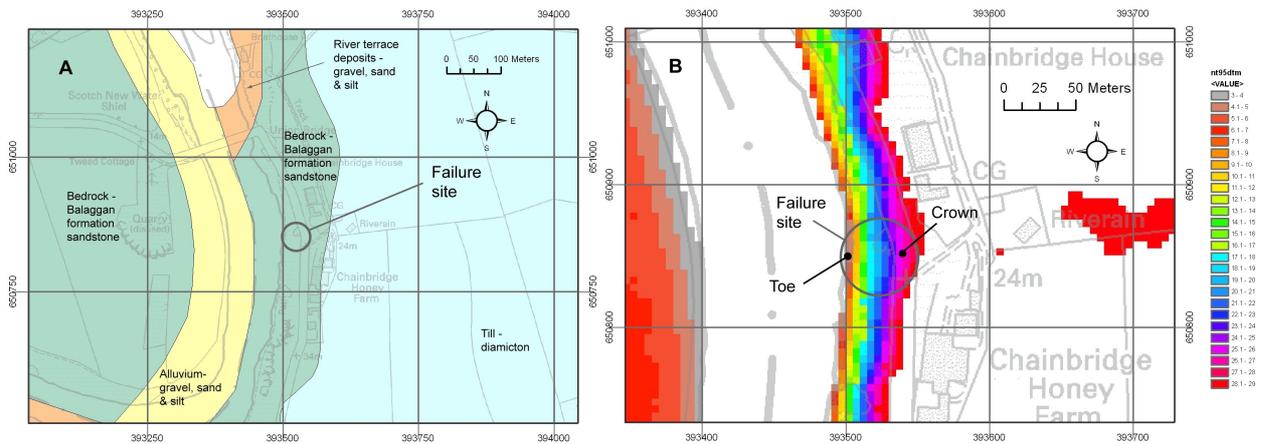
Bedrock thought to underlie the site is sandstone, siltstone and mudstone of the Balaggan Formation. Outcrops at the eastern end of the Chain Bridge revealed this to be a cross-bedded medium to coarse-grained red sandstone. No bedrock was seen at the failure site, however. The failure appears to have occurred in the overlying Superficial deposits, comprising principally a soft, red and grey mottled, silt and sand-dominated weakly cohesive diamicton. The matrix becomes increasingly firm with depth, particularly below 1.7 m. The matrix contains sufficient clay-grade sediment to impart a slight tendency to cleave or fracture when dug, particularly where it is more consolidated. The diamicton contains sub-angular (SA) and sub-rounded (SR) cobbles of the local red sandstone, as well as more angular, but weak, blocks of grey mudstone.

Other mapped deposits in the surrounding area (Fig. 3A) include alluvial and river terrace deposits associated with the River Tweed. These were not investigated during the site visit since they occur only to the west and north of the site, but are likely to be composed of gravel, sand and silt, in variable proportions. The road at the failure site occurs at the top of a steep bank (Fig. 3B). The road was underlain by at least two units of different types of fill (Fig. 4). To the south of the site, the exposed sequence revealed a red unit overlying a black unit, which in turn overlay the upper (possibly disturbed) part of the reddish diamicton. The red and black fills appeared to be composed of brick and coal rubble respectively, and were laterally continuous from south to north except in the central portion of the backscarp where the recent water mains maintenance had excavated through the sediments and been backfilled with gravel. Both red and black units were relatively thin (0.15-0.3 m thick), but of more-or-less constant thickness.

Figure 3. A. Geological map of the area surrounding the failure site, based on BGS 1:50 000 scale Sheet 26 (Berwick), and B. digital terrain data for the river bank at the failure site, from NEXTMap. Note the different scales of A & B.
