**The Geology and Cliff Stability at Nefyn,
North Wales –
Interim Report**

A.D. Gibson and A.J. Humpage

May 2001

Gibson, A.D. and Humpage, A.J. (2001).
The Geology and Cliff Stability at Nefyn, North Wales – Interim Report
British Geological Survey Commissioned Report
CR/01/101

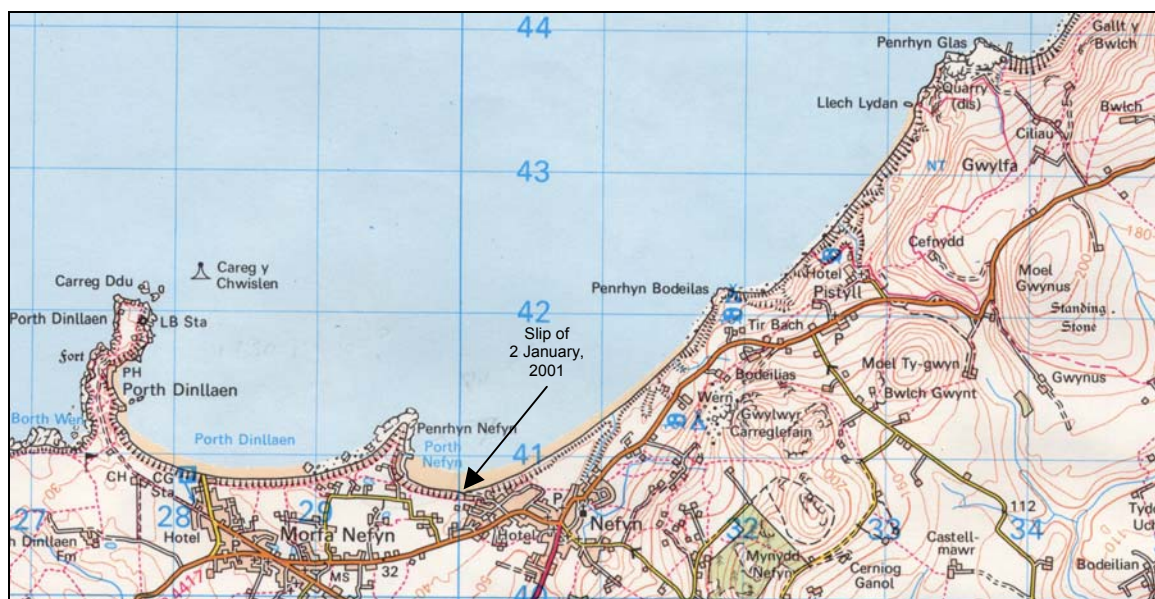
The cliffs fringing the bay between Penrhyn Nefyn and Penrhyn Bodeilas, within which sits Porth Nefyn, (Figure 1), have been subject to minor landsliding activity for many years. One such slip that occurred on 2 January 2001 resulted in the death of a visitor to the area. Following this incident, the British Geological Survey (BGS) has carried out a number of site visits to the area in order to investigate the geology and to conduct an outline assessment of the causes and mechanisms of landsliding in the area. This report presents the initial findings of ongoing research and considers the area immediately surrounding the location of the slip of 2 January.

Figure 1: Location of landslide of 2 January 2001 within Nefyn Bay
Ordnance Survey Topography © Crown Copyright

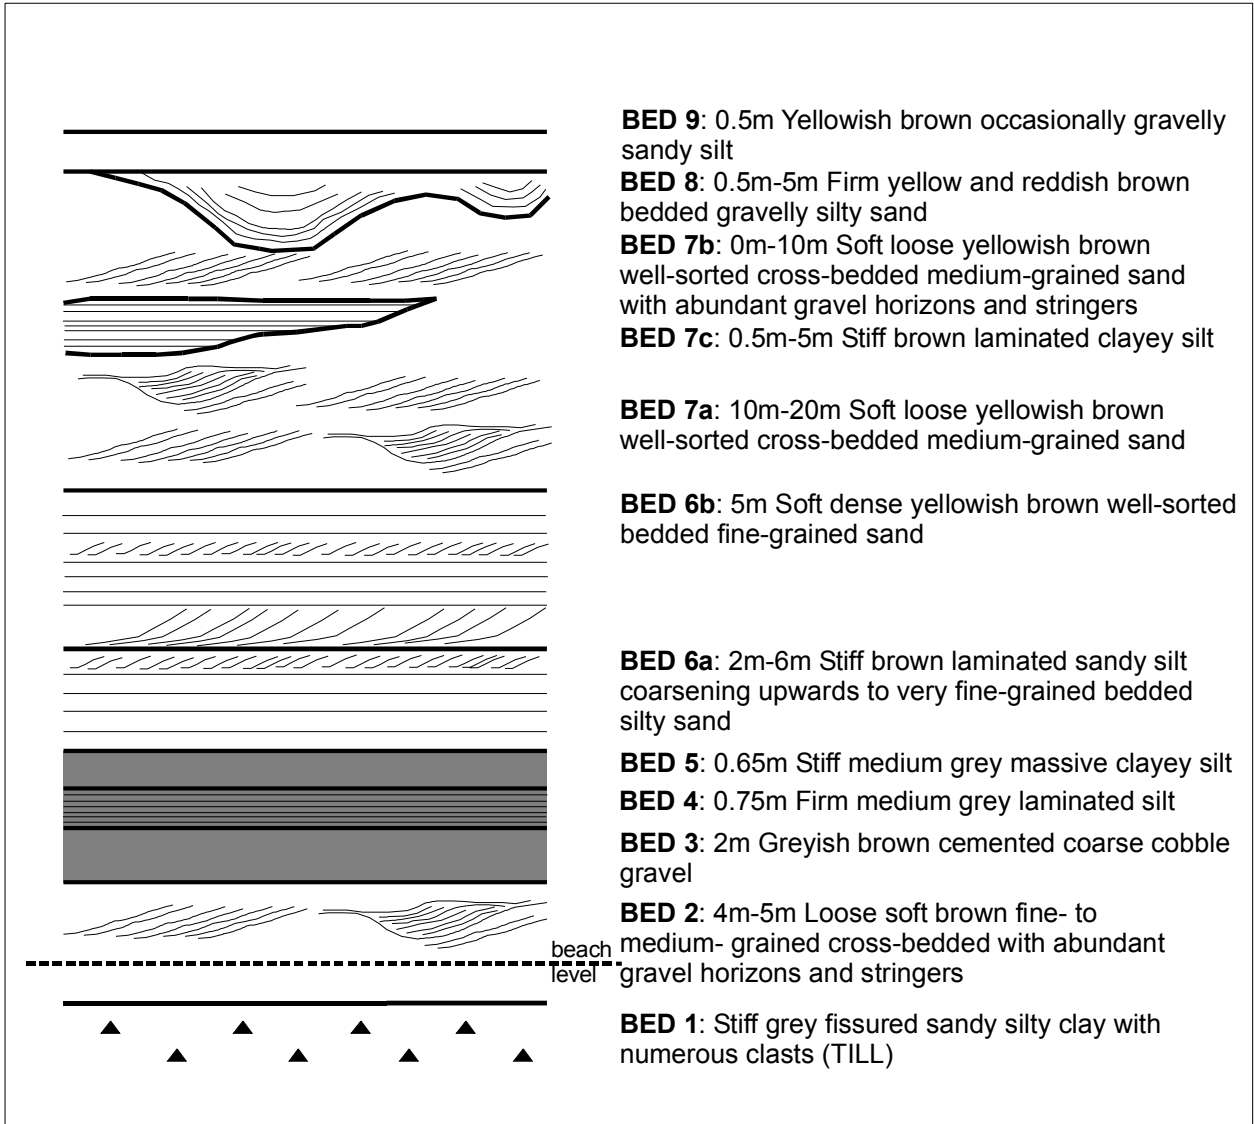
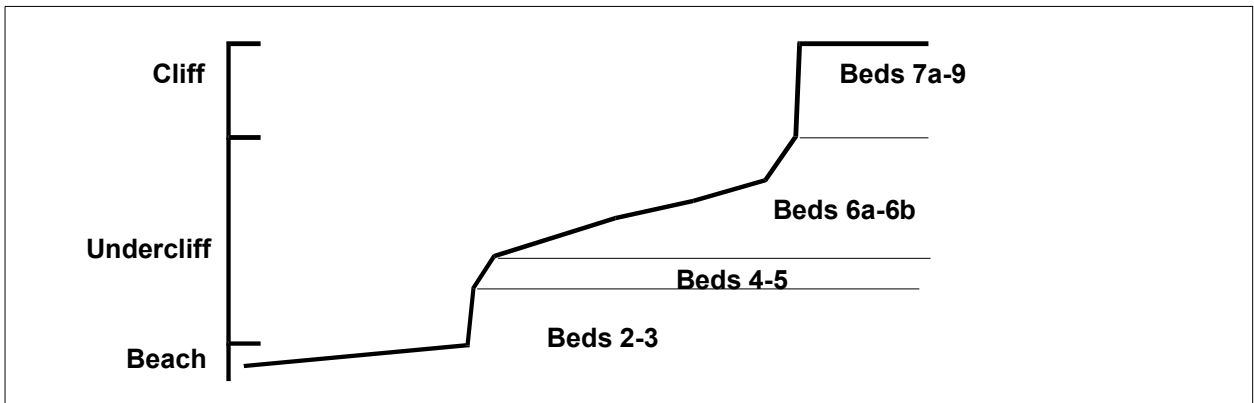
The generalised sequence identified in this part of Nefyn Bay is shown schematically in Figure 2. Below beach level, and only observed in trial pits, is a stiff grey silty clay with numerous sub-angular to sub-rounded pebbles which is probably a glacial till (Bed 1). Overlying the till, and seen in the foot of the cliff, is approximately 4m to 5m of loose, bedded, fine- to medium-grained sand with abundant gravel dominated units (up to 1m thick) and thin gravel stringers, which often show evidence of channel deposition (Bed 2). Overlying these sands and gravels, is a distinct, erosive-based coarse cobble gravel bed (Bed 3). Up to 2m in thickness, the matrix between coarse material in this unit is cemented, thus making the upper surface effectively impermeable to water, or else restricting water to flowing within discrete conduits through it.

Overlying Bed 3 is a medium grey laminated silt, up to 1m in thickness, which can be traced around much of the bay (Bed 4). Above this, a stiff, structureless, blocky fractured clayey silt

Figure 2: a) generalised geological succession occurring in the cliff sections in the southern half of Nefyn Bay
 b) schematic profile showing the relationship with the geological beds and the terminology used in this report

(Bed 5) contains clasts of the underlying laminated silt. This passes rapidly up into a brown sandy silt (Bed 6a) and then into a fine cross-bedded sand (Bed 6b), which gradually coarsens upwards into well-sorted, cross-bedded, medium-grained sand (Bed 7a), which makes up much of the upper half of the cliff in the southern-most third of Nefyn Bay. In some locations, overlying Bed 7a is a variably thick loose, bedded, fine- to medium-grained sand with abundant gravel units and stringers, which often show evidence of channel deposition similar to Bed 2 (Bed 7b in Figure 2). Locally, laminated silt and clay units also occur (Bed 7c). At the top of the cliffs, variably thick, localised, channelised deposits of gravelly, silty sand, identified as a possible Head deposits were recorded (Bed 8) and immediately below the top of the cliff, patches of up to 0.5m of wind-blown silt (Bed 9) were identified.
