Research & Consultancy Report No. 18

NOC Liverpool Unit 117 Glider deployment report
for the DEFRA MAREMAP Project
April - May 2012 deployment

C Balfour & P Knight

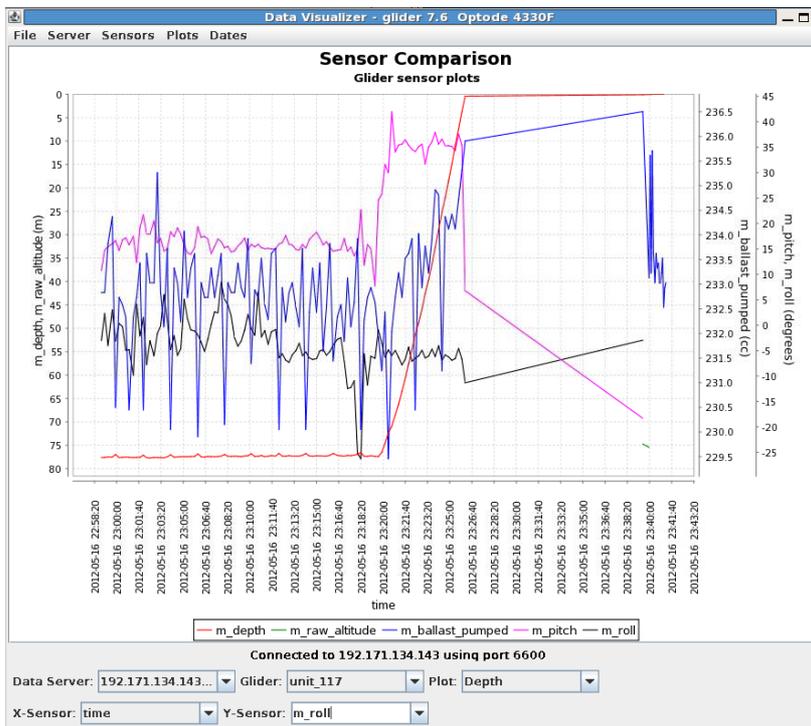
Fig. F8. Glider Surfacing after Jettison Weight Release

After the jettison weight is released the glider pitch seems to oscillate, possibly indicating the added buoyancy has released the glider. As the glider climbs the pitch seems to go positive indicating the nose of the glider is pointing upwards and possibly the vehicle hydrodynamics is causing the glider to climb at $\sim +35^\circ$ pitch to the surface, where a mission abort was reported.

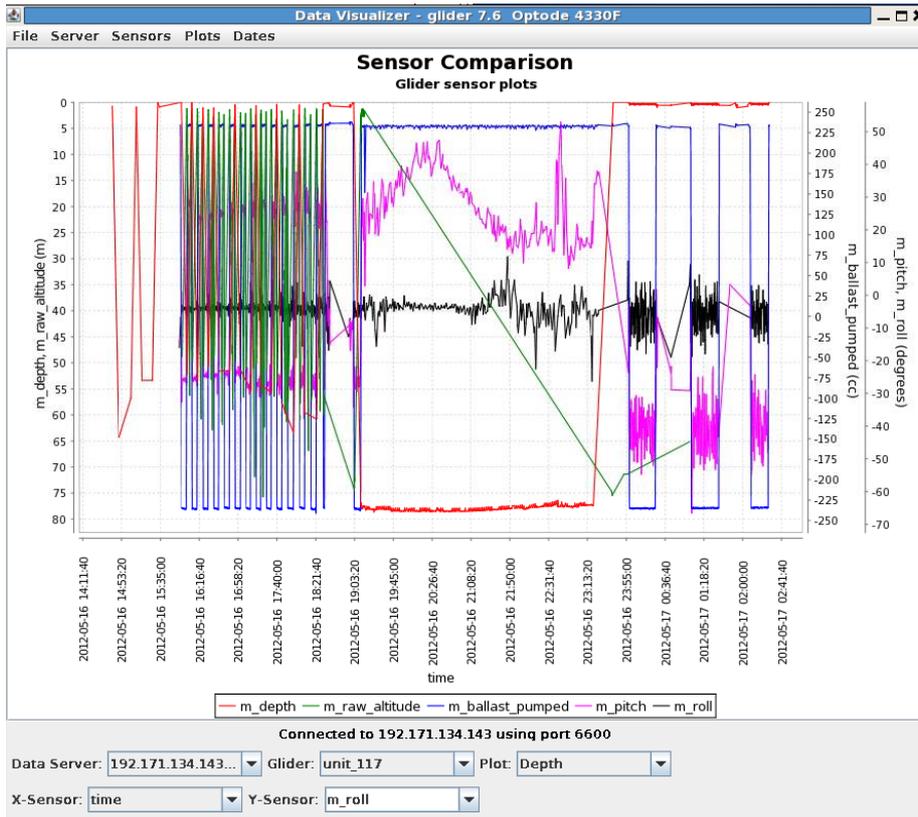
Fig. F9. Zoomed out plots leading up to and beyond the suspected entanglement occurring

When the glider is apparently lodged at ~80m some large variations in the pitch and roll can be seen. This would seem to support the entanglement and dragging scenario that was suggested in the initial report shortly after the unit 117 emergency recovery
