Source, character and weathering style of building stone in Culzean Castle & Country Park, Ayrshire

Commissioned Report

CR/14/114N

Martin R Gillespie, Paul A Everett and Emily A Tracey

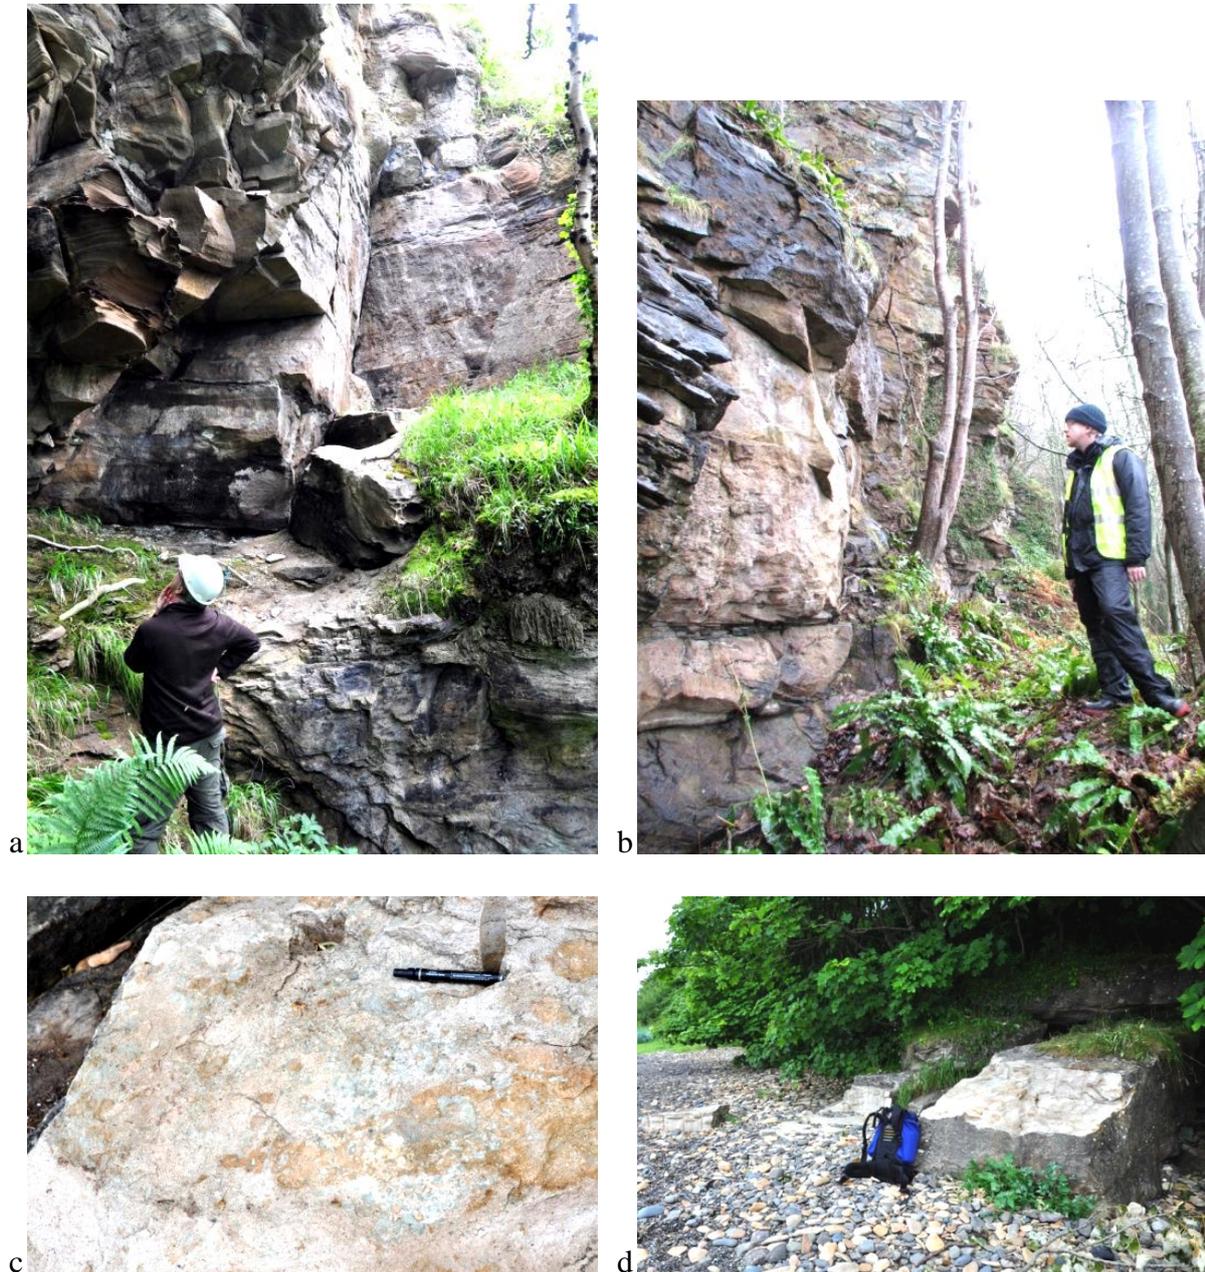
Figure 3 Quarries in the local (Ayrshire) outcrop of Swanshaw Sandstone Formation

a and b – Typical areas of worked former sea cliff forming ‘Gas House’ quarry. c – Buff sandstone with scattered greenish grey mud flakes and several large orange (ferruginous) patches developed on a fresh bedding plane surface revealed in a recently worked boulder on the beach at Gas House quarry. d – Boulders on the beach at Gas House quarry; the boulders were probably detached from the natural cliff face (hidden in the trees) during earlier (original) workings at the quarry; fresh surfaces on the two boulders in the photograph are the result of recent trials by NTS masons to determine whether suitable stone to use in CCCP can still be obtained from this site.

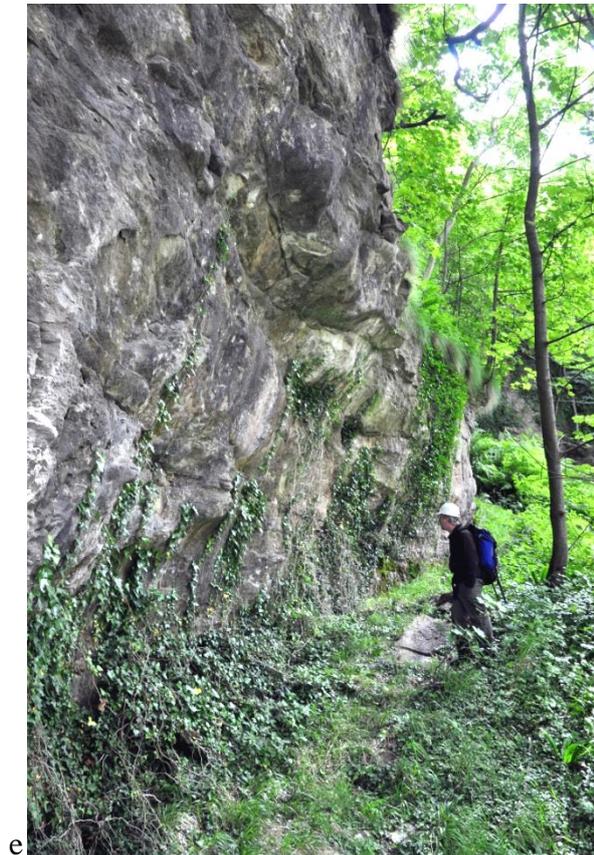
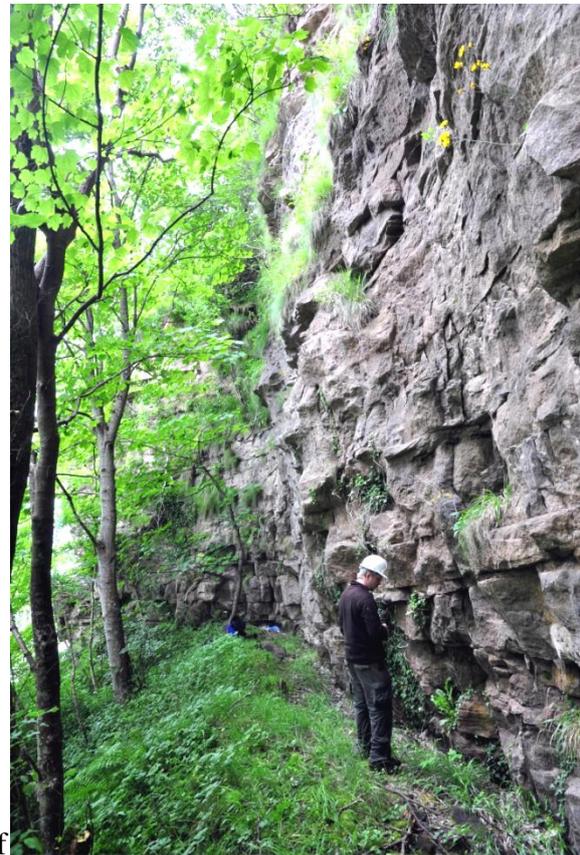
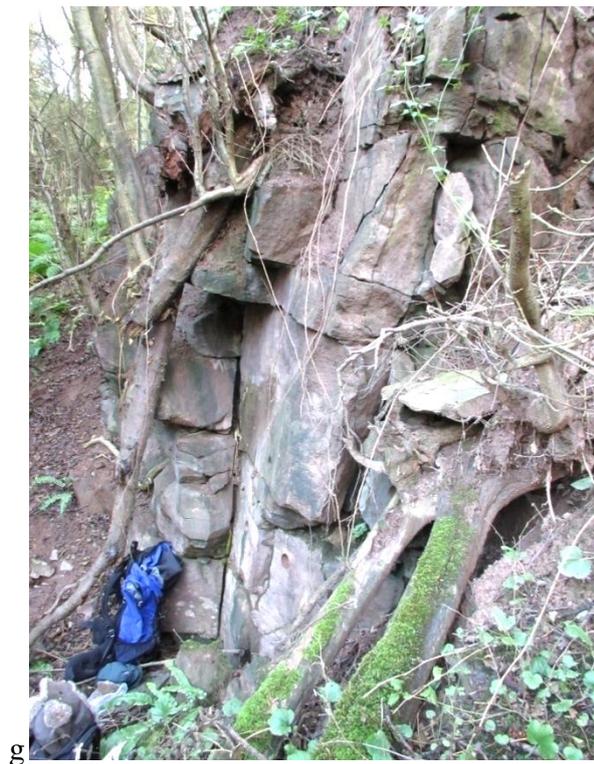
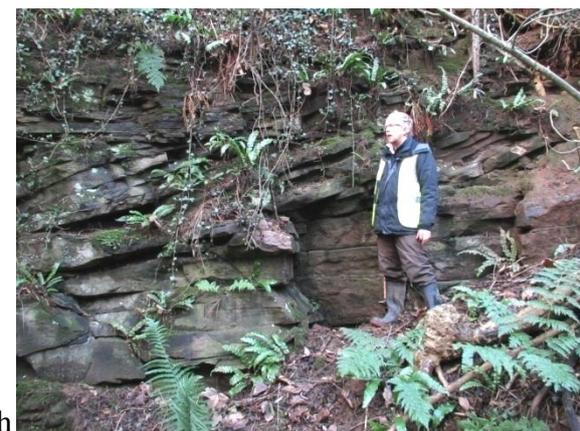
Figure 3 continued

e – Swallowcraigs quarry, lower level. f – Swallowcraigs quarry, upper level.

g – Bedrock exposed on the steep back wall of Ballochneil quarry. h – Bedrock exposed in an over-deepened part of the floor of Ballochneil quarry.

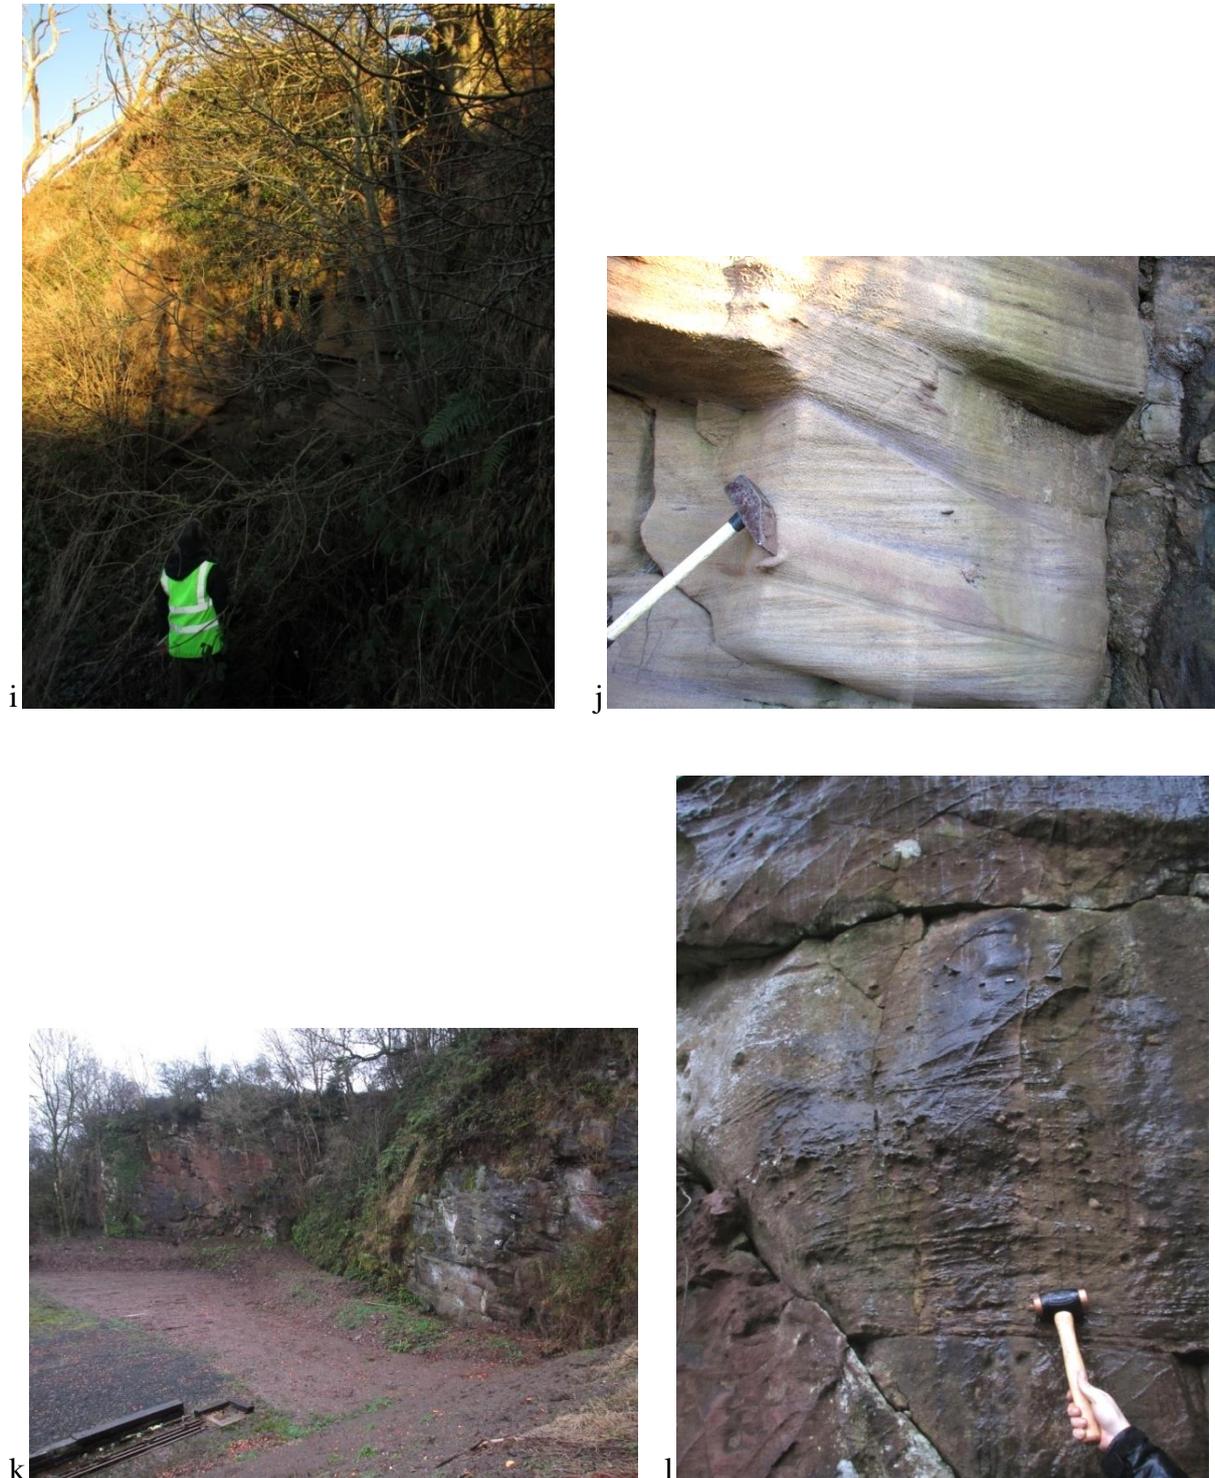
Figure 3 continued

i – Rancleugh Burn quarry; the quarry is choked with brambles, trees and other vegetation; the main remaining worked face is faintly visible in shadow, immediately to the right of the image centre. j – Cross-bedding and colour variation in Swanshaw sandstone exposed in Rancleugh Burn quarry. k – The north side of St Murray’s quarry (main pit); the quarry and worked faces are readily accessible. l – Part of the exposed worked face in St Murray’s quarry, showing Swanshaw sandstone with granulation seams (narrow ribs that stand proud) and scattered pebbles of quartz and granite.

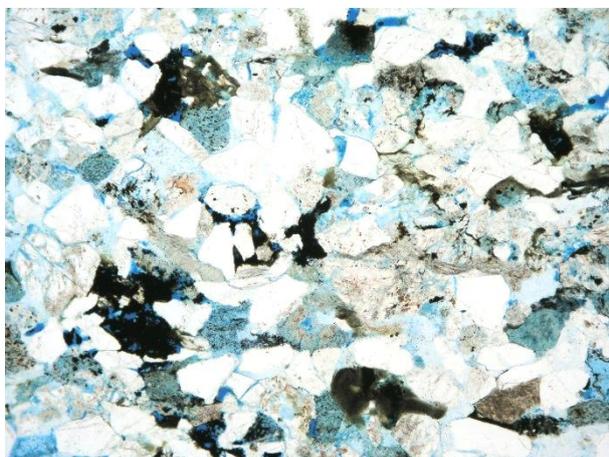
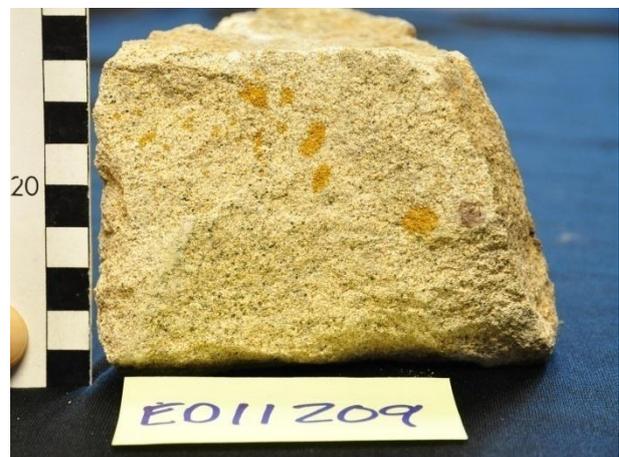
- 1) Local concentrations of iron oxide form orange spots 5-10 mm wide in the hand sample.
- 2) Most of the opaque material in the thin section is iron oxide which forms patches in intergranular spaces; moldic pores developed locally suggest the iron oxide has formed as the result of an iron-rich carbonate mineral dissolving. Most of this carbonate has now dissolved.
- 3) Elongate flakes of mica are aligned and indicate the bedding direction. Most of the mica present is biotite that has altered to green chlorite. Rock fragments also display a “greenish” tinge, due to the alteration of mafic minerals to green chlorite.
- 4) The hand sample contains several small (<5 mm), grey and purplish brown mud flakes.

At left: thin section photograph of sample ED11209. The image was taken in plane-polarised light and the field of view is c.3.3 mm wide. Pore space appears blue. At right: photograph of hand sample ED11209.

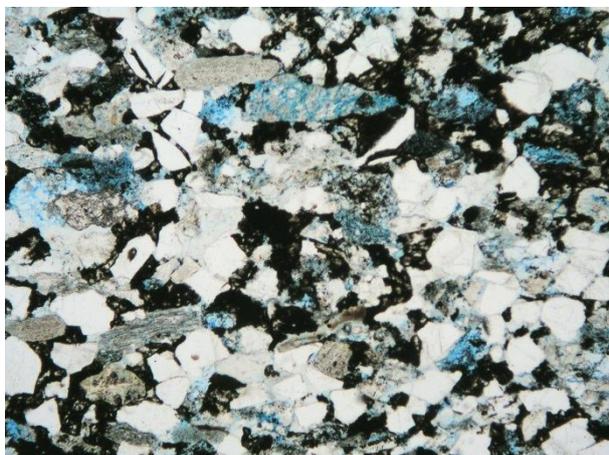
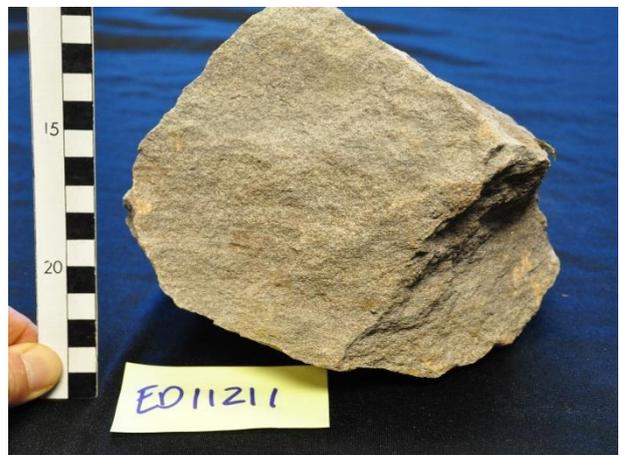
- 1) Alternating slightly darker and slightly lighter layers define a faint bedding fabric in the hand sample.
- 2) The mineral tourmaline is present in trace proportions (<1%).
- 3) The sample reacts strongly to 10% HCl solution; indicating the presence of calcite. Two carbonate minerals are observed in thin section; calcite and an iron-rich carbonate mineral (possibly ankerite, dolomite or siderite). The calcite appears fresh but the iron-rich carbonate has experienced significant dissolution.
- 4) Most of the opaque material in the thin section is iron oxide which forms patches in intergranular spaces and probably formed through alteration of dolomite. Fresh calcite has crystallised in intergranular spaces, enclosing (and therefore post-dating) the iron oxide.

At left: thin section photograph of sample ED11211. The image was taken in plane-polarised light and the field of view is c.3.3 mm wide. Pore space appears blue. At right: photograph of hand sample ED11211.

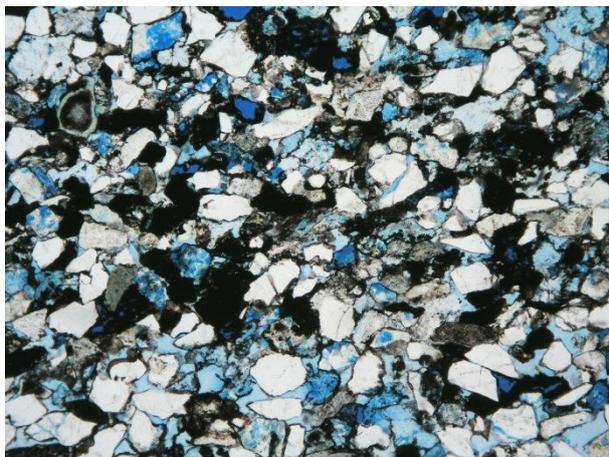
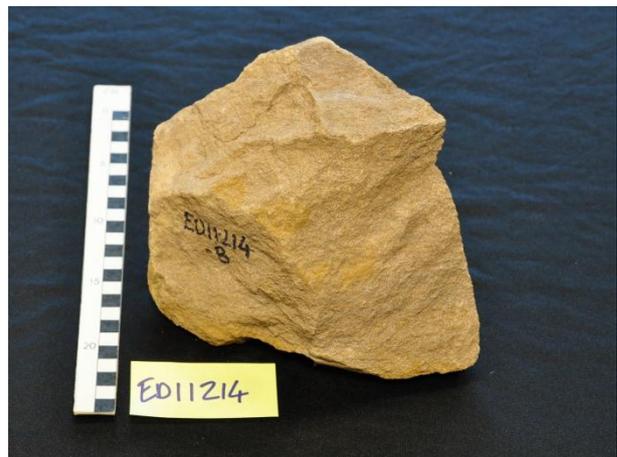
- 1) Alternating slightly darker and slightly lighter layers define a faint bedding fabric in the hand sample.
- 2) Most of the opaque material in the thin section is iron oxide which forms patches in intergranular spaces; moldic pores developed locally suggest the iron oxide has formed as the result of an iron-rich carbonate mineral dissolving. The thin section contains no carbonate mineral indicating that this component has dissolved entirely.

At left: thin section photograph of sample ED11214. The image was taken in plane-polarised light and the field of view is c.3.3 mm wide. Pore space appears blue. At right: photograph of hand sample ED11214.

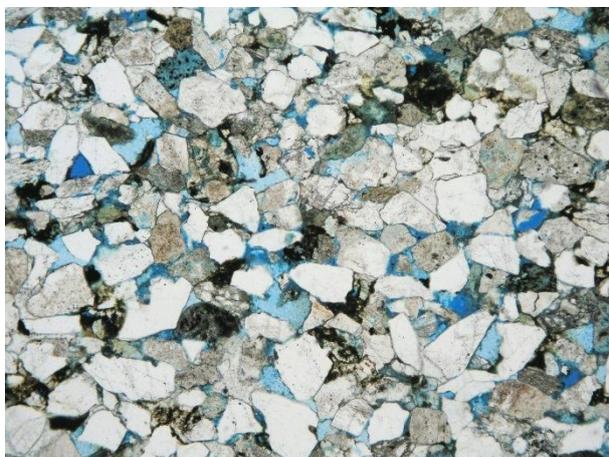
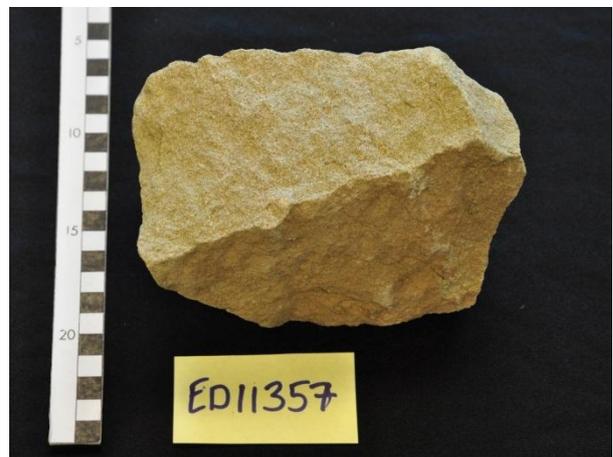
- 1) Alternating slightly darker and slightly lighter layers define a faint bedding fabric in the hand sample.
- 2) Most of the carbonate is calcite, and the remainder (c. 2% of the thin section volume) is iron-rich carbonate (ankerite, siderite or dolomite). The calcite appears fresh.
- 3) Rock fragments display a greenish tinge due to the alteration of mafic minerals to green chlorite.
- 4) Most of the opaque material in the thin section is iron oxide which forms patches in intergranular spaces and developed through dissolution of iron-rich carbonate.

At left: thin section photograph of sample ED11357. The image was taken in plane-polarised light and the field of view is c.3.3 mm wide. Pore space appears blue. At right: photograph of hand sample ED11357.
