**RRS DISCOVERY  
CRUISE 122**

**30 JUNE – 27 JULY 1981**

**PHYSICAL OCEANOGRAPHY OF THE  
N.E. ATLANTIC OCEAN**

**CRUISE REPORT NO 118**

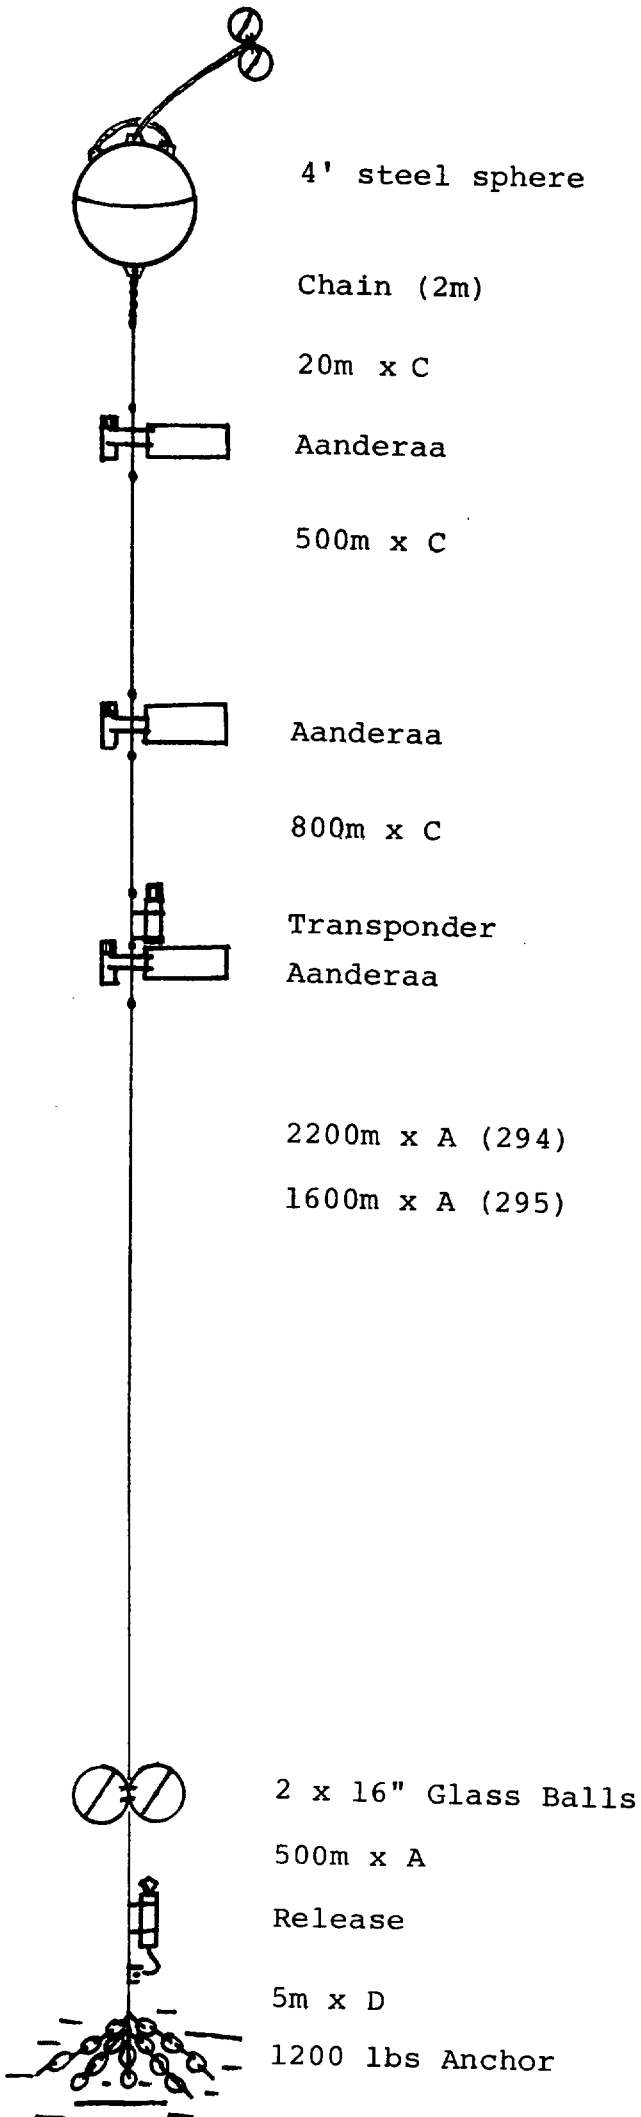
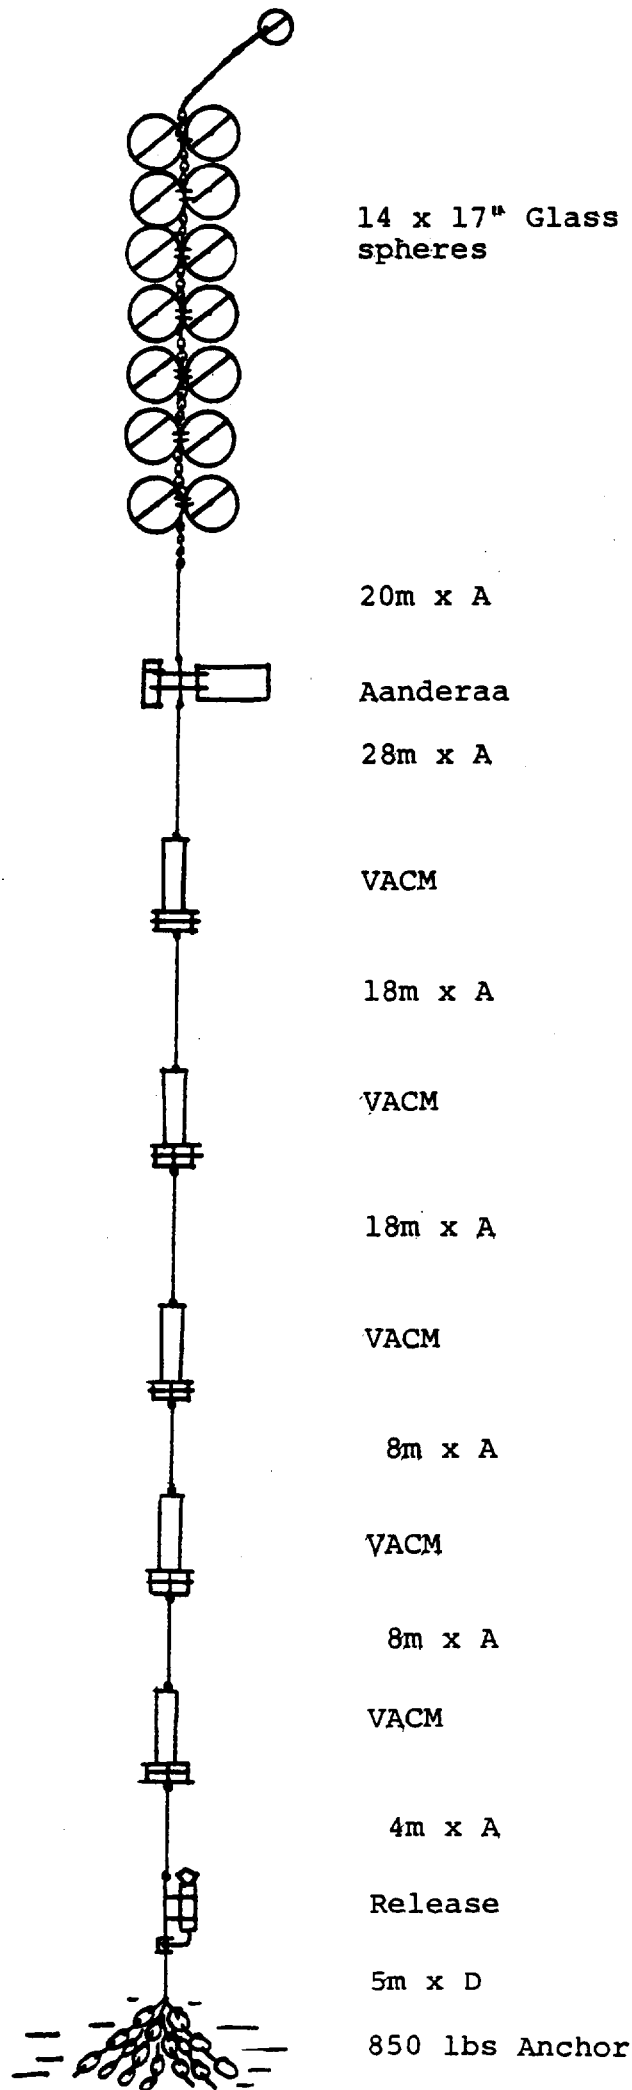
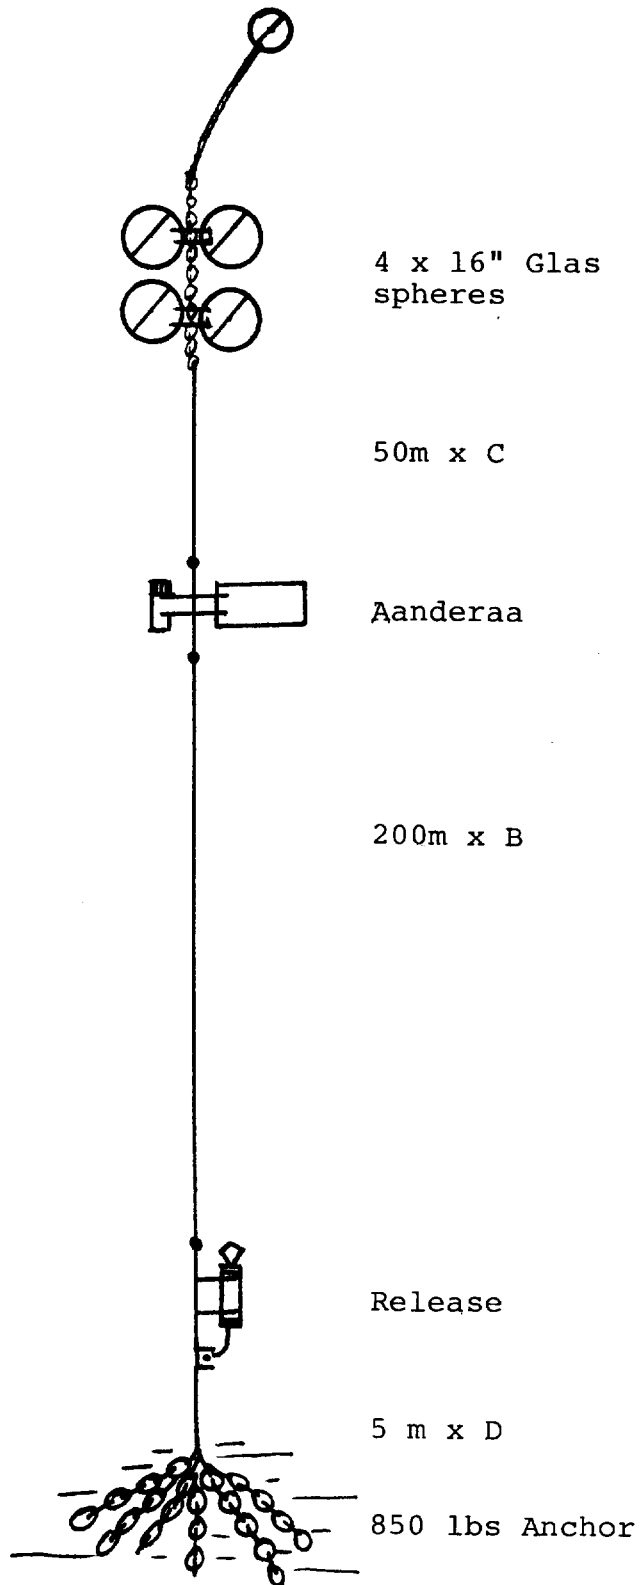
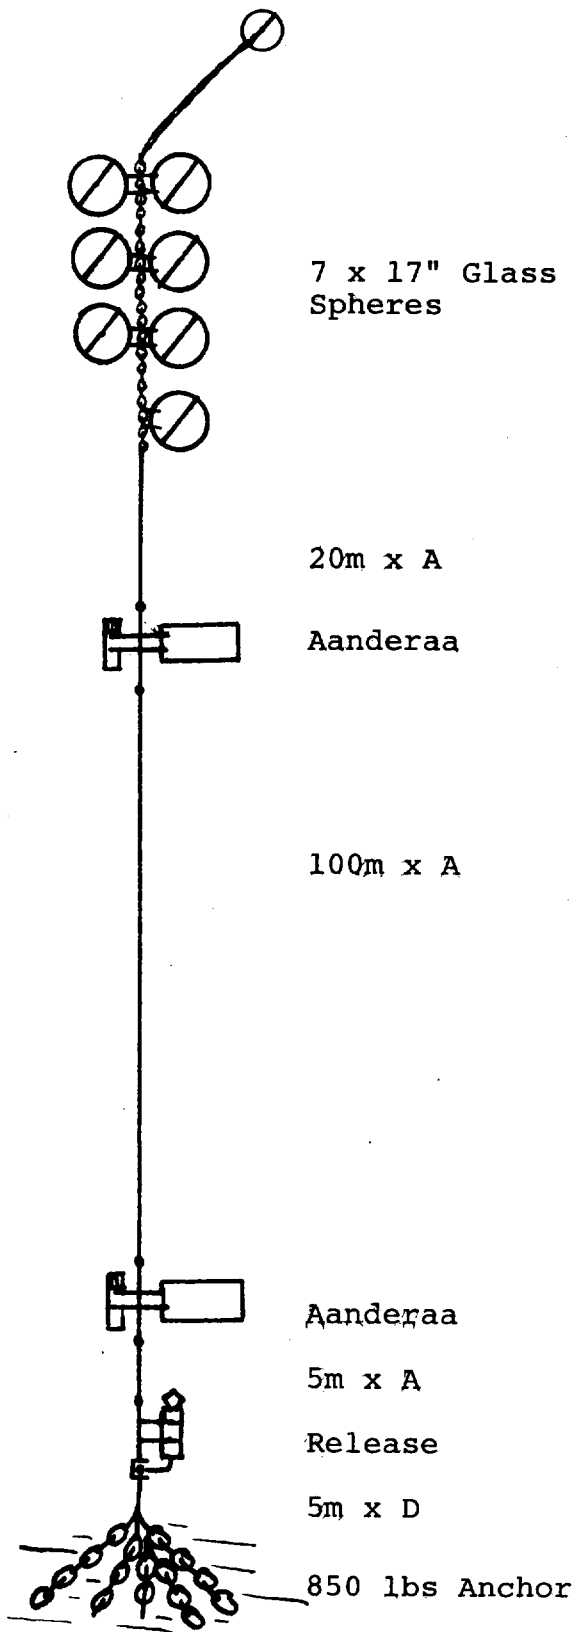
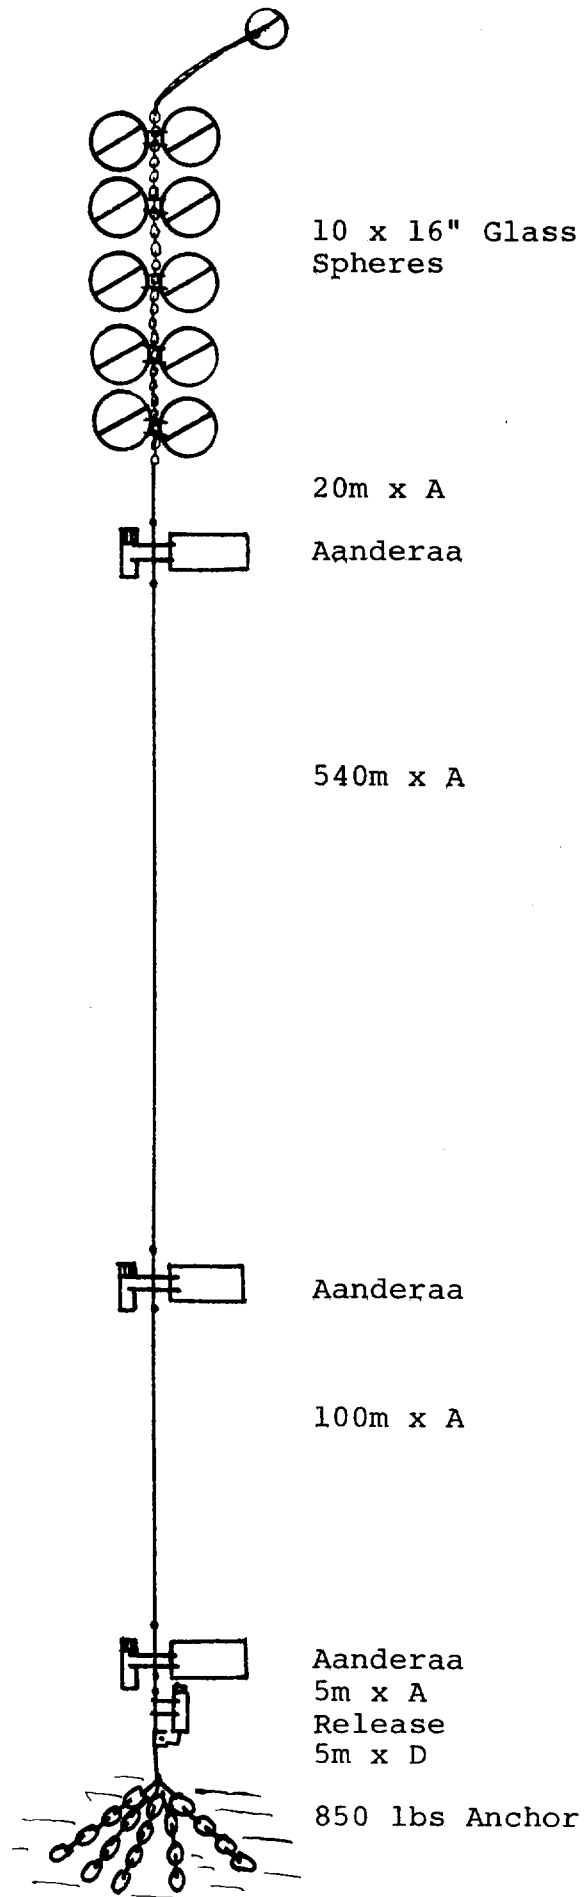
| C | 8 mm kilindo wire |
| D | 12 mm trawl warp |

- Fig. 1      Track Chart
- Fig. 2      Bathymetry in gap between Iberian and Madeira abyssal plains. Positions of moorings are shown.
- Fig. 3      Satellite navigation ship track during BENCAT dragging attempt.
- Fig. 4      Acoustic navigation track during BENCAT dragging attempt.
- Fig. 5      Schematic diagrams of moorings recovered and deployed on Cr. 122
- (1)    Moorings (294, 295)
  - (2)    Central VACM mooring of benthic array (303)
  - (3)    Moorings set in MADIB Gap (309, 310)
  - (4)    Benthic array moorings (298, 301, 302)
  - (5)    Benthic array moorings (296, 299, 300)
