Risk analysis for Autonomous Underwater Vehicle Operations in Extreme Environments **ABSTRACT**

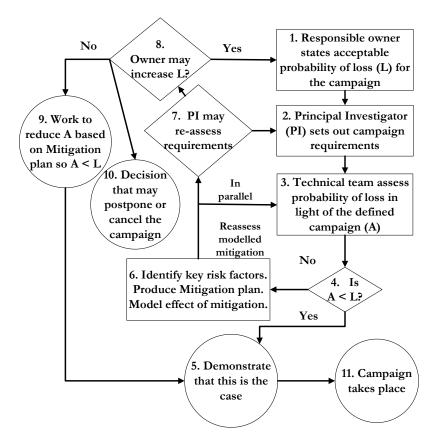
The process consists of a sequence of steps that must be performed by an individual or groups of stakeholders; Figure 1 presents a flow-diagram representation of the process. The process is generic, when applied to marine science campaigns the user is the principal investigator (PI) and the owner is the head of the laboratory. In a different industrial sector, for example commercial

**Figure 1** Operation Risk Acceptance Process proposed by Griffiths and Trembranis<sup>(11)</sup>.

In phase 3, the risk assessor calculates the AUV computed probability of loss (A) for the campaign. If the computed probability of loss is lower than the acceptable probability of loss, the process jumps to phase 5, the campaign is recommended to proceed. Otherwise, if the computed probability of loss is higher then the acceptable probability of loss (A > L), a recommendation is made not to pursue the campaign but to revisit the risks. Risk mitigation actions may reduce the computed probability of loss to a value lower than the acceptable probability of loss. This feature is represented by the link from phase 6 to phase 3. The campaign acceptance decision may also be reached if the AUV owner decides to increase the acceptable probability of vehicle loss to a value greater than the computed probability of loss or the AUV user sets out requirements with lower risk.

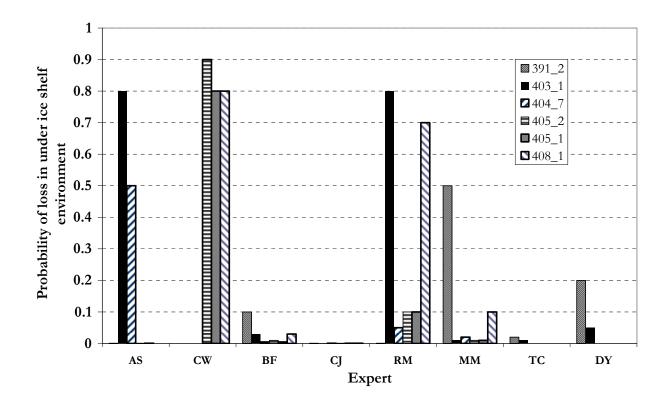
The longitudinal distribution of the probability judgments provided a visual mechanism for identifying major discrepancies in expert judgments. The method allowed us to identify major discrepancies in six faults in open water, three in coastal, five in sea ice and six under an ice shelf. Figure 2 presents the probability judgments where there were major discrepancies for the under-ice shelf environment. Failure 391\_2 concerns a fault with the GPS antenna, which can significantly effect the system navigation. Some experts deemed this fault critical, but others did not consider it critical when actually under ice where it is never used. The remaining faults occurred either during recovery or when the vehicle was onboard. One might expect these faults to be deemed of low criticality. However, our aim was not to impose our views, but simply to highlight differences in opinion.

**Figure 2** Comparison of expert judgments for ice shelf. Expert judgments for faults 391\_2, 403\_1, 404\_7, 405\_2, 405\_1, and 408\_1.

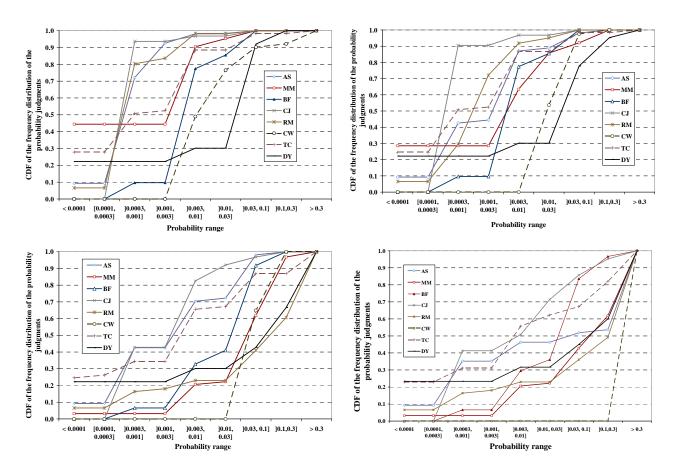
The cumulative distribution (Figure 3) shows that some experts use a wider range of probability in their judgments than others. A P(L|F,E) of 0 is only assigned by five experts; a minimum P(L|F,E) of 0.001 was assigned by two experts and a minimum of 0.01 by one. Only one expert assigns P(L|F,E) values between 0.001 and 0 (0.0001 in four instances). Six experts

have at least 98% of all their P(L|F,E) judgments under 0.03; two are more pessimistic, one with 90% and one with 92% below 0.03.

**Figure 3** Comparison of the cumulative probability Cumulative frequency of the expert probability judgments. Open water (top left), Coastal water (top right), Sea ice (bottom left) and Ice shelf (bottom right).

by a significant gap. For ice shelf, the average judgment is dominated by an increased view of risk from six of the eight experts. The distributions presented in Figure 3 do not capture the influence of each expert's confidence on his/her risk assessment. The following section considers how the experts' self assessment of confidence influences the aggregated opinion for each of the four environments.

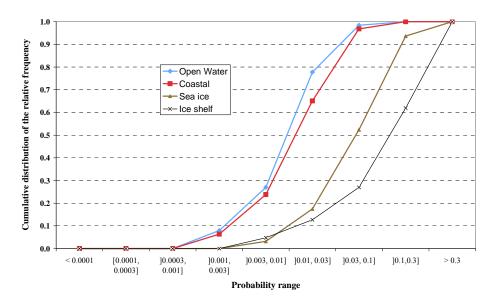
If we compute the un-weighted average of the expert judgments for all four environments we obtain the distribution depicted in Figure 4.

**Figure 4** Comparison of the cumulative probability distribution of the un-weighted average for four operating scenarios. Open water (blue), Coastal water (red), Sea ice (brown) and Ice shelf (black).

The distributions across all four environments cluster into two groups. Group 1 comprising open water and coastal water and group 2 sea ice and ice shelf. These two groups are separated

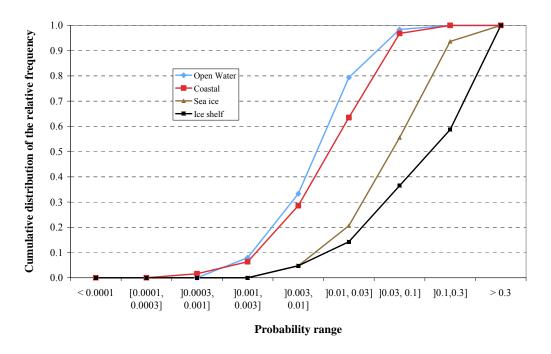
Figure 5 depicts the linear weighted cumulative distribution for each of the four environments. Comparing the relative frequency of the judgments for open and coastal water, the distribution shows that whilst the shape of both distributions is similar, the coastal water distribution presents a shift of judgments towards greater risk. Similarly to open water, the majority of probability judgments for coastal water lie in the range [0.01, 0.03]. However there was 17% increase in judgments in the range [0.03, 0.1] and two failures are assigned a P(L| F,E) greater than 0.1 but lower than 0.3.

**Figure 5** Comparison of the cumulative probability distribution of the linear-weighted average for four operating scenarios. Open water (blue), Coastal water (red), Sea ice (brown) and Ice shelf (black).

The shift of probability judgments towards greater risk becomes more evident in the aggregated judgments for sea ice and ice shelf. Ice shelf is the most severe environment where 41% of all failures are assigned a P(L|F,E) > 0.3. A summary of the statistical properties of the P(loss) distributions obtained using the linear aggregated opinion pool is presented in Table I.

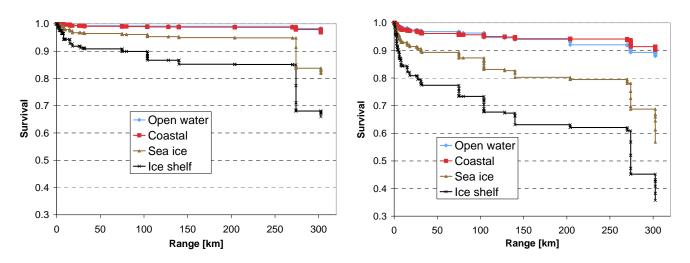
We implemented equation 1 in a Visual Basic program running on Excel 2003. Figure 6 presents the survival distribution obtained for open water, coastal water, sea ice and ice shelf, separately for the optimistic and pessimistic subgroups.

**Figure 6** Kaplan Meier optimistic assessment (left) and pessimistic assessment (right) for the survival of Autosub3, for all four operational environments prior to any mitigation measures.

The optimistic Kaplan-Meier survival distribution for operations under ice shelf (Figure 6) shows a steep decline in the probability of survival at shorter distances, whereas at mid distances the survival distribution is almost flat. For managing the risk, if we can monitor the AUV at these shorter ranges and recover the vehicle to address any problems if they emerge, the risk

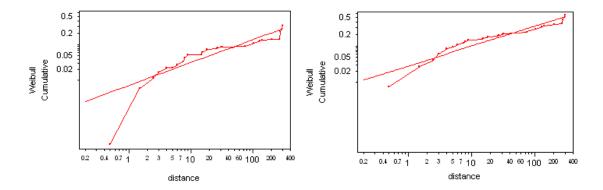
The flat shape of the nonparametric Kaplan-Meier survival distribution does not lend itself to an analysis to quantify the effect of mitigation measures such as varying the monitoring distance. This effect is better captured by a parametric survival distribution such as a Weibull distribution derived from the failure distance and the expert judgments on the probability of loss for each failure. We took a simulation-based approach to deriving the Weibull parameters for the case of loss given our experts' judgments. For each fault or incident we generated 1000 copies, with integer  $(1 - P(e_i))$ \*1000 entries censored, the others marked as losses. We then obtained the parameters of the Weibull distribution (Figure 7) using JMP software package from SAS.

**Figure 7** Weibull survival distribution (left) optimistic assessment and (right) pessimistic assessment for loss under an ice sheet before any mitigation measures. The straight red line is the best fit used to estimate the Weibull parameters alpha and beta.

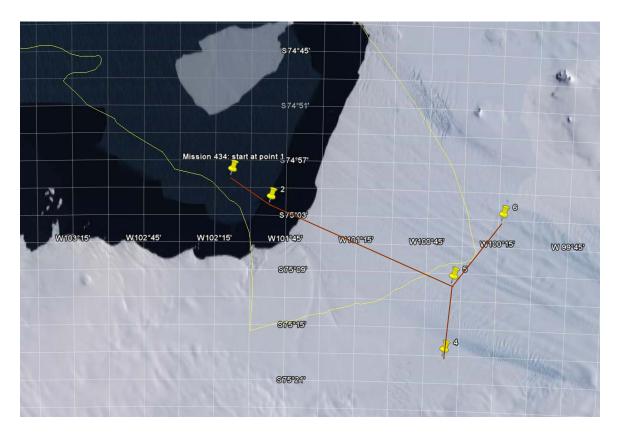
**Figure 8** Plan for mission 434 (in red). Autosub3 started at point 1, -102.003° Longitude, -75.007° Latitude. The vehicle was set to perform the following path:  $1 \rightarrow 2 \rightarrow 5 \rightarrow 4 \rightarrow 5 \rightarrow 6 \rightarrow 5 \rightarrow 2 \rightarrow 1$ . Courtesy of Google Earth. The Google Earth drawing of the coastal line, in yellow, is not exact is just an estimation.

The discovery of a ridge running across the ice cavity during mission 431 led to a new science requirement. The PI requested two more missions. The first of these (mission 433) involved a run on the north side of the cavity, travelling approximately 50km into the cavity and 50km out, using bottom track for navigation. Mission 434 involved a run of approximately 30km into the cavity (from point 2 to point 5 in Figure 8), then a turn south, travelling 15km (from point 5 to point 4 in Figure 8) whilst profiling the new ridge. It would then turn north and travel 30km (from point 4 to point 6 in Figure 8).
