**OPERATIONAL EXPERIENCES WITH
WAVERIDER BUOYS AND THEIR MOORINGS**

REPORT NO 145

INSTITUTE OF OCEANOGRAPHIC SCIENCES

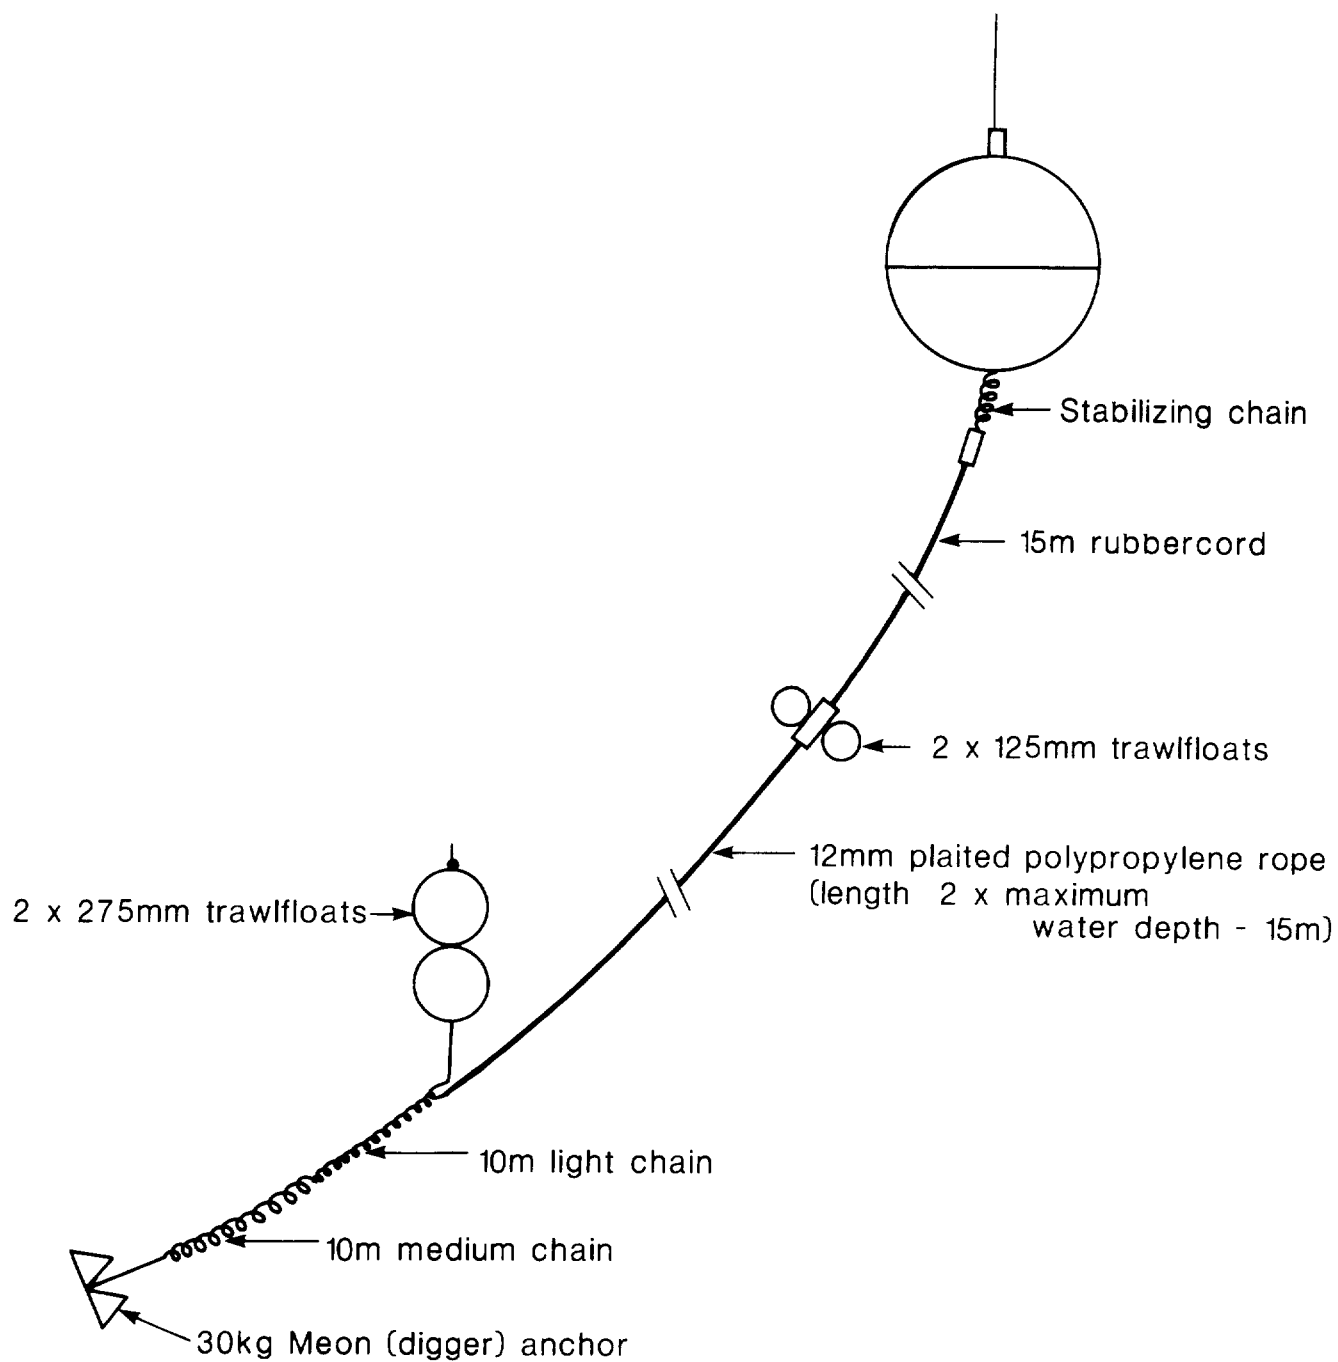
Fig 3 The "Standard" Waverider mooring.

4.1 The standard mooring (see Fig 3)

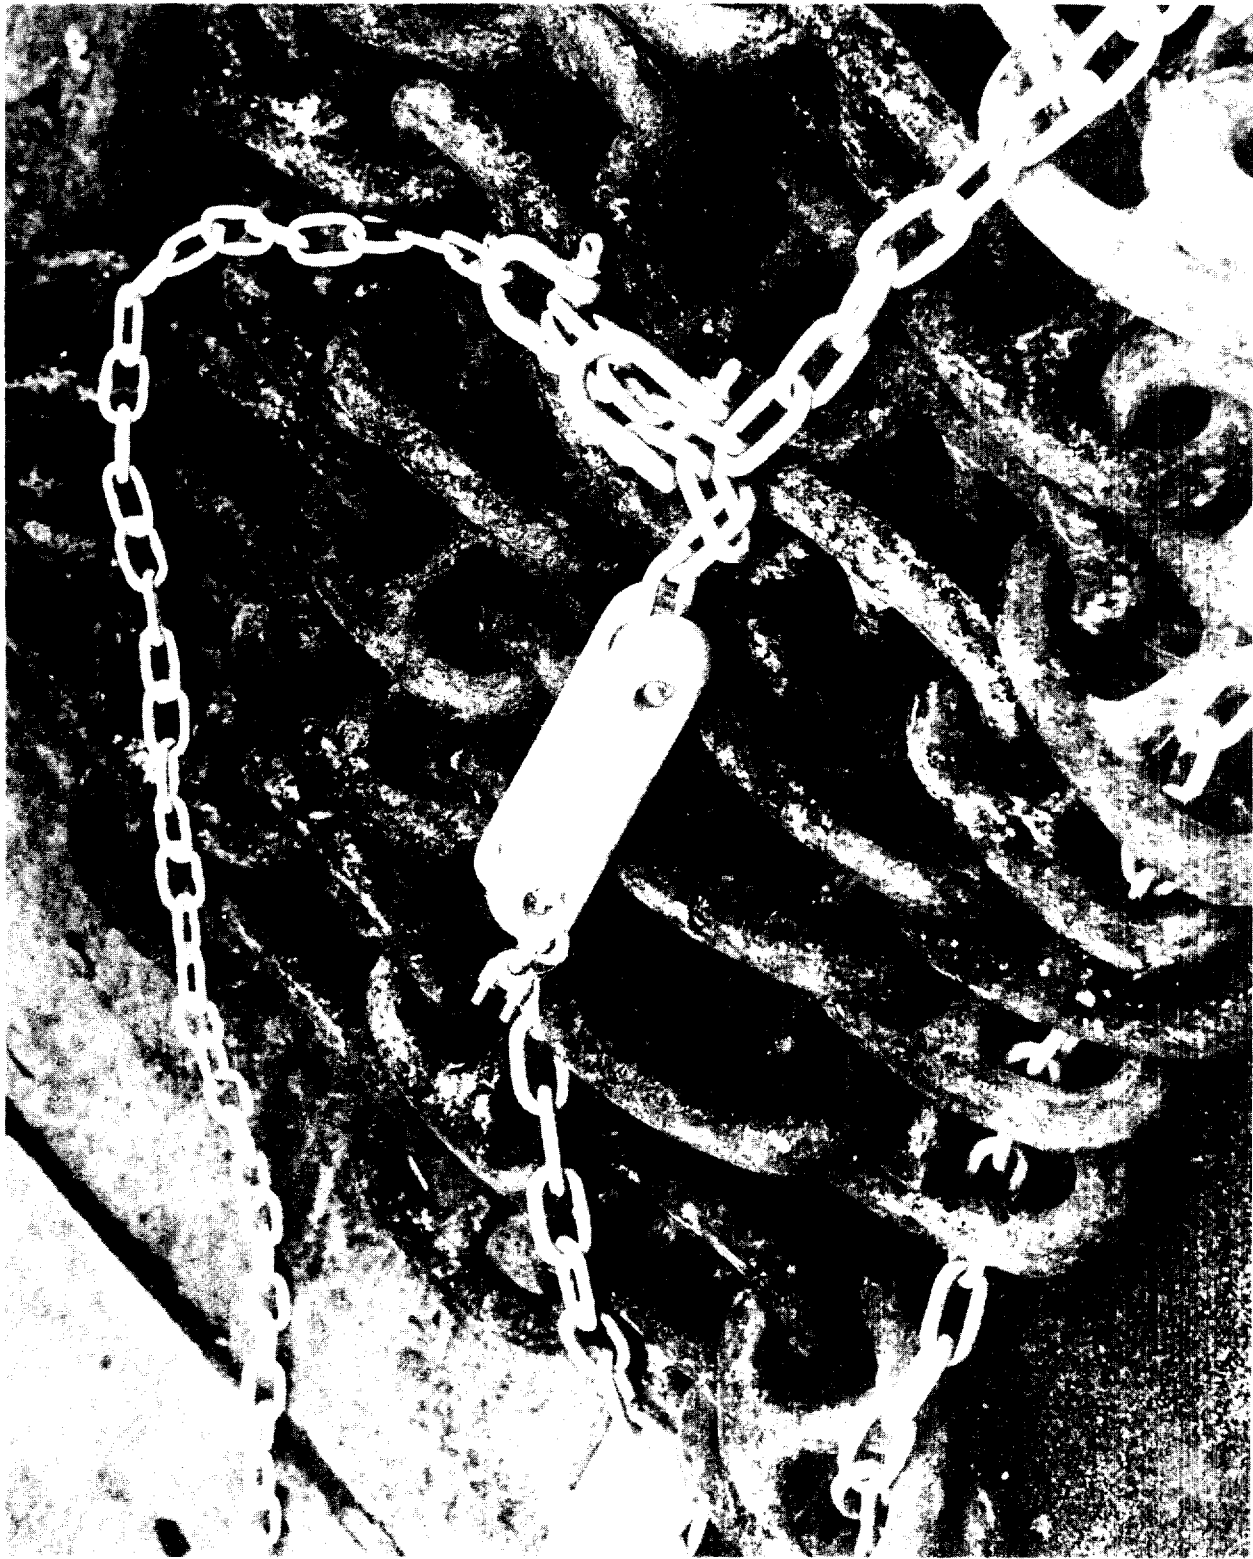
Fig 6 1 tonne anchor clump with 12.5 mm chain strop and sacrificial anode, riser chain and shackles.

- anchor clump, $\frac{1}{2}$ -1 tonne of 2 m lengths approximately of heavy chain
- anchor strop - a three metre length approximately 12.5 mm long link galvanised chain, used to hold the anchor clump together. It may be protected by a sacrificial anode, (see Fig 6). Note: the second D-shackle on the strop attaches a 13 mm wire lowering - cable to the chain strop; the clump is lowered to the bottom, and the cable is cut when there is no danger of the cut end fouling the SSF or upper part of the mooring.

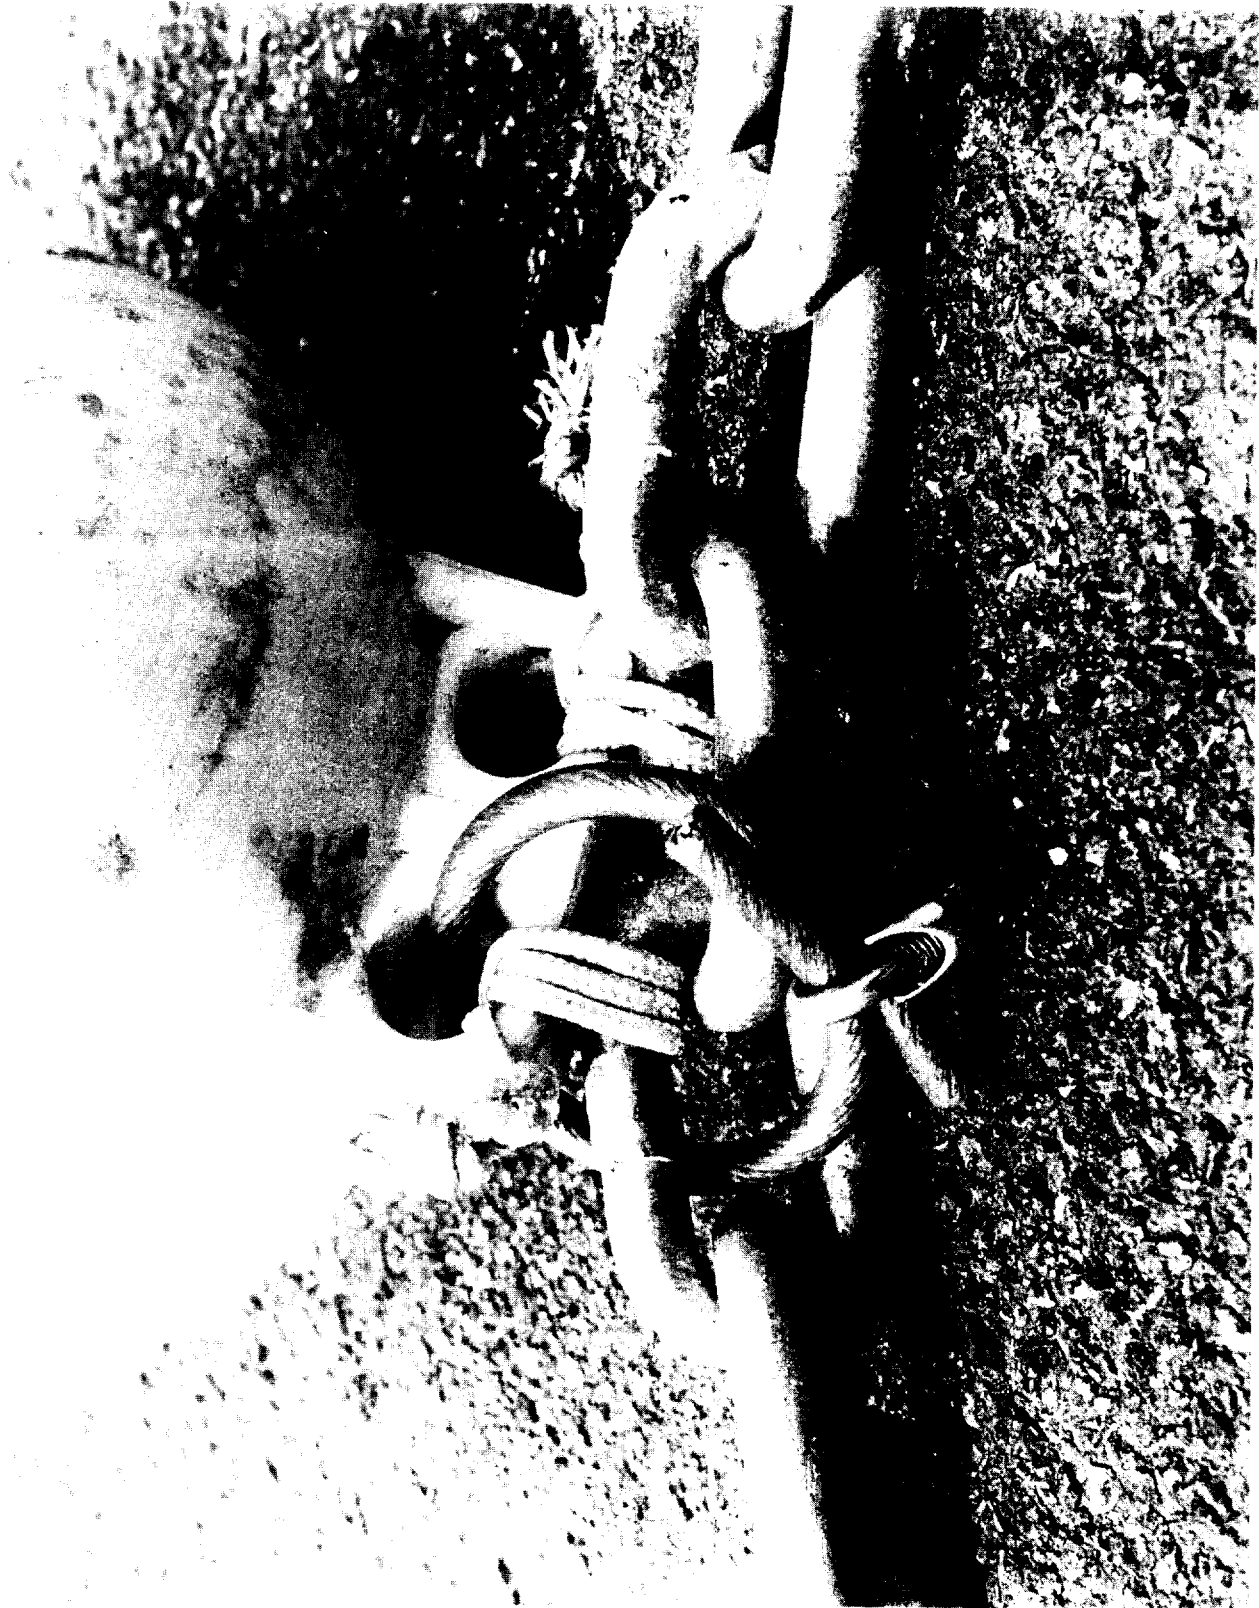
Fig 11 200 mm side-handle trawlfloot attached to 12.5 mm galvanised long link chain.
