# RIVER HABITAT SURVEY In the picos de Europa, Northern spain

RESULTS FROM 2008

A report by Paul Raven<sup>1</sup>, Nigel Holmes<sup>2</sup>, Peter Scarlett<sup>3</sup>, Mike Furse<sup>3</sup> and José Barqúin Ortiz<sup>4</sup>

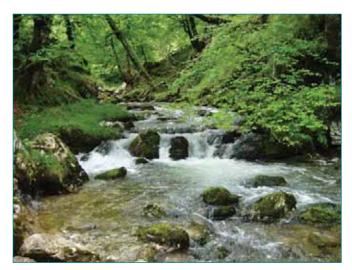
Diversity of natural in-channel, bank and riparian habitat produces a high HQA score; Picos-8.

**Habitat Quality Assessment (HQA)** is a broad indication of overall habitat diversity provided by natural features in the channel and river corridor. Points are scored for the presence of features such as point, side and mid-channel bars, eroding cliffs, coarse woody debris, waterfalls, backwaters and floodplain wetlands. Additional points reflect the variety of channel substratum, flow-types, in-channel vegetation, and also the extent of banktop trees and the extent of near-natural land-use adjacent to the river.

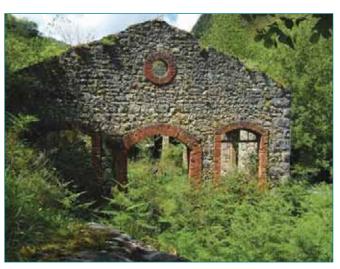
The ruins of Spain's first HEP station, in the Casaño valley.

There are several stone-built Roman bridges, whilst the ruins of the first HEP station in Spain, located in the Casaño valley 500m downstream from Picos-7, is a feature of more recent historical interest.

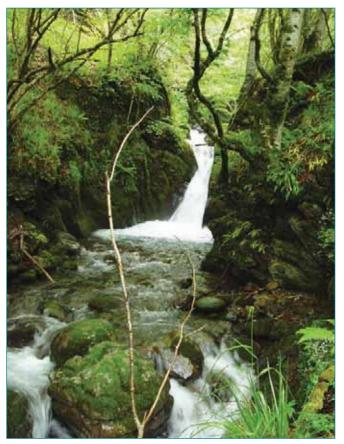
Bedrock chute at the downstream end of Picos-16.

A large spring-fed tributary, the Volta de Mobeja, joins in Picos-15, increasing the discharge considerably, whilst at the downstream end of Picos-16 the channel narrows to form a deep bedrock chute. Glacial valley terraces appear in Picos-16 and continue down the rest of the valley where they support herb-rich meadows.
